Inspection Report

Property Address:
27435 Whispering Maple Way
Spring Tx 77386

PROPERTY INSPECTION REPORT

By: Mark Little Texas Professional Home Inspector / Hilsher Group LLC 6/30/2018

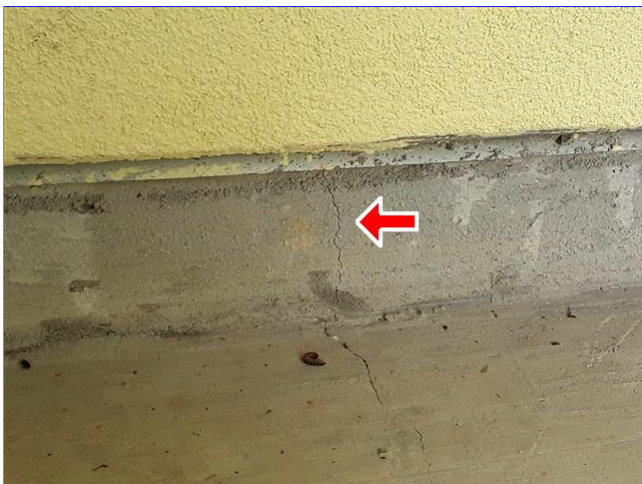
A. Item 1(Picture) rear of home

(2) The foundation wall has visible cracking. I recommend having a foundation company or Structural Engineer further evaluate.

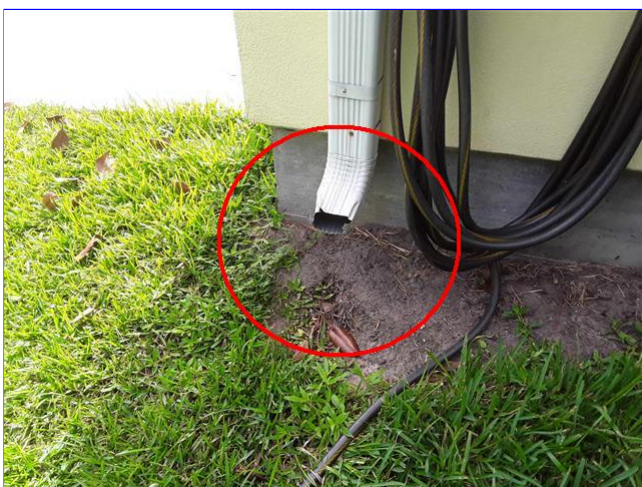
B. Item 1(Picture) multiple areas of home

The downspouts needs splash-blocks at the exterior areas.

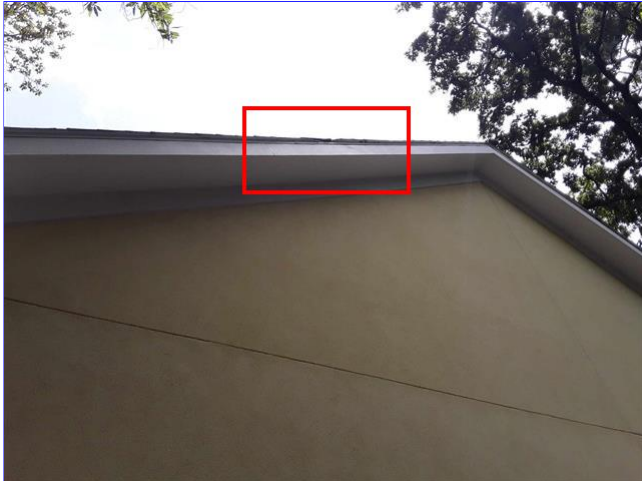
C. Item 1(Picture) left of home

(2) The roof covering is damaged in areas. These areas may need replacement and or periodic maintenance. A qualified roofing contractor should inspect and repair as needed.

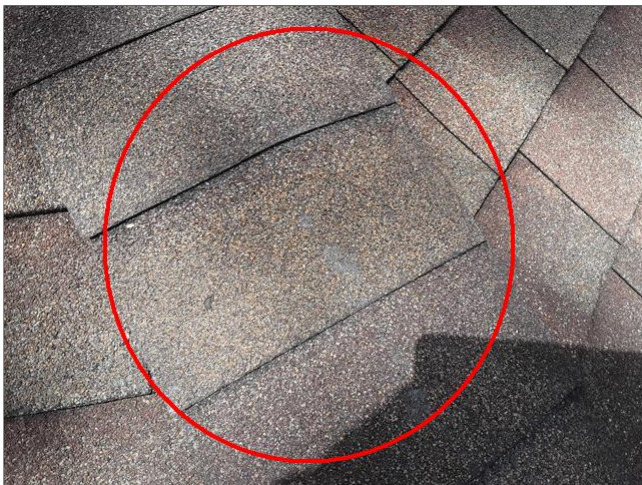
C. Item 9(Picture) front of roof

(4) The ridge shingles are showing excessive wear. I recommend having a qualified person make repair or replace as needed.

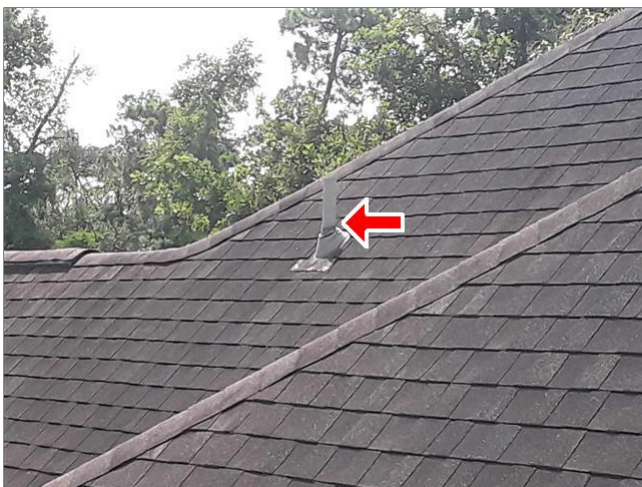
C. Item 15(Picture) front of roof

(6) The plumbing vent flashings appear to have seals that are weathered and beginning to show signs of deterioration. I recommend having a qualified roof professional make repairs as needed,

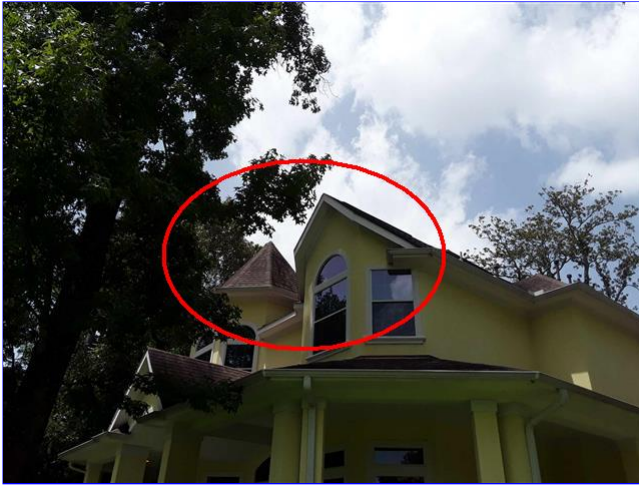
C. Item 17(Picture) front of roof

(7) The steep pitches in areas of the roof limited the inspection to areas that were safely accessible at the time of inspection.

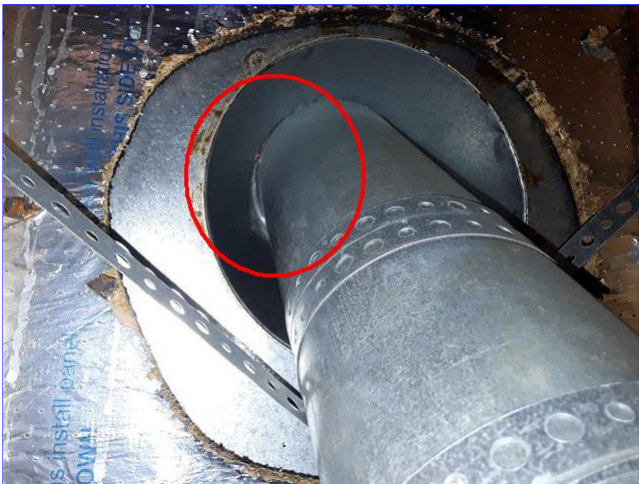
D. Item 1(Picture) attic

(1) Visible daylight in attic space. This is not considered today's standard. I recommend having a qualified contractor to inspect and make repairs as needed.

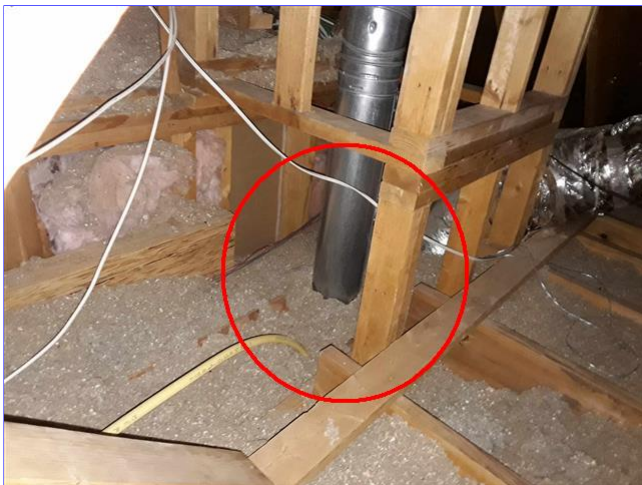
D. Item 2(Picture) attic

(2) Insulation is in contact with chimney flu piping in attic. This is not considered today's standard. I recommend having a qualified contractor to inspect and make repairs as needed.

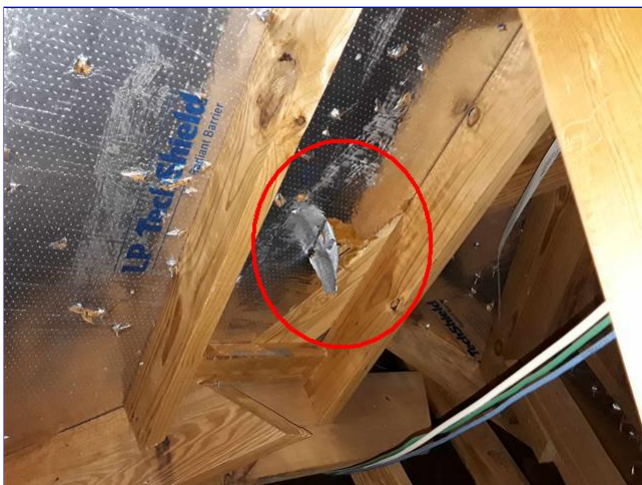
D. Item 3(Picture) attic

(3) Roof sheathing is damaged in areas of the attic. This is not considered today's standard. I recommend having a qualified contractor inspect and make repairs as needed.

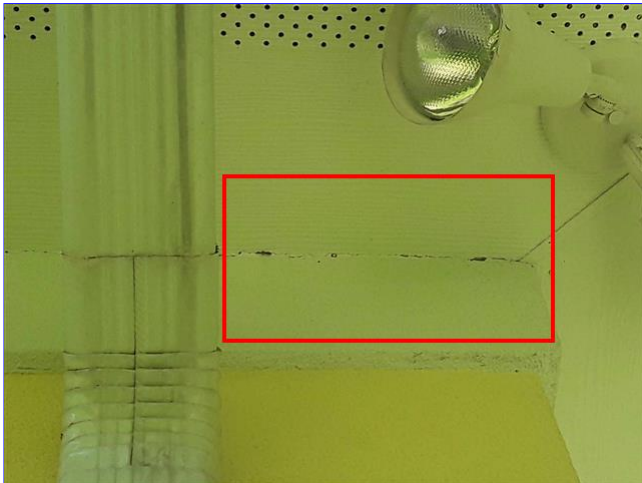
E. Item 1(Picture) garage

(1) The siding exterior has caulking that is weathered or missing. Deterioration can eventually occur if not corrected. A qualified person should repair as needed.

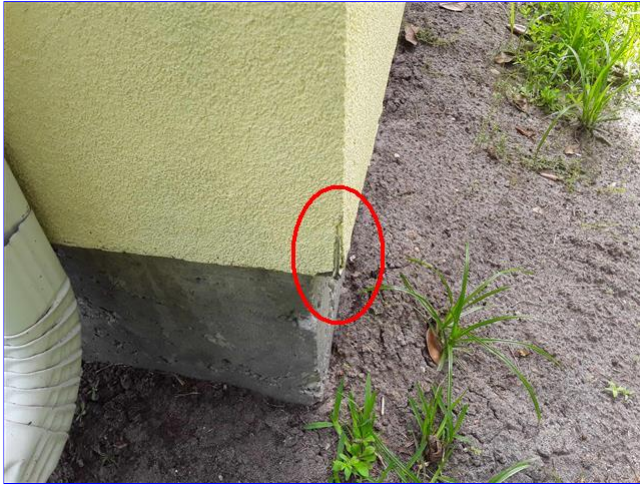
E. Item 6(Picture) garage

(2) The Stucco coating exterior in areas is damaged. Further deterioration can occur if not corrected. A qualified contractor should inspect and repair as needed. There is vegetation growth on exterior of the home. This can cause damage, contribute to premature deterioration and create conducive conditions for certain wood destroying insects. I recommend removal of vegetation and having a qualified pest control company inspect and treat as needed,

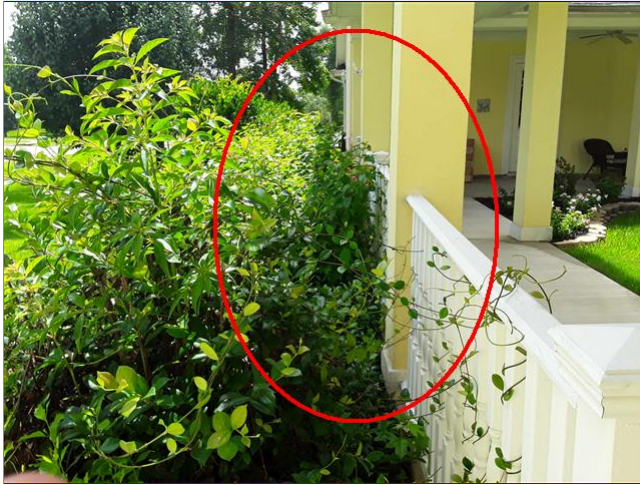
E. Item 9(Picture) multiple areas of home

(3) There is vegetation growth on exterior of the home. This can cause damage, contribute to premature

deterioration and create conducive conditions for certain wood destroying insects. I recommend removal of vegetation and having a qualified pest control company inspect and treat as needed,

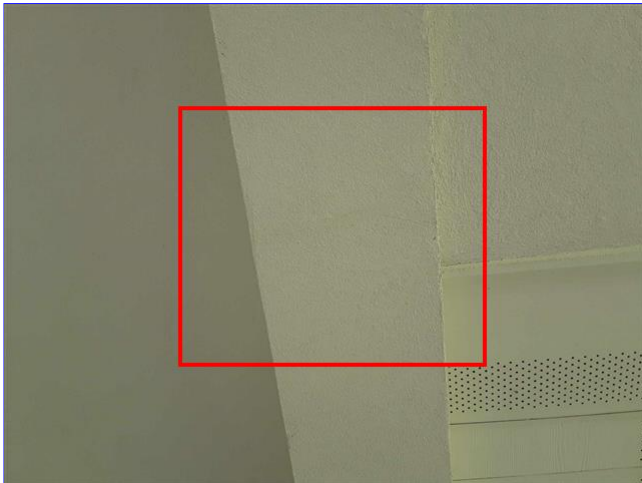
E. Item 11(Picture) rear of home

(4) The Stucco coating exterior in areas has hairline cracks. Deterioration can eventually occur if not corrected. A qualified contractor should inspect and repair as needed.

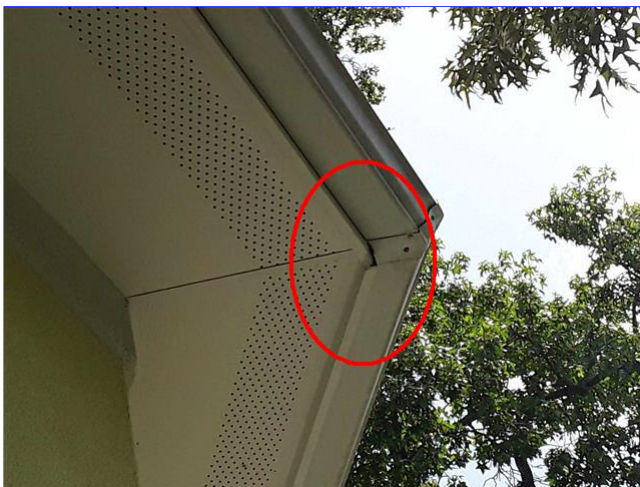
E. Item 19(Picture) front of home

(5) The exterior siding and trim is damaged in areas. Further deterioration will occur if not corrected. A qualified contractor should inspect and repair as needed.

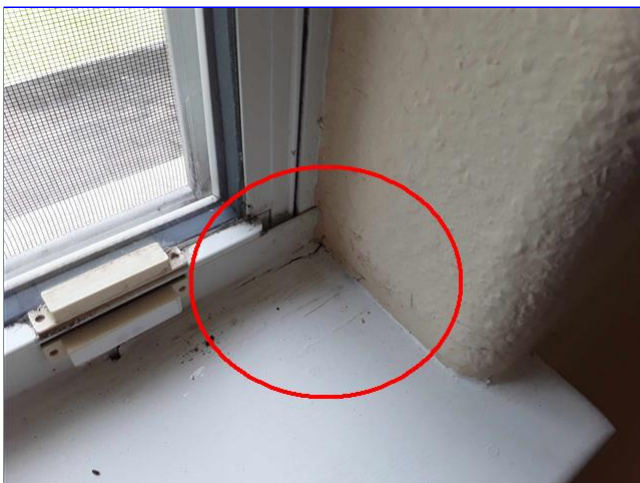
E. Item 20(Picture) front upstairs guest room

(6) The drywall on the wall is damaged. While this damage is cosmetic, it needs to be repaired. A qualified person should repair or replace as needed.

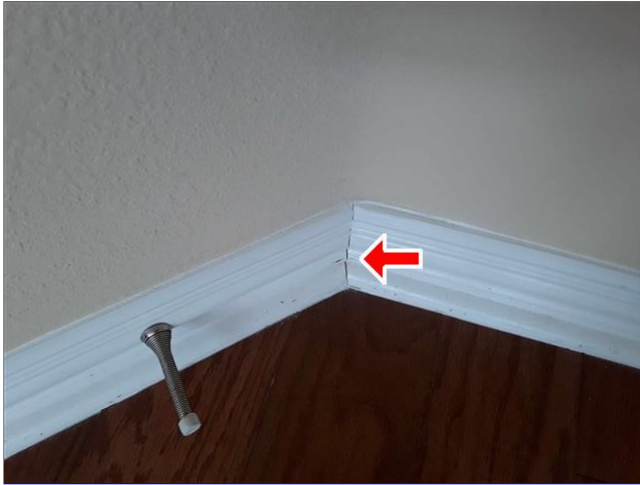
E. Item 21(Picture) upstairs guest room

(7) Baseboards have some separation and deterioration of caulking. I recommend having a qualified person make repairs of needed.

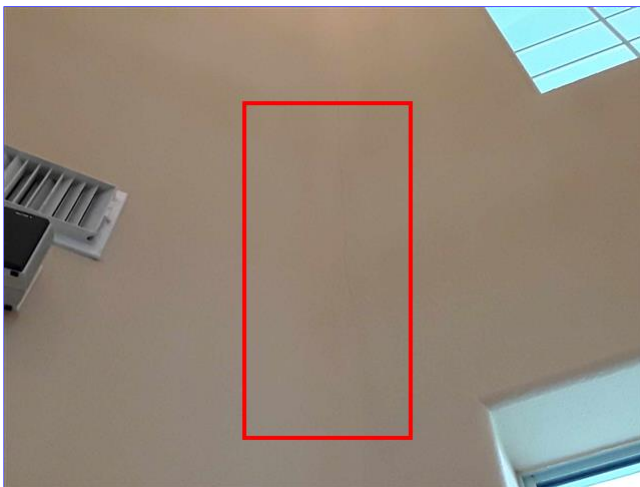
E. Item 24(Picture) living room

(8) The drywall on the wall reveals tape lines and nail bed areas (cosmetic). While this damage is cosmetic, it needs to be repaired. A qualified person should repair or replace as needed.

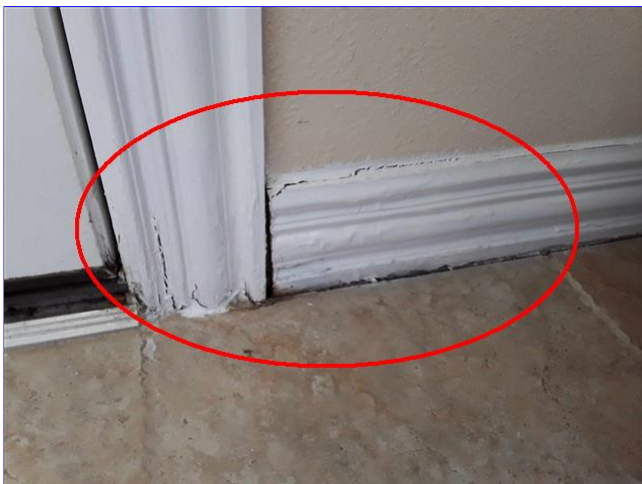
E. Item 25(Picture) laundry

(9) Baseboards in laundry area appear to show signs of deterioration. Further deterioration occur if not corrected. I recommend having a qualified contractor inspect and to make repairs as needed.

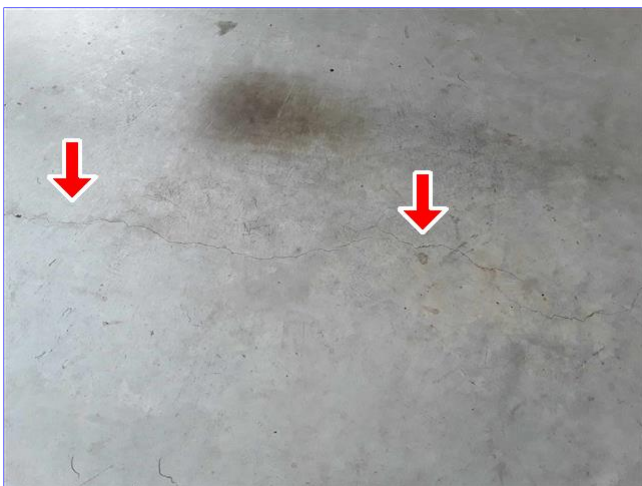
F. Item 1(Picture) garage

(1) The concrete floor of garage is cracked in areas. Further settlement may occur. . A qualified contractor should inspect and make repairs as needed.

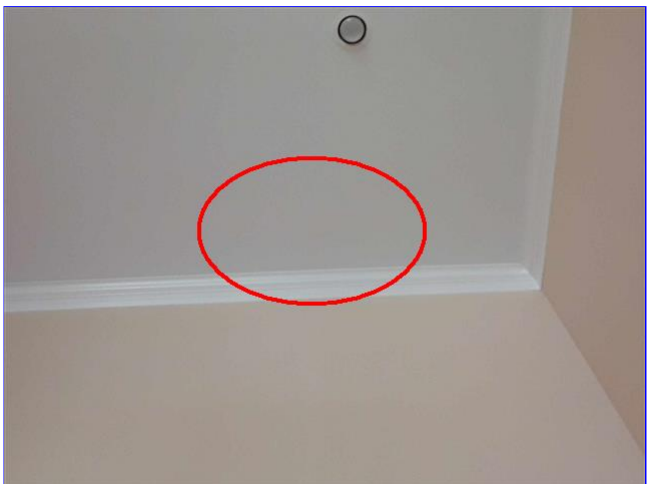
F. Item 2(Picture) living room

(2) The Sheetrock on the ceiling reveals a water stain indicating a leak did or still exists in areas. While this damage is cosmetic, it needs to be repaired. A qualified contractor should inspect and repair as needed.

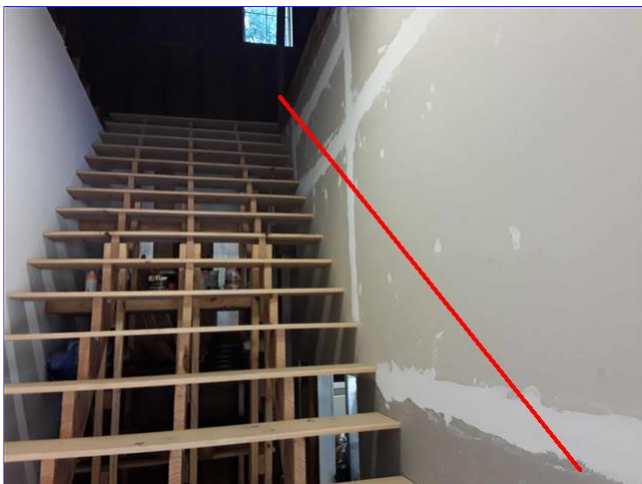
I. Item 1(Picture) garage

Handrails are missing at garage stairs. This is a safety issue. I recommend having a qualified contractor inspect and make repairs as needed.

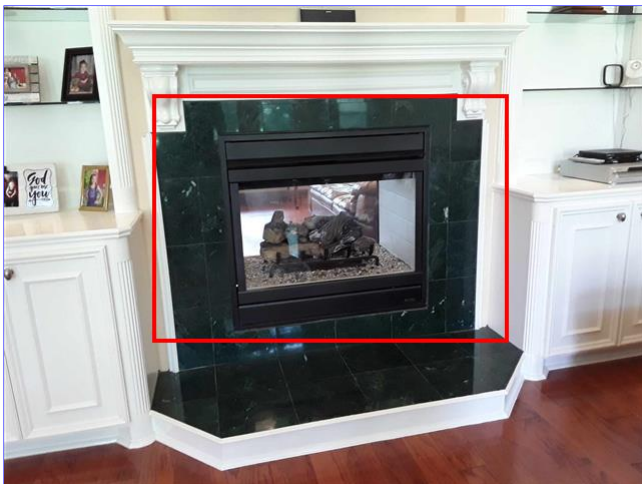
J. Item 1(Picture) living room

Gas log fireplace would not lite when tested. I recommend having sellers demonstrate.

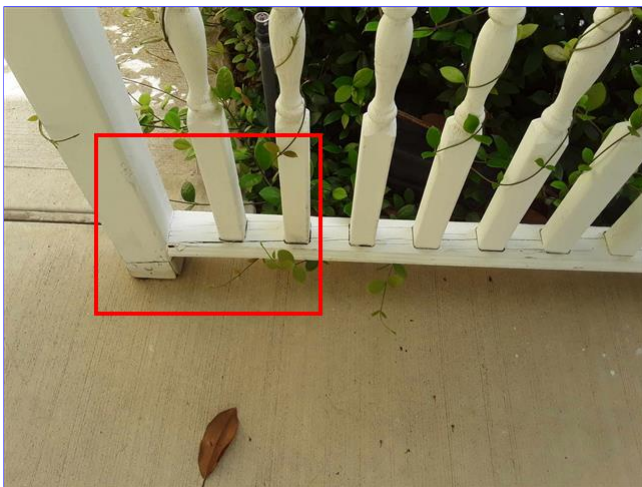
L. Item 3(Picture) rear of home

(1) Handrails are loose and not properly secure at rear of home. Signs of deterioration is also present. This is not considered todays standard. I recommend having a qualified contractor inspect and make repairs as needed.

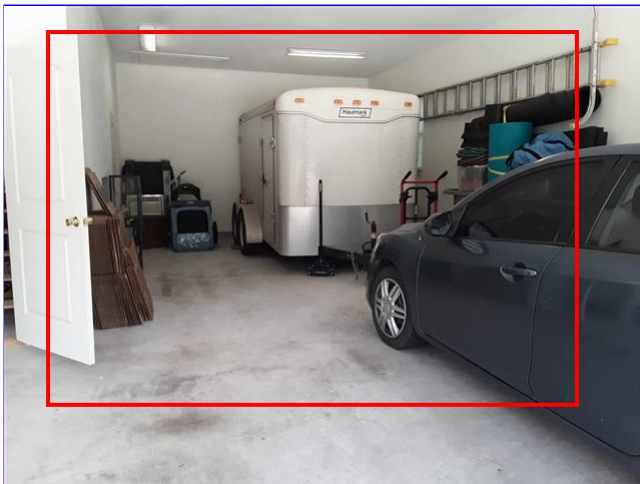
L. Item 6(Picture) garage

(2) Areas of the home have limited access due to furniture or occupants belongings. This is for your information.

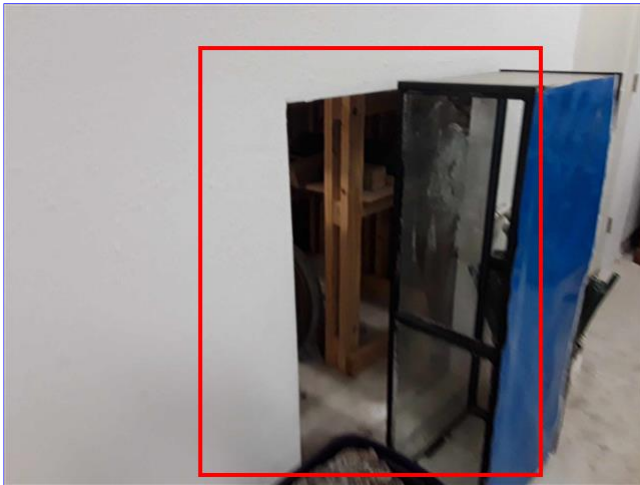
L. Item 7(Picture) multiple areas of garage

(3) Areas of the garage is not finished. This is for your information. I recommend having a qualified contractor inspect and make repairs as needed.

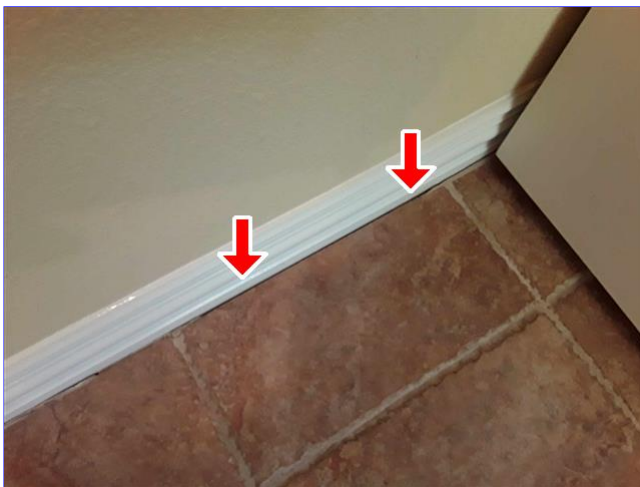
L. Item 12(Picture) master bath

(5) Areas of the home have caulking/grout missing in areas. I recommend having a qualified contractor inspect and make repairs as needed.

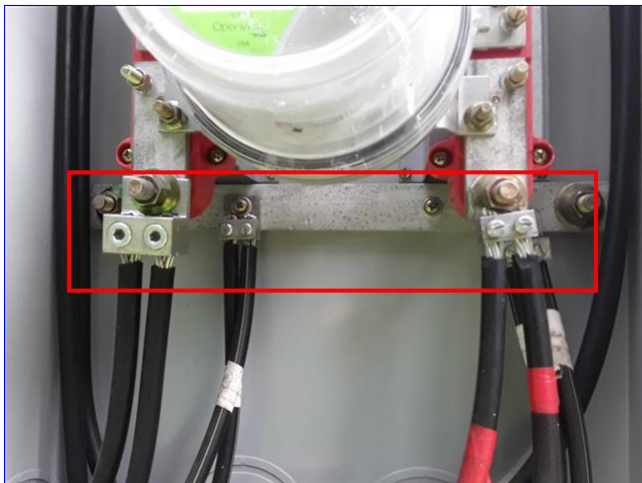
A. Item 1(Picture) panel

(1) There is no antioxidant on aluminum conductors feeding panel. This is not considered to be today's standard. I recommend having a qualified electrician evaluate make repairs as needed.

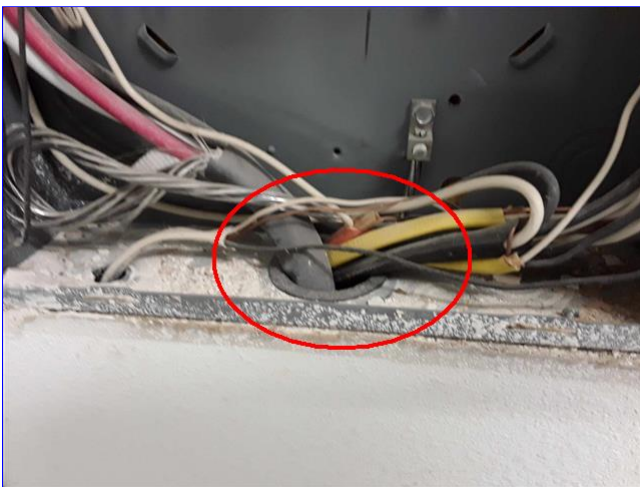
A. Item 4(Picture) panel

(2) The electrical panel has branch circuit wires bundled together that are entering the panel through one to two entry points. This is not considered today's standard. It is recommended that each sheathed wire enter the panel independently and be sealed for fire blocking purposes. I recommend having a qualified electrician evaluate and make repairs as needed.

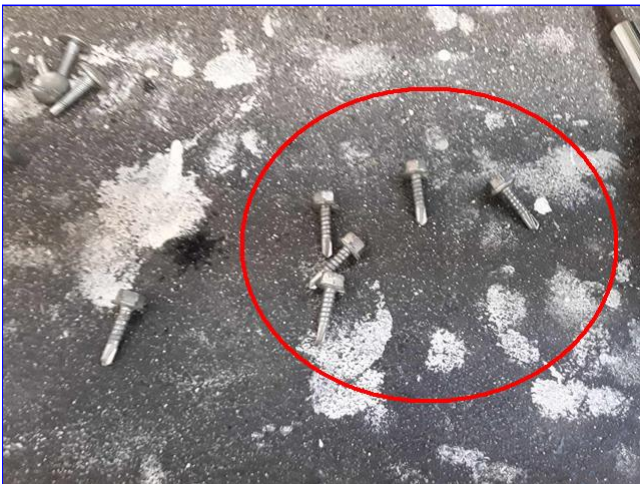
A. Item 5(Picture) panel

(3) The panel cover is using (sharp) improper screws. This is a safety hazard until corrected. I recommend having a qualified person make repairs as needed,

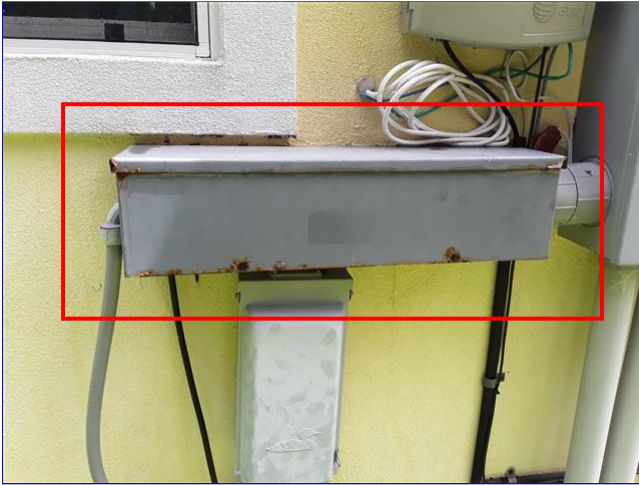
A. Item 6(Picture) garage

(4) Electrical box had screen that were rusted and deteriorated. I could not open to inspect. This is for your information.

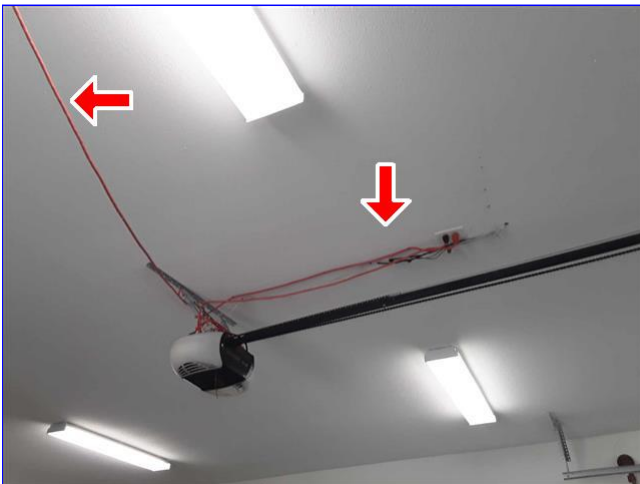
B. Item 4(Picture) garage

(4) There is an extension cord being used as permanent wiring, and needs to be properly wired or removed.

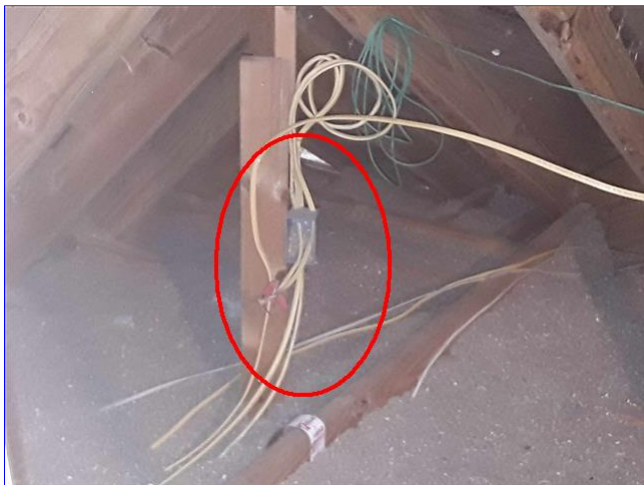
B. Item 5(Picture) attic

(5) Several open splices needs placing inside a box with a cover-plate in the attic space. A qualified licensed electrical contractor should perform repairs that involve wiring.

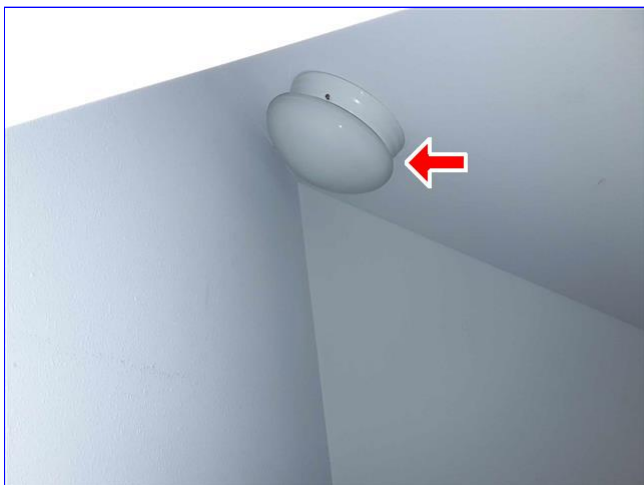
B. Item 6(Picture) under stairs

(6) The light fixture does not work (try bulb first). Electrical issues are considered a hazard until repaired. A qualified licensed electrical contractor should perform repairs that involve wiring.

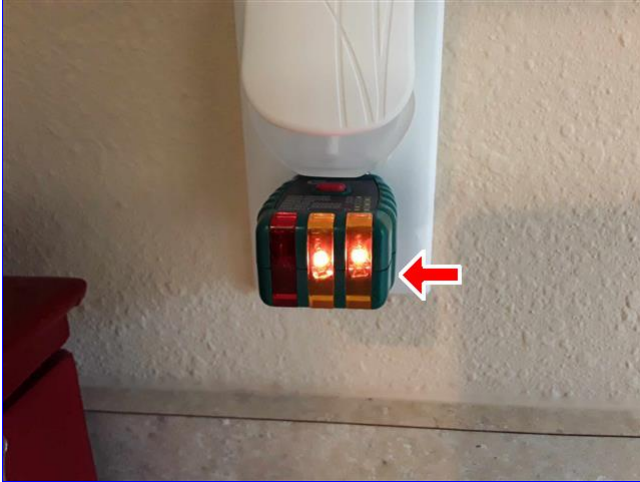
B. Item 7(Picture) laundry

(7) There are no GFCI protected circuits in required area's. This is not considered to be today's standard. I recommend having a qualified electrician make repairs as needed.

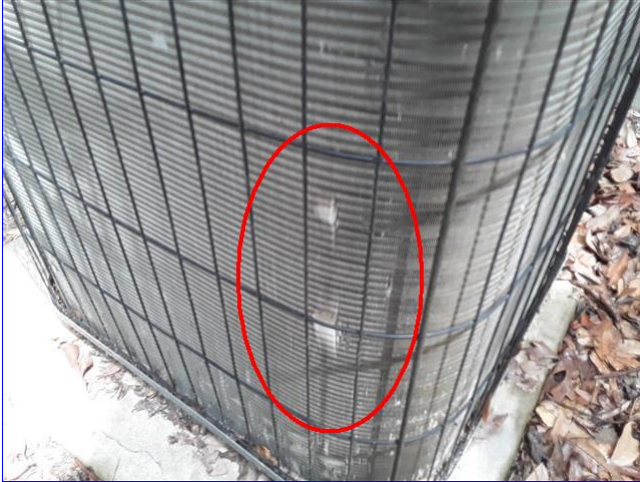
B. Item 1(Picture) left of home

- (1) It is recommended to have HVAC systems serviced annually.
- (2) The condenser appear damaged and may no longer work properly. A more thorough inspection by a qualified contractor is needed. A qualified HVAC person should inspect further and repair or replace as needed.

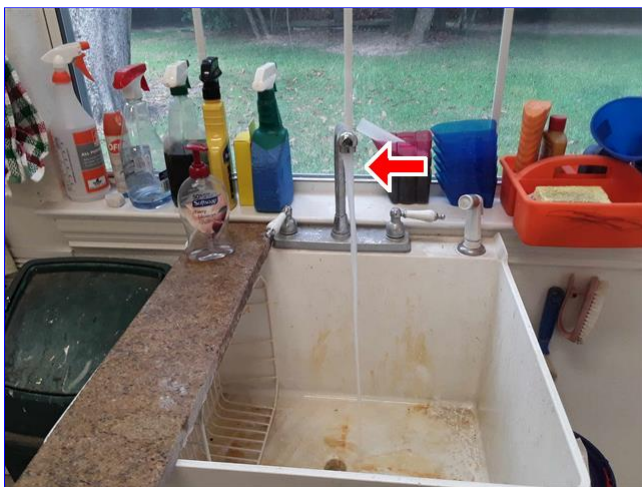
A. Item 1(Picture) garafe

(1) No hot water at garage sink. This is for your information. I recommend having a plumber inspect and make repairs as needed.

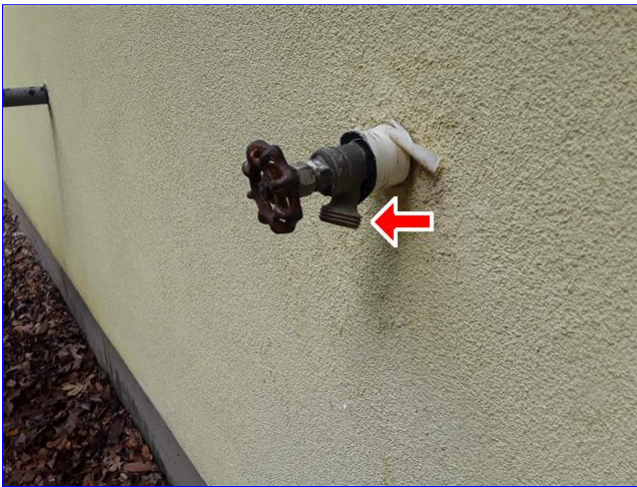
A. Item 3(Picture) all exterior outlets

(2) There is no Anti Siphon device installed on exterior faucet(s). This is not considered to be today's standard. I recommend having a qualified person make repairs as needed.

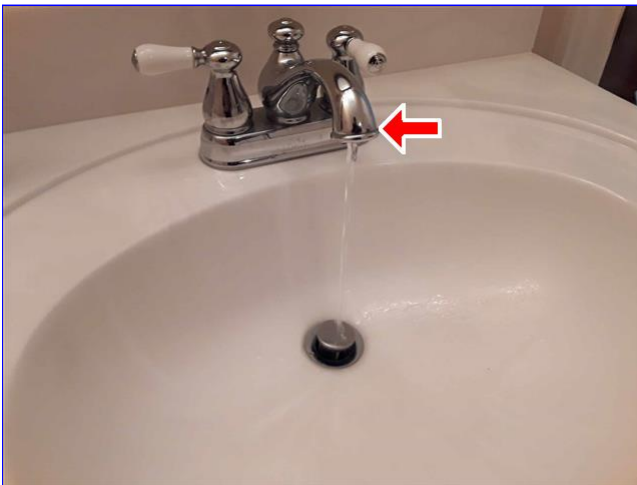
A. Item 4(Picture) upstairs guest bath

(3) Water pressure is low at upstairs guest bath sink. I recommend having a qualified plumber inspect and make repairs as needed.

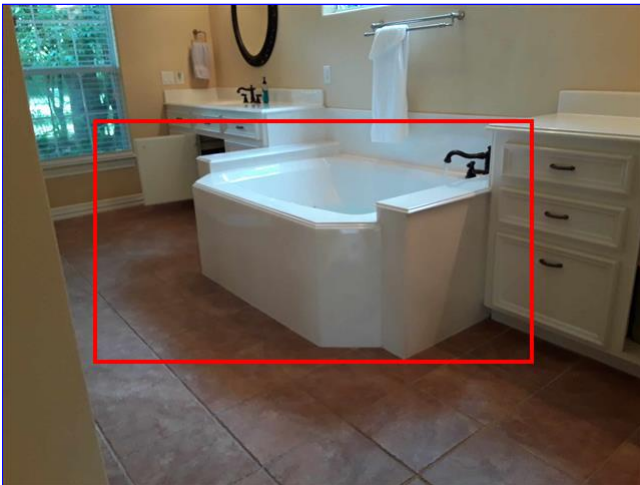
D. Item 1(Picture) master

(1) The jetted tub is missing access panel. I recommend adding access panel.

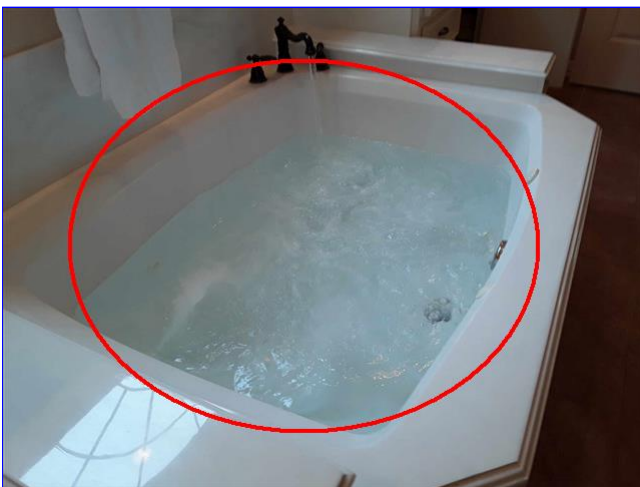
D. Item 2(Picture) master

(2) The Hydro-Massage Therapy equipment worked properly at time of inspection.

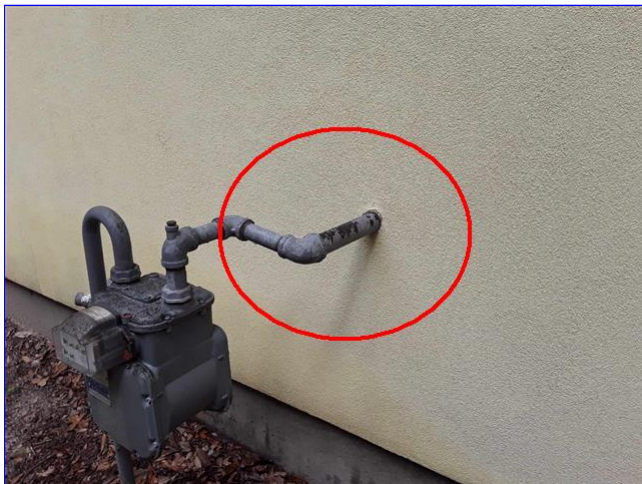
E. Item 1(Picture) left of home

(1) Bonding/grounding wire not present at time of inspection. I recommend having the proper authorities to inspect and make repairs as needed.

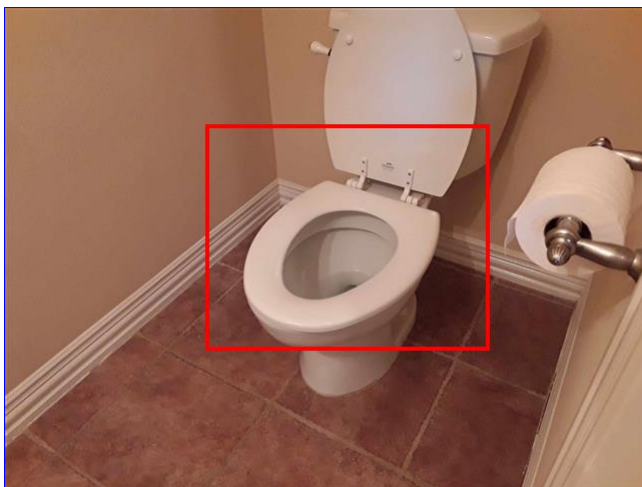
E. Item 2(Picture) half bath

(2) Toilet lid is loose at half bath downstairs. I recommend having a qualified person replace and inspect and as needed.

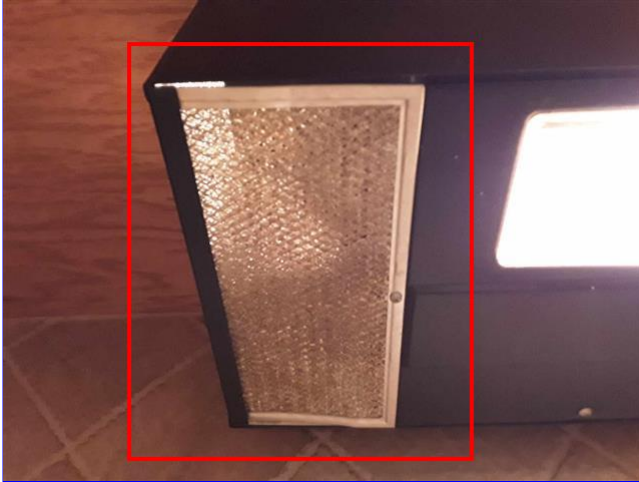
C. Item 1(Picture) kitchen

The range hood fan noisy or vibrates. I recommend repair or replace as needed.

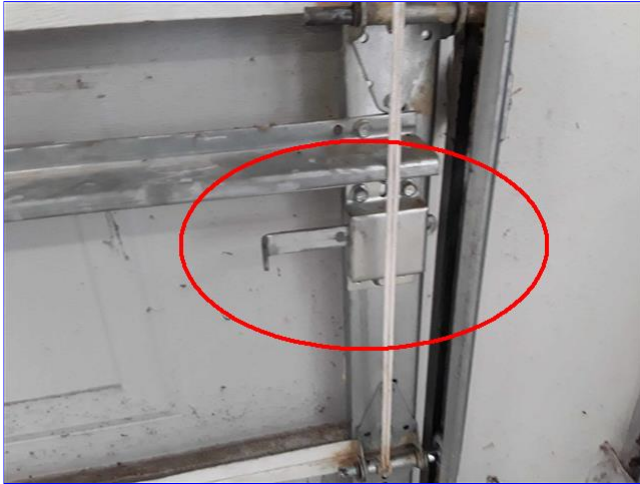
G. Item 1(Picture) garage x 2

The garage door at the front of home has a lock that has not been disabled for automatic opener. This is considered unsafe and needs correcting. A qualified contractor should inspect and repair as needed.

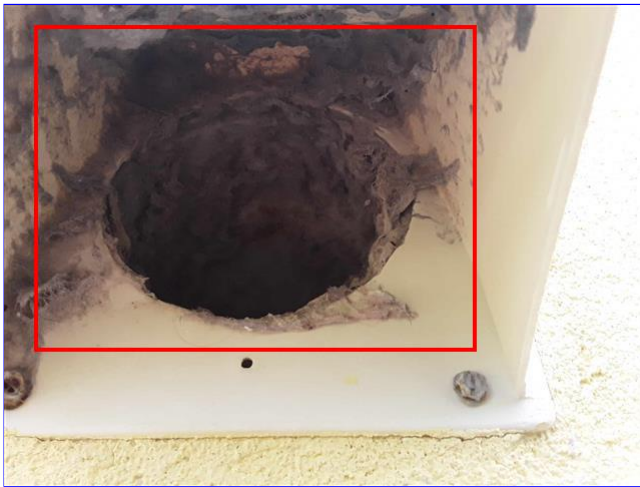
H. Item 1(Picture) right of home

Excess amount of lint in vent piping. I recommend having it cleaned and inspect by a qualified person.

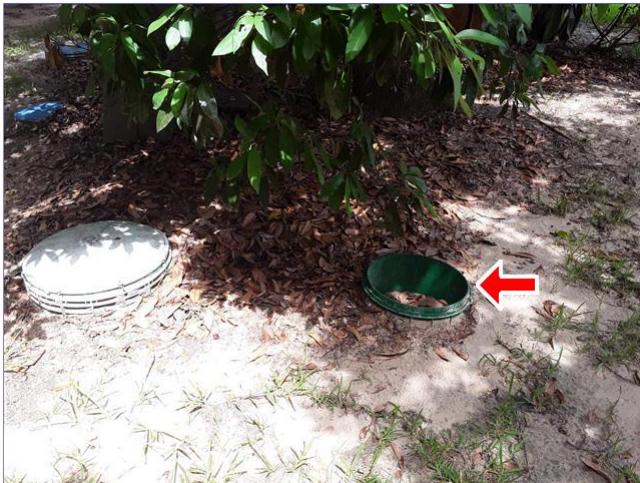
E. Item 1(Picture) rear of home

(1) Septic lid cover is missing at left of home. This is not considered today's standard. I recommend having a qualified person inspect and make repairs as needed.

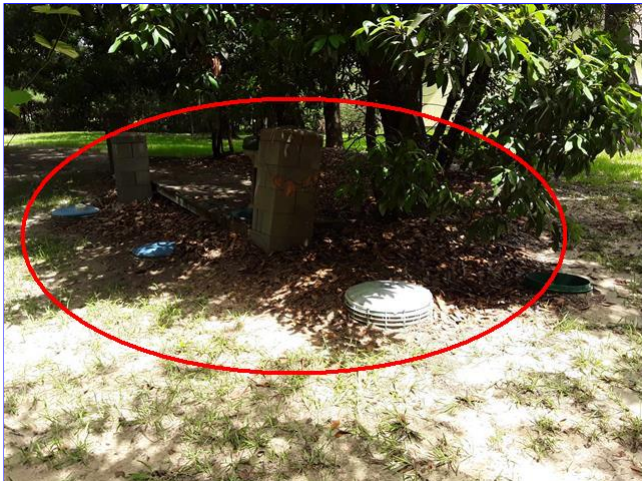
E. Item 2(Picture) rewr of home

(2) I inspected the property in the location of the drain field area of septic. There were no signs of failure or blockage and the grounds appear normal. I did visually locate the septic tank however the inside of tank and drain lines were not inspected for size or condition. Changes in water volume use can sometimes have an impact on septic tanks that before were working properly. Most septic contractors recommend that if the septic tank hasn't been pumped and inspected in the last 4-5 years, you should have it pumped and inspected visually during the inspection process to determine its true condition.

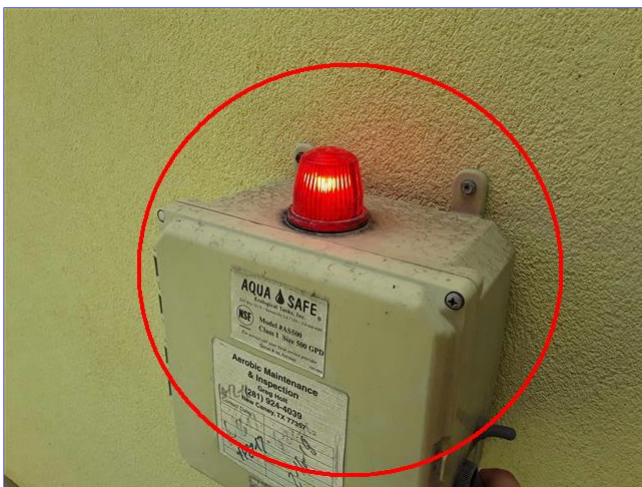
E. Item 3(Picture) rear of home

(3) Auditable alarm not working at time of inspection. I recommend having a septic company to further inspect.
