## RESIDENTIAL INSPECTION REPORT

18327 Blanchmont Ln  
Houston TX 77058

JUNE 11, 2020

# PROPERTY INSPECTION REPORT

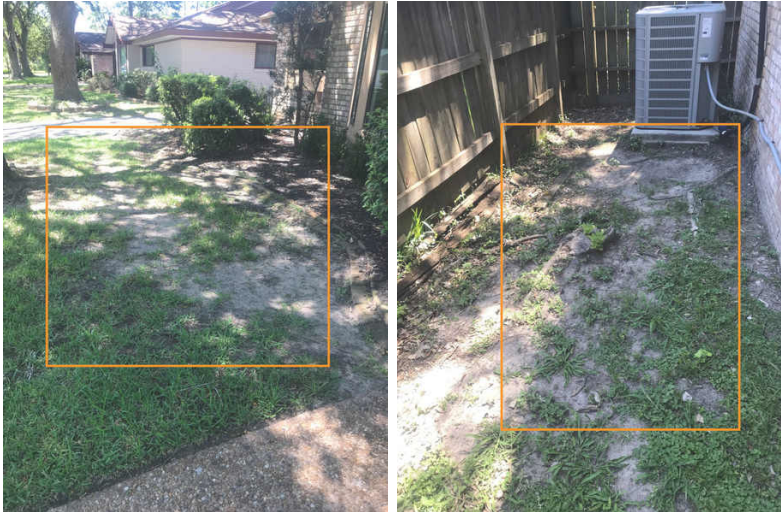
**1: Grading & Drainage: Soil Erosion**

Soil erosion was observed which can lead to grading issues. Evaluation and remedy by a landscaping contractor as needed to prevent further erosion is recommended.

Recommendation: Contact a qualified landscaping contractor

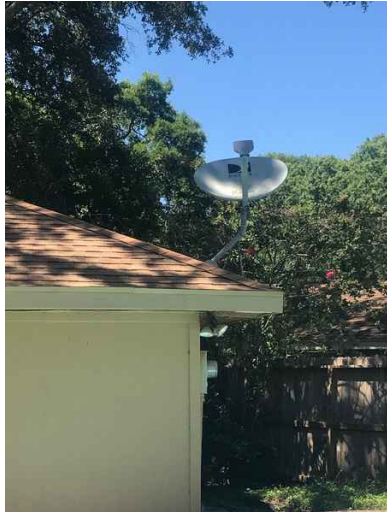
Satellite dish(es) mounted to the roof. The inspector was unable to determine the condition of the roofing materials underneath. Remedy as needed.

Recommendation: Contact a qualified roofing professional.

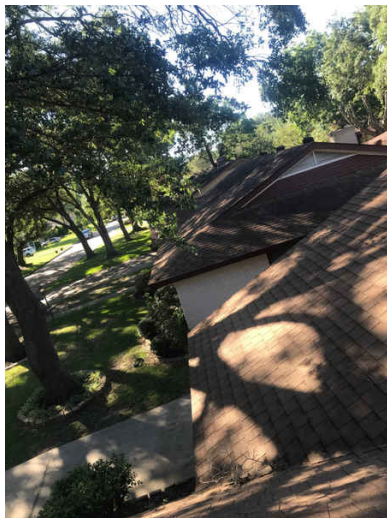
**2: Tree limbs on/near roof**

Tree limbs that are in contact with roof or hanging near roof should be trimmed to prevent damage to the roofing materials.

Recommendation: Contact a qualified tree service company.

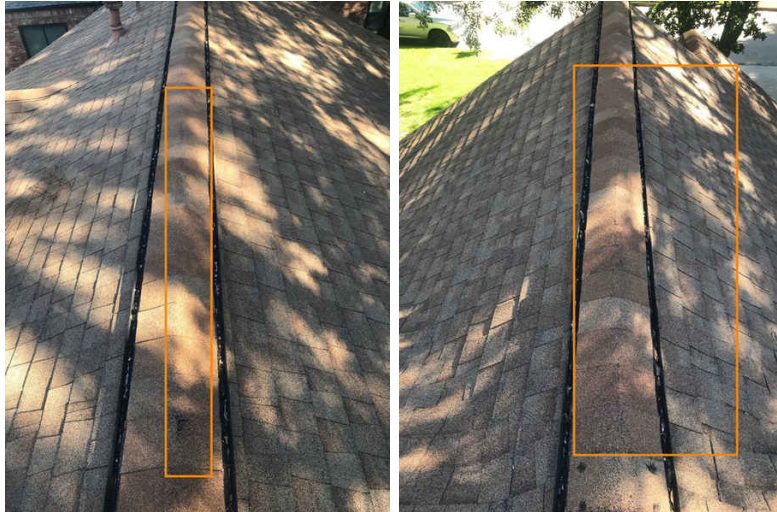
**3: Localized Granule Loss**

Localized granule loss on the shingle surface was observed. Among other things, this can be as a result of mechanical damage, impurities in the asphalt, or anomalies in the manufacturing process. Evaluation and repair by a qualified roofing professional is recommended.

Recommendation: Contact a qualified roofing professional.

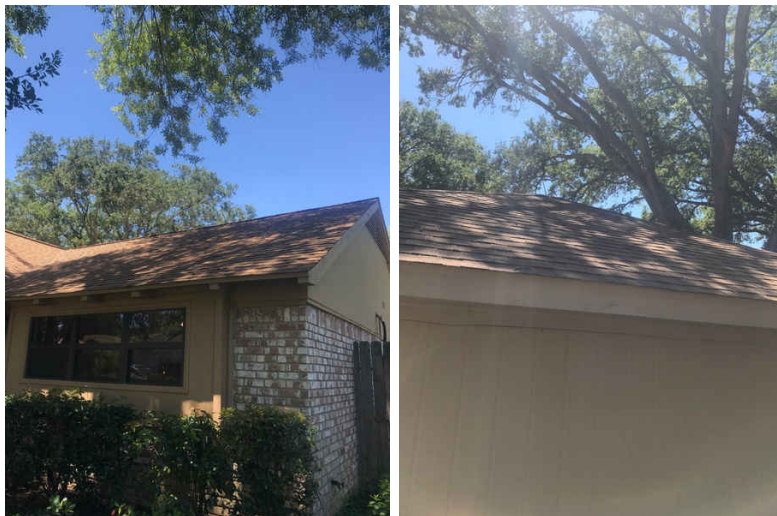
**4: Debris on roof**

Debris was present on roof surface. The condition of the roof covering underneath could not be determined. Removal of debris and evaluation of the roofing materials underneath is recommended.

Recommendation: Contact a qualified professional.

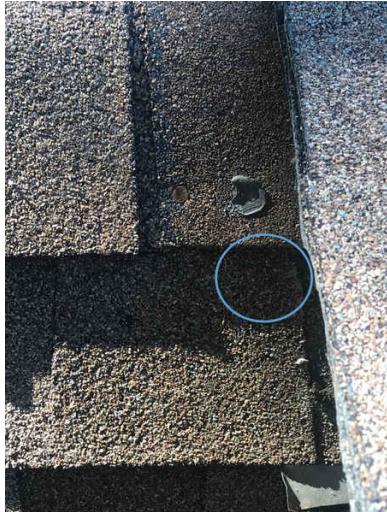
**5: Exposed Nails**

Under-driven or exposed nails were found in one or more roof coverings. Evaluation and repair by a qualified roofing professional is recommended.

Recommendation: Contact a qualified roofing professional.

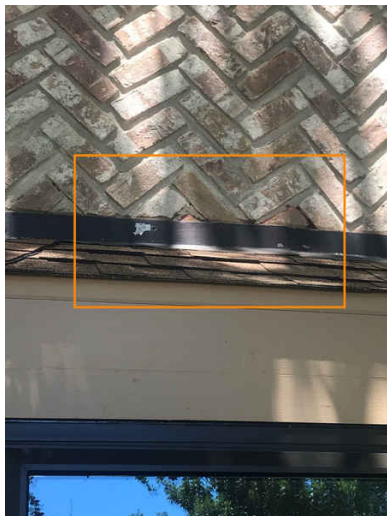
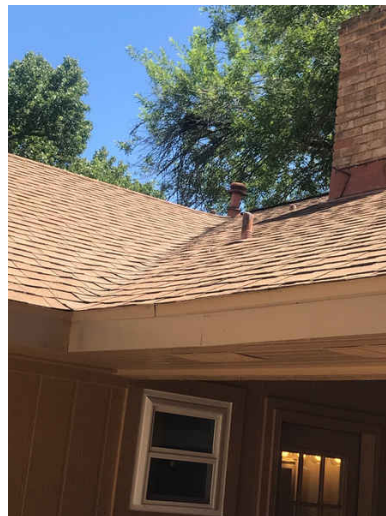
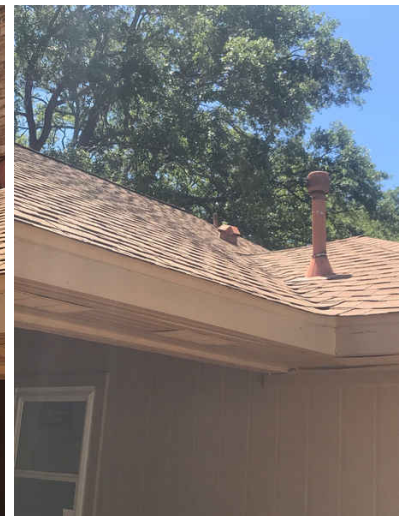
**6: Flashing: Unpainted Materials**

Roof materials were not painted (flashings, roof jacks). This can help extend the life of the flashing material, but also helps maintain a consistent look with other roofing materials. Remedy as needed.

Recommendation: Contact a qualified roofing professional.

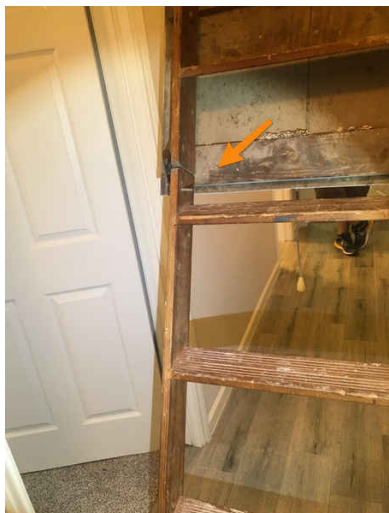
**2: Pulldown stairs/ladder: Missing/loose nuts and bolts**

Pulldown stairs/ladder was missing or had loose nuts or bolts. All missing/loose nuts and bolts on the attic access ladder should be tightened or replaced.

Recommendation: Contact a qualified professional.

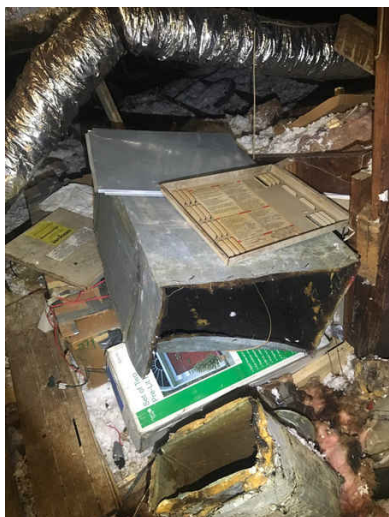
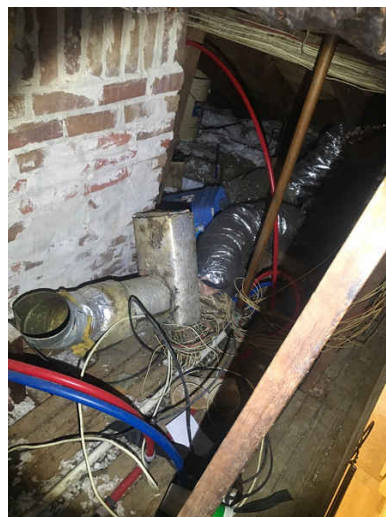
**3: Debris Present**

Scrap wood/trash/debris was observed in the attic.

Recommendation: Contact a qualified professional.

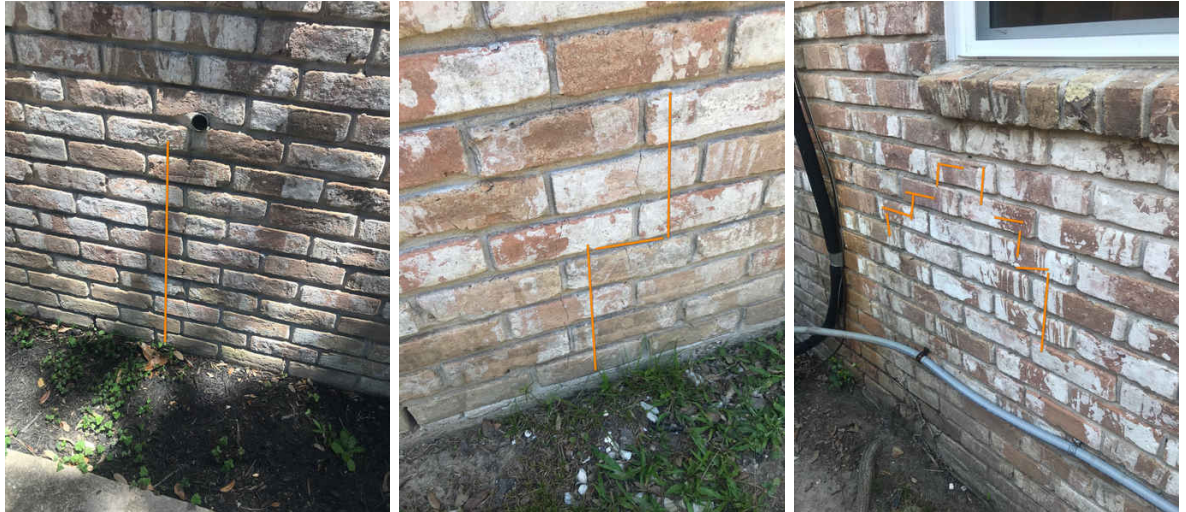
**2: Exterior Masonry: Cracks**

Cracks were observed in the brick/masonry siding. Common causes may include:

- building settlement,
- thermal expansion and contraction, or
- mechanical damage.

Cracked masonry or mortar may be cosmetic, but also may allow water into the wall which could damage the interior structure of the building. Cracks may grow with time at a constant (increasing or decreasing) rate and may open and close as seasons change. Remedy as needed.

Recommendation: Contact a qualified masonry professional.

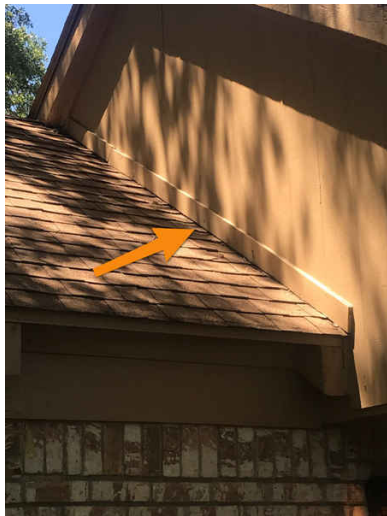
**3: Exterior- Siding: Siding too close to roof surface**

The siding does not adequately clear the roof surface. Installation guidelines generally require 1-2 inches of clearance between the siding and the roof covering. Evaluate and remedy as needed.

Recommendation: Contact a qualified professional.

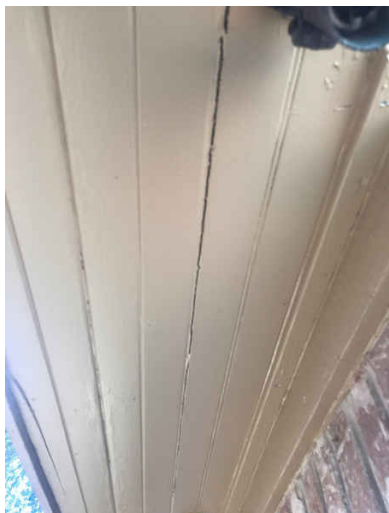
**4: Exterior- Caulking: Deteriorated/Missing**

Caulking around siding or trim was deteriorated or missing.

Recommendation: Contact a qualified professional.

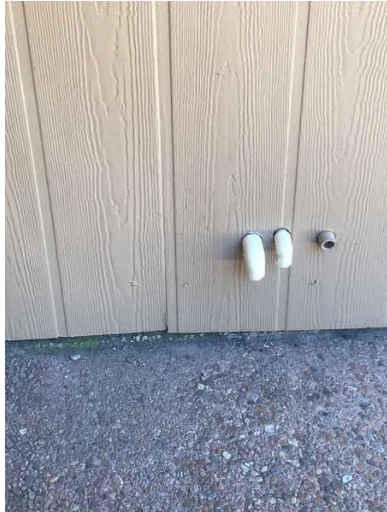
**6: Exterior: PVC Lines Unpainted**

All exterior PVC line should be painted to prevent UV damage and deterioration.

Recommendation: Contact a qualified professional.

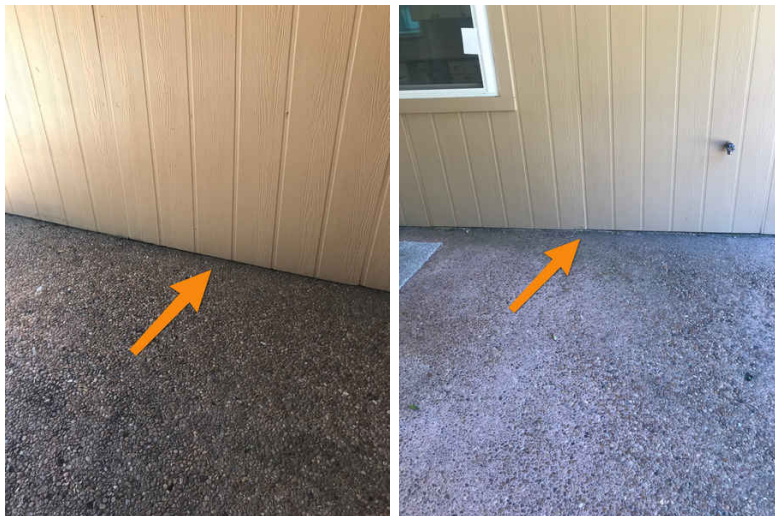
**7: Exterior- Siding: Too close to concrete**

Siding was installed too close to concrete. The siding should be installed a minimum 1 1/2 inches above concrete. Remedy as needed.

Recommendation: Contact a qualified professional.

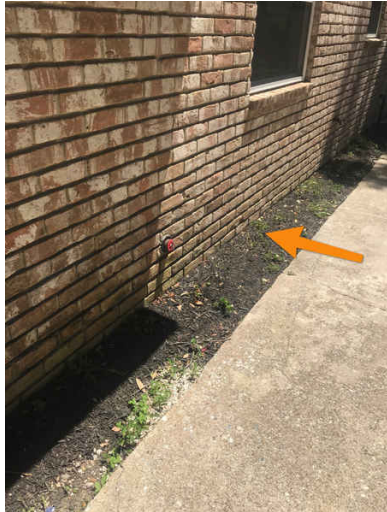
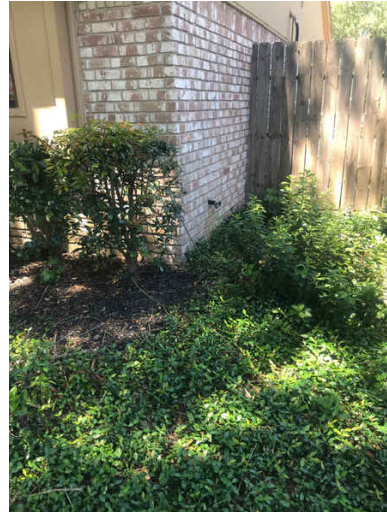
**8: Exterior: High Soil**

A high soil level was observed. The foundation should have at least 4 inches of exposure. Remedy as needed.

Recommendation: Contact a qualified landscaping contractor

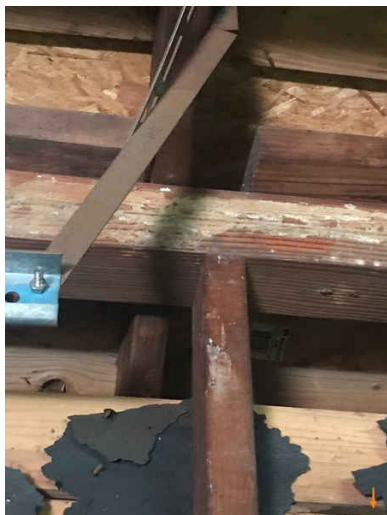
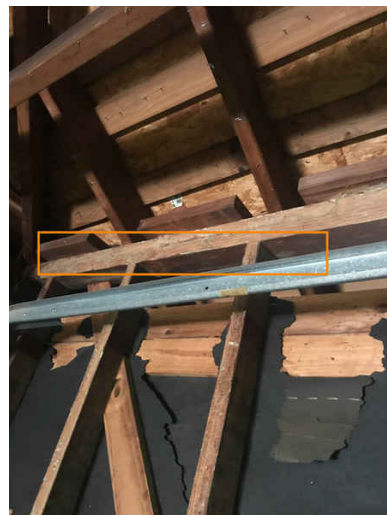
### 9: Wood Destroying Insect Activity

There was evidence of wood destroying insects (WDI) in one or more areas. The extent of damage inside walls (if any) is not visible. Further evaluation by a pest control company is recommended.

Recommendation: Contact a qualified pest control specialist.

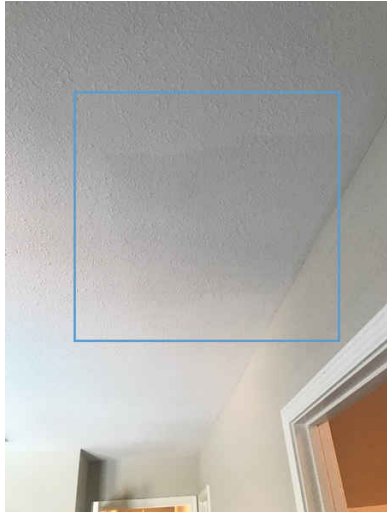
#### 1: Note: Patched Ceilings

Patched ceiling areas were observed at the time of inspection. Obtaining all previous work documentation is recommended.

Recommendation: Contact a qualified professional.

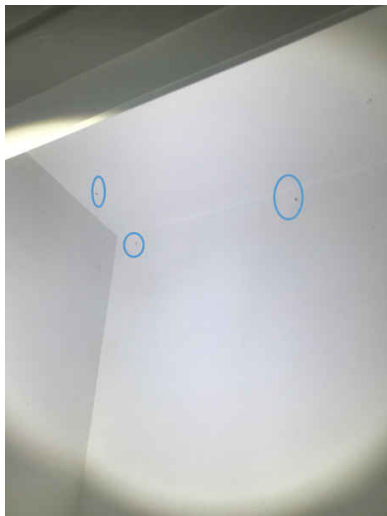
**2: Ceiling: "Popped" Nails**

"Popped" (loose) drywall nails are observed on the ceiling. This condition is typically considered cosmetic. Re-seat and seal as needed.

Recommendation: Contact a handyman or DIY project

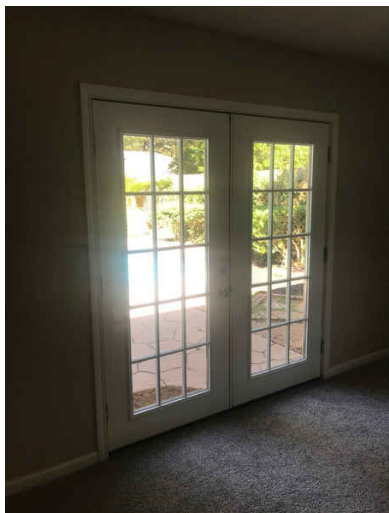
**1: Door: Sticks/Difficult to Operate**

Door sticks and is tough to open. Remedy as needed.

Recommendation: Contact a handyman or DIY project

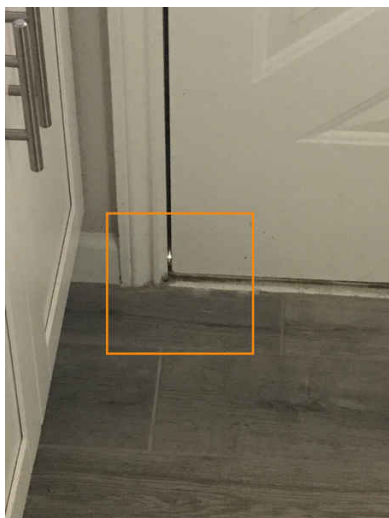
## 2: Door: Noticeable Gap at Frame

Gaps were observed between the door and frame, which could result in energy loss. Evaluate and remedy as needed.

Recommendation: Contact a qualified door repair/installation contractor.

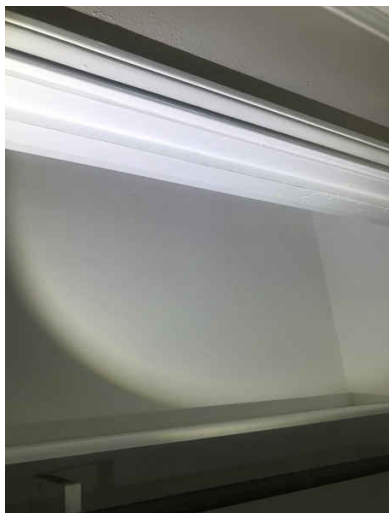
## 3: Door Hardware: Missing/Damaged Hardware

One or more door had missing or damaged hardware. Evaluation and remediation is recommended.

Recommendation: Recommended DIY Project

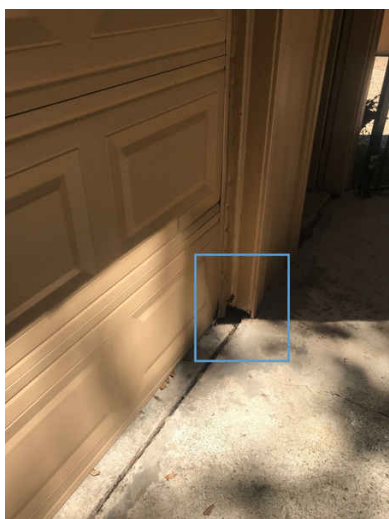
**4: Garage Vehicle Door: Wood Rot at Base of Frame**

Wood rot was observed at the base of the garage door frame. Remedy as needed.

Recommendation: Contact a qualified handyman.

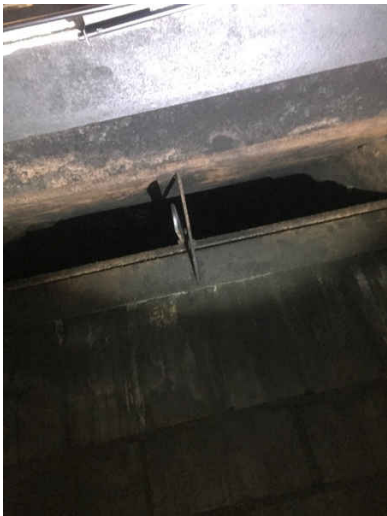
No apparent safety clip on the damper. Typically when gas logs are present, a safety clip must be installed on the damper to keep it from closing fully. Remedy as needed.

Recommendation: Contact a qualified professional.

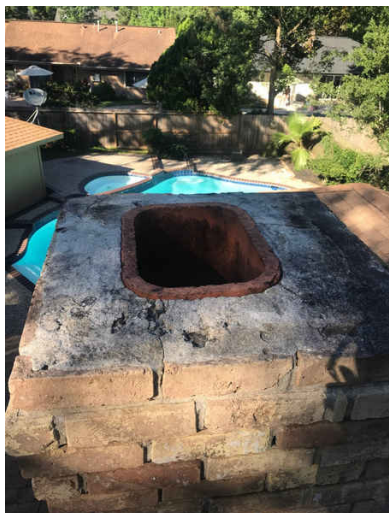
**3: Cap: Masonry Deterioration**

Masonry at the chimney cap was cracked, damaged, and/or deteriorated. This may allow for moisture penetration.

Recommendation: Contact a qualified professional.

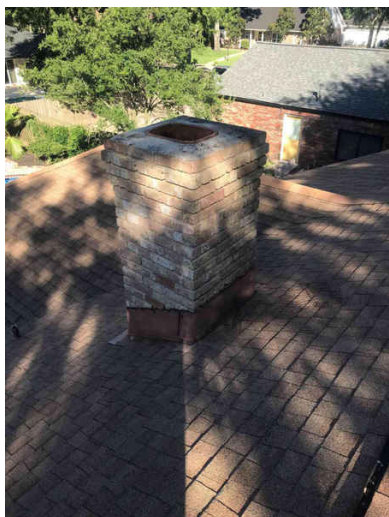
**4: Cap: Rain cap missing**

Rain cap was missing. Remedy as needed.

Recommendation: Contact a qualified professional.

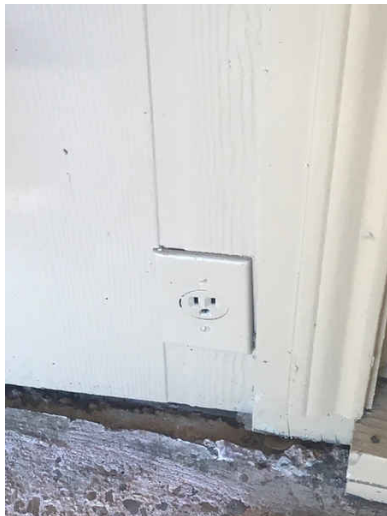
**1: Receptacles: GFCI Protection Inadequate/Missing**

GFCI protection was inadequate or missing. Current building standards recommend the installation of ground fault protection:

GFCI protection was not present in one or more of these locations. Evaluate and remedy as needed.

Recommendation: Contact a qualified electrical contractor.

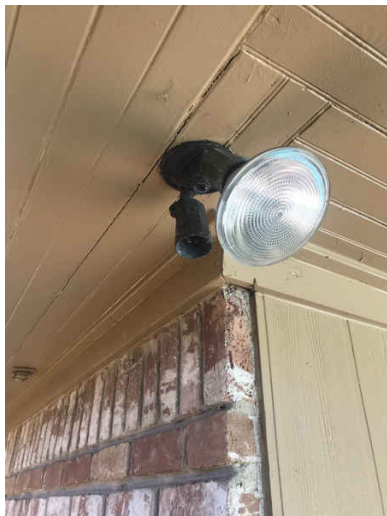
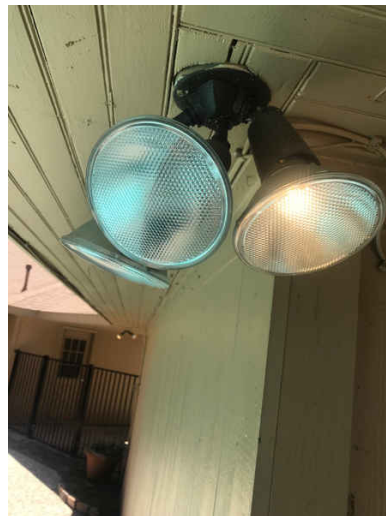
**2: Light: Inoperable**

One or more lights were not operating. New light bulb possibly needed. Remedy as needed.

Recommendation: Contact a qualified electrical contractor.

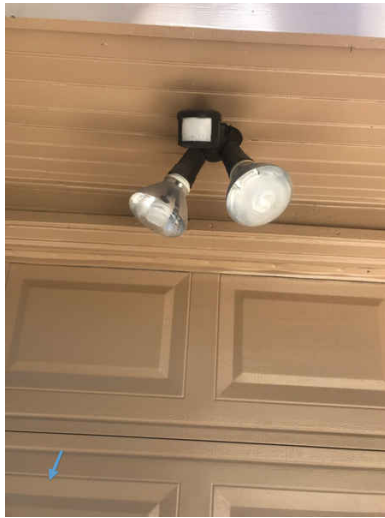
**3: Light: Photocell-faulty**

The dusk to dawn photocell sensor switch was faulty. The exterior light did not function as designed with the change in exterior daylight.

Recommendation: Recommended DIY Project

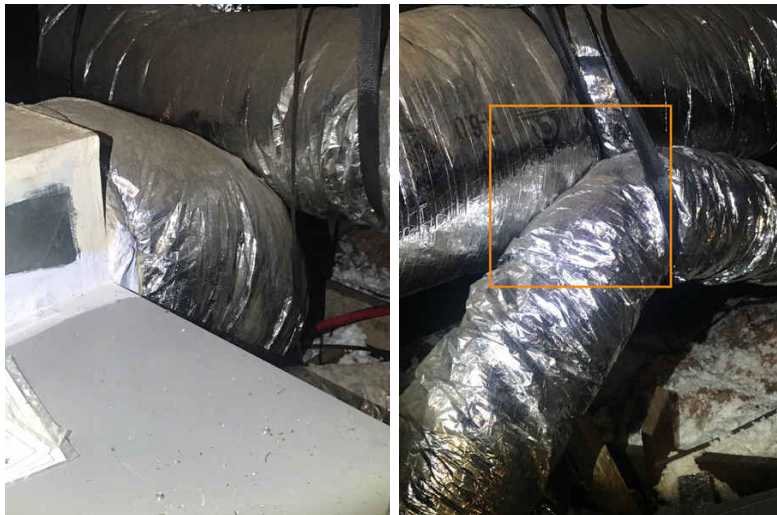
Ducts were resting on each other. This can result in condensation forming between the two sections of ductwork. Remedy as needed.

Recommendation: Contact a qualified professional.

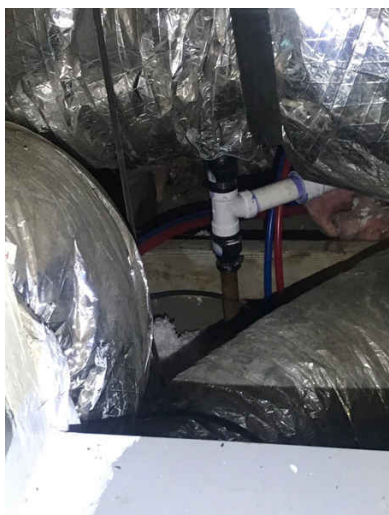
**1: Note: Prior Repairs**

Evidence of prior plumbing repairs was present in one or more areas of the home. It is recommended that you request repair documentation such as invoices, work orders, permits, or further explanation from the seller.

Recommendation: Contact the seller for more info

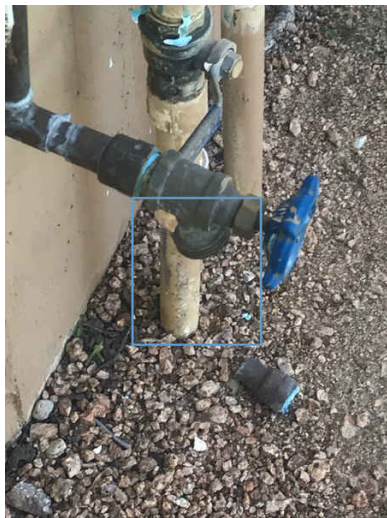
**2: Hose bibb (outdoor faucet): Backflow Prevention Missing**

A hose bibb was missing a backflow preventer. These devices are inexpensive and easily installed, and help to prevent contamination of potable water. Remedy as needed.

Recommendation: Contact a handyman or DIY project

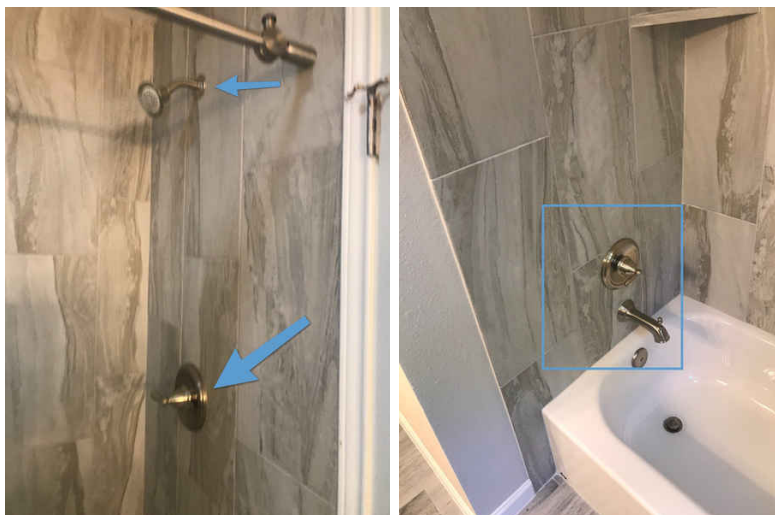
**3: Fixtures: Not Sealed at Wall**

The bathtub faucet was not sealed at the wall. Remedy as needed.

Recommendation: Contact a handyman or DIY project

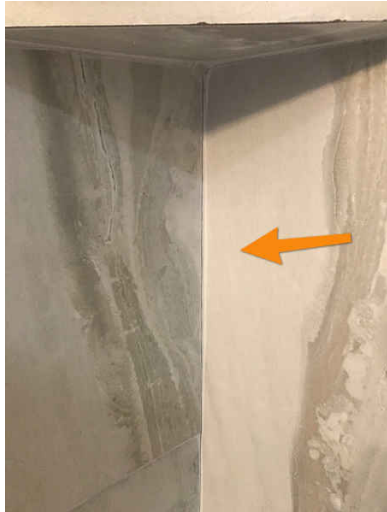
**4: Shower: Missing/Deteriorated Caulking or Grout**

For Example: Hall Bathroom

Recommendation: Contact a qualified professional.

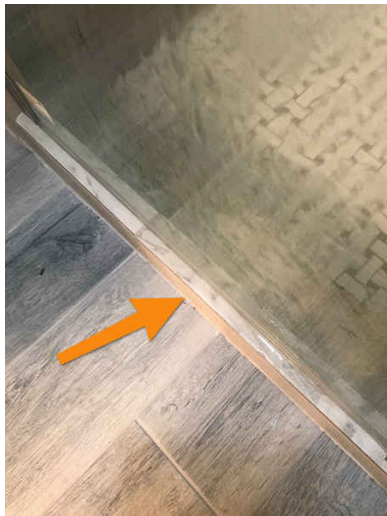
**5: Shower: Water leak under shower glass**

Water leaked underneath the shower stall glass panel. This can indicate a poor seal. Remedy as needed.

Recommendation: Contact a qualified professional.

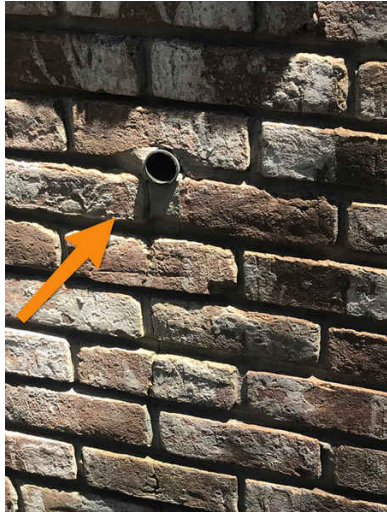
**1: Drain piping: Clean-out cap damaged/missing**

A clean-out cap was damaged or missing. Remedy as needed.

Recommendation: Contact a qualified plumbing contractor.

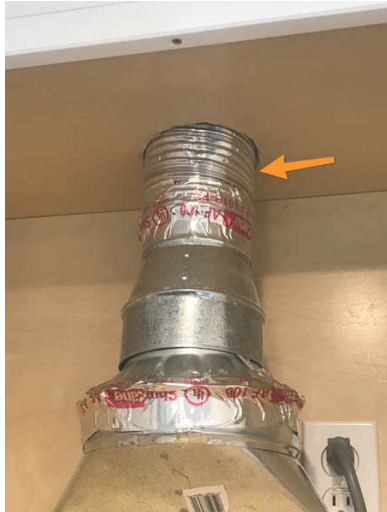
**1: Flex Vent Pipe Improper**

Section(s) of the kitchen exhaust vent pipe were corrugated. Smooth-walled material is recommended to prevent grease build-up inside the vent pipe.

Recommendation: Contact a qualified professional.

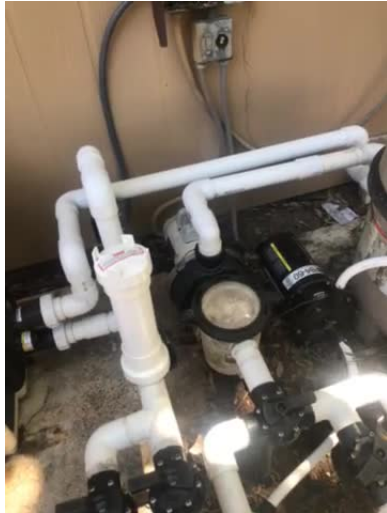
Water pump was unusually noisy. This could be from a number of issues. Recommend a pool professional evaluate and repair.

Recommendation: Contact a qualified professional.

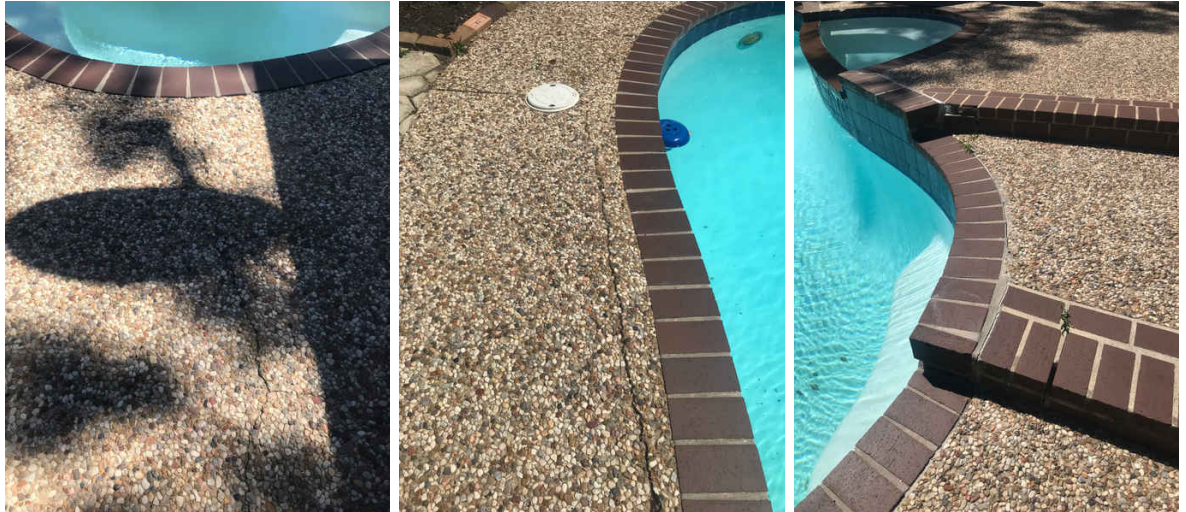
**5: Settling Noted**

Evidence of settling was noted. The settling noted should be repaired and monitored for any additional changes.

Recommendation: Contact a qualified professional.
