# Inspection Report

**Property Address:**  
4014 Kitchen Hill Lane  
Sugarland TX 77479

**HG HOME INSPECTION**

# PROPERTY INSPECTION REPORT

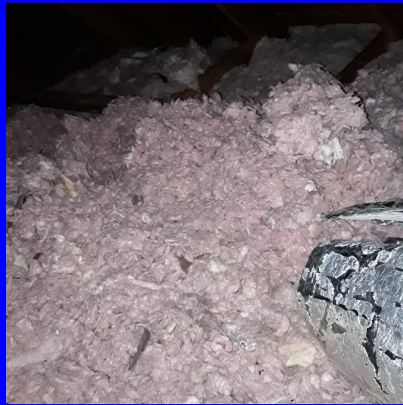
blown insulation less than 6 inches

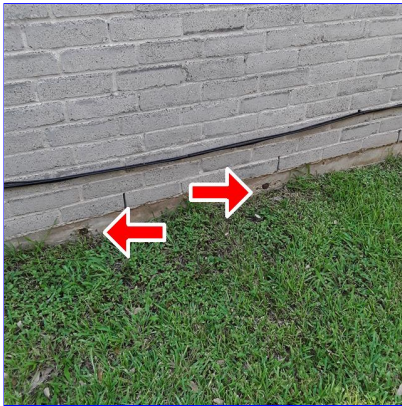
A. Item 1(Picture) left

(3) The post tension foundation has exposed cable ends that are starting to show signs of deterioration.

This is a maintenance issue. Further deterioration will occur if not corrected. I recommend having a qualified person make repairs as needed.

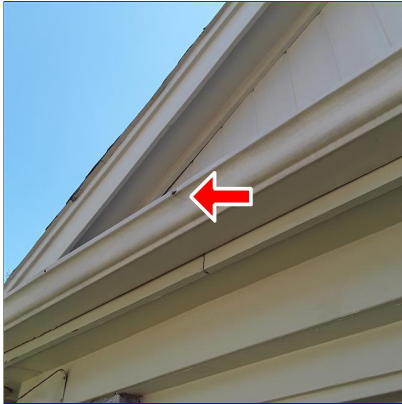
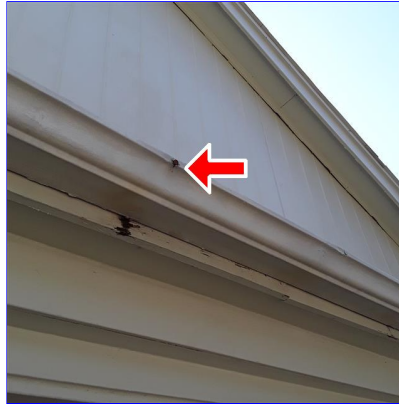
B. Item 1(Picture) garage

(1) Gutters are not properly secured to the home. Further deterioration or erosion can occur if not corrected. I recommend having a qualified person make repairs as needed.

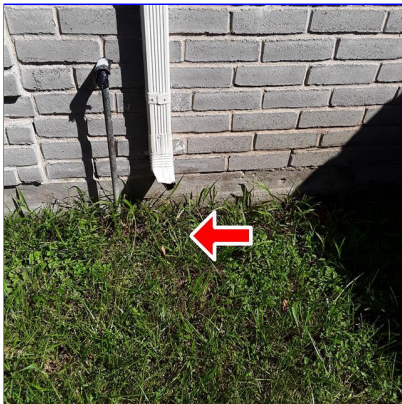
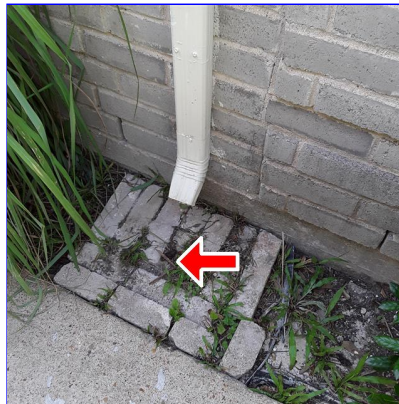
B. Item 4(Picture) front right

(2) The gutter downspout(s) are missing deflector(s) at the exterior. Erosion can continue or become worse if not corrected. A qualified contractor should inspect and replace as needed.

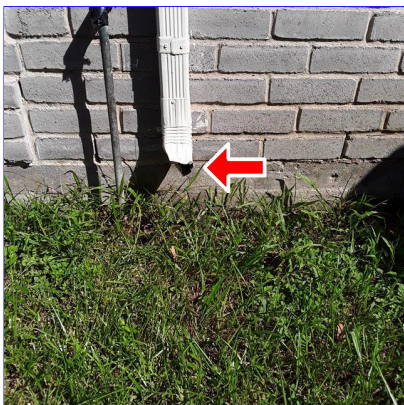
B. Item 6(Picture) front right

(3) The downspout is damaged at the exterior. Gutters that drain poorly or clogged can lead to many costly problems such as deterioration of fascia, soffit or roof edge. It can also cause gutters to pull loose and lead to possible water intrusion. A qualified person should repair or replace as needed.

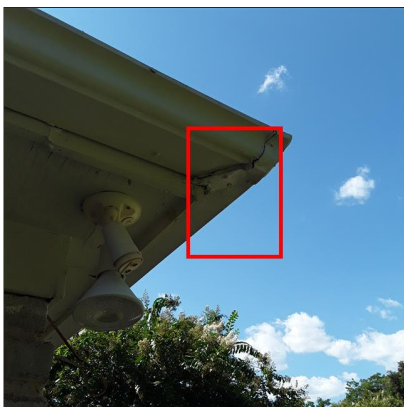
B. Item 7(Picture) entry

(4) The gutter is rusted and deteriorated in various areas throughout and needs replacing.

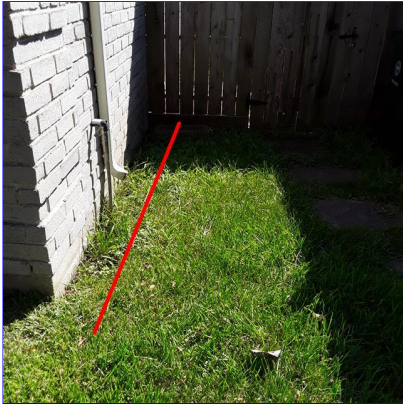
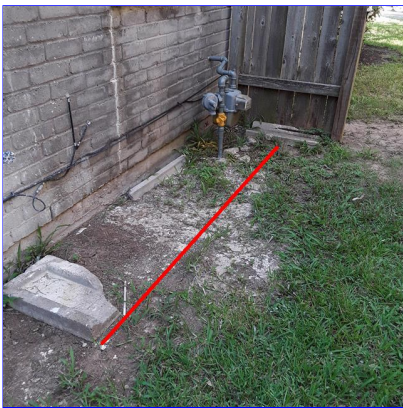
B. Item 9(Picture) right

(5) There is a negative slope at the exterior areas and can cause or contribute to water intrusion or deterioration. I recommend correcting landscape to drain water away from home.

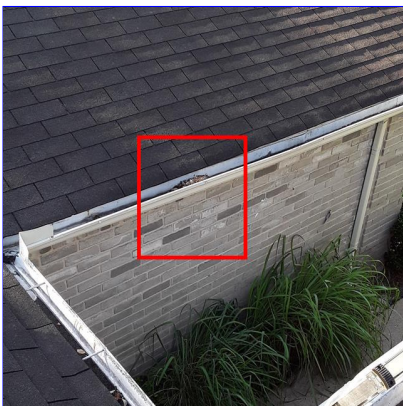
B. Item 13(Picture)

(6) The gutters are full of debris in areas and need to be cleaned. The debris in gutters can also conceal rust, deterioration or leaks that are not visible until cleaned, and I am unable to determine if such conditions exist.

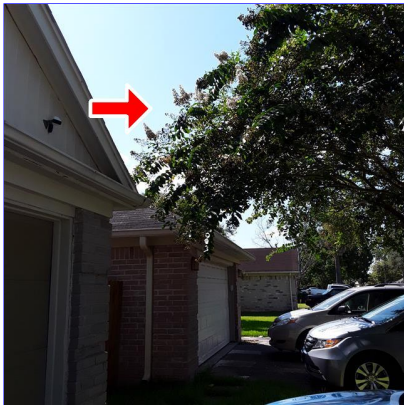
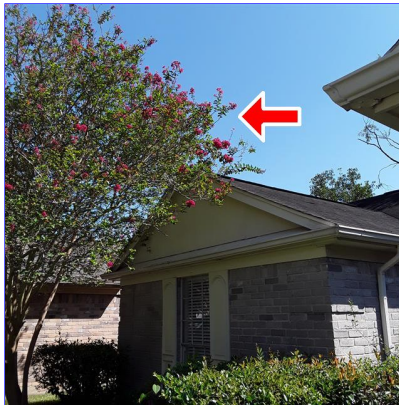
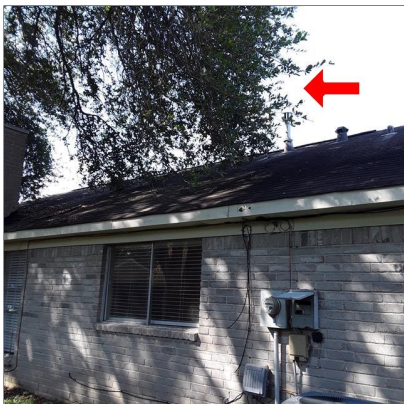
C. Item 1(Picture) front

- (1) This inspection does not warrant against roof leaks.
- (2) The tree limbs that are in contact with roof or hanging near roof should be trimmed.

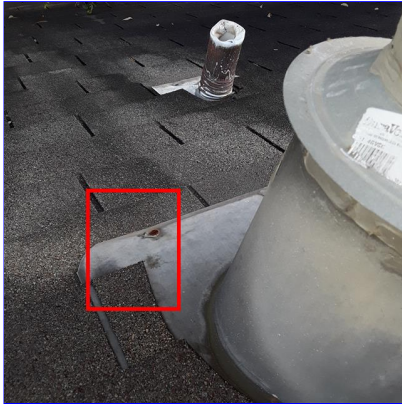
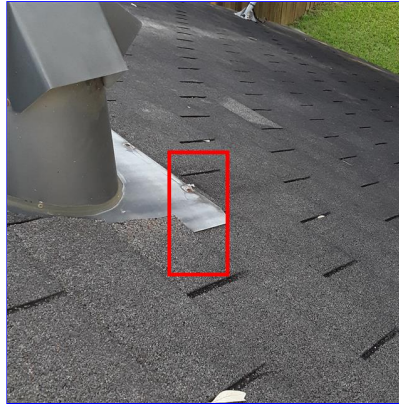
C. Item 4(Picture) multiple areas

- (3) The roofing surface has exposed nail heads that are showing signs of deterioration. Further deterioration will occur if not corrected. I recommend having a qualified person repair or replace as needed.

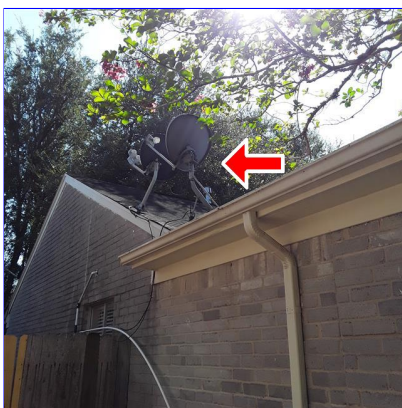
C. Item 7(Picture) left

(4) There is a satellite dish bracket mounted on roof that is screwed directly through roofing surface. This is not considered to be today's standard. I recommend having a qualified person remove and patch roofing as needed. (The area will need periodic maintenance)

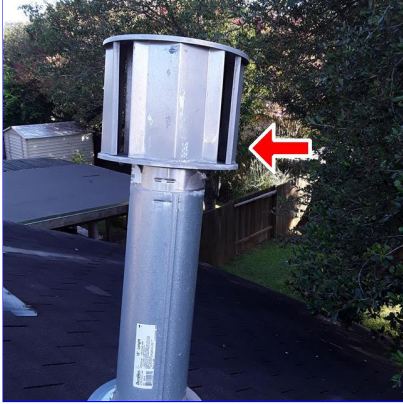
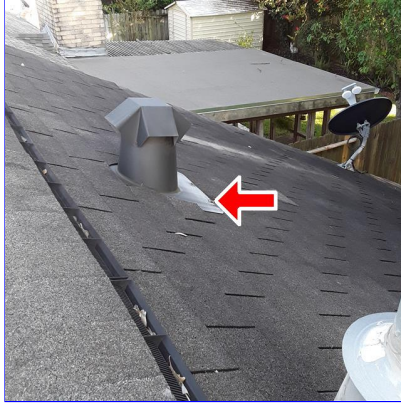
C. Item 8(Picture)

(5) The plumbing and appliance venting at roof level does not have adequate weather coating (Paint) to prevent premature deterioration. This is not considered to be today's standard. I recommend having a qualified person make repairs as needed.

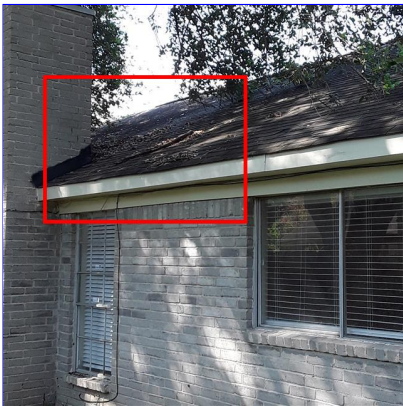
C. Item 10(Picture) rear

(6) Debris is present on roof surface in multiple areas. Having debris present can lead to shingle deterioration and possible moisture problems. I recommend having a qualified contractor remove, inspect and make repairs as needed.

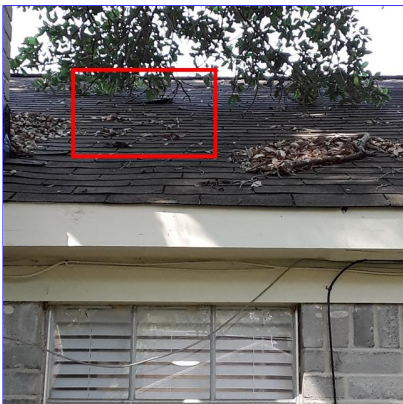
C. Item 11(Picture) rear

(7) The roof covering is damaged in areas. These areas may need replacement and or periodic maintenance. A qualified roofing contractor should inspect and repair as needed.

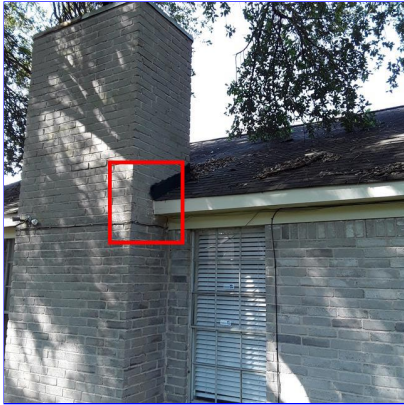
C. Item 12(Picture) rear

(8) Kick out flashing is missing in areas of the roof. This is not considered today's standard. I recommend having a qualified roofing company make repairs as needed.

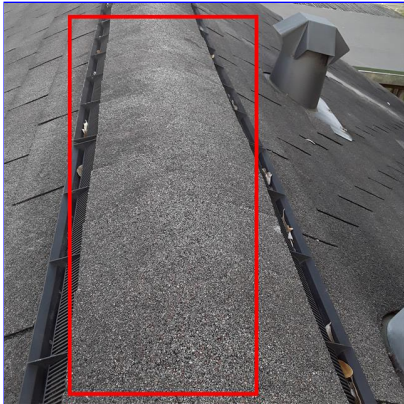
C. Item 14(Picture)

(9) The roof covering is old or worn and the life of covering has expired. The covering does need to be replaced. While it could last a few year or so, some areas may need patching with tar as leaks develop.

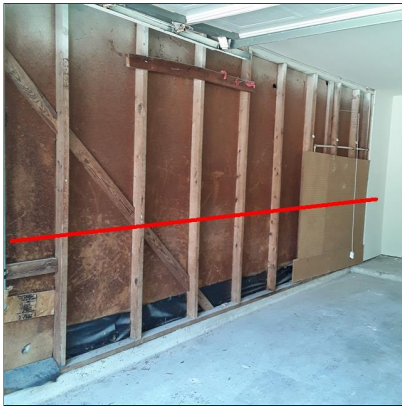
D. Item 1(Picture) garage

(2) There is inadequate fire blocking. This is a safety hazard and should be corrected. I recommend having a qualified person repair or replace as needed.

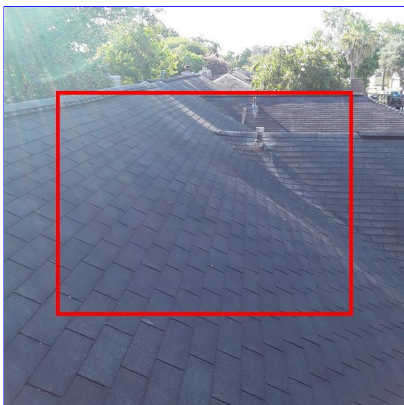
D. Item 4(Picture) front

(3) There are some dips or sags in the roof in areas. The deflection is great enough to need repair or reinforcement. A qualified contractor should repair as needed.

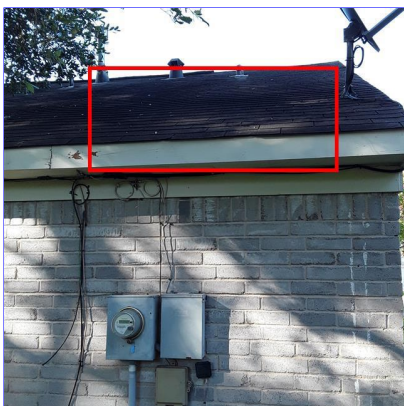
D. Item 5(Picture) rear

(4) There are some dips or sags in the roof in areas. This is typical of older construction where possibly the rafters were undersized and created a sag. A qualified contractor should repair as needed.

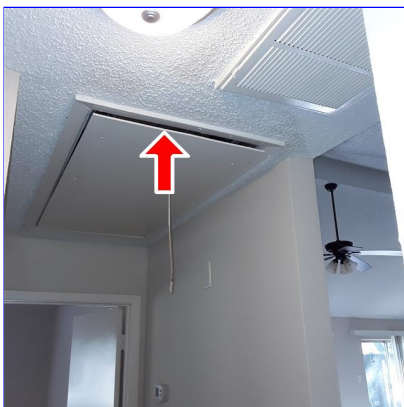
D. Item 7(Picture)

(5) The pull down stairs does not shut properly. This can cause some heat loss in winter and loss of cool air in summer if not corrected. A qualified contractor should inspect and repair as needed.

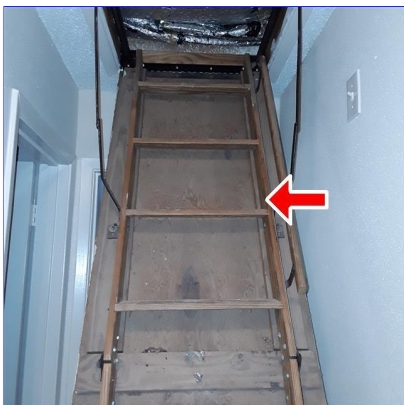
D. Item 8(Picture)

(6) The pull down stairs are not properly insulated. This can cause some heat loss in winter and loss of cool air in summer if not corrected. I recommend repair as desired.

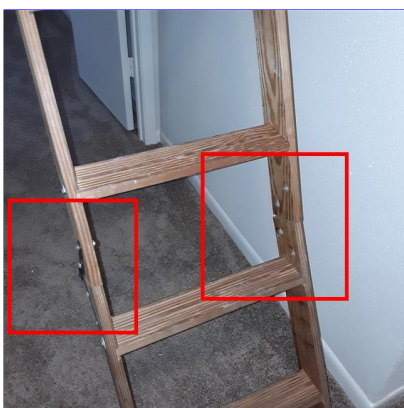
D. Item 9(Picture)

(7) The pull down stairs are weak and not stable. Injury could result if not repaired. A qualified person should repair or replace as needed.

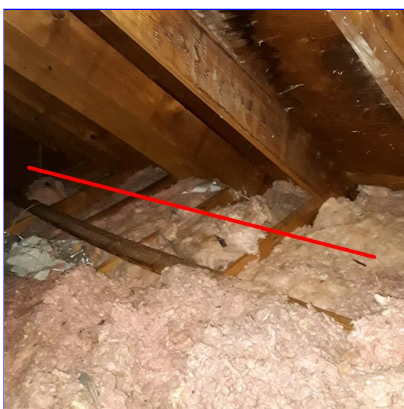
D. Item 10(Picture)

(8) The attic space has areas of thin insulation. This is causing energy loss and is not today's standard. I recommend having a qualified person evaluate and add insulation as needed.

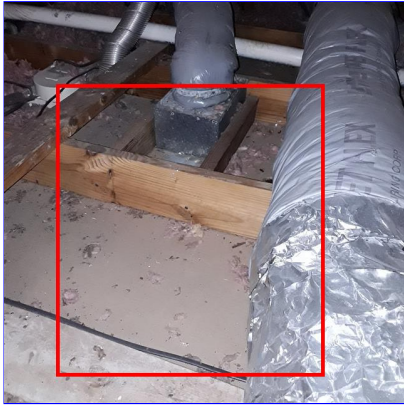
D. Item 11(Picture)

(9) The attic space has areas of missing insulation. This is causing energy loss and is not today's standard. I recommend having a qualified person evaluate and add insulation as needed.

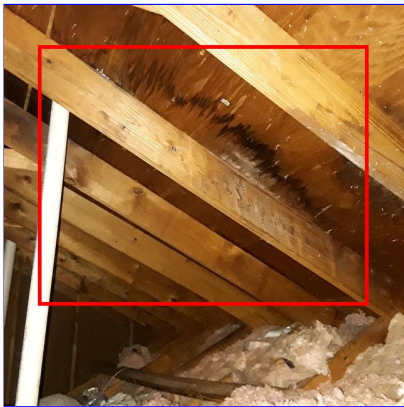
D. Item 13(Picture)

(10) Water signs are on plywood resulting from a roof leak found around the plumbing exhaust pipe. I am unable to determine if leak has been corrected. A qualified roofing contractor should inspect further and correct as needed.

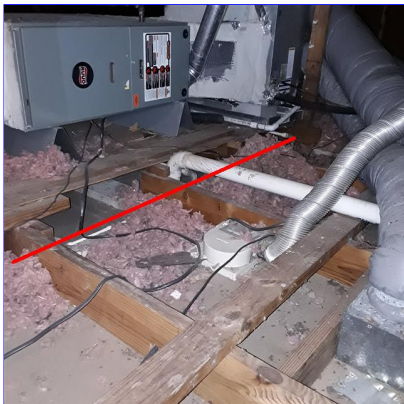
D. Item 14(Picture)

(11) The attic space is missing adequate service access decking. This is not considered to be today's standard. I recommend having a qualified person install decking.

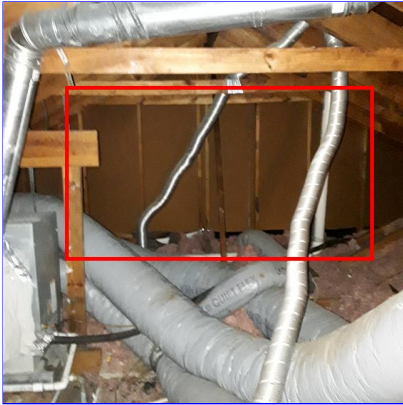
D. Item 15(Picture)

(12) The moisture barrier is missing in the attic. This is not considered today's standards. I recommend repair by a qualified person.

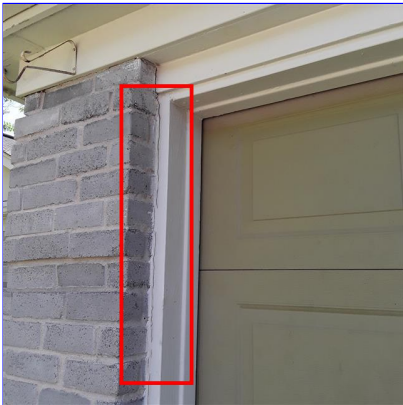
E. Item 1(Picture) garage

(1) The siding exterior has caulking that is weathered or missing and some lifted nails. Deterioration can eventually occur if not corrected. A qualified person should repair as needed.

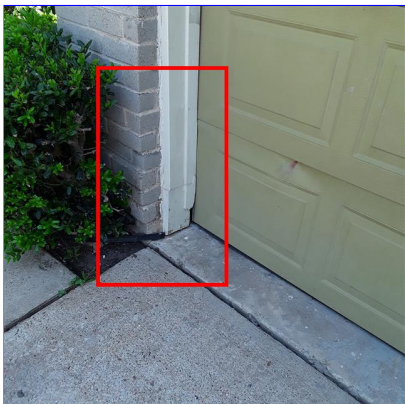
E. Item 4(Picture) garage

(2) The paint is failing. I recommend prep and paint at the exterior.

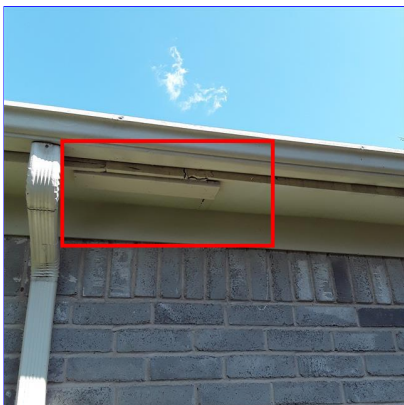
E. Item 7(Picture) front right

(3) The exterior siding and trim is deteriorated in areas. Further deterioration will occur if not corrected. A qualified contractor should inspect and repair as needed.

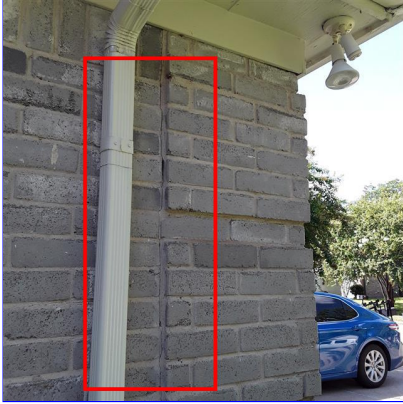
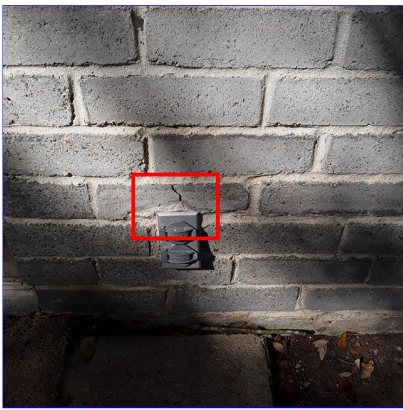
E. Item 17(Picture) entry

(5) The brick siding at the exterior has hairline cracks. Deterioration can eventually occur if not corrected. A qualified contractor should inspect and repair as needed.

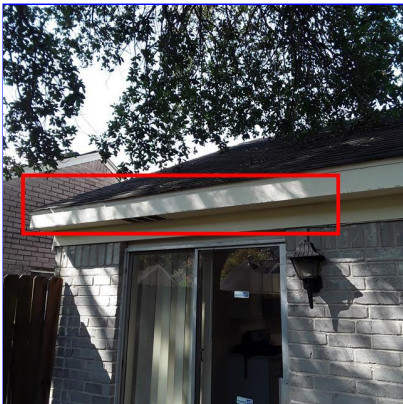
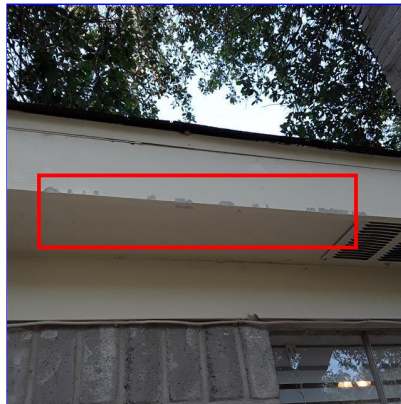
E. Item 20(Picture) rear

(6) The cement board exterior is damaged. Deterioration can eventually occur if not corrected. A qualified person should repair or replace as needed.

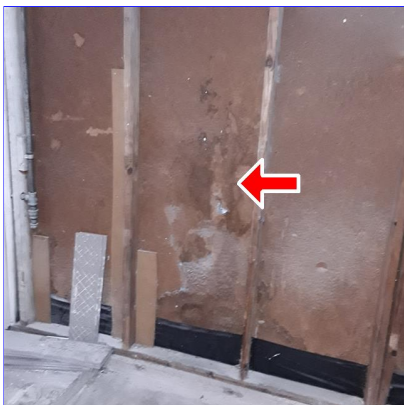
E. Item 22(Picture) garage right

(7) The composition board on the wall is damaged garage. While this damage is cosmetic, it needs to be repaired. A qualified person should repair or replace as needed.

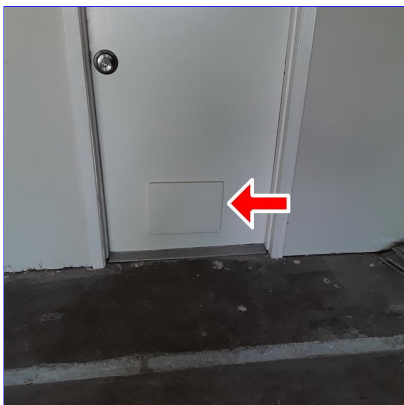
G. Item 1(Picture) garage

(1) The main entry door had a pet access door installed. This is a maintenance issue and is for your information. A qualified person should repair or replace as needed.

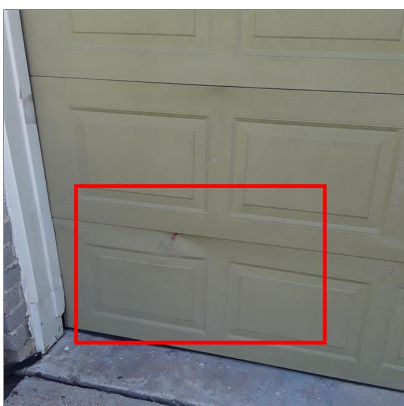
G. Item 2(Picture)

(2) The garage door at the front of home is damaged at panel. This is a maintenance issue and is for your information. A qualified person should repair or replace as needed.

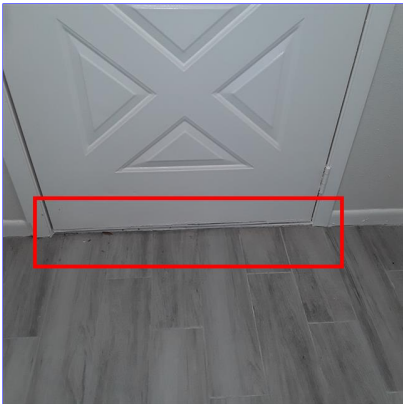
G. Item 6(Picture) entry

(6) There are door stops missing in the home. This is not considered to be today's standard I recommend having a qualified person make repairs as needed.

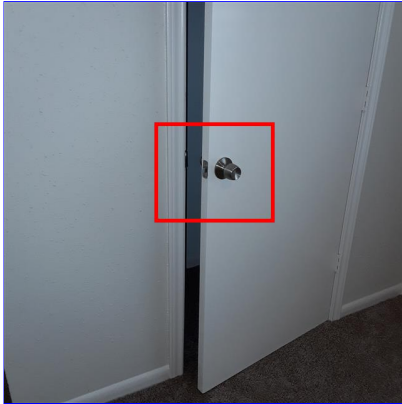
G. Item 8(Picture) front bedroom

(8) The door does not stay open properly and needs adjustment . A repair or replacement is needed. A qualified person should repair or replace as needed.

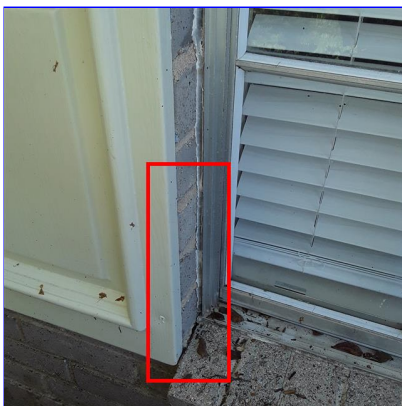
H. Item 1(Picture) front

(1) There are window frames that are not properly sealed. This can cause energy loss. I recommend having a qualified person seal and repair as needed.

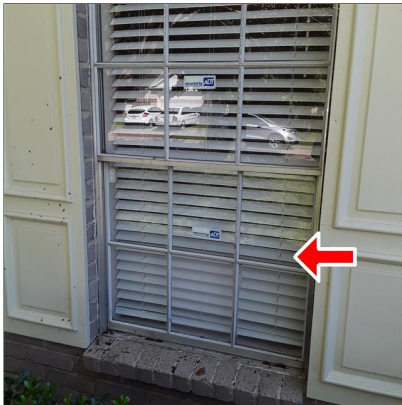
H. Item 3(Picture) front

(3) Lintels above windows are showing signs of deterioration in areas. Further deterioration may occur if lintels are not primed and painted. A qualified person should repair as needed.

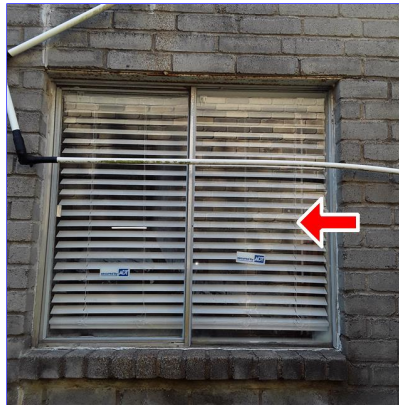
H. Item 4(Picture) multiple windows exterior

(4) There is a damaged window that has been replaced with plexiglass. I recommend having a qualified person make repairs as needed.

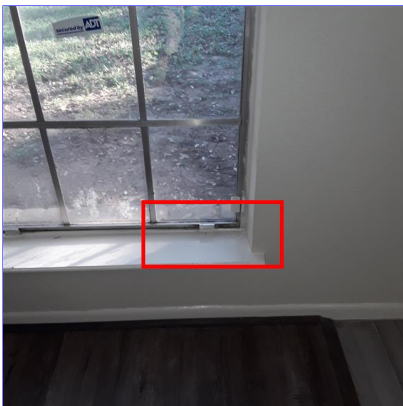
H. Item 7(Picture) living room  
right

(5) Some windows do not lock properly in areas. Further deterioration may occur if not repaired. A qualified person should repair or replace as needed.

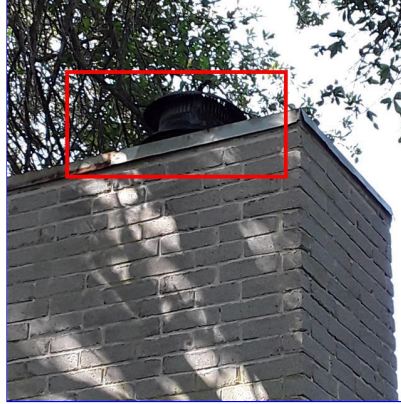
J. Item 2(Picture) rear

(2) Metal rain cap on chimney crown is rusting and is damaged. I recommend repair by a qualified person.

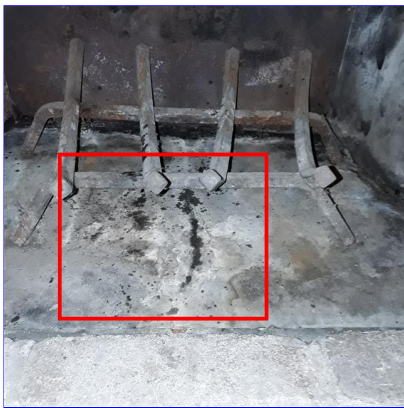
J. Item 3(Picture) water present in fireplace

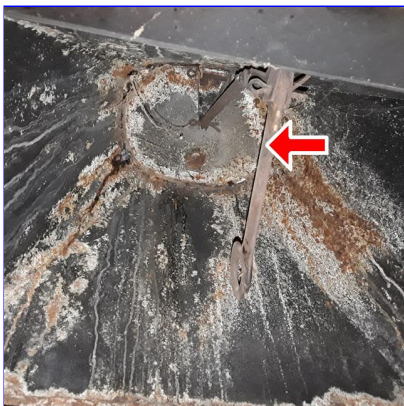
J. Item 4(Picture)

(3) The damper for fireplace is rusted tight or "seized" (non-operational). Repairs should be made so unit works properly. I recommend a qualified contractor inspect and repair as needed.

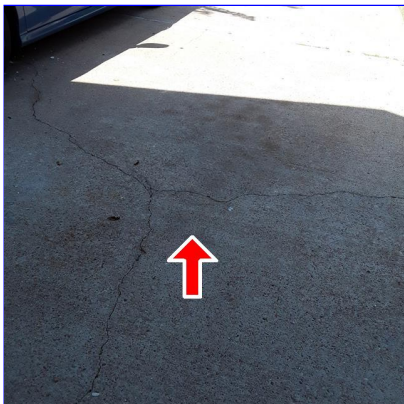
L. Item 1(Picture)

(1) The concrete drive at the garage has settlement cracks. Further deterioration can occur if not repaired. A qualified person should repair or replace as needed.

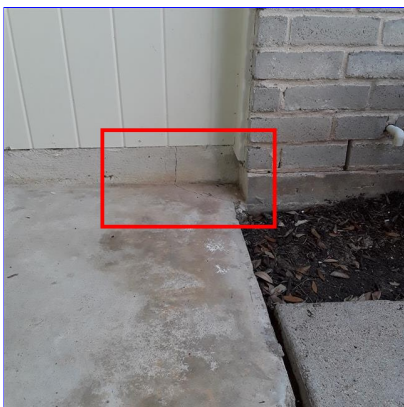
L. Item 2(Picture) entry right

(2) The concrete walkway in areas of home has settlement cracks. Further deterioration can occur if not repaired. A qualified person should repair or replace as needed.

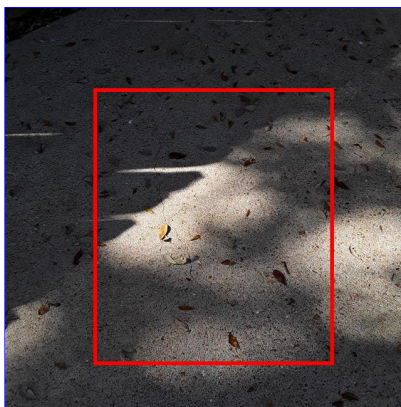
L. Item 3(Picture) rear

(3) There is debris stacked against the structure creating conducive conditions for certain types wood destroying insects. I recommend removal of debris and having a qualified pest control company inspect and treat as needed.

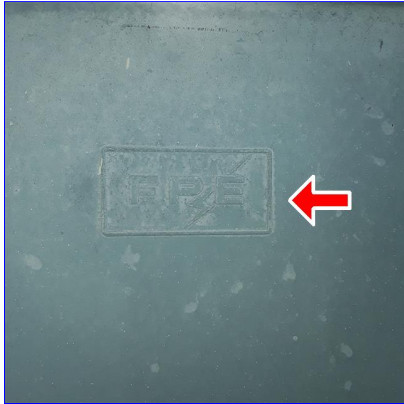
A. Item 1(Picture)

(1) You have a Federal Pacific panel which is legal, but there is a possibility that the circuit breakers may not trip when shorted possibly causing an electrical hazard. Opinions by most licensed electrical contractors on this panel is that it is unsafe. I recommend you consult a licensed electrical contractor for necessary replacement.

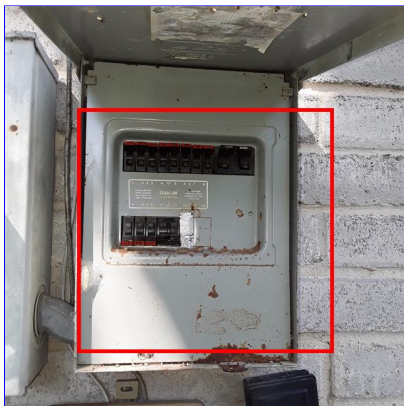
A. Item 2(Picture)

(2) The panel is missing circuit identification. **This is a safety hazard.** I recommend having a qualified person mark circuits as needed.

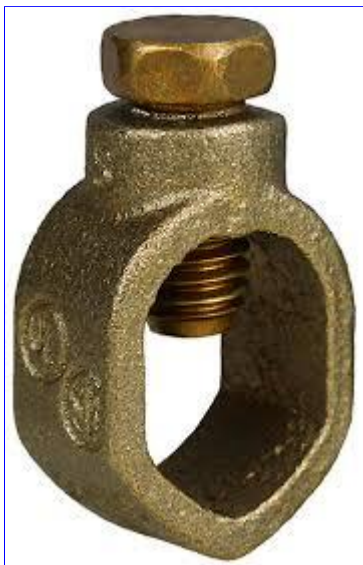
A. Item 3(Picture)

(3) The grounding rod near meter is using improper clamp for grounding of main panel (solid brass clamp is recommended). This is not considered to be today's standard. I recommend having a qualified person replace with proper clamp to assure proper grounding.

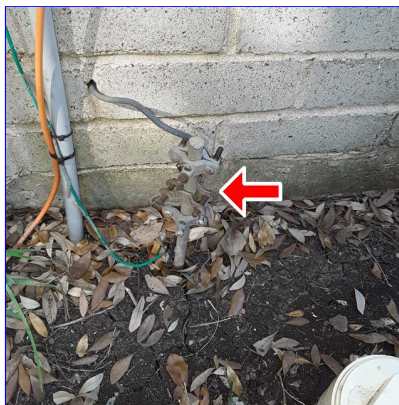
A. Item 4(Picture) rear

(4) The panel is showing deterioration and is not sealed properly. Electrical issues are considered a hazard until repaired. I recommend having a qualified person make repair or replace as needed.

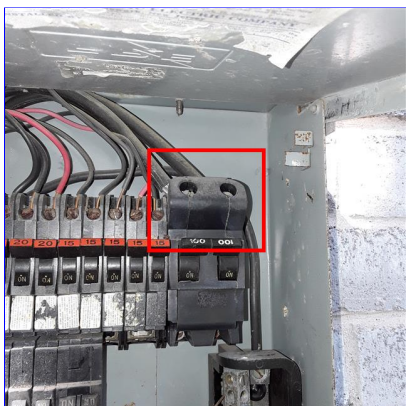
A. Item 7(Picture)

(6) There is no antioxidant on aluminum conductors feeding panel. This is not considered to be today's standard. I recommend having a qualified electrician evaluate make repairs as needed.

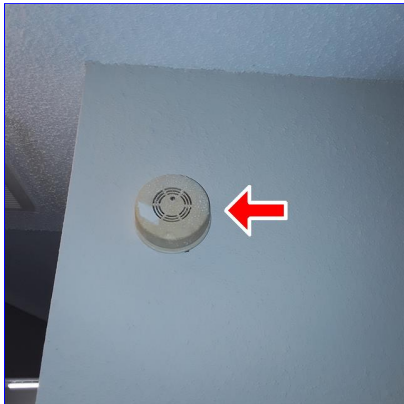
B. Item 1(Picture)

(2) The light fixture is missing cover in areas. This is a safety issue that needs to be corrected. I recommend repair as needed.

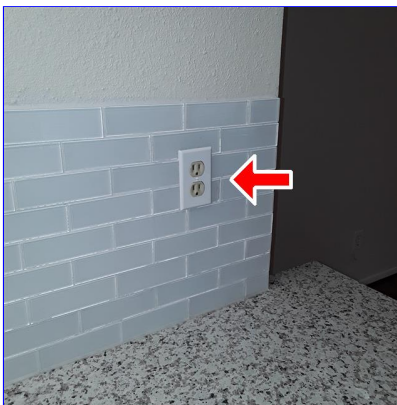
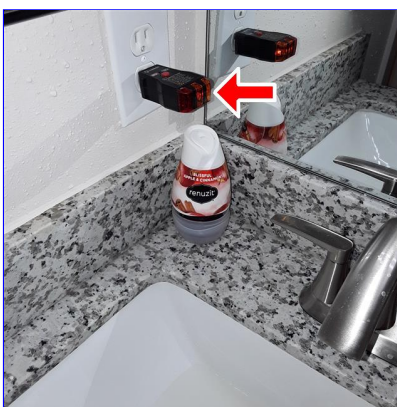
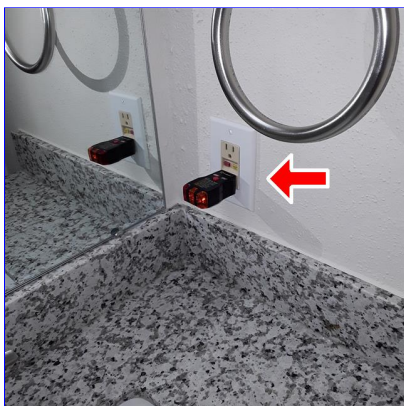
(4) There is exposed wiring in areas of the home. This is a safety hazard. I recommend having a qualified electrician inspect and make repairs as needed.

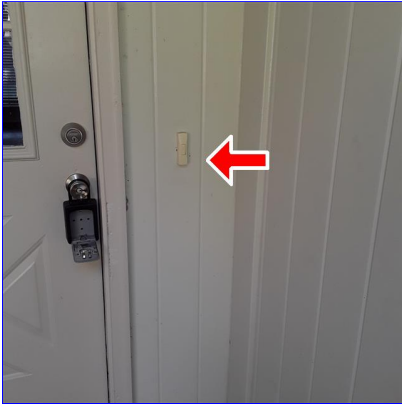
B. Item 13(Picture)

(6) Problem(s) discovered with Branch Circuits such as amateur wiring installation, doubled wiring at neutral/grounding bar and any other problems that an electrical contractor may discover while performing repairs need correcting. I recommend a licensed electrical contractor inspect further and correct as needed.

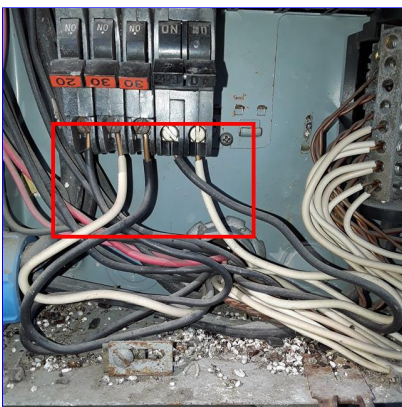
B. Item 16(Picture) white wires should be marked black

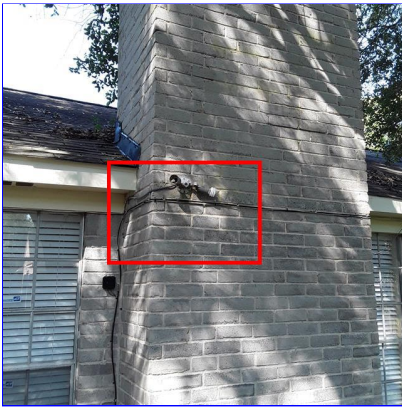
B. Item 18(Picture) rear

(8) The light fixture does not work (try bulb first). Electrical issues are considered a hazard until repaired. A qualified licensed electrical contractor should perform repairs that involve wiring.

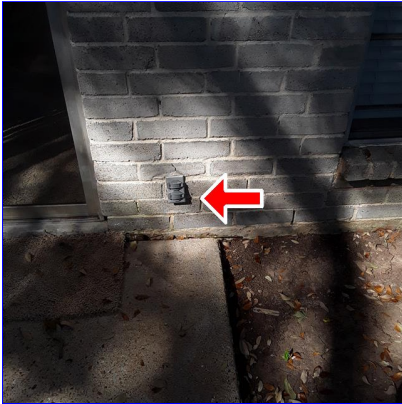
B. Item 21(Picture) patio

(9) The exterior outlet at the rear of home did not work or there is no power to outlet. Electrical issues are considered a hazard until repaired. A qualified licensed electrical contractor should perform repairs that involve wiring.

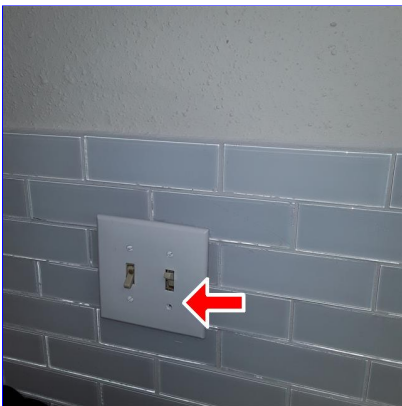
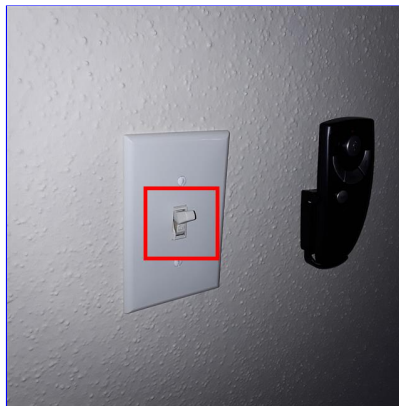
(10) The wall switch is loose in the wall. Electrical issues are considered a hazard until repaired. A qualified licensed electrical contractor should perform repairs that involve wiring.

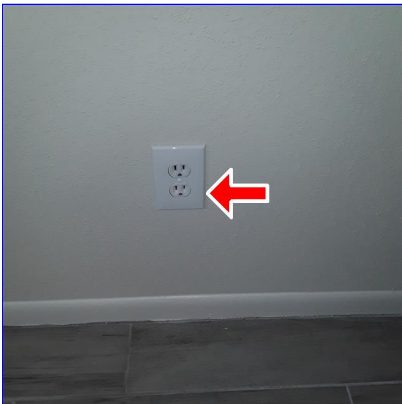
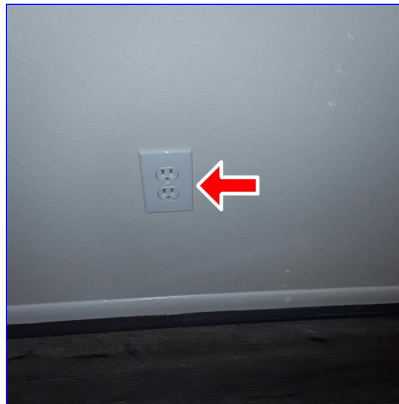
(11) "Three-prong" outlets are are loose in wall in most if not all rooms. Electrical issues are considered a hazard until repaired. A qualified licensed electrical contractor should perform repairs that involve wiring.

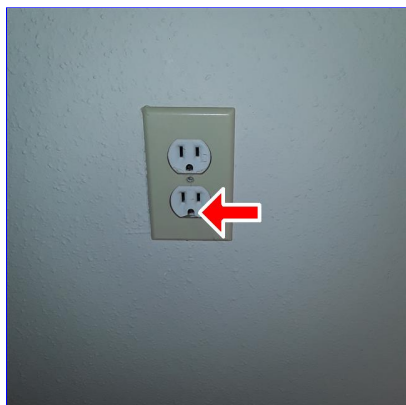
B. Item 26(Picture) breakfast area    B. Item 27(Picture) multiple areas

(12) "Three-prong" outlets are broken or damaged. Electrical issues are considered a hazard until repaired. A qualified licensed electrical contractor should perform repairs that involve wiring.

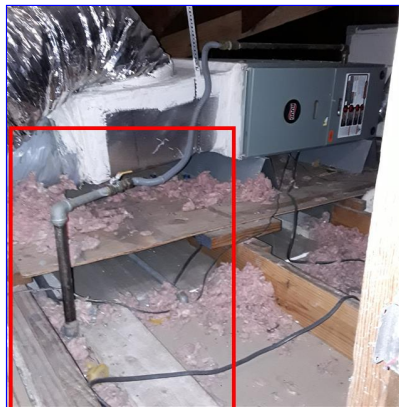
A. Item 3(Picture)

(4) The gas furnace is installed without the recommended sediment trap or "drip leg" that is designed to extend the life of the unit. This is not considered to be today's standard. I recommend having a qualified person make repairs as needed.

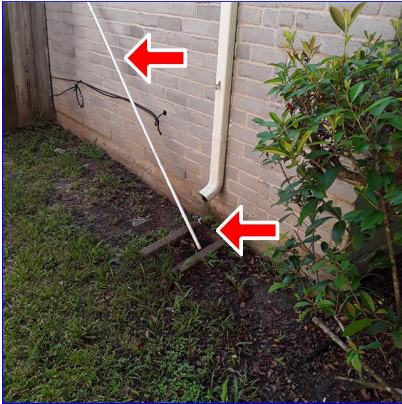
B. Item 1(Picture) left

(2) The ac condensate line discharges next to the home. This can cause foundation problems. I recommend repair by a qualified person.

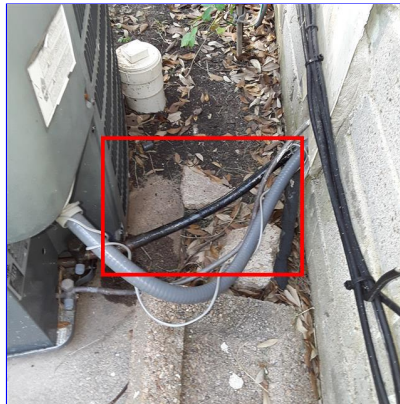
B. Item 3(Picture)

(3) The condenser is not level and is missing foam sleeve in area(s). This can cause damage to the unit or shorten its life span. A licensed HVAC contractor should service or repair unit.

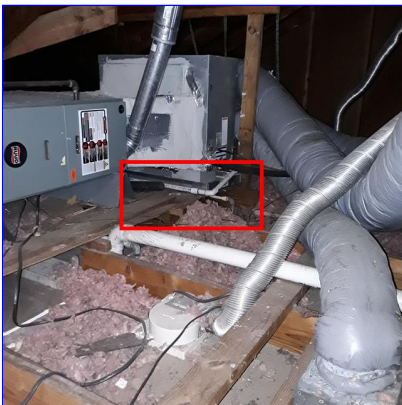
B. Item 4(Picture)

(4) The air handler is missing foam sleeve in area(s). A replacement is needed. I recommend service or repair as needed.

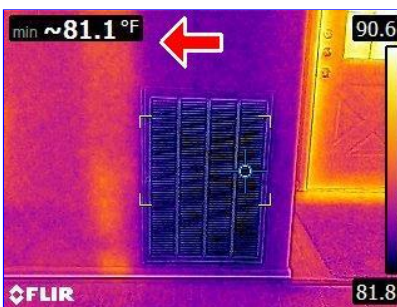
B. Item 6(Picture) return

(5) The ambient air test was performed by using infrared thermal equipment at the supply vents of Air conditioner to determine if the difference in temperatures of the supply and return air are between 14

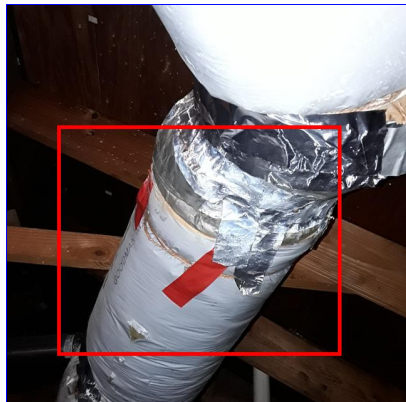
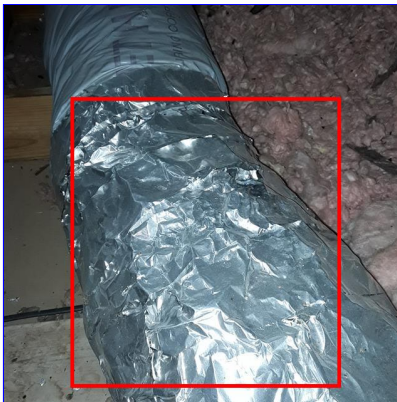
- (1) I recommend changing all HVAC filters upon move in.
- (2) The supply is damaged in the attic. Energy loss is occurring where duct tape has failed. I recommend service or repair as needed.

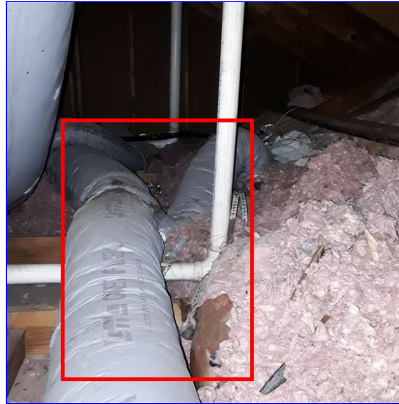
C. Item 4(Picture)

- (3) The supply needs support straps in the attic. Energy loss is occurring. I recommend service or repair as needed.

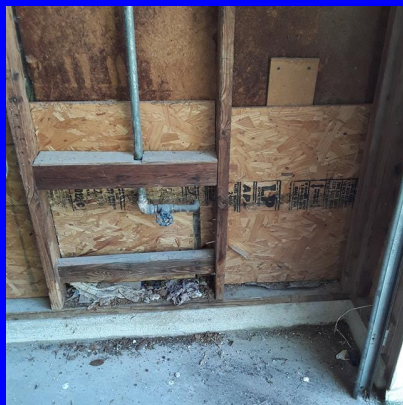
water shut off garage

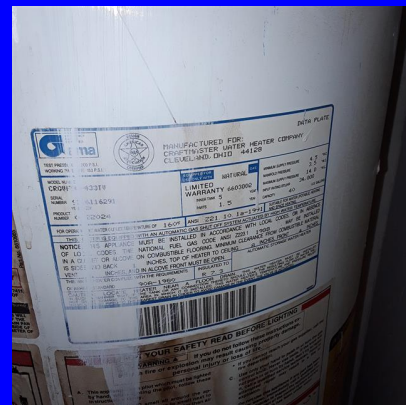
data plate

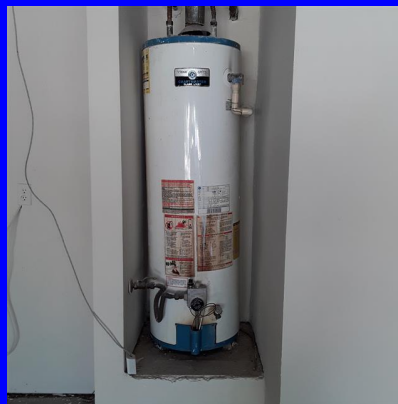
40 gallon water garage

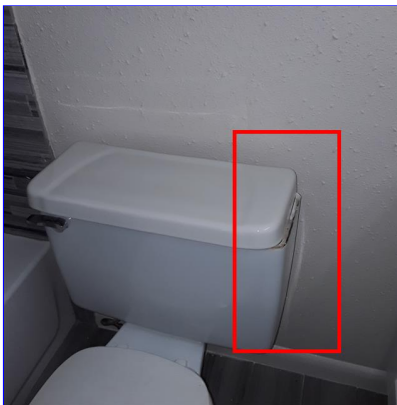
A. Item 6(Picture) toilet lid does not fit properly primary bath

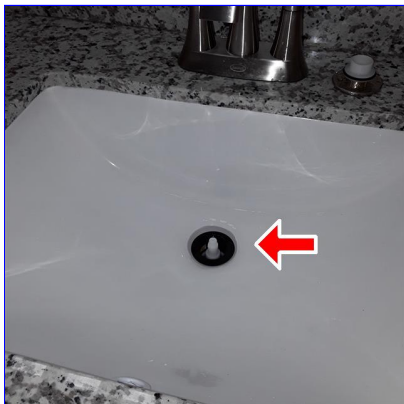
B. Item 1(Picture) primary bath

The bath sink stopper mechanism is not working properly. I recommend repairs as needed.

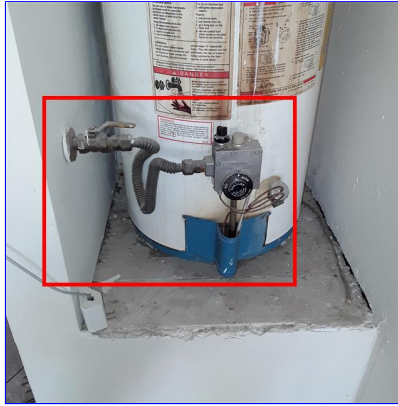
C. Item 2(Picture)

(2) The water heater is installed without the recommended emergency overflow drain pan. This is not considered to be today's. I recommend having a drain pan installed by a qualified person.

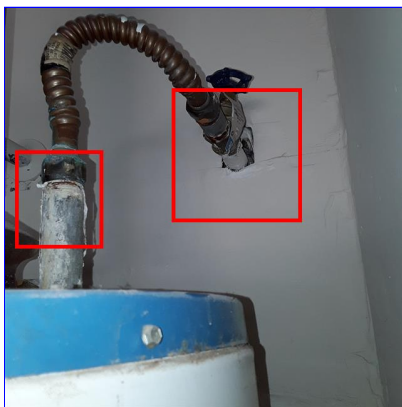
C. Item 4(Picture)

(3) The water heater has corrosion at fittings. I recommend having a qualified person make repairs as needed.

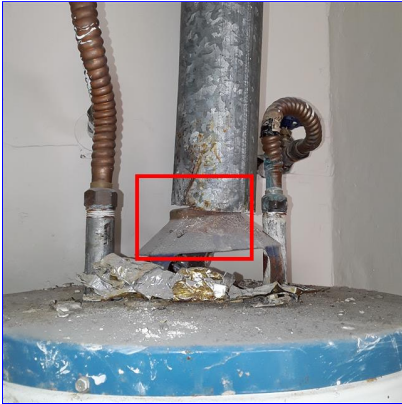
C. Item 5(Picture) pipe not connected

(5) The existing piping for T&P valve on water heater fails to extend downward to within six inches of ground. This is a safety issue and should be repaired. A qualified licensed plumber should repair or correct as needed.

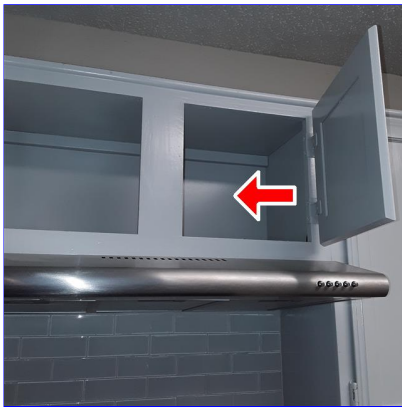
C. Item 1(Picture)

(2) The kitchen vent hood does not vent to the outdoors. This is not considered to be today's standard.

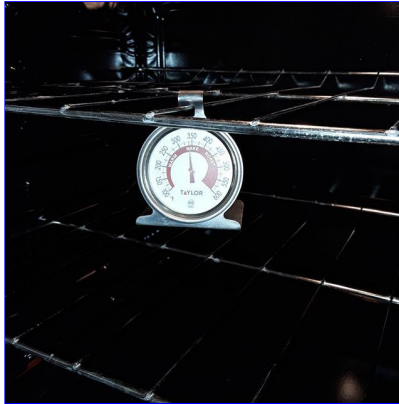
D. Item 2(Picture) oven tested at 350 degrees

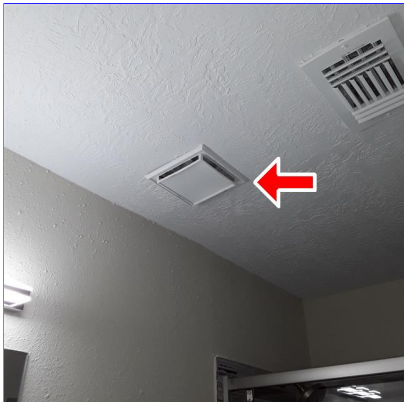
F. Item 1(Picture)

The exhaust fan is noisy at the hall bath. This is for informational purpose to you. A qualified person should repair or replace as needed.
