Inspection Report

Property Address:
19614 Bear Springs Dr
Katy TX 77449

PROPERTY INSPECTION REPORT

By: Ryan Andrasek 21573 / SEI Inspections 8/6/2020

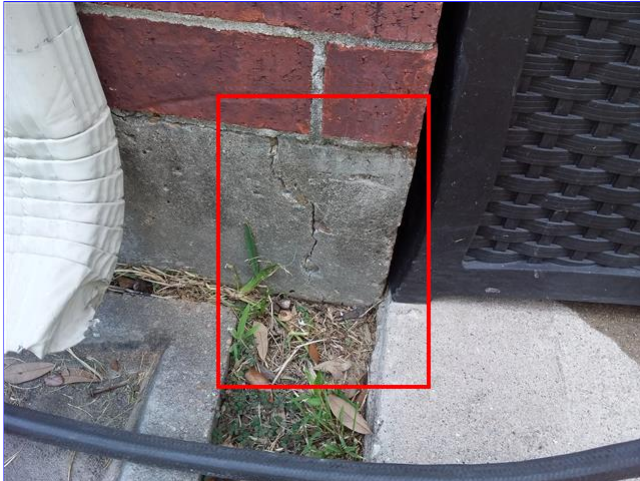
A. Item 1(Picture) A crack in the foundation was discovered at the left front corner.

- Corner cracks in foundations are not a structural issue. However corner cracks are an excellent entry point for wood destroying insects. It's recommended that the cracks be sealed.

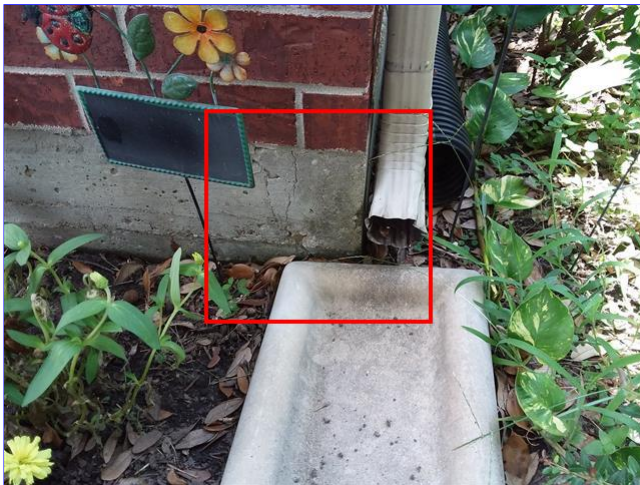
A. Item 2(Picture) A crack was discovered at the right front corner of the garage.

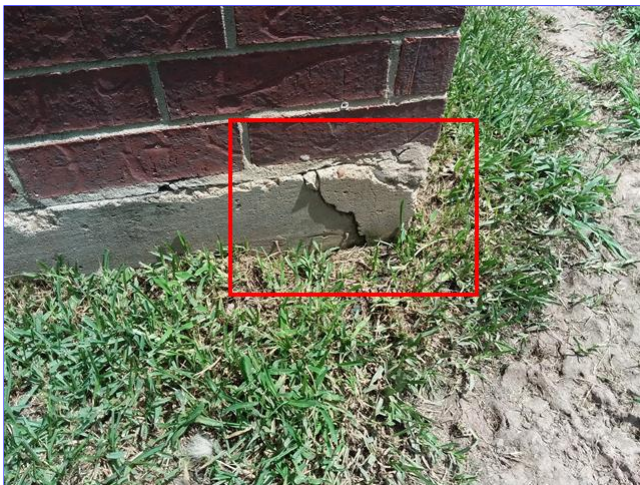
A. Item 3(Picture) Cracks at the corners of the foundation at multiple areas.

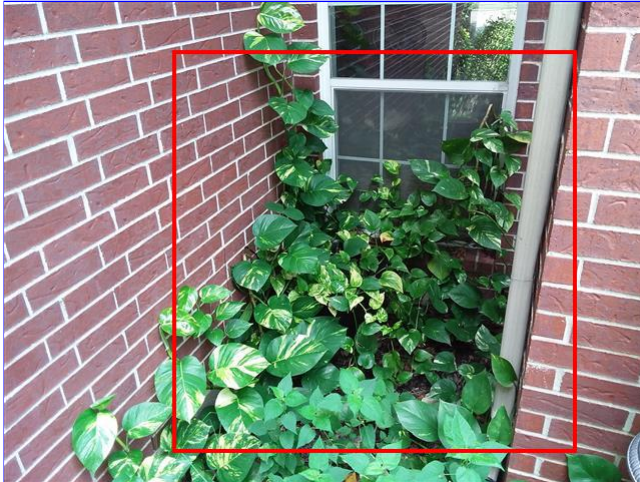
B. Item 1(Picture) Vegetation should not be on the structure.

- In order to protect the structure from moisture and or insect damage, it is recommended to have a professional landscaper cut all vegetation back to at least six inches from the structure.

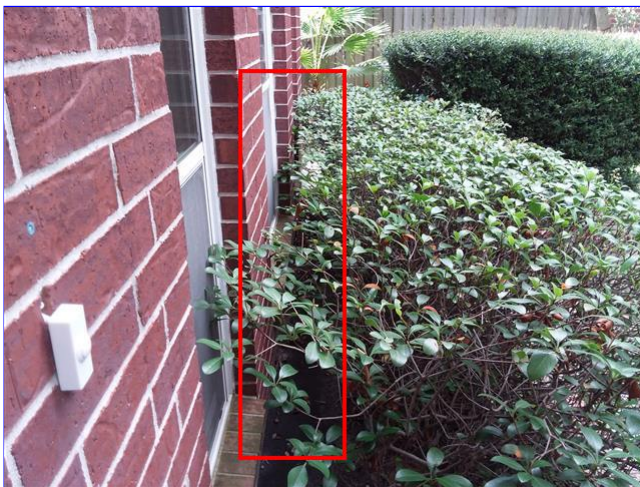
B. Item 2(Picture) Vegetation at the front of the home is too close to the structure.

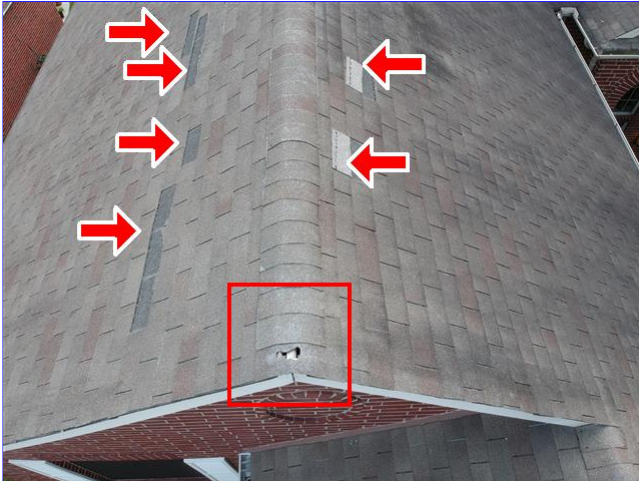
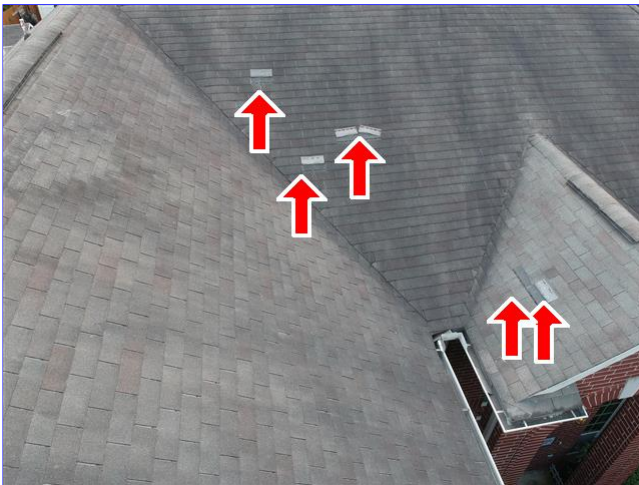
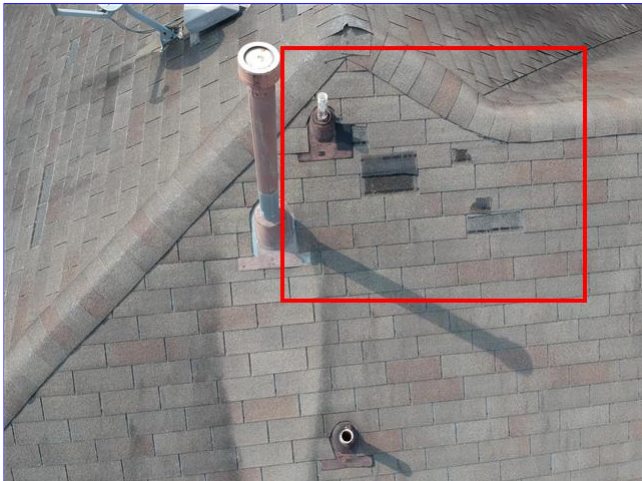
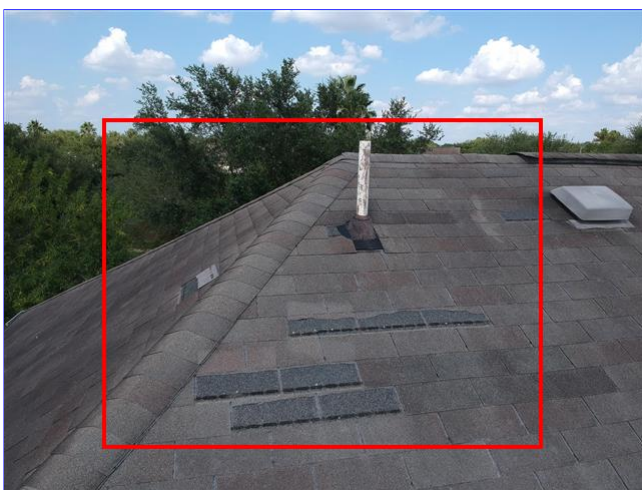
C. Item 1(Picture) Shingles are missing and or damaged at the multiple areas of the roof.

C. Item 2(Picture) Shingles are missing and or damaged at the multiple areas of the roof.

C. Item 3(Picture) Shingles are missing and or damaged at the multiple areas of the roof.

C. Item 4(Picture) Shingles are missing and or damaged at the multiple areas of the roof.

- In order to prevent potential water intrusion into the home, it's recommended that the missing shingles be secured.

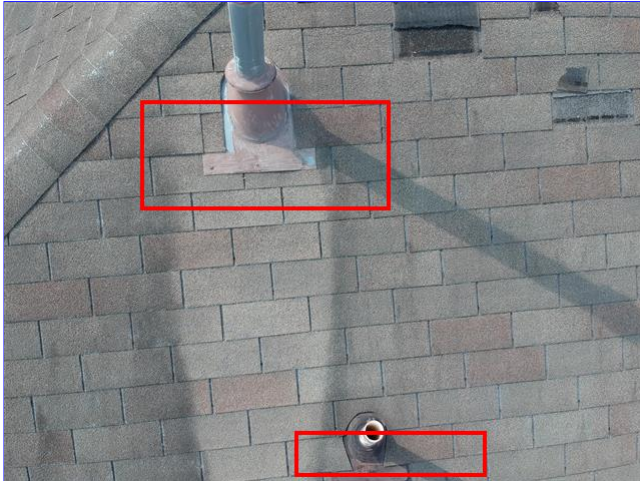
C. Item 5(Picture) Exposed nail heads at multiple areas around the home.

- In order to prevent premature corrosion of the roof nails, which could lead to potential water leaks and lifted flashing or shingles, it's recommended that all exposed nail heads on the roof system be covered with a roofing sealant.

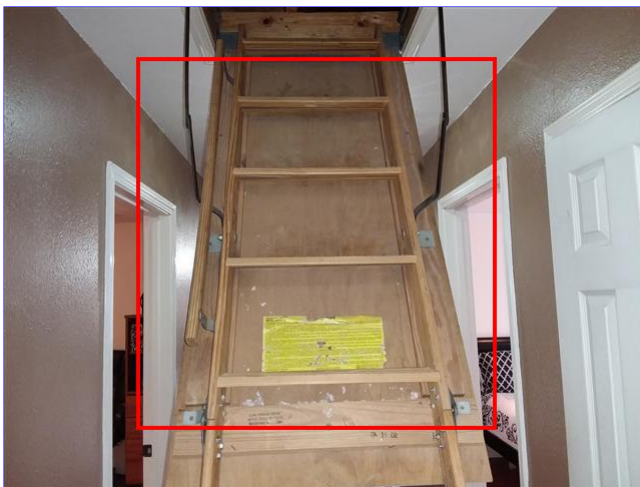
D. Item 1(Picture) Insulation missing from attic ladder assembly.

- In order to prevent heat transfer from the attic into conditioned spaces, it is recommended to have a licensed contractor install insulation at the attic ladder assembly.

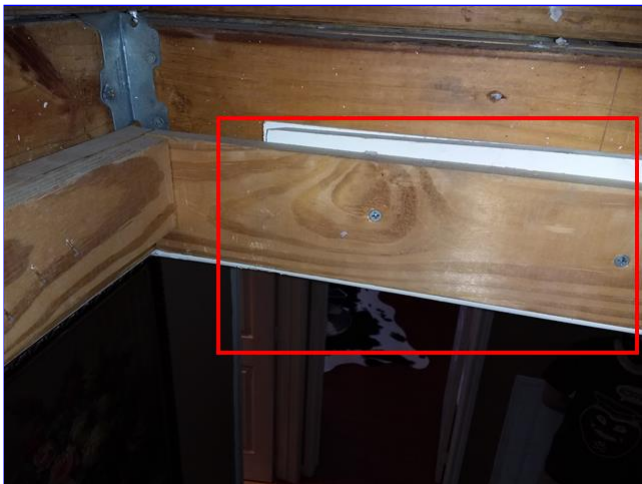
D. Item 2(Picture) The incorrect fasteners were used at the attic ladder assembly.

- In order for the attic pull down stairs to be properly secured, the pull down stair framing needs to have 3-16d nails or 3" lag screws on the long sides (one nail installed at each pivot hinge) and 2-16d nails or 3" lag screws on the short sides. It's recommended that a professional carpenter install the proper amount of nails.

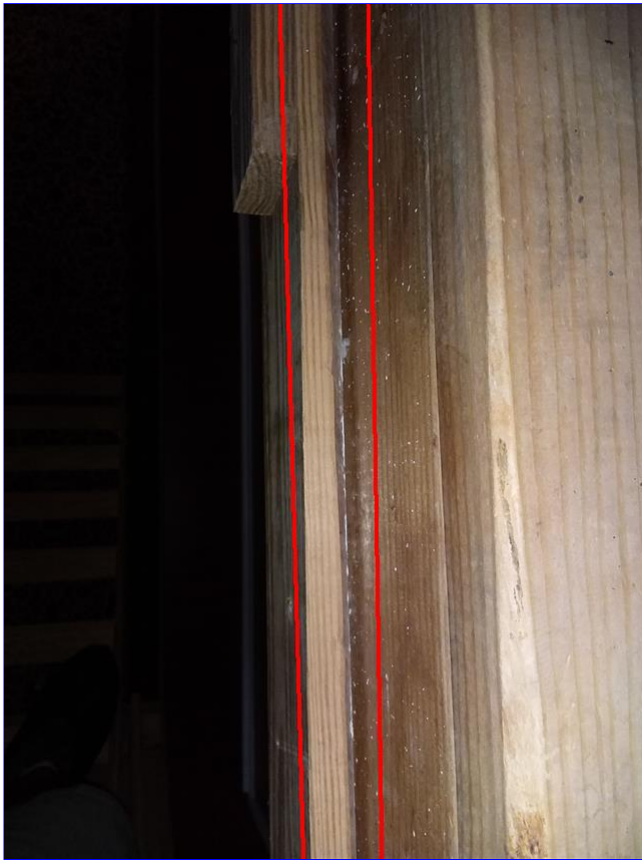
D. Item 3(Picture) foam seal is missing from the attic rough opening.

- In order to ensure the home is properly sealed and insulated, it's recommended that the missing foam insulation be installed between the attic access jamb and the rough frame opening.

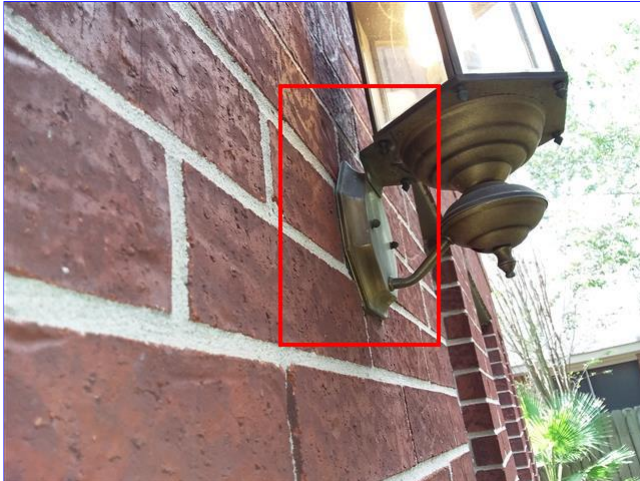
E. Item 1(Picture) Wall mounted light fixtures should be sealed to the wall.

- In order to prevent water penetration into the home and/or the electrical wiring of the fixture, it's recommended that all exterior light fixtures be sealed to the wall they are installed on.

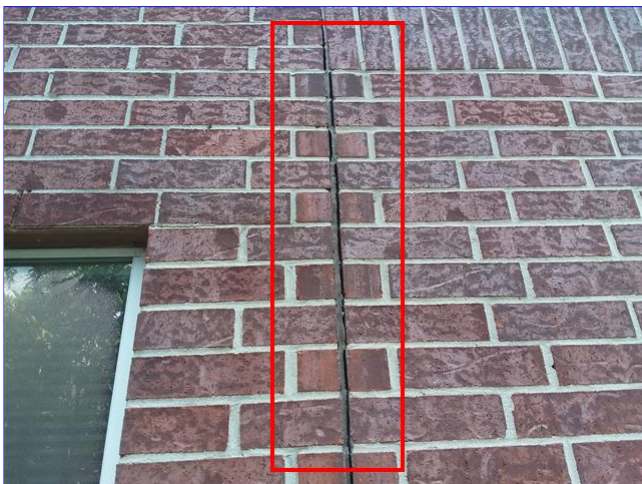
E. Item 3(Picture) Re caulk the expansion joint at the right exterior.

- In order to prevent excessive water intrusion behind the brick, it's recommended that all expansion joints be sealed with an exterior caulk.

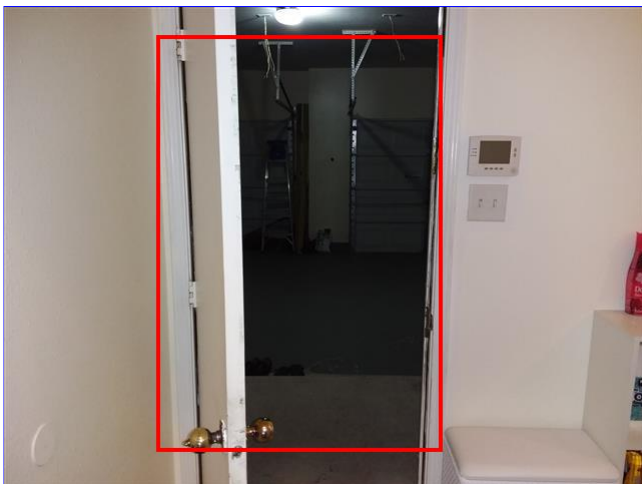
F. Item 1(Picture) Garage walk in door should self close.

- In order to slow the spread of a potential fire, prevent potential stored chemical vapors and automotive exhaust from entering the home, it's recommended that the garage to interior door have self closing hinges activated or installed.

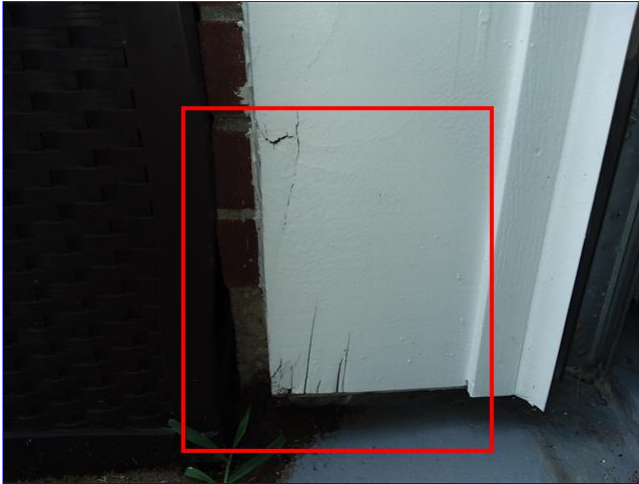
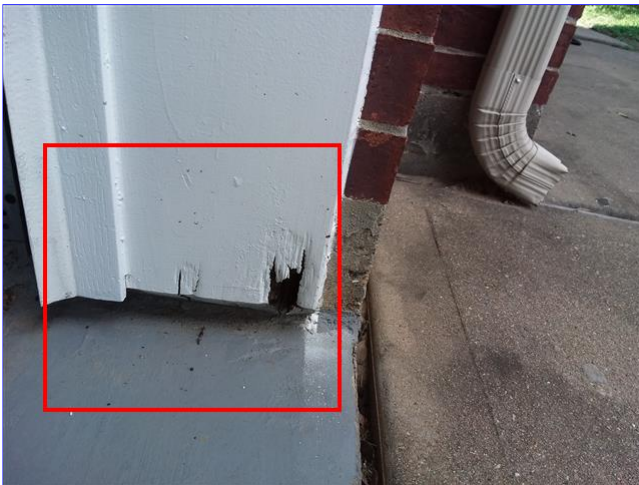
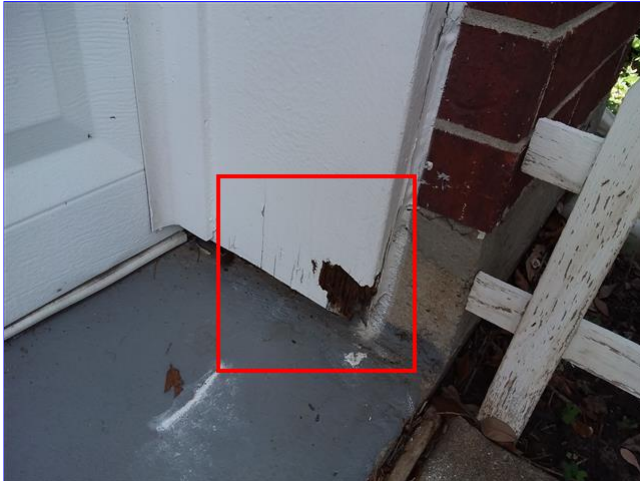
F. Item 2(Picture) Wood rot was discovered at the base of both garage doors frames.

F. Item 3(Picture) Wood rot was discovered at the base of both garage doors frames.

F. Item 4(Picture) Wood rot was discovered at the base of both garage doors frames.

- In order to prevent water damage to the frame of the home, it's recommended that the rotted door jamb be repaired or replaced by a professional carpenter.

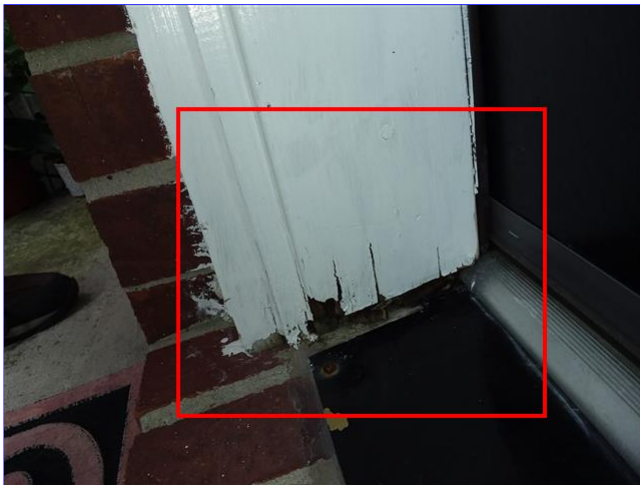
F. Item 5(Picture) Wood rot is discovered at the front door frame base.

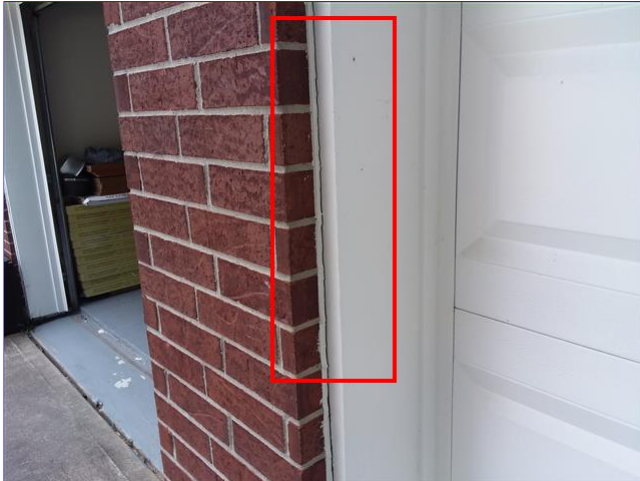
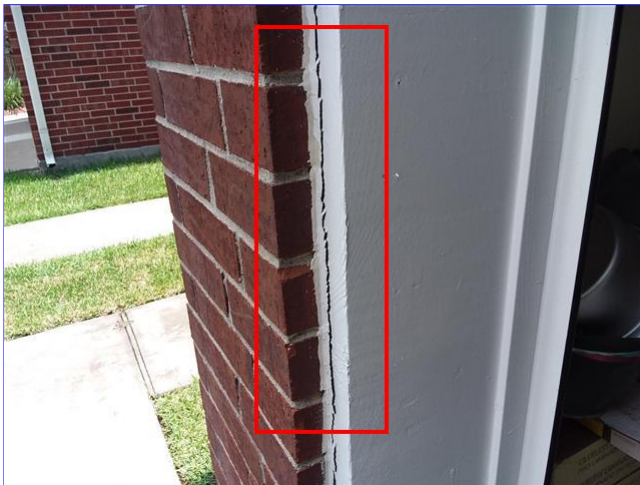
F. Item 6(Picture) Caulking is separating at the garage door frames.

F. Item 7(Picture) Caulking is separating at the garage door frames.

(3) In order to prevent moisture from getting into the interior of the home, it is recommended to re caulk all areas that around the home.

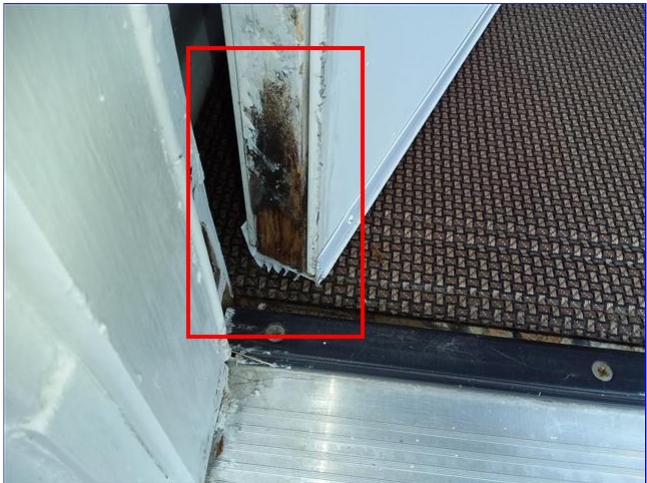
F. Item 8(Picture) Rear entry door is showing signs of wood rot on the inside.

- (4)
- In order to prevent further damage to the door, it is recommended to have a professional contractor evaluate for remedy or replacement.

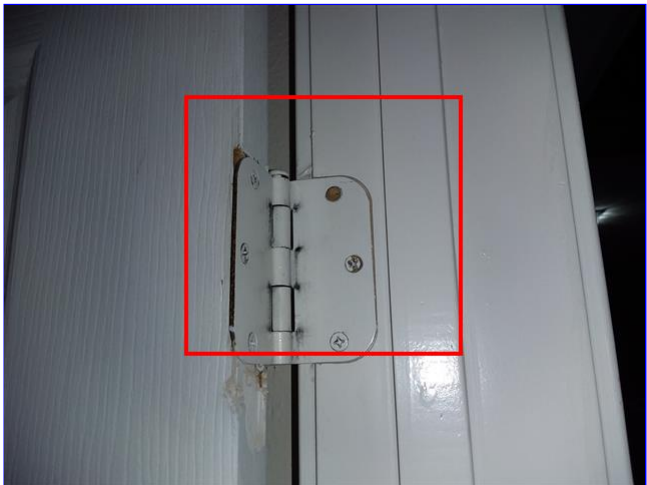
F. Item 9(Picture) Hinge screw is missing from second floor left front bedroom.

- (5)
- In order to prevent damage to the door jamb, it's recommended that a professional carpenter install the missing hinge screws at the areas indicated in this section of the report.

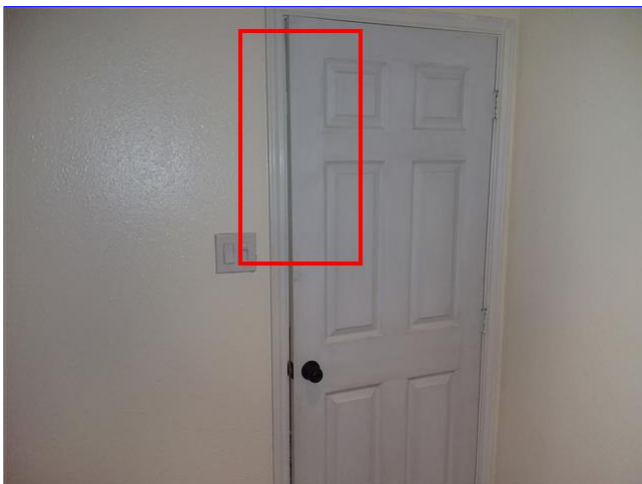
F. Item 10(Picture) Door to the second floor office is not hung correctly and will not close.

- (6)
- In order to prevent damage to the interior doors, it's recommended that a professional carpenter adjust the rubbing doors so they open and close with out any friction between the jamb and door.

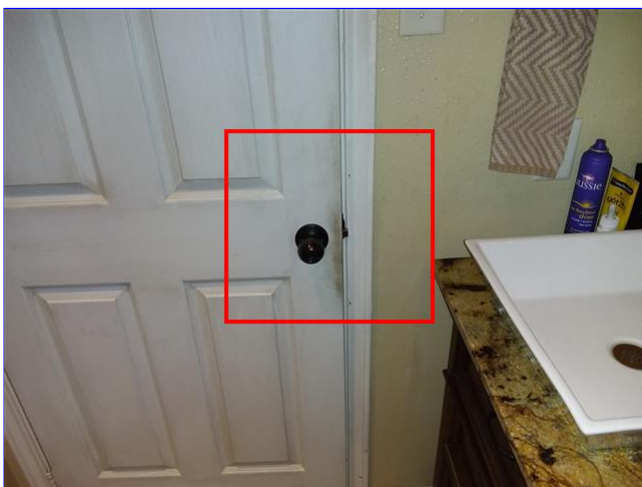
F. Item 11(Picture) Second floor hallway bathroom door will not katch at the hardware.

- It's recommended that a professional carpenter adjust the non latching door in this section of the report, so it closes and latches fully to the striker plate.

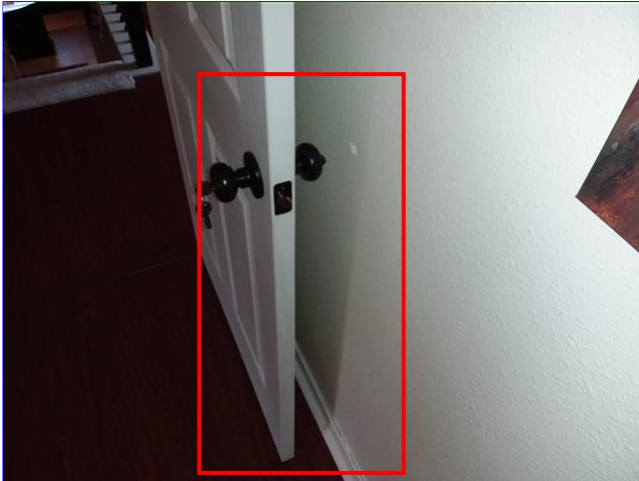
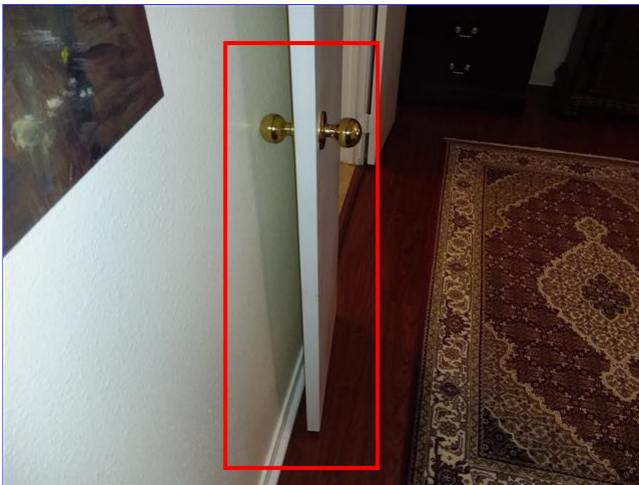
F. Item 12(Picture) Door stops missing from multiple doors around the home.

F. Item 13(Picture) Door stops missing from multiple doors around the home.

- In order to prevent damage to the walls and/or doors, it's recommended that a professional carpenter replace all missing or damaged door and/or hinge stops in the home.

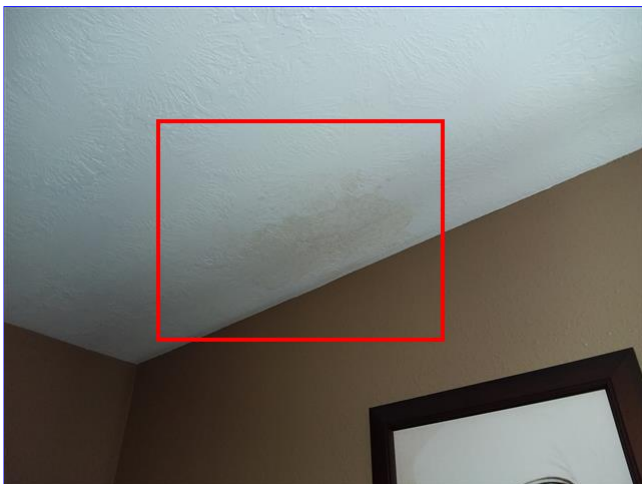
G. Item 1(Picture) Moisture staining was discovered at the ceiling in the second floor living room.

- It is recommended that the water stained areas be monitored during rain events and if moisture shows up, a professional roofer should be contacted for further inspection.

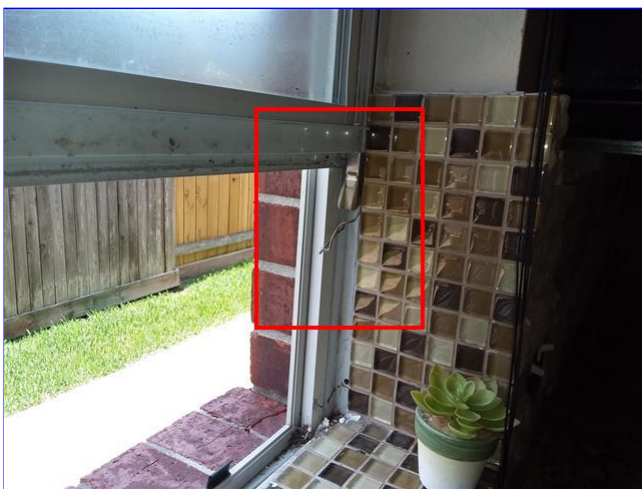
H. Item 1(Picture) Guide spring is detached at the kitchen window.

- In order to ensure the safe and proper function of the windows, it's recommended that a professional window glazer re-install the loose window springs.

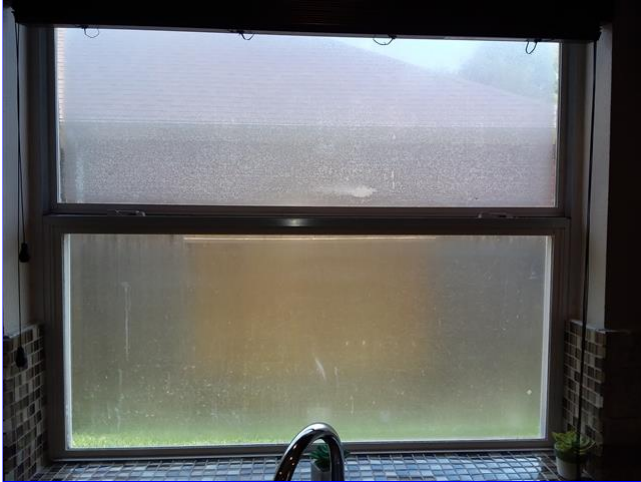
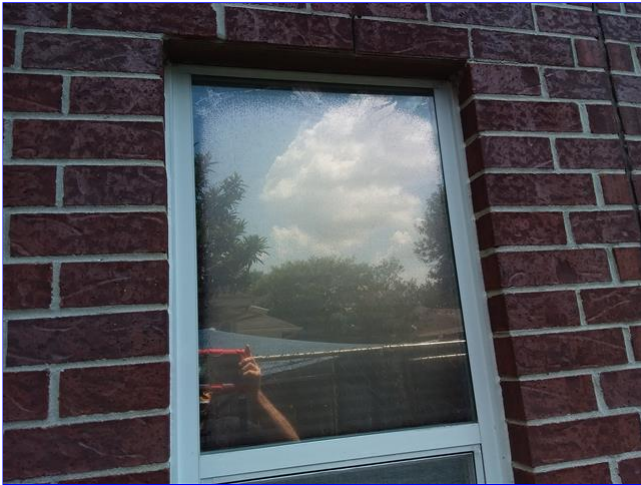
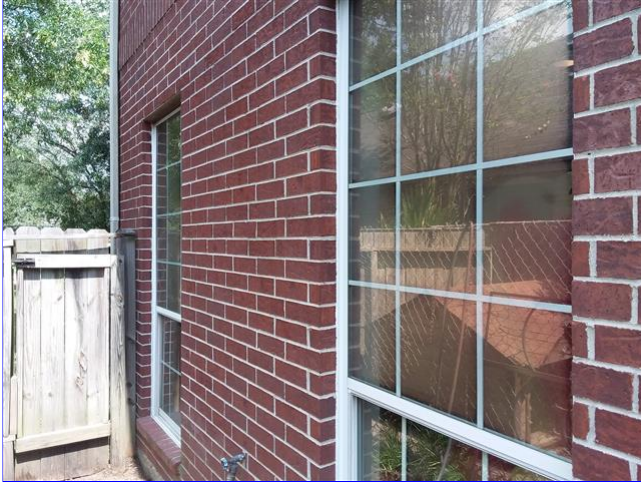
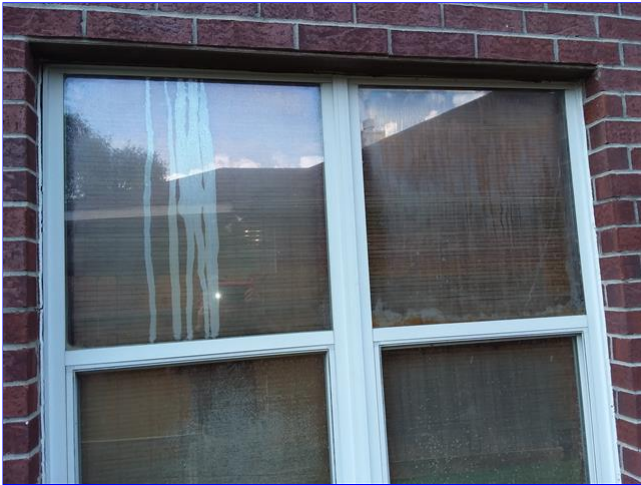
H. Item 2(Picture) Thermal seal is damaged at kitchen window.

H. Item 3(Picture) Thermal seal is damaged at kitchen window.

H. Item 4(Picture) Multiple windows around the home have damaged thermal seals.

H. Item 5(Picture) Multiple windows around the home have damaged thermal seals.

- Due to the break down in the protective shield, it is recommended to always replace.

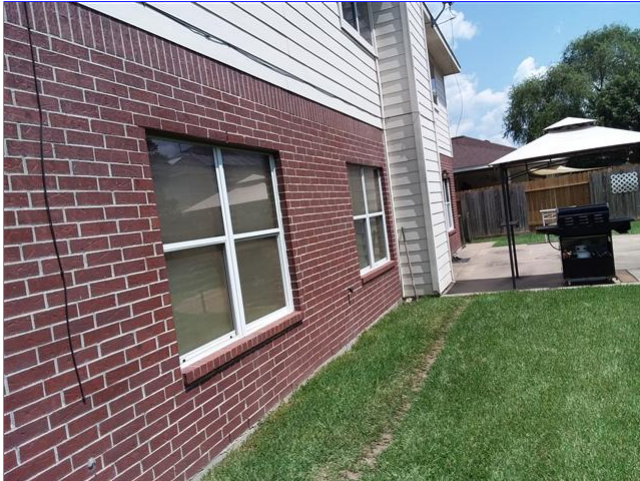
H. Item 6(Picture) Screens are missing from multiple windows around the home.

- In order to prevent the intrusion of flying insect into the home when the windows are open, it's recommended that the missing window screens be replaced.

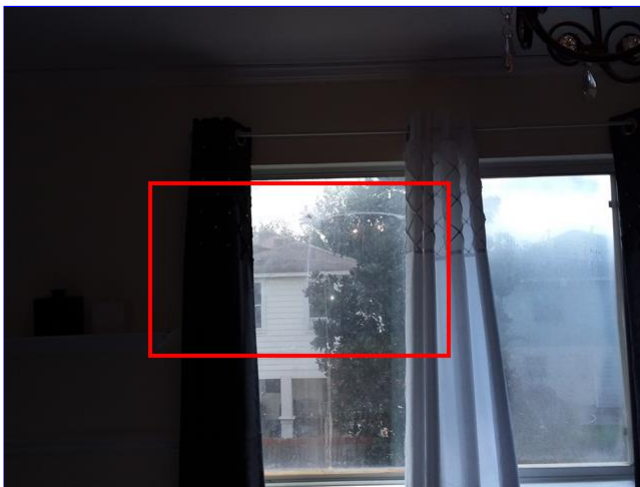
H. Item 7(Picture) Cracked window in the second floor left rear bedroom.

- For safety purposes and to prevent water intrusion into the home, it's recommended that the broken window pane be replaced by a professional window glazer.

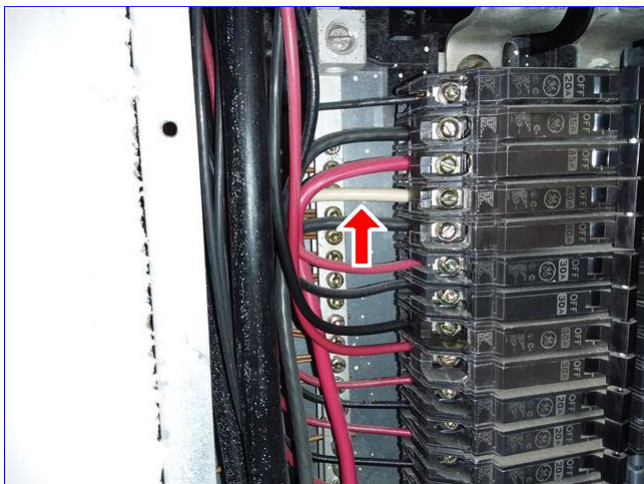
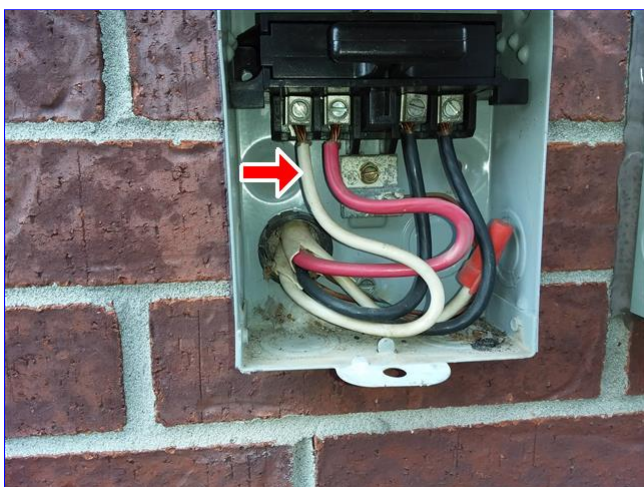
A. Item 1(Picture) White wires are not marked black in the electrical service panel.

A. Item 2(Picture) White wires are not marked black in a/c cutoff switches at the left exterior.

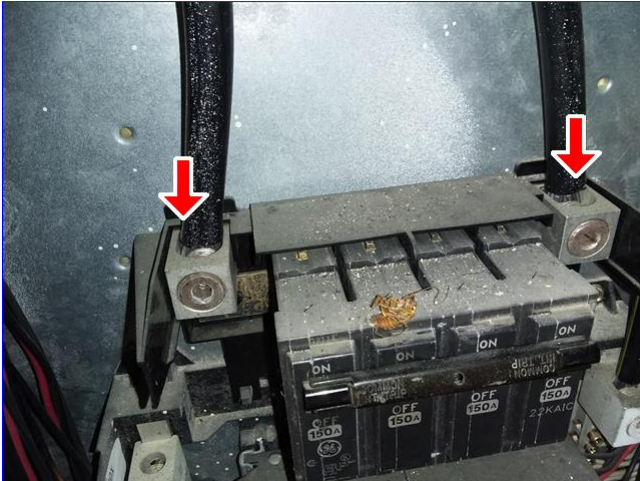
A. Item 3(Picture) Aluminum wiring in electrical service panel is missing anti oxidant paste.

- In order to prevent oxidation of the aluminum electric service line connection at the electric panel service box (which could lead to loose connections in the future), it's recommended that a licensed electrician apply the anti oxidant paste at the connections.

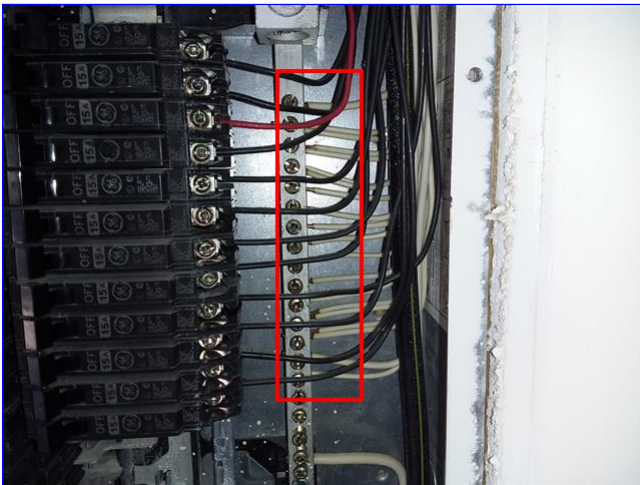
A. Item 4(Picture) Neutral wires are double lugged in the electrical service panel.

- In order to prevent the neutral wires from becoming loose, it is recommended to have a licensed electrician install each neutral wire on its own lug.

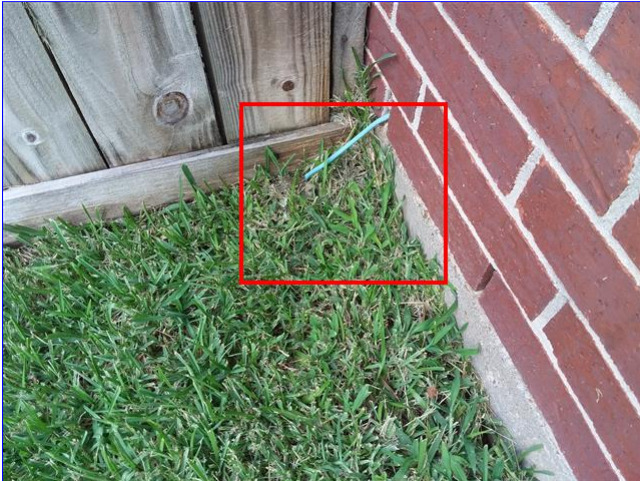
A. Item 5(Picture) Secondary ground wire is not attached to grounding rod.

- In order to be properly grounded, it is recommended to have a licensed electrician properly secure the grounding cable.

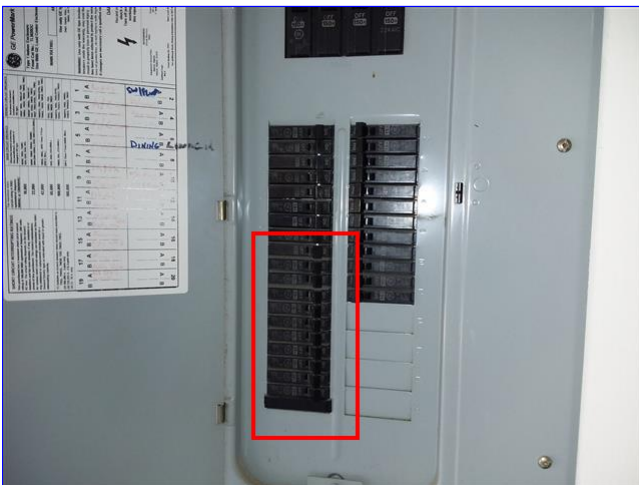
A. Item 6(Picture) Arc fault breakers missing from the electrical service panel.

- It is recommended that a licensed electrician inspect the items listed in this section of the report and make any necessary repairs and/or replacements.

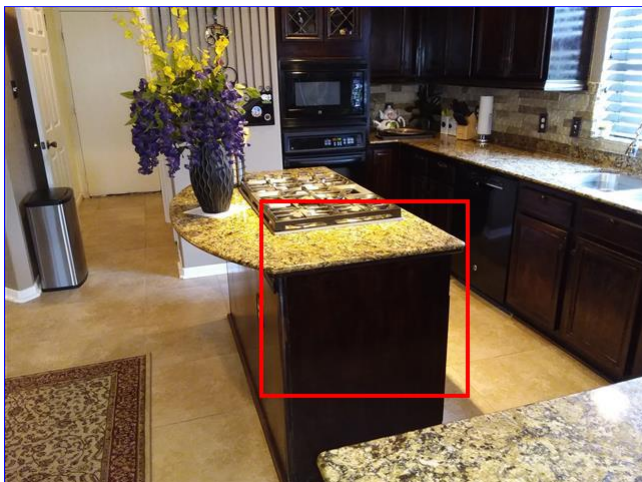
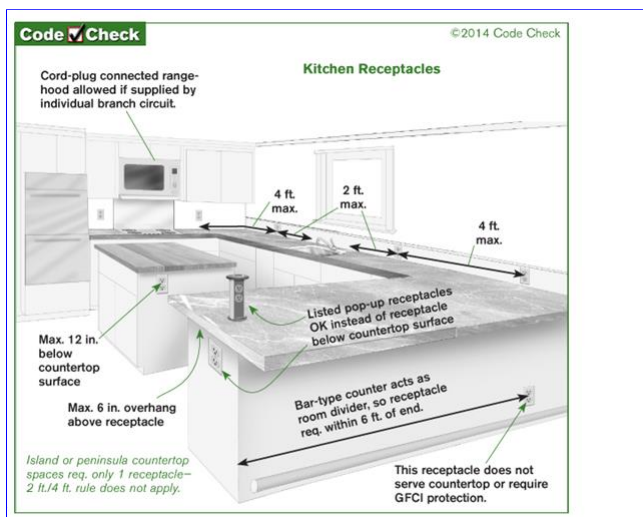
B. Item 1(Picture) There is not an electrical outlet receptacle in the island to service appliances.

B. Item 2(Picture) Example of proper outlet placement in the kitchen.

- In order to use an appliance on the island it is recommended that a licensed electrician install an electrical outlet receptacle in the proper areas.

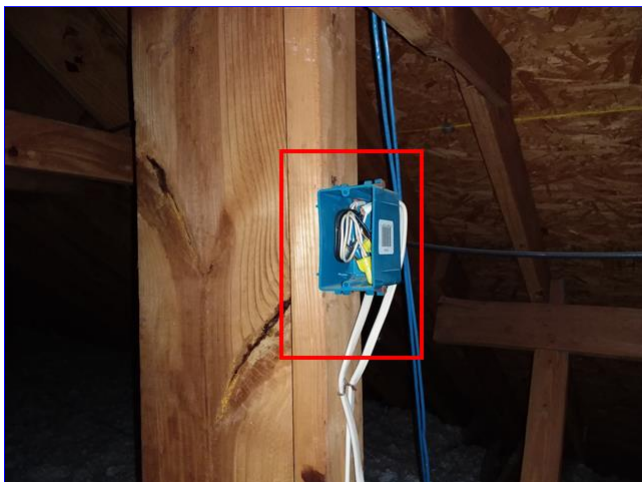
B. Item 3(Picture) The cover is missing from the electrical outlet receptacle in the attic.

- In order to help protect the occupants of the home and the internal electrical components, it's recommended that all missing or damaged cover plates for the electrical outlet receptacles and the light switches be replaced.

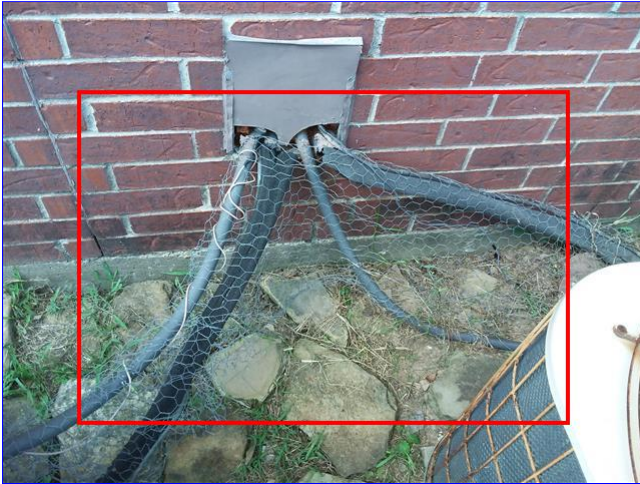
B. Item 3(Picture) Refrigerant line insulation is inadequate.

- (2)
- In order for the A/C system to run effectively and efficiently, it's recommended that the low pressure line be insulated.

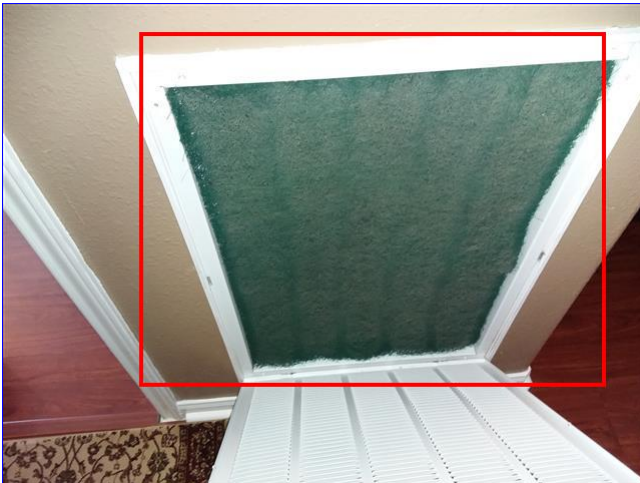
C. Item 1(Picture) Second floor return air filter needs to be replaced.

- It is recommended to replace the filters with new filters that have rigid edges to them.

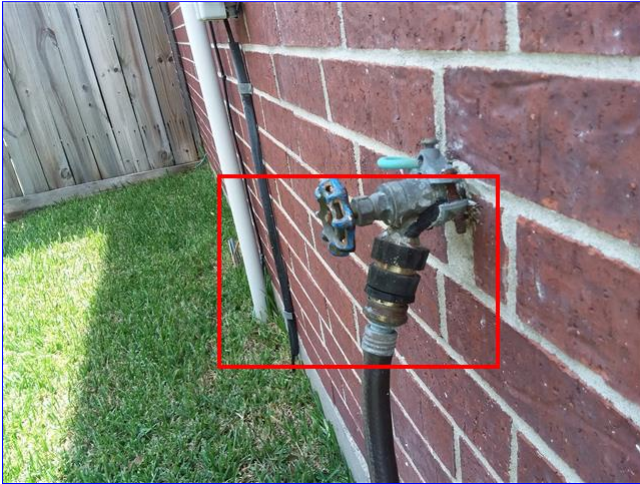
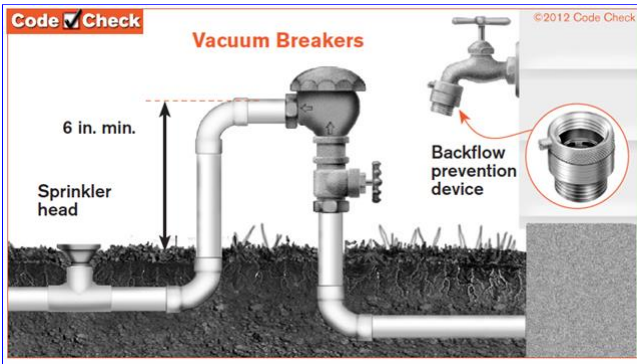
A. Item 1(Picture) Anti backflow device is missing from left exterior hose bib.

A. Item 2(Picture) Example of proper backflow device.

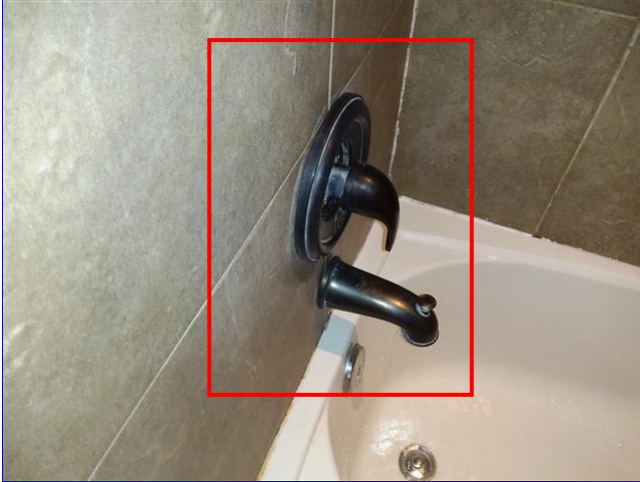
B. Item 1(Picture) Recommend to seal the spout and escutcheon plate in the second floor hallway bathroom.

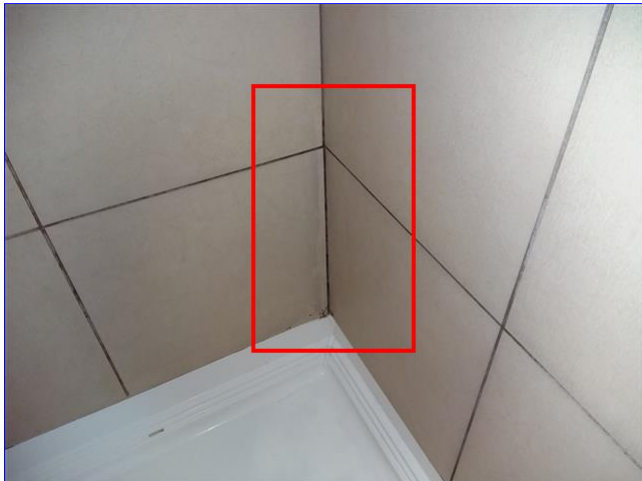
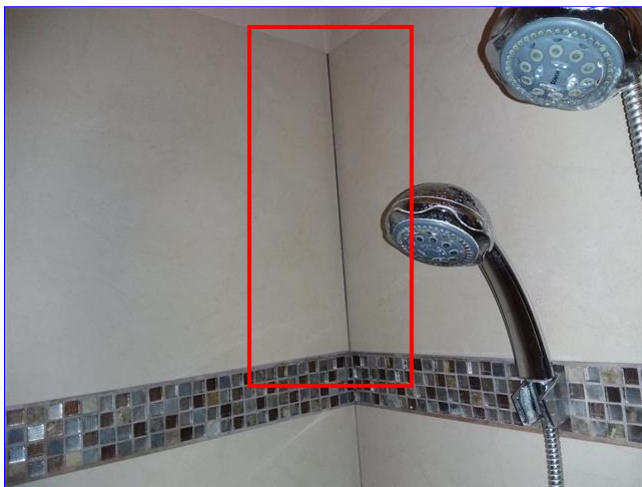
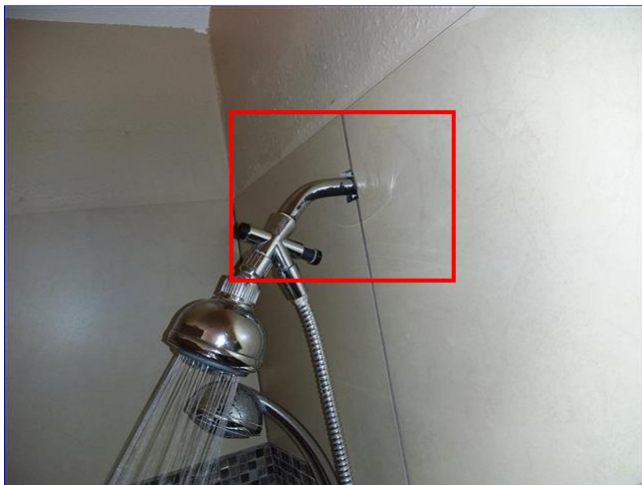
B. Item 2(Picture) Caulking and grout are missing from master shower enclosure.

B. Item 3(Picture) Caulking and grout are missing from master shower enclosure.

B. Item 4(Picture) Caulking and grout are missing from master shower enclosure.

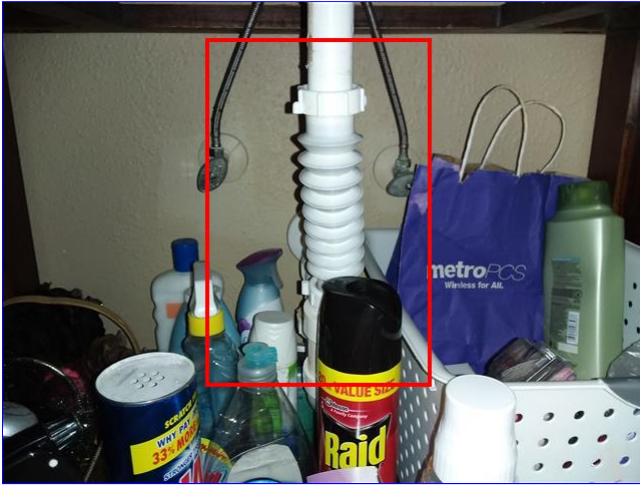
B. Item 5(Picture) Corrugated drain piping is improper at the master bathroom left vanity.

- Plumbing drain lines must have a smooth interior wall in order for it to be allow in a sewer drain line. It's recommended that a licensed plumber replace the corrugated plumbing with the proper drain pipe.

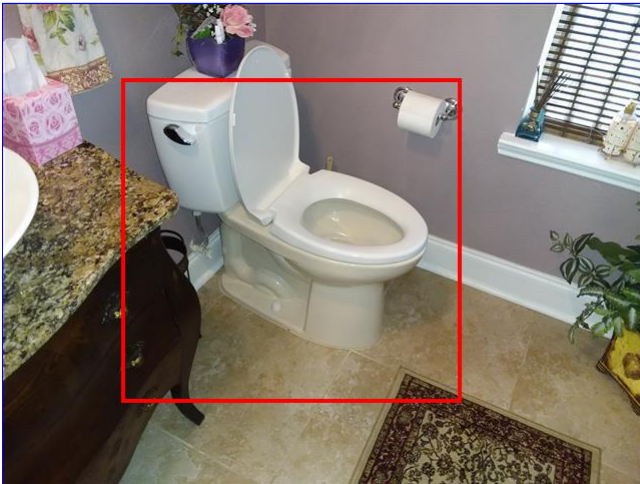
B. Item 6(Picture) Toilet in the first floor powder room is not secure to the floor.

- In order to prevent a water leaks and damage to the toilet, it's recommended that a license plumber secure the loose toilet base.

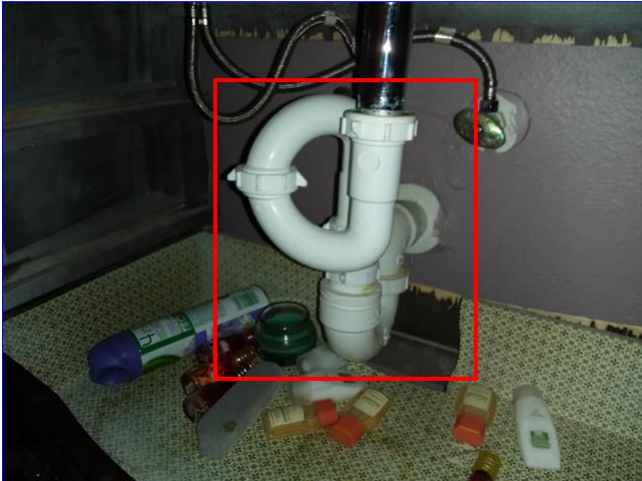
B. Item 7(Picture) Plumbing drain for vanity in the first floor powder room is incorrect.

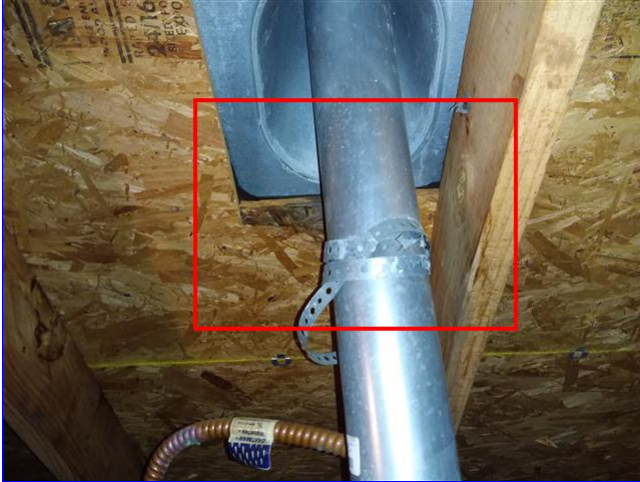
C. Item 2(Picture) Vent strap is missing from the water heater vent pipe.

- (2) In order to prevent the vent pipe from moving, it is recommended to have a licensed professional carpenter install a strap.

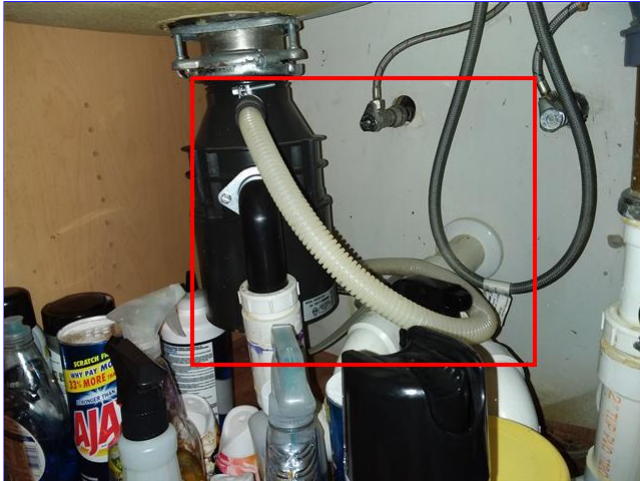
A. Item 2(Picture) High loop is missing from the dishwasher drain line in the kitchen.

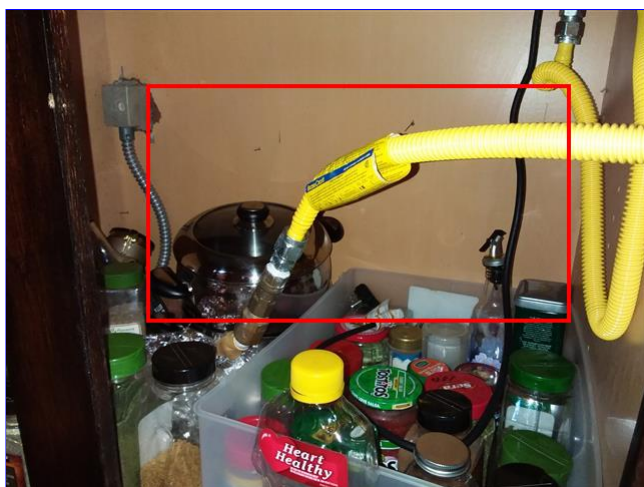
D. Item 2(Picture) There is no electrical outlet receptacle under the cooktop to plug it in to.

- In order for the stove ignitors to work properly, it is recommended to have a licensed electrician install an electrical outlet receptacle installed under the cabinet.

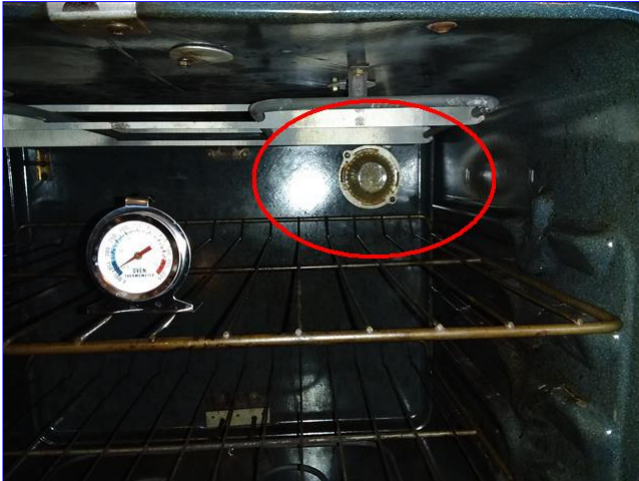
D. Item 3(Picture) Oven light is inoperable.
