Inspection Report

Property Address:
13727 Colwood Court
Richmond TX 77407

PROPERTY INSPECTION REPORT

By: BYRON LEE TREC #23870 / HG HOME INSPECTION 9/26/2020
(Name and License Number of Inspector) (Date)

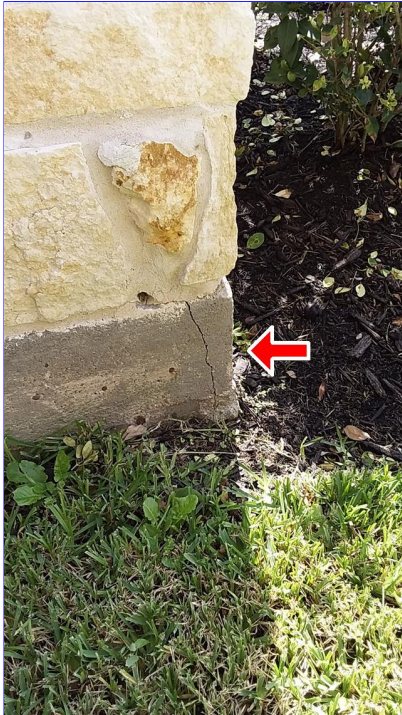
A. Item 1(Picture) front left

- (1) This is not an engineering report, but is only an opinion based on observation of conditions known to be related to foundation performance, using the knowledge and experience of the inspector.
- (2) The foundation is poured on grade and appears to be performing as designed.
- (3) The foundation has large corner pop(s) that are larger than 4 inches. Further deterioration will occur if not corrected. I recommend having a qualified person make repairs as needed.

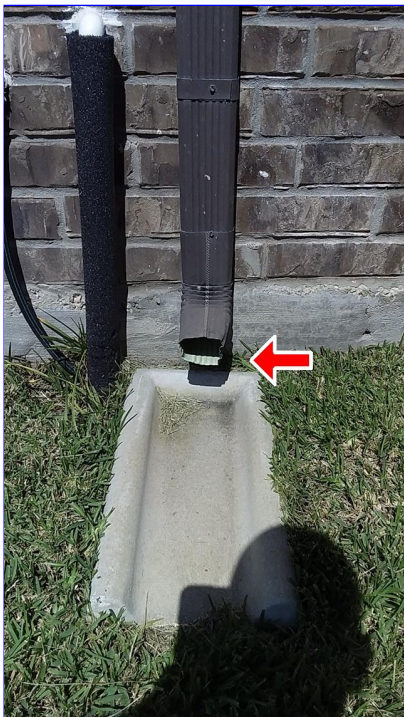
B. Item 1(Picture) right

(1) The downspout is damaged at the exterior. A qualified person should repair or replace as needed.

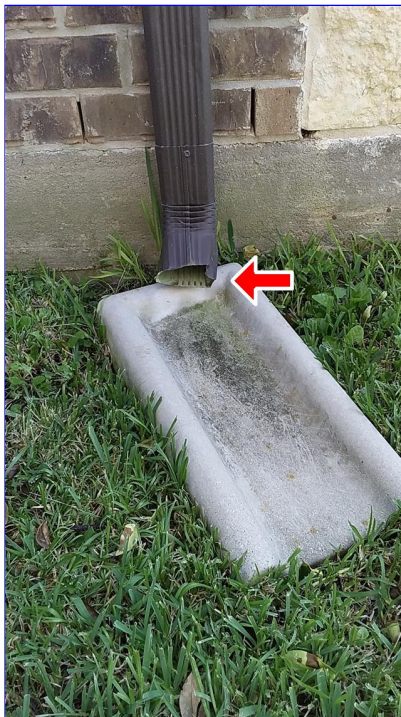
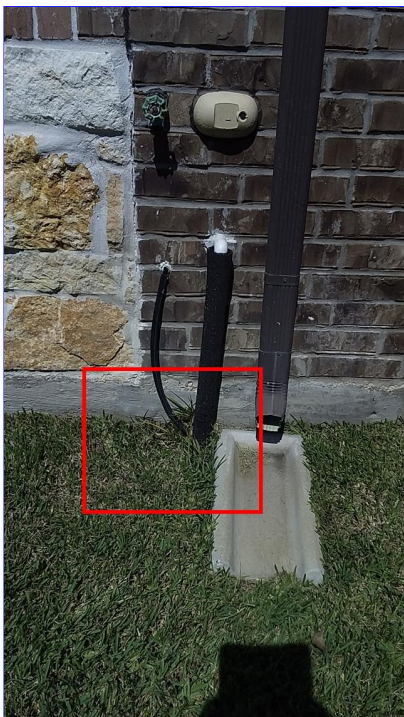
B. Item 2(Picture) front left

(2) There is a negative slope at the exterior areas and can cause or contribute to water intrusion or deterioration. I recommend correcting landscape to drain water away from home.

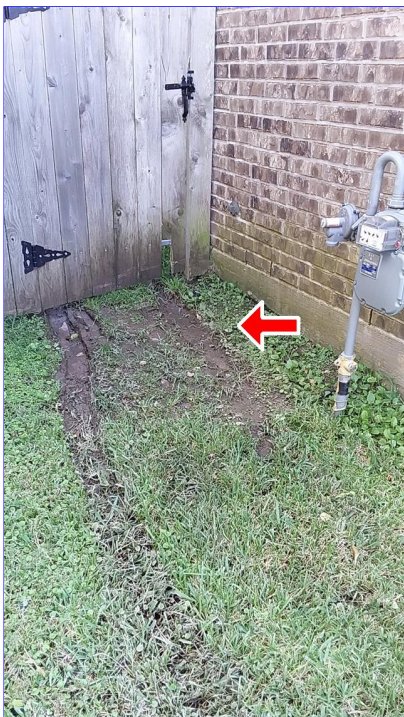
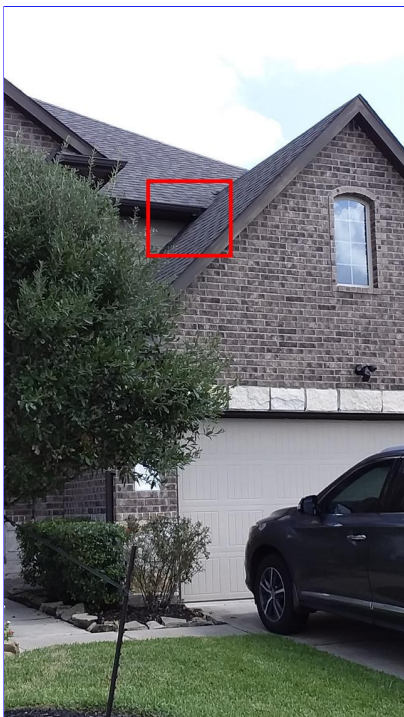
B. Item 5(Picture) left

(3) Downspouts discharges onto roofing surface in areas of the roof. Deterioration could occur if not corrected. I recommend having a qualified contractor make repairs as needed.

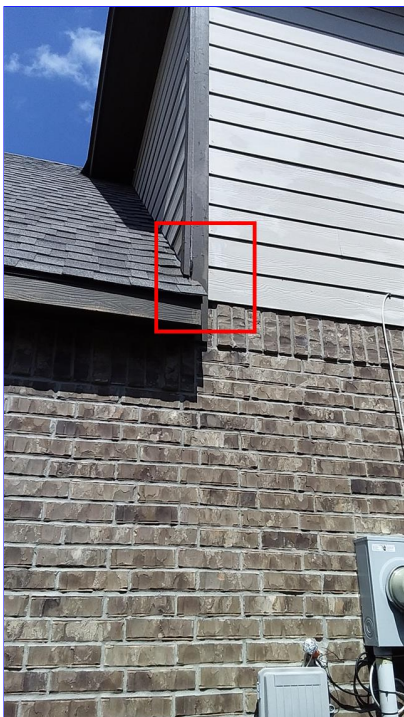
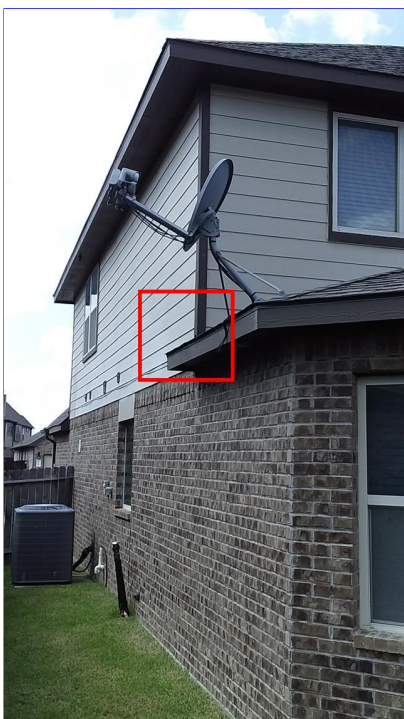
C. Item 1(Picture) right

- (1) This inspection does not warrant against roof leaks.
- (2) The steep pitches in areas of the roof limited the inspection to areas that were safely accessible at the time of inspection.
- (3) Kick out flashing is missing in areas of the roof. This is not considered today's standard. I recommend having a qualified roofing company make repairs as needed.

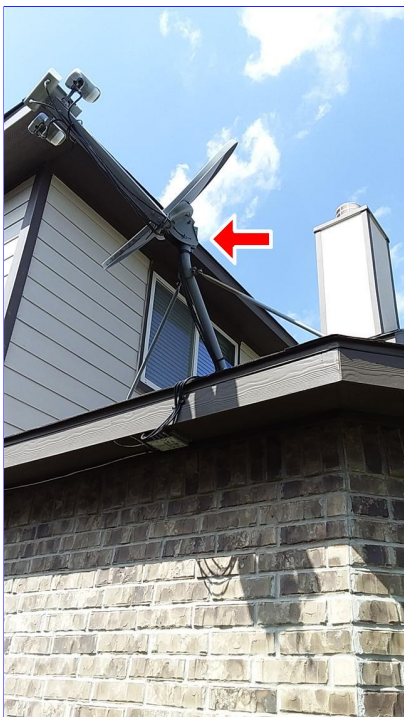
C. Item 4(Picture) rear

(4) There is a satellite dish bracket mounted on roof that is screwed directly through roofing surface. This is not considered to be today's standard. I recommend having a qualified person remove and patch roofing as needed. (The area will need periodic maintenance)

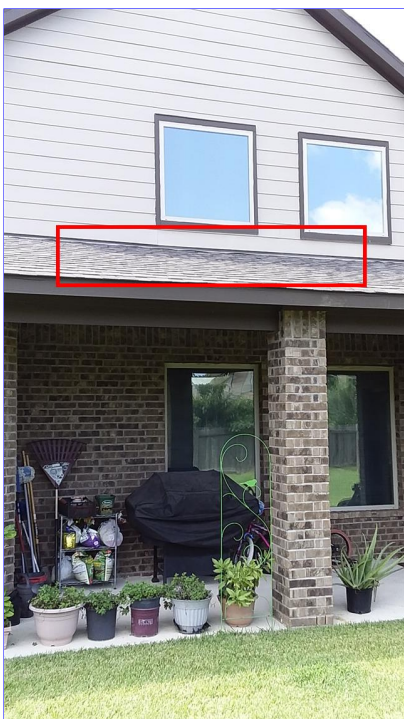
C. Item 5(Picture) rear

(5) The flashing is loose and needs repair. I recommend having a qualified person make repairs as needed.

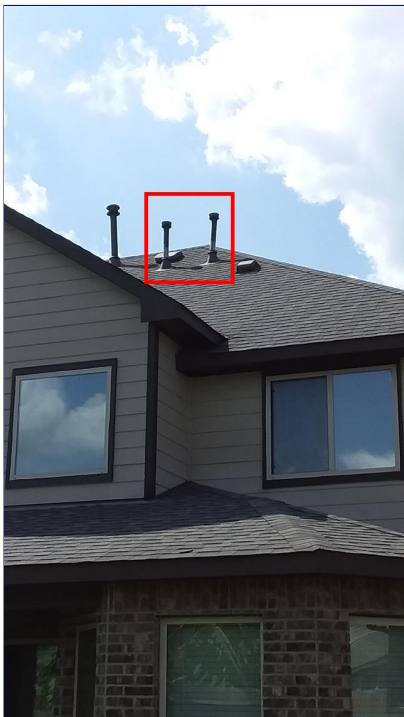
C. Item 6(Picture) rear

(6) The plumbing and appliance venting at roof level does not have adequate weather coating (Paint) to

prevent premature deterioration. This is not considered to be today's standard. I recommend having a qualified person make repairs as needed.

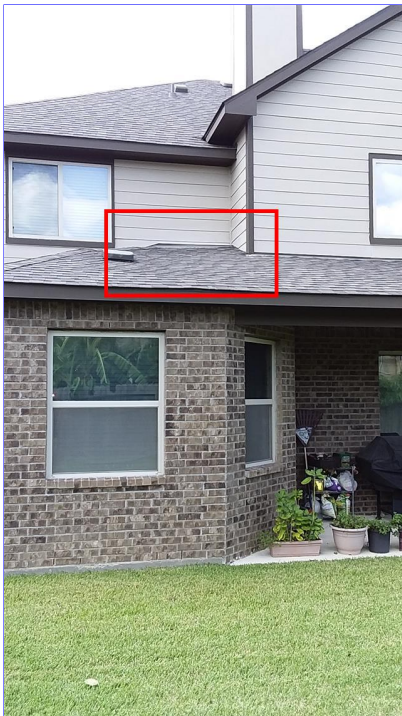
D. Item 2(Picture) rear

(2) There are some dips or sags in the roof in areas. The deflection is great enough to need repair or reinforcement. A qualified contractor should repair as needed.

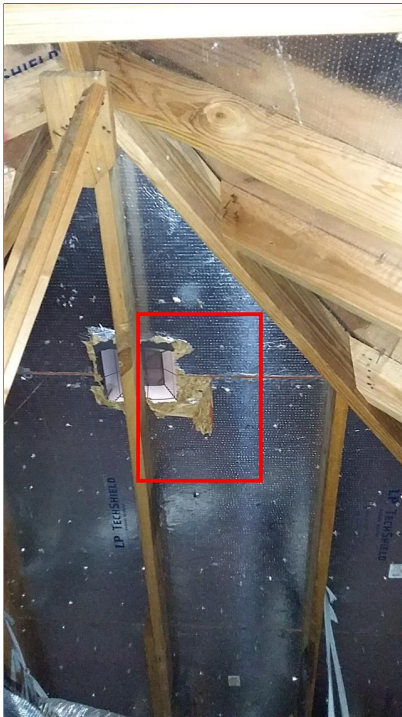
D. Item 3(Picture)

(3) There is damaged decking in the attic. This is considered cosmetic. I recommend having a qualified person evaluate and repair as needed.

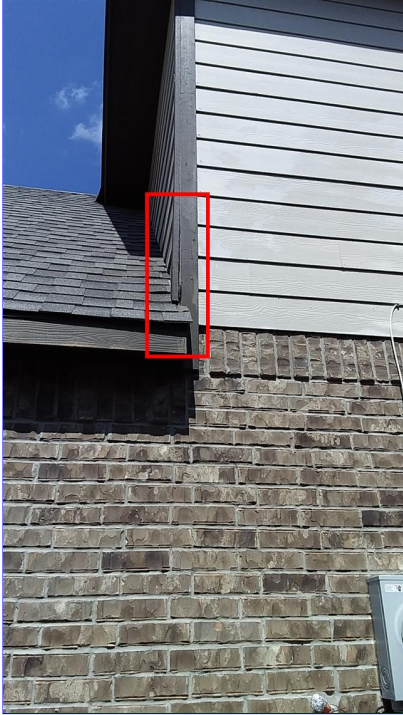
E. Item 1(Picture) right

(1) The trim exterior is loose. Deterioration can eventually occur if not corrected. A qualified contractor should inspect and repair as needed.

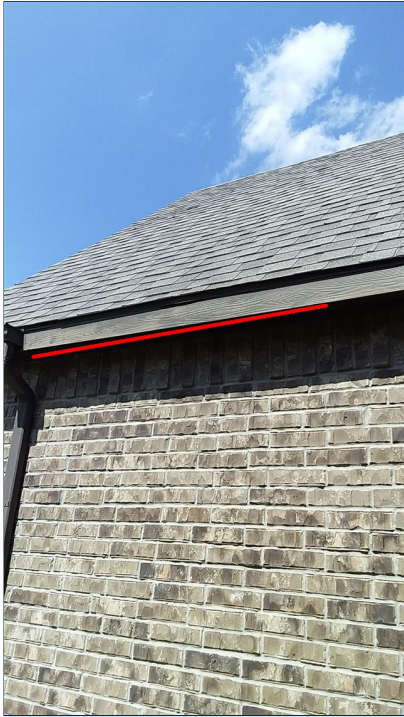
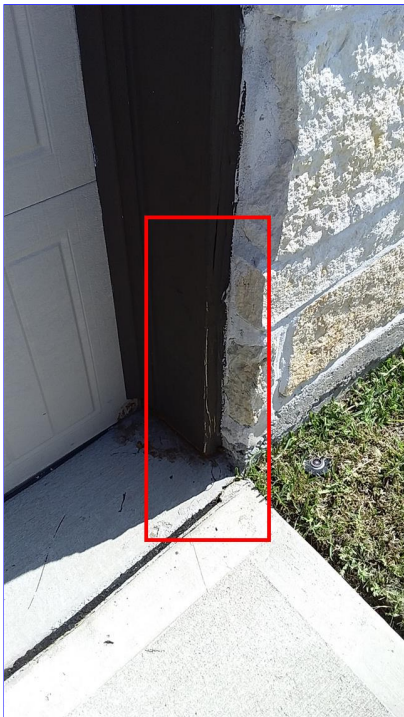
E. Item 2(Picture) right

(2) The paint is failing. I recommend prep and paint at the exterior.

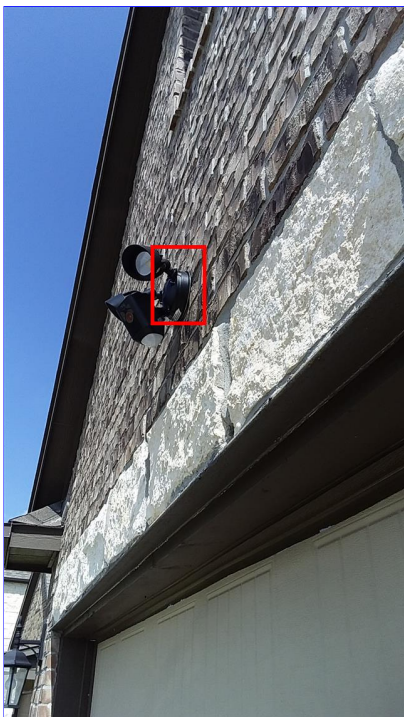
E. Item 5(Picture) front

(3) Areas where wiring or piping passes through walls should be sealed. I recommend having a qualified person seal as needed.

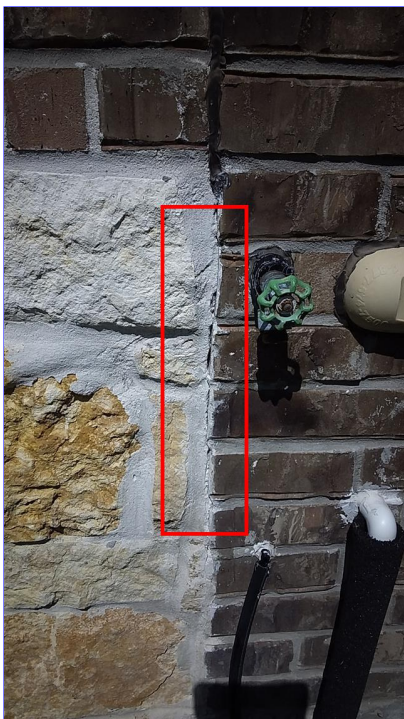
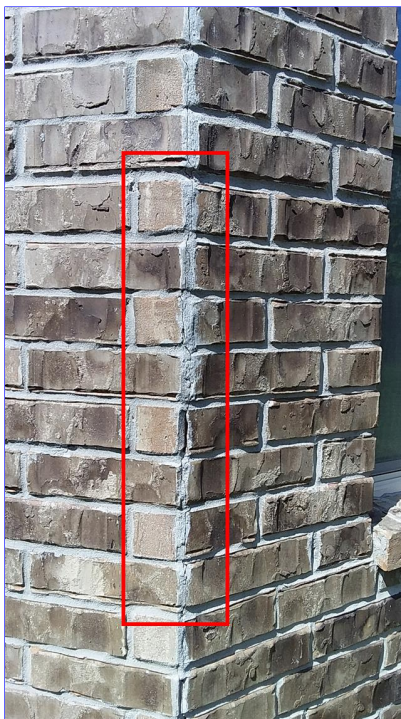
E. Item 6(Picture) front right

(4) The brick siding at the exterior has hairline cracks. Deterioration can eventually occur if not corrected. A qualified contractor should inspect and repair as needed.

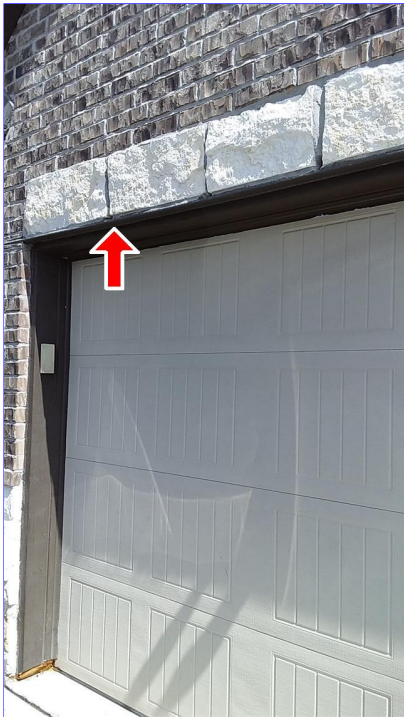
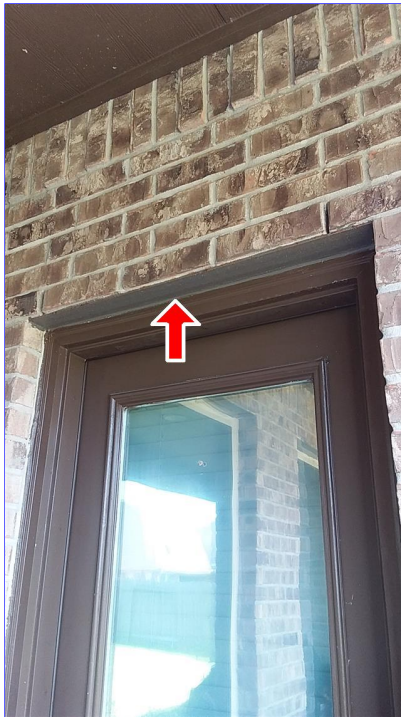
E. Item 8(Picture) garage

(5) Lintels above exterior doors are showing signs of deterioration. Further deterioration may occur if lintels are not primed and painted. A qualified person should repair as needed.

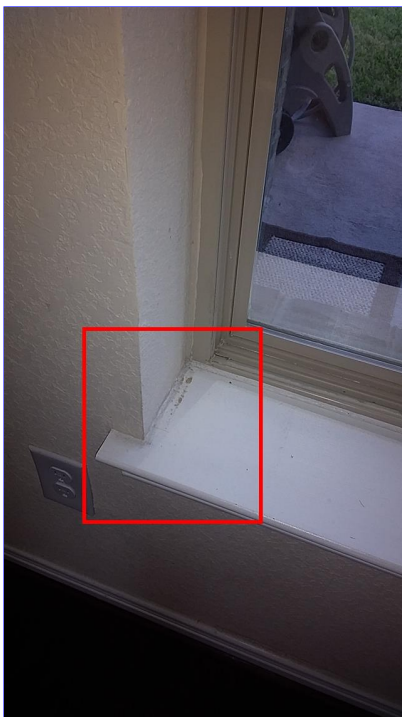
E. Item 12(Picture) living room

(7) Interior trim is damaged or peeling paint in areas. This is a cosmetic issue. I recommend repair as desired.

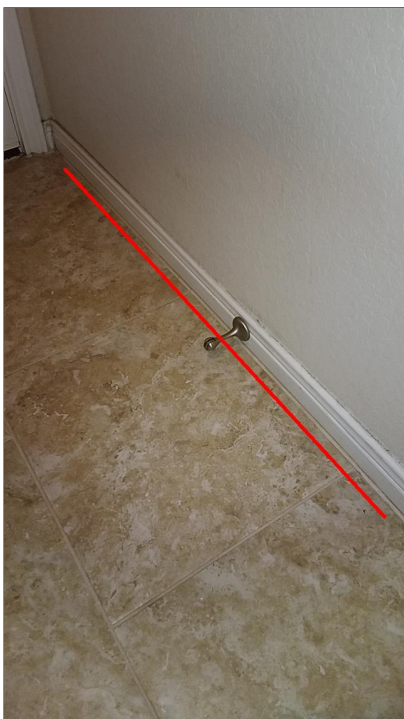
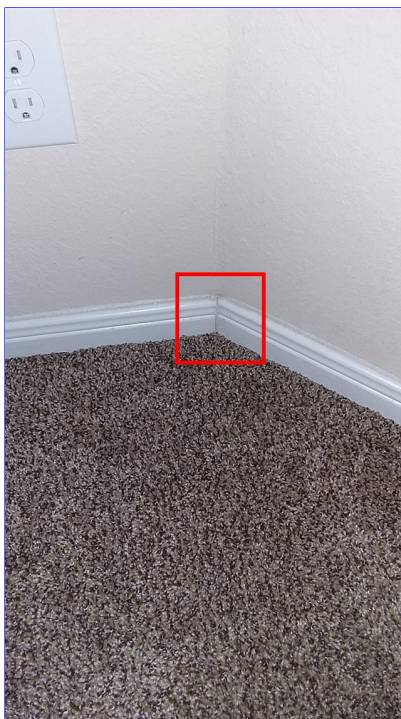
E. Item 13(Picture) laundry room

(8) Baseboards have some separation and deterioration of caulking. I recommend having a qualified person make repairs of needed.

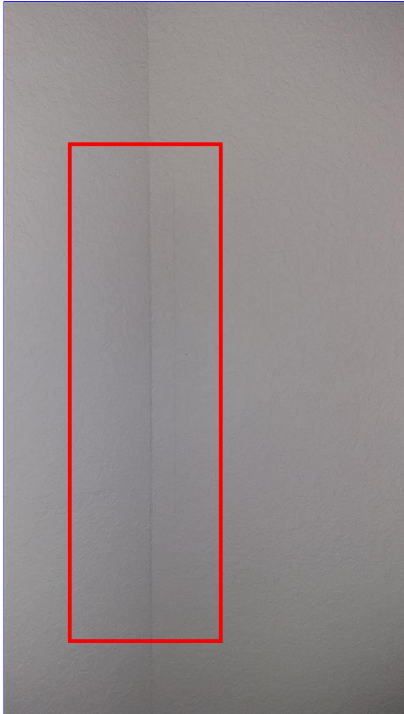
E. Item 15(Picture) primary bedroom right

(9) The drywall on the wall reveals tape lines and nail bed areas (cosmetic). While this damage is cosmetic, it needs to be repaired. A qualified person should repair or replace as needed.

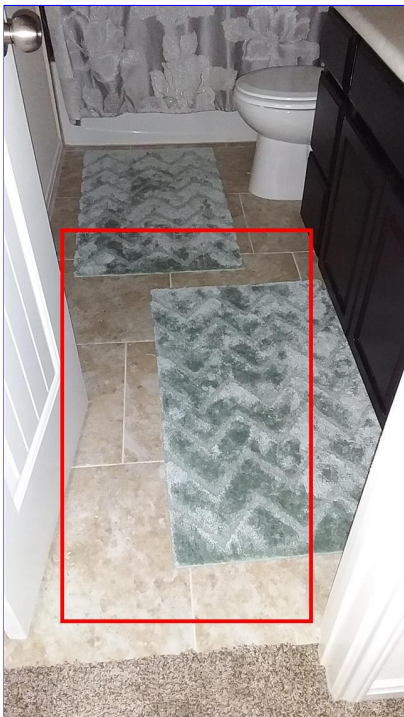
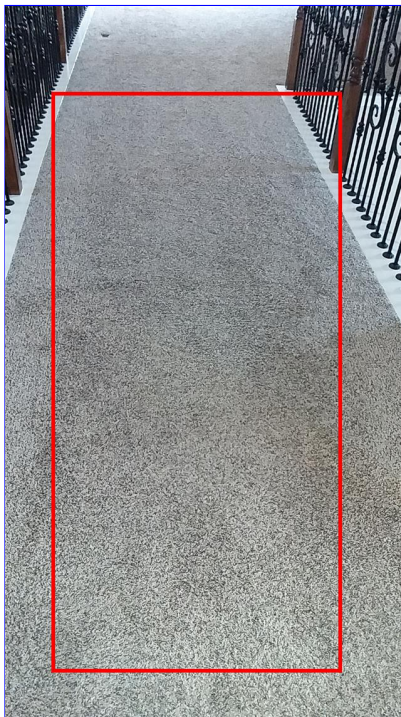
F. Item 1(Picture) right bath upstairs

(1) The sub floor squeaks in areas (nuisance only). This damage is considered cosmetic. A qualified person should repair or replace as needed.

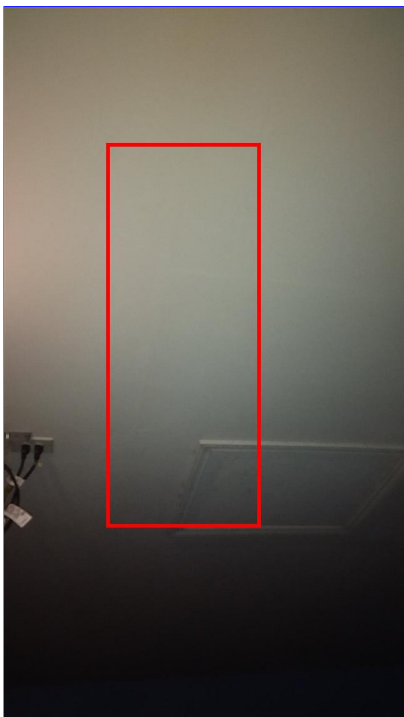
F. Item 3(Picture) garage

(2) The drywall on the ceiling reveals tape line and nail bed areas (cosmetic). This damage is considered cosmetic. A qualified contractor should inspect and repair as needed.

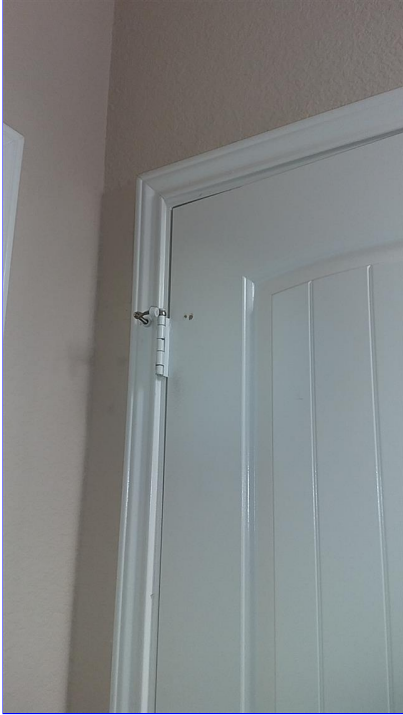
G. Item 1(Picture) left bath upstairs

The entry door is damaged in areas. This is a maintenance issue and is for your information. A qualified person should repair or replace as needed.

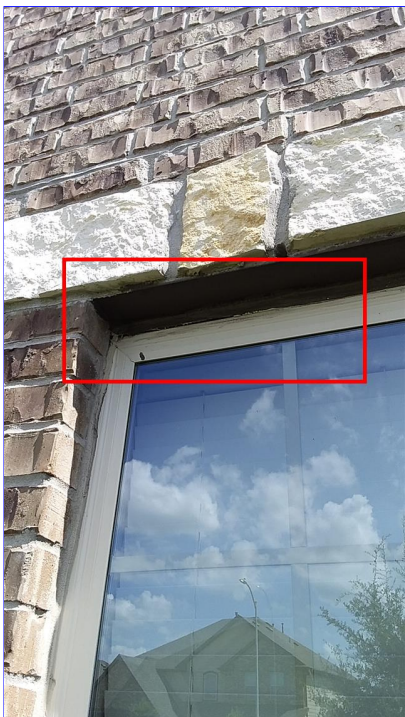
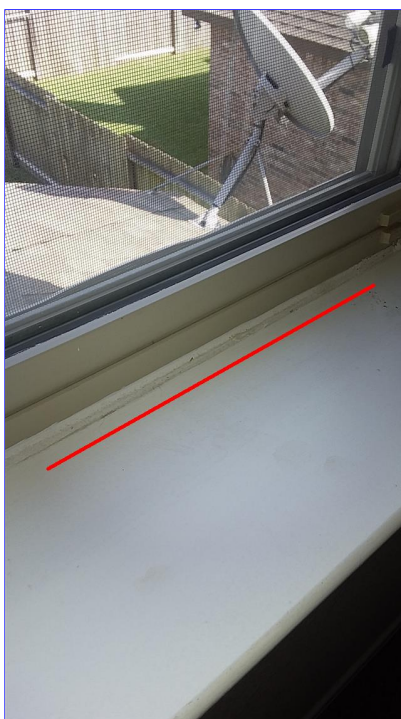
H. Item 1(Picture) front

(1) There are window frames that are not properly sealed. This can cause energy loss. I recommend having a qualified person seal and repair as needed.

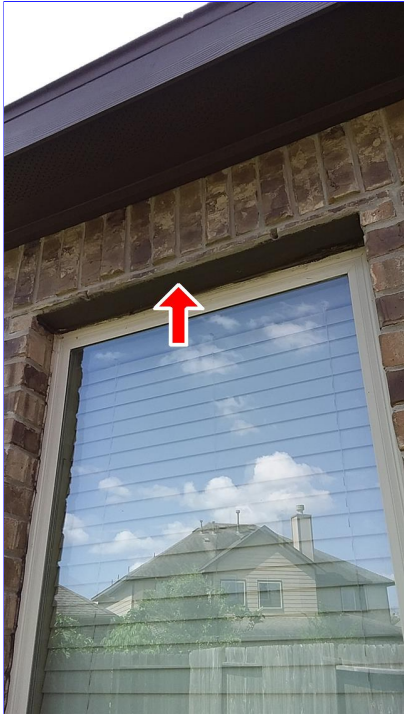
H. Item 5(Picture) rear

(2) Lintels above windows are showing signs of deterioration in areas. Further deterioration may occur if lintels are not primed and painted. A qualified person should repair as needed.

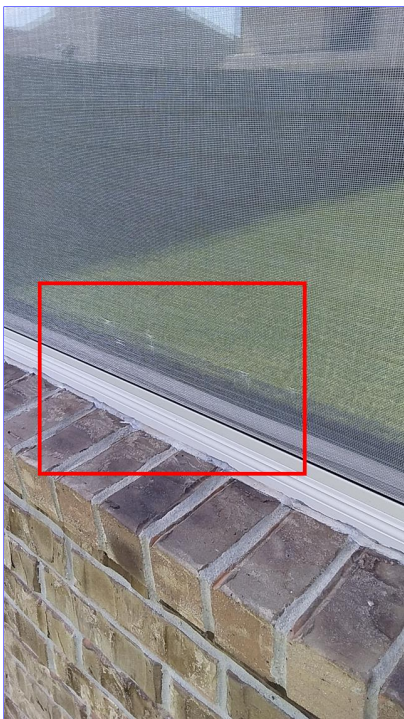
H. Item 6(Picture) rear

(3) Windows have damaged or missing screens. This is not considered to be today's standards. I recommend having a qualified person make repairs as needed.

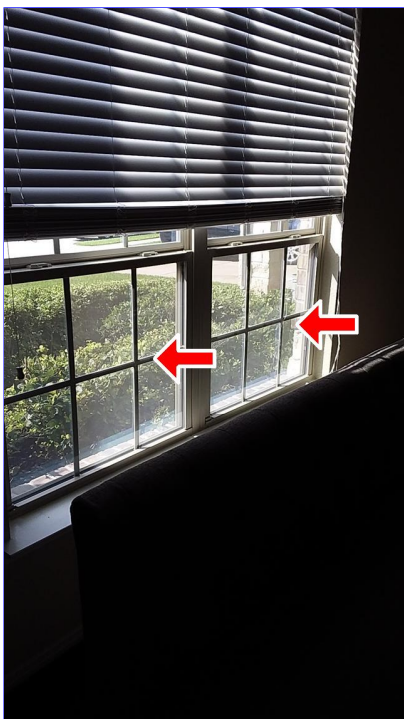
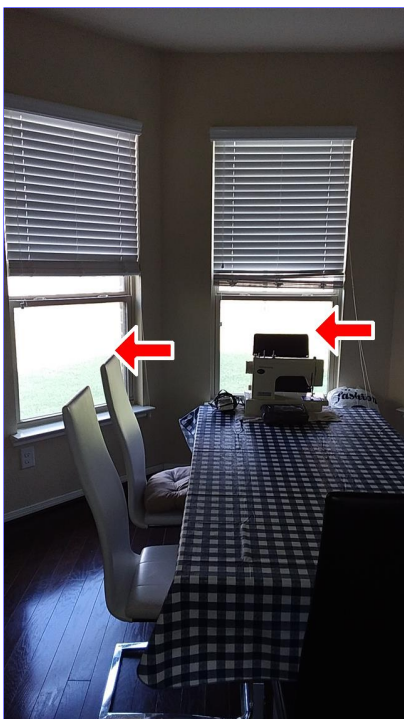
H. Item 7(Picture) dining room

(4) Some windows do not operate in areas. This is a maintenance issue and is for your information. A qualified person should repair or replace as needed.

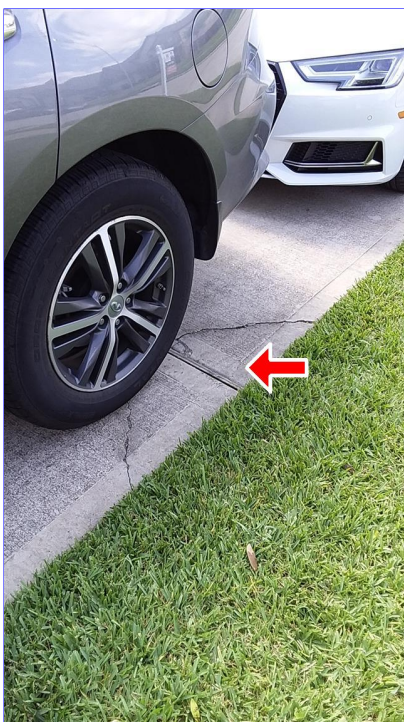
L. Item 2(Picture) left

(2) The concrete drive at the front of home has settlement cracks. Further deterioration can occur if not repaired. A qualified person should repair or replace as needed.

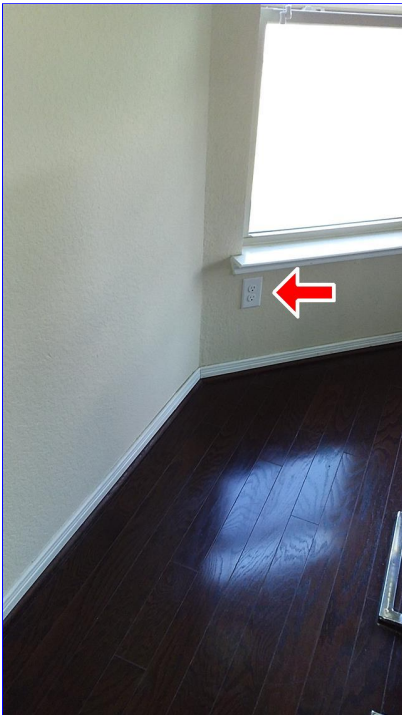
B. Item 2(Picture) breakfast area left

(3) There are GFCI protected circuits in areas that are not required. This is not considered to be today's standard. I recommend having a qualified electrician make repairs as needed.

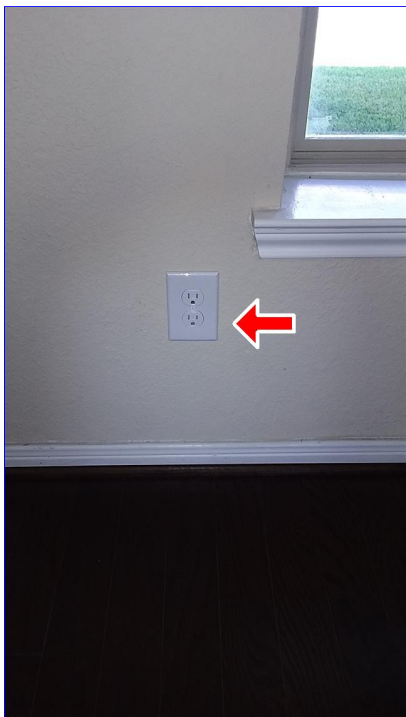
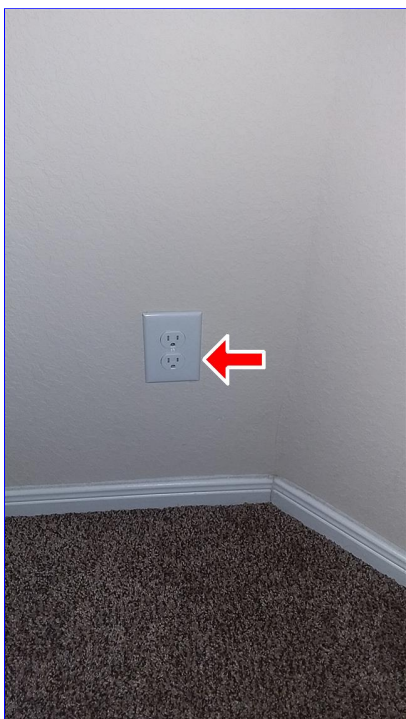
B. Item 4(Picture) living room

(4) "Three-prong" outlets are loose in wall. Electrical issues are considered a hazard until repaired. A qualified licensed electrical contractor should perform repairs that involve wiring.

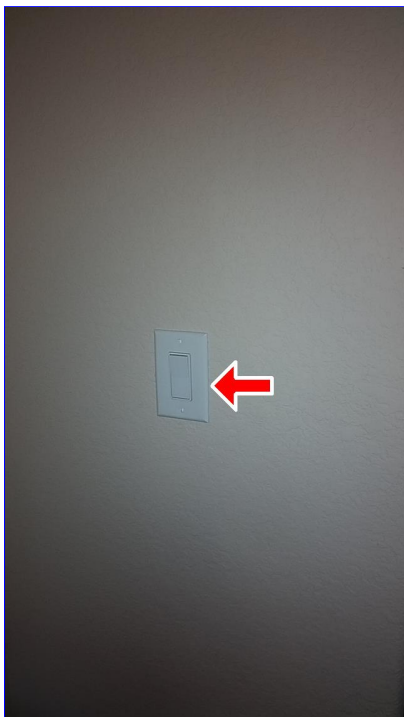
B. Item 7(Picture) dining room left

(5) The wall switch purpose is unknown (could not identify) in areas. This is for your information. A qualified licensed electrical contractor should perform repairs that involve wiring.

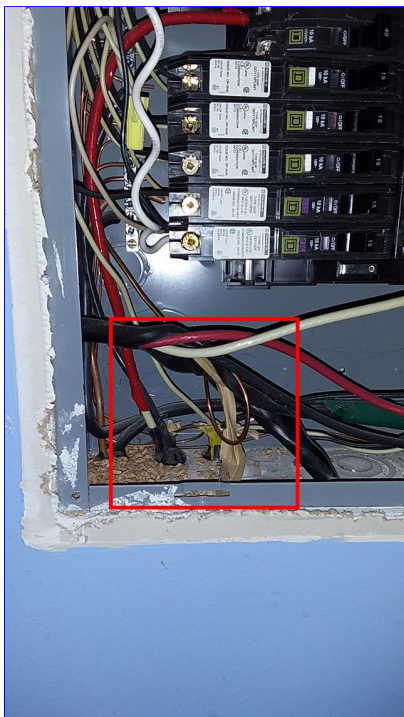
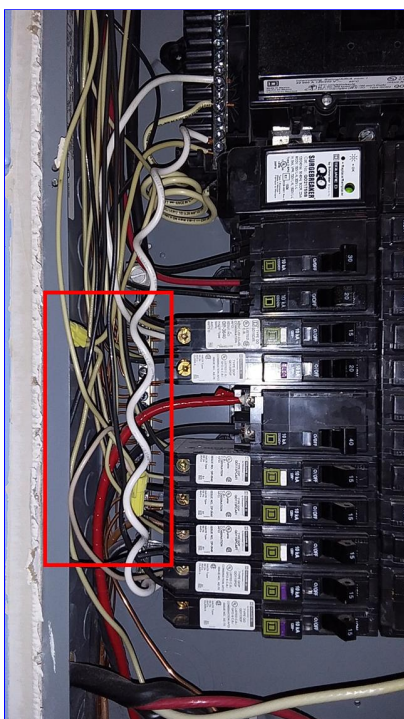
B. Item 9(Picture) excess sheathing present

(6) Problem(s) discovered with Branch Circuits such as amateur wiring installation doubled wiring at neutral/grounding bar, and any other problems that an electrical contractor may discover while performing repairs need correcting. I recommend a licensed electrical contractor inspect further and correct as needed.

B. Item 10(Picture) combustible debris present

B. Item 11(Picture) splices present

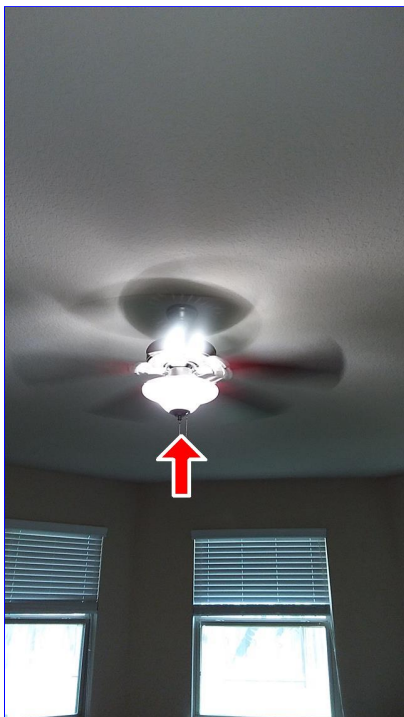
B. Item 12(Picture) primary bedroom

(7) The ceiling fan "wobbles" in areas. Some fans that wobble cannot be corrected without replacement. A qualified licensed electrical contractor should perform repairs that involve wiring.

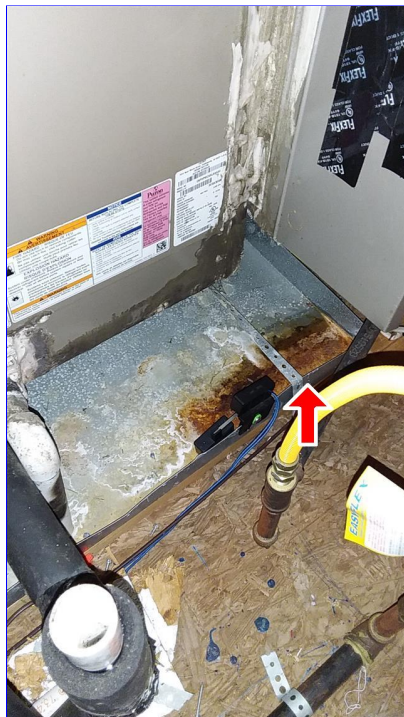
B. Item 1(Picture)

- (1) It is recommended to have HVAC systems serviced annually.
- (2) The emergency overflow drain pan for the HVAC system is showing signs of deterioration. Further deterioration may occur if not corrected. I recommend having a qualified person make repairs as needed.

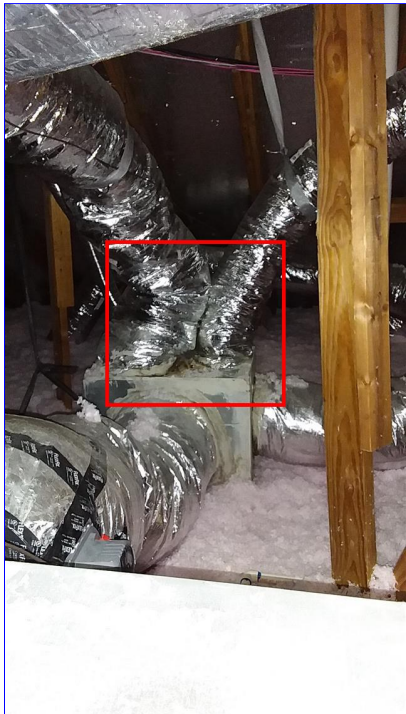
C. Item 1(Picture)

- (1) I recommend changing all HVAC filters upon move in.
- (2) The supply is in contact with each other in the attic. Separation is needed to prevent possible condensation.

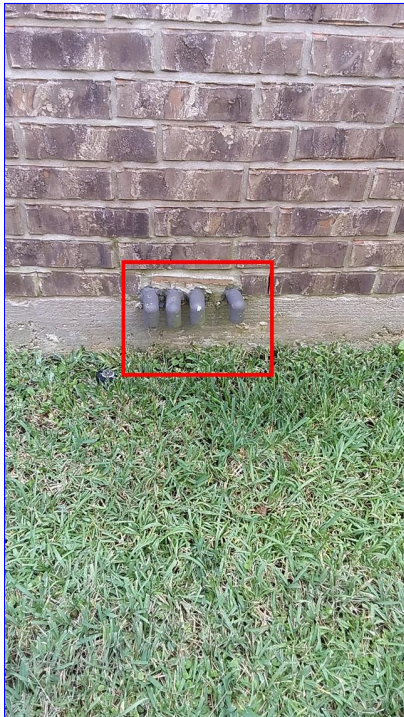
C. Item 1(Picture) left

The existing piping for T&P valve on water heater fails to extend downward to within six inches of ground. This is a safety issue and should be repaired. A qualified licensed plumber should repair or correct as needed.

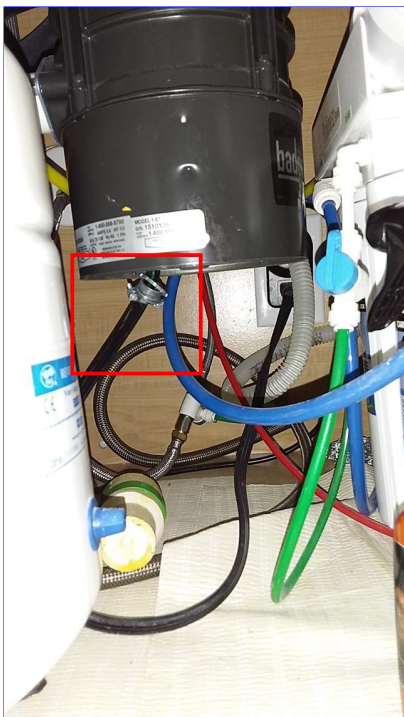
B. Item 3(Picture) kitchen

(3) The food disposer wiring is missing a wire connector (anti-strain device). I recommend repair as needed.

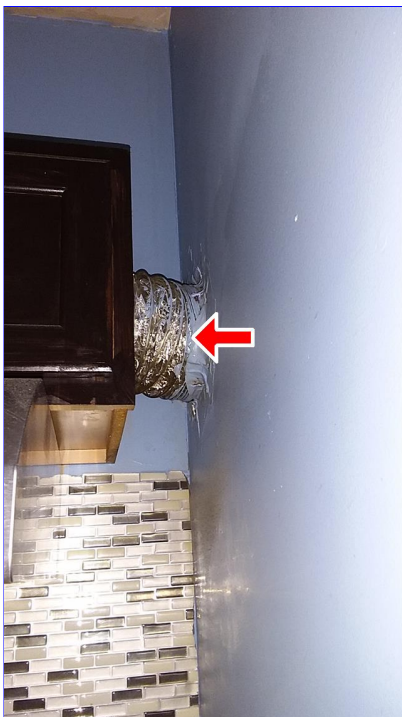
C. Item 2(Picture) incorrect vent pipe

(3) The range hood fan is vented with incorrect material. I recommend repair or replace as needed.

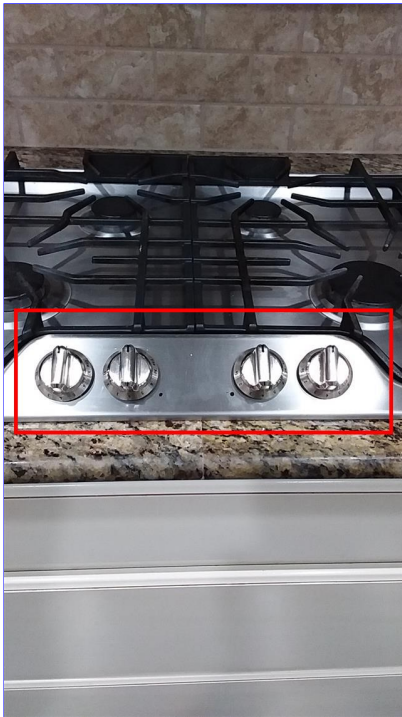
D. Item 5(Picture)

(2) The control knobs (on cook top) are difficult to read or understand setting. I recommend repair as needed.

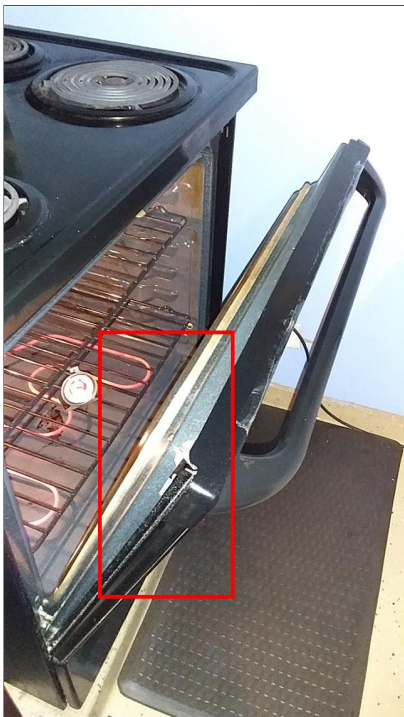
D. Item 9(Picture) garage

(5) The oven door (on oven) is damaged. I recommend repair as needed.

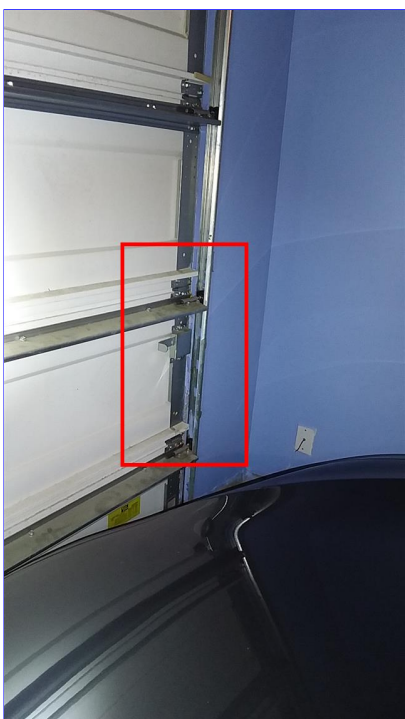
G. Item 1(Picture)

(1) The garage door at the front of home has a lock that has not been disabled for automatic opener. This is considered unsafe and needs correcting. A qualified person should repair or replace as needed.

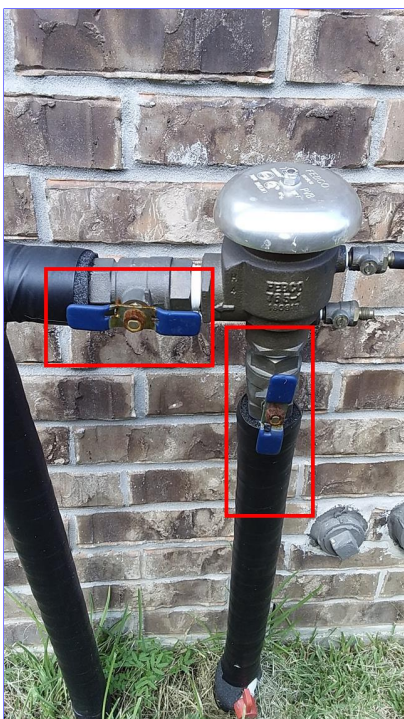
A. Item 2(Picture)

(3) The sprinkler system back flow preventer handles are deteriorated. I recommend having a qualified person make repairs as needed.
