Inspection Report

Property Address:
315 Peacedale Court
Houston TX 77015

HG Home Inspection

PROPERTY INSPECTION REPORT

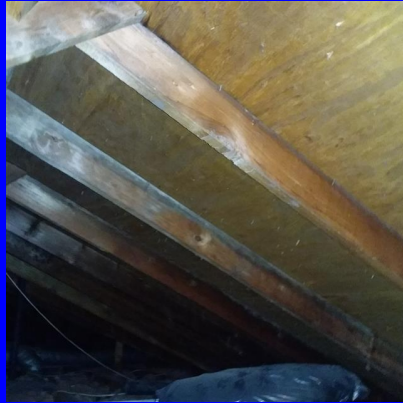
Roof structure stick built

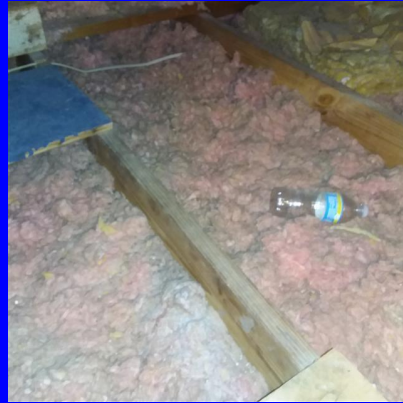
5 inches of blown insulation

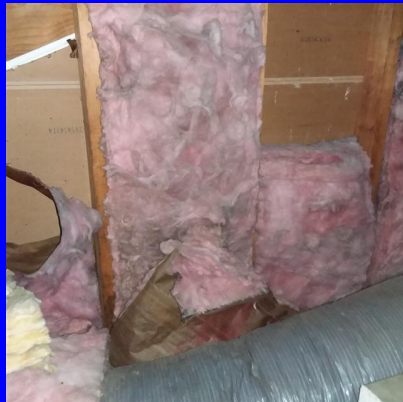
5 inches of batt insulation

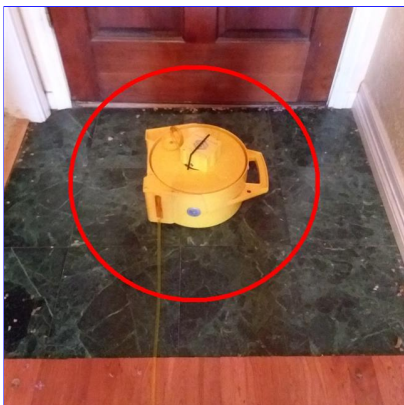
A. Item 3(Picture) Base point of measurement main entry

(4) The foundation is showing signs of movement. I recommend consulting with a Structural Engineer or foundation professional.

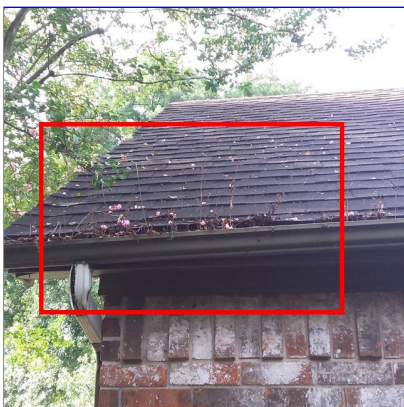
B. Item 1(Picture) Front of home

(1) The gutters are full of debris in areas and needs to be cleaned. The debris in gutters can also conceal rust, deterioration or leaks that are not visible until cleaned, and I am unable to determine if such conditions exist.

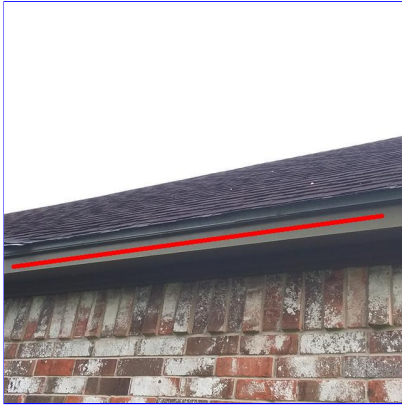
B. Item 2(Picture) Front left side of home

(2) The gutter is missing end cap at the exterior. Erosion can continue or become worse if not corrected. A qualified person should repair or replace as needed.

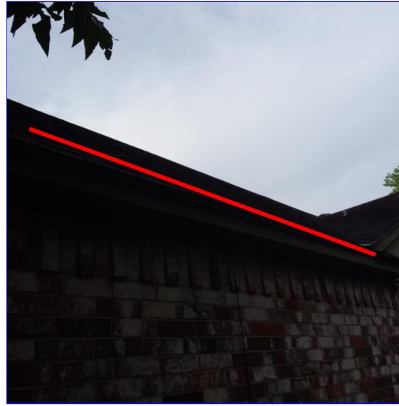
B. Item 3(Picture) Front right side of home

(3) The home does not appear to have adequate drainage. This will cause erosion if not corrected. I recommend having a qualified person install needed gutters.

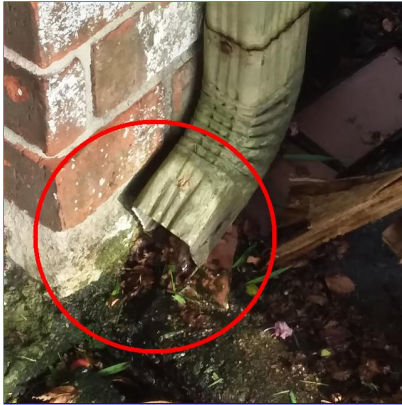
B. Item 4(Picture) Front of home

(4) The downspout needs an extension and a buried drain line to carry water away from the home at the front of home.

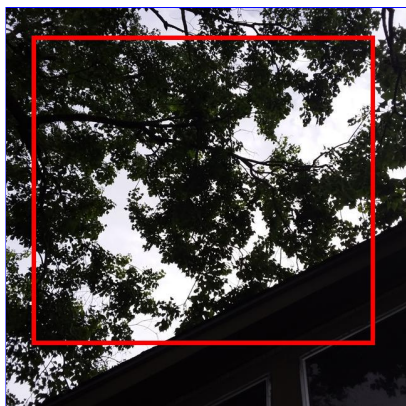
C. Item 3(Picture) Rear of home

- (3) The flashing is loose and needs repair. I recommend having a qualified person make repairs as needed.

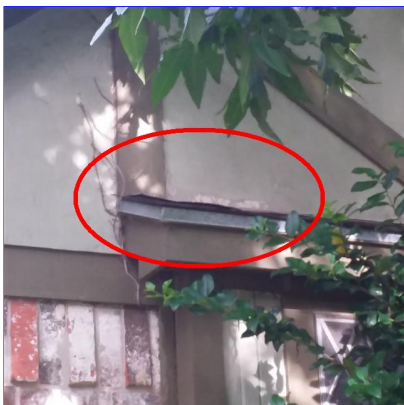
C. Item 4(Picture) Front right of home

(4) The roof covering is old or worn, and the life of covering has expired. The covering does need to be replaced. While it could last a few year or so, some areas may need patching with tar as leaks develop.

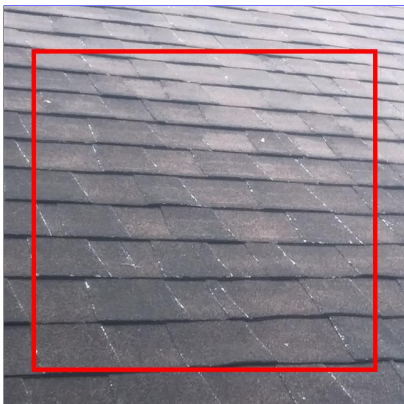
C. Item 5(Picture) Excessive wear

(5) The roof covering is damaged in areas. These areas may need replacement and or periodic maintenance. A qualified roofing contractor should inspect and repair as needed.

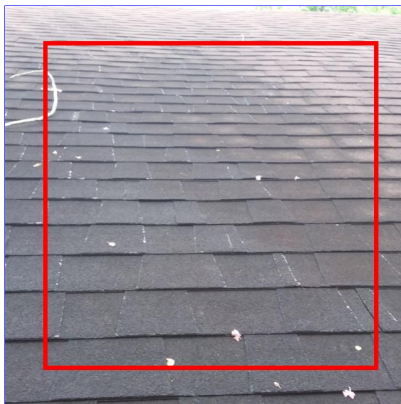
C. Item 6(Picture) Excessive wear

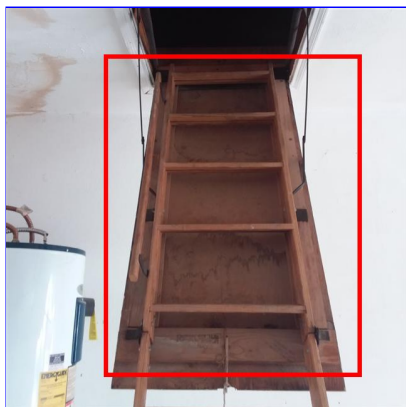
D. Item 1(Picture)

(1) The pull down stairs are not properly insulated. This can cause some heat loss in winter and loss of cool air in summer if not corrected. I recommend repair as desired.

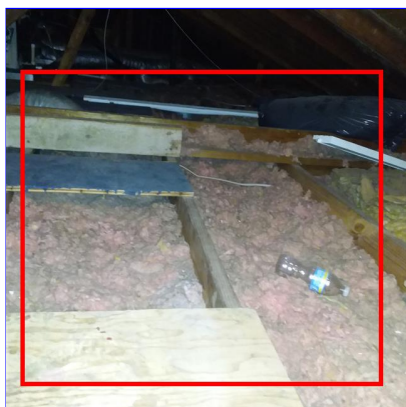
D. Item 2(Picture)

(2) The attic space has area's of thin insulation. This is causing energy loss and is not today's standard. I recommend having a qualified person evaluate and add insulation as needed.

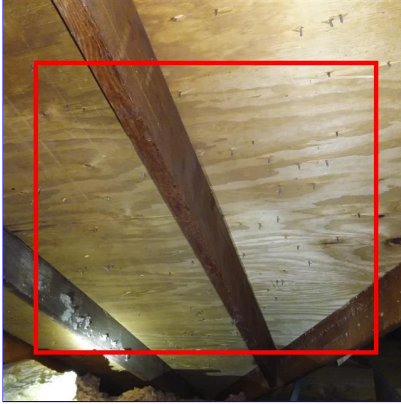
D. Item 3(Picture) Attic

(3) The roof sheathing is installed without the recommended "H" clips that are designed to increase the roof decking stability. It is not cost effective to repair until next roof.

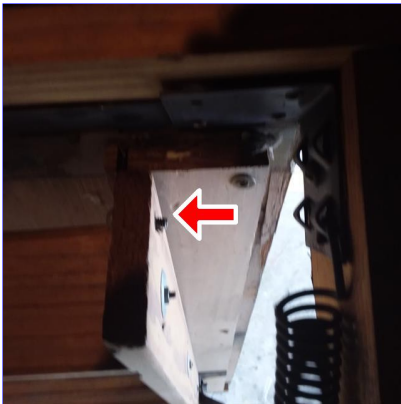
D. Item 4(Picture)

(4) The pull down stairs missing nut to secure step. Injury could result if not repaired. A qualified person should repair or replace as needed.

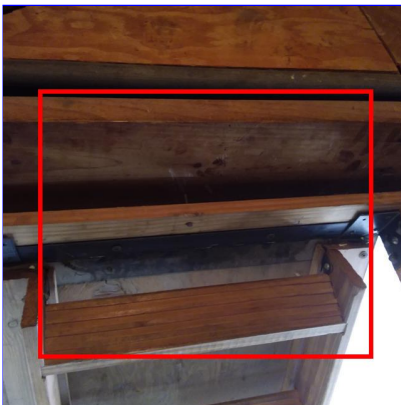
D. Item 5(Picture)

(5) The pull down stairs are weak and not stable. Injury could result if not repaired. A qualified person should repair or replace as needed.

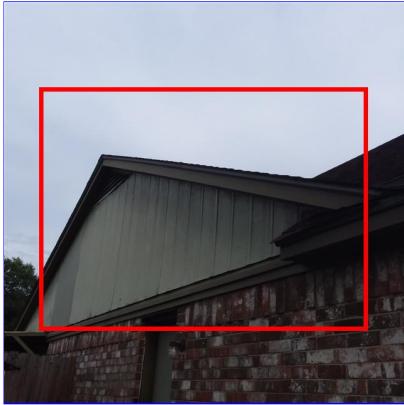
E. Item 1(Picture) Left side of home

(1) The exterior siding and trim is deteriorated in areas. Further deterioration will occur if not corrected. A qualified contractor should inspect and repair as needed.

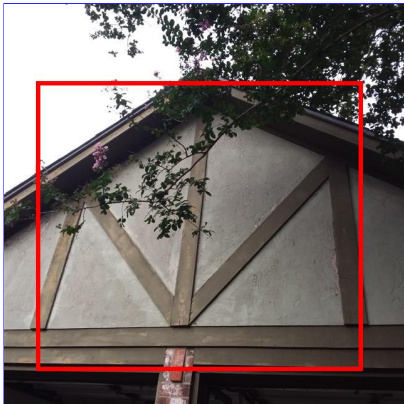
E. Item 9(Picture) Front right of home

(2) The paint is failing. I recommend prep and paint at the exterior.

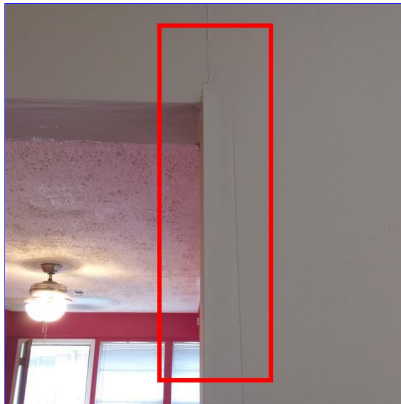
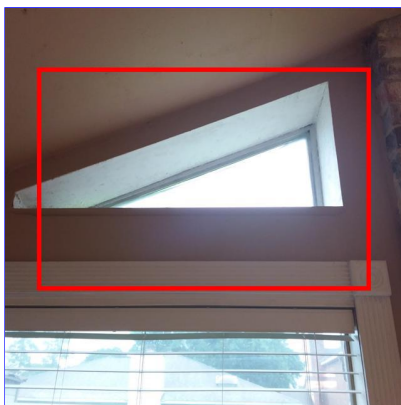
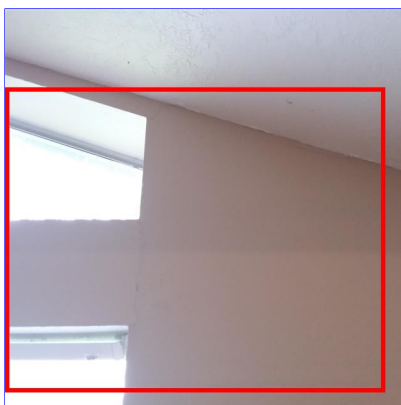
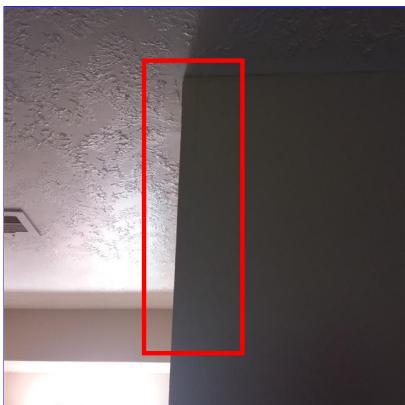
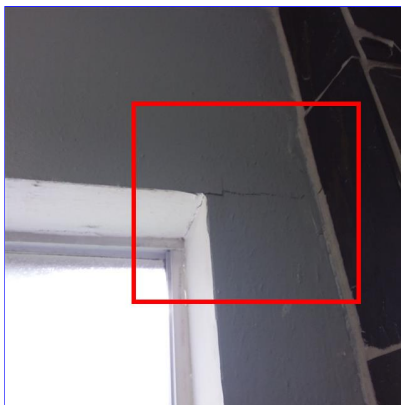
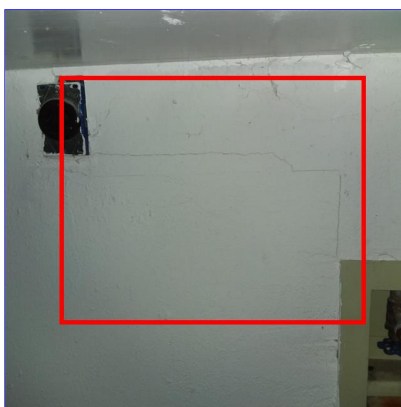
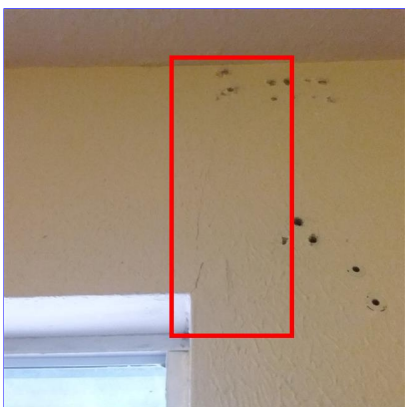
(3) The drywall on the wall reveals tape lines and nail bed areas (cosmetic). While this damage is cosmetic, it needs to be repaired. A qualified person should repair or replace as needed.

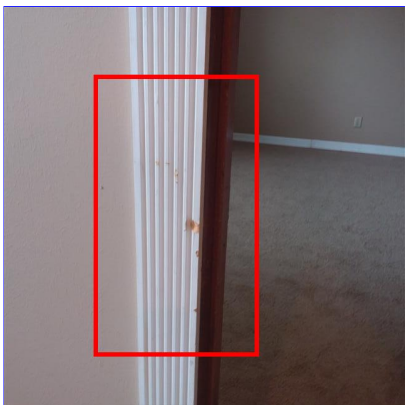
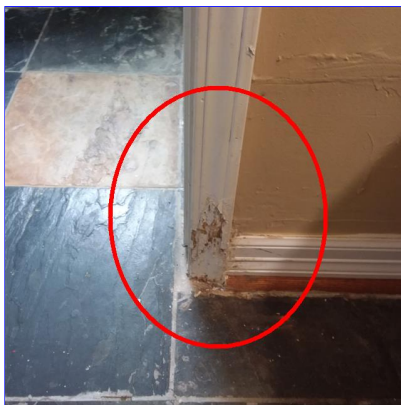
(4) Interior trim is damaged or peeling paint in areas. This is a cosmetic issue. I recommend repair as desired.

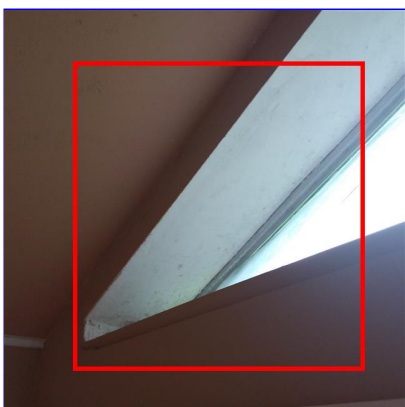
E. Item 25(Picture) Rear of living room

(5) The drywall on the wall is peeling paint in areas. While this damage is cosmetic, it needs to be repaired. A qualified person should repair or replace as needed.

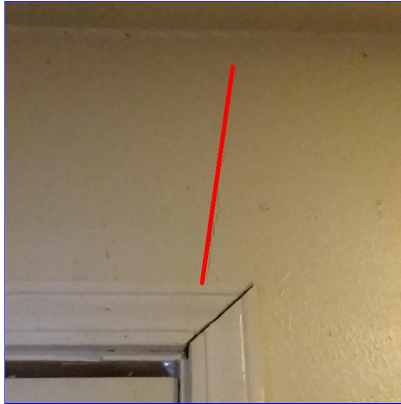
E. Item 27(Picture) Front of washer/dryer room

(7) The drywall on the wall has settlement cracks Washer/Dryer room. Repairs are needed. A qualified person should repair or replace as needed.

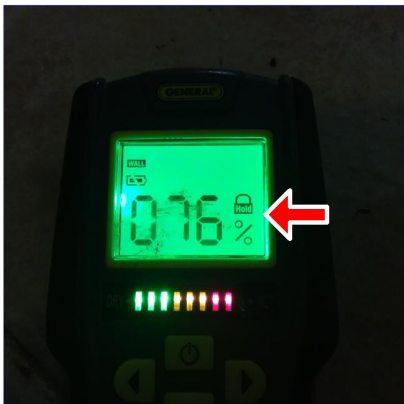
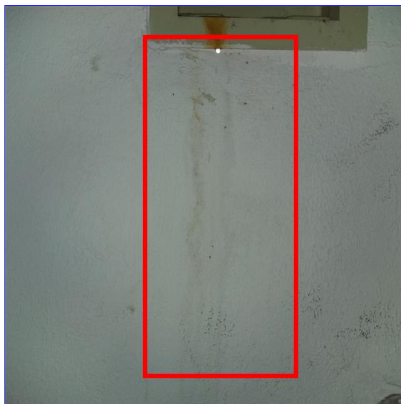
(8) The drywall on the wall shows wet stains indicating moisture or intrusion did or still may occur Washer/Dryer room. The moisture meter was used and it recorded 19% or higher, which indicates the leak has not been corrected. A qualified person should repair or replace as needed.

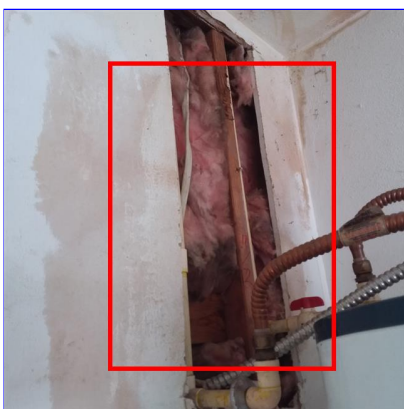
E. Item 36(Picture) Right rear of garage

(13) The drywall on the wall is missing piece garage. Repairs are needed. A qualified person should repair or replace as needed.

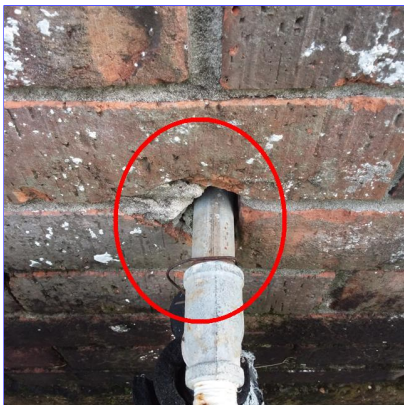
E. Item 37(Picture) Front left side of home

(14) Areas where wiring or piping passes through walls should be sealed. I recommend having a qualified person seal as needed.

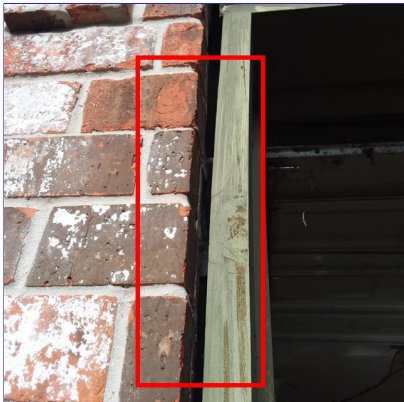
E. Item 40(Picture) Front left of home

(16) The Wood trim front of home is loose. Further deterioration can occur if not corrected. A qualified person should repair or replace as needed.

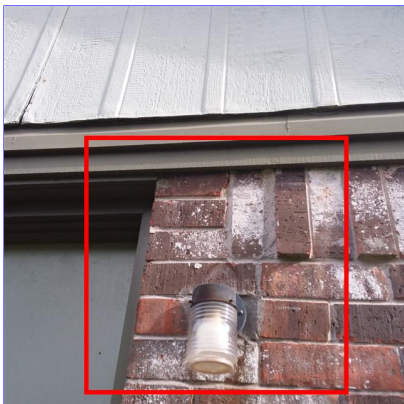
E. Item 41(Picture) Left side of home

(17) The Brick siding left side (facing front) is loose. Further deterioration can occur if not corrected. A qualified person should repair or replace as needed.

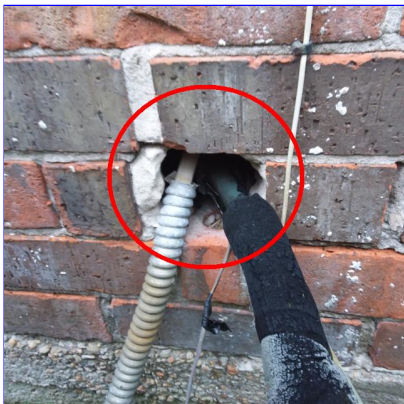
E. Item 42(Picture) Right side of home

(18) The hole in siding needs closing off with sealant or liquid foam at the right side (facing front) where compressor lines enter the home.

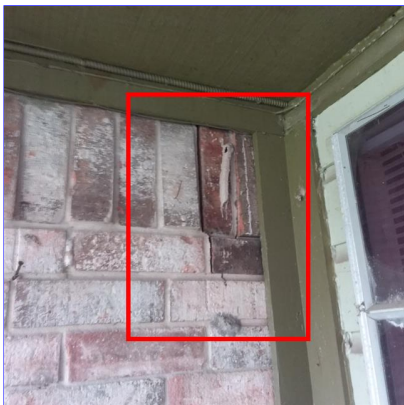
E. Item 43(Picture) Left rear of home

(19) The Brick siding rear of home has settlement cracks. Further deterioration can occur if not corrected. A qualified person should repair or replace as needed.

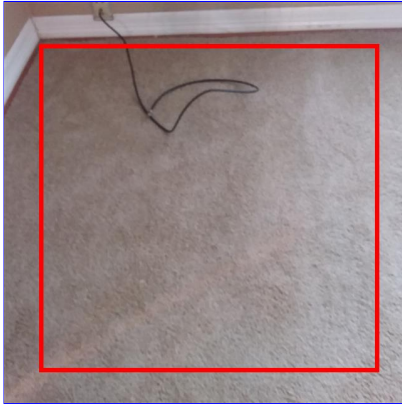
F. Item 1(Picture) Left rear of master bedroom

(1) The Carpet is loose at the Master Bedroom. While this damage is cosmetic, it needs to be repaired. A qualified person should repair or replace as needed.

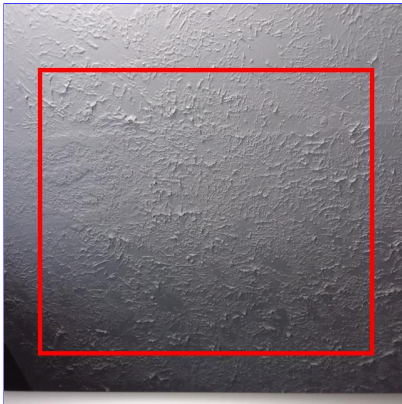
F. Item 2(Picture) Master bath

(2) The Drywall on the ceiling shows repair signs in areas. This damage is considered cosmetic. A qualified person should repair or replace as needed.

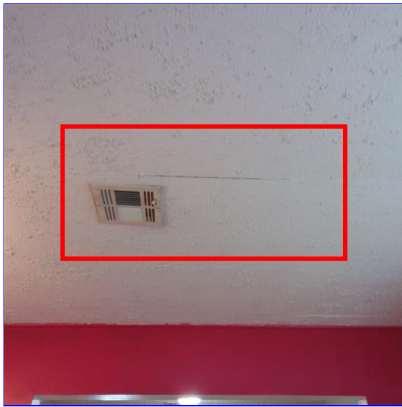
F. Item 9(Picture) Left side of sunroom

(6) The Panels on the ceiling is peeling or loose Sunroom. While this damage is cosmetic, it needs to be repaired. A qualified person should repair or replace as needed.

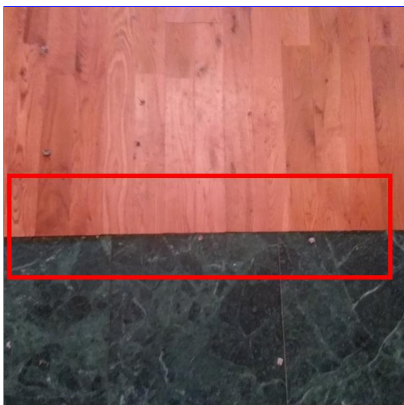
F. Item 12(Picture) Main entry

(8) The wood style flooring was not installed according to standard workmanlike practices in areas. Repairs are needed. A qualified contractor should inspect and repair as needed.

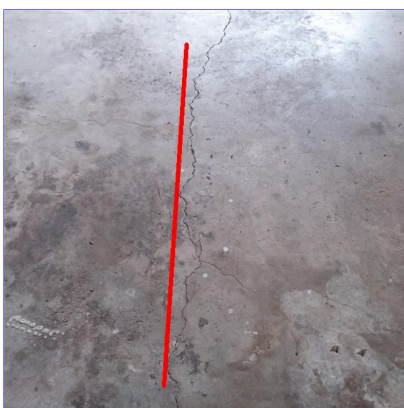
F. Item 13(Picture)

(9) The concrete floor of garage is cracked in areas. Further settlement may occur. I recommend a structural engineer inspect to determine the integrity of floor and repair as needed.

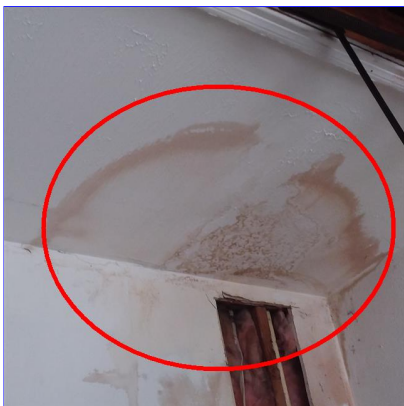
F. Item 14(Picture) Right rear of garage

(10) The Drywall on the ceiling reveals a light stain which appears from a water leak. Stain appears old garage. The moisture meter was used and it did not indicate an active leak. A qualified person should repair or replace as needed.

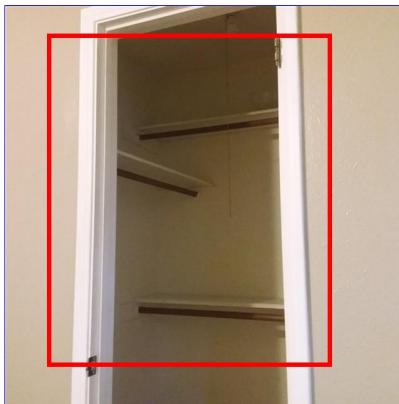
G. Item 5(Picture) Front bedroom

(2) The Closet door is missing in areas. A repair or replacement is needed. A qualified person should repair or replace as needed.

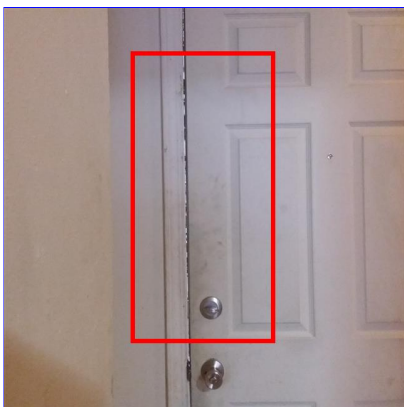
G. Item 7(Picture) Garage

(4) The garage reveals daylight when latched at areas missing weather-stripping. This can cause some heat loss in winter and loss of cool air in summer if not corrected. A qualified person should repair or replace as needed.

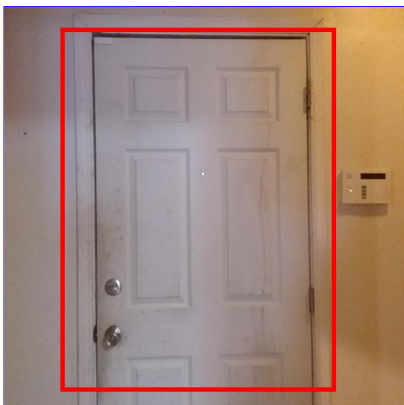
G. Item 8(Picture) Garage entry

(5) The occupant door from inside garage to inside the home is not a fire rated door. This means that should a fire occur in garage, the occupant door does not afford protection until fireman arrive. This door should be replaced with a fire rated door.

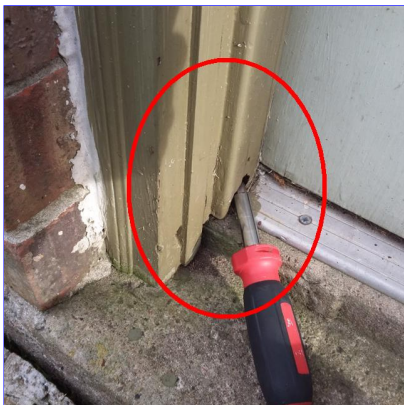
G. Item 11(Picture) Left side of home

(8) The left side (facing front) deteriorated at bottom of jamb (s). Further deterioration may occur if not repaired. A qualified person should repair or replace as needed.

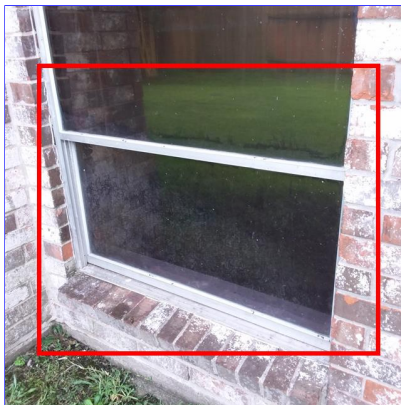
H. Item 4(Picture) Rear of home

(1) There are window frames that are not properly sealed. This can cause energy loss. I recommend having a qualified person seal and repair as needed,

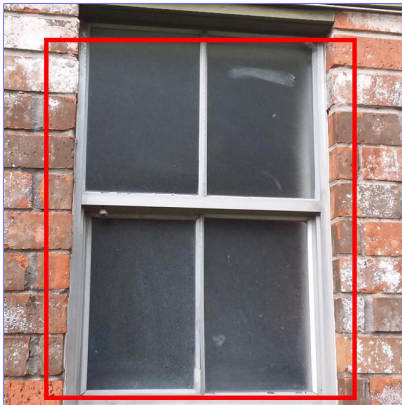
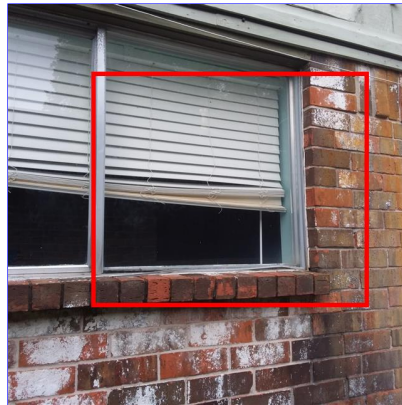
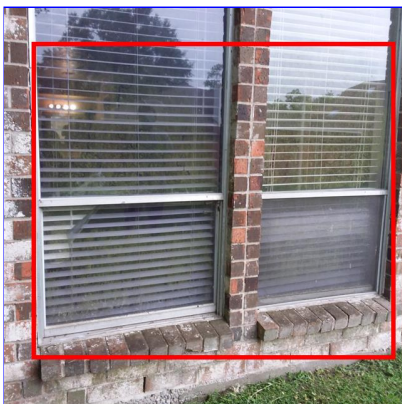
(4) There are window frames that are not properly sealed. This can cause energy loss. I recommend having a qualified person seal and repair as needed,

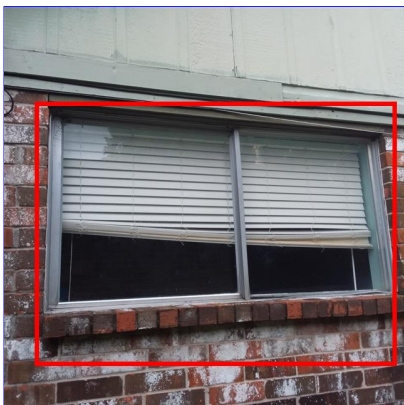
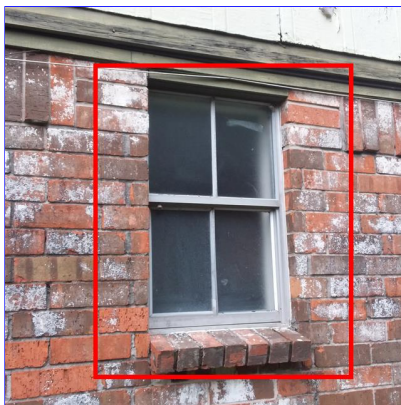
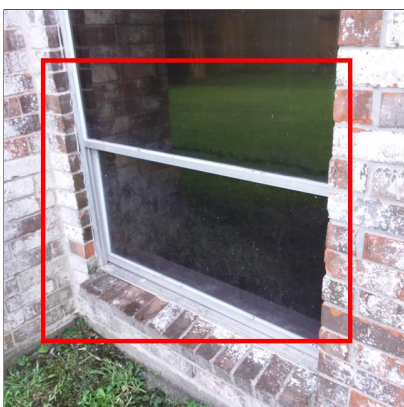
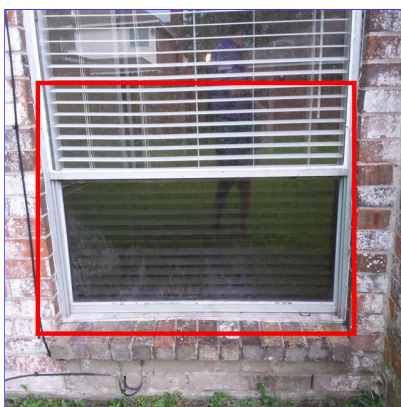
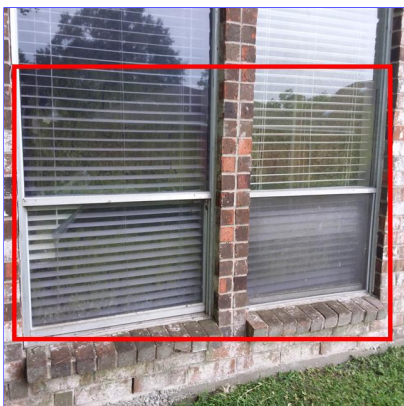
(5) Windows have damaged or missing screens. This is not considered to be today's standards. I recommend having a qualified person make repairs as needed.

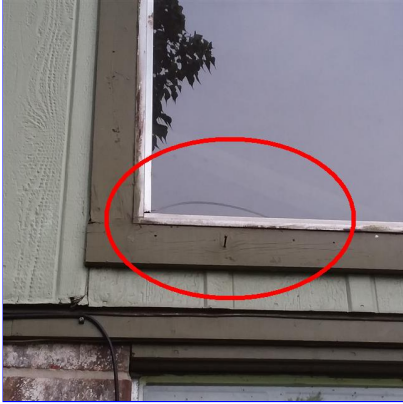
H. Item 15(Picture) Rear of home

(6) There is a cracked glass pane in window. I recommend having a qualified person make repairs as needed.

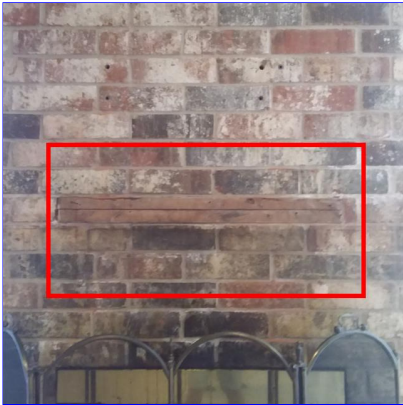
J. Item 1(Picture)

(1) Mantle for fireplace at the Living room is missing. I recommend repair as needed.

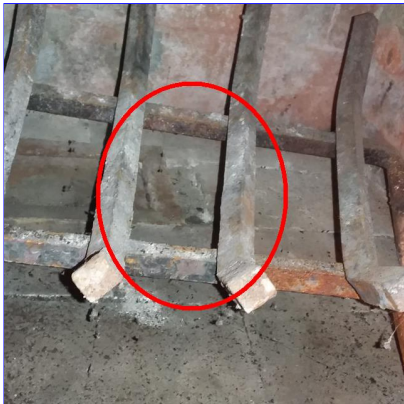
J. Item 2(Picture)

(2) The Fire-bricks (Burn Area) for the fireplace at the same location is missing. This burn area should be fireproof. Any repairs should be performed according to the manufacturer's specifications.

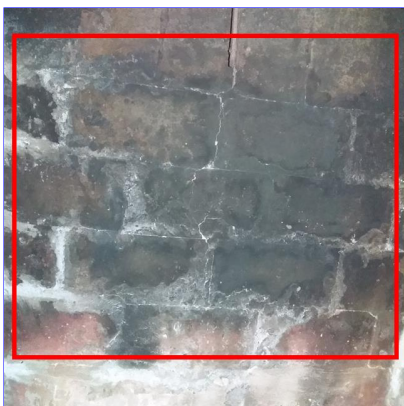
J. Item 3(Picture)

(3) The Fire-bricks (Burn Area) for the fireplace at the Living room is loose, and failing. This burn area should be fireproof. Any repairs should be performed according to the manufacturer's specifications.

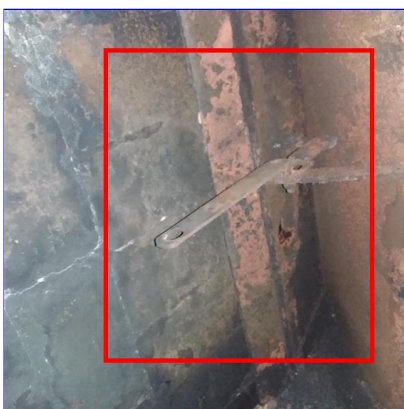
J. Item 4(Picture)

(4) The damper for fireplace at the same location is rusted tight or "seized" (non-operational). Repairs should be made so unit works properly. I recommend a qualified contractor inspect and repair as needed.

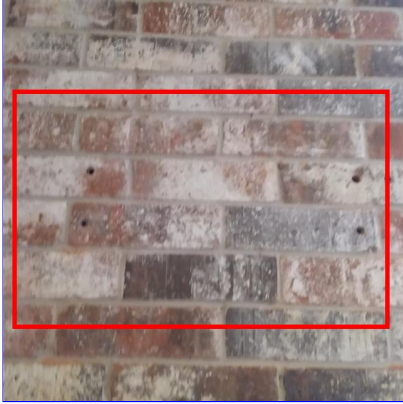
J. Item 5(Picture)

(5) Brick for fireplace at the same location are damaged. I recommend repair or replace as needed.

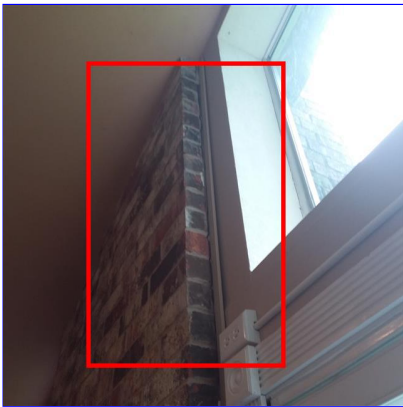
J. Item 6(Picture) Living room

(6) The chimney is leaning or has pulled away from home. A leaning chimney is considered unsafe until inspected by a structural engineer and anyone else needed such as a chimney sweep. I recommend a qualified structural engineer inspect and repair as needed.

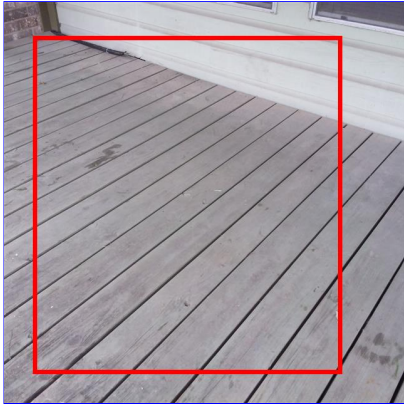
K. Item 1(Picture) Rear of home

- (1) The weight load capabilities are not part of this inspection.
- (2) The patio is built with wood to ground to structure contact. This creates conducive conditions for certain types of wood destroying insects. I recommend having a qualified pest control company inspect and treat as needed.

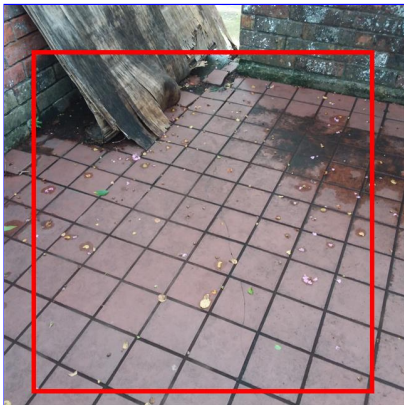
K. Item 2(Picture) Front of home

(3) The tile floor on the patio at the front of home has cracked in some areas (which are cosmetic) and loose, and missing in areas. Further deterioration can occur if not repaired. A qualified person should repair or replace as needed.

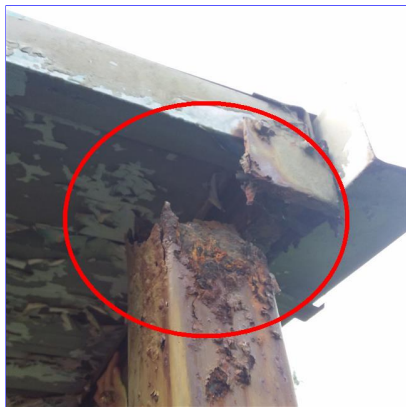
K. Item 4(Picture) Rear of home

(5) The support post(s) on the covered patio at the rear of home is deteriorated (at top). An injury could occur if not corrected. A qualified contractor should repair or replace as needed.

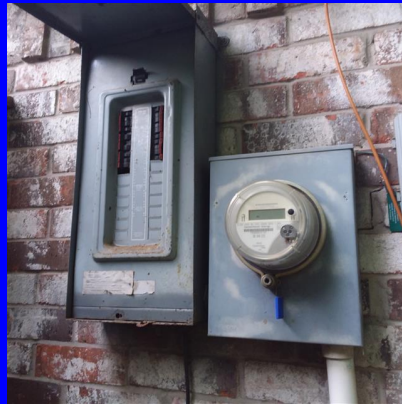
Below ground service located at right side of home

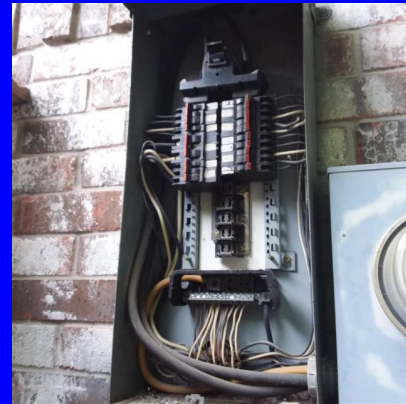
150 AMP main panel located at right side of home

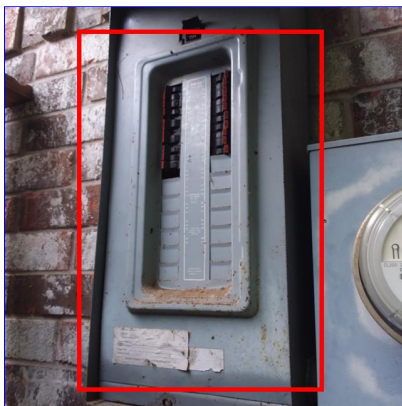
A. Item 1(Picture)

(1) The panel is missing circuit identification. **This is a safety hazard.** I recommend having a qualified person mark circuits as needed.

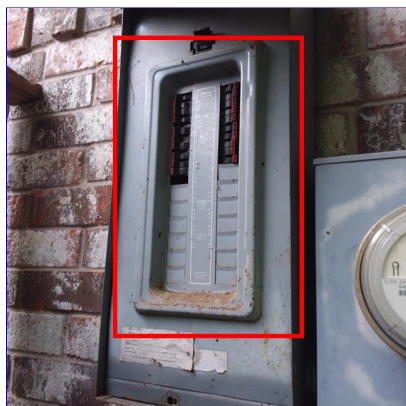
A. Item 3(Picture)

(3) You have a Federal Pacific panel which is legal, but there is a possibility that the circuit breakers may not trip when shorted possibly causing an electrical hazard. Opinions by most licensed electrical contractors on this panel is that it is unsafe. I recommend you consult a licensed electrical contractor for necessary replacement.

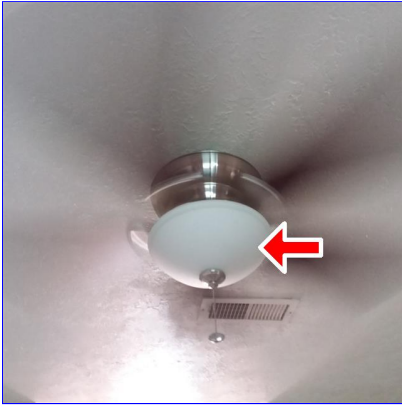
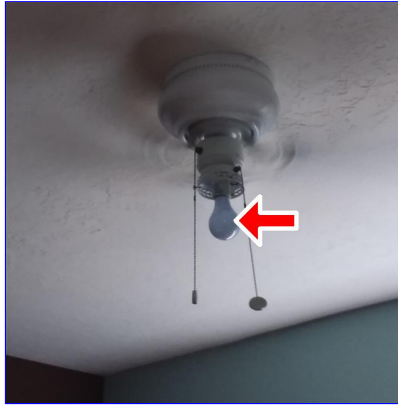
(3) The light fixture does not work (try bulb first). Electrical issues are considered a hazard until repaired. A qualified licensed electrical contractor should perform repairs that involve wiring.

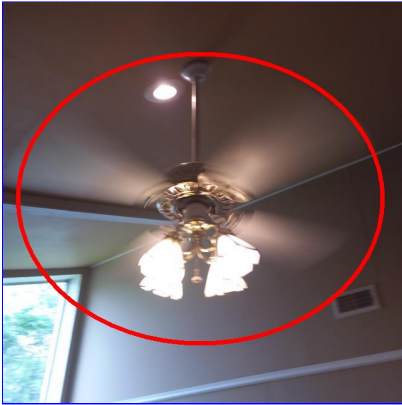
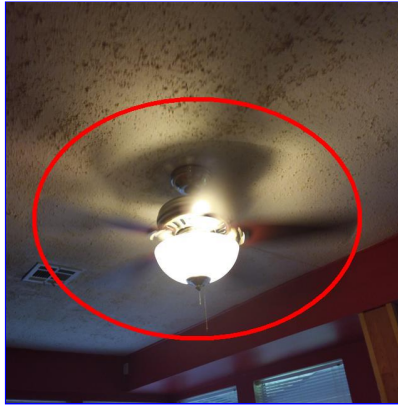
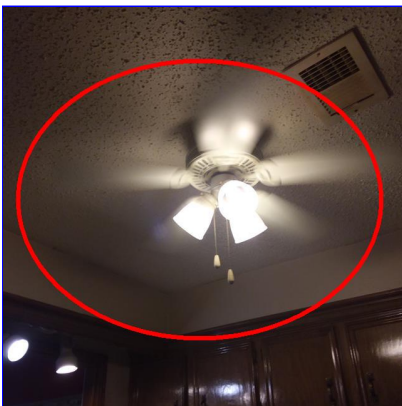
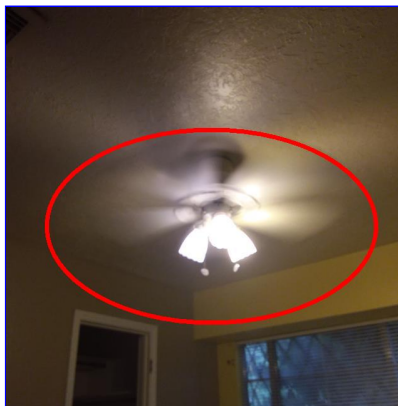
(4) The ceiling fan "wobbles" in most if not all rooms. Some fans that wobble cannot be corrected without replacement. A qualified licensed electrical contractor should perform repairs that involve wiring.

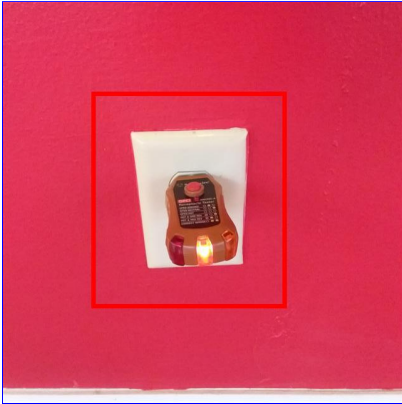
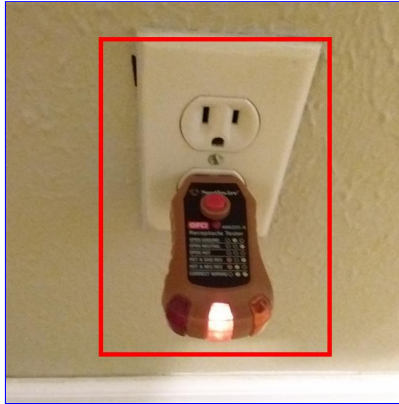
(5) "three-prong" outlets are not grounded in area's. Electrical issues are considered a hazard until repaired. A qualified licensed electrical contractor should perform repairs that involve wiring.

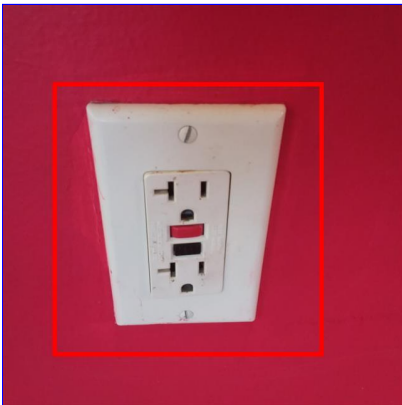
B. Item 10(Picture) Front right of sunroom

(6) GFCI (Ground Fault Circuit Interrupter) outlets in area's wont "trip" when tested. Electrical issues are considered a hazard until repaired. A qualified licensed electrical contractor should perform repairs that involve wiring.

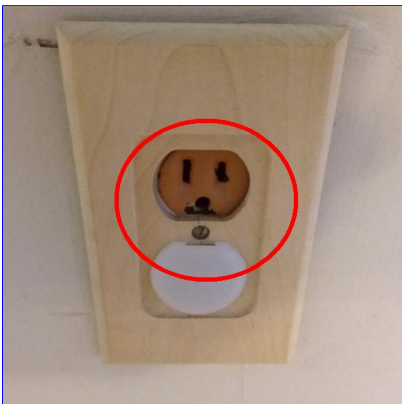
(7) "three-prong" outlets are broken or damaged in most if not all rooms. Electrical issues are considered a hazard until repaired. A qualified licensed electrical contractor should perform repairs that involve wiring.

B. Item 12(Picture) Damaged outlets in multiple area's

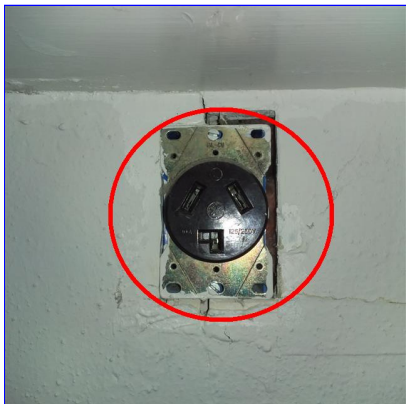
B. Item 13(Picture)

(8) A three prong outlet for dryer is present in laundry room. This is not considered today's standard. Today's standard requires a four prong outlet be installed. I recommend having a qualified electrician to inspect and make repairs as needed.

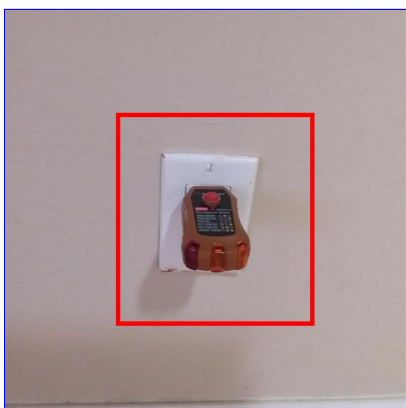
B. Item 16(Picture) Right side of dining room

(11) GFCI (Ground Fault Circuit Interrupter) outlet at the Dining Room did not work or there is no power to outlet. Electrical issues are considered a hazard until repaired. A qualified licensed electrical contractor should perform repairs that involve wiring.

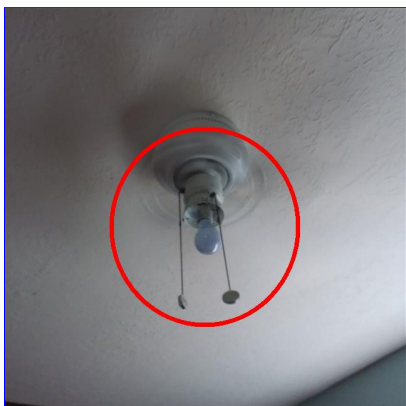
B. Item 17(Picture) Rear bedroom

(12) The light fixture is missing globe at the Bedroom. Electrical issues are considered a hazard until repaired. I recommend repair as needed.

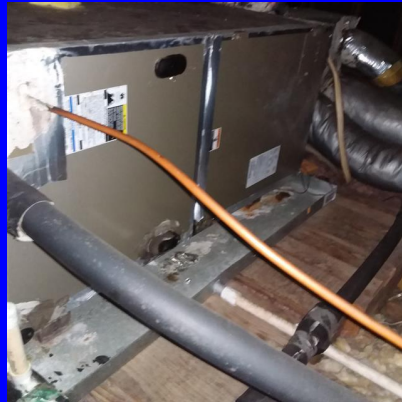
Electric furnace

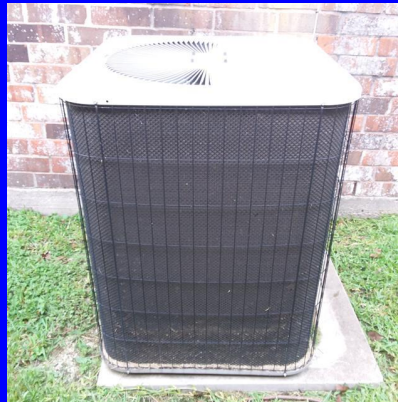
HVAC outside condenser

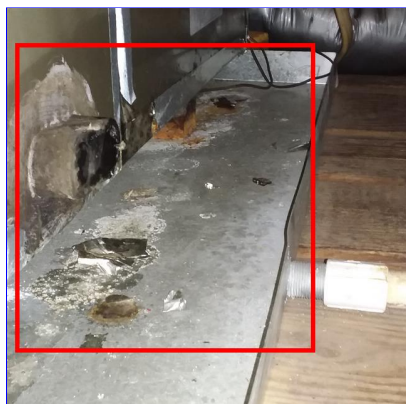
B. Item 1(Picture)

- (1) It is recommended to have HVAC systems serviced annually.
- (2) The emergency overflow drain pan for the HVAC system is showing signs of deterioration. Further deterioration may occur if not corrected. I recommend having a qualified person make repairs as needed.

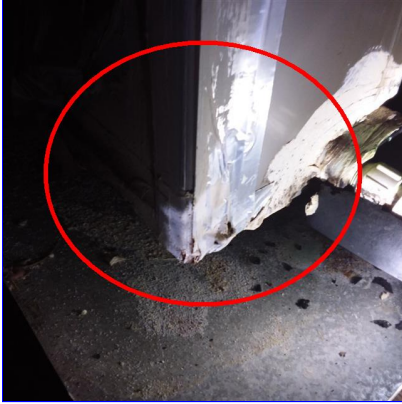
B. Item 2(Picture)

- (3) Signs of fungi growth is present on ductwork or furnace in the attic space. This could indicate that furnace may not sealed properly. We did not inspect, test or determine if this growth is or is not a health hazard. The underlying cause is moisture. I recommend having the unit serviced and properly cleaned.

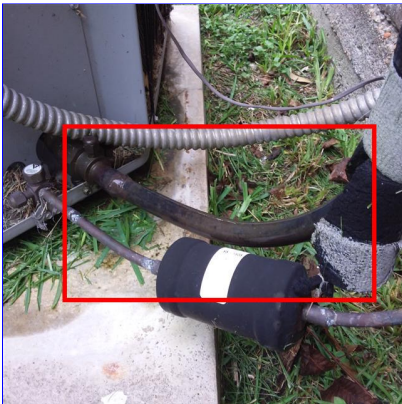
B. Item 3(Picture)

(4) The foam sleeve on suction line is missing foam sleeve in area(s). Missing foam on suction line can cause energy loss and condensation. A licensed HVAC contractor should service or repair unit.

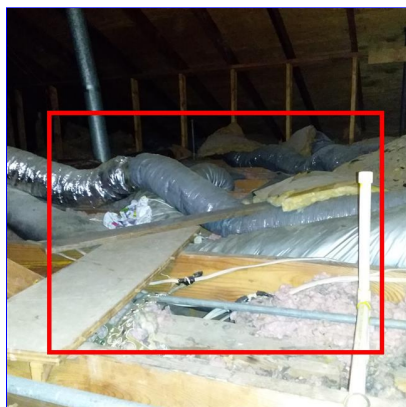
C. Item 1(Picture)

(2) The duct pipe needs support straps in the attic. Energy loss is occurring. A licensed HVAC contractor should service or repair unit.

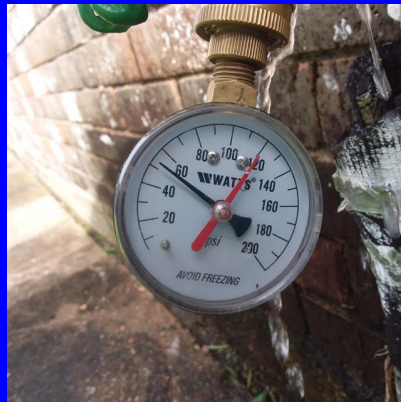
53 psi water pressure

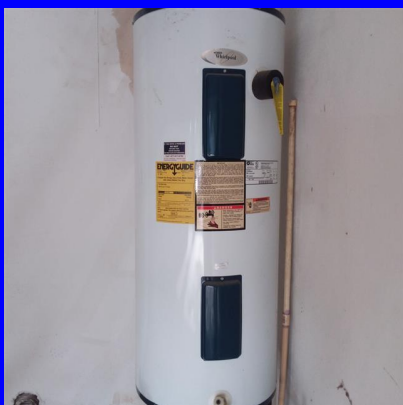
50 gallon electric water heater located in garage

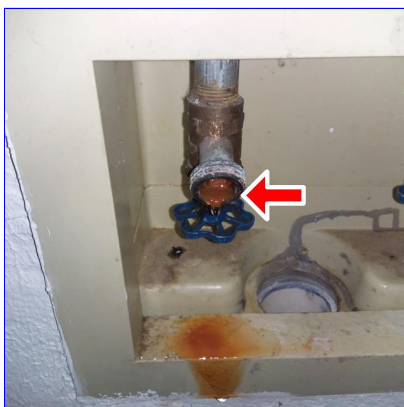
A. Item 2(Picture)

(3) The hot supply valve at clothes washer is leaking. I recommend repair or replace as needed.

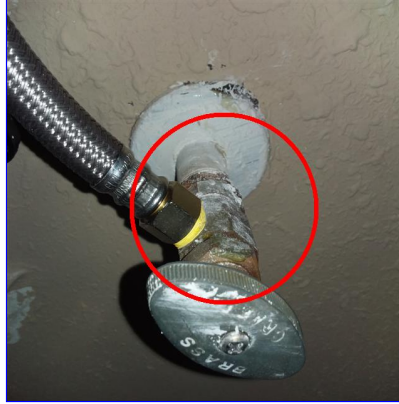
A. Item 4(Picture) Hall bath sink

(4) The old galvanized supply line has a corroded wet joint at connection in area's. Repairs are needed. A qualified licensed plumber should repair or correct as needed.

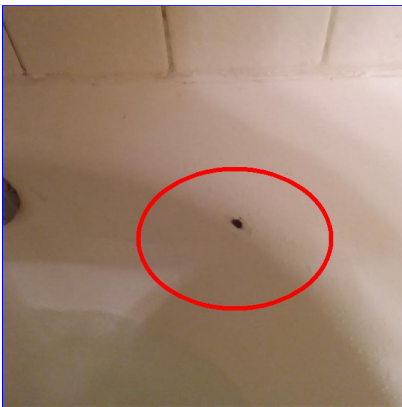
A. Item 6(Picture) Hall bath

(6) The bathtub is chipped (Cosmetic) at the hall bath. This is a cosmetic issue for your information A qualified person should repair as necessary.

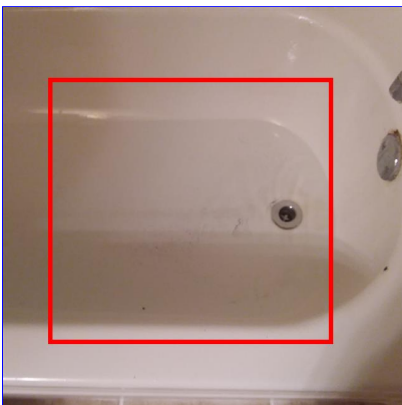
B. Item 2(Picture) Hall bath

(2) Tub drain is slow or clogged at hall bath.

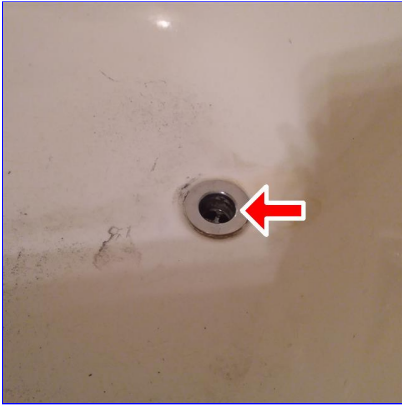
B. Item 3(Picture)

(3) Tub drain plug is damaged or missing and no longer operates. A drain plug is being used instead at hall bath.

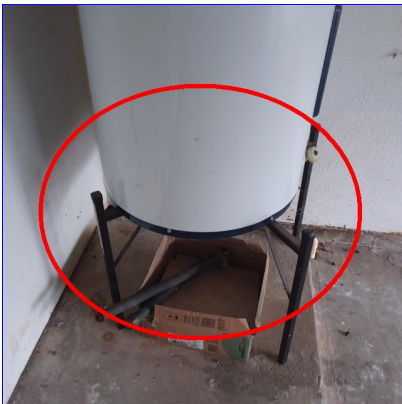
C. Item 1(Picture)

(1) The water heater is installed without the recommended emergency overflow drain pan. This is not considered to be today's. I recommend having a drain pan installed by a qualified person.

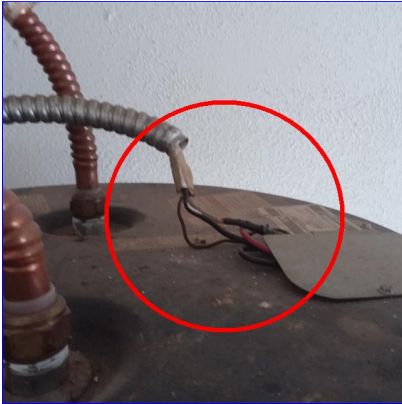
C. Item 2(Picture)

(2) The wiring for the water heater is exposed. Electrical issues are considered a hazard until repaired. I recommend a licensed electrical contractor correct as necessary.

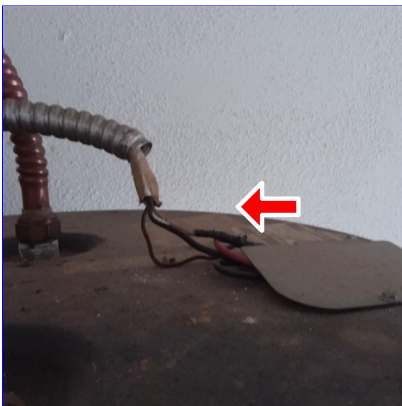
C. Item 3(Picture)

(3) Electric water heater is missing anti wire fray fitting. Electrical issues are considered a hazard until repaired. I recommend having a qualified person make repairs as needed,

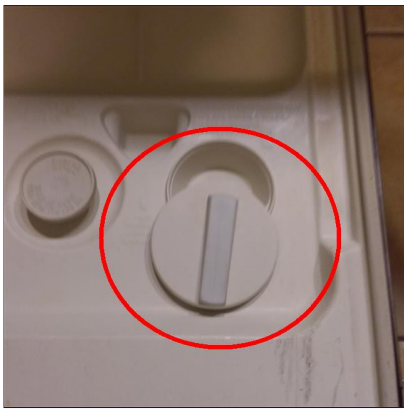
A. Item 3(Picture)

(5) The dispenser lid for detergent does not close properly. I recommend repair as necessary.

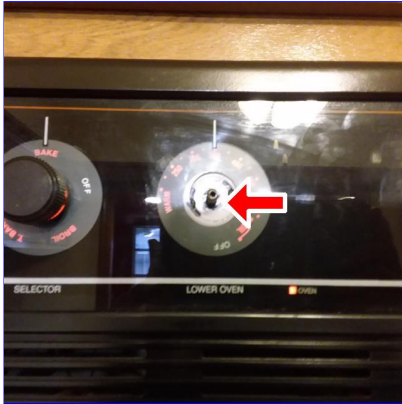
D. Item 1(Picture)

(1) The control knobs for oven is missing. I recommend repair as needed.

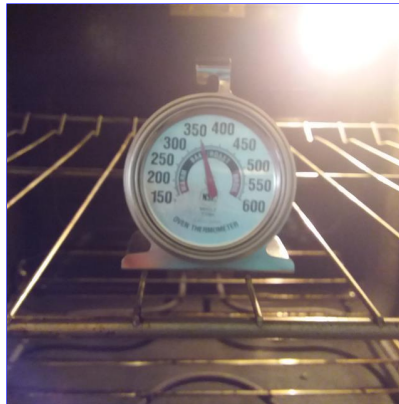
D. Item 3(Picture) Lower oven tested at 350°

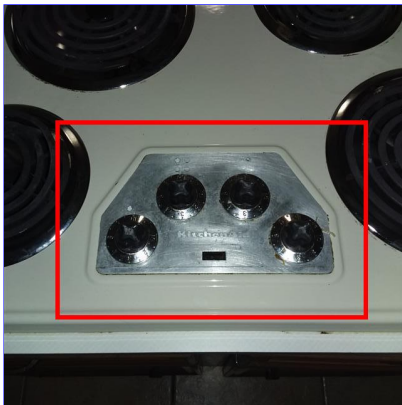
D. Item 4(Picture)

- (4) The control knobs for range are difficult to read or understand setting. I recommend repair as needed.

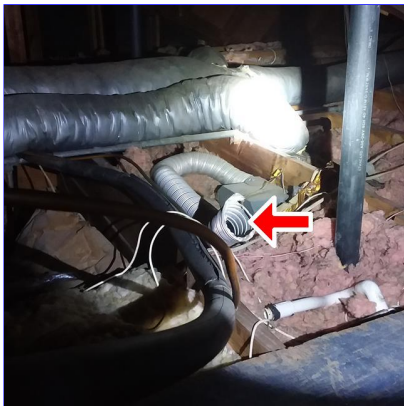
F. Item 1(Picture)

(2) The Exhaust fan does not vent to outside at the hall bath. Vent pipes that terminate in attic space can sometimes cause moisture that can lead to mold or cause condensation. A qualified person should repair or replace as needed.

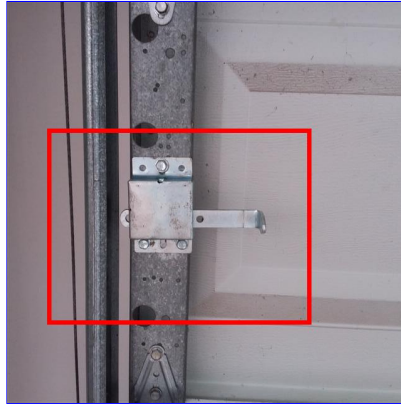
G. Item 2(Picture) Right door

(2) The automatic openers for at the front of home has electronic sensors located higher than six inches off floor which may not be installed according to manufacturers specification. This is considered unsafe and needs correcting. A qualified person should repair or replace as needed.

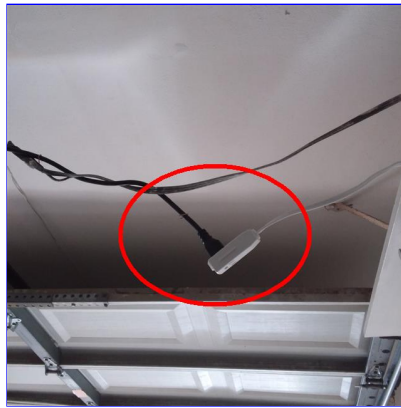
G. Item 4(Picture) Left door

(4) The automatic openers for at the front of home is using an extension cord as permanent wiring, and should have its own outlet (GFCI recommended). A repair or replacement is needed. A qualified person should repair or replace as needed.

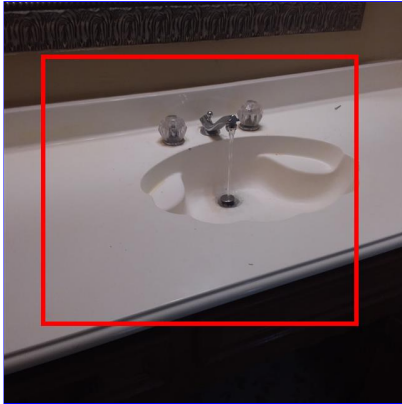
I. Item 1(Picture) Master bath

(1) Countertop is painted over . This is a cosmetic issue for your information. Recommend repair or replace as necessary.

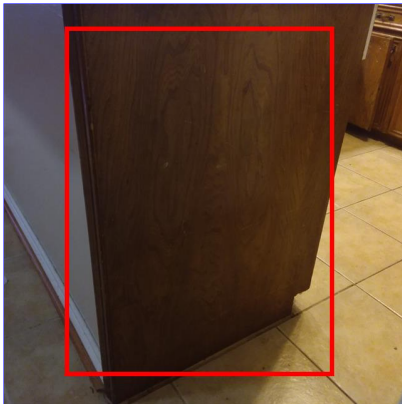
I. Item 2(Picture) Front left of kitchen

(2) Base cabinetry is damaged . This is a cosmetic issue for your information. Recommend repair or replace as necessary.

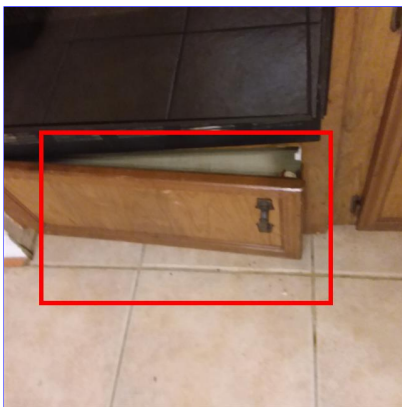
I. Item 3(Picture) Front of kitchen

(3) Some cabinet doors need magnets or hardware to stay shut.

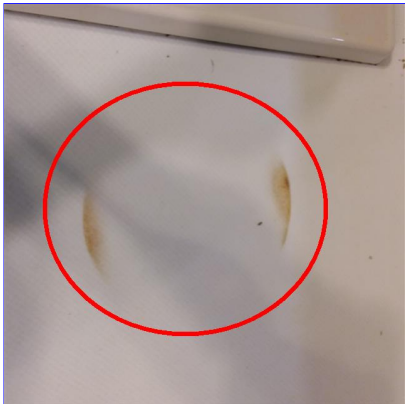
I. Item 4(Picture) Left side of kitchen

(4) Laminated countertop has a burn mark (right of stove). This is a cosmetic issue for your information. Recommend repair or replace as necessary.
