Inspection Report

Property Address:
315 Peacedale Court
Houston TX 77015

HG Home Inspection

PROPERTY INSPECTION REPORT

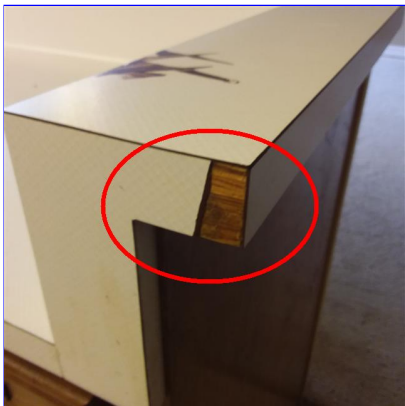
I. Item 6(Picture) Front right of kitchen

(6) Laminated countertop is damaged . This is a cosmetic issue for your information. Recommend repair or replace as necessary.
