**1321 Altavilla Ln**

**League City, TX 77573**

**081720-1321**

# PROPERTY INSPECTION REPORT

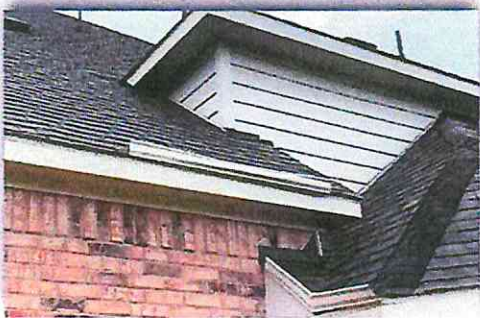
Lifted roof flashing detail noted at center rear of home, should be properly repaired and sealed.

*repaired*

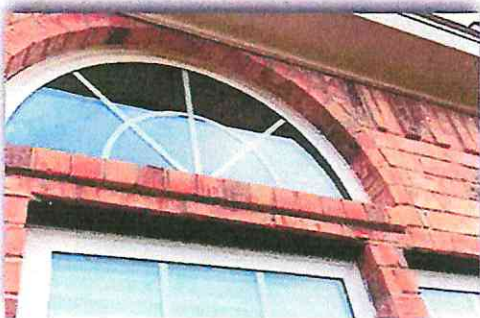
Failed thermal seal(s) noted at approx. 3+ rear living room window(s), failed seals no longer retain their insulation properties leading to a decrease in energy efficiency, window should be replaced.

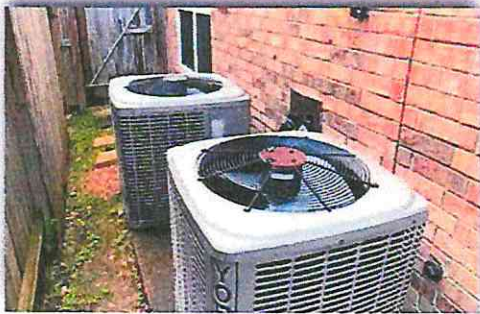
Note: Exterior AC's are approx. 10 years old, units did not appear to be functioning optimally at time of inspection due to loud noises.

*Replaced Downstair evap. w/4 Ton Unit*

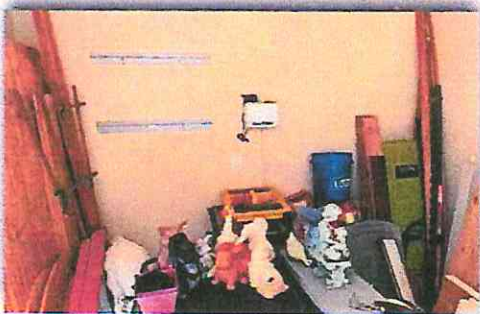
Note: Sprinkler system panel was un-plugged and not accessible during inspection, recommend having inspected / serviced by specialist.

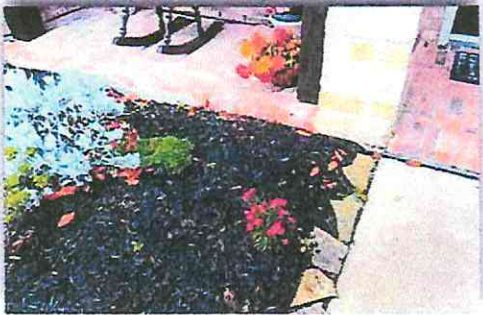
High grading / vegetation levels noted at exterior of home, minimum of 4 inches of slab face needs to be visible for foundation monitoring / drainage & ventilation.

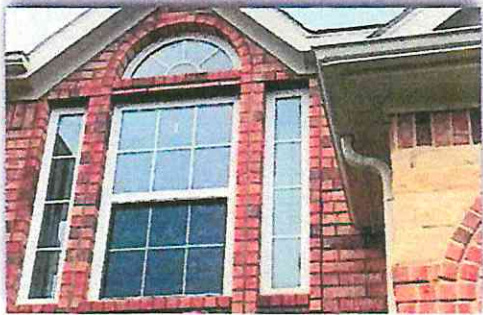
Failed thermal seal(s) noted at approx. 4-5 front second floor guest bedroom window(s), failed seals no longer retain their insulation properties leading to a decrease in energy efficiency, window should be replaced.

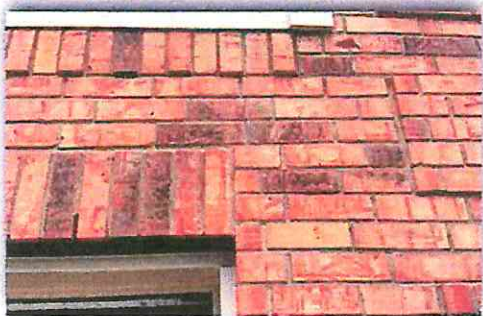
Stress crack(s) noted in exterior brick veneers, no significant related effects found at time of inspections recommend sealing / monitoring.

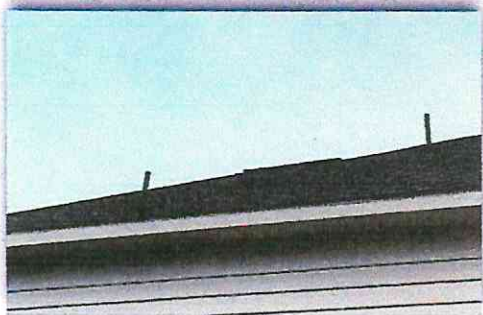
Properly re-seat & seal around ALL exhaust vents & plumbing vent pipes where they exit the boot jack gaskets on roof surface.

*These needed re sealed were addressed Hot Water heaters*

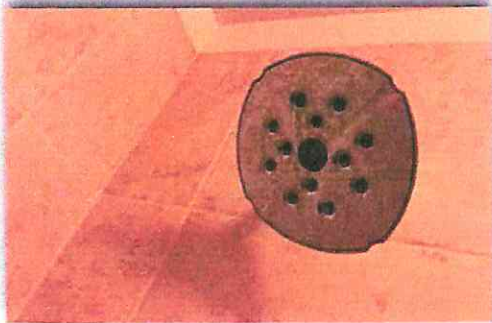
Several interior plumbing fixtures throughout home are corroded, should be repaired.

*Cosmetic*

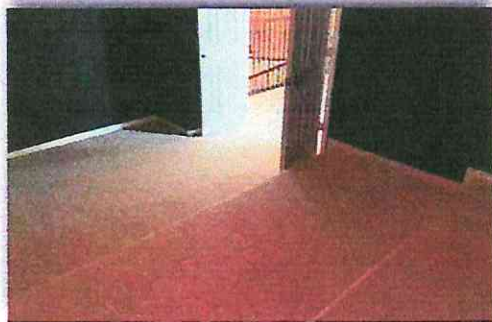
Floor decking at second story is not properly fastened to framing in several areas, (floor pops & squeaks), should be repaired.

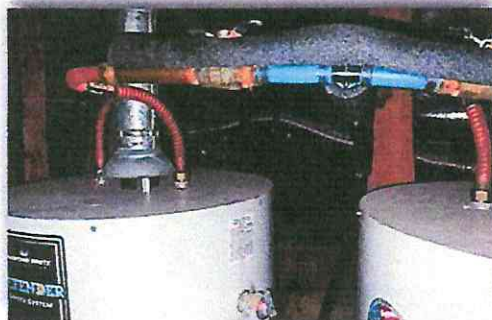
Rust / corrosion present at plumbing connections for water heater unit, damaged connections should be replaced to help prevent leaks from occurring.

*Replaced  
Boiler*

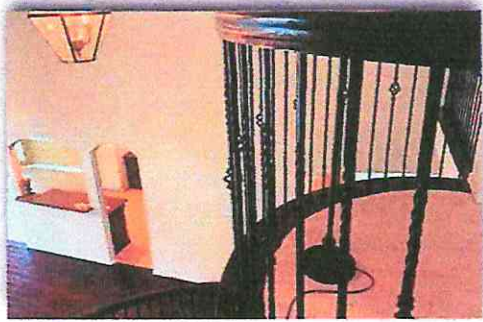
Several balusters / newel posts for stairway railings & second floor guard rails are not properly secured, should be repaired for safety.

*repaired*

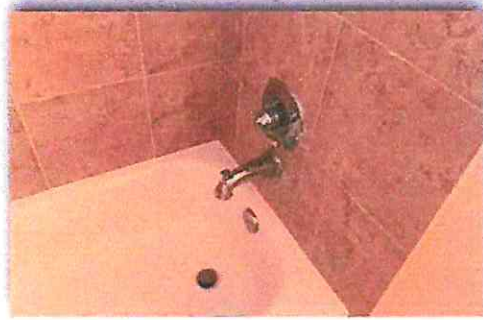
Both guest bathroom's tub / shower valves & spouts are not properly secured in / at wall, should be repaired & sealed around.

*Contractor checked*

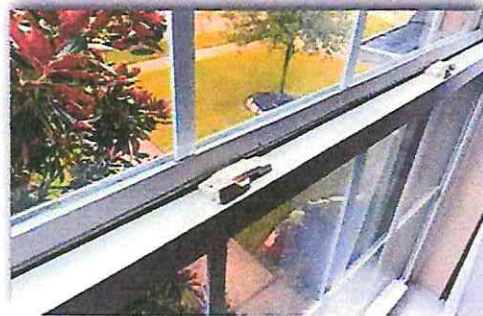
Front-right guest bedroom window would not fully close / latch, should be repaired.

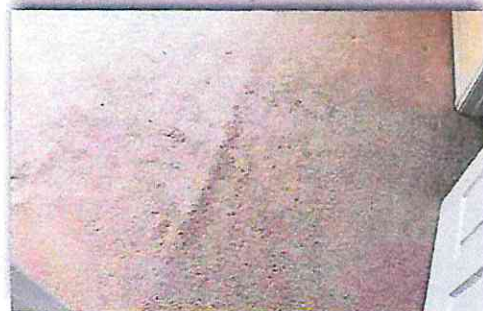
Carpet flooring second floor level should be properly re-stretched for safety. (trip hazard)

*repaired*

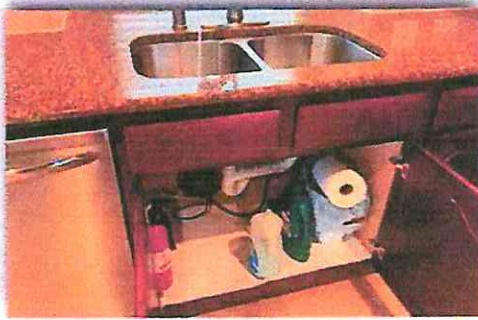
Kitchen sink food disposal was in a bind at time of inspection and would not operate correctly, should be repaired.

*repaired*

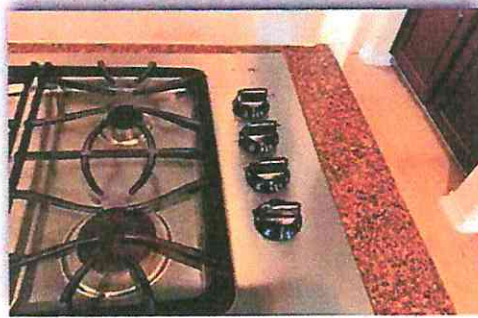
Kitchen stove-top burner control knob indication lines for lighting & gas control are missing, should be repaired / replaced for safety.

*faded not missing*

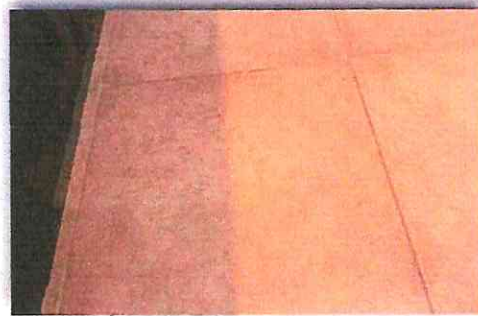
Several cracked floor tiles noted in kitchen and guest bathroom areas, damaged tiles should be replaced.

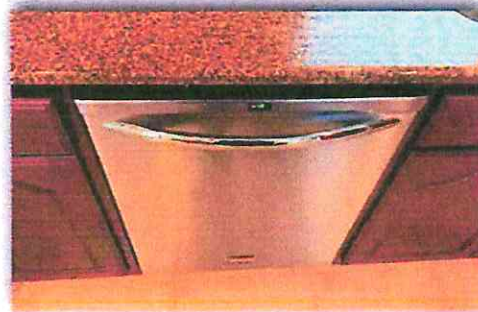
Kitchen dishwasher unit's front handle / panel cover is not fully secured, should be corrected.

*repaired*

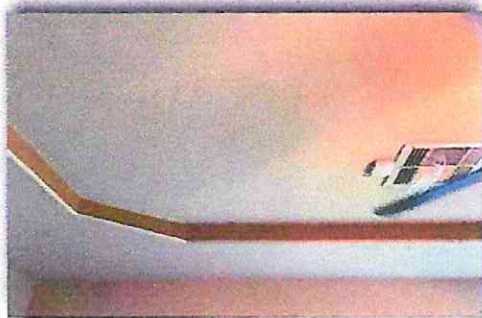
Moisture stains noted at master bedroom & living room ceilings, no current moisture detected at time of inspection.

*not aware of master stain  
- Living room -  
~~Repaired~~  
A/C Replace*

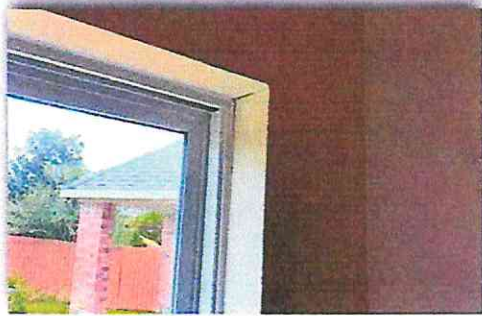
Minor separation cracks noted at interior window framing areas, should be resealed.

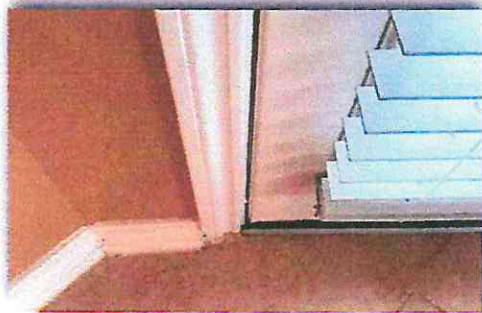
Rear door does not seal properly at framing / threshold, should be repaired to help prevent air loss.

*Bryan + Bryan  
V/d with*

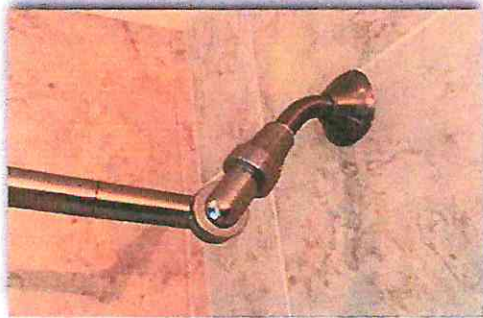
Properly seal around all tub/shower spouts, valve covers & walls to help prevent moisture from entering wall cavity.

*Checked By Contractor OK*

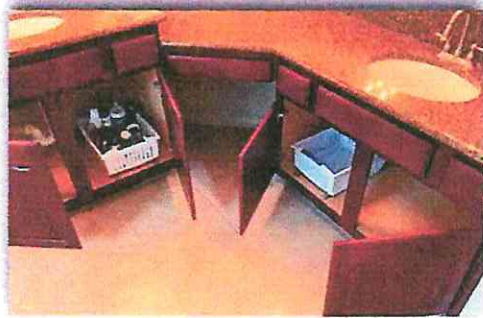
Several loose hardware components at cabinet doors & drawers noted in kitchen / bathroom areas, cabinet door hinges should be tightened & doors adjusted for proper closure.

*Repaired*

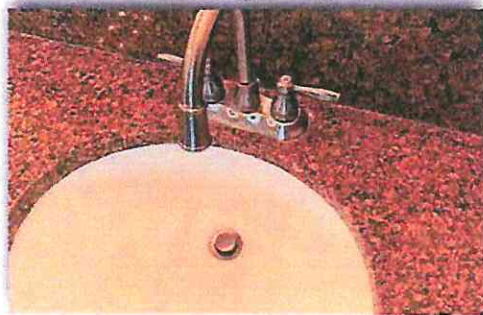
Right master bathroom sink fixture appears to leak at base when operating, should be repaired.

*Repaired*

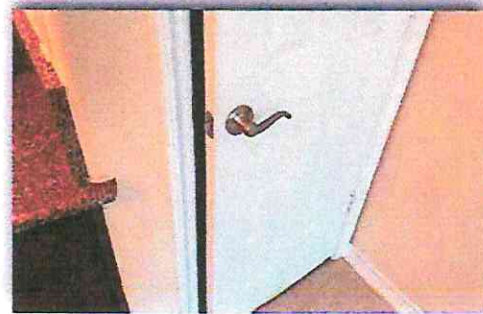
Master bathroom linen closet door & kitchen pantry door did not latch at strike plate, should be repaired.

*Bygar  
Bygar  
found  
to be  
OK*

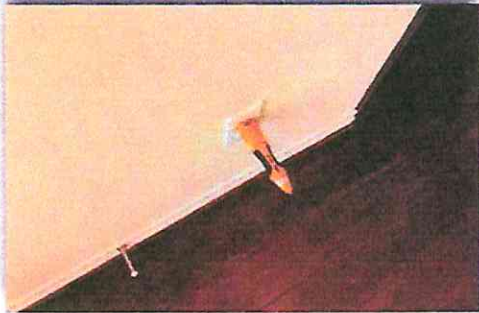
Several electrical outlets throughout home are not properly secured in the wall / junction box, should be repaired for safety.

*Bryan + Bryan did not find wrong*

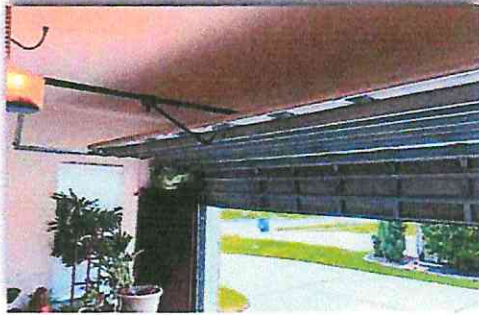
Garage door opener's belt / chain has excess slack present, door binds support track when closed, needs servicing.

*Bryan + Bryan Confirmed no issue*

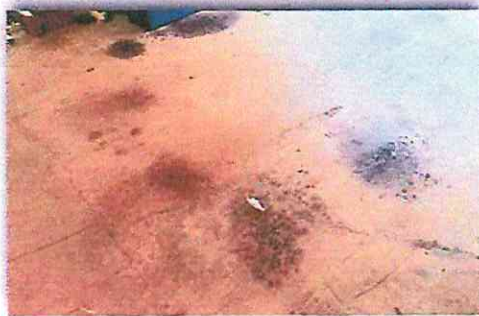
Stress crack(s) present in garage / patios / drive & walkway slabs, no significant related effects found in areas at time of inspection, recommend monitoring.

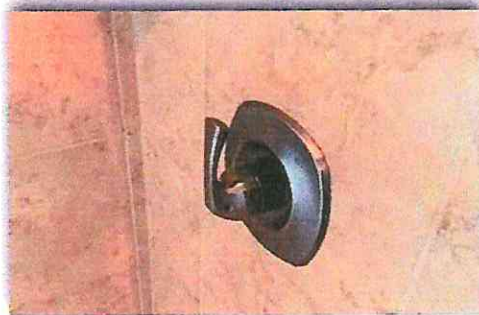
Master bathroom shower handle id not secured, shower head leaks when operated, should be corrected.

*Repair*
