Inspection Report

Property Address:
5003 Caprock Dr
Pearland TX 77584

PROPERTY INSPECTION REPORT

By: Reevis Coleman Schultz Texas Professional Home Inspector / Hilsher Group
LLC 8/16/2017

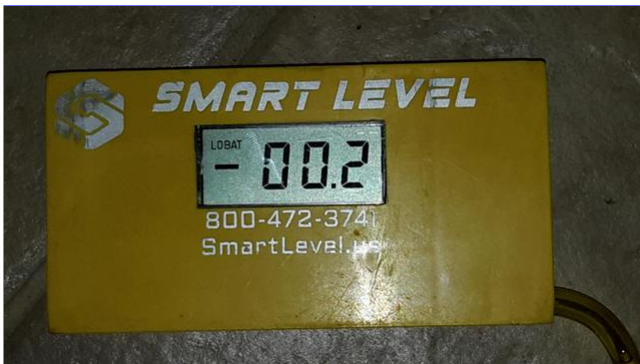
A. Item 4(Picture) front left corner of home

(4) The foundation is showing significant signs of movement. I recommend consulting with a Structural Engineer or foundation professional.

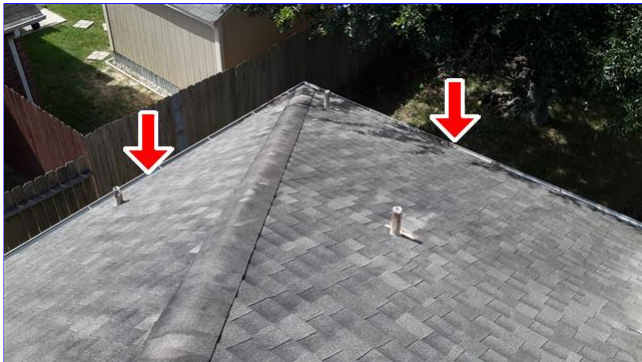
B. Item 1(Picture) left side and rear of home.

The gutters are full of debris in areas and needs to be cleaned. The debris in gutters can also conceal rust, deterioration or leaks that are not visible until cleaned, and I am unable to determine if such conditions exist.

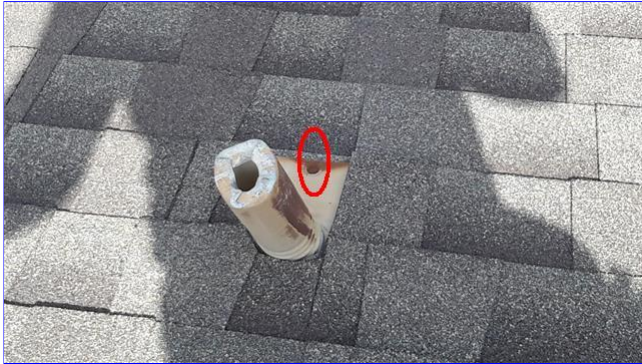
C. Item 5(Picture)

(5) The roof shingles is damaged at the left side. I recommend consulting with a roofing professional.. A qualified contractor should inspect and repair as needed.

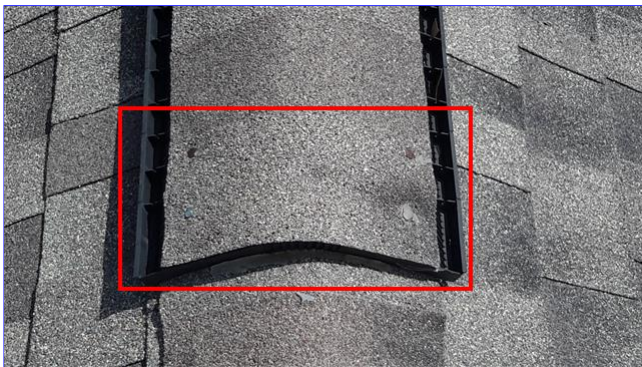
C. Item 6(Picture)

(6) The roof shingles showing wear at the front of home. I recommend consulting with a roofing professional.. A qualified contractor should inspect and repair as needed.

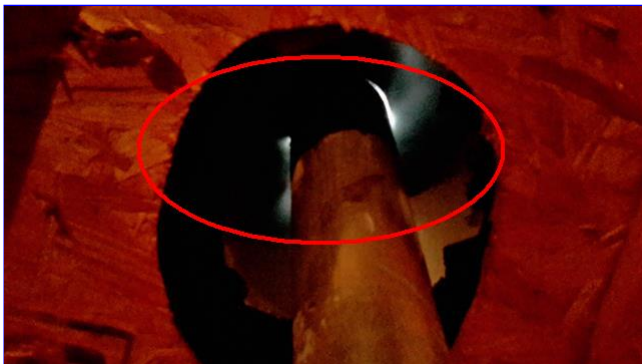
D. Item 1(Picture) water heater

Water heater roof penetration reveals daylight. This is not considered today's standard. I recommend having a qualified person inspect and make repairs as needed.

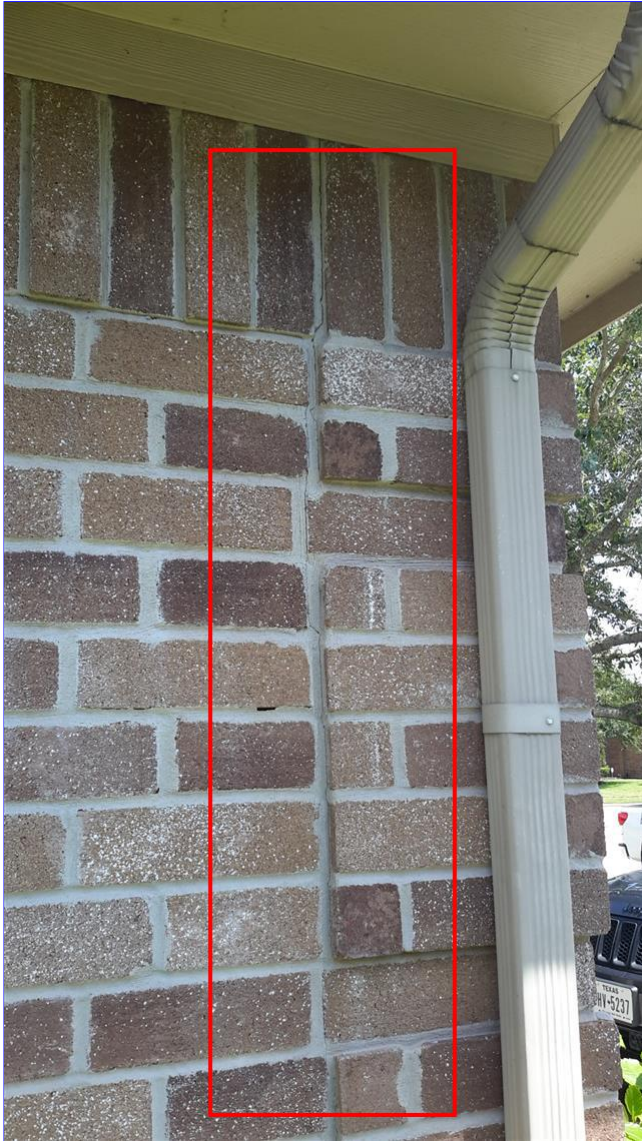
E. Item 1(Picture) left side of home

(1) The Brick siding exterior has hairline cracks. Further deterioration can occur if not corrected. A qualified contractor should inspect and repair as needed.

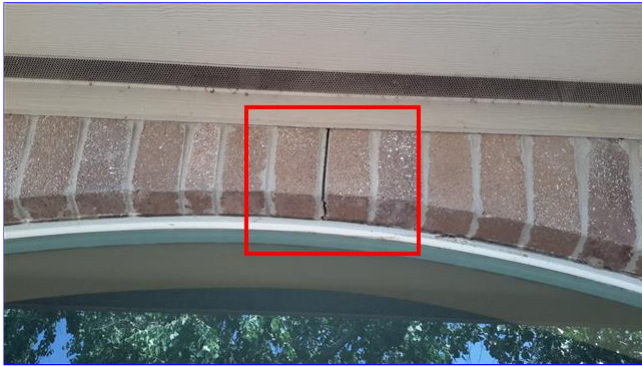
E. Item 8(Picture) rear of home

(2) The Trim or Siding exterior has caulking that is weathered or missing. Deterioration can eventually occur if not corrected. A qualified contractor should inspect and repair as needed.

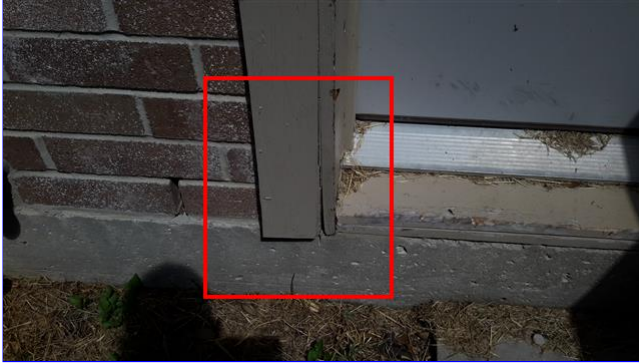
E. Item 13(Picture) left side of home

(3) Steel lintel is showing signs of rust. This is not considered today's standard. I recommend repair as needed.

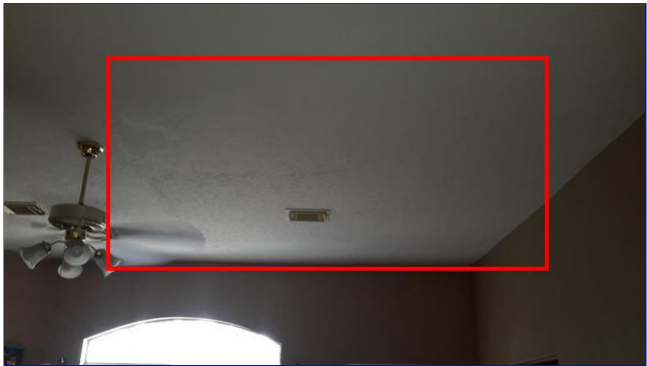
F. Item 6(Picture) living room

(2) The Drywall on the ceiling shows repair signs in areas's. This damage is considered cosmetic. A qualified contractor should inspect and repair as needed.

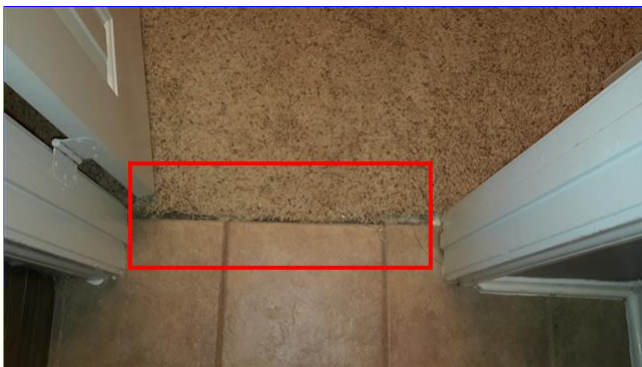
F. Item 9(Picture) master bath

(4) Flooring transition is missing. This is not considered today's standard. I recommend repair as needed.

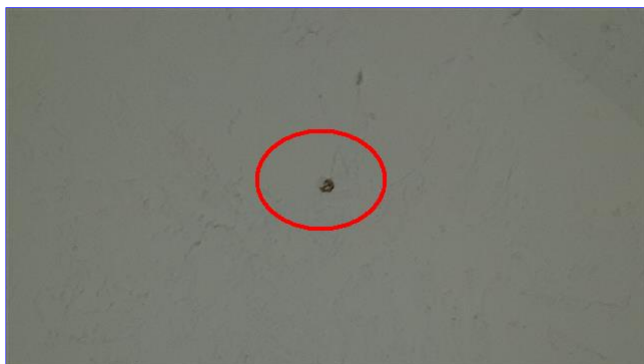
F. Item 10(Picture) master bath

(5) The Drywall on the ceiling has some "nail pops," (cosmetic) in areas's. This damage is considered cosmetic. A qualified contractor should inspect and repair as needed.

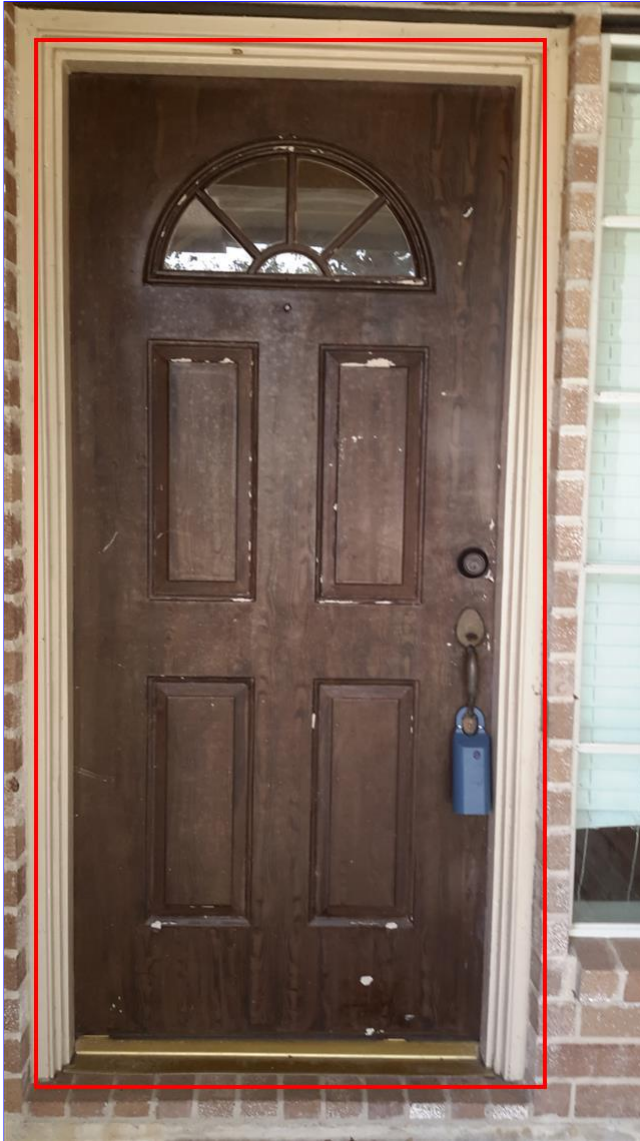
G. Item 1(Picture) front door

(1) The main entry door shows areas of peeling paint. This is a maintenance issue and is for your information. A qualified contractor should inspect and repair as needed.

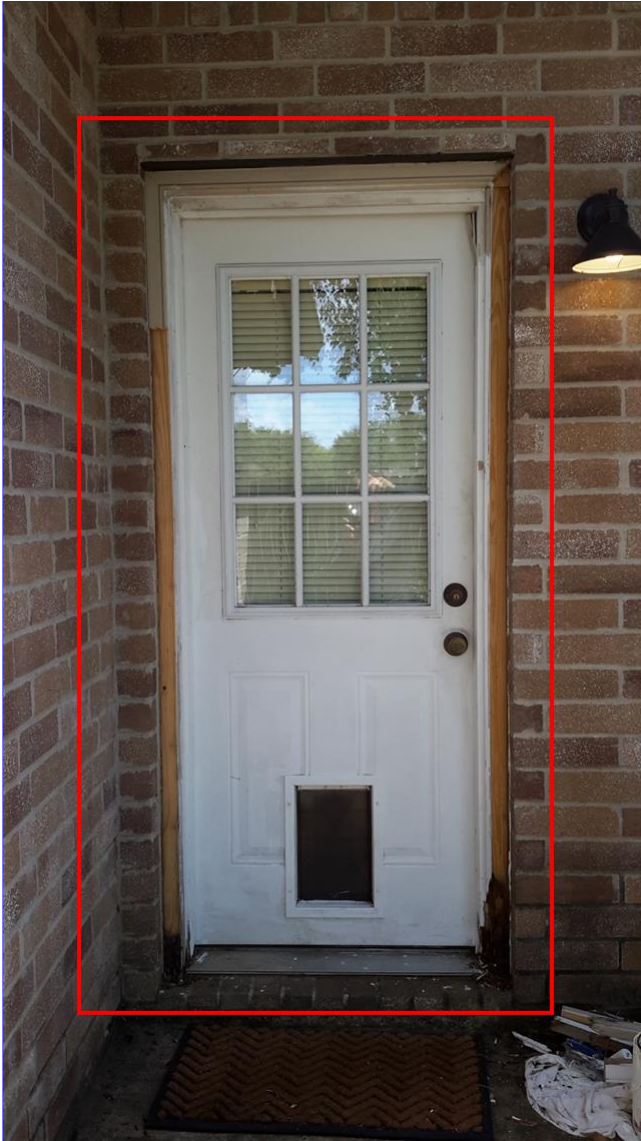
G. Item 2(Picture) rear door

(2) The rear of home has deteriorated at brick-mold or trim (exterior). This is a maintenance issue and is for your information. A qualified contractor should inspect and repair as needed.

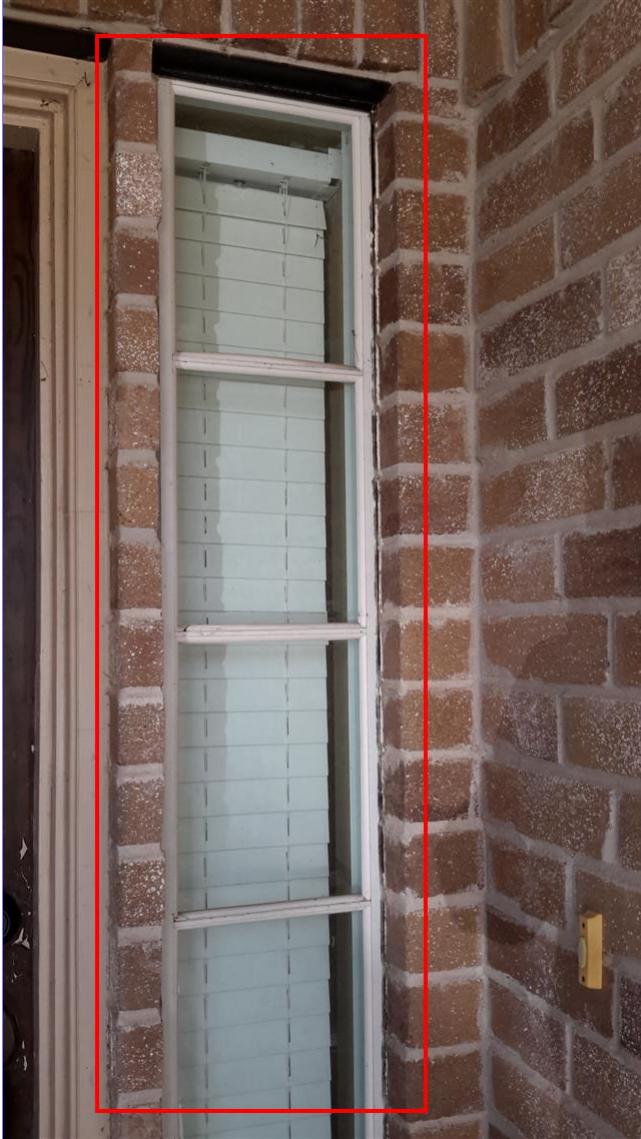
H. Item 1(Picture) entry

(1) There are window frames that are not properly sealed. This can cause energy loss. I recommend having a qualified person seal and repair as needed,

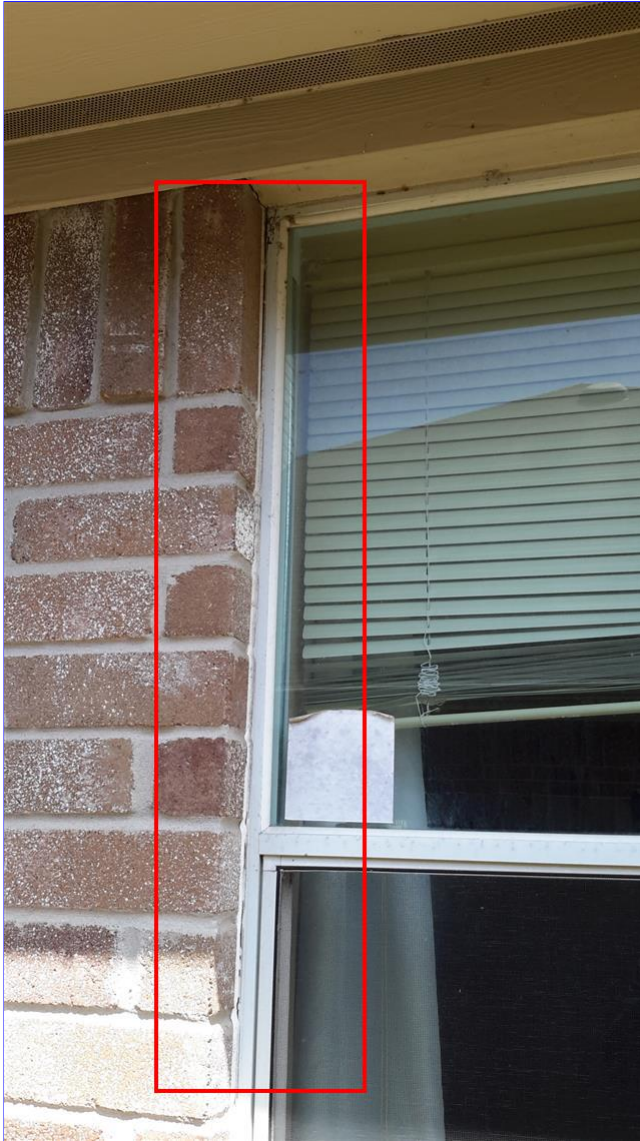
H. Item 5(Picture) left side of home

(2) Several windows have damaged or missing screens. This is not considered to be today's standards. I recommend having a qualified person make repairs as needed.

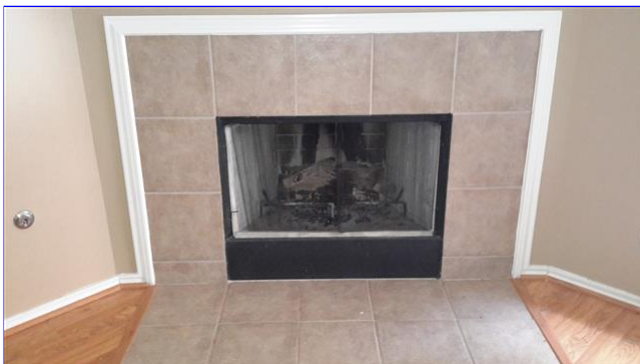
J. Item 1(Picture) living room

vented fire logs (natural gas) in the Living room pipe has creosote build-up. I did not inspect for safe use or operation. A qualified contractor should inspect and repair as needed.

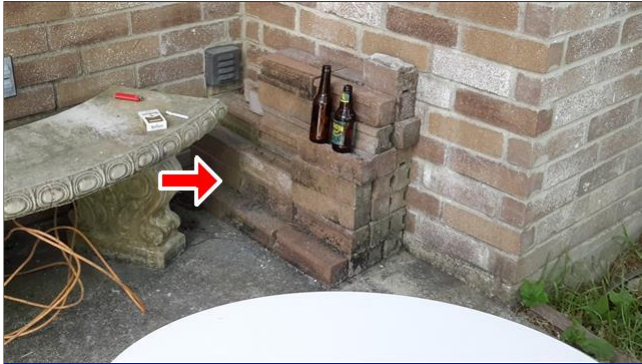
L. Item 17(Picture) rear patio

(2) There is debris stacked against the structure creating conducive conditions for certain types wood destroying insects. I recommend removal of debris and having a qualified pest control company inspect and treat as needed.

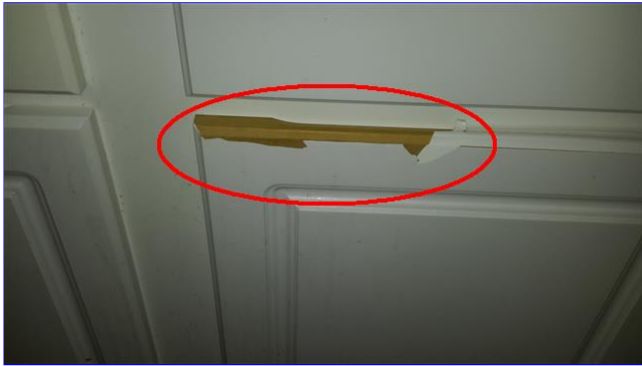
L. Item 23(Picture) guest bath

(3) Cabinets are peeling paint from usage. This is not considered today's standard. I recommend repair as needed.

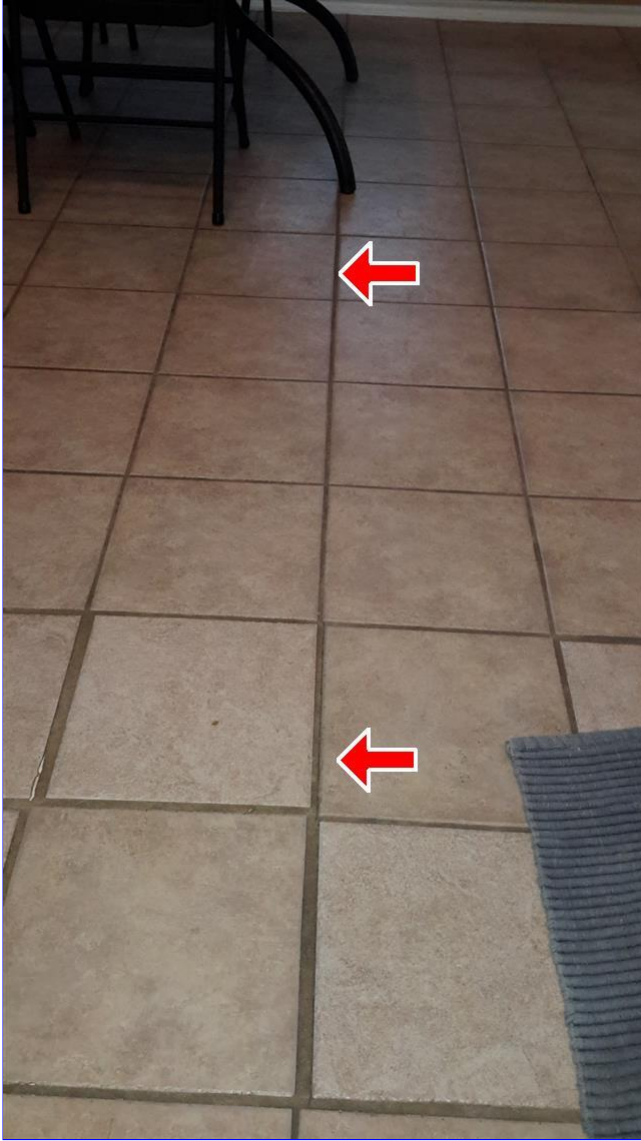
L. Item 24(Picture) kitchen and breakfast area

(4) Caulking /grout missing in areas. This is not considered today's standard. I recommend repair as needed.

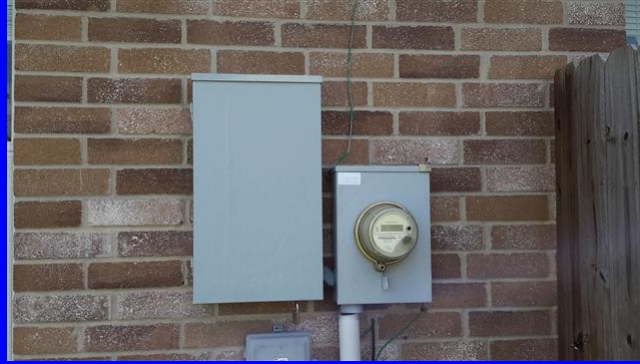
Meter box and breaker box right side of home

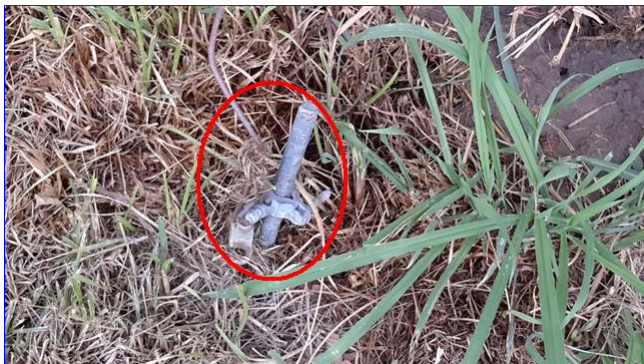
A. Item 1(Picture)

(1) The grounding rod near meter is using improper clamp for grounding of main panel (solid brass clamp is recommended). This is not considered to be today's standard. I recommend having a qualified person replace with proper clamp to assure proper grounding.

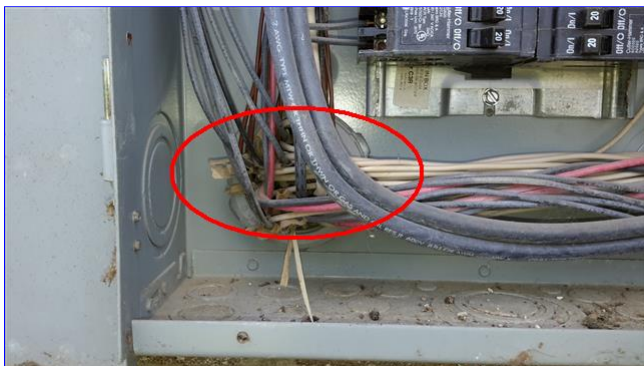
A. Item 3(Picture)

(2) The electrical panel has branch circuit wires bundled together that are entering the panel through one to two entry points. This is not considered today's standard. It is recommended that each sheathed wire enter the panel independently and be sealed for fire blocking purposes. I recommend having a qualified electrician evaluate and make repairs as needed.

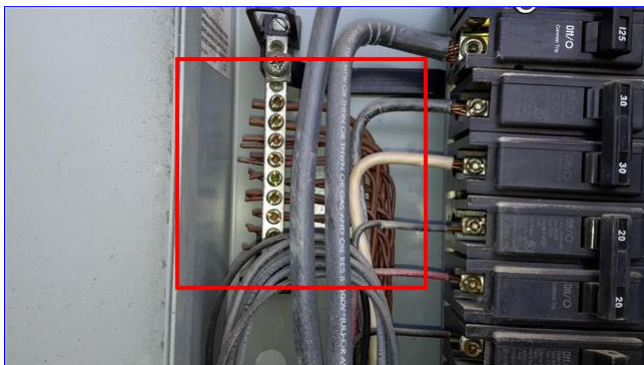
A. Item 4(Picture) Ground wires

(3) Ground wires and neutral wires are double lugged. This is not considered today's standard. I recommend having a qualified electrician inspect and make repairs as needed.

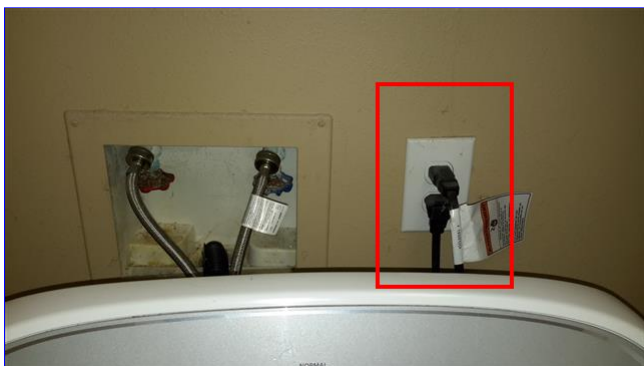
B. Item 1(Picture) laundry room

(2) There are no GFCI protected circuits in required area's. This is not considered to be today's standard. I recommend having a qualified electrician make repairs as needed.

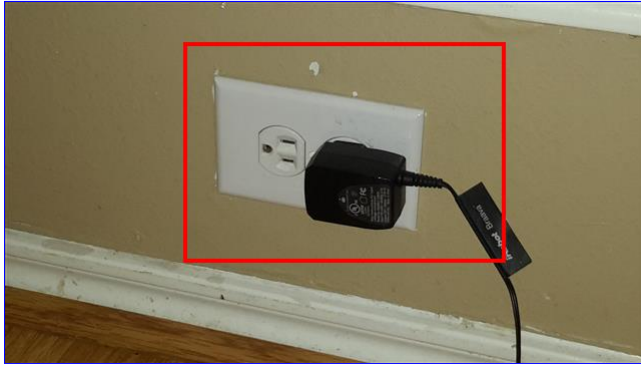
B. Item 2(Picture) living room

(3) At least one loose in wall in most if not all rooms. This is a safety issue that needs to be corrected

Electrical issues are considered a hazard until repaired. A qualified licensed electrical contractor should perform repairs that involve wiring I recommend repair as needed.

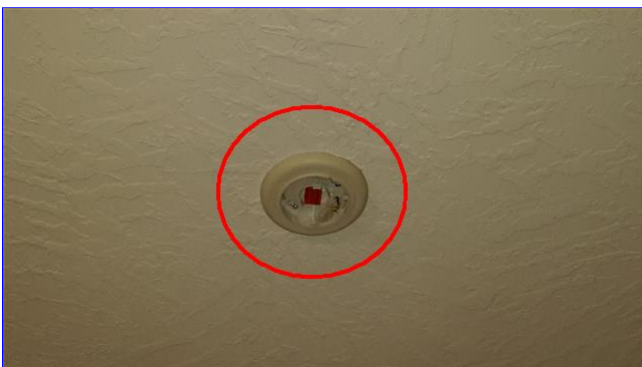
B. Item 6(Picture) master bedroom

(5) The smoke detector has been disconnected intentionally at bedroom.

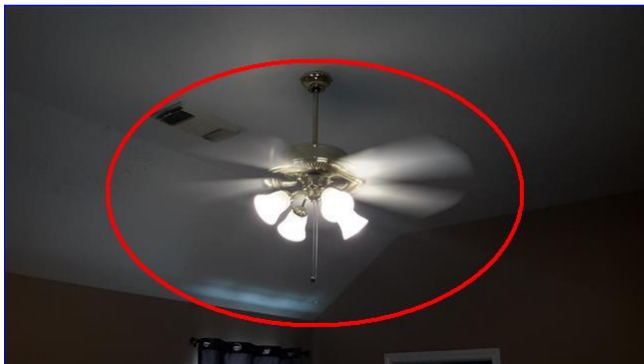
B. Item 7(Picture) master bedroom

(6) The ceiling fan "wobbles" in the bedroom. Some fans that wobble cannot be corrected without replacement This is for your information. A qualified licensed electrical contractor should perform repairs that involve wiring I recommend repair as needed.

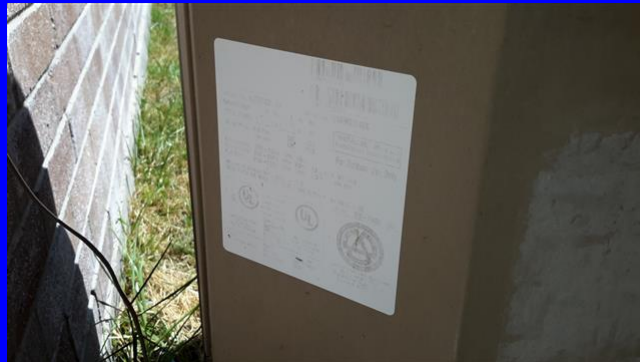
data plate faded MFD not listed

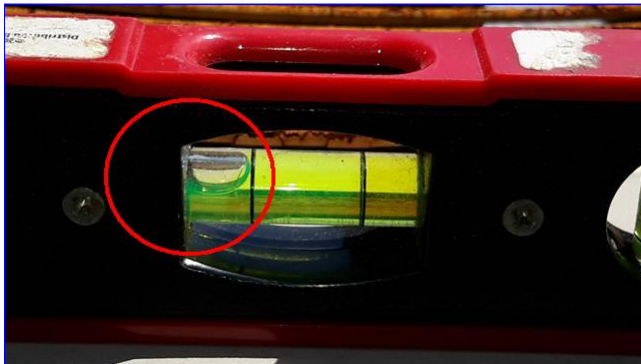
B. Item 1(Picture)

- (1) It is recommended to have HVAC systems serviced annually.
- (2) The condenser is not level. This can cause damage to the unit or shorten its life span. A licensed HVAC contractor should service or repair unit.

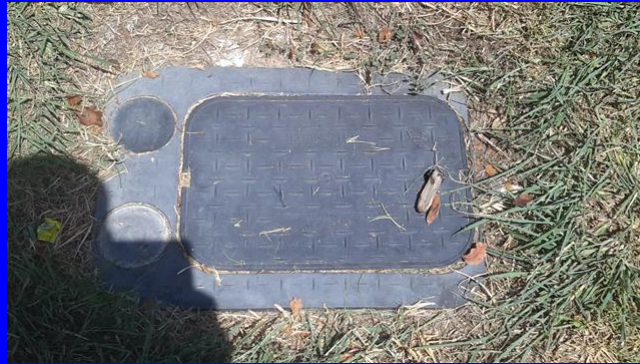
water meter front right of home

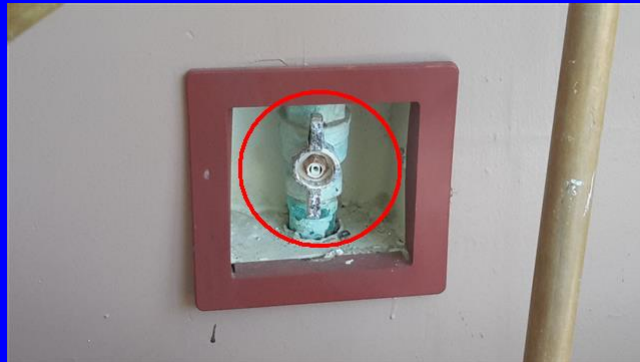
water shutoff inside garage right side

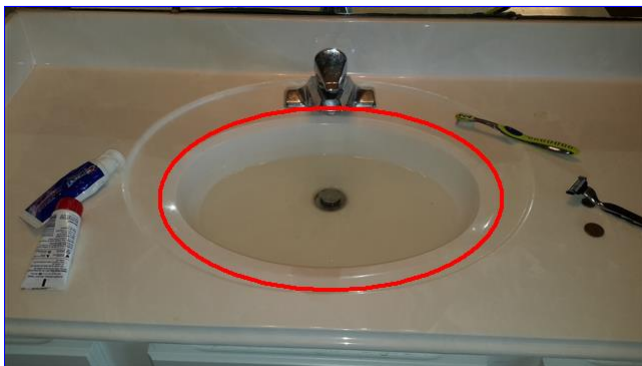
B. Item 1(Picture) master bath sink left side

Plumbing waste line is slow or clogged at Master Bath sink.

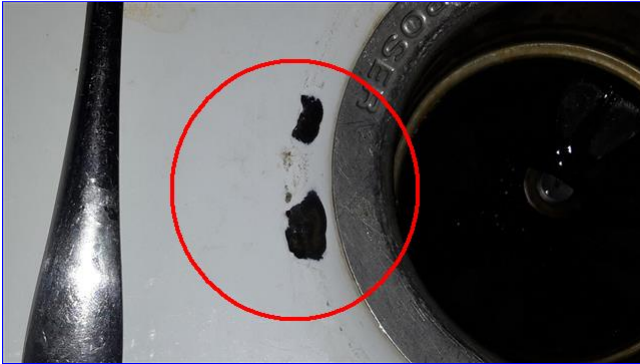
D. Item 1(Picture) kitchen sink

(1) The sink is chipped (Cosmetic) at the . This is a cosmetic issue for your information A qualified person should repair as necessary.

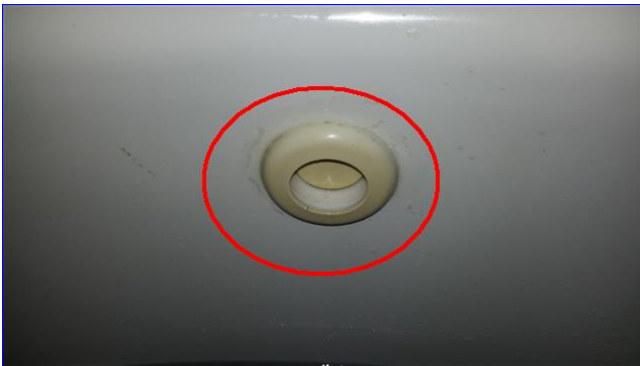
D. Item 2(Picture) master bath

(2) The Hydro-Massage Therapy equipment did not work properly at time of inspection.

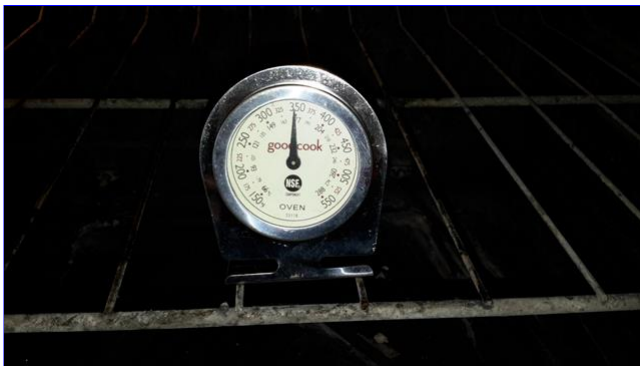
Tested and working properly at the time of inspection.

D. Item 1(Picture) tested at (350) F

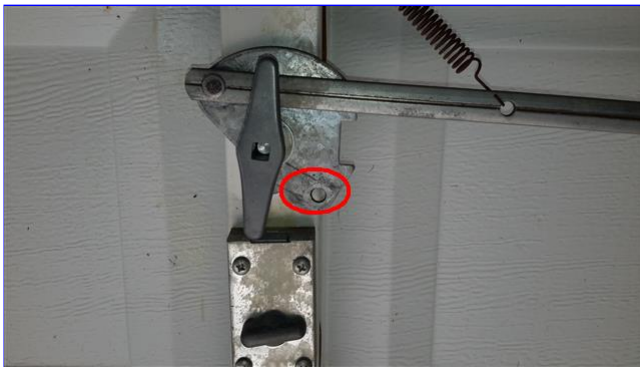
G. Item 2(Picture)

(2) The garage door at the front of home has a lock that has not been disabled for automatic opener. This is a maintenance issue and is for your information. A qualified contractor should inspect and repair as needed.
