Jay Hicks Inspection Service
" STRUCTURAL & MECHANICAL INSPECTION REPORT "

Property Address: 117 Mackeral

City: Galveston

PROPERTY INSPECTION REPORT**Jay Hicks Inspection Services**

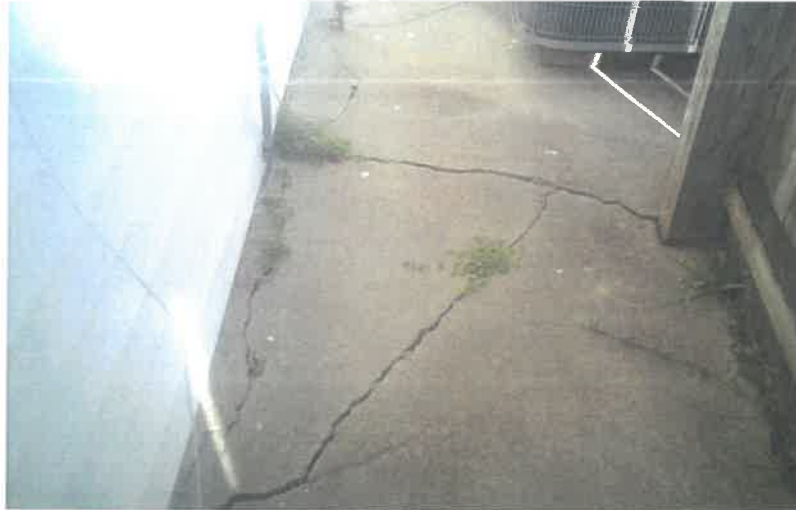
A. Foundations

Type: concrete pier and beam block and beam
Vantage Point not accessible crawled from sides using flashlight

"Normal Settlement Indicated"

- Differential movement of walkways, driveways, and patios:
- Previous foundation repairs suspected - see warranty for details:
- Recommend professional foundation repair company inspect and repair as needed

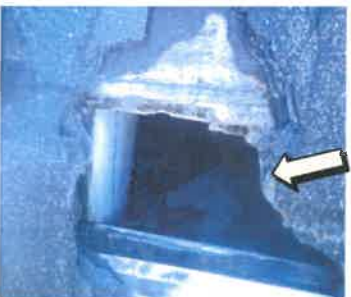
D. Roof Structure and Attic

- Access: Good Very Limited Not Accessible
- Insulation Type: Blanket Loose Fill
- Approximate Depth: ___ inches Thickness: ___ inches

- Radiant barrier in use:
- Water damaged roof decking: *back soffitt*
- Missing section(s) of attic insulation: *over the garage*
- Damaged/deficient attic access ladder: *missing pull string*
- Rafters pulling away from ridge board

A professional roofer should inspect the roof and make the appropriate recommendations.

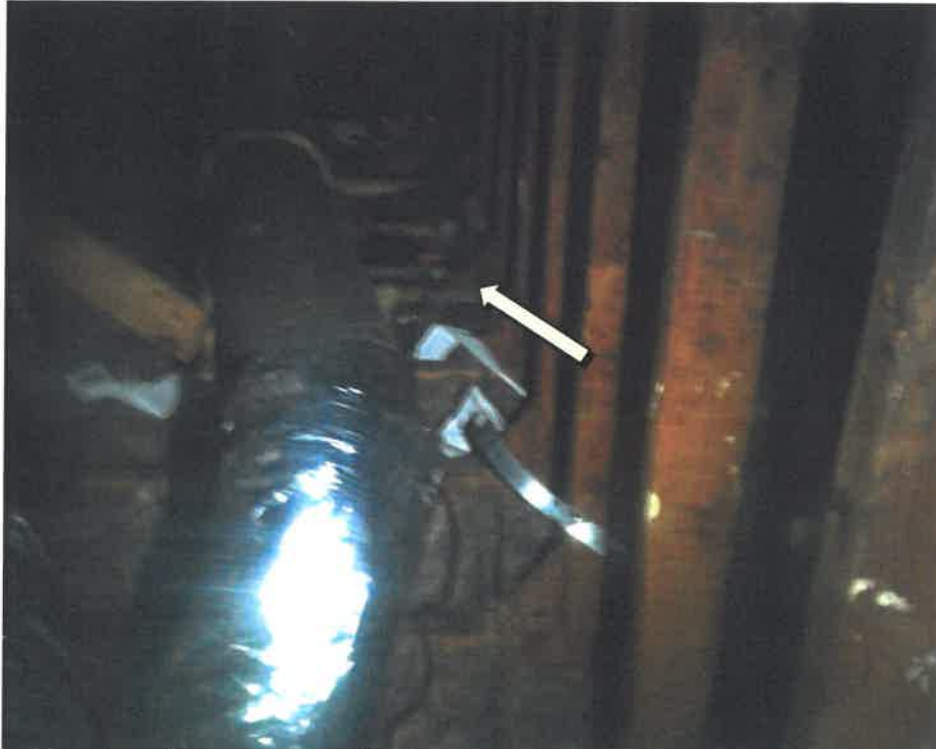
Supply Air: 124
Return Air: 71
Differential: 53

- Improper gas line in use. (MUST be yellow flex)
- Missing drip leg (gas trap):.
- Deficient thermostat: *touch buttons do not operate properly*
- Recommend a licensed A/C Heat technician inspect and issue a report containing their state license number and contact information detailing their findings and all needed repairs.**

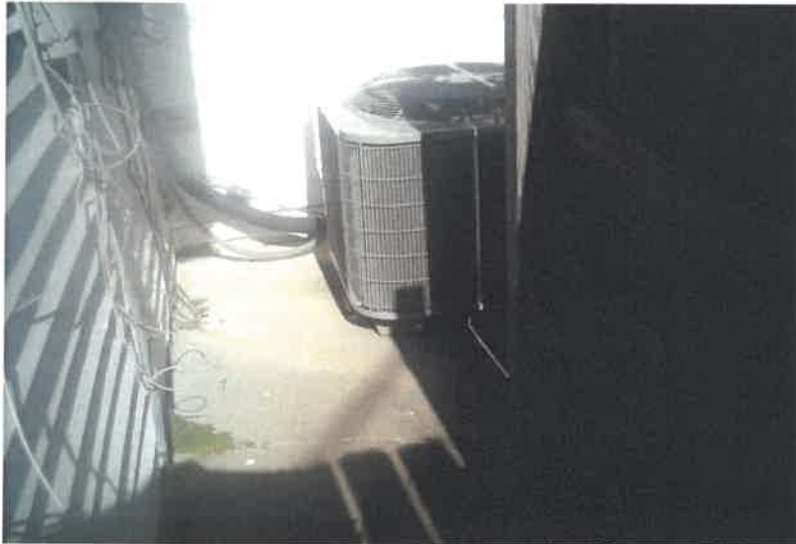
Unit # 1 AMPS 30
 Unit is cooling as intended:
 Unit is NOT cooling as intended:
Return Air: 65
Supply Air: 50
Differential: 15

- Reinsulate refrigerant pipe::
- Exterior unit is not level or is not secured to pad
- Recommend a licensed A/C Heat technician inspect and issue a report containing their state license number and contact information detailing their findings and all needed repairs.**

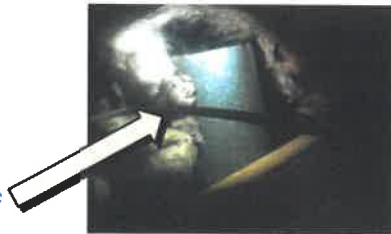
C. Duct Systems, Chases, and Vents

- Comments:
- Ducts:
- Damaged A/C ducts or insulation A/C duct is not secured to the plenum
 - Improper or inadequate clearances of ducts and/or plenums A/C ducting is not suspended in attic
- Chases:
- Gas pipes, electrical wiring, junction boxes, or sewer vents in chase - Improper
- Vents:
- Reseal around all vents at roof level
 - Improper vent pipe on gas water heater:
 - Improper vent pipe on gas furnace:
 - Improper vent cap on gas water heater:
 - Improper vent cap on gas furnace
 - Kitchen vent pipe does not terminate outside: *attic*
