**Rachel Tolar**  
**14318 Corktree Knolls**  
**Cypress, TX 77429**

**March 7, 2018**

## PROPERTY INSPECTION REPORT

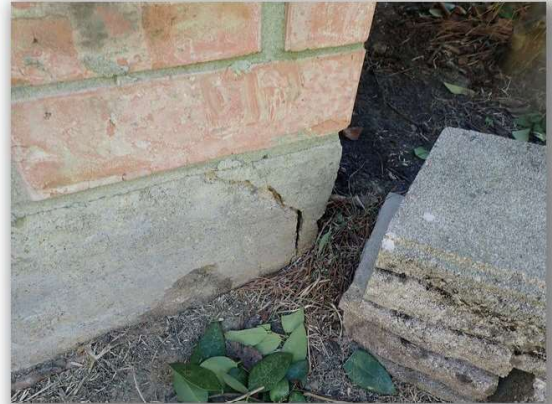
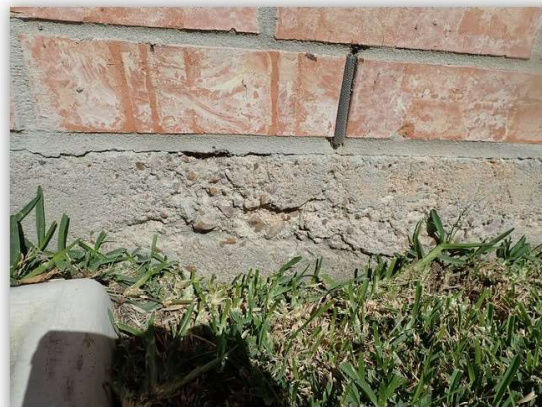
- One or more of the foundation perimeter beam corners were observed to be sheared off (corner pop). This is a common condition to observe and is do to thermal expansion and contraction of the different building materials. This condition does not adversely affect the foundation performance. However, in some cases, some cosmetic improvements may be necessary.
- The concrete beam was observed to have some deterioration (scaling and/or spalding) on the north and south sides of the structure.

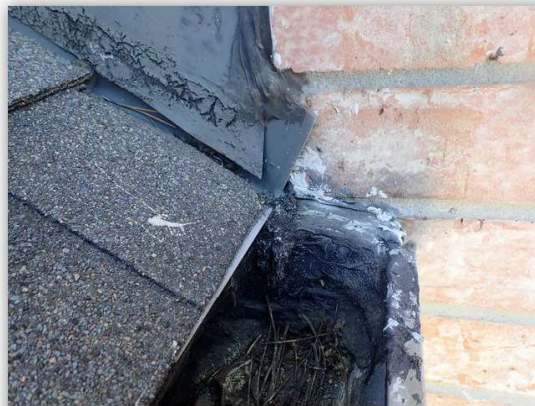
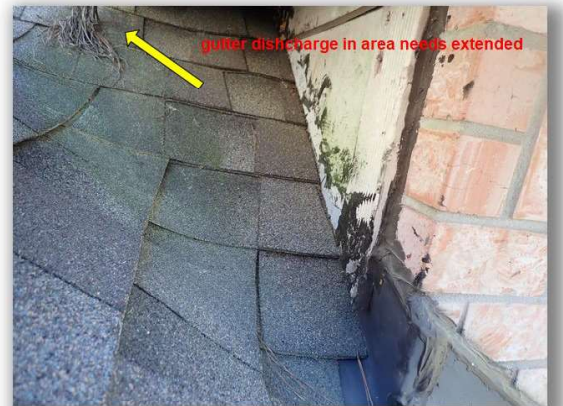
- **Note:** It appears that tar has been used to perform previous roof repairs in one or more locations on the roof. This type of repair is temporary in nature and is not considered to be a long term solution to an existing roofing problem.
- **Note:** Prior repairs to the roofing material and/or flashing were observed in one or more locations.

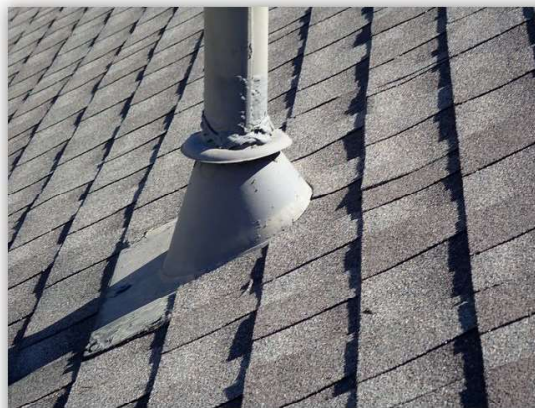
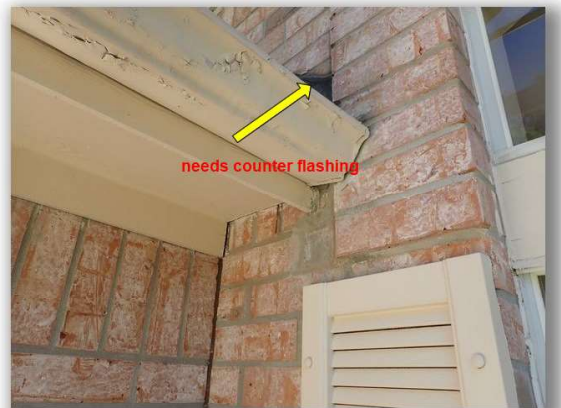
- There was no kickout flashing details observed at the lower bottom edge of the roof line interface and the sidewall that continues past the edge of the roof. The lack of this kickout flashing will allow water to penetrate at these points.

The flashing details needs to be checked, reset or repaired as necessary. The observations made to support the rendering of this opinion are listed but may not be limited to:

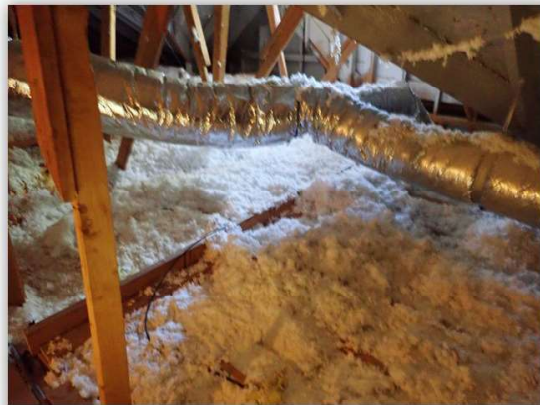
- **Note:** There are visible water stains on the roof sheathing (decking) in one or more locations (above bed room closet).

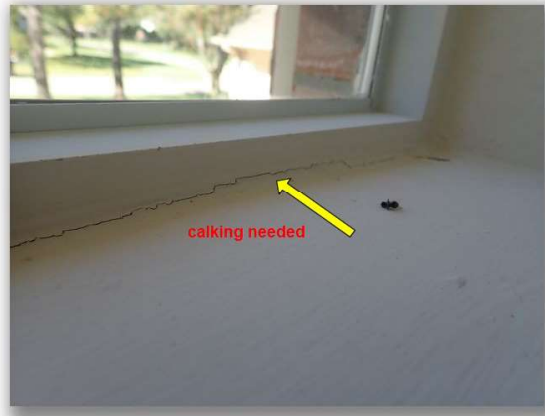
- Caulking improvements are recommended for the area between the walls and the window frames. It is recommended to use an elastomeric caulking.

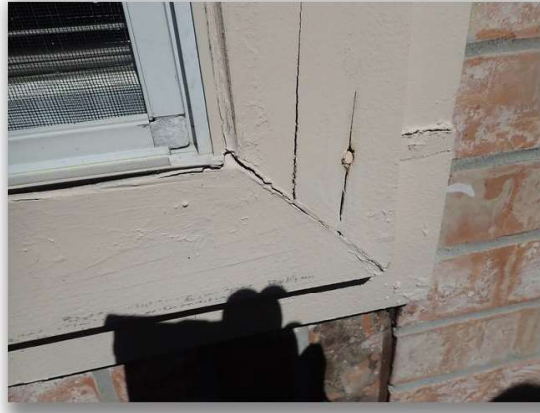
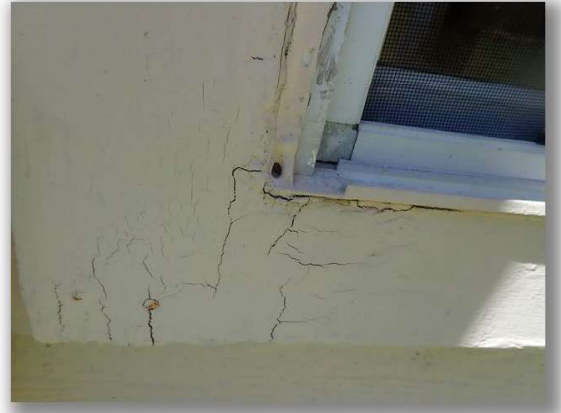
- The wood veneer trim has some deterioration or damage on the north, east, west and south sides of the structure.

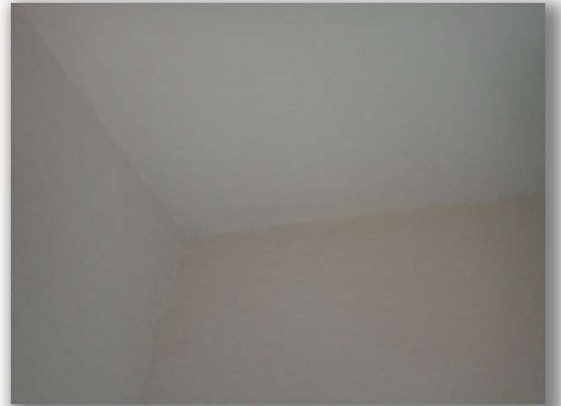
- The ceiling was observed to be water damaged in the front middle bedroom closet.
- Ceiling joint cracks were observed in the garage.

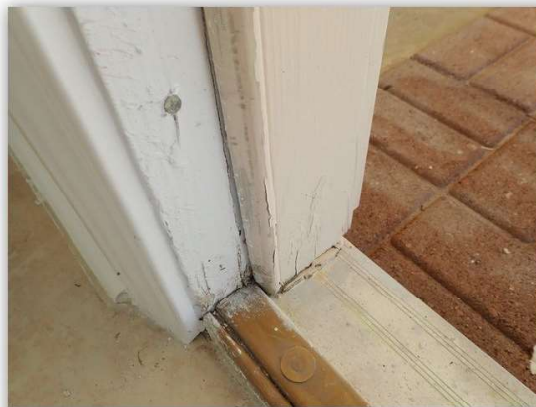
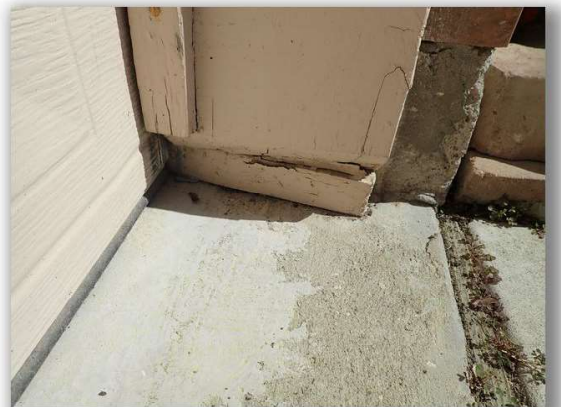
- The exterior door frame has some deterioration and/or damage to the backyard entry, garage door(s).

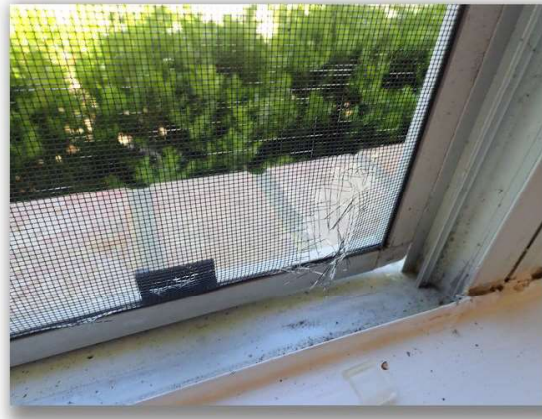
- One or more of the window screens were observed to be damaged.

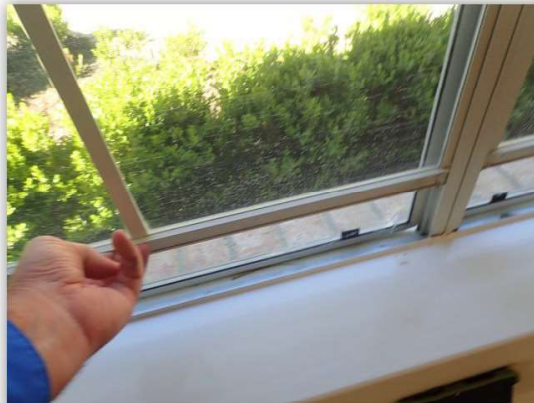
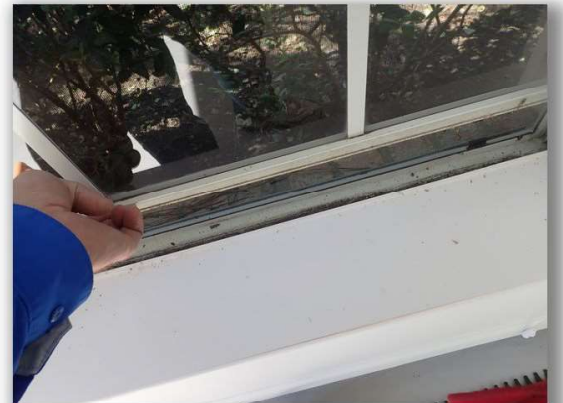
- The window guide was observed to be damaged and the window will not stay in the open position in the front dining room, garage.

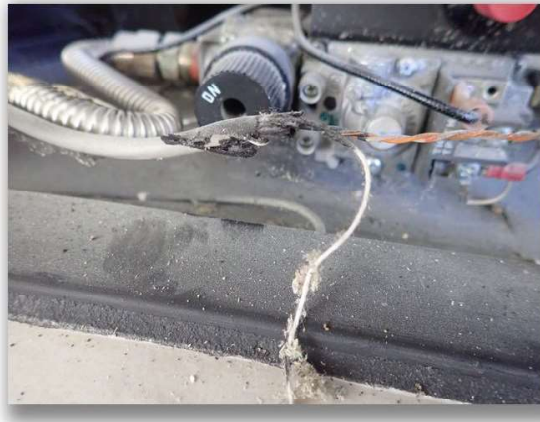
- The gas log assembly appears to be inoperative at the time of this inspection. I was unable to get the gas logs to respond to the pilot assembly / controls. This condition needs to be further evaluated and corrected as necessary.

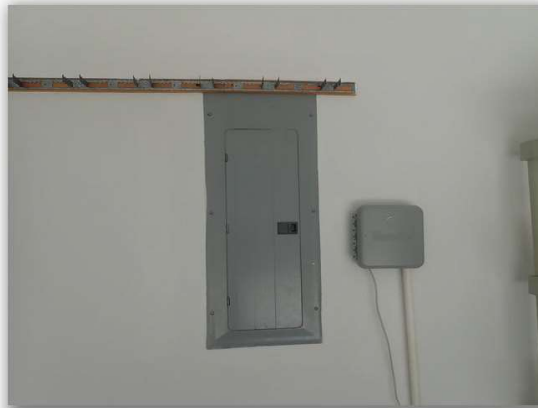
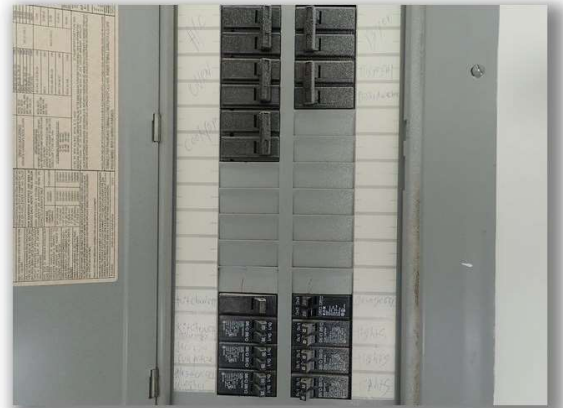
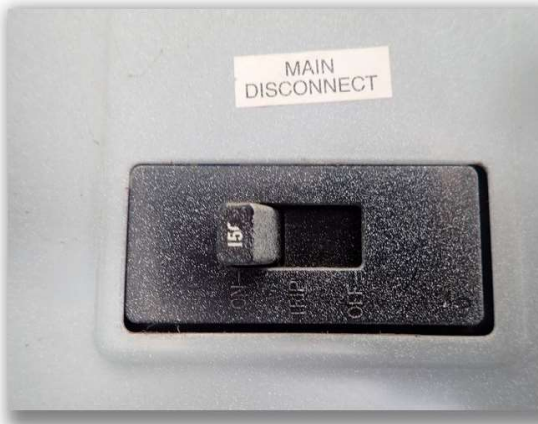
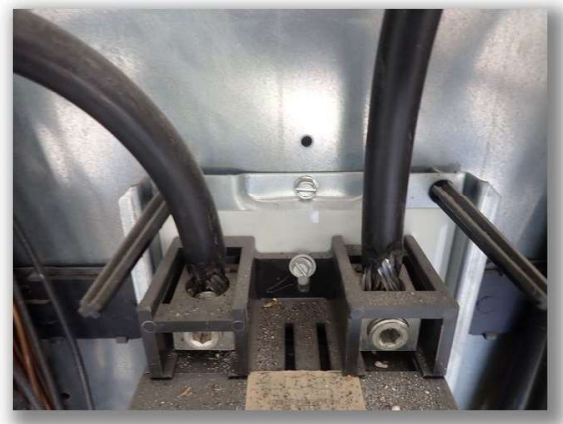
- There was no anti-oxidant gel observed on the exposed aluminum conductor terminations.

The buyer should have the electrical system checked by a Qualified Licensed Electrician. The observations made to support the rendering of this opinion are listed but not limited to the following:

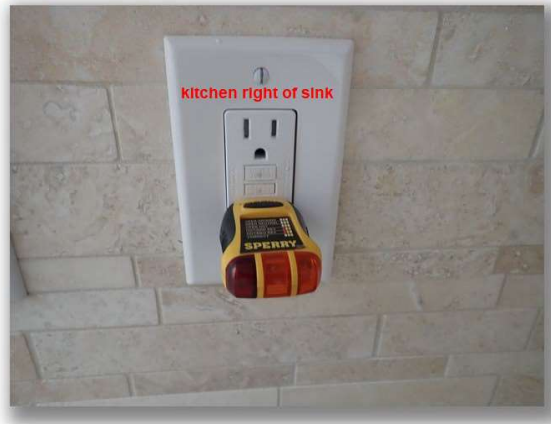
- One of the ground fault circuit interrupter (GFCI) devices does not appear to be functioning properly at the time of this inspection. The device in question is located in the kitchen area.
- One or more of the receptacles appears to be inoperative. This receptacle(s) and circuit should be investigated and corrected as necessary. Receptacle(s) were located in the kitchen.
- One or more of the receptacles were observed to be loose at the wall mount in the various locations throughout the house.

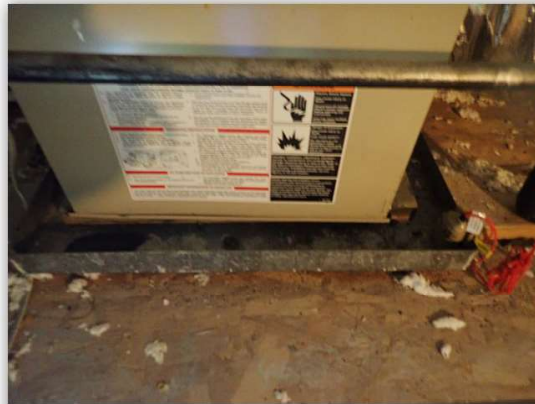
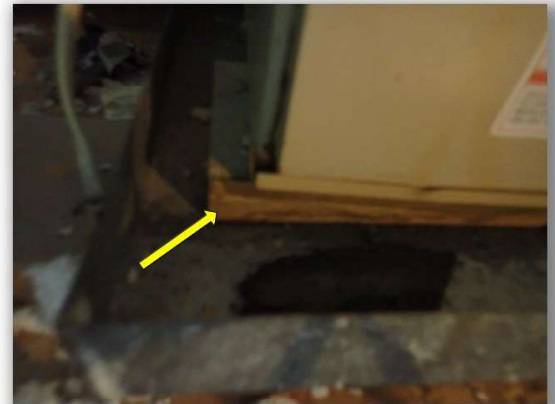
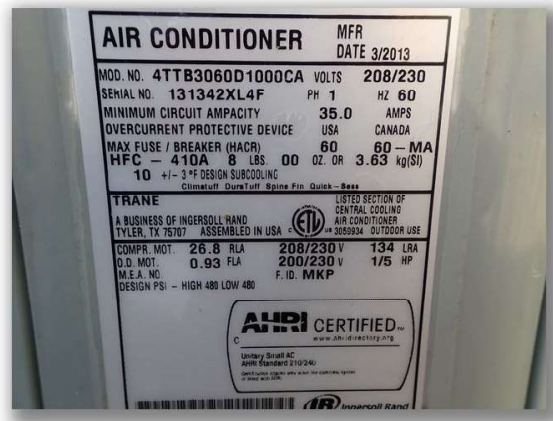
- **Note:** The auxiliary/secondary drain pan under the coil housing should be free of all debris. The debris in the pan could clog the drain line and cause water to leak to the interior of the house.
- The material used to support the heating and cooling equipment in the secondary condensate drain pan is not made of a water resistant material. This condition does not meet current mechanical installation standards.
- The outdoor unit of the air conditioning system is noisy. The cause and remedy should be further evaluated and corrected as necessary.

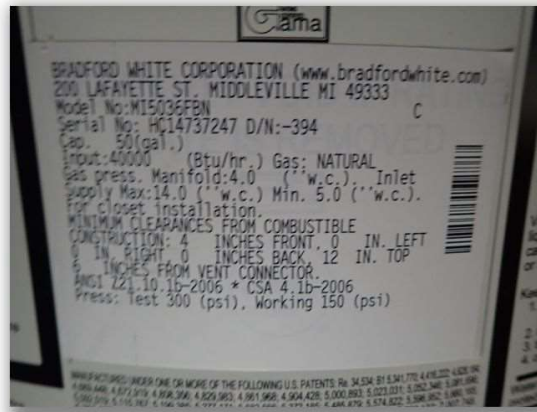
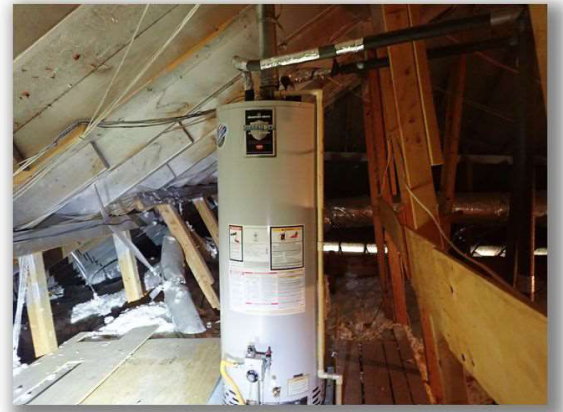
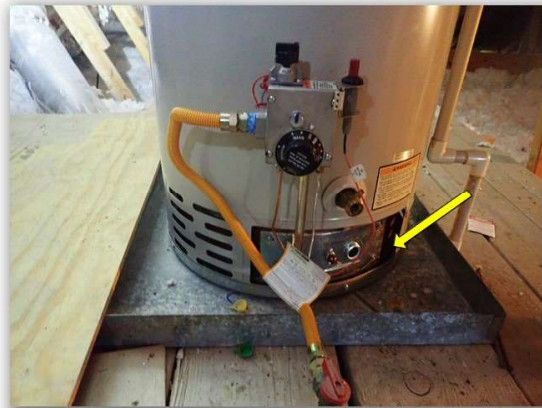
- The water heater burner chamber cover is missing. This should be replaced for reason of safety and efficient combustion.

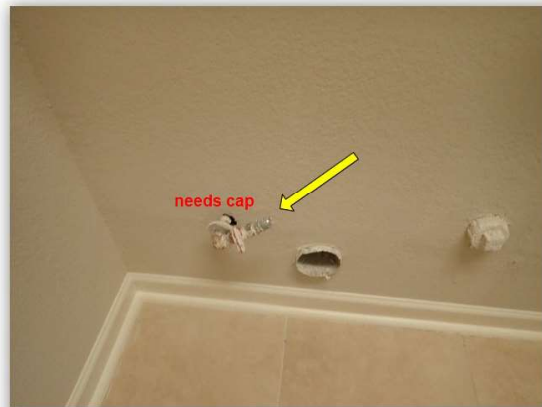
- All unused gas valve ends should be capped off for safety purposes.

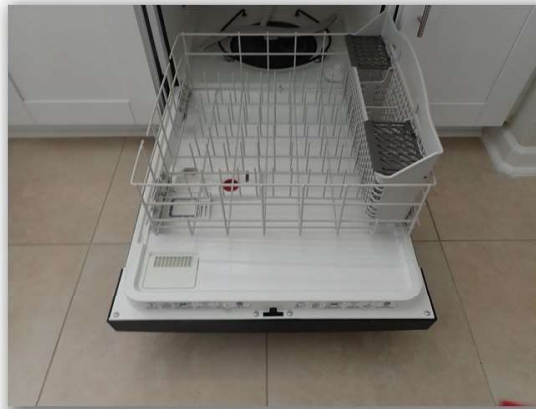
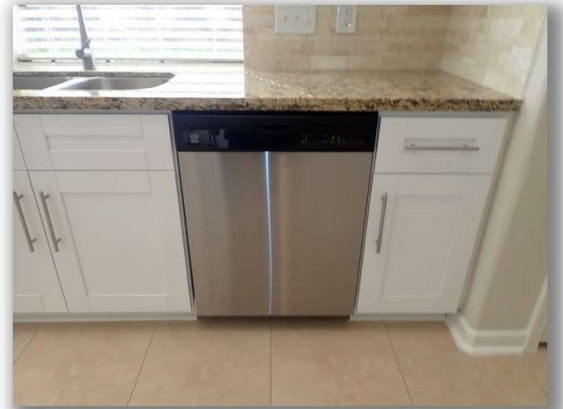
- The dishwasher is loose at the cabinetry and should be better secured.

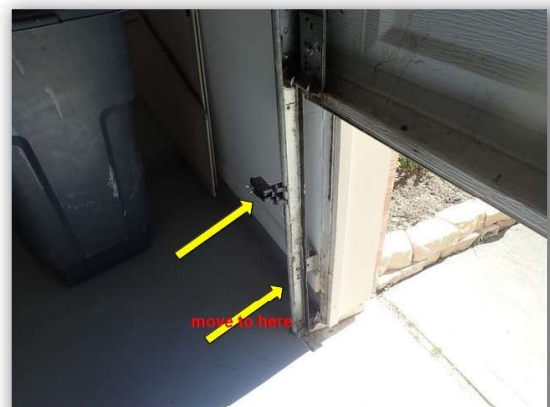
- When an automatic garage door opener is in use, the manual lock should be disabled or removed.
- The garage door reverse sensors are not properly installed. The garage door reverse sensors should be installed within 6-inches of the garage floor.
