PROPERTY INSPECTION REPORT

Concerning: 118 Highland Terrace Drive, League City, TX 77573
(Address or Other Identification of Inspected Property)

By: Kenneth K Kerby, Lic #21565 01/13/2021
(Name and License Number of Inspector) (Date)

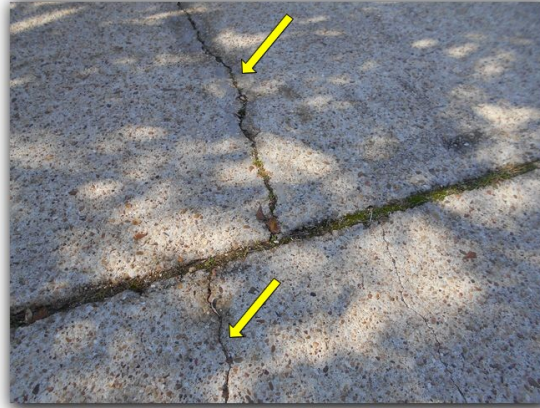
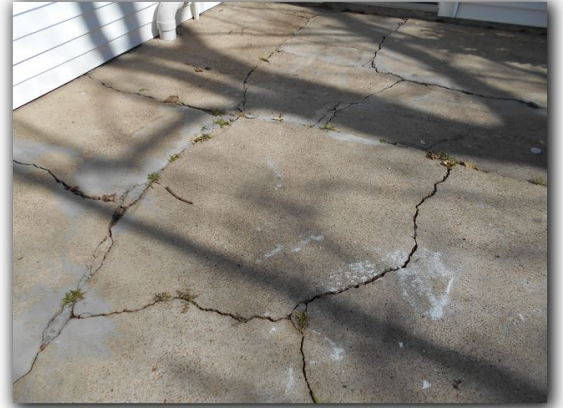
* There is various cracking in the concrete of the driveway, rear patios, etc. of the home - this cracking is fairly common but need to monitor as this could be a sign of ground movement.

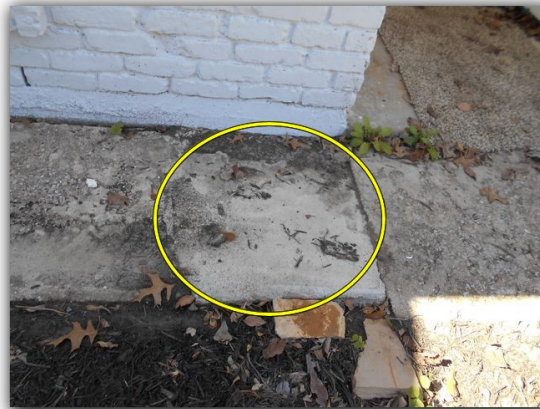
* There is evidence of previous foundation repair and leveling - recommend receiving all paperwork for these previous repairs and/or having further evaluation of the foundation repairs by a qualified foundation expert.

- * There is evidence of previous foundation repair and leveling - recommend receiving all paperwork for these previous repairs and/or having further evaluation of the foundation repairs by a qualified foundation expert.

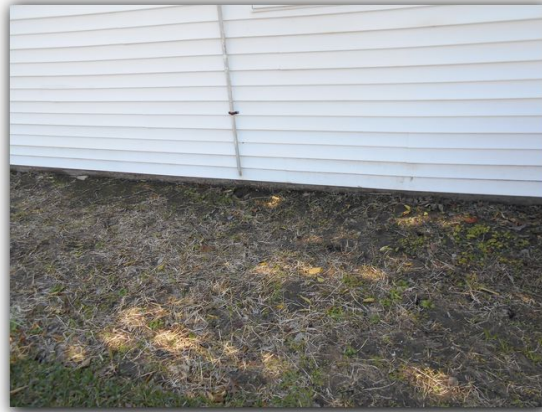
* There are various areas around the foundation of the home that have evidence of pooling of water such as behind the garage for the home - need to grade all surrounding soil of the home to direct water away from the foundation and assure no pooling of water at the foundation to protect the foundation from further damage.

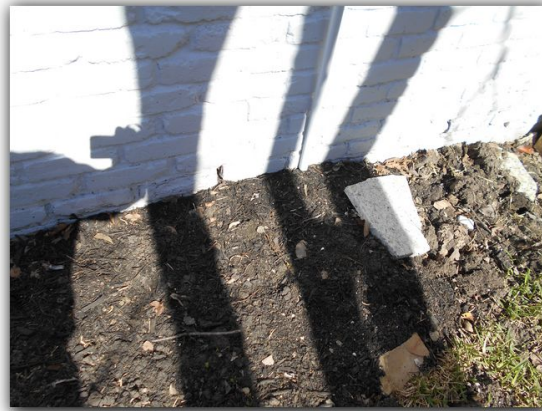
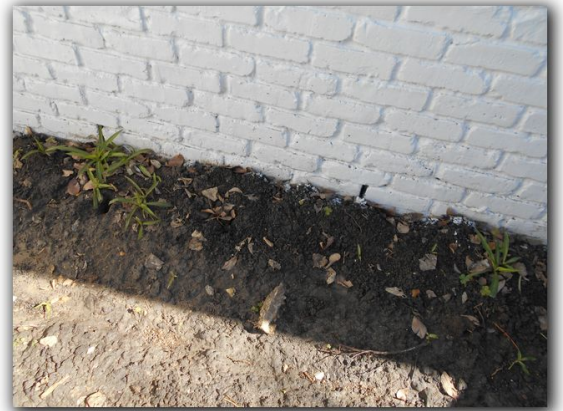
* The landscaping at the left side and the rear of the home is too high and over the brick line of the home - need to lower this landscaping to be under the brick line of the home as this is an invitation for insects to enter the exterior walls of the home.

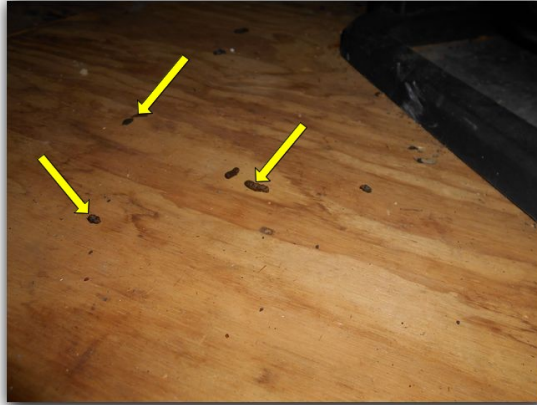
* There is evidence of rodents in the attic of the home - recommend having further evaluation and possible removal of rodents by a qualified pests control technician.

- * There is evidence of rodents in the attic of the home - recommend having further evaluation and possible removal of rodents by a qualified pests control technician.

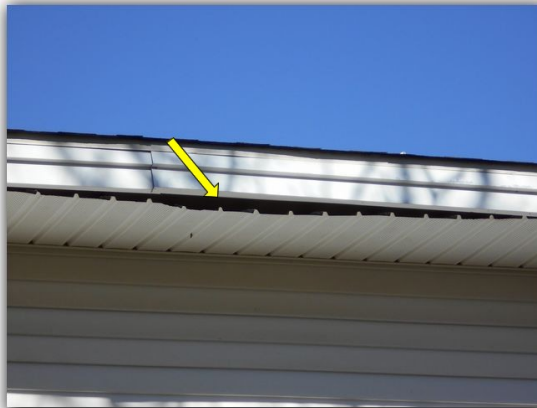
* There is an opening in the soffit at the garage of the home - recommend further evaluation and sealing of the soffit for the home by a qualified technician to assure no further damage will occur and assure no unwanted pests will enter the attic of the home.

- * There is an opening in the soffit at the garage of the home - recommend further evaluation and sealing of the soffit for the home by a qualified technician to assure no further damage will occur and assure no unwanted pests will enter the attic of the home.

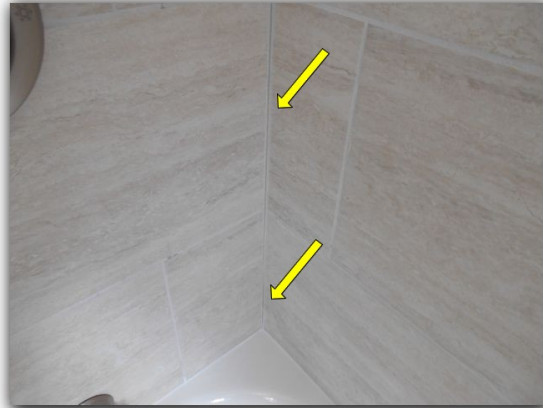
* The tile walls for the hall bathroom tub in the home are not sealed at the interior corners – need to seal the interior corners of the tile to protect the walls behind the tile from water damage.

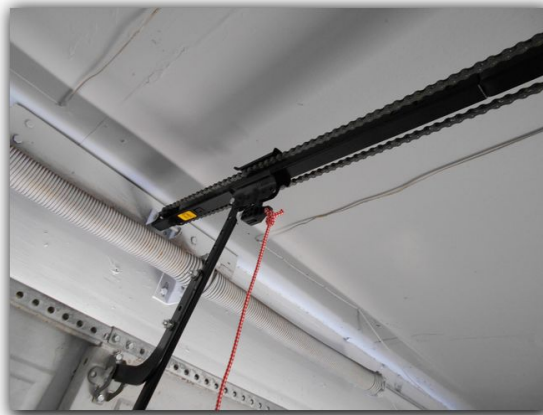
* The top panel of the garage door for the home is damaged and the door will not open and close correctly - recommend further evaluation of the door and repair/replacement by a qualified technician.

- * The top panel of the garage door for the home is damaged and the door will not open and close correctly - recommend further evaluation of the door and repair/replacement by a qualified technician.

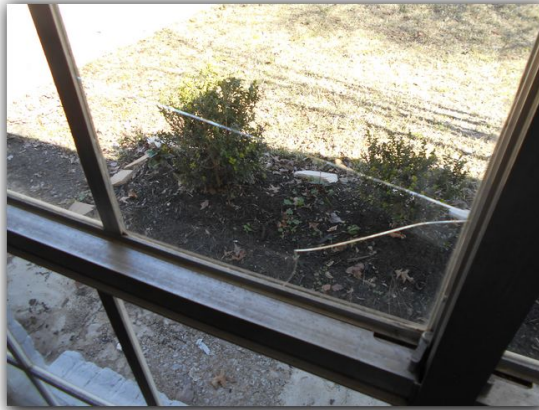
* The window located in the front living room of the home has a broken window pane - need to replace the broken pane for the window.

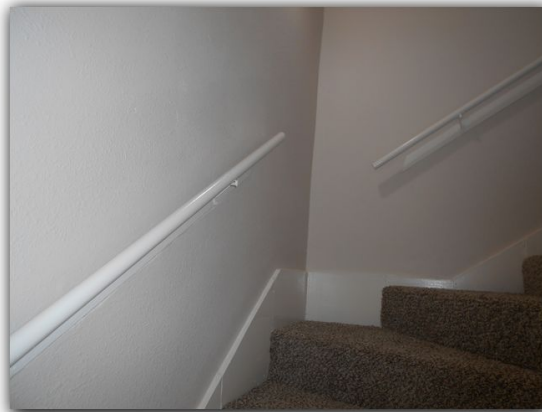
* The stairway of the home did not have a continuous handrail - need to place a continuous handrail at the stairway of the home for safety.

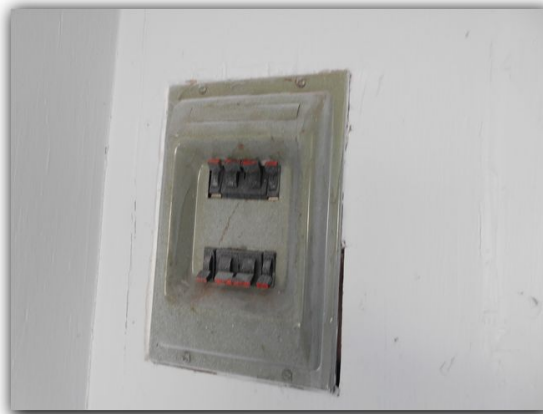
* The smaller electrical panel located in the garage of the home is a federal pacific panel - federal pacific panels have been determined to be a fire hazard, recommend having further evaluation of the panel by a qualified electrical contractor.

- * The smaller electrical panel located in the garage of the home is a federal pacific panel - federal pacific panels have been determined to be a fire hazard, recommend having further evaluation of the panel by a qualified electrical contractor.

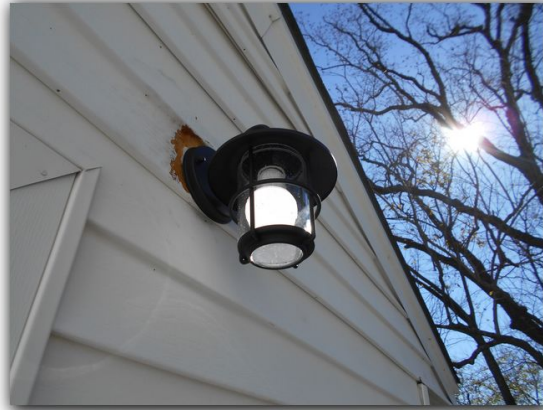
* The exterior carriage lights around the home are loose from the wall - need to secure and seal these lights to the exterior wall of the home to protect the lights and for safety.

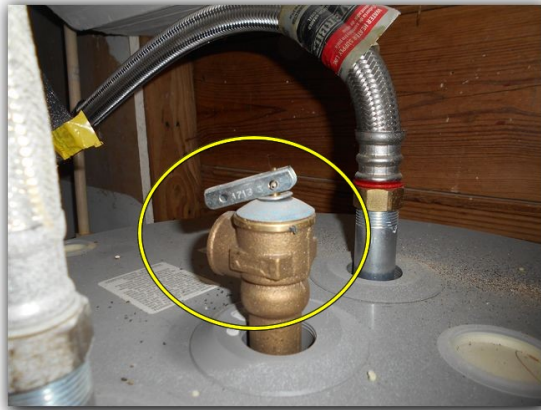
* The water heater located in the garage of the home does not have the temperature and pressure valve draining to the outside of the home - need to drain the valve to the outside of the home within 6 inches of the ground for safety.

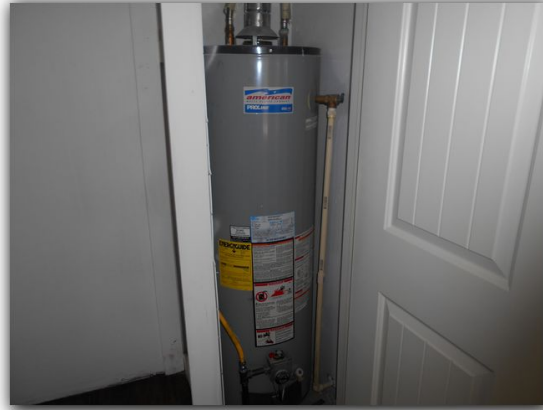
* There appears to be not adequate combustible air vents for the gas water heater located in the closet of the home - recommend further evaluation and placement of air vent for the water heater by a qualified technician.

- * There appears to be not adequate combustible air vents for the gas water heater located in the closet of the home - recommend further evaluation and placement of air vent for the water heater by a qualified technician.

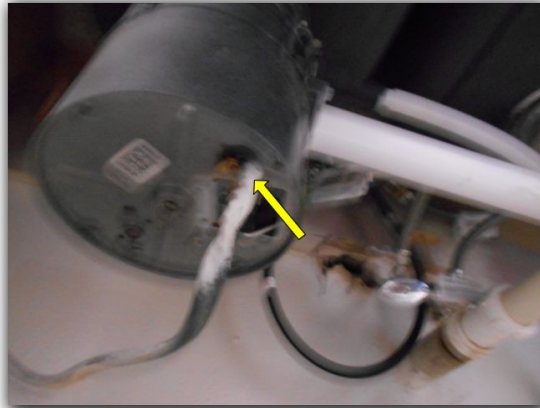
* The food waste disposer at the kitchen sink of the home is missing the protective clamp for the power cord - need to place the clamp for the power cord to prevent damage to the disposer and the cord.
