## PROPERTY INSPECTION REPORT

Concerning: 7615 Goudin Dr., Missouri City, TX. 77489  
(Address or Other Identification of Inspected Property)

By: Chad Ware – TREC #9144 9/12/2018 – 11:30 AM  
(Name and License Number of Inspector) (Date)

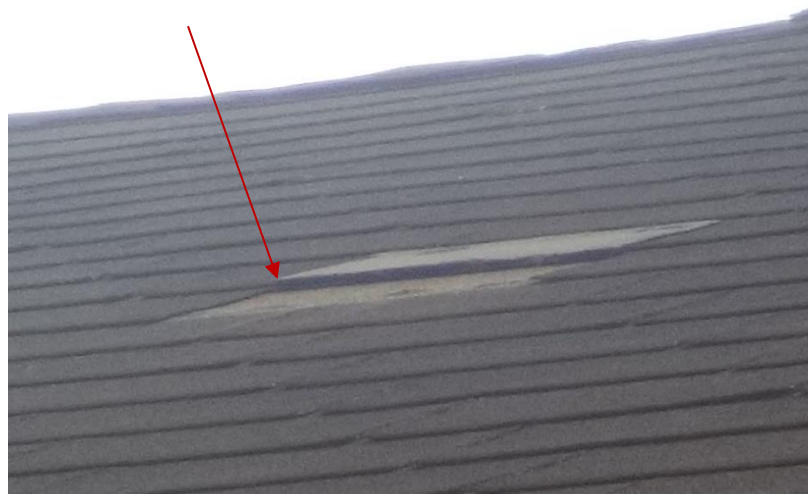
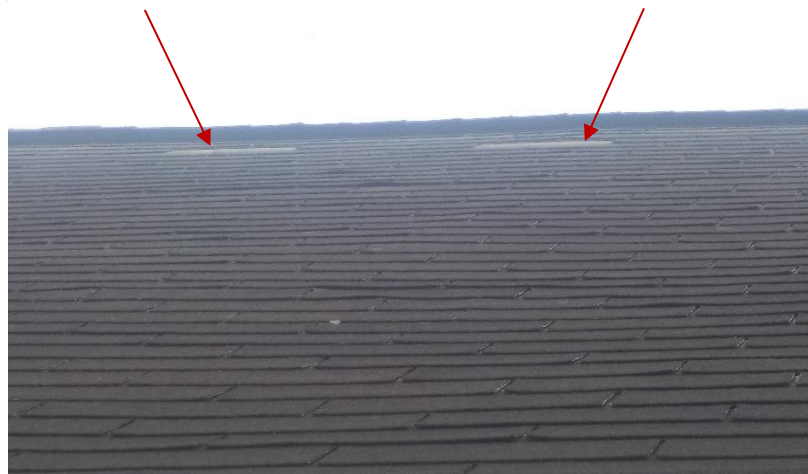
**There Are Some Shingles Around The Roof Surface That Are Either Worn, Brittle Or Damaged And Are In Need Of Repair Or Replacement.**

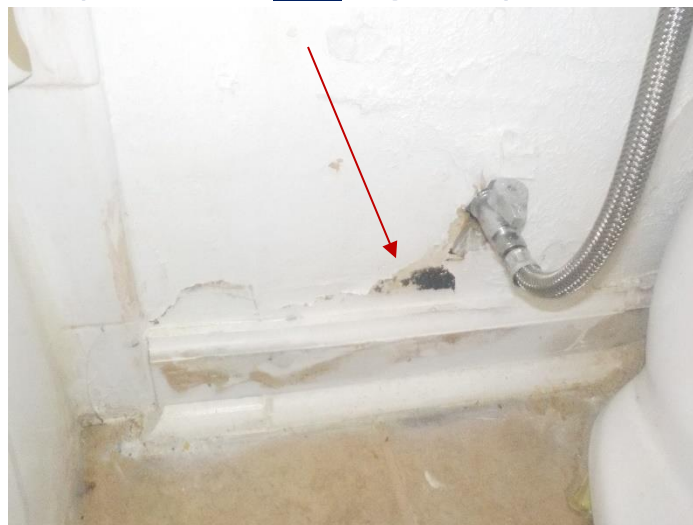
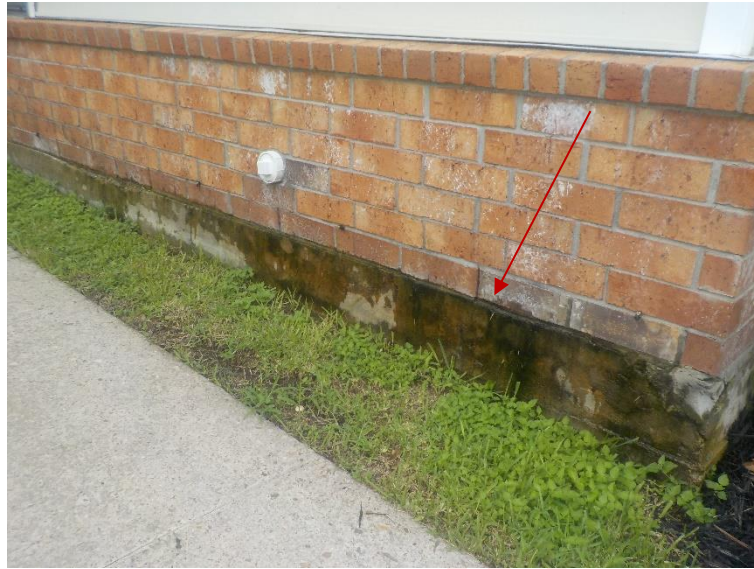
**There Is A Mildew Looking Substance On The Wall Behind The Toilet In The Master Bathroom. (This Is Not A Mold Inspection.)**

**There Is A Water Leak In The Wall Behind The Master Bathroom Toilet And It Looks To Have Been Leaking For Some Time.**

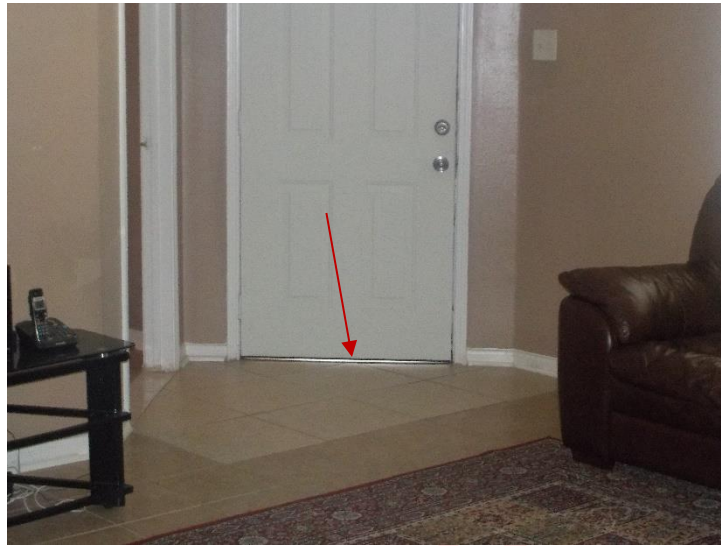
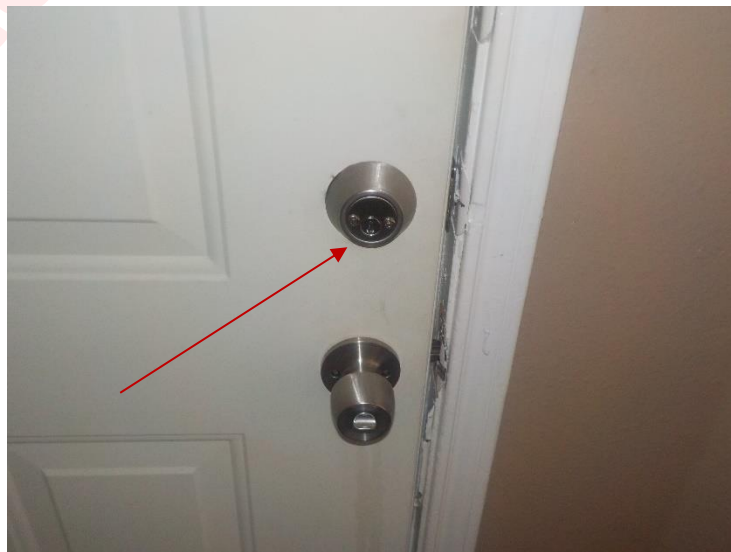
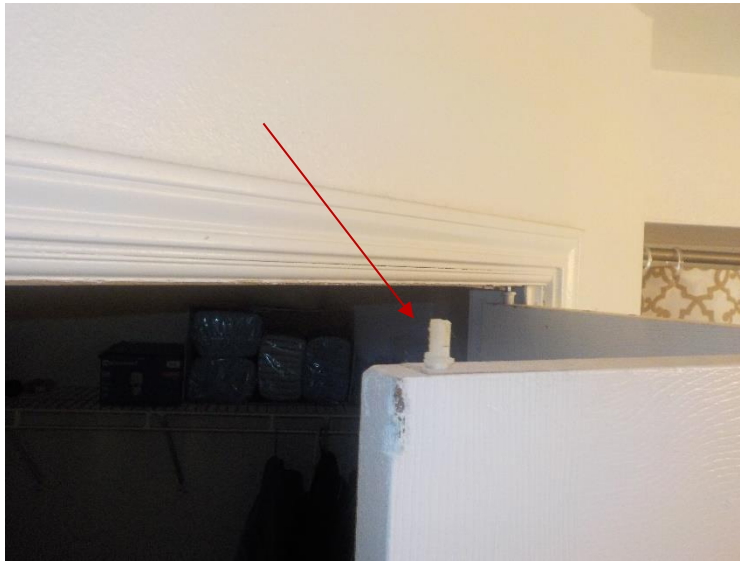
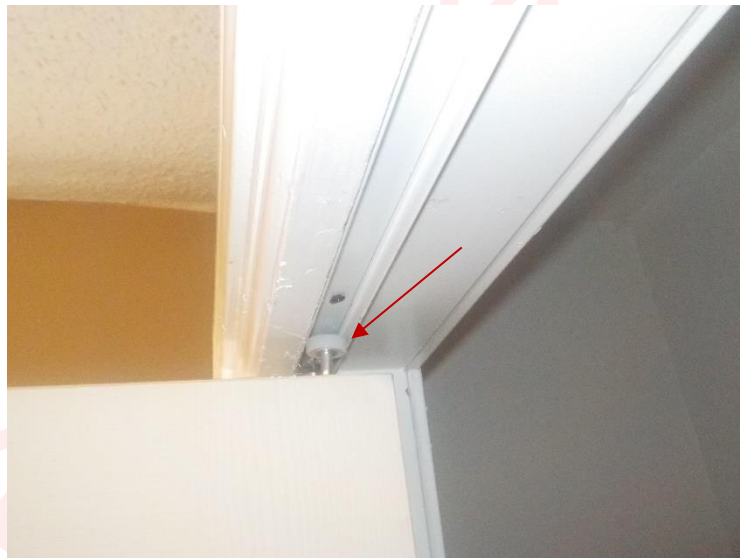
**The Weather Stripping Or Door At The Bottom Of The Front Entry Needs Adjustment Or Repair To Prevent Negative Airflow Or Possible Moisture Entry.**

**The Self-Closing Hinges For The Garage Entry Doors Are Not Working As Intended And Adjustment Is Needed.**

**There Are According Doors That Either Are Damaged And Are Not Working As Intended And Adjustment Or Repair Is Needed.**

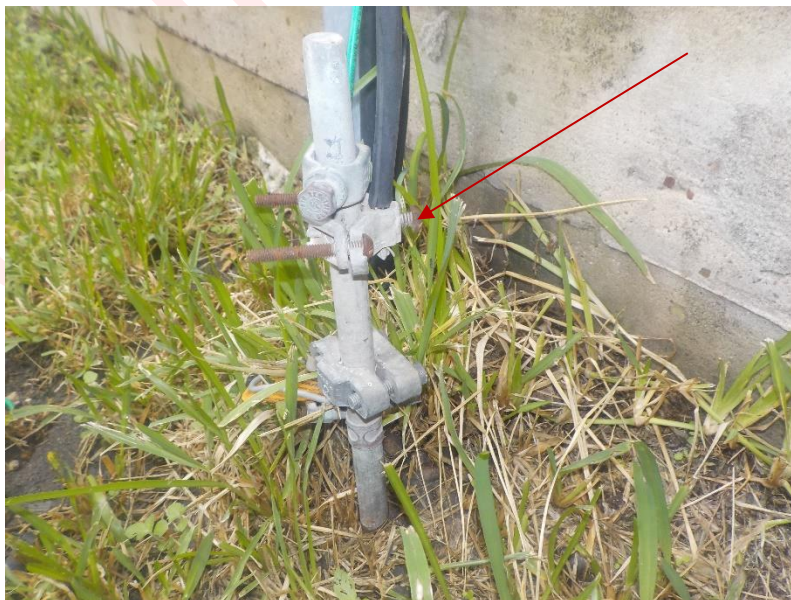
**“Pipe Clamps” Can Not Be Used For A Ground Clamp On The Ground Rod.**

**The Service Panel Is Not Properly Labeled.**

**The 2008 National Electrical Code Requires All 15 And 20 Amp Circuits That Are Not Being Protected By A GFCI Circuit, An Outlet That Is Designated For An Alarm System, Or Outlets For Built-In Appliances To Be Protected With ARC-Fault Protection Breakers. The 2003 Code Only Required The Bedrooms And Smoke Detectors To Be Protected. As A TREC Inspector I Am Required To Note These Items If Not Present As “Deficient” Per Our New 2009 Standards of Practice. This House Was Not Built To The 2003 Code But Was Built To The 2008 Code. (Please refer to [TEXAS REAL ESTATE CONSUMER NOTICE CONCERNING HAZARDS OR DEFICIENCIES](#) on page 3 of this report.)**

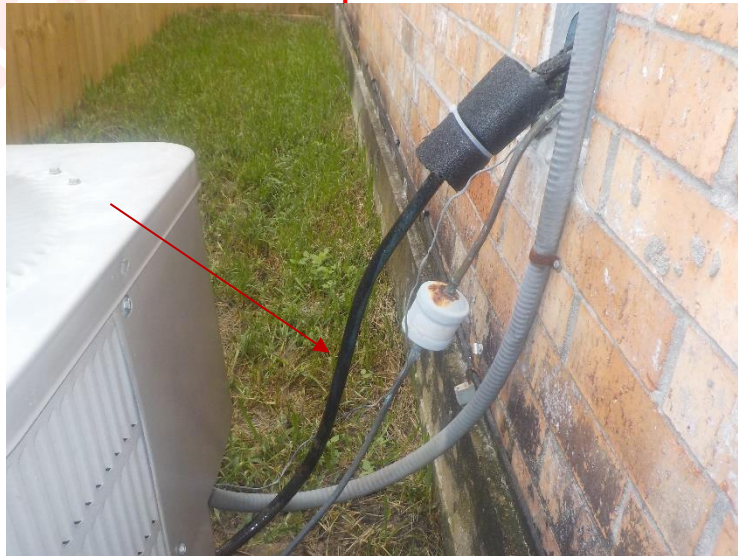
**The Insulation Around The A/C Compressor Freon Lines Is Missing.**
