# PROPERTY INSPECTION REPORT

**Concerning:** 12206 Meadows Park Ct., Houston, TX 77477  
(Address or Other Identification of Inspected Property)

**By:** Robert S Tyler, Lic #: 7841 832-724-6757 12-12-2020  
(Name and License Number of Inspector) (Date)

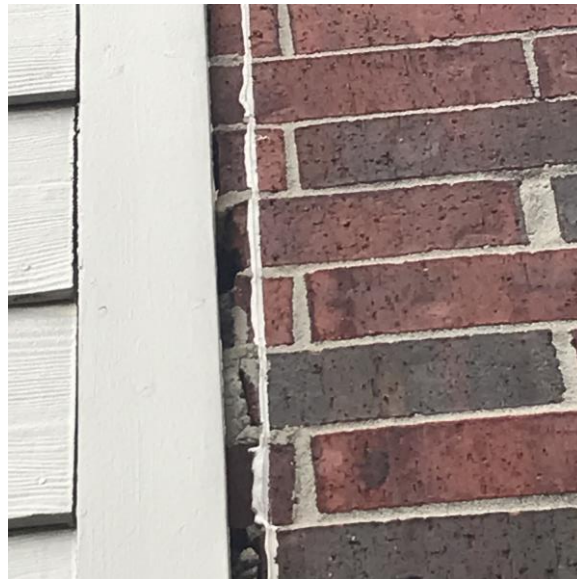
**E. Walls (Interior & Exterior) – Comments:**  
At the window on the east end of the south wall, the window trim is not wide enough to seal against the brick to stop rain penetration.

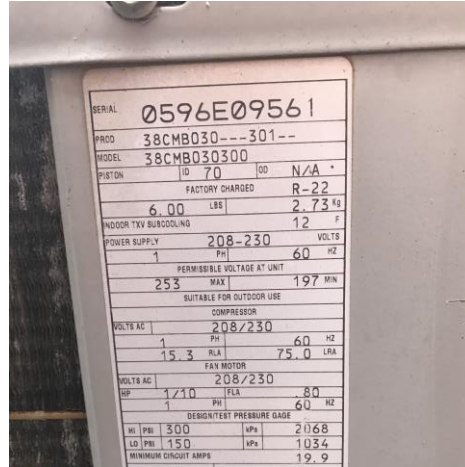
FYI Based on the serial number, it appears that the downstairs condenser is 24 years old. I consider 20-25 years to be a normal service lifetime, so the buyer should be aware that a replacement will be required in the near future.

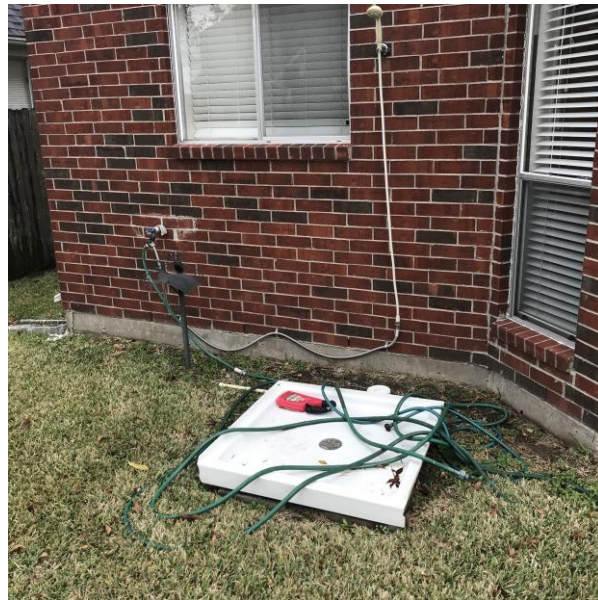
There is a shower pan in the back yard by the swimming pool. It appears that the drain is connected to the main sewer line from the house. This will allow rainwater to enter the sanitary sewer system, which is not permitted.

Additionally, if there is no p-trap in the pipe, sewer gasses will escape to the air.

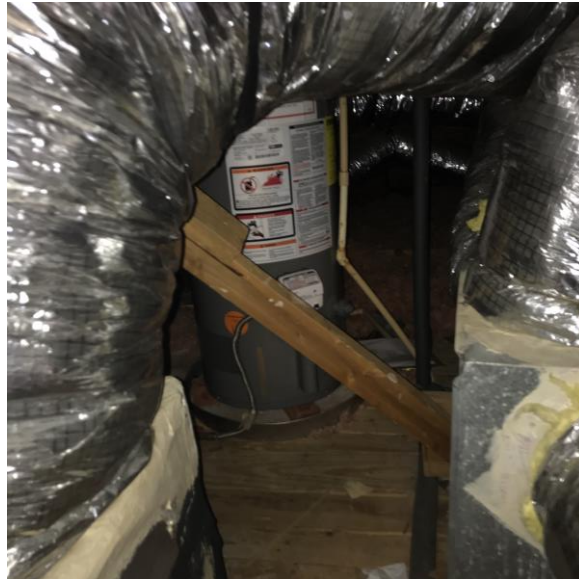
The water heater, located in the attic, is inaccessible behind framing and an air handler.

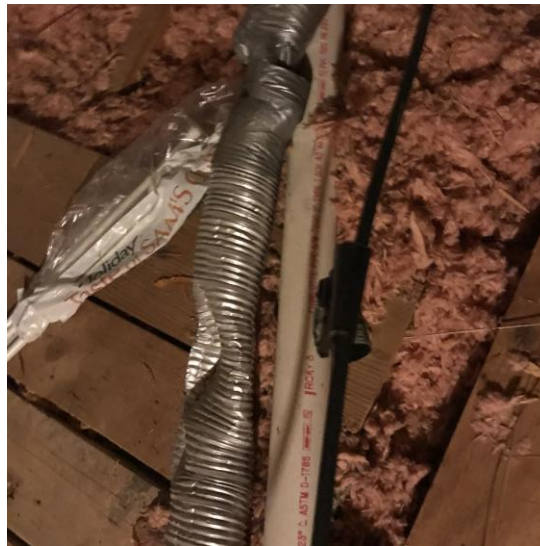
- A. **Dishwasher** – *Comments:*  
The dishwasher drain has no high loop or vacuum breaker.
- B. **Food Waste Disposer** – *Comments:*
- C. **Range Exhaust Vent** – *Comments:*  
The light above the range does not work.
- D. **Ranges, Cooktops and Ovens** – *Comments:*  
The left front burner will not light off.
- E. **Microwave Oven** – *Comments:*
- F. **Mechanical Exhaust Vents and Bathroom Heaters**  
The part of the powder room exhaust vent that is laying on the attic floor is crushed and improperly spliced.

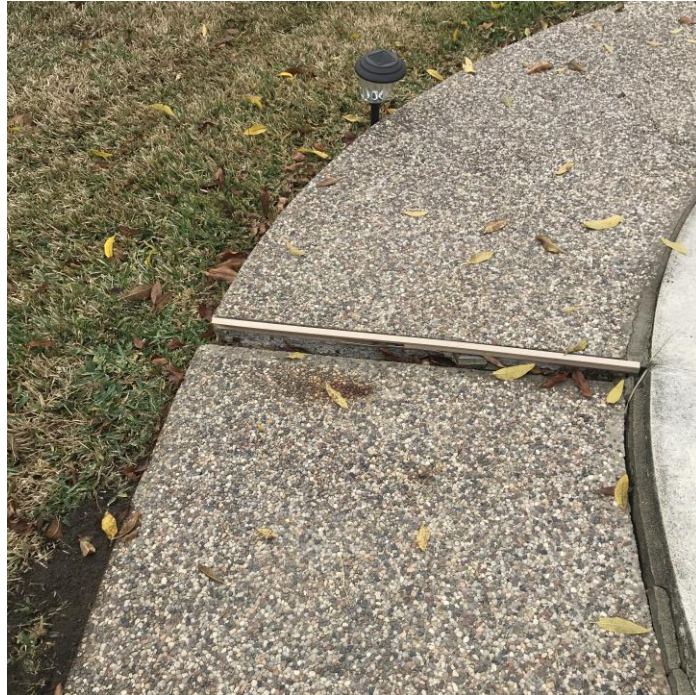
Several sections of the apron have subsided and present a tripping hazard. The ground at the back of the apron has subsided and there is an unmarked step down that presents a falling hazard.
