Mold Investigation Report

235 Litchfield
Houston, TX 77024

Limited Mold Assessment Report

Christopher Skidmore unit 235

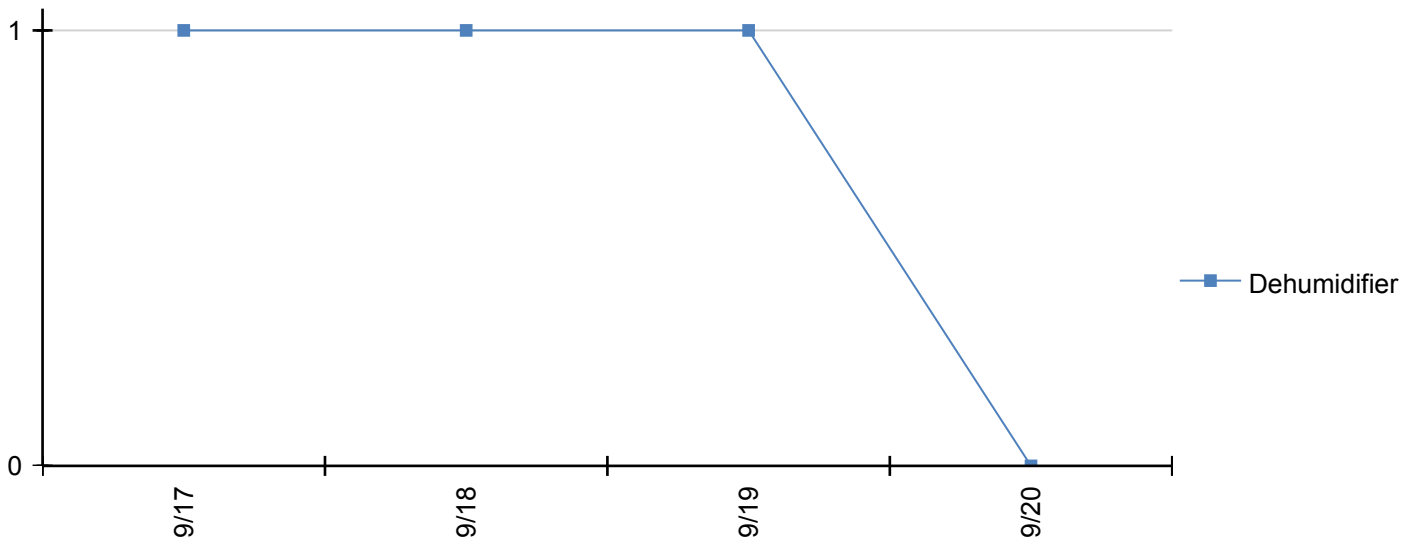
Usage Chart

Day	9/17	9/18	9/19	9/20	Total
Dehumidifier	1	1	1	0	3
Total	1	1	1	0	3

Equipment Type	Room	Equipment Model	Asset Number	Placed	Removed	Total Days*	Total Hours*
Dehumidifier	Livingroom	7000XLI	NRH192	9/17/2017 8:38 AM	9/20/2017 8:55 AM	3.01	72.2
	Total					3.01	72.2
Total						3.01	72.2

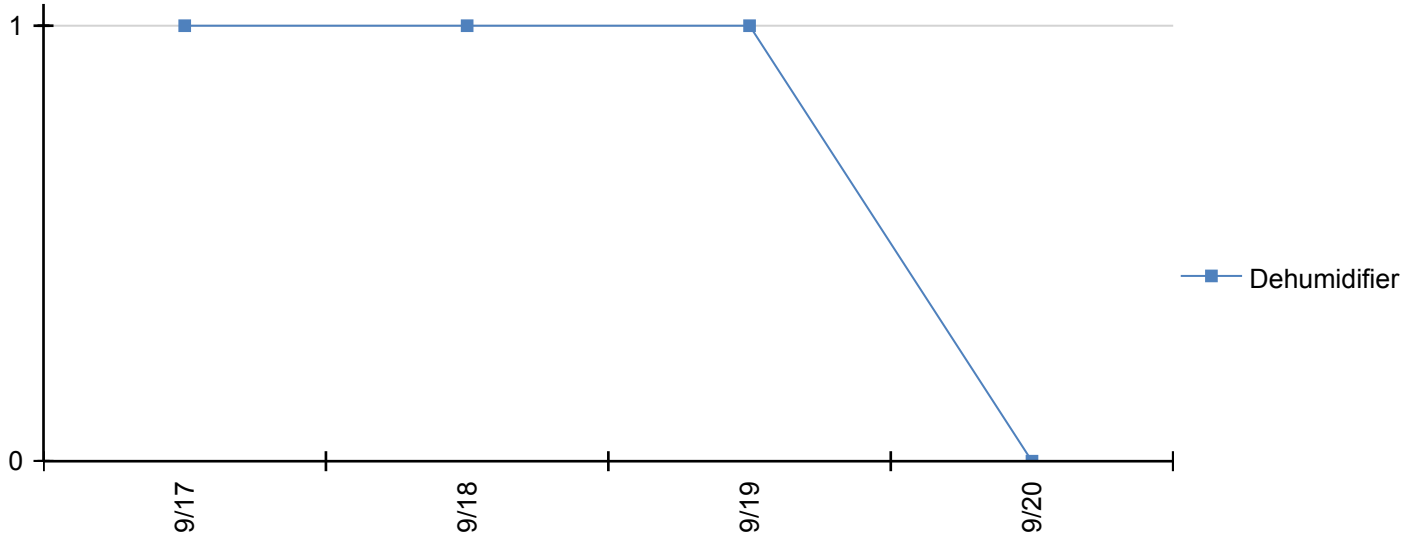
Zone 1 Equipment Usage

Date	Room	Air Mover Count	Dehu Model	Dehu Rating	Asset No	Dehu Hour Counter
9/17/2017 8:38 AM Tech: We	Livingroom	0	7000XLI	130 PPD	NRH192	0
			1	130 PPD		0
9/18/2017 4:02 PM Tech: We	Livingroom	0	7000XLI	130 PPD	NRH192	0
			1	130 PPD		0
9/19/2017 9:28 AM Tech: We	Livingroom	0	7000XLI	130 PPD	NRH192	0
			1	130 PPD		0
