PROPERTY INSPECTION REPORT

Concerning: 6414 Smoke Tree Ct Sugar Land, Texas 77479

Inspection Date: 03/09/2021

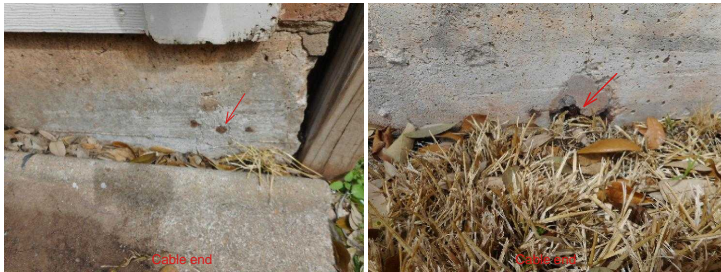
A. Foundations

Comments: Foundation appears to be functioning as intended There are corner cracks at one or more than one corner of the home. These are conducive to pest penetration

Foundation cable ends exposed on left side and back of house

Evidence of previous repairs to foundation, concrete patches in garage floor

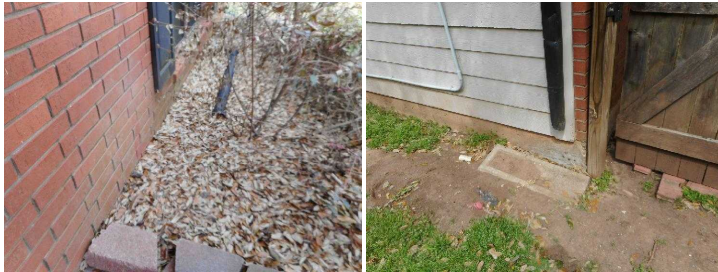
B. Grading and Drainage - Comments: Flat, Minor slope, High soil level in front right flower bed Down spout missing kick out at back left corner of house

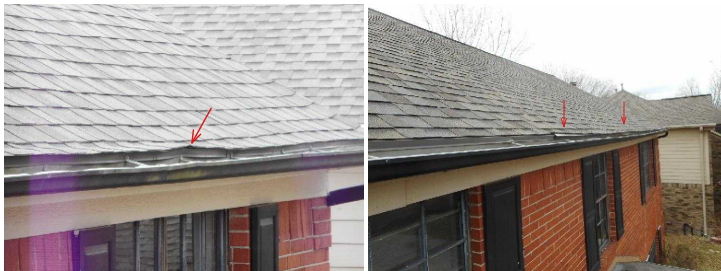
C. Roof Covering Materials

Comments: Asphalt shingle Drip edge on front of house lifting bottom edge of shingles

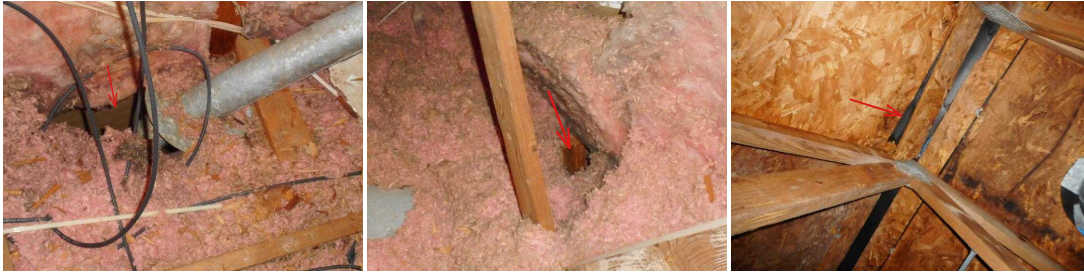
D. Roof Structures and Attics (continued)

Comments: 2x4 Truss Attic floor not fire stopped at water heater vent pipe chase and HVAC chase

Roof decking at center ridge not 24 inches wide and a least 1 piece of decking has been damaged

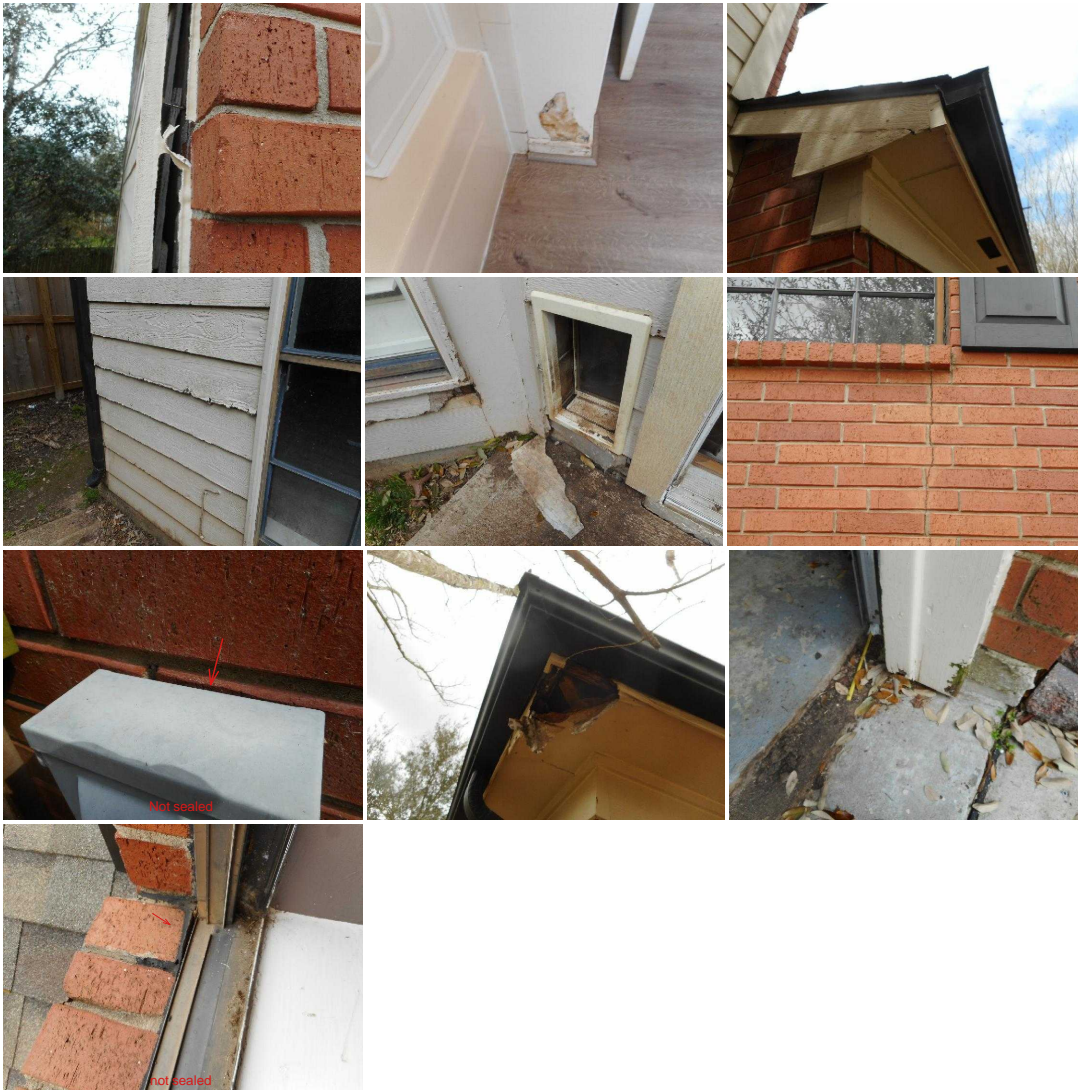
E. Walls (Interior and Exterior) - Comments: Drywall/Brick, Cement fiber board, Press board, Back wall is press board siding that is deteriorated
Deteriorated soffit and fascia at left front corner of garage, and right end of front porch cover.
Siding on left side second floor not sealed to brick
Moisture damaged drywall at hall bath tub
Crack in brick veneer at front right under second floor window

All exterior wall penetrations should be caulked/sealed to help prevent water intrusion into the wall cavity. Including but not limited to: Windows, door jambs, electrical lighting, water lines.

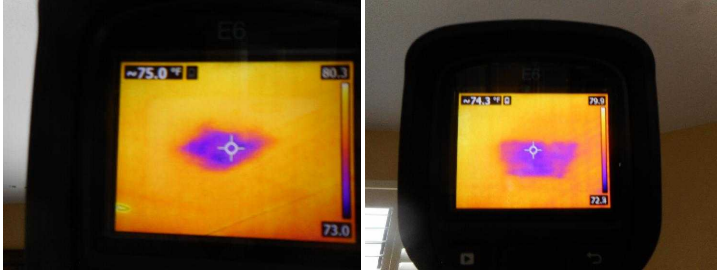
F. Ceilings and Floors - Comments: Drywall and Tile, Laminate, Moisture present at repairs under 2nd floor bathrooms

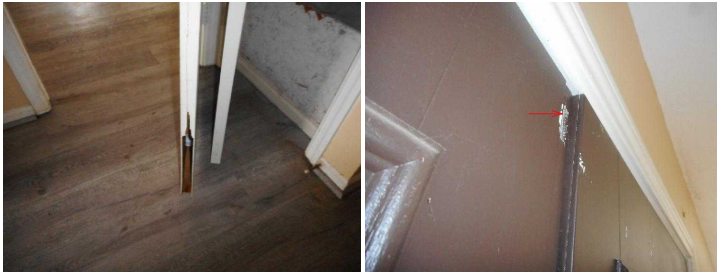
G. Doors (Interior and Exterior) - Comments: Solid wood, Metal clad, Hollow wood, Back door not flush in jamb
Mud room entrance, second floor hall bathroom linen closet and bedroom door damaged

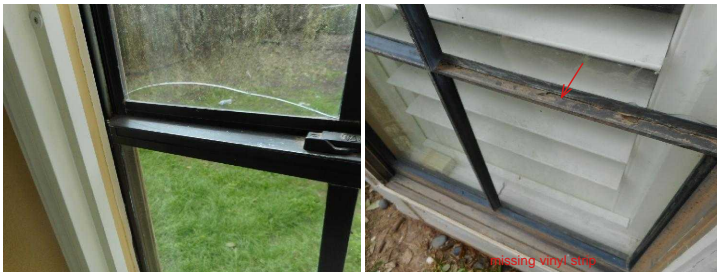
H. Windows - Comments: Aluminum single hung, Front middle bedroom window has cracked pane of glass, breakfast room window pane cracked
Windows screens missing, (observed multiple window screens in attic above garage)
Damaged and missing vinyl glazing strips

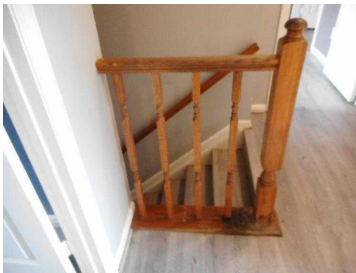
I. Stairways (Interior and Exterior) - Comments: Wood stairs with wood handrails, Intermediate balusters improperly allow an object greater than 4 inches in diameter to pass through

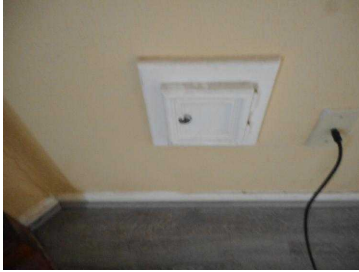
J. Fireplaces and Chimneys - Comments: Prefab, Door to gas valve at fire place is locked, valve not inspected

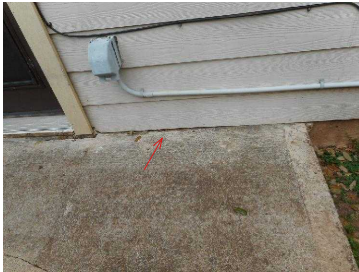
K. Porches, Balconies, Decks, and Carports - Comments: Concrete patio, Concrete patio not 6 inches below siding
Concrete patio is cracked

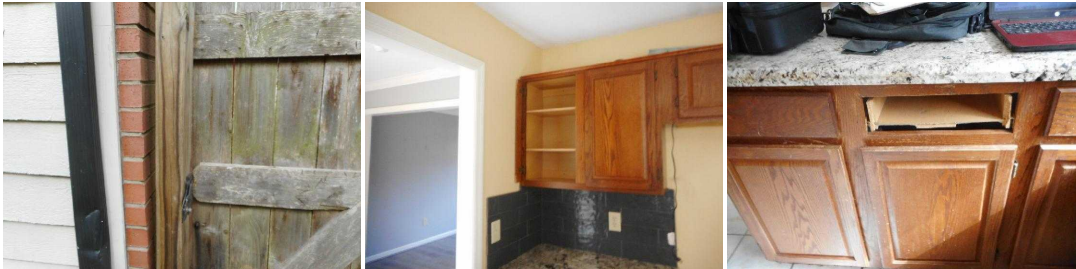
L. Other - Comments: Fence, Cabinets, Fence gate binds on latch
Cabinet drawer front missing, cabinet door missing

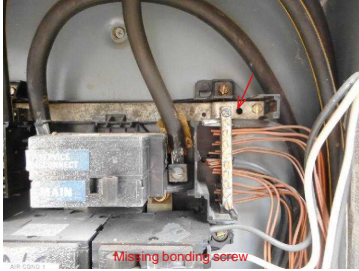
A. Service Entrance and Panels - Comments: Aluminum, Bonding screw on neutral/ground not present

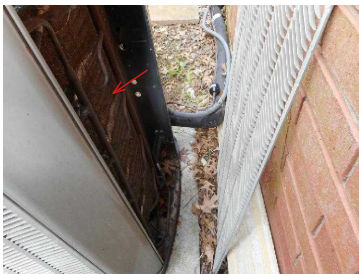
Comments: American Standard Condenser coils externally covered with dirt and debris back cover of condenser not installed

Due to condition of return air and no filter installed in return air, a service and cleaning of HVAC system is recommended

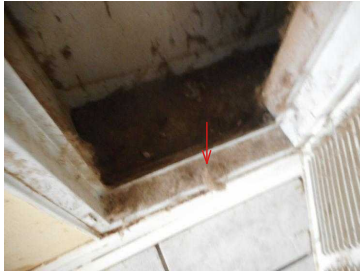
C. Duct Systems, Chases, and Vents - Comments: Insulated flex, Return air plenum not sealed, excessive dirt in return air plenum

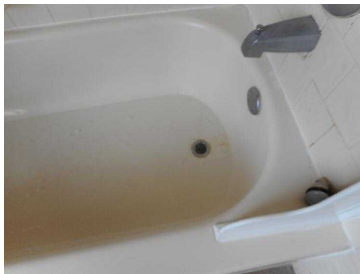
B. Drains, Wastes, and Vents - Comments: PVC, Hall bathtub missing stopper and slow drain

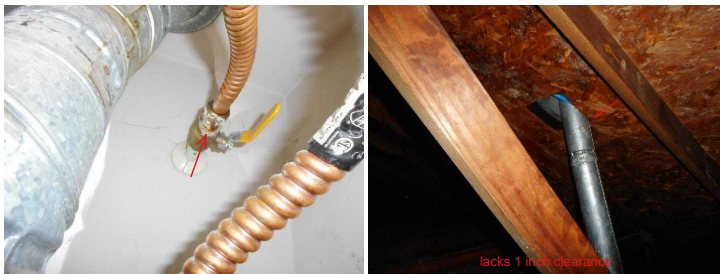
C. Water Heating Equipment

Energy Sources: Natural gas
Capacity: 40 Gals
Comments: Bradford White No sediment trap in gas supply line
vent pipe lack 1 inch clearance to combustibles at roof
Vent pipe not secured to framing
Water heater was functioning, gas off at valve

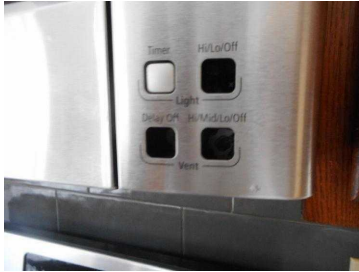
C. Range Hood and Exhaust Systems - Comments: Samsung, vent controls damaged

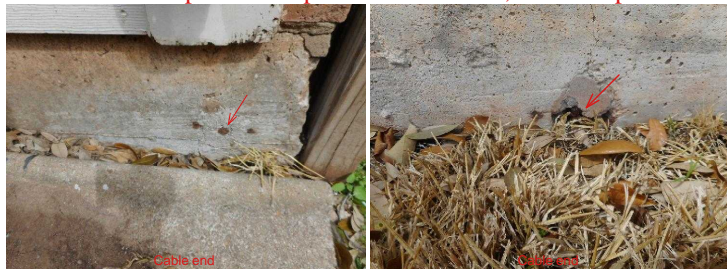
- A. Foundations Foundation appears to be functioning as intended, **There are corner cracks at one or more than one corner of the home. These are conducive to pest penetration**
Foundation cable ends exposed on left side and back of house
Evidence of previous repairs to foundation, concrete patches in garage floor Type of Foundation(s): Slab on grade

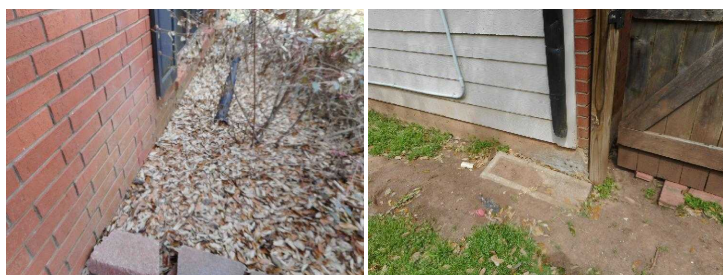
- B. Grading and Drainage Flat, Minor slope, **High soil level in front right flower bed**
Down spout missing kick out at back left corner of house

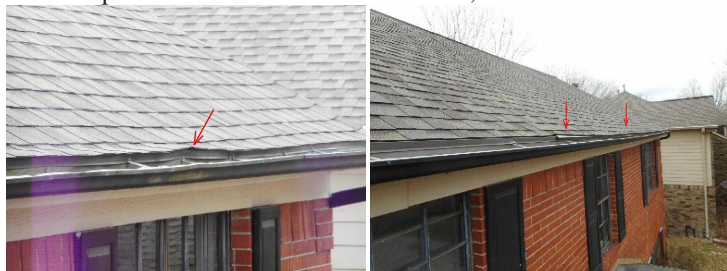
- C. Roof Covering Materials Asphalt shingle, **Drip edge on front of house lifting bottom edge of shingles** Types(s) of Roof Covering:
Composition Viewed From: Ground, Surface of roof

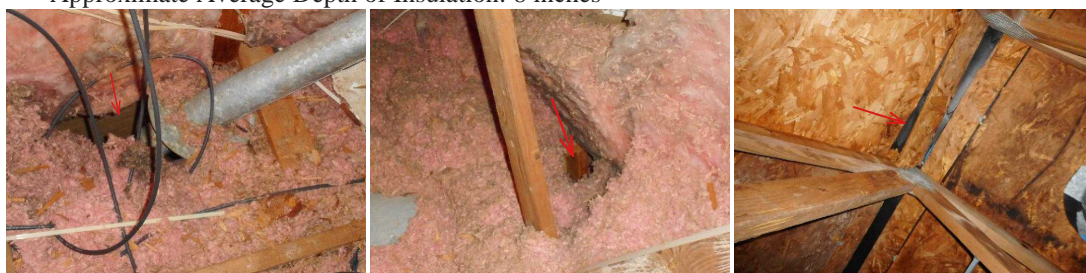
- D. Roof Structures and Attics 2x4 Truss, **Attic floor not fire stopped at water heater vent pipe chase and HVAC chase**
Roof decking at center ridge not 24 inches wide and a least 1 piece of decking has been damaged Viewed From: Attic opening
Approximate Average Depth of Insulation: 8 inches

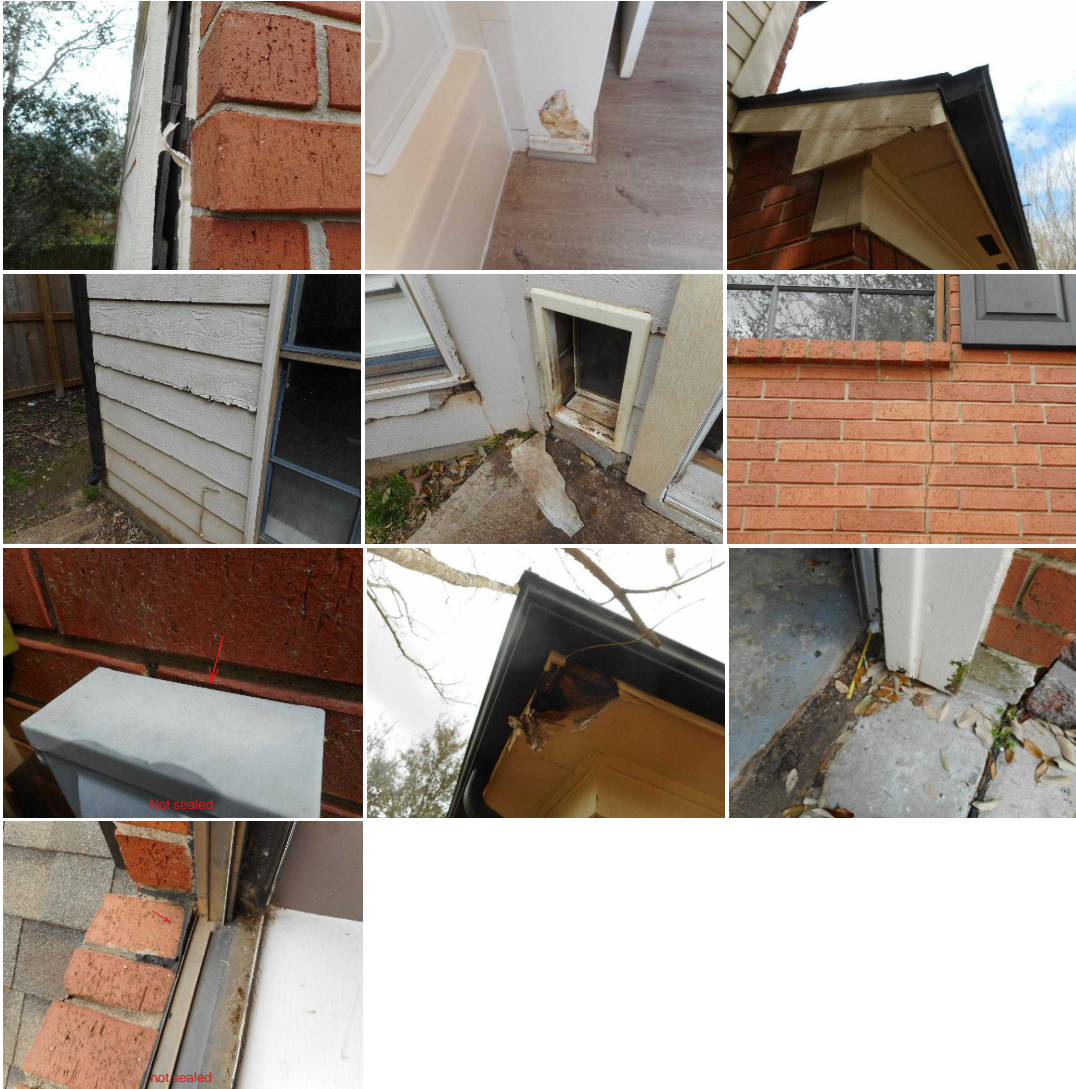
E. Walls (Interior and Exterior) (continued)

- E. Walls (Interior and Exterior) Drywall/Brick, Cement fiber board, Press board, **Back wall is press board siding that is deteriorated**
Deteriorated soffit and fascia at left front corner of garage, and right end of front porch cover.
Siding on left side second floor not sealed to brick
Moisture damaged drywall at hall bath tub
Crack in brick veneer at front right under second floor window

All exterior wall penetrations should be caulked/sealed to help prevent water intrusion into the wall cavity. Including but not limited to: Windows, door jambs, electrical lighting, water lines.

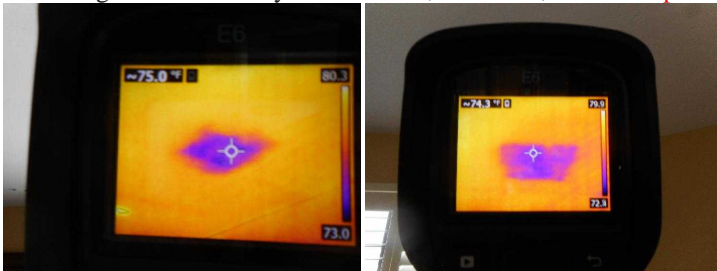
F. Ceilings and Floors Drywall and Tile, Laminate, Moisture present at repairs under 2nd floor bathrooms

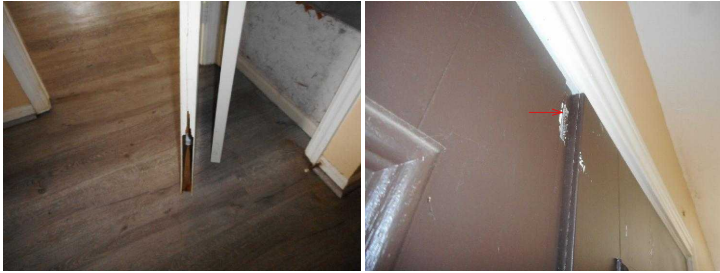
G. Doors (Interior and Exterior) (continued)

G. Doors (Interior and Exterior) Solid wood, Metal clad, Hollow wood, Back door not flush in jamb Mud room entrance, second floor hall bathroom linen closet and bedroom door damaged

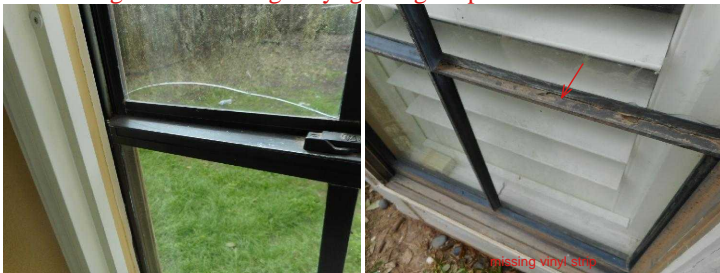
H. Windows Aluminum single hung, Front middle bedroom window has cracked pane of glass, breakfast room window pane cracked Windows screens missing, (observed multiple window screens in attic above garage) Damaged and missing vinyl glazing strips

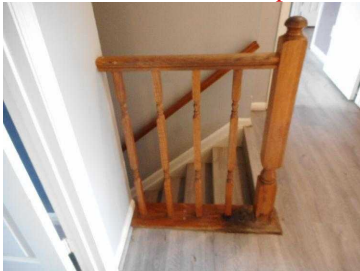
I. Stairways (Interior and Exterior) Wood stairs with wood handrails, Intermediate balusters improperly allow an object greater than 4 inches in diameter to pass through

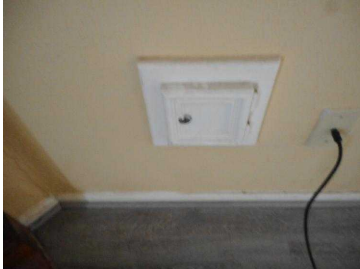
J. Fireplaces and Chimneys Prefab, Door to gas valve at fire place is locked, valve not inspected

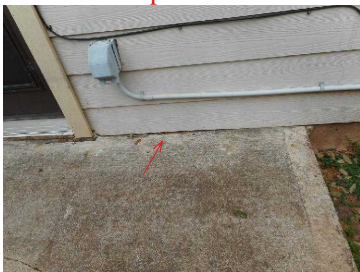
K. Porches, Balconies, Decks, and Carports Concrete patio, Concrete patio not 6 inches below siding Concrete patio is cracked

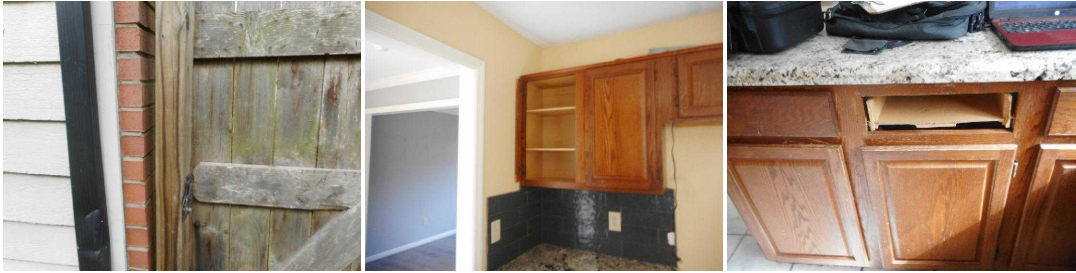
L. Other (continued)

L. Other Fence, Cabinets, Fence gate binds on latch Cabinet drawer front missing, cabinet door missing

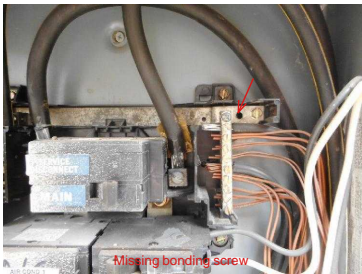
A. Service Entrance and Panels Aluminum, **Bonding screw on neutral/ground not present**

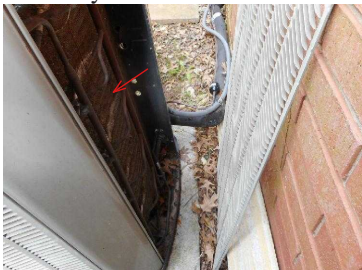
B. Cooling Equipment American Standard, **Condenser coils externally covered with dirt and debris back cover of condenser not installed** **Due to condition of return air and no filter installed in return air, a service and cleaning of HVAC system is recommended** Type of System: Central forced air

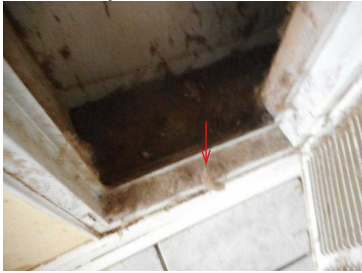
C. Duct Systems, Chases, and Vents Insulated flex, **Return air plenum not sealed, excessive dirt in return air plenum**

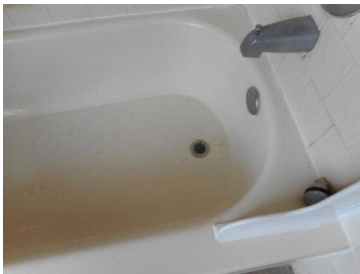
B. Drains, Wastes, and Vents PVC, **Hall bathtub missing stopper and slow drain**

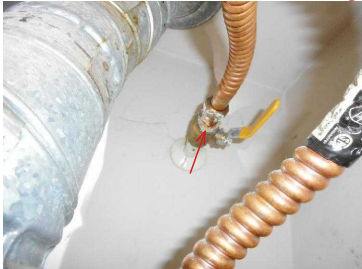
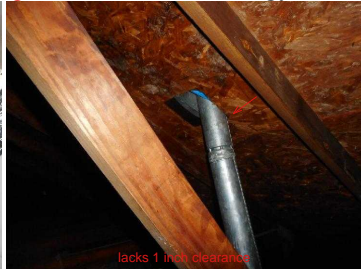
C. Water Heating Equipment Bradford White, **No sediment trap in gas supply line vent pipe lack 1 inch clearance to combustibles at roof**

Vent pipe not secured to framing

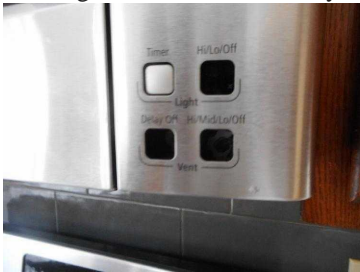
C. Range Hood and Exhaust Systems Samsung, **vent controls damaged**
