# Inspection Report

**Property Address:**  
606 Marshall St B6  
Houston TX 77006

# PROPERTY INSPECTION REPORT

**By:** Steven Walters TREC#22910 / Home Plate Inspections, LLC 4/6/2021

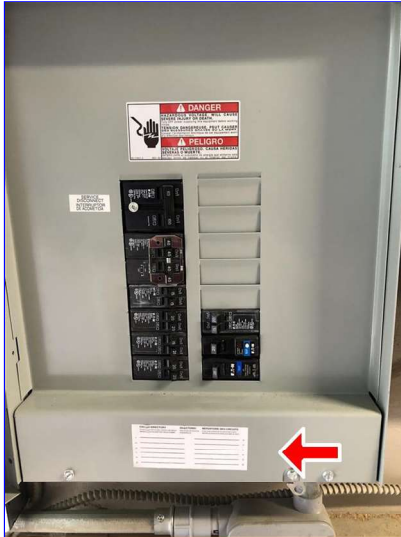
A. Item 1(Picture)

The panel is located in the common hallway between building A and B. The panel was not labeled as it should be. Recommend an electrician to assess and label panel. Item 1(Picture) Item 2(Picture)

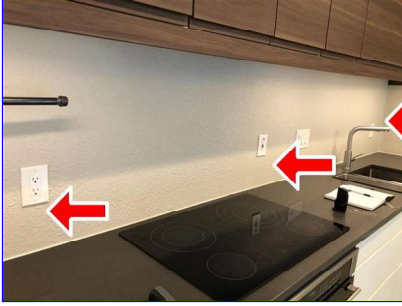
B. Item 1(Picture)

The plugs in the back splash in the kitchen are GFCI protected but will not reset at the plug like they are designed to. Recommend electrician to assess and make needed repairs. Item 1(Picture)

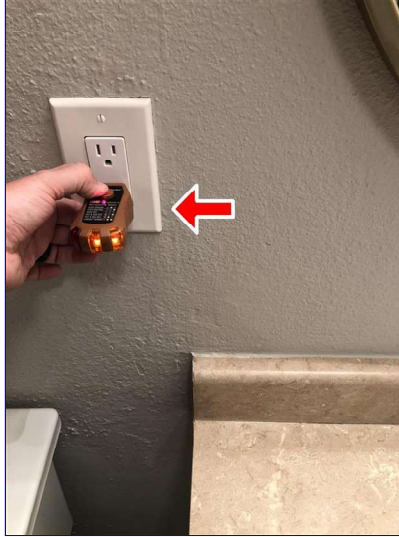
B. Item 2(Picture)

The plug in the bathroom is not GFCI protected and should be. Plug needs to be replaced with GFCI plug. Item 2(Picture)

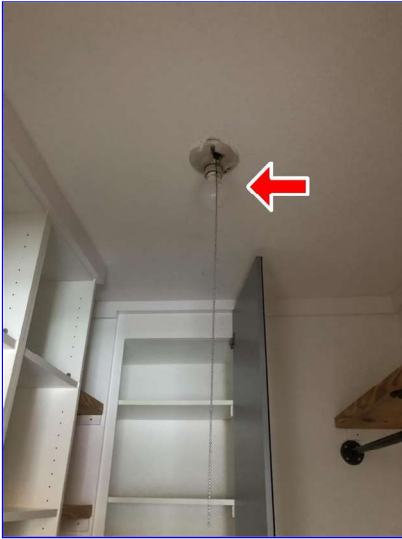
B. Item 3(Picture)

Light in closet needs a globe over the bulb. Closet bulbs should have a globe over them to protect the bulb from possibly getting broken. Item 3(Picture)

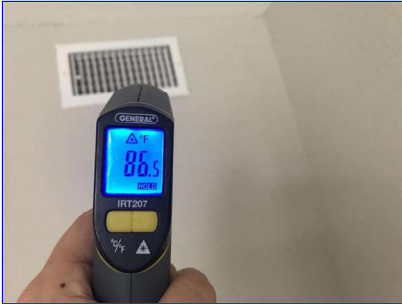
A. Item 1(Picture)

Heat was tested and working as intended at the time of inspection. Item 1(Picture)

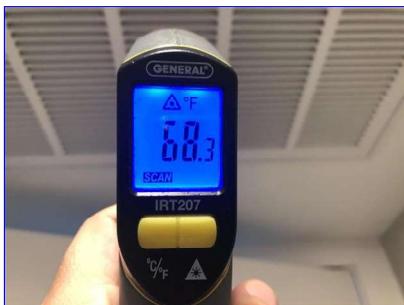
B. Item 1(Picture)

The ambient air test was performed by using thermometers on the air handler of Air conditioner to determine if the difference in temperatures of the supply and return air are between 14 degrees and 22 degrees which indicates that the unit is cooling as intended. The supply air temperature on your system read 51 degrees, and the return air temperature was 68 degrees. This indicates the range in temperature drop is normal. Item 1(Picture) Item 2(Picture)

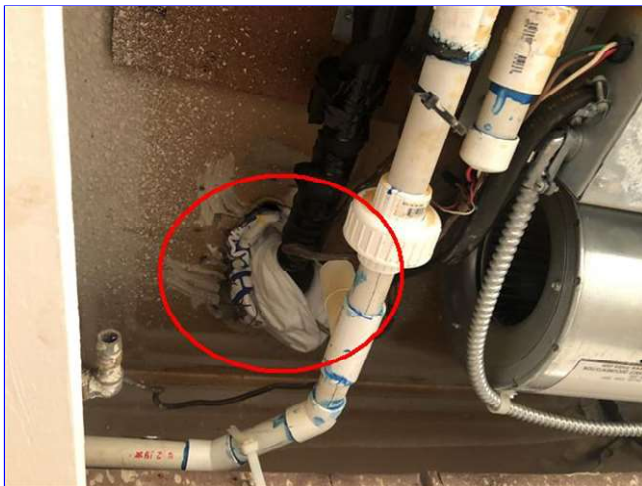
B. Item 3(Picture)

Recommend sealing the area around the suction line with proper materials (not a tshirt). Was unable to inspect all aspects of the system due to height restrictions. Item 3(Picture) Item 4(Picture)

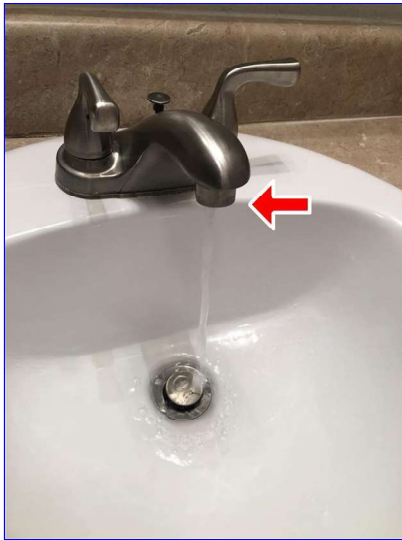
A. Item 1(Picture)

Water pressure at all faucets and tub/shower was low. Pressure was unable to be tested on a gauge - there was not a spot to screw the gauge on. Recommend a plumber to assess water pressure and make any needed repairs. Item 1(Picture)

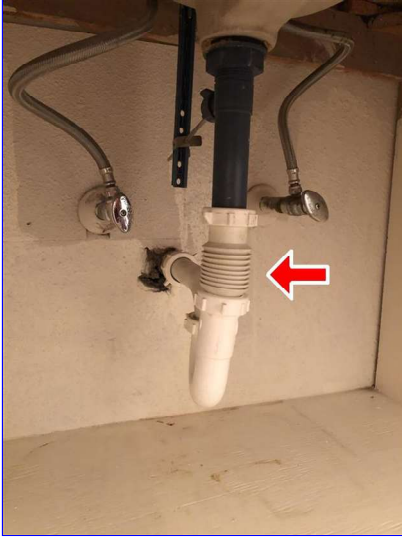
B. Item 1(Picture)

Sink drain in bathroom is constructed using a flex pipe. This is not an acceptable material to be used. When flex pipe is used there is risk of kinks or obstruction. Recommend a plumber to re-pipe drain with proper solid pipe. Item 1(Picture)
