Summary Only

Property Address:
606 Marshall St B6
Houston TX 77006

Home Plate Inspections, LLC
Steven Walters TREC#22910
14918 Gyrfalcon Fork
Cypress, TX 77429
281-541-2013

General Summary

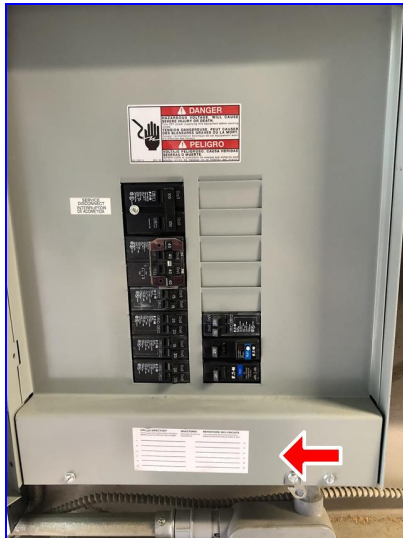
A. Item 1(Picture)

The panel is located in the common hallway between building A and B. The panel was not labeled as it should be. Recommend an electrician to assess and label panel. Item 1(Picture) Item 2(Picture)

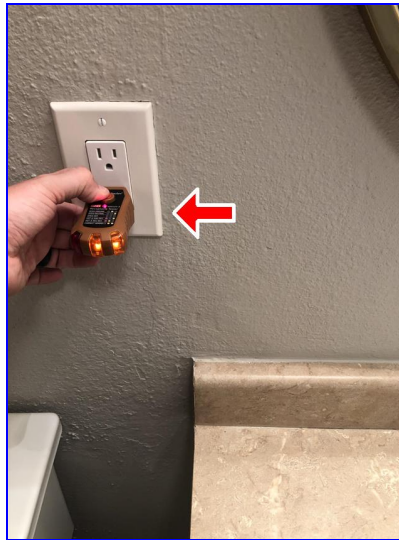
B. Item 2(Picture)

The plug in the bathroom is not GFCI protected and should be. Plug needs to be replaced with GFCI plug. Item 2 (Picture)

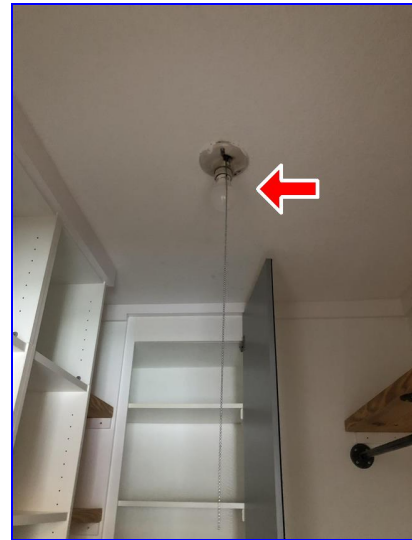
B. Item 3(Picture)

Light in closet needs a globe over the bulb. Closet bulbs should have a globe over them to protect the bulb from possibly getting broken. Item 3(Picture)

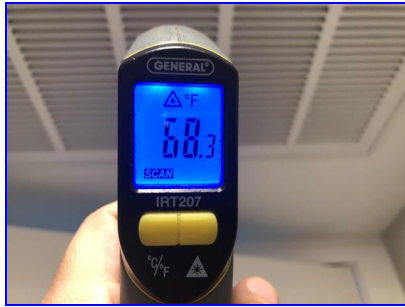
B. Item 1(Picture)

The ambient air test was performed by using thermometers on the air handler of Air conditioner to determine if the difference in temperatures of the supply and return air are between 14 degrees and 22 degrees which indicates that the unit is cooling as intended. The supply air temperature on your system read 51 degrees, and the return air temperature was 68 degrees. This indicates the range in temperature drop is normal. Item 1(Picture) Item 2 (Picture)

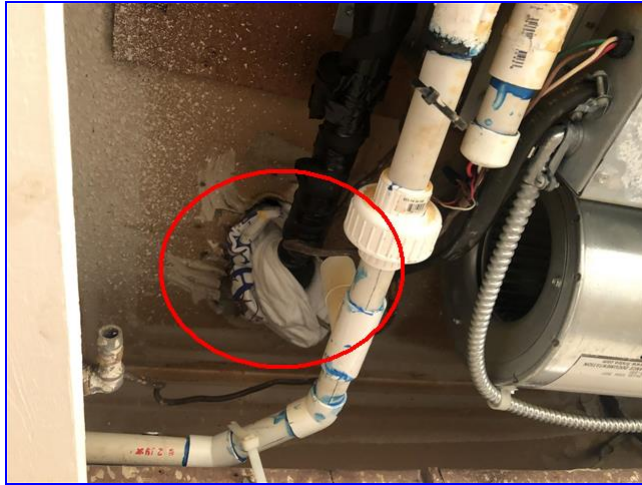
B. Item 3(Picture)

Recommend sealing the area around the suction line with proper materials (not a tshirt). Was unable to inspect all aspects of the system due to height restrictions. Item 3(Picture) Item 4(Picture)

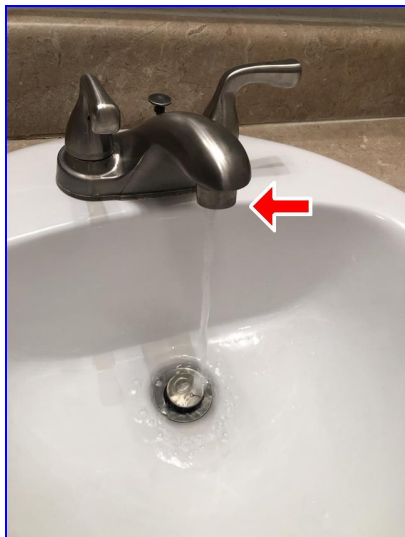
A. Item 1(Picture)

Water pressure at all faucets and tub/shower was low. Pressure was unable to be tested on a gauge - there was not a spot to screw the gauge on. Recommend a plumber to assess water pressure and make any needed repairs.
Item 1(Picture)
