PROPERTY INSPECTION REPORT

Concerning: 167 E Bracebridge Cir, The Woodlands, TX 77382
(Address or Other Identification of Inspected Property)

By: David Schmeck, Lic #22972 02/04/2021
(Name and License Number of Inspector) (Date)

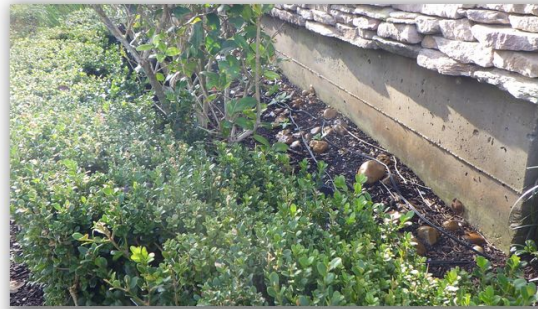
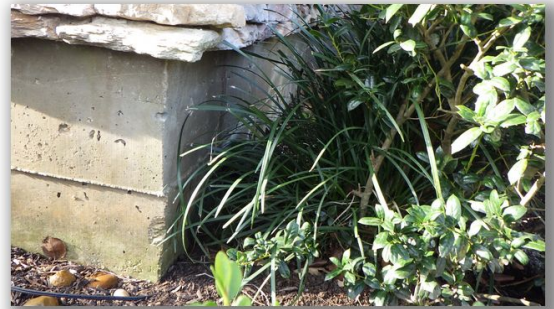
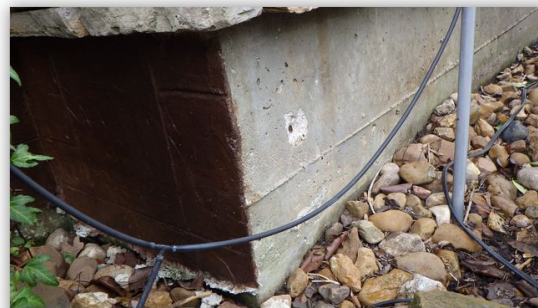
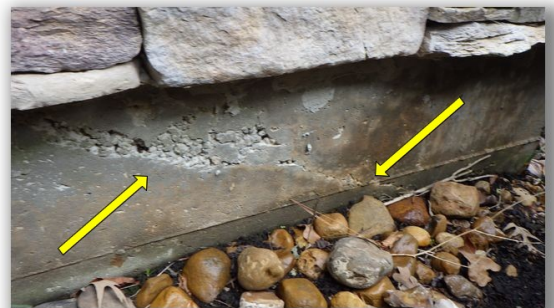
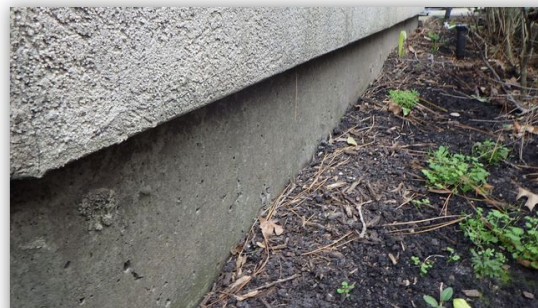
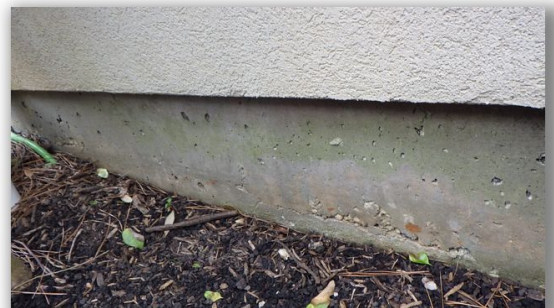
- A stress crack was observed in the exterior foundation perimeter beam.

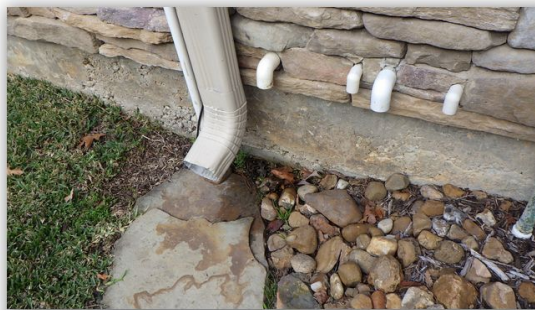
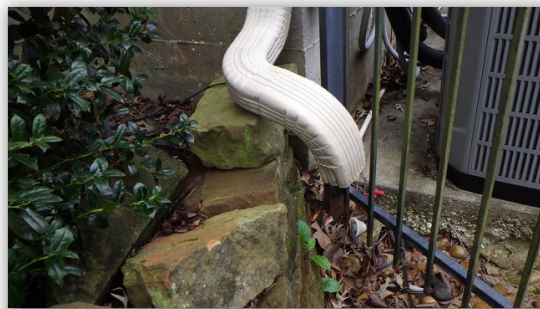
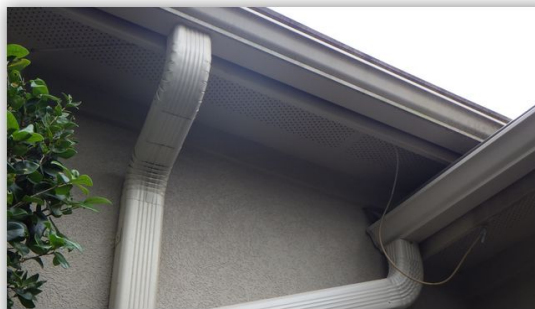
- The gutters require cleaning.
- The downspout lower turn spout is missing on the north side of the structure.

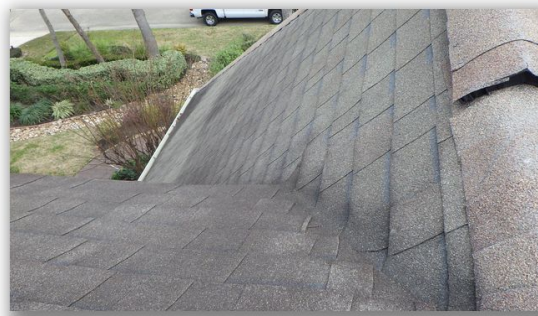
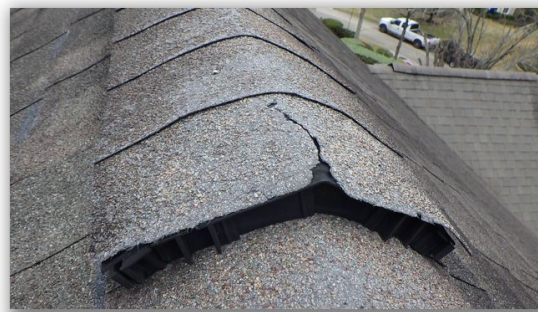
- One or more of the shingles were observed to be lifting on the east side, west side of the roof structure.
- Damaged shingles were observed on the south side of the roof structure.
- One or more of the ridge cap shingles were observed to be damaged.
- Exposed fasteners were observed at the shingles in one or more locations.
- The composition roofing material has experienced granular loss in various locations throughout the roof.
- Some blistering of the roofing material was observed at the time of this inspection.
- Some cracking and cupping of the roofing material was observed.

Note: Due to the limited nature of a general home inspection, it is possible that additional deficiencies will be discovered by a licensed technician. It is recommended to have the system serviced prior to the expiration of any option/warranty period.

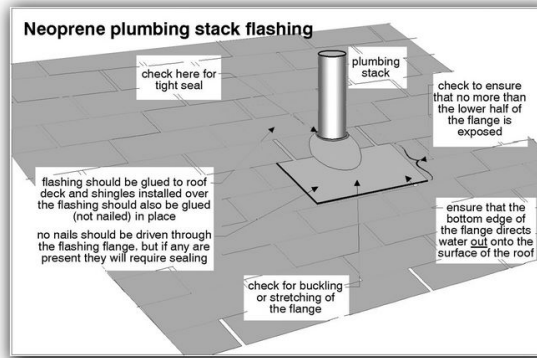
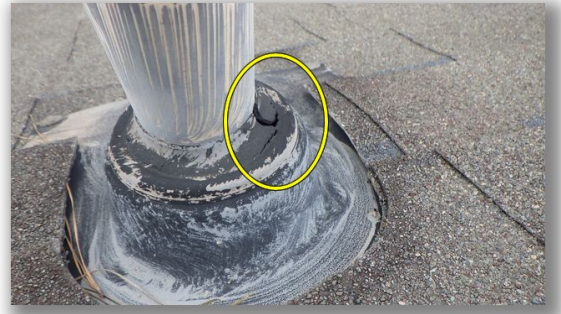
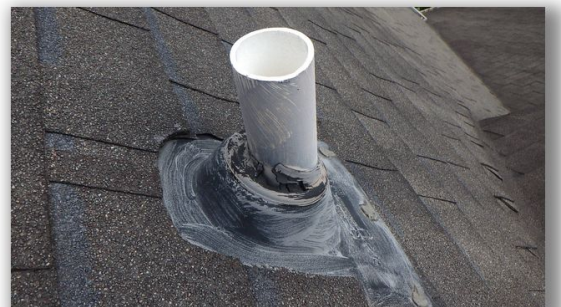
Flashing Details

- One or more of the roof level plumbing vent stack flashing details have some damage to the rubber seal around the stack. This condition could allow water penetration at this point.
- The roof level chimney flashing details need to be checked, reset or repaired. There is visible evidence of water intrusion at and around this location.
- The metal valley flashing details were observed to be rusted and should be corrected as necessary.
- Some of the metal flashing details were observed to be rusted and should be corrected as necessary.

Note: Roof fasteners (nails and/or staples) were observed to be exposed and should be properly sealed at the ridge caps and flashing areas.

Note: Due to the limited nature of a general home inspection, it is possible that additional deficiencies will be discovered by a licensed technician. It is recommended to have the system serviced prior to the expiration of any option/warranty period.

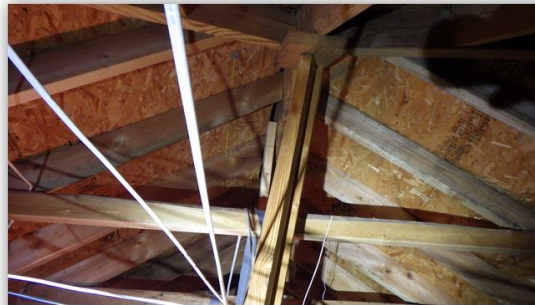
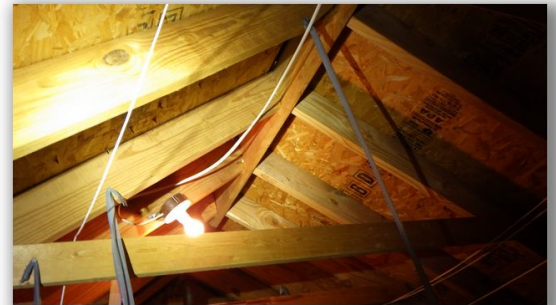
Attic Ventilation

- The roof structure attic space ventilation appears to be marginal at the time of this inspection. It is recommended to increase the amount of lower and upper ventilation to help prevent heat buildup in the attic space area.

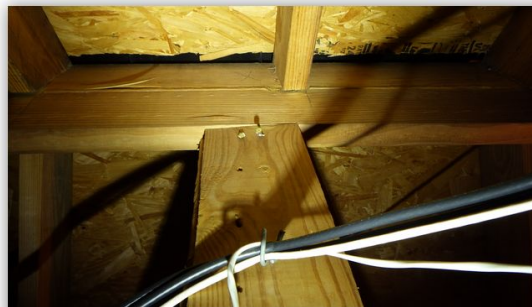
Attic Insulation

- The attic insulation is lower than typical and it is recommended to add additional insulation to achieve at least a R-30 rating.
- The attic floor insulation needs to be redistributed in one or more locations.

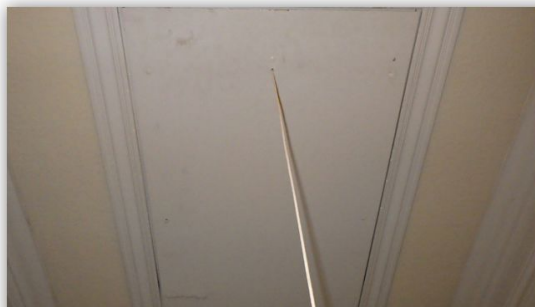
Attic Ladder

- The ladder cover was observed to be damaged. This condition should be corrected for reasons of safety.

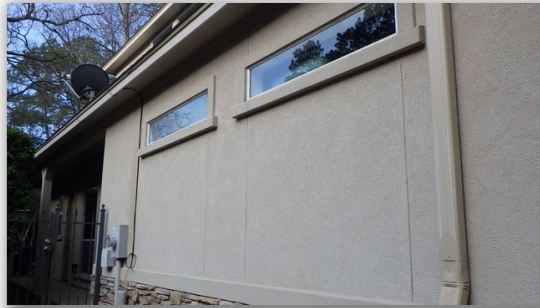
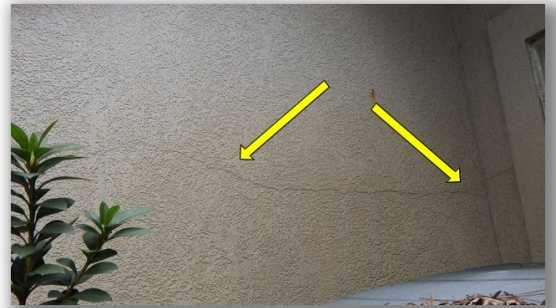
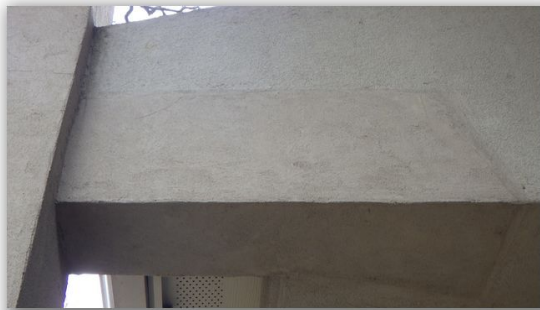
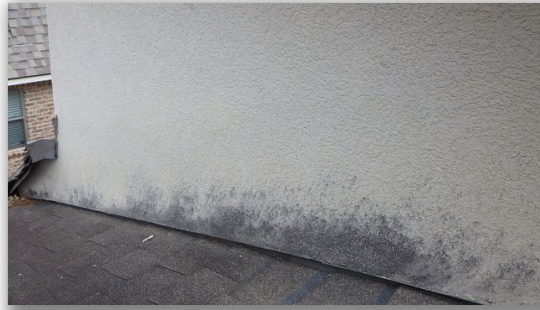
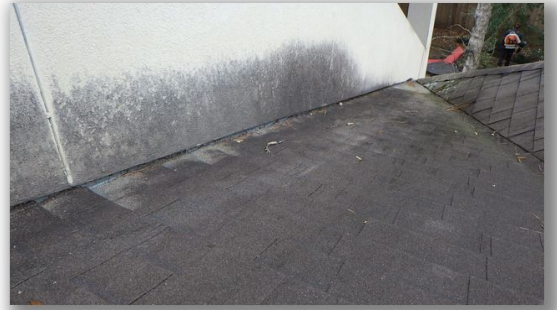
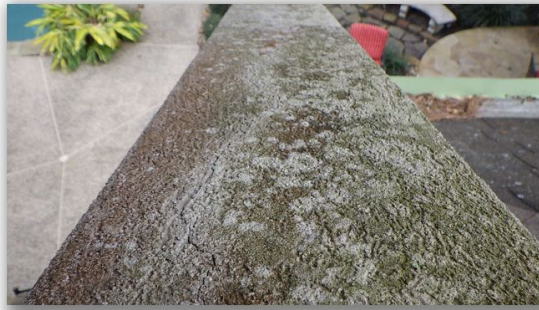
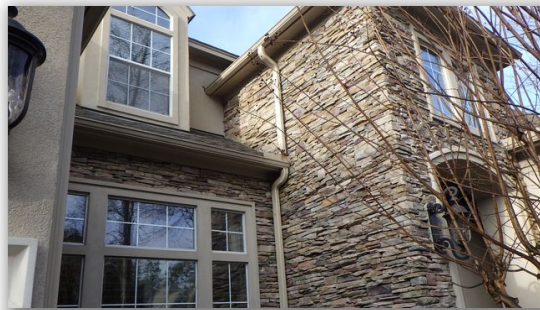
- Cracking of the stucco type veneer/cladding was observed on the south side, east side, west side of the structure. This condition should be further evaluated and corrected as necessary.
- Some discoloration and/or staining of the stucco type veneer/cladding was observed on the south side of the structure.
- There is possible water intrusion through the stucco cladding system on the south side of the structure. This condition has caused some visible damage to the stucco cladding. This condition should be further evaluated and corrected as necessary.

Note: Prior repairs to the stucco were observed.

- The stucco cladding appears to have conditions that are beyond normal. It is recommended to have an intrusive stucco/moisture evaluation performed prior to the expiration of any option or warranty time periods. A-Action Home Inspection Group offers intrusive stucco inspections at an additional price. Please contact our office at 713-730-3151 if you would like to schedule an additional stucco inspection.

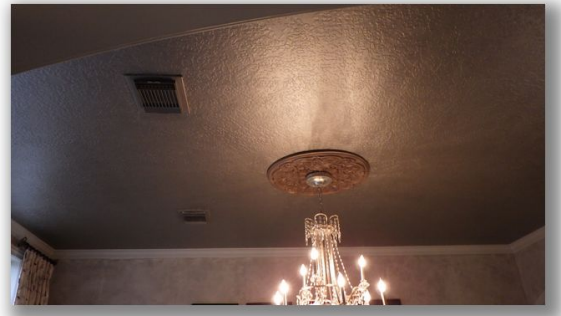
Note: There is evidence of painting and patching to the interior finish and prior interior finish repairs. This condition could limit the Inspectors visual observations and ability to render accurate opinions as to the performance of the structure.

Note: Nail heads were observed to be pushing through the interior finish in one or more locations.

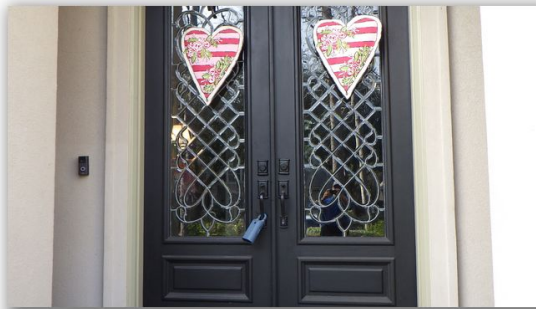
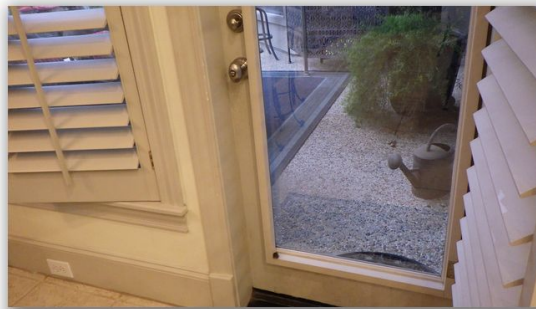
Exterior Doors

- The exterior door threshold has some deterioration and/or damage to the backyard entry.

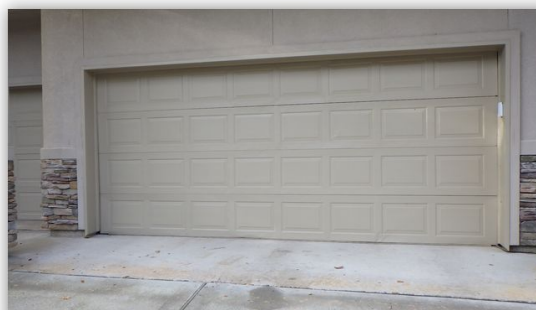
Overhead Garage Door (2)

- Some damage to the overhead garage door (double) was observed.

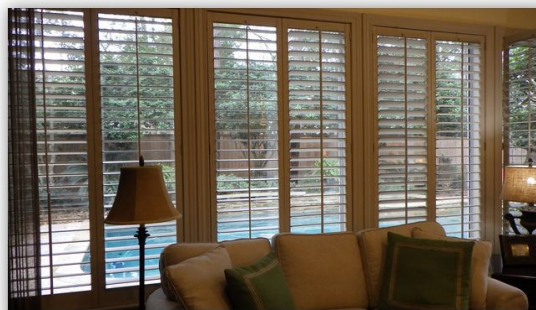
Window Screens

- One or more of the window screens were observed to be damaged.

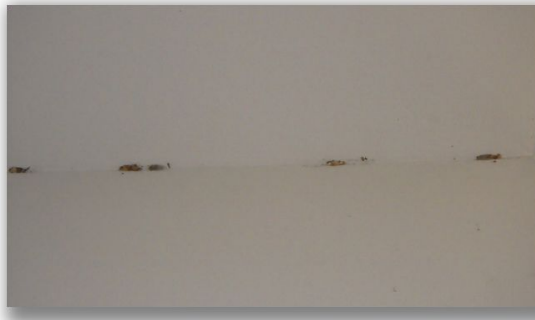
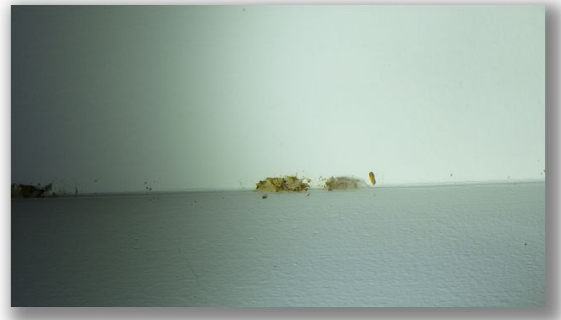
These insects are located in the pantry, they appear to be weevil like.

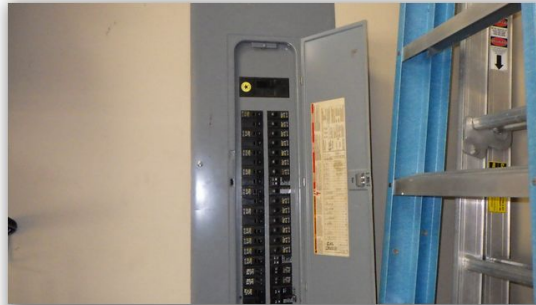
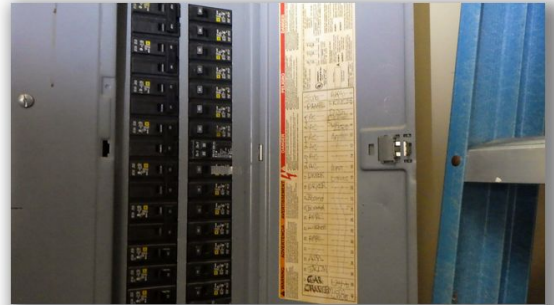
- There are multiple neutral wires secured under one lug/screw on the neutral bus bar. This type of installation does not meet current electrical standards. These conditions may not have violated building codes or common practices at the time of the construction of the home, or they may have been “grandfathered” because they were present prior to the adoption of codes prohibiting such conditions.

The buyer should have the electrical system checked by a Qualified Licensed Electrician. The observations made to support the rendering of this opinion are listed but not limited to the following:

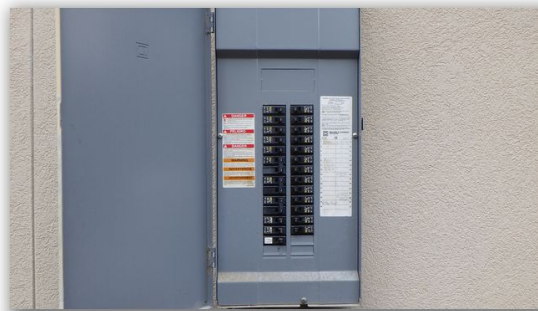
- There are multiple neutral wires secured under one lug/screw on the neutral bus bar. This type of installation does not meet current electrical standards. These conditions may not have violated building codes or common practices at the time of the construction of the home, or they may have been “grandfathered” because they were present prior to the adoption of codes prohibiting such conditions.

The buyer should have the electrical system checked by a Qualified Licensed Electrician. The observations made to support the rendering of this opinion are listed but not limited to the following:

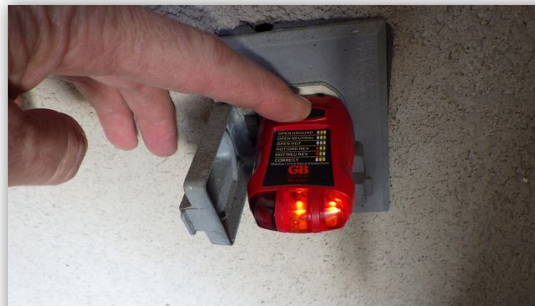
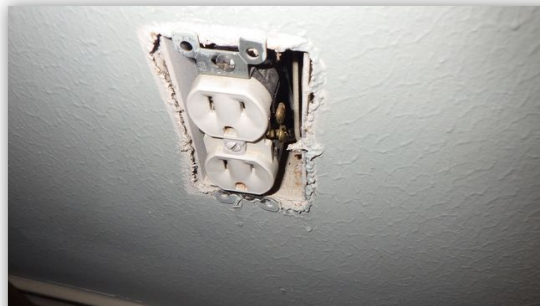
- One or more of the receptacles is missing its cover plate in the media room.
- One of the ground fault circuit interrupter (GFCI) devices does not appear to be functioning properly at the time of this inspection. The device in question is located in the north exterior wall.
- No access to garage GFCI reset, ground fault circuit interrupter (GFCI) protection was observed for the receptacles in the garage area The GFCI was covered by home effects.

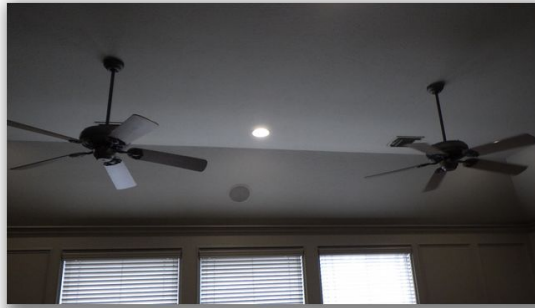
- The ceiling fan appears to be inoperative in the media room.
- One or more of the light fixtures do not appear to be functioning properly in the garage.

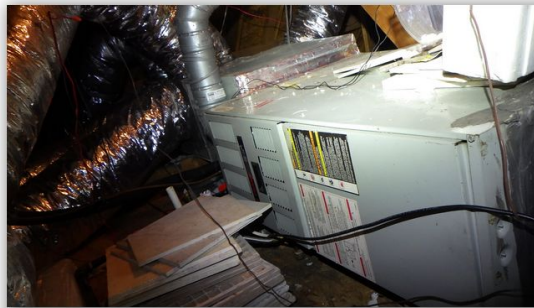
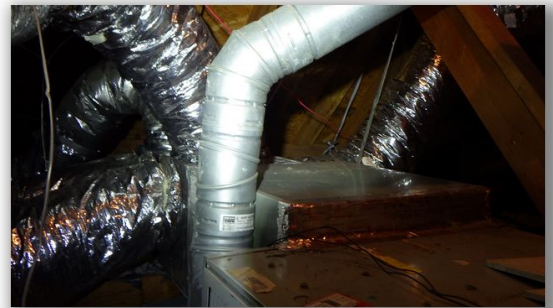
Unable to inspect furnace system due to obstructions. Personal effects on and around Unit.

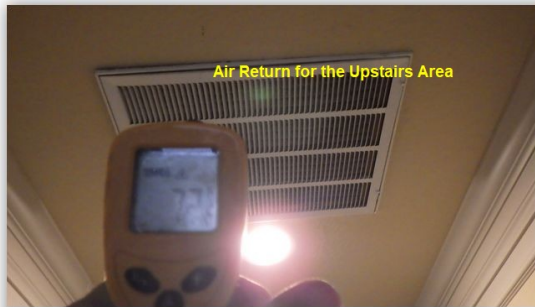
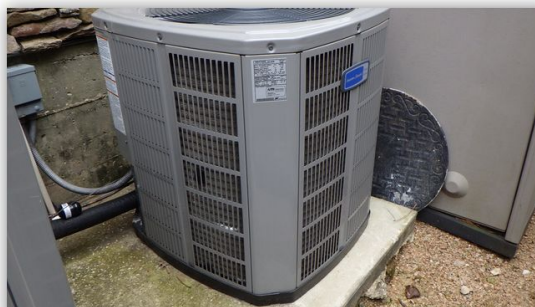
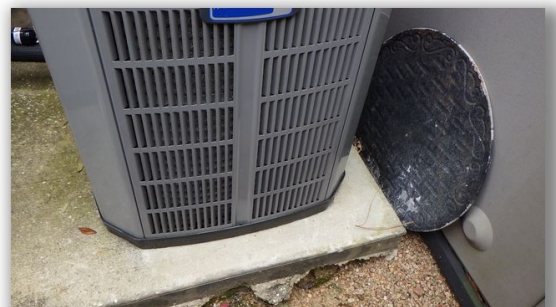
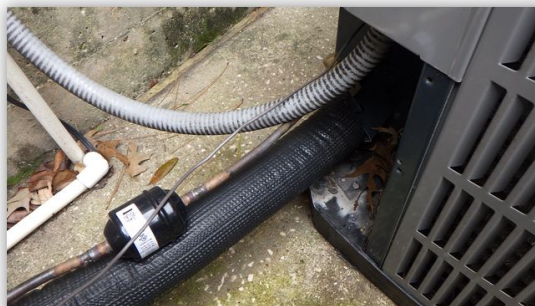
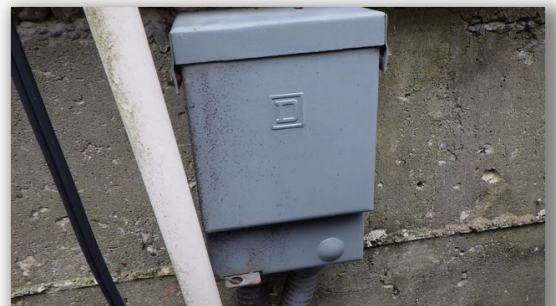
Central Cooling System (Upstairs)

Today's Temperature Differential (Delta-T): 18

Brand Name: American Standard

This component appears to be performing adequately at the time of this inspection. It is achieving an operation, function, or configuration consistent with accepted industry practices for its age.

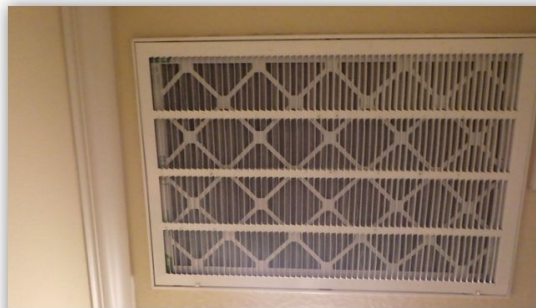
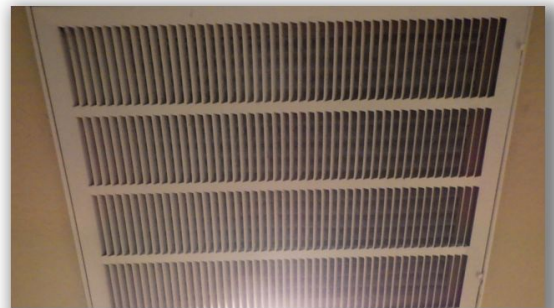
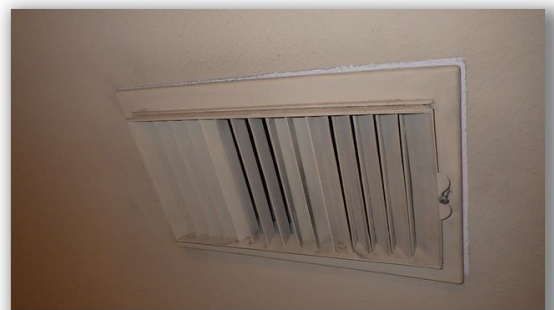
- There is visible dust and/or mildew on the air registers in the various locations throughout the house. The cause and remedy should be further evaluated. It is recommended to have the air registers and duct system cleaned for air quality purposes.
- The duct work in the attic area does not appear to be properly separated to help prevent condensation from developing. It is recommended to separate the duct work with a minimum intervals of 1.5-inches.
- The duct work in the attic area does not appear to be properly suspended and separated to help prevent condensation from developing. It is recommended to separate and suspend the duct work with supports in minimum intervals of 4-feet that have a minimum width of 1.5-inches.

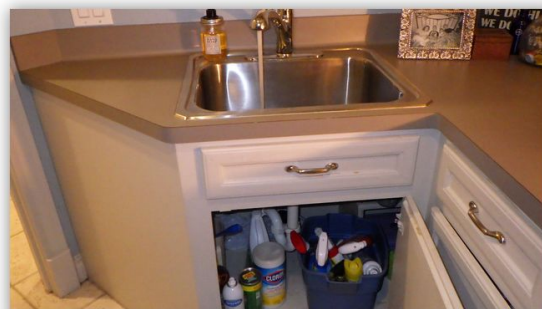
Rear Corner Bedroom Bathroom

- The stopper does not appear to be functioning properly.

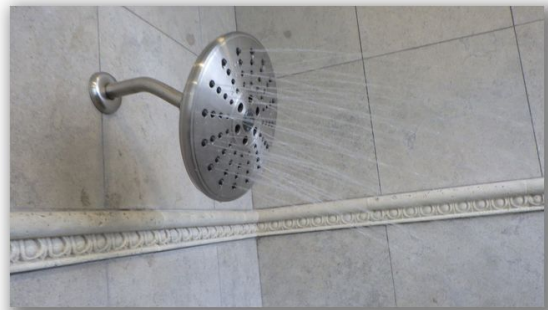
Upstairs Side Middle Bedroom Bathroom

- The faucet assembly is not sealed at the wall. This condition has the potential to allow water to leak back into the wall cavity.
- The bathtub shower head diverter is not functioning properly.

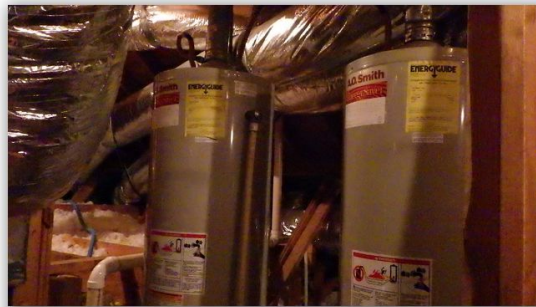
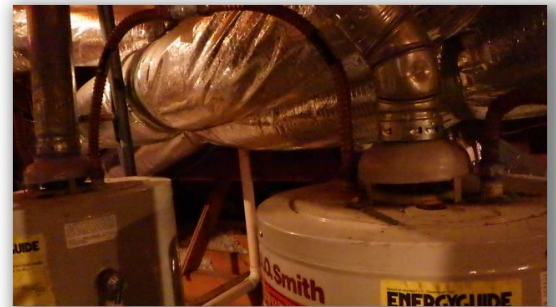
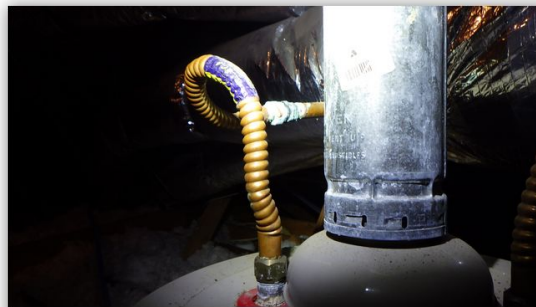
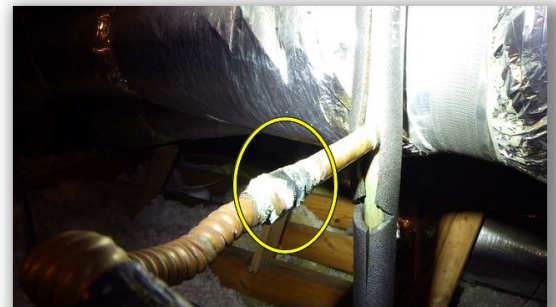
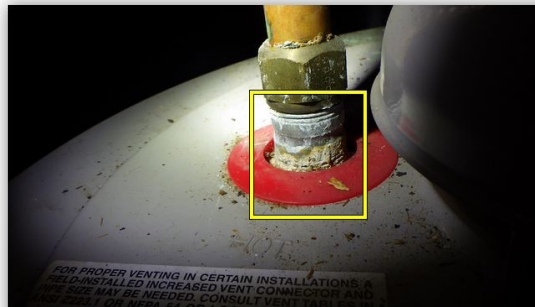
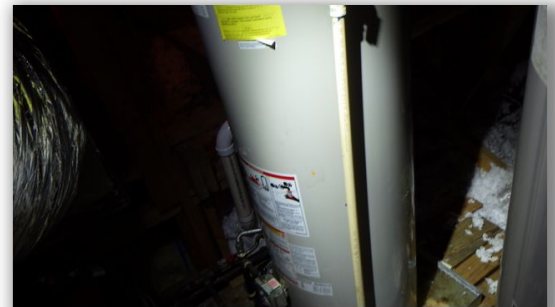
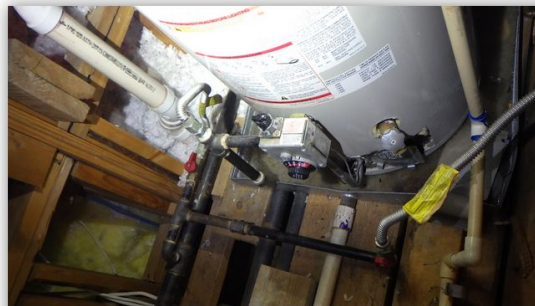
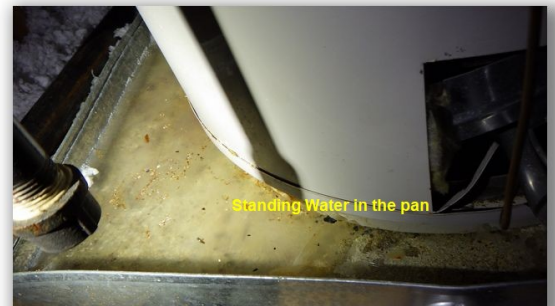
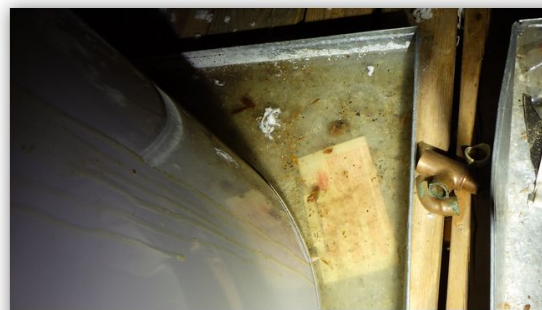
- Some corrosion was observed at the water supply connections at the top of the water heater.
- The fittings at the top of the water heater are made of dissimilar metals (galvanized steel connected to copper and/or brass). It is recommended to replace the galvanized steel fittings with brass or copper fittings or install a dielectric union between the two dissimilar metals to prevent electrolysis from occurring.
- The auxiliary/secondary drain pan under the water heater is holding water at the time of this inspection. The cause and remedy should be further evaluated and corrected as necessary.

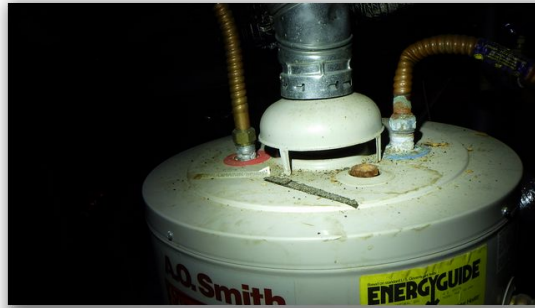
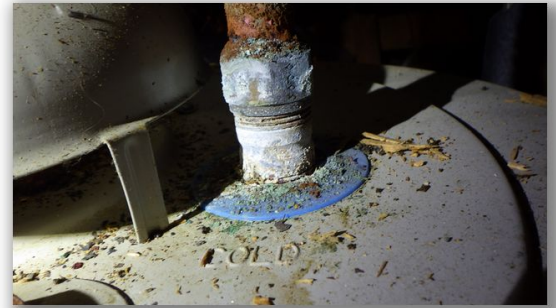
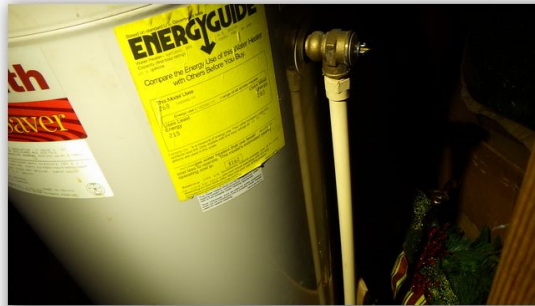
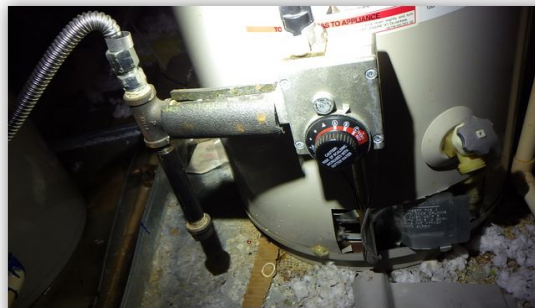
Water Heater – Energy Source: **Gas**

- Some corrosion was observed on the water supply shutoff valve.
- Some corrosion was observed at the water supply connections at the top of the water heater.
- The fittings at the top of the water heater are made of dissimilar metals (galvanized steel connected to copper and/or brass). It is recommended to replace the galvanized steel fittings with brass or copper fittings or install a dielectric union between the two dissimilar metals to prevent electrolysis from occurring.

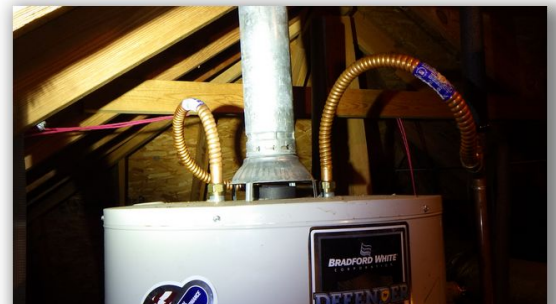
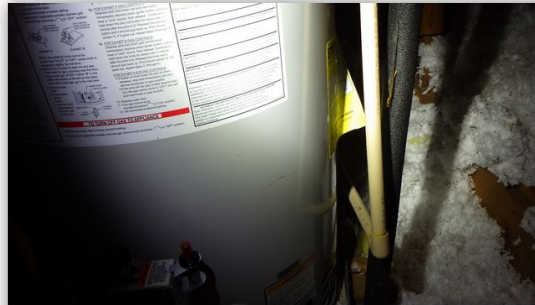
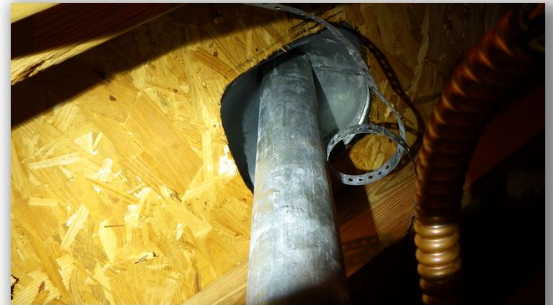
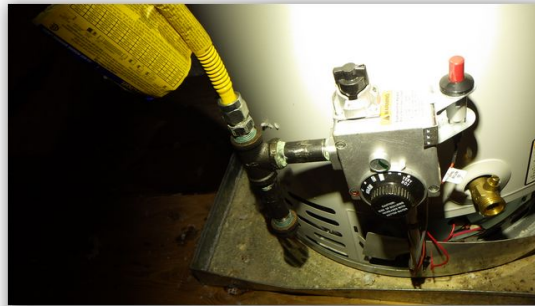
Water Heater – Energy Source: Gas

This component appears to be performing adequately at the time of this inspection. It is achieving an operation, function, or configuration consistent with accepted industry practices for its age.

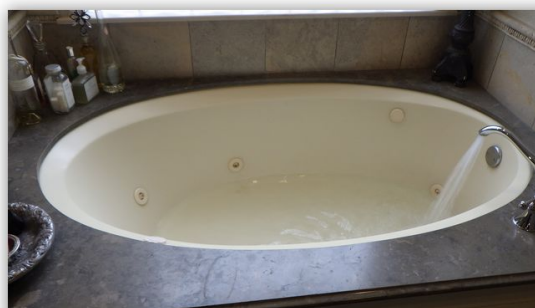
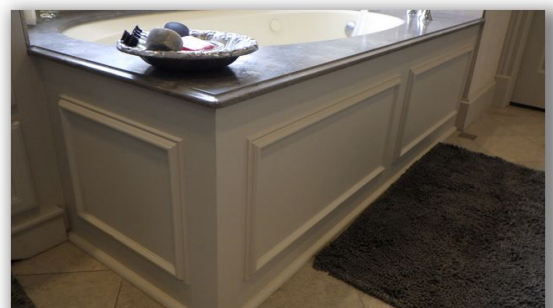
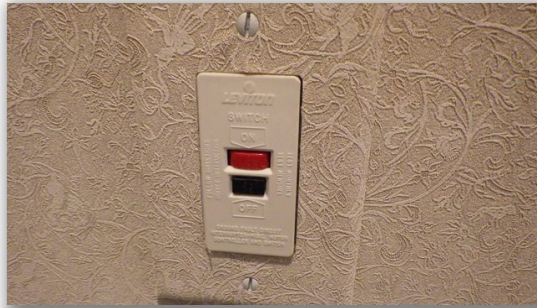
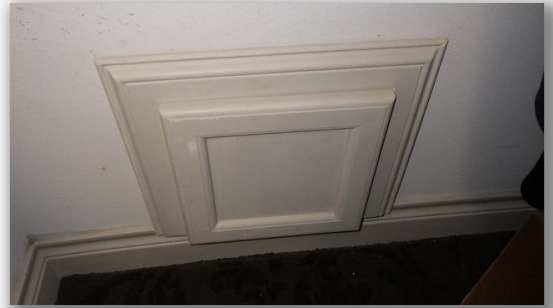
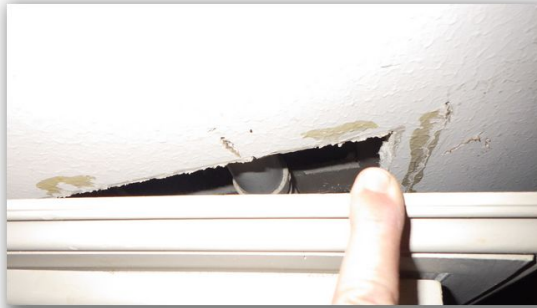
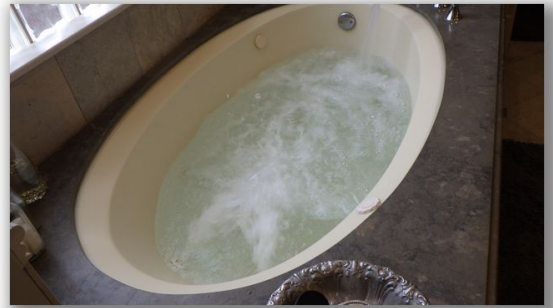
D. Hydro-Massage Therapy Equipment

Location of GFCI: In commode closet area.

This component appears to be performing adequately at the time of this inspection. It is achieving an operation, function, or configuration consistent with accepted industry practices for its age.

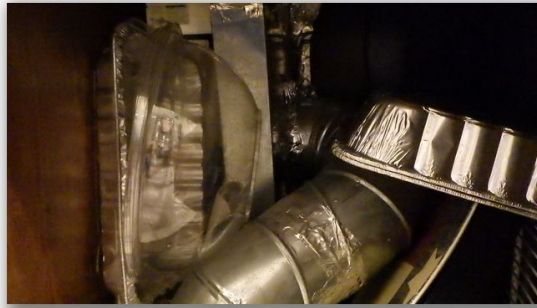
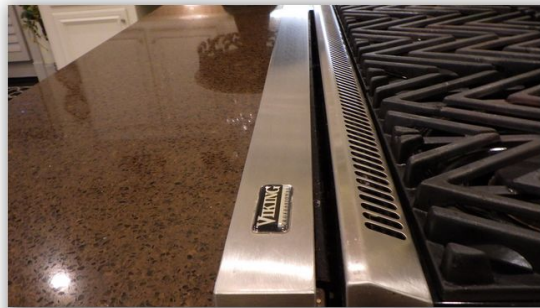
- The range exhaust vent fan is inoperative. control panel failed to function the vent system.

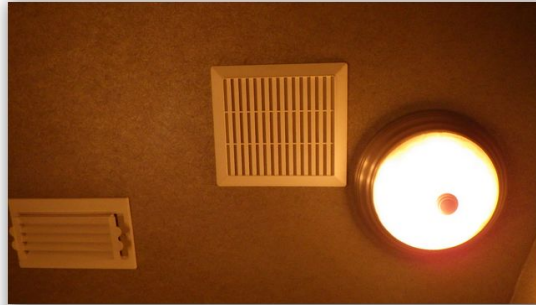
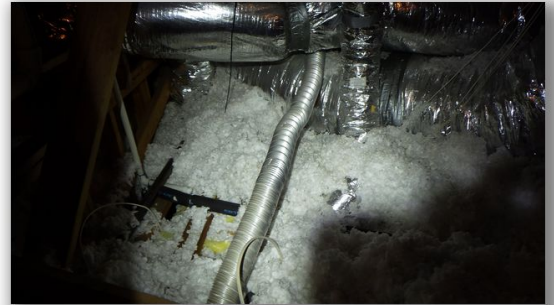
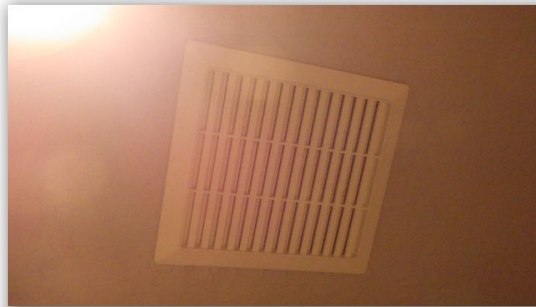
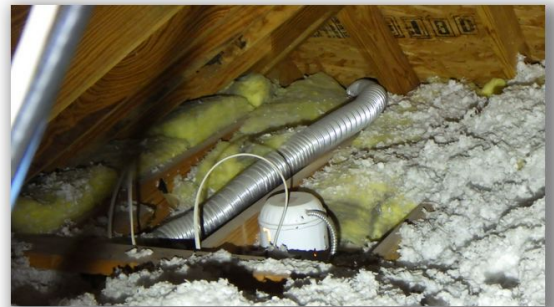
- One or more of the bathroom/laundry room areas are not equipment with a mechanical exhaust vent. Under current building standards, all wet areas are required to have mechanical exhaust ventilation. This is an **“as-built”** condition.

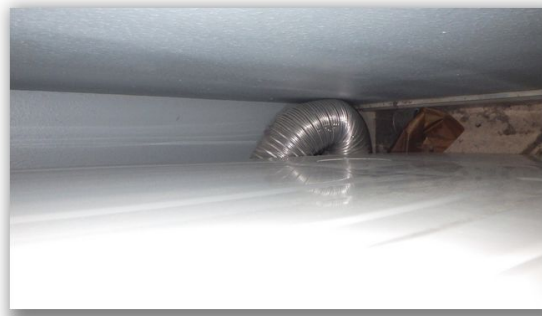
-
- The dryer exhaust duct (vent pipe) is dirty and needs to be cleaned.

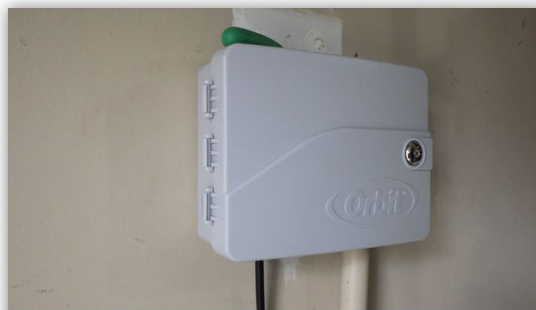
- One or more of the sprinkler heads need to be adjusted so not to disperse water onto concrete flatwork (such as; roadways, sidewalks, porches, patios or driveways) in station(s); **1, 2.**
- One or more of the sprinkler heads were observed to be damaged and/or missing in station(s); **2.**
- One or more of the sprinkler heads need to be adjusted so not to spray water onto the exterior walls, surfaces or windows in stations; **2, 3, 5, 7.**
- Sprinkler station(s) **6** did not respond when tested in the manual setting. The cause and remedy should be further evaluated and corrected as necessary.

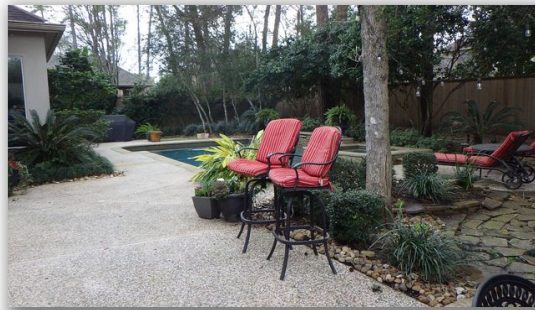
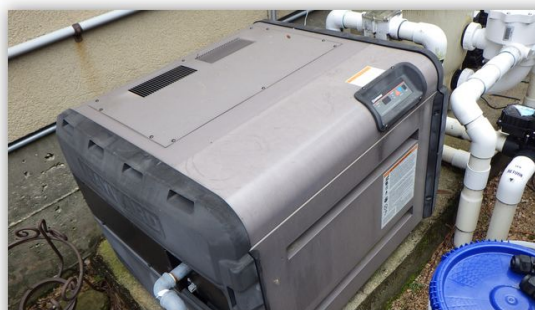
- The heater service light is on while the heater is turned on. This condition should be further evaluated and corrected as necessary.
- The pool heater did not respond to controls when tested in the manual / service settings. The cause and remedy should be further elevated.
