Inspection Report

Property Address:
1022 Buoy Rd
Houston TX 77062

PROPERTY INSPECTION REPORT

By: Kristi Hart TREC# 21276 / HG Home Inspection 3/3/2021

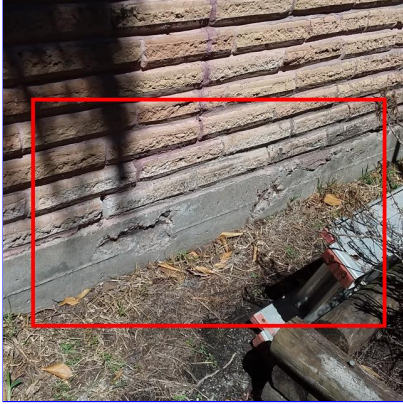
A. Item 1(Picture) Rear of garage

(3) The foundation is poured on grade and appears to be performing as designed.

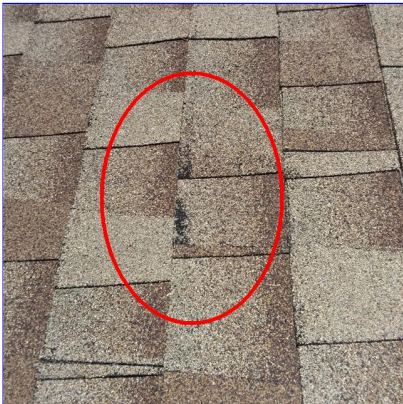
C. Item 1(Picture) Rear of home

(2) The roof shingles showing wear and granular loss. (Granules provide UV protection for shingles. Once the granules erode away the sun is able to deteriorate the asphalt and shortens the life of the roofing material.) I recommend consulting with a roofing professional.. A qualified person should repair or replace as needed.

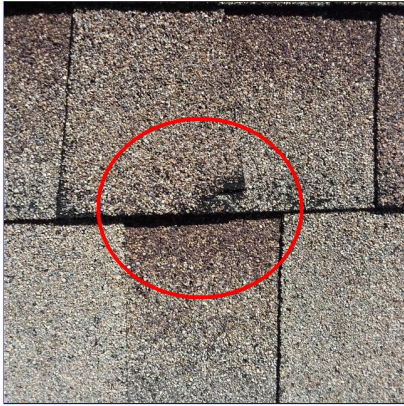
C. Item 2(Picture) Front left of home

(3) The roof covering is damaged in areas. These areas may need replacement and or periodic maintenance. A qualified roofing contractor should inspect and repair as needed.

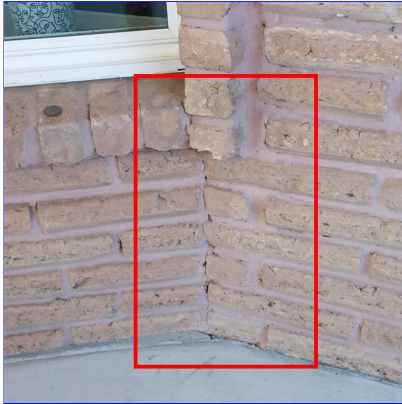
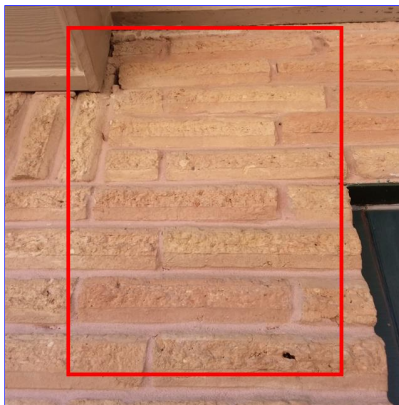
(1) The Brick siding exterior in areas has loose, and missing mortar. Further deterioration can occur if not corrected. A qualified person should repair or replace as needed. (3/18/2021)

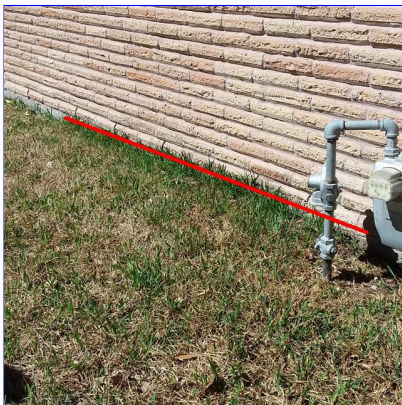
E. Item 5(Picture) Rear of home

(2) The Brick siding rear of home is in contact with ground. Ground clearances are recommended to prevent deterioration and for a pest control company to monitor for wood eating insects. A qualified person should repair or replace as needed.

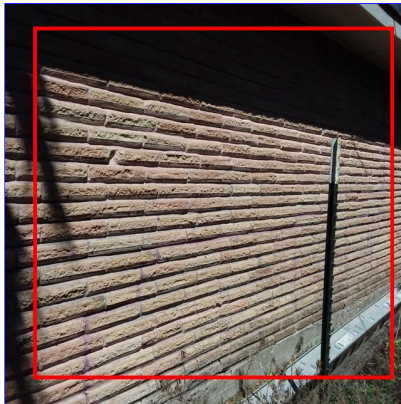
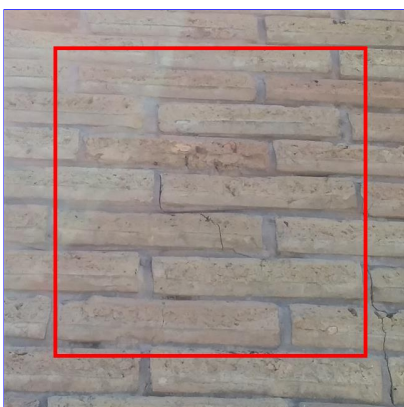
(3) The Brick siding at the exterior has step cracks caused from settlement. Deterioration can eventually occur if not corrected. A qualified contractor should inspect and repair as needed.

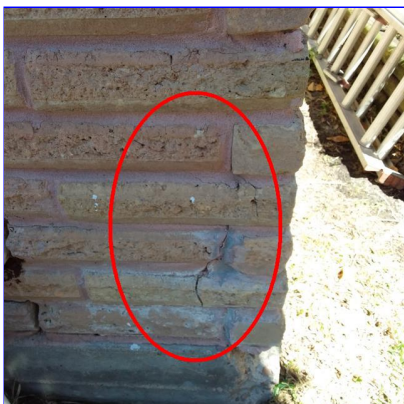
E. Item 9(Picture) Right rear side of garage

(4) The Brick siding garage is damaged. Further deterioration can occur if not corrected. A qualified person should repair or replace as needed.

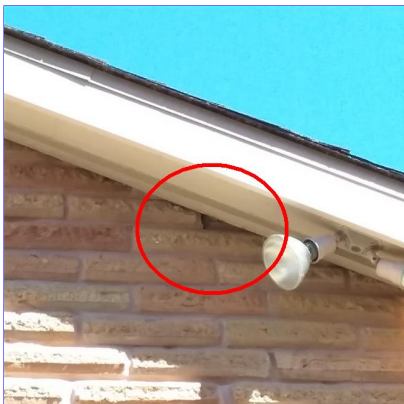
E. Item 11(Picture) Right side of home

(6) The Brick siding right side (facing front) is loose. Further deterioration can occur if not corrected. A qualified person should repair or replace as needed.

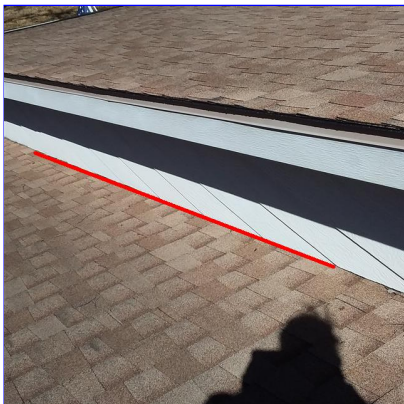
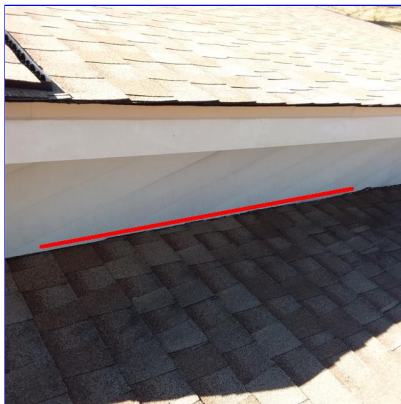
(7) Siding appears to be in contact with the roof surface in areas (unable to verify proper flashing). I recommend having a qualified contractor evaluate and make repairs as needed.

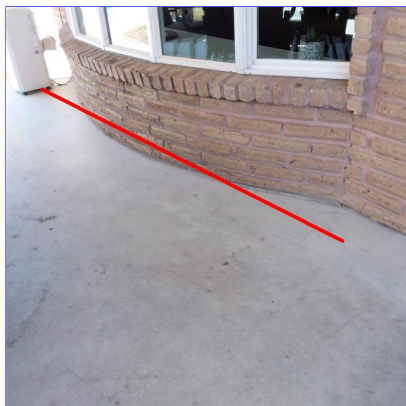
K. Item 1(Picture) Rear of home

- (1) The weight load capabilities are not part of this inspection.
- (2) The patio is poured even or above the foundation line of the home. This can contribute to water intrusion and creates conducive conditions for certain types of wood destroying insects. I recommend having a qualified pest control company inspect and treat as needed.

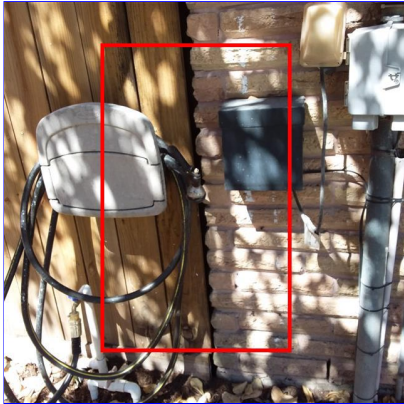
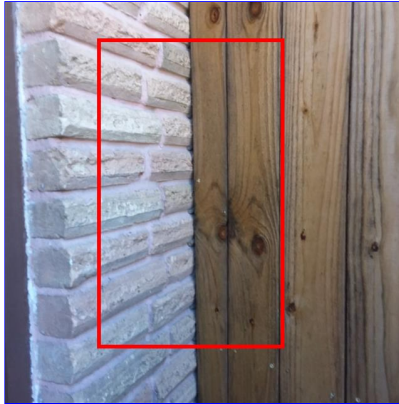
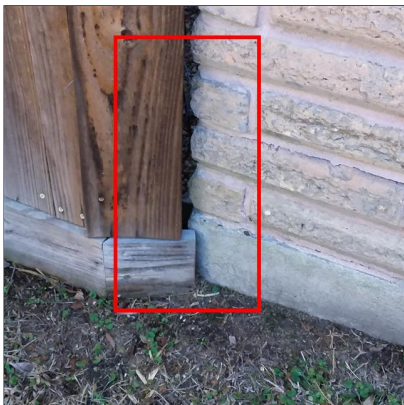
- (1) Areas of the home have limited access due to furniture or occupants belongings. This is for your information.
- (2) There is wood to ground to structure contact. This create conducive conditions for certain types of wood destroying insects. I recommend having a qualified pest control company inspect and treat if necessary.

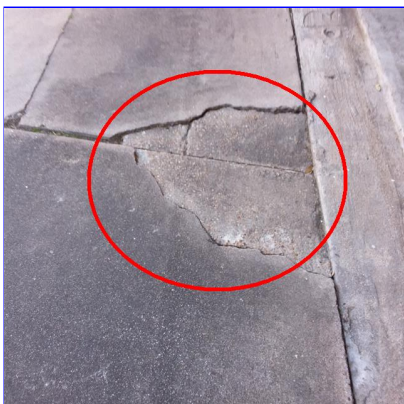
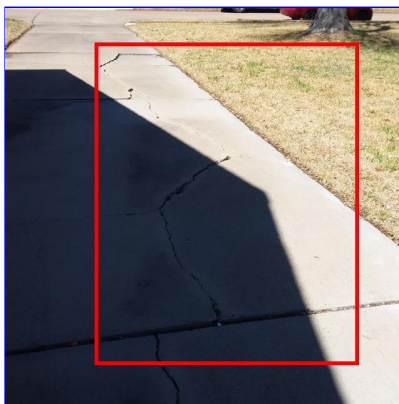
(3) The concrete drive at the left side of home deteriorated in areas. Further deterioration can occur if not repaired. A qualified person should repair or replace as needed.

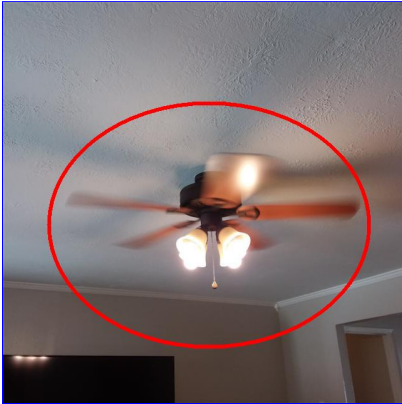
(3) The ceiling fan does work, but is controlled by a pull chain only in the living room. This is for your information. I recommend repair as needed.

(4) Arc fault breakers are not in required areas of home at electrical panel. This is not considered today's standard. I recommend having a qualified electrician inspect and make repairs as needed.

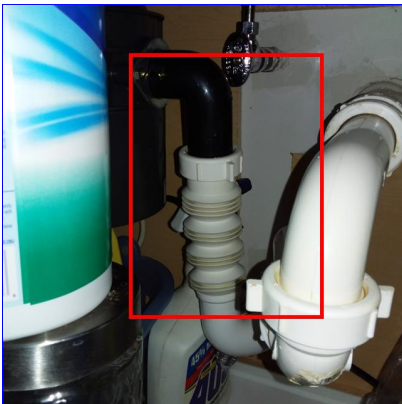
B. Item 2(Picture) Kitchen sink

(2) The plumbing waste line has been repaired improperly. This is not considered up to today's standard. While repair is amateur, there are no leaks at present. A qualified licensed plumber should repair or correct as needed.

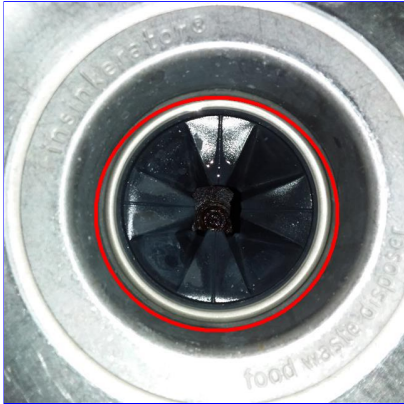
B. Item 1(Picture)

- (1) Tested and working properly at the time of inspection.
- (2) The food disposer is rusted inside at the blades. I recommend repair as needed.

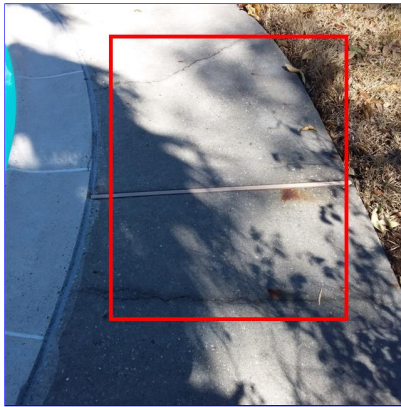
(3) Floor or grounds around pool perimeter is cracked. Does not appear to go below water line.
