# Inspection Report

**Property Address:**  
26803 Longleaf Valley Dr  
Katy TX 77494

# PROPERTY INSPECTION REPORT

**By:** Matt Smith - 23130 / HG Home Inspections 2/22/2021

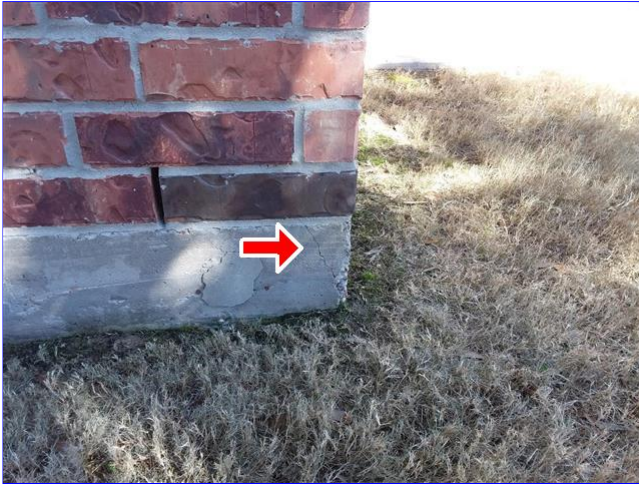
A. Item 1(Picture) minor corner pop back of home

- (1) This is not an engineering report, but is only an opinion based on observation of conditions known to be related to foundation performance, using the knowledge and experience of the inspector.
- (2) The foundation is poured on grade with post tension cables and appears to be performing as designed.
- (3) The foundation has minor corner pop(s) that are considered cosmetic. Further deterioration may occur if not corrected. I recommend having a qualified person make repairs as needed.

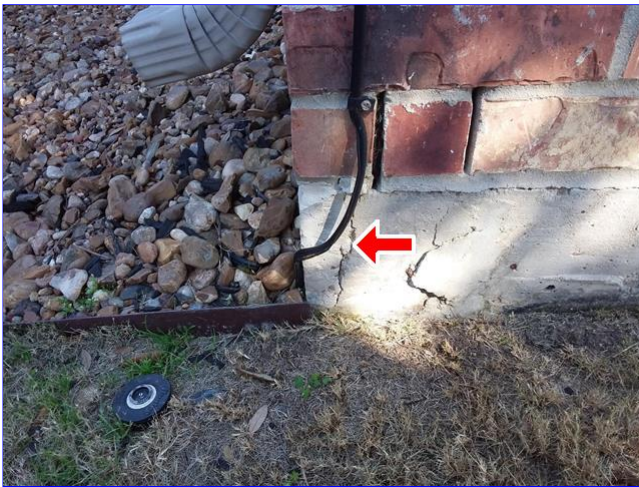
A. Item 2(Picture) corner pop back right

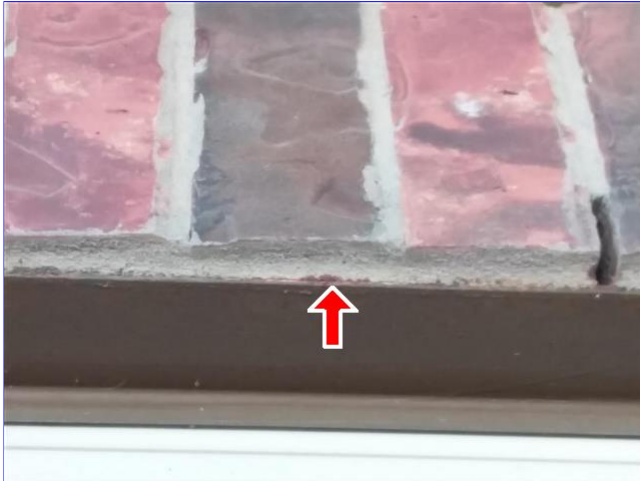
Lintels above windows and doors are showing signs of deterioration in area's. Further deterioration may occur if lintels are not primed and painted. A qualified person should repair as needed.

E. Item 1(Picture) window lintel rust

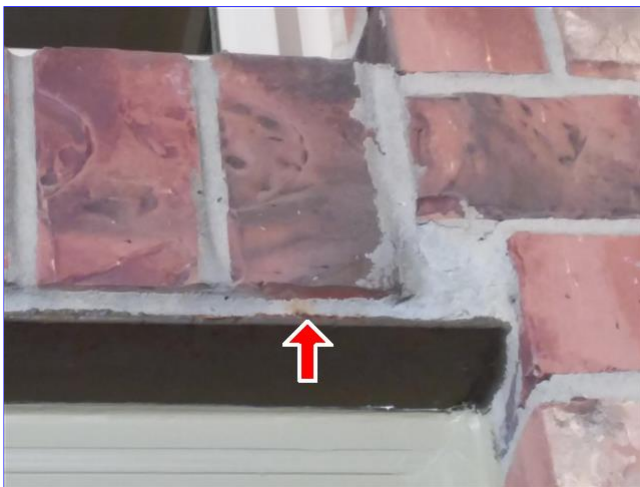
E. Item 2(Picture) door lintel rust

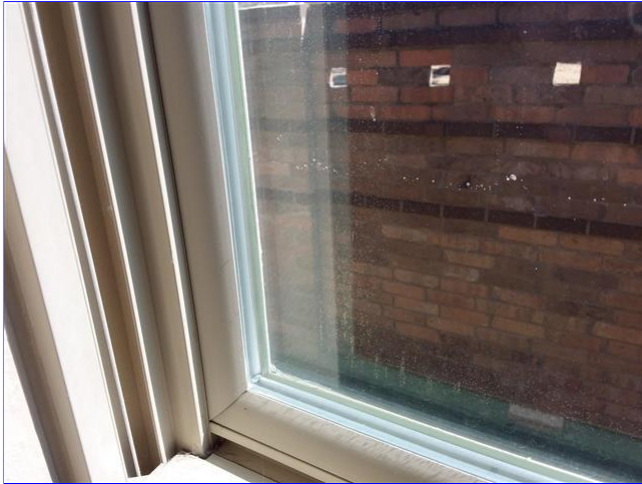
The glazing between glass panes appear to be failing at some windows causing cloudy glass (If there are multiple windows that are the same age and style it is safe to assume others will soon start to fail as well). I recommend having a qualified person make repairs as needed.

H. Item 1(Picture) cloudy glass kitchen area

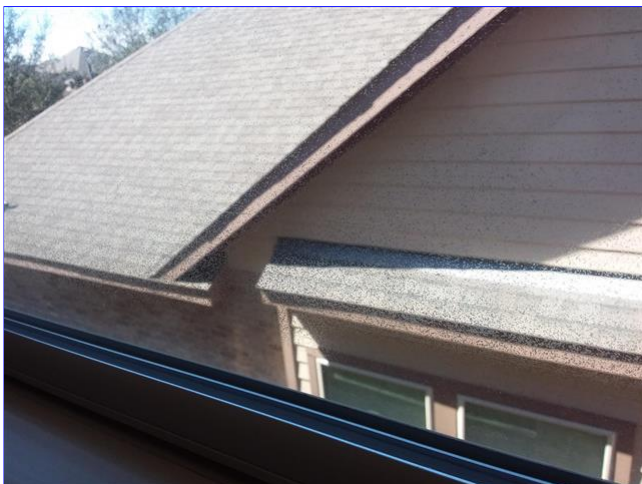
H. Item 3(Picture) cloudy glass second floor living room

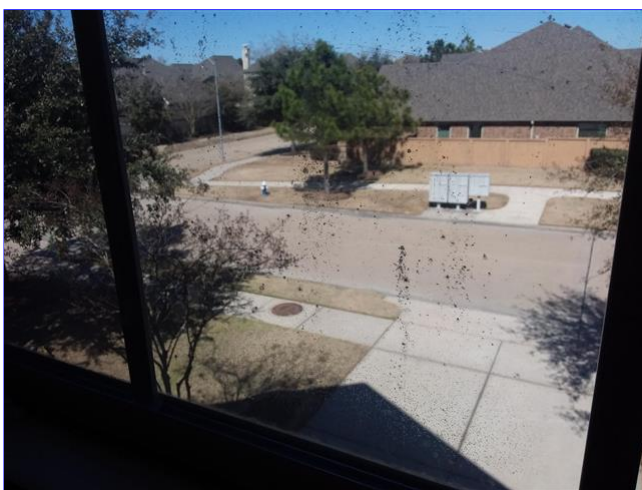
H. Item 4(Picture) cloudy glass second floor front bedroom

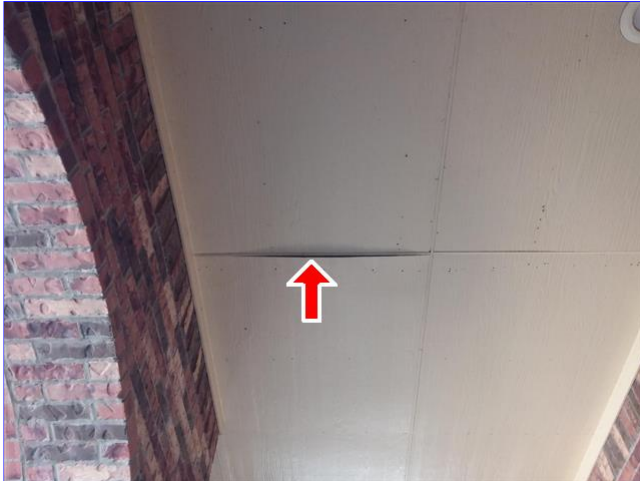
(2) The patio roof cover at the front of home is loose. A qualified person should repair as needed.

K. Item 1(Picture) loose cover at entryway

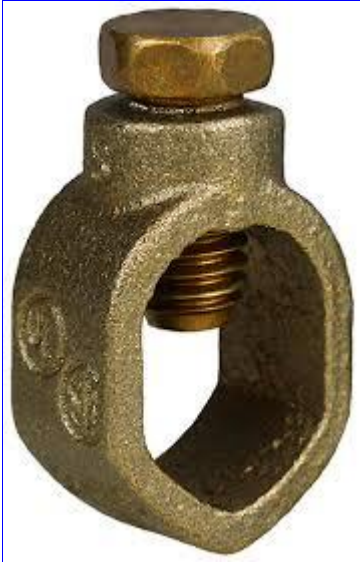
A. Item 1(Picture)

(1) The grounding rod near meter is using improper clamp for grounding of main panel (solid brass clamp is recommended). This is not considered to be today's standard. I recommend having a qualified person replace with proper clamp to assure proper grounding.

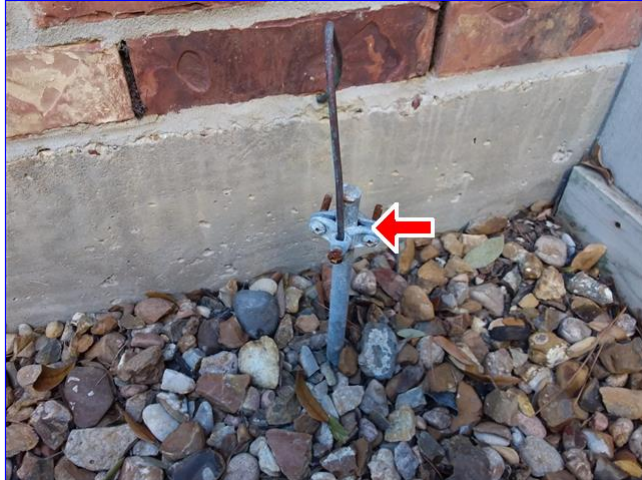
A. Item 2(Picture) improper grounding clamp

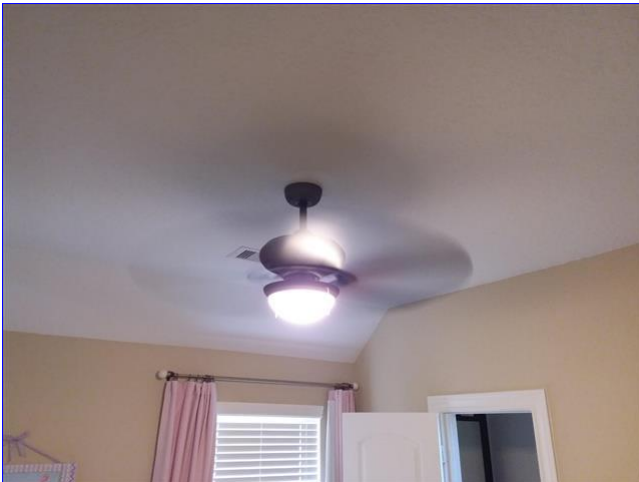
(3) The ceiling fan "wobbles" in the bedroom. Some fans that wobble cannot be corrected without replacement. I recommend repair as needed.

B. Item 1(Picture) fan wobbles second floor middle bedroom

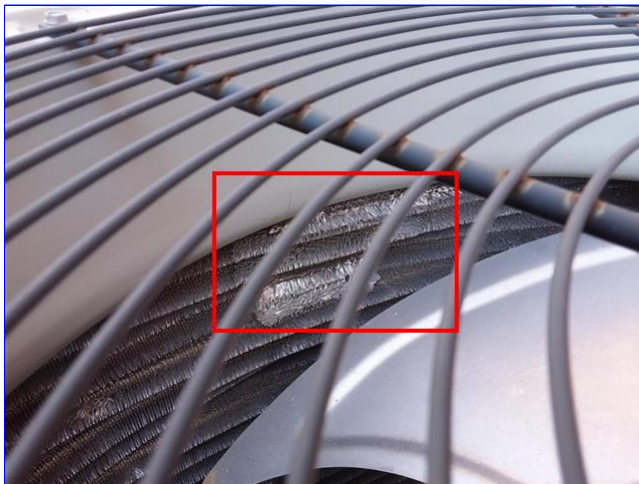
(3) Condenser coil at exterior of home is damaged in areas. This damage can shorten the life expectancy of the unit. I recommend having a qualified HVAC company inspect and make repairs as needed.

B. Item 5(Picture) minor coil damage observed

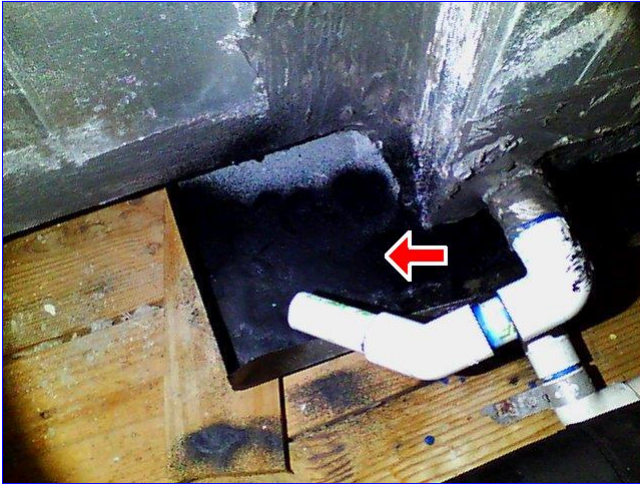
(4) The overflow pan under the furnace in the attic has been coated to prevent deterioration.

B. Item 6(Picture) coated overflow pan

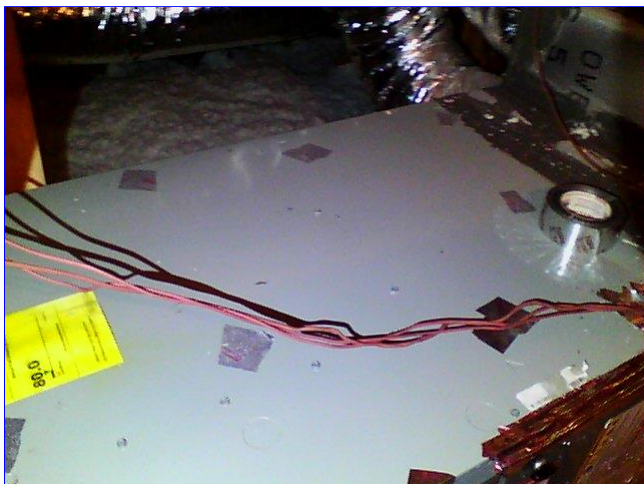
(5) The fungal growth has been cleaned from the furnace in the attic.

B. Item 7(Picture) fungal growth removed on furnace

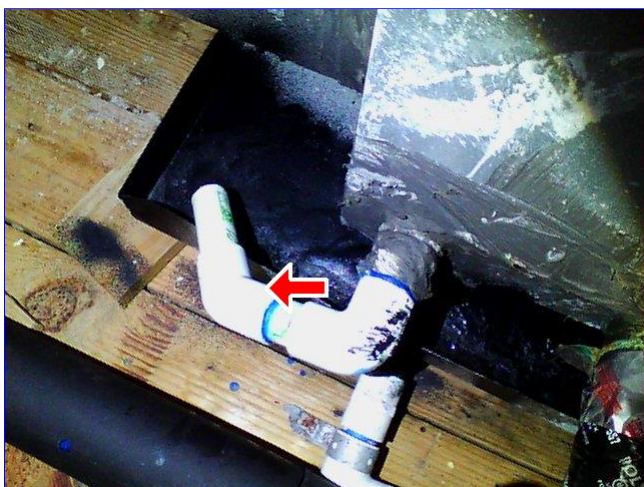
B. Item 8(Picture) fungal growth removed on furnace piping

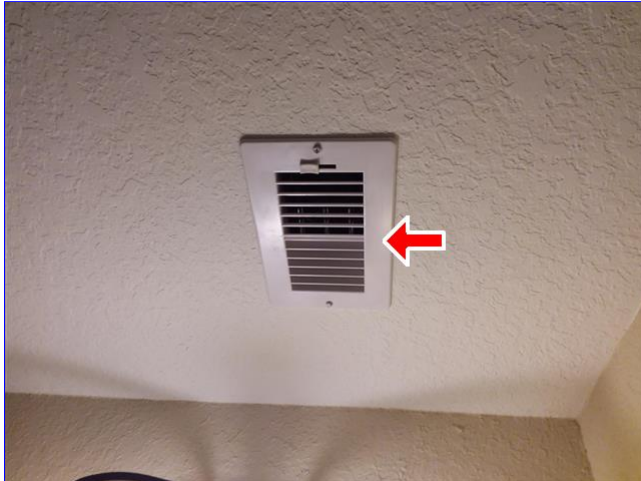
(2) Low air flow was observed at the register. The vent or duct may be obstructed. Further evaluation from a HVAC technician is recommended.

C. Item 1(Picture) low air flow 2nd floor middle bathroom

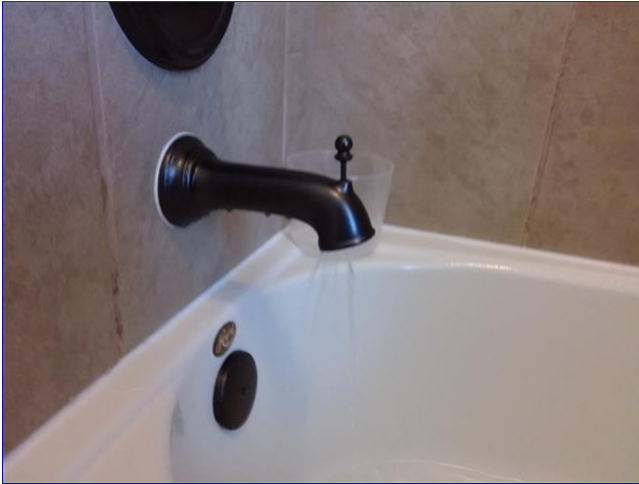
Tub spout leaks when shower is in use. This is not considered today's standard. I recommend having a qualified person make repairs as needed.

A. Item 1(Picture) leaking second floor faucet diverter
