PROPERTY INSPECTION REPORT

Concerning: 16910 Canyon Laurel Ct, Spring TX 77379

01/21/2021 9:00 am

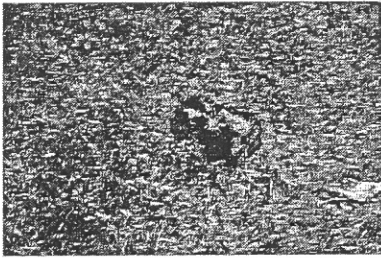
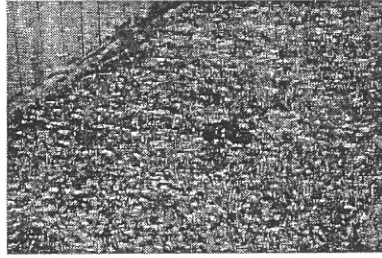
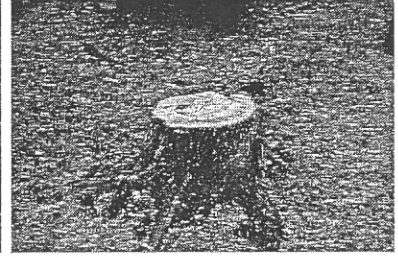
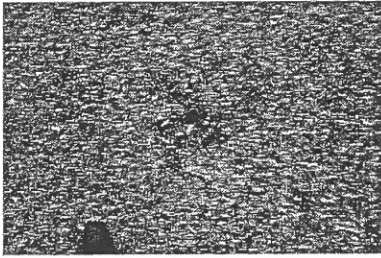
1: Tree Stump(s)/ Tree Roots

Remove the tree stumps from the back yard. Tree stumps can become a haven for pest such as termites.

Recommendation: Contact a qualified tree service company.

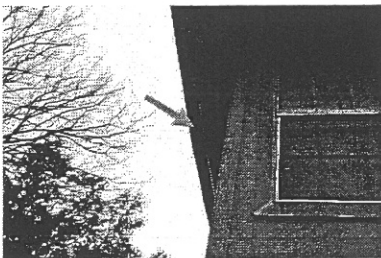
2: Gutters- Repairs

The gutter is loose at the right side of the home. Repairs are needed to prevent possible moisture damage.

Recommendation: Contact a qualified professional.

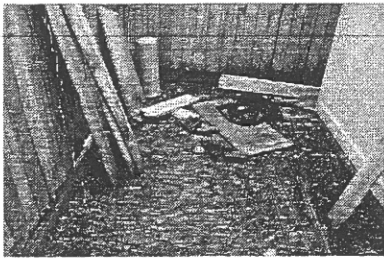
3: Debris

Remove unused objects from the yard.

Recommendation: Recommended DIY Project

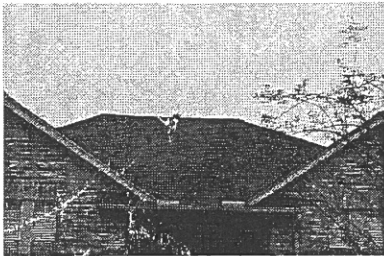
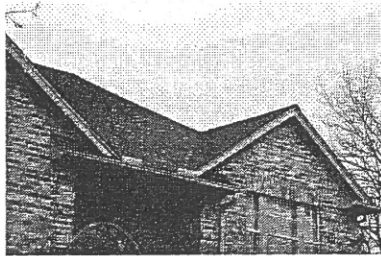
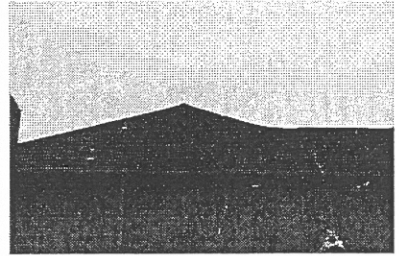
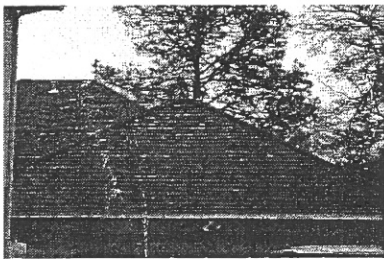
Roof

The 30yr. composition shingle roof covering is in good condition.

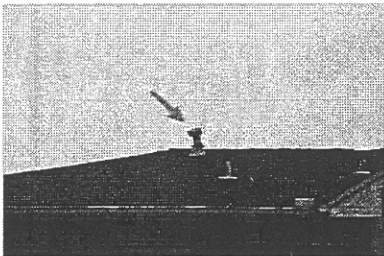
1: Roof Vents

Adjustments and repairs are needed at the exhaust vents on the roof to prevent possible moisture intrusion.

Adjust to vertical position and nail down the flashing

Recommendation: Contact a qualified professional.

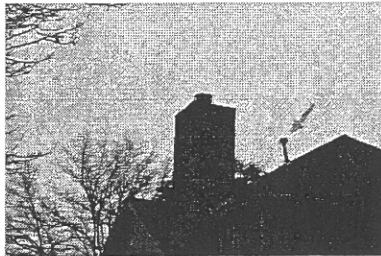
Adjust to the vertical position.

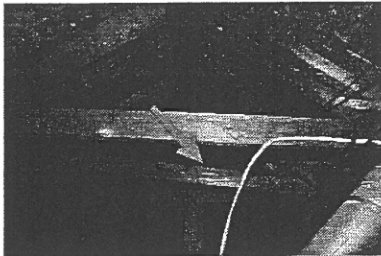
Adjustments are needed at the collar tie in the attic space.

Recommendation: Contact a qualified professional.

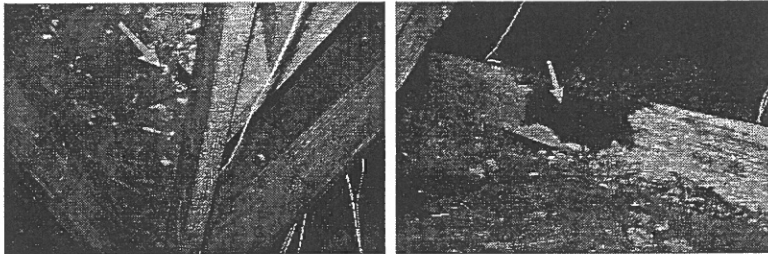
2: Sheathing Damage

Roof sheathing show signs of damage. Moisture intrusion is present. Repairs are needed to prevent further damage.

Recommendation: Contact a qualified roofing professional.

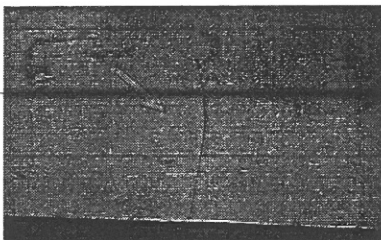
1: Hearth

Signs of a settlement crack is present at the fireplace hearth.

Recommendation: Contact a qualified fireplace contractor.

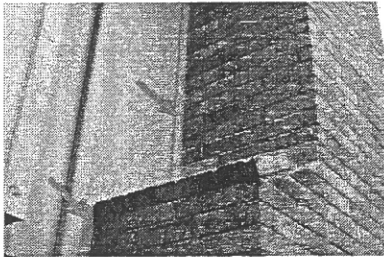
2: Settlement Cracks

typical settlement cracks are present at the side of the chimney. Repairs are needed to prevent further damage.

Recommendation: Contact a qualified professional.

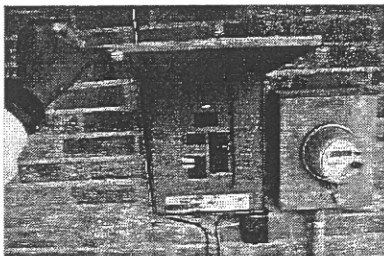
The service entrance panel dated but functioning as intended.

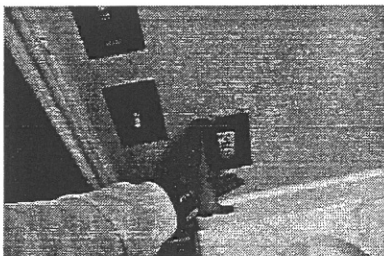
1: Cover Plates

Replace the missing cover screw.

Recommendation: Recommended DIY Project

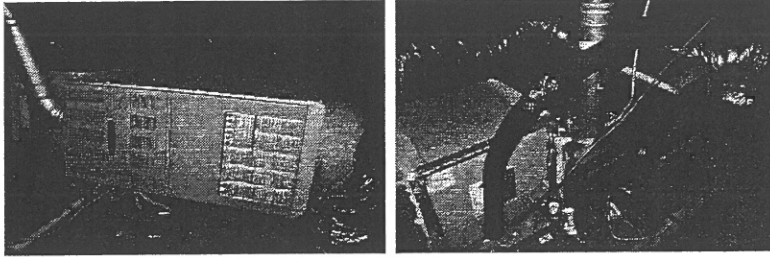
Both furnaces are functioning as intended.

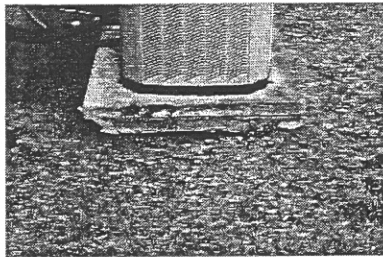
1: Pad

More dirt is needed around the base of both units to prevent possible movement.

Recommendation: Contact a handyman or DIY project

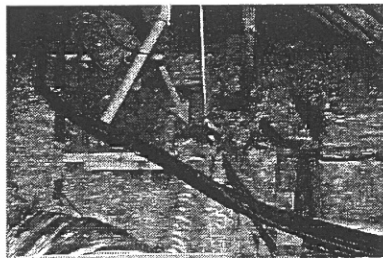
1: Pinched

The air duct at the far end of the attic space is slightly pinched preventing proper air flow. A simple adjustment may remedy this issue.

Recommendation: Contact a qualified professional.

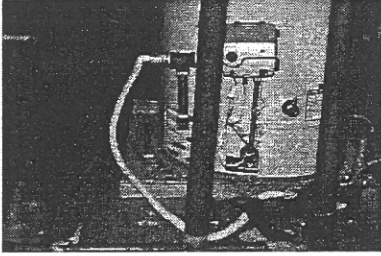
1: Water Heater Knocking

A knocking sound can be heard coming from the water heater. Knocking sound are caused by sediments or mineral deposits that have collected at the bottom of your water heater tank. Once the hot water is used inside the home the knocking sound can be heard.

Recommendation: Contact a qualified plumbing contractor.

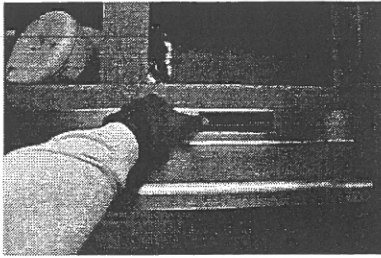
1: Fan Motor

The fan speed switch is not functioning.

Recommendation: Contact a qualified appliance repair professional.

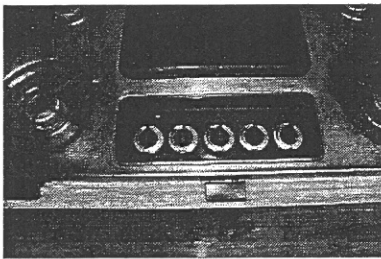
1: Silk Screen Print

The silk screen print for the temperature controls of the gas burners are worn away.

Recommendation: Contact a qualified professional.

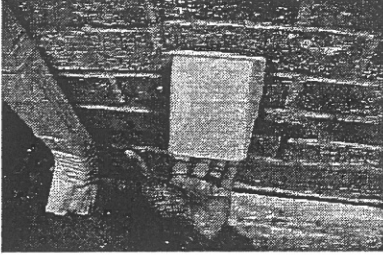
1: Lint

Remove the lint build up from the dryer vent. Lint build up can become combustible if too much build

Recommendation: Contact a qualified professional.
