PROPERTY INSPECTION REPORT

Concerning: 2541 Papoose Trail, Willis, TX 77378
(Address or Other Identification of Inspected Property)

By: Josh Arnaud TREC#10585 Apr 20, 2021
(Name and License Number of Inspector) (Date)

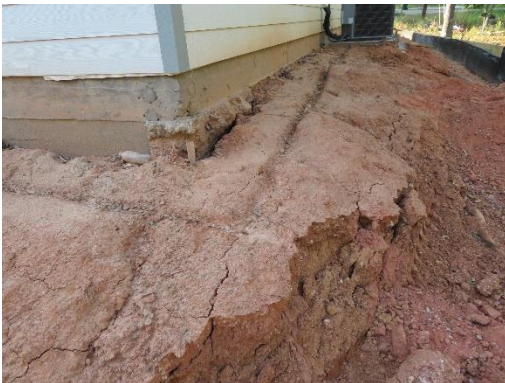
Item#1(sample area)

1. The north and west sides of the property is not properly grading. Several areas of erosion in these areas.
2. The south driveway has negative slope toward the garage. This could be an area of possible water penetration.

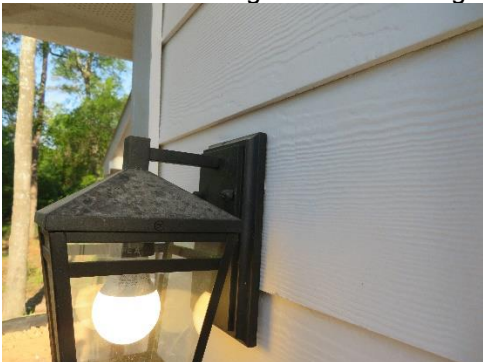
Item#2(sample area)

1. The exterior outlets are missing their proper "bubble" covers. The covers will protect the outlets from the exterior elements.
2. The exterior coach lights need to be sealed to the walls they are secured to help prevent water penetration.
3. There is a hot wire penetrating at the east soffit vent. Exposed wires should be concealed in a junction box for safety.
4. The kitchen counter outlets are not GFCI protected. All outlets serving the kitchen counters are required to be GFCI protected.
5. The southeast kitchen outlet was not functioning at the time of inspection.
6. The GFCI outlets are not properly labeled.
7. The guest bathroom light is connected to the exhaust fan. They should be on separate circuits.
8. The guest bathroom light was "flickering" at the time of inspection.

Additional Notes: Recommend a licensed electrician to further evaluate.

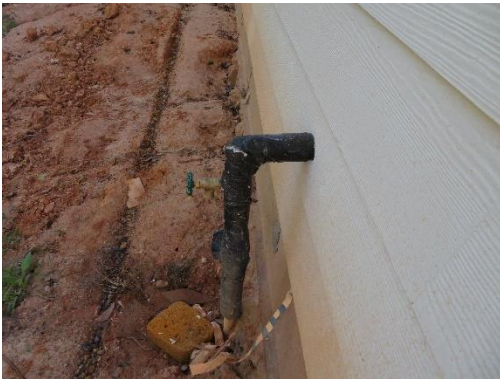
Item#2(sample area)

- 1. The west master sink's hot/cold fixtures are reversed.*
- 2. The exterior hose bibs are missing their anti-siphon devices. The devices are needed to prevent possible "dirty" water from backing up into the main water supply of the home.*

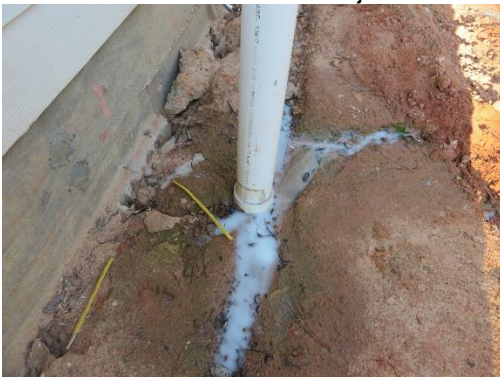
- 1. There is a major leak at the north plumbing cleanout pipe.*

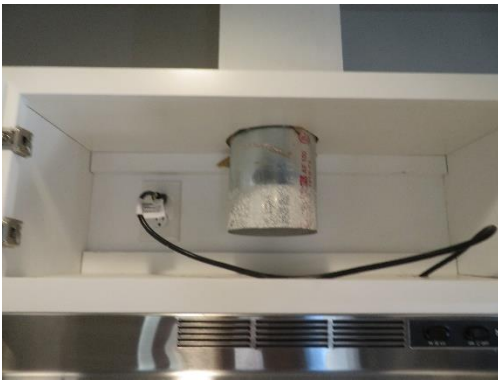
Item#1

1. The range exhaust pipe is not connected in the cabinet above the unit.
2. The bulb was missing at the range hood.
