PROPERTY INSPECTION REPORT

Concerning: 8147 Caddo Rd, Houston, TX, 77078

By: Jeffrey Ashley, 23924

Saturday, May 22, 2021

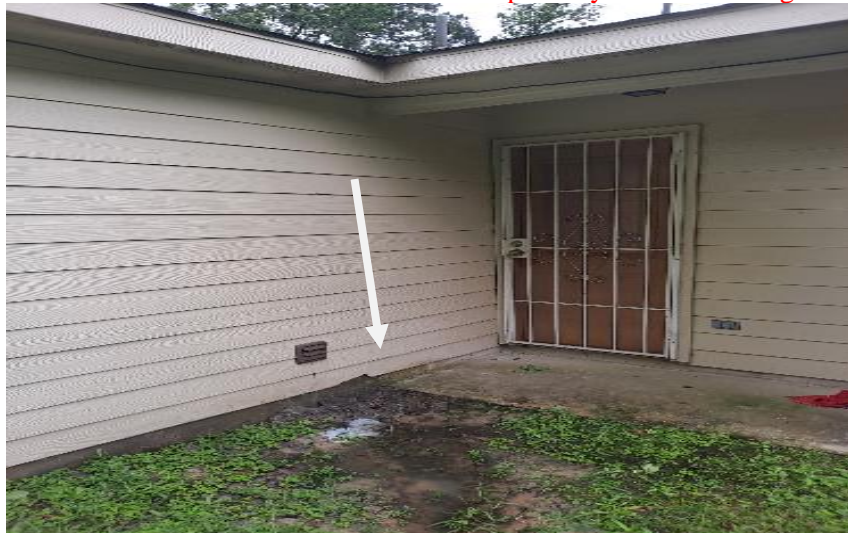
- Observed ponding water at the rear of the home near the back door. Recommend building up soil in this area. Erosion in this area is possibly due to lack of gutters.

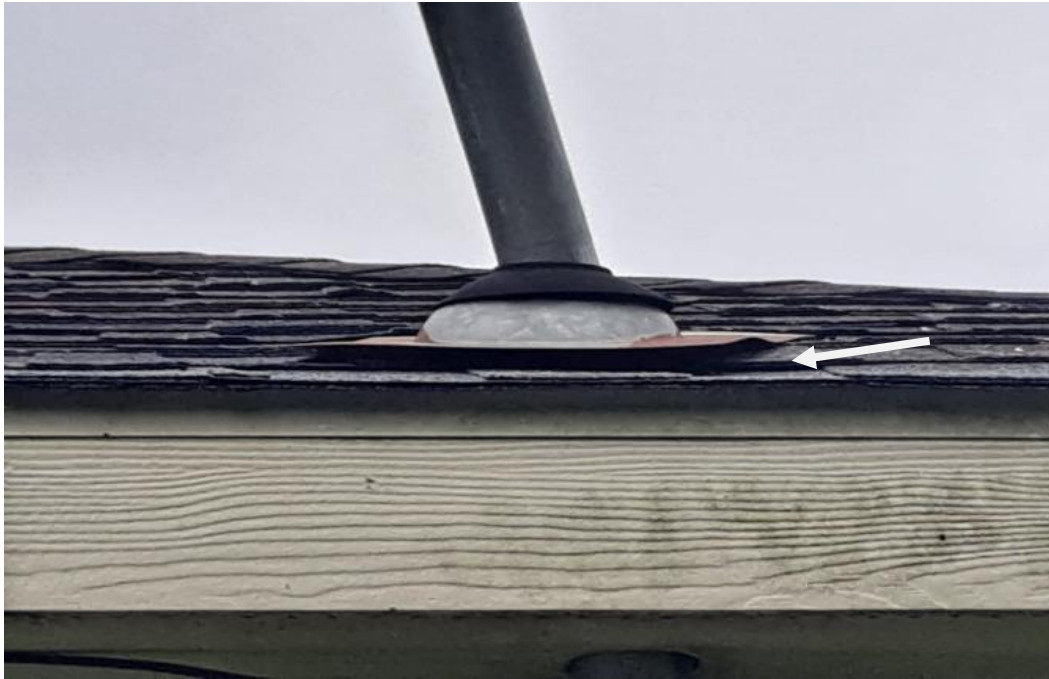
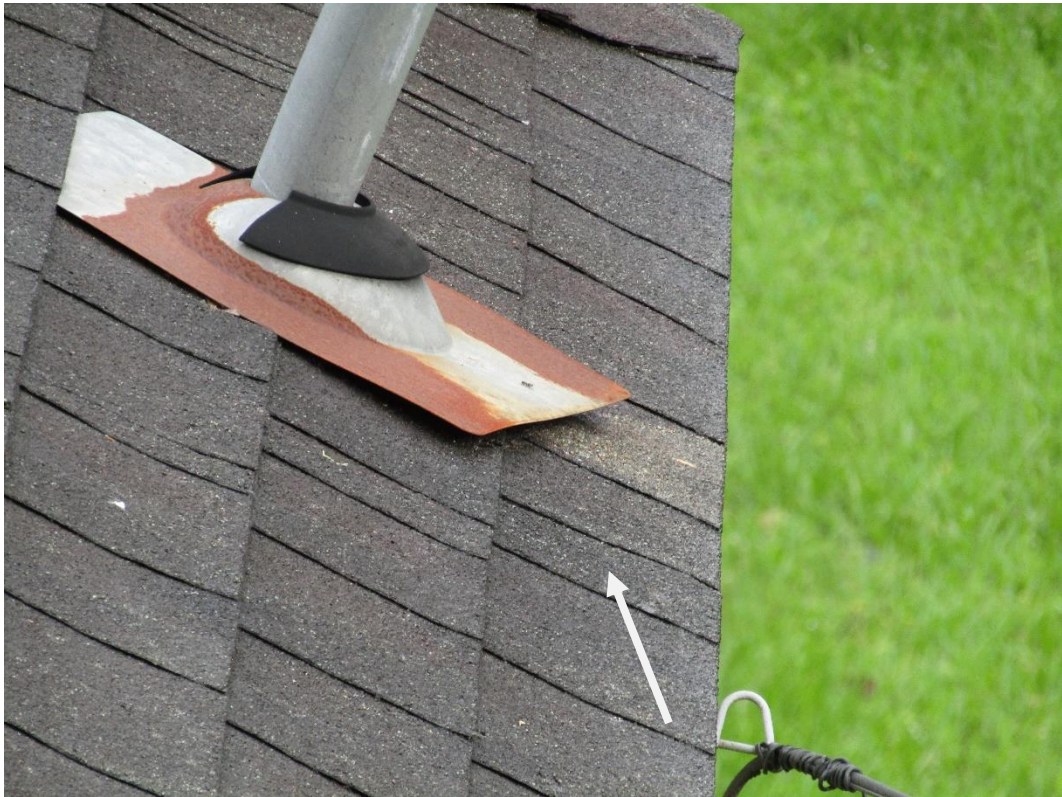
- Observed unsealed flashing on roof at overhead mast penetration point. Recommend sealing.

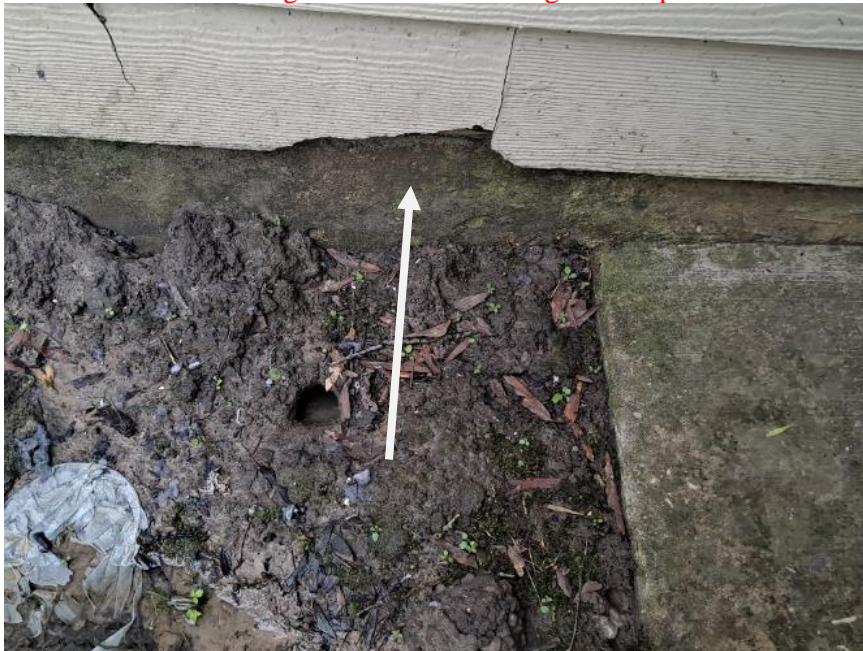
- Observed damaged cement fiber siding in multiple locations.

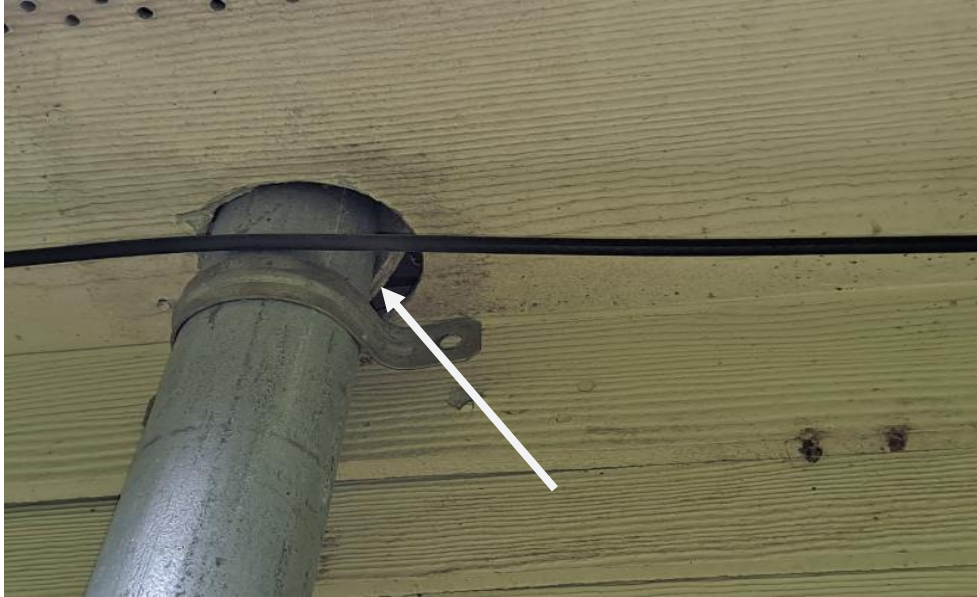
- Overhead mast lacks sealant at soffit penetration point. Recommend sealing.

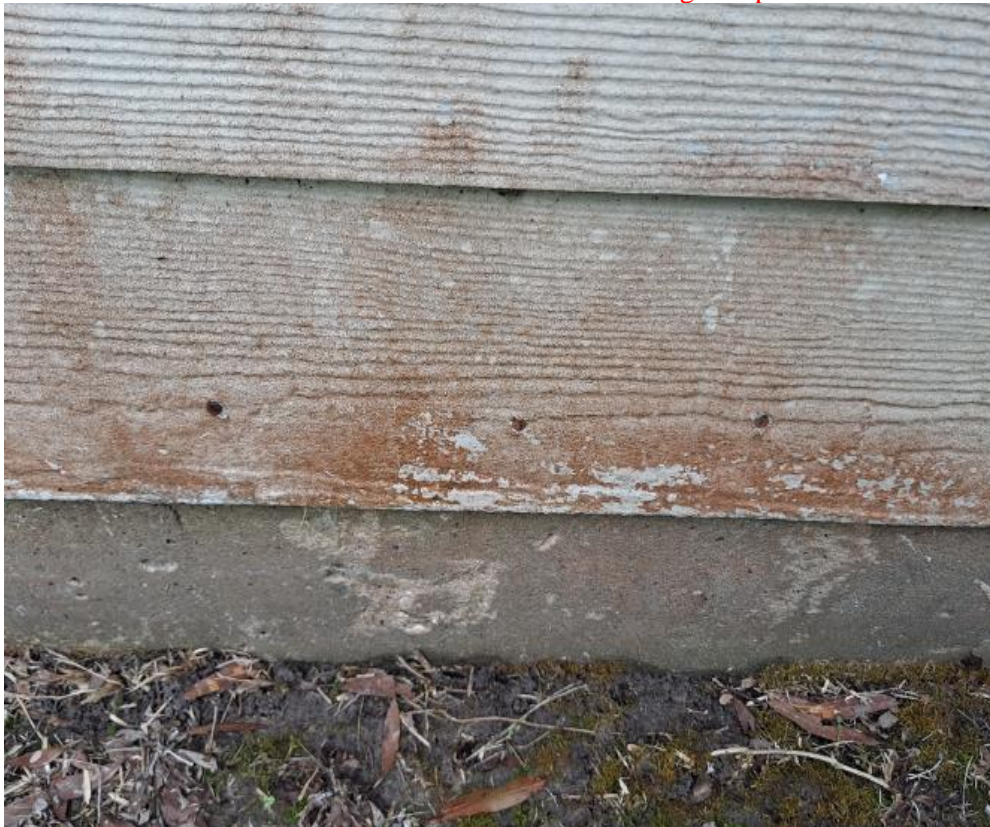
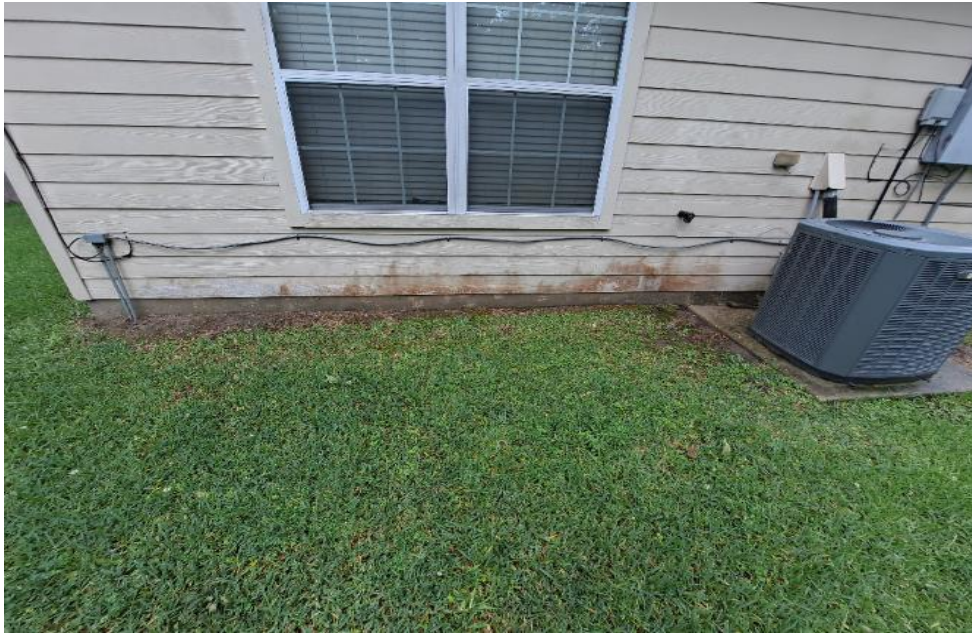
- Rear of the home unsealed nails and stained siding was present.

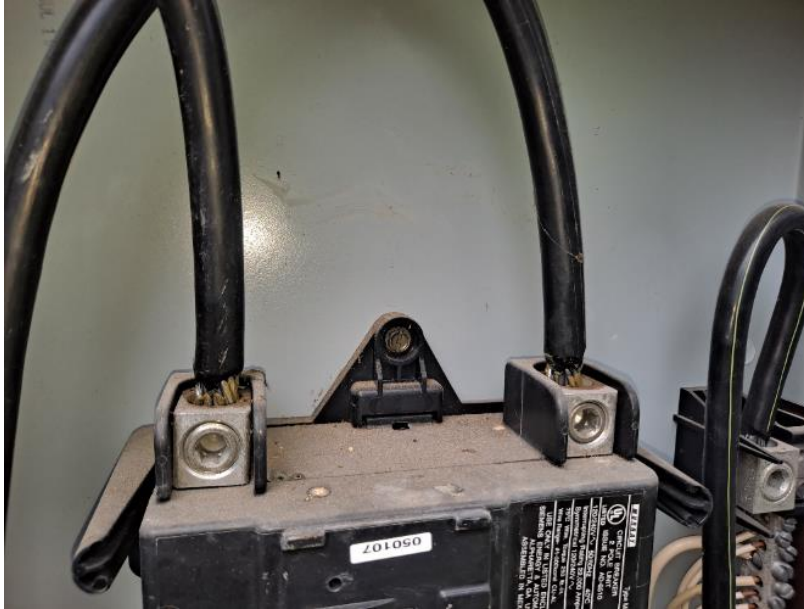
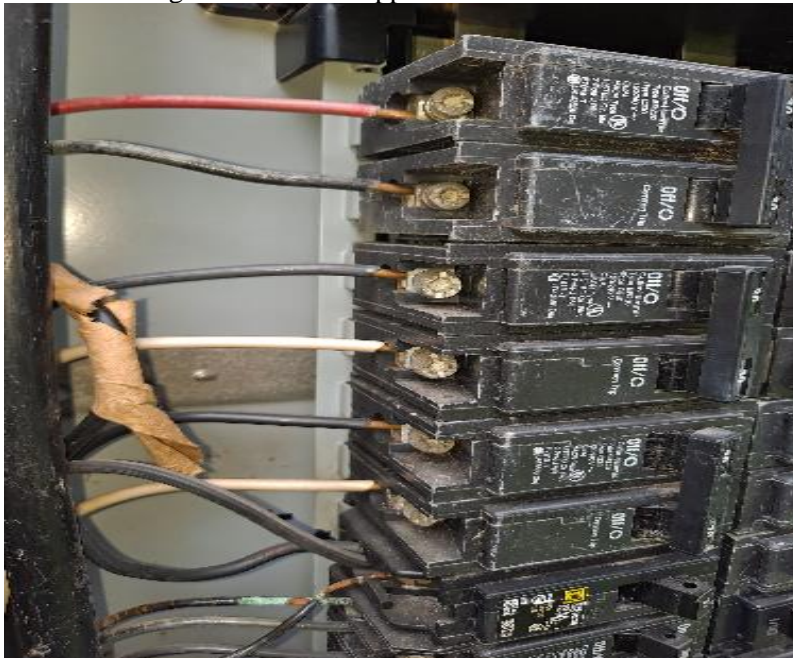
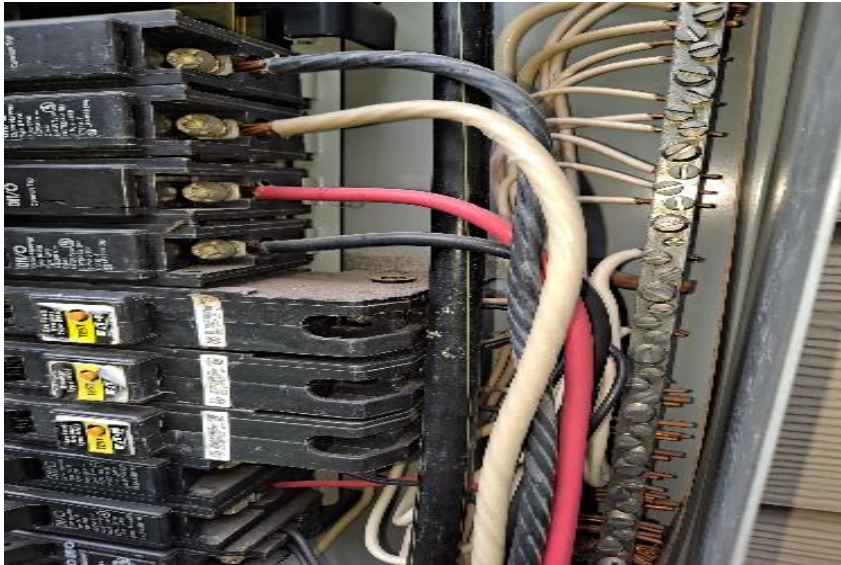
- Panel Brand: Murray
- Panel Rating: 150 Amps
- Location: Exterior rear wall
- Service Entrance Wiring: Aluminum

- Wiring to Breakers: Copper

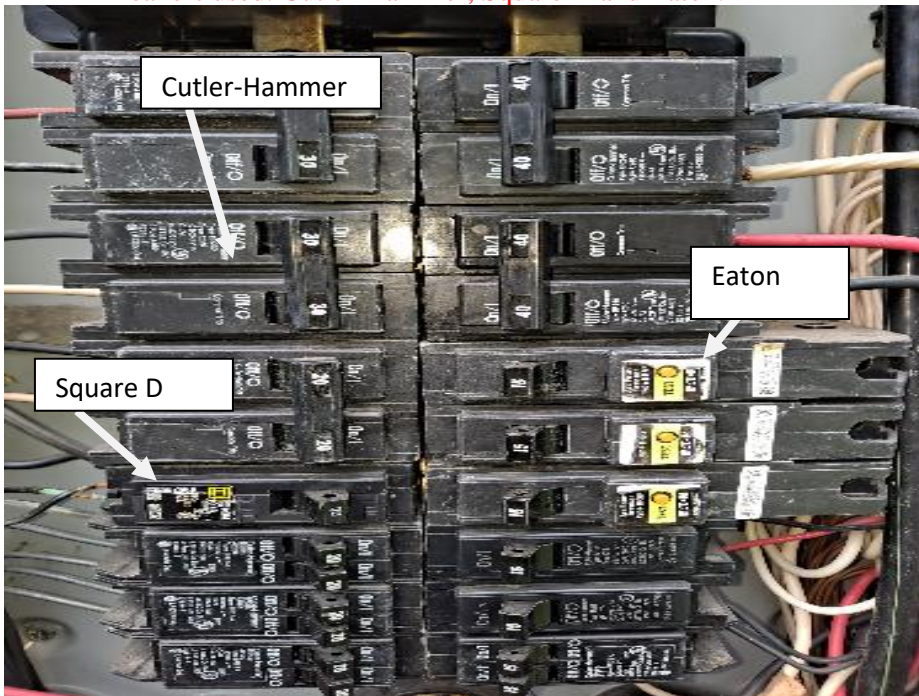
- Observed 3 different circuit breakers brand being used in the panel. Recommend further evaluation by a licensed electrician to determine if each breaker is compatible with panel. Breakers used: Cutler-Hammer, Square D and Eaton.

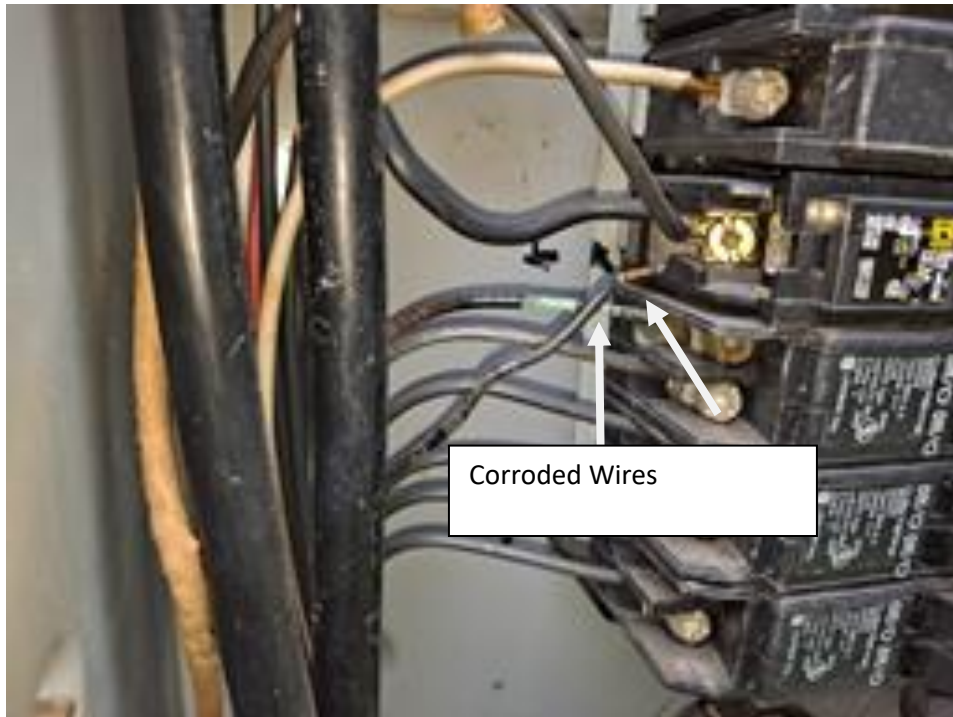
- Observed corroded wires in panel.

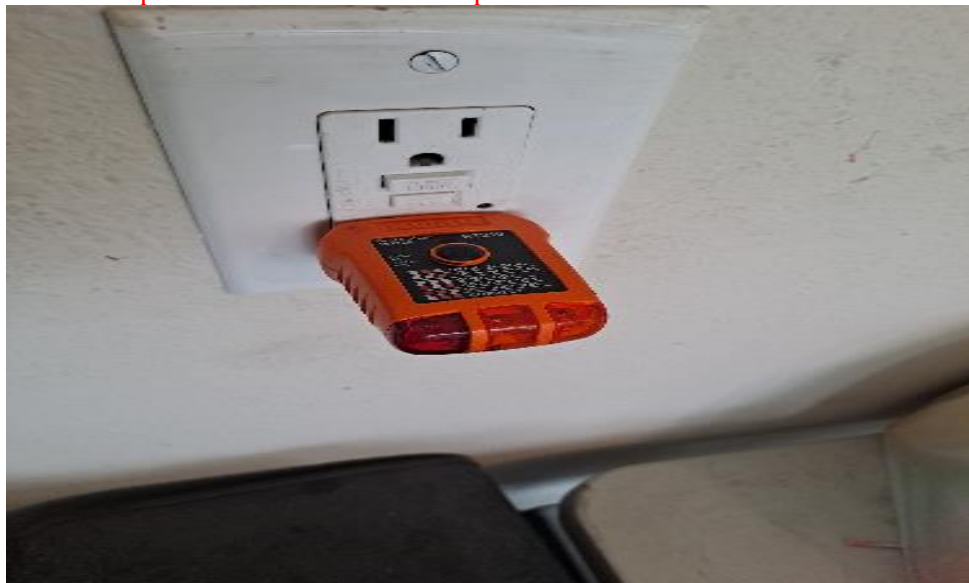
- Gfci outlet in garage inoperable. This outlet potentially controls all exterior outlets which are also inoperable at the time of the inspection.

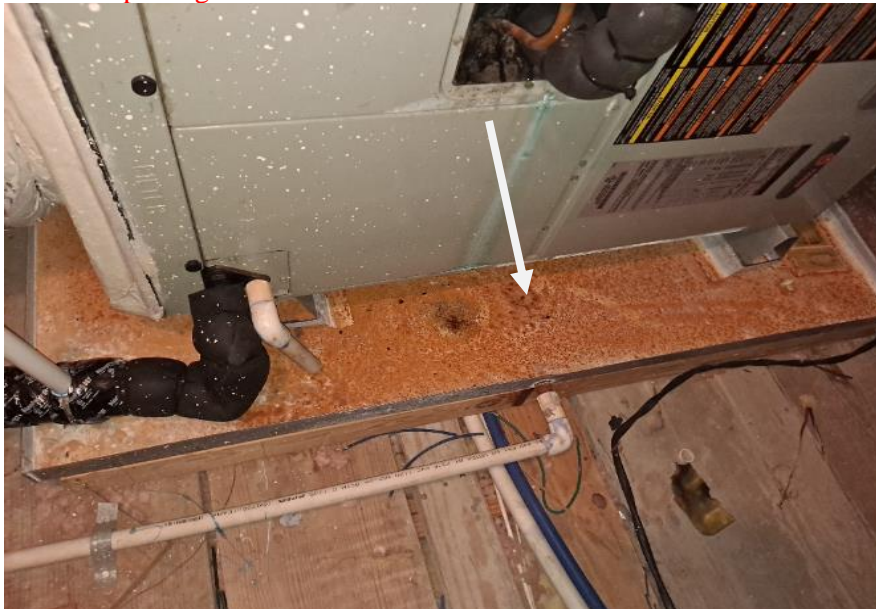
- Rust observed in drain pan possible indicator that previous repairs were performed. Recommend replacing.

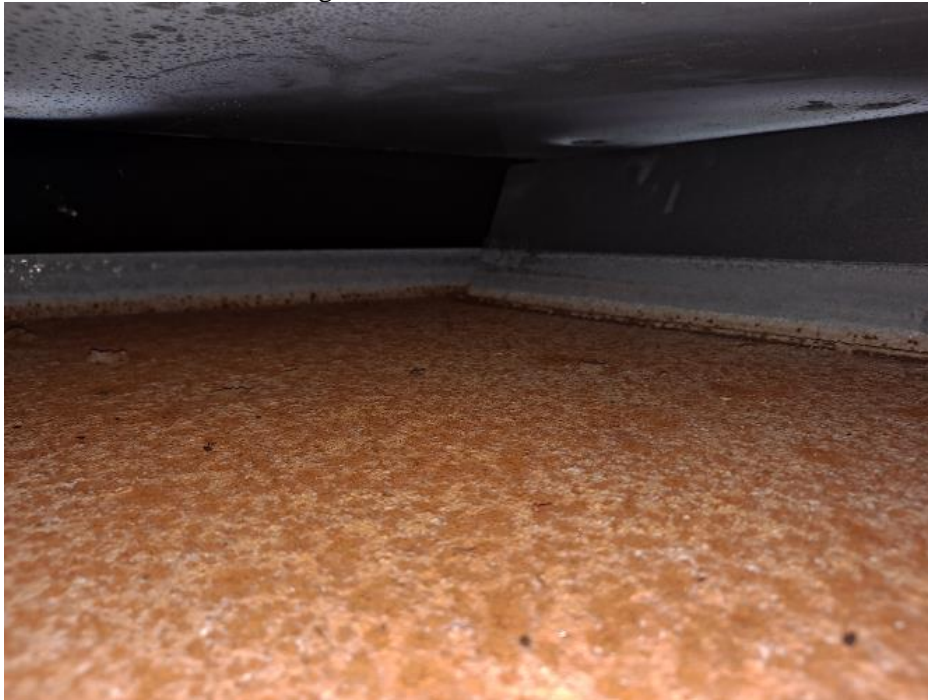
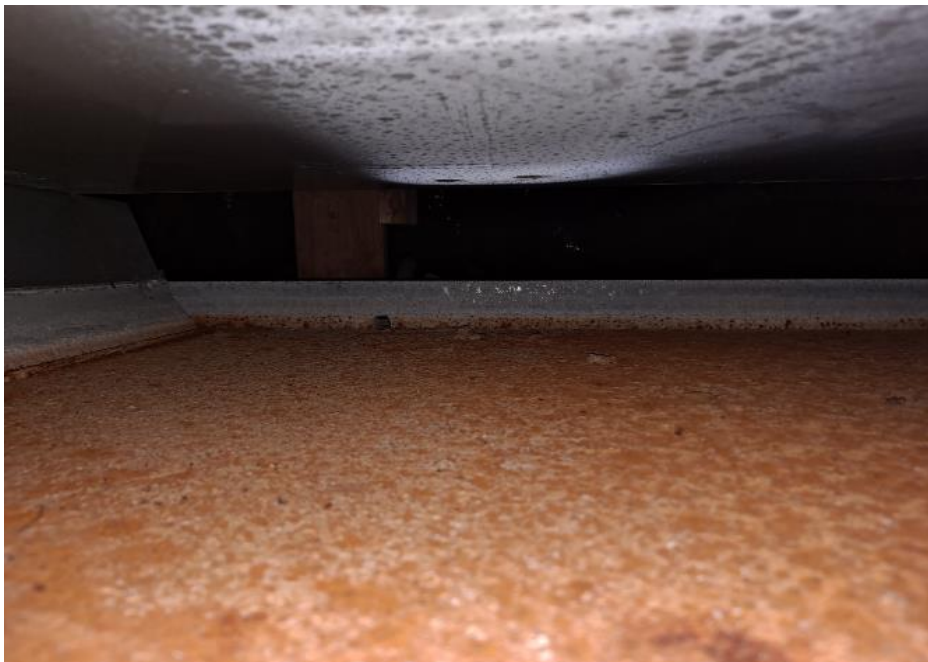
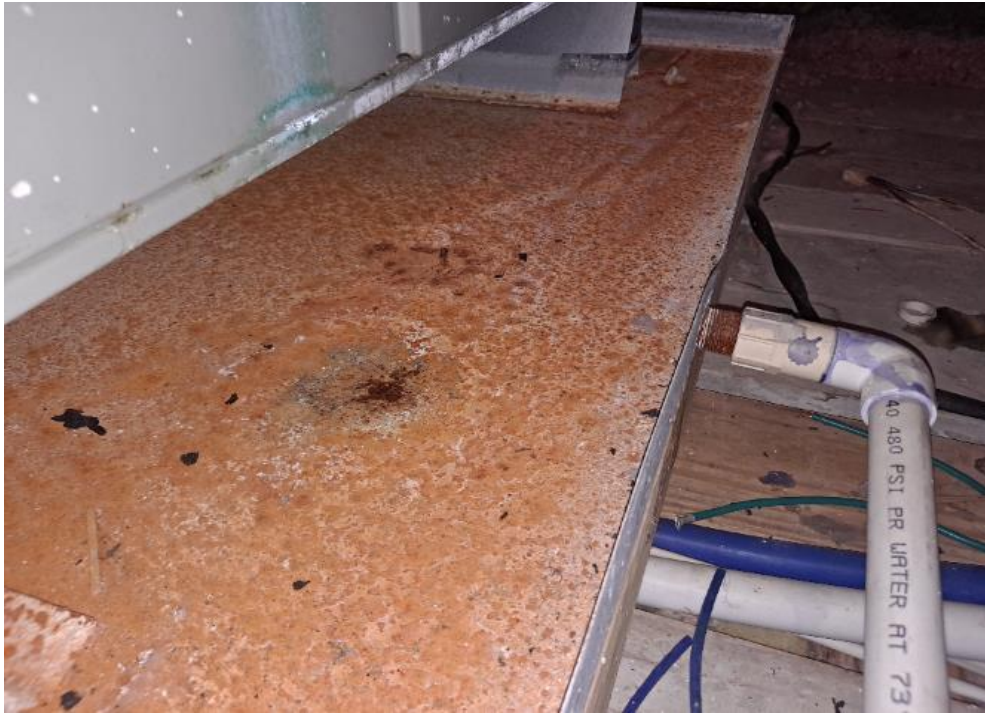
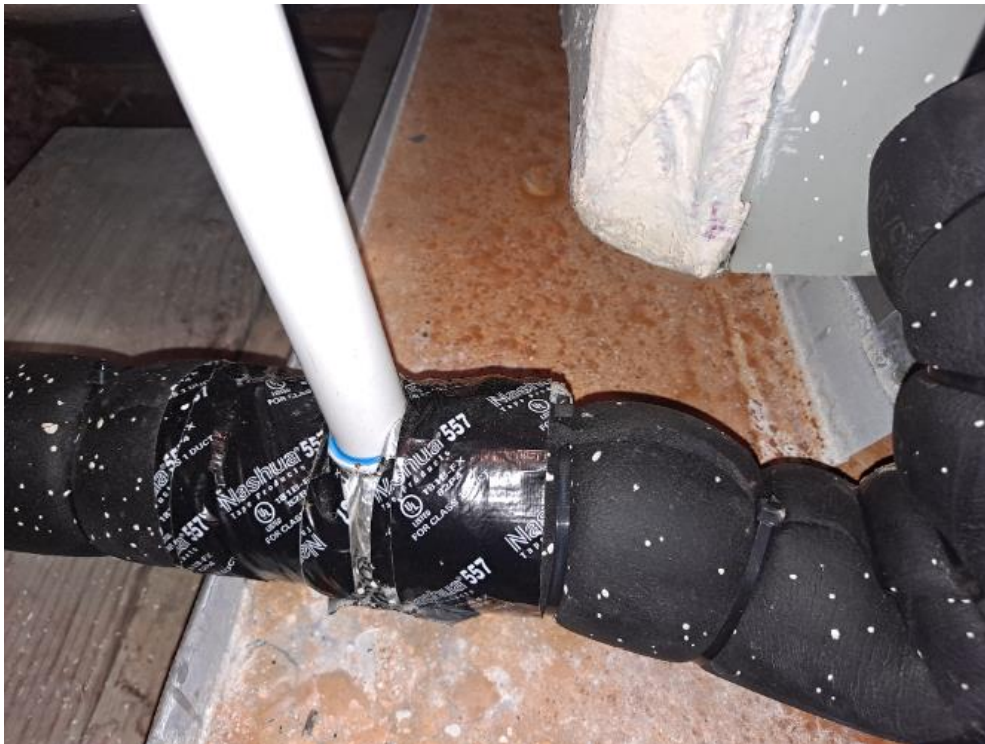
- Float switch not present on secondary drain pan. A HVAC wet switch/float switch, also known as a condensate overflow switch, serves to prevent this pan from overflowing if the AC drain stops working properly. The switch is activated when the level of the water in the pan comes above a certain point, causing the switch mechanism to trip/float to rise. When this happens, the switch will then send a message to the AC unit, and it will shut off, stopping the phase conversion and creation of condensation. At this point, a technician can locate and fix the source of the leak before water damage occurs.

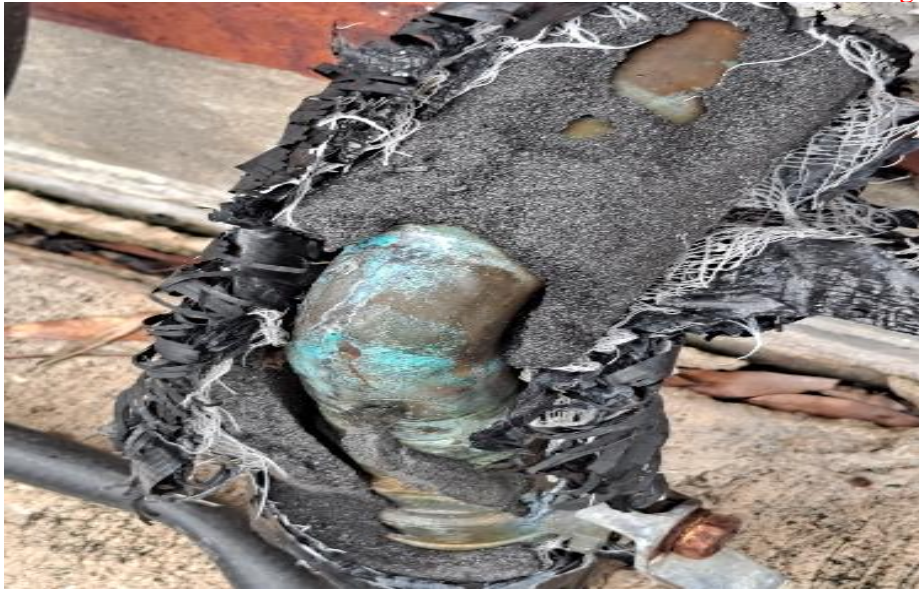
- **Shutoff valve lacks insulation on the exterior. Recommend insulating.**

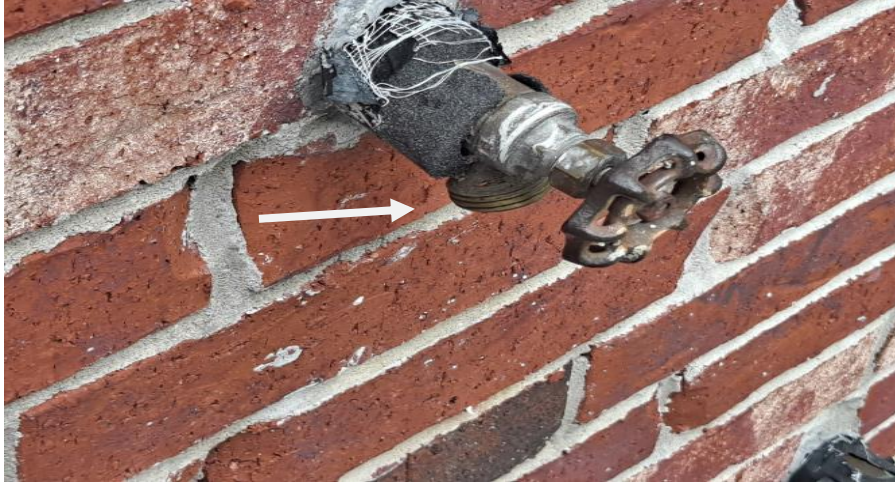
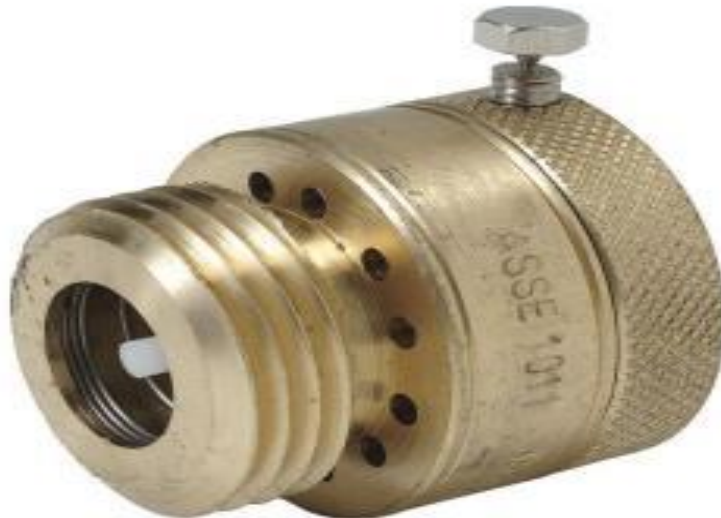
- Exterior faucet missing anti-siphon. These anti-siphon devices are essentially one-way valves designed to stop the flow of potentially contaminated water back into the drinkable (potable) water supply. Anti-siphoning capabilities are required by code on certain plumbing devices, such as exterior faucets (sill-cocks) or utility sink faucets.

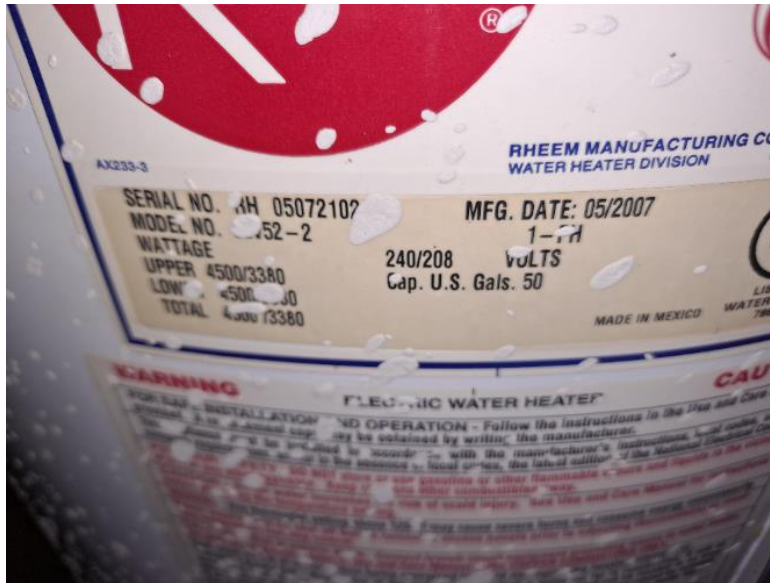
- Brand: Rheem
- Energy Source: Electric
- Energy Source: Natural Gas
- Capacity: 50 Gallons
- Location: Attic
- Data Sticker

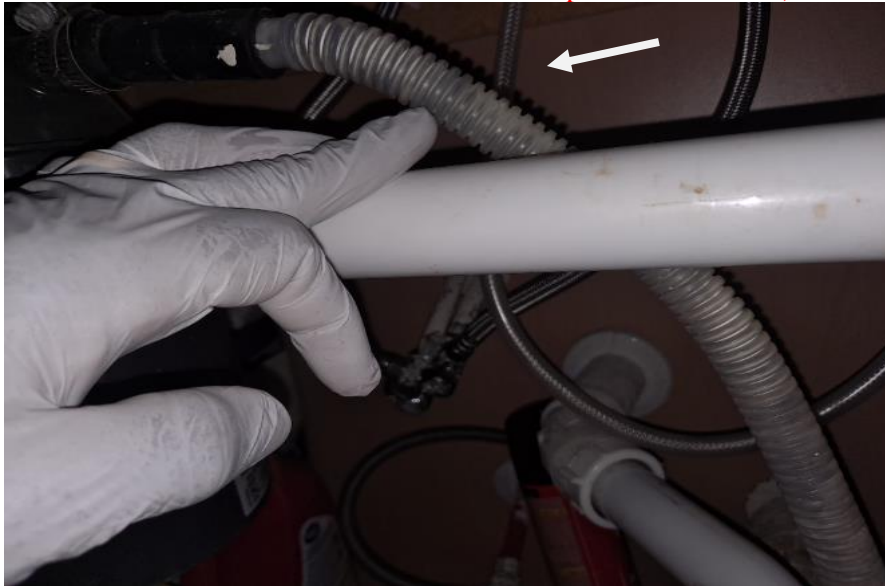
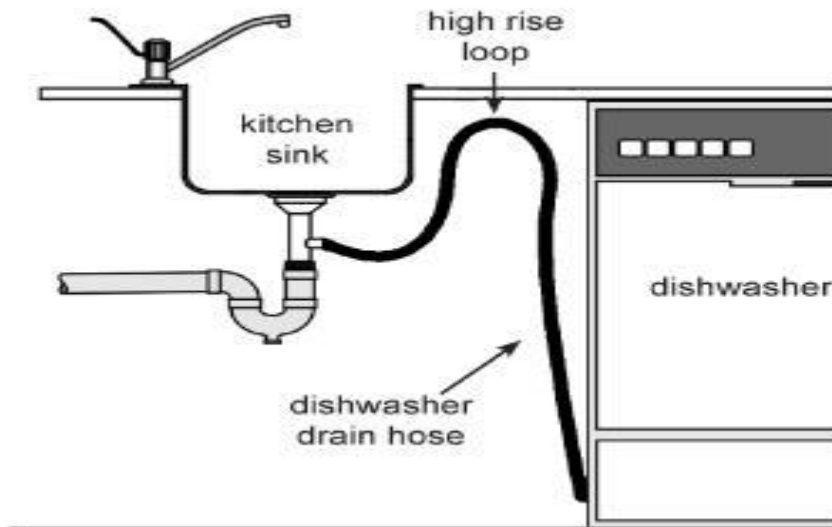
- **Missing High Loop.** (The high loop is recommended to prevent dirty water from going back into the dishwasher when the food waste disposer is turned on.)

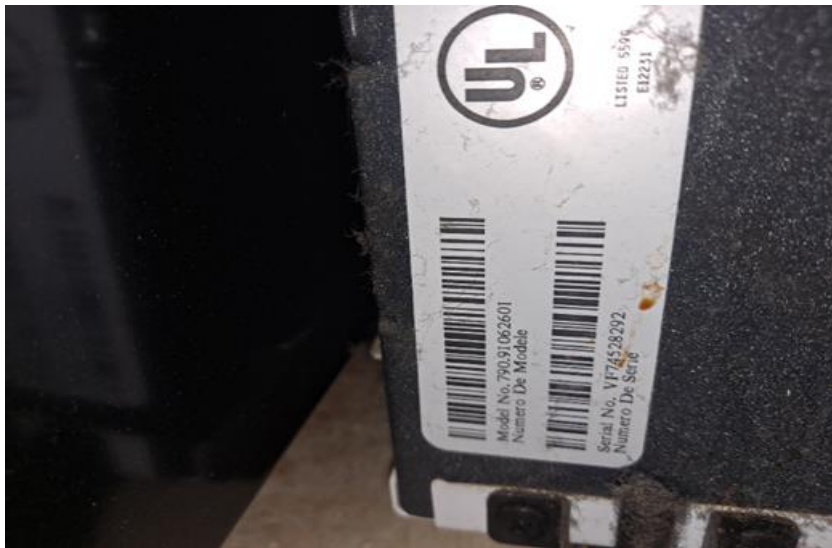
- Brand: Kenmore
- Energy Source: Electric
- Data Sticker:
