# TrueCall Inspections

**PROPERTY INSPECTION REPORT**

**Concerning:** 526 Bienville Ln, Houston, TX 77015  
(Address or Other Identification of Inspected Property)

**By:** Kenneth Scott TREC#20728 Jul 07, 2021  
(Name and License Number of Inspector) (Date)

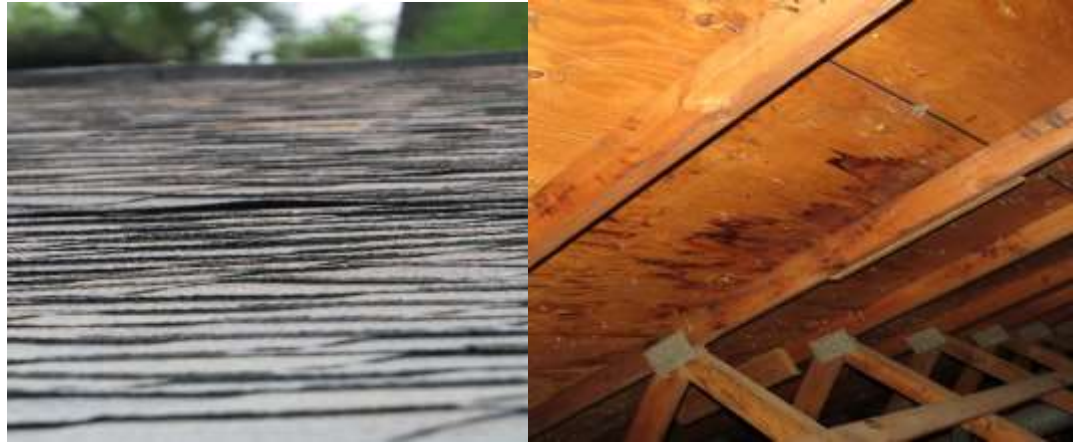
Comments: *Multiple areas sloping. Decking appears to have gotten wet. Did not find an active leak, but decking underneath has water stains. See pic.*

Additional Notes: *(This inspector is not a roofing expert. Client should have a roofing company inspect the roof for further evaluation if the Client so chooses)*

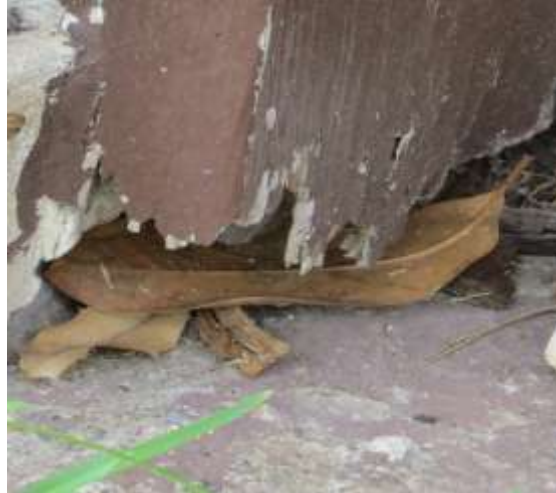
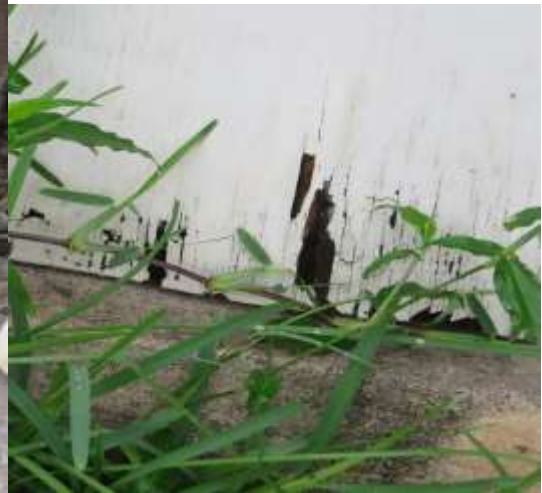
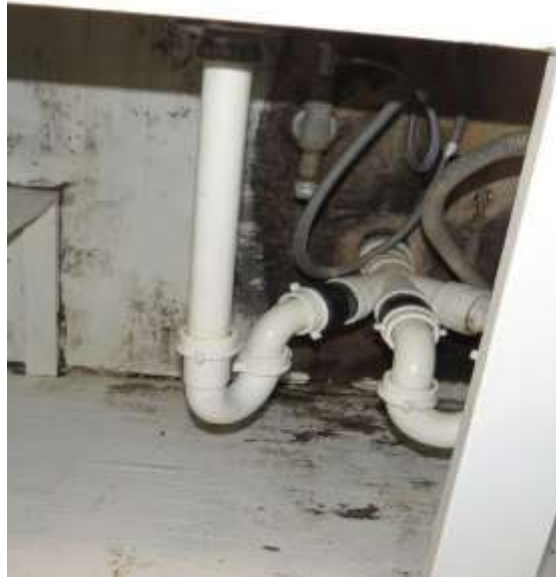
Comments: Rotted wood on exterior, and a build up under kitchen sink. See pics.

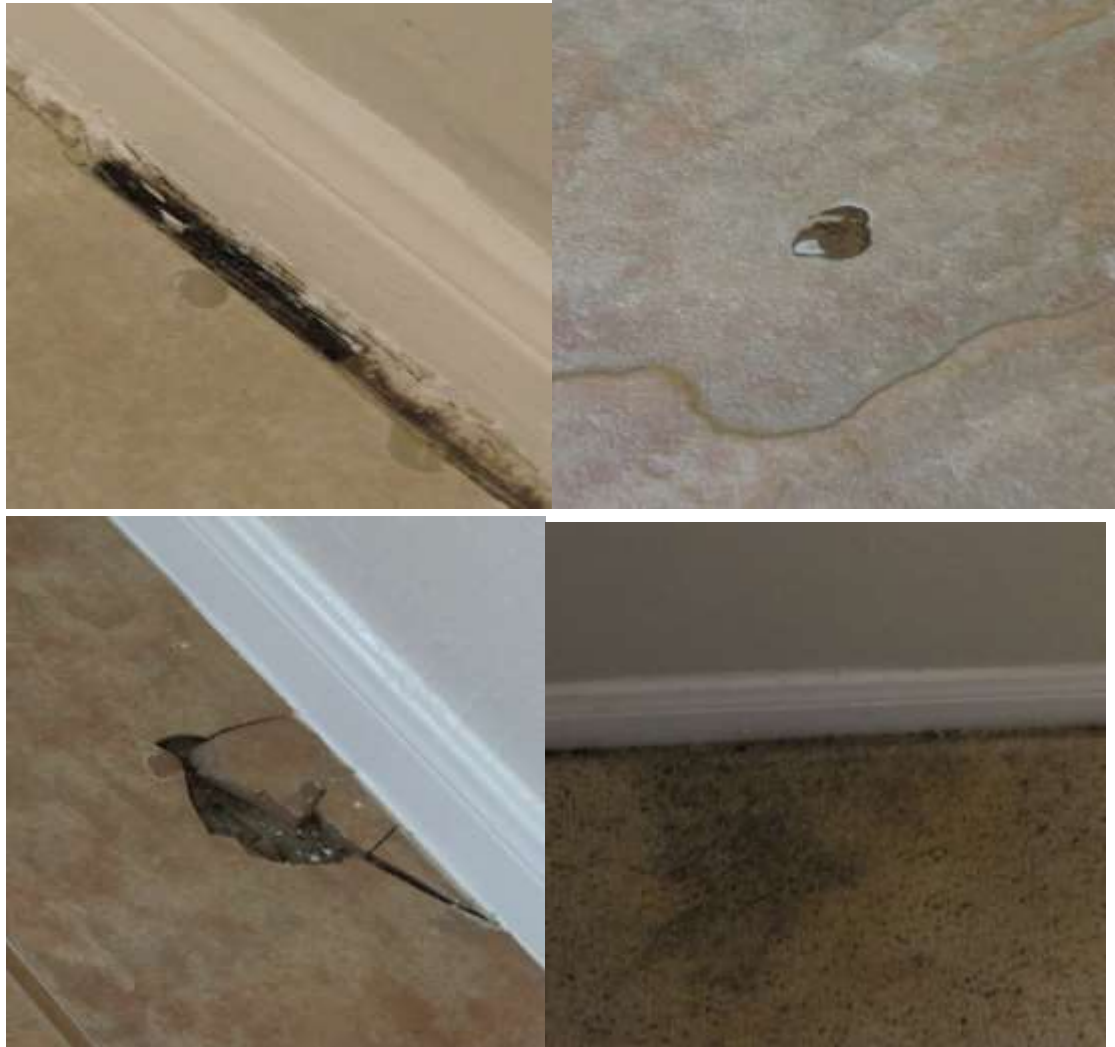
Comments: *Multiple cracked tile and grout missing see pics.*

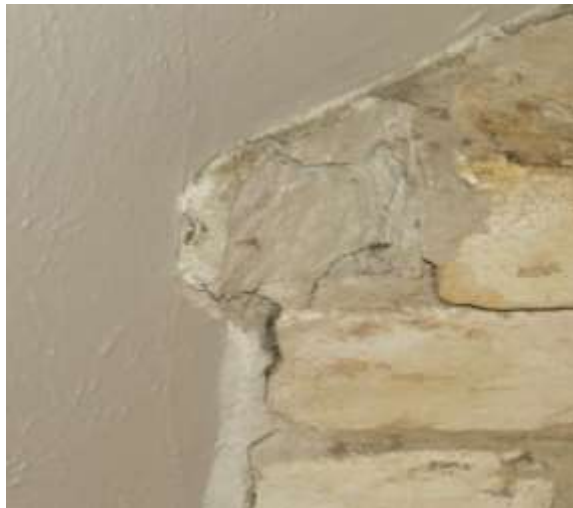
Comments: **Brick surround cracked in multiple places.**  
 Type of fireplace gas logs      Fuel Source: gas  
 Damper: **Not staying in place**  
 Firebox:  
 Mortar missing behind face bricks       Mortar missing rear wall  
 Cracks/Lintel       Soot build-up  
 Poor draft evident       Hearth insufficient/damage  
**Chimney:**  
 Crumbling brick       Damaged/missing cap  
 Spark arrestor missing       Insufficient height/clearance  
 Additional Notes:

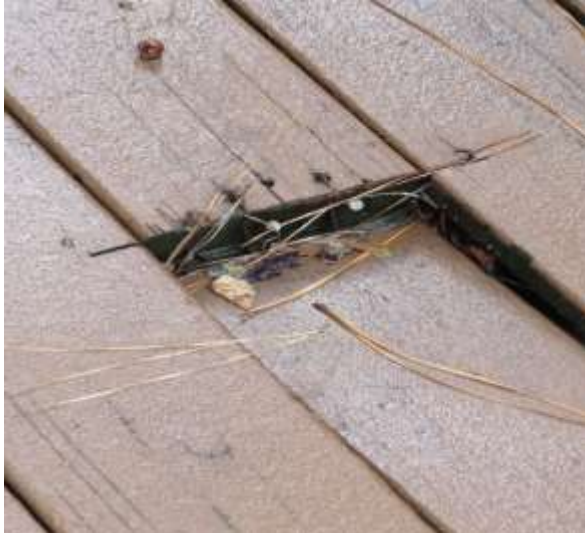
Comments: **Trip hazard on back deck.**  
 Rotting evident       Insect Damage       Wood/soil contact  
 Trip Hazard       Loose boards       Handrail/railing missing/damaged  
 Areas inaccessible

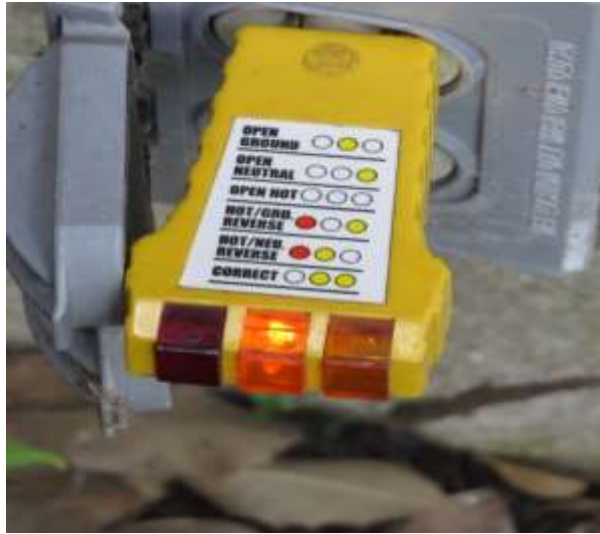
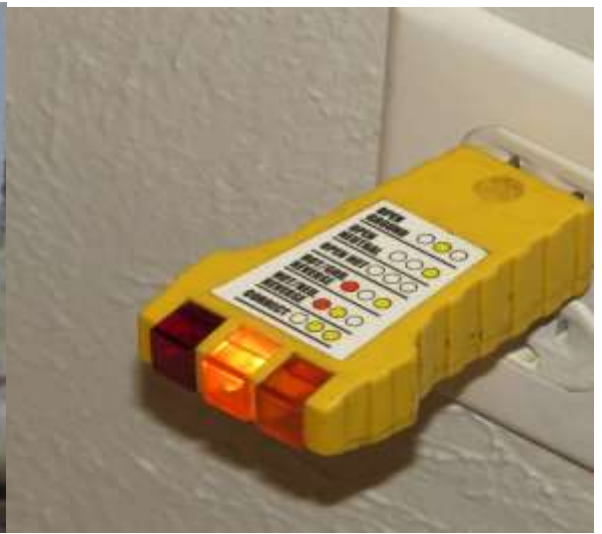
Comments: No AFCI or GFCI breaker present. No panel labeling and no contact grease on entry cables.

Type of Wiring: copper
Comments: There are 2 prong and 3 Prong outlets. Also there are multiple outlets with open grounds. Smoke detection not working.

- Grounding Electrode present: yes
Note: All systems in the house could not be verified for bonding.
Due to defects observed, recommend service and complete system check by licensed electrician
Due to aluminum wiring being found, recommend service and complete system check by licensed electrician
Lack of electrical bonding and grounding, and lack of bonding on gas piping, including corrugated stainless steel tubing (CTTS).

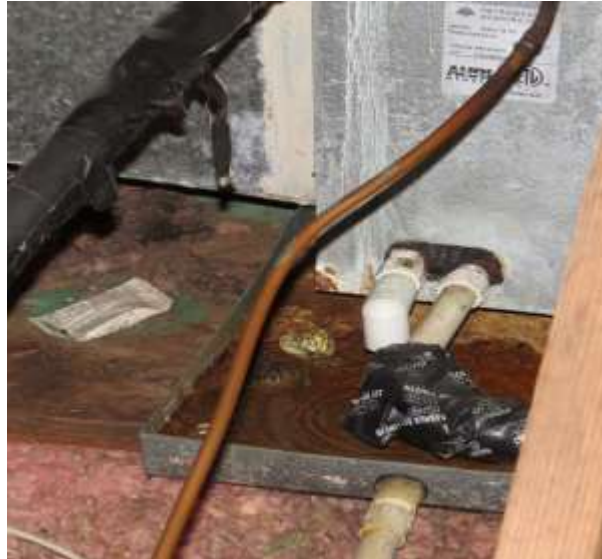
Comments: **A/C meets delta range, but primary drain pan rusted out.**

Due to defects observed, recommend service by qualified H.V.A.C Service Company  
 Note: RECOMMEND MAINTENANCE AND SERVICE PRIOR TO USE.

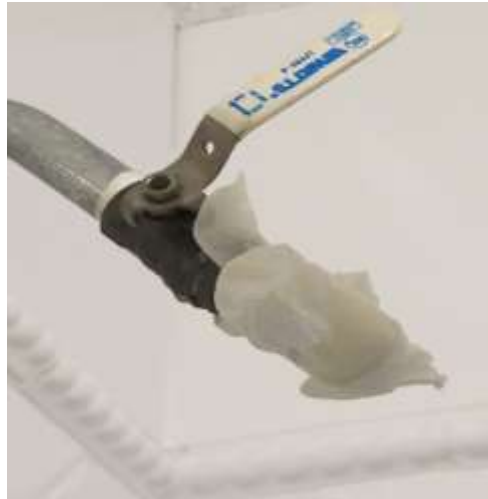
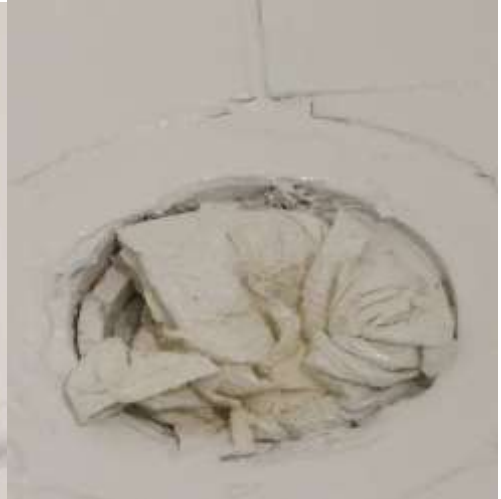
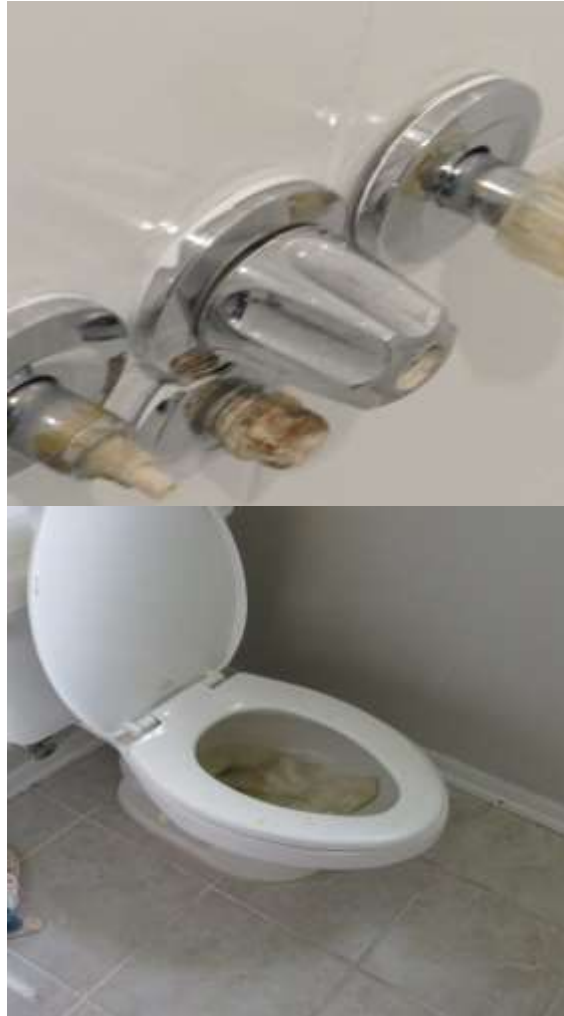
Comments: *Multiple fixtures broke are missing. See pics.*
