Inspection Report

Property Address:
26 N Waxberry
The Woodlands TX 77381

PROPERTY INSPECTION REPORT

By: Reevis Coleman Schultz Texas Professional Home Inspector / Hilsher Group LLC
5/11/2021
(Name and License Number of Inspector) (Date)

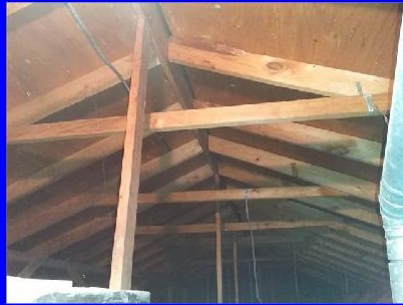
stick built with out radiant barrier

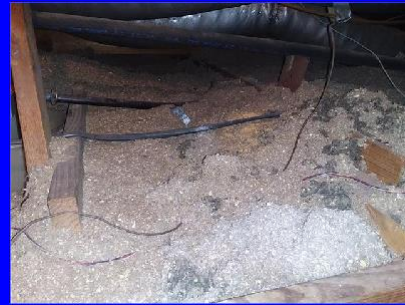
cellulose insulation 6 inches average

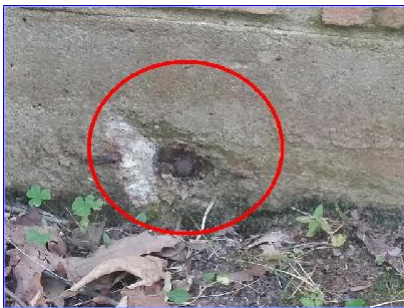
A. Item 1(Picture) right side of home

(2) The post tension foundation has exposed cable ends that are starting to show signs of deterioration.

This is a maintenance issue. Further deterioration will occur if not corrected. I recommend having a qualified person make repairs as needed.

Fixed - Per Seller

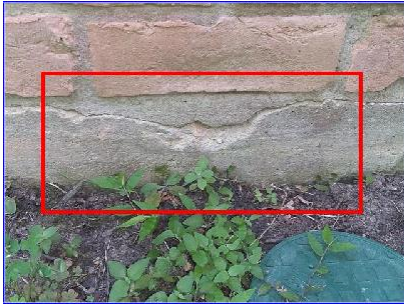
A. Item 2(Picture) right side of home

(3) The foundation wall appears to be showing signs of flaking and deterioration. I recommend having a qualified person make repairs as needed.

Fixed – Per Seller

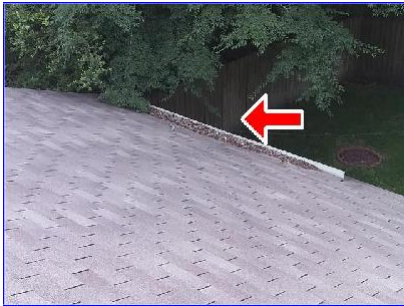
B. Item 1(Picture)

(1) The gutters are full of debris in areas and needs to be cleaned. The debris in gutters can also conceal rust, deterioration or leaks that are not visible until cleaned, and I am unable to determine if such conditions exist.

Fixed – Per Seller

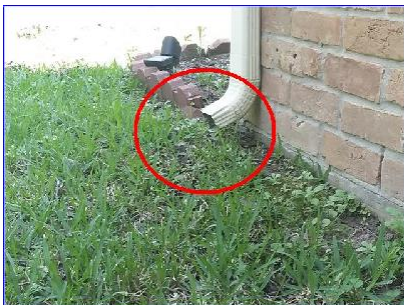
B. Item 2(Picture) right side of home

(2) The gutter downspout(s) missing deflector(s) at the exterior. Erosion can continue or become worse if not corrected. A qualified contractor should inspect and replace as needed.

Fixed – Per Seller

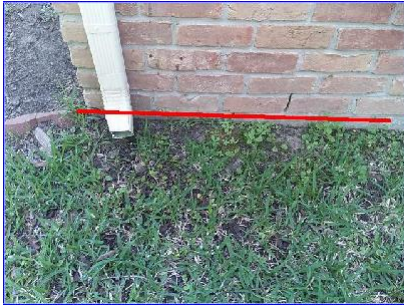
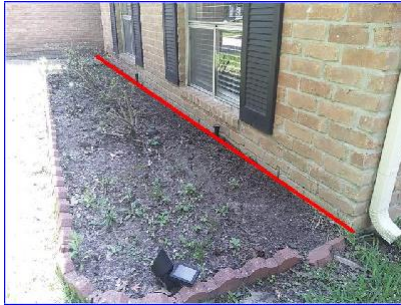
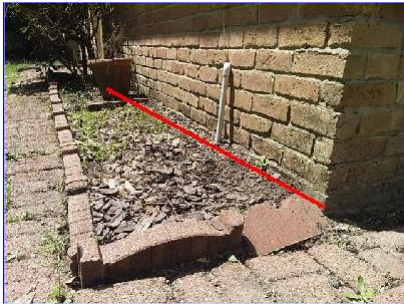
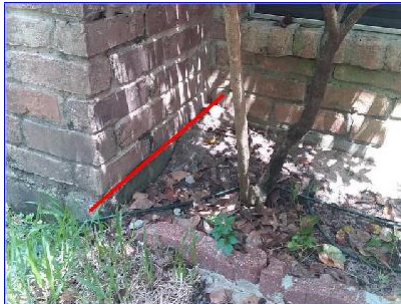
(3) There is a negative slope towards the exterior areas. This area does not appear to drain water away from home and needs landscaping and drainage corrected to show a minimum of 4 inches of slab.

B. Item 3(Picture) right side of home

B. Item 4(Picture) front of home

B. Item 5(Picture) left side of home areas

B. Item 6(Picture) rear of home areas

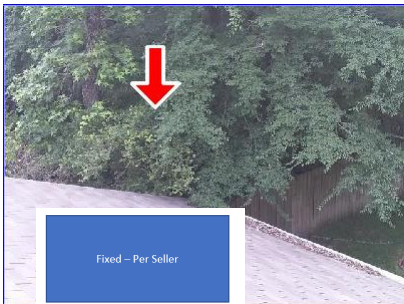
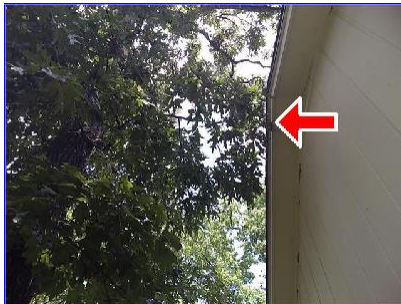
(2) The tree limbs that are in contact with roof or hanging near roof should be trimmed.

C. Item 1(Picture) rear of home areas

C. Item 2(Picture) right side of home

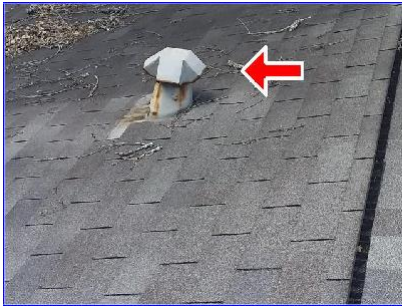
C. Item 3(Picture) multiple areas

prevents premature deterioration. This is not considered to be today's standard. I recommend having a qualified person make repairs as needed.

Fixed - Per Seller

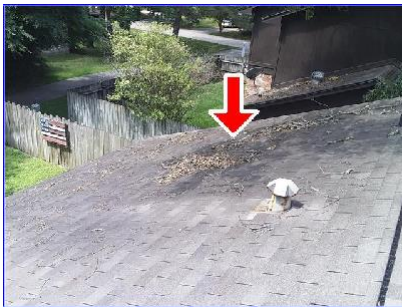
C. Item 4(Picture) multiple areas

(4) Debris is present on roof surface in multiple areas. Having debris present can lead to shingle deterioration and possible moisture problems. I recommend having a qualified contractor remove, inspect and make repairs as needed.

Fixed - Per Seller

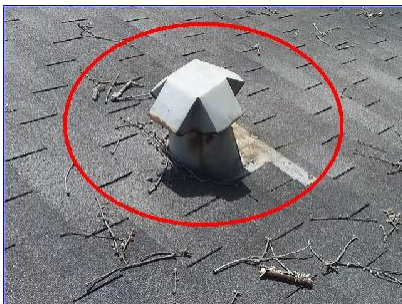
C. Item 5(Picture) furnace and water heater

(5) Appliance vent on roof does not appear to have the proper clearance from roof vent or roof in areas. This is not considered today's standard. I recommend having a qualified contractor further evaluate and make repairs as needed.

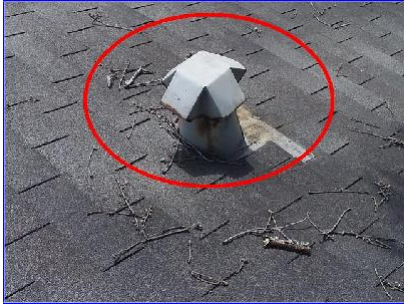
C. Item 6(Picture)

(6) Water heater and furnace flue piping appear to wrong style of piping penetration. I recommend having a qualified contractor inspect and repair as needed.

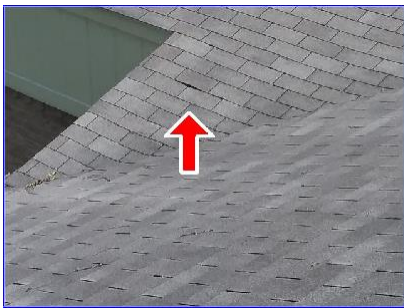
C. Item 7(Picture) various areas

(7) Shingles appear to be lifted in areas of the roof. Damage could occur if not corrected. I recommend having a qualified roofing contractor further evaluate and make repairs as needed.

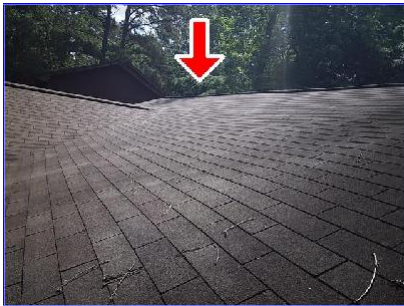
C. Item 8(Picture) multiple areas

(8) Roof sheathing appears to be wavy in areas. I recommend having a qualified roofing contractor inspect and repair as needed.

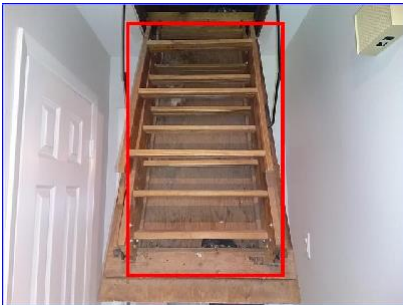
D. Item 2(Picture) hallway access

(3) The pull down stairs are not properly insulated. This can cause some heat loss in winter and loss of cool air in summer if not corrected. I recommend repair as desired.

Fixed – Per Seller

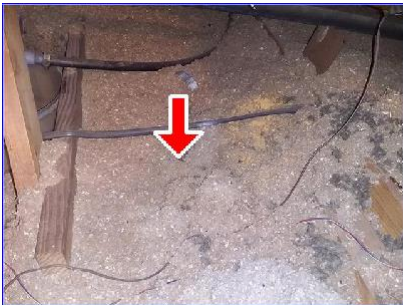
D. Item 3(Picture)

(4) The attic space has area's of thin insulation. This is causing energy loss and is not today's standard. I recommend having a qualified person evaluate and add insulation as needed.

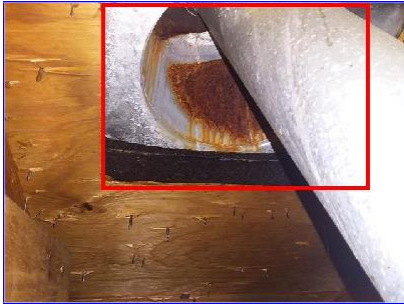
D. Item 4(Picture)

(5) Furnace flue piping vent is rusting. I recommend having a qualified roofing contractor inspect and repair as needed.

Fixed – Per Seller

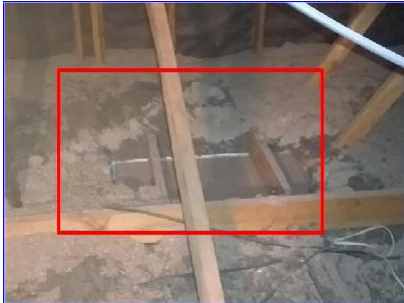
D. Item 5(Picture)

(6) The attic space has area's of missing insulation. This is causing energy loss and is not today's standard. I recommend having a qualified person evaluate and add insulation as needed.

Fixed – Per Seller

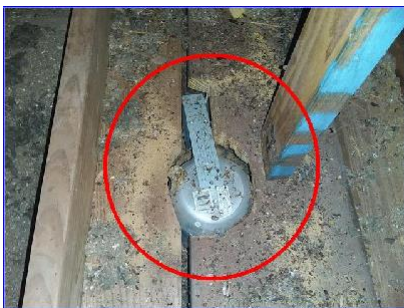
(7) Unable to verify if lighting is rated to be in contact with insulation or combustible materials. I recommend having a qualified contractor inspect and repair as needed.

Fixed – Per Seller

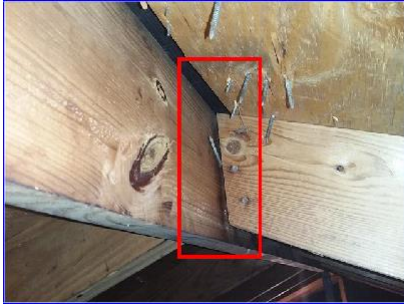
D. Item 7(Picture) various areas

(8) Rafters appear to show signs of separation from ridge board in the attic space (most likely caused from movement). Further separation may occur if not corrected. I recommend having a qualified contractor further evaluate and make repairs as needed.

Fixed - Per Seller

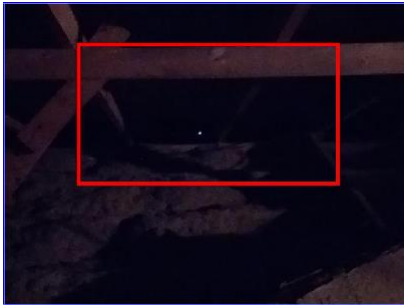
D. Item 8(Picture) chimney areas

(9) Visible daylight in areas of attic space. This is not considered today's standard. Further deterioration can occur if not corrected. I recommend having a qualified contractor inspect and make repairs as needed.

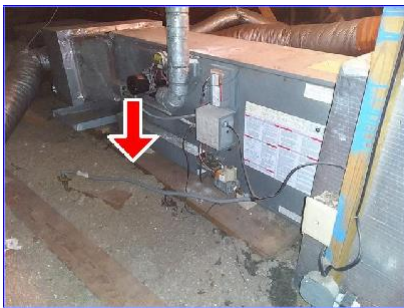
(10) The attic space is missing adequate service access decking. This is not considered to be today's standard. I recommend having a qualified person install decking.

Fixed - Per Seller

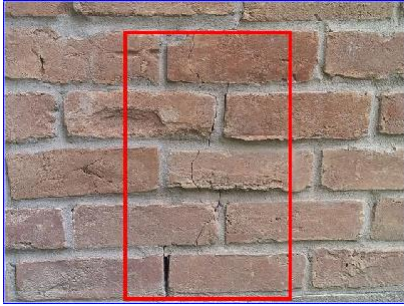
E. Item 4(Picture) right side of home

(3) The Brick siding exterior in areas has settlement cracks. Deterioration can eventually occur if not corrected. A qualified contractor should inspect and repair as needed.

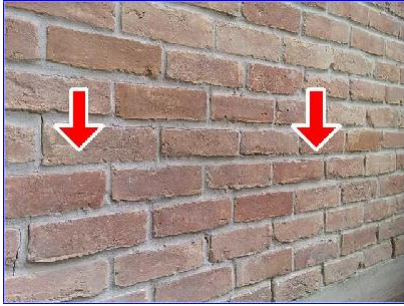
E. Item 8(Picture) right side of home

(4) The Brick siding at the exterior has hairline cracks. Deterioration can eventually occur if not corrected. A qualified contractor should inspect and repair as needed.

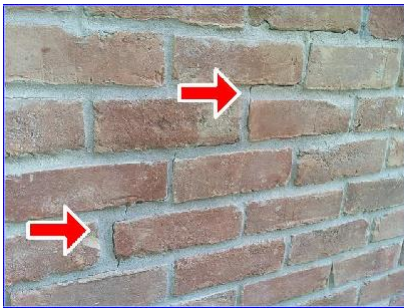
E. Item 13(Picture) right side of home

(5) The Brick siding at the exterior has step cracks caused from settlement. Deterioration can eventually occur if not corrected. A qualified contractor should inspect and repair as needed.

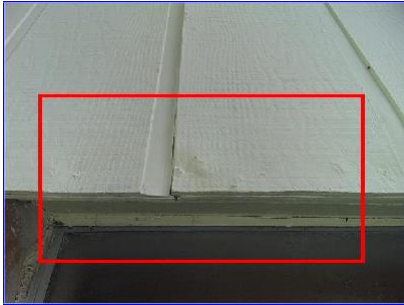
E. Item 15(Picture) various areas right side of home

(6) The exterior siding and trim is deteriorated or damaged in areas. Further deterioration will occur if not corrected. A qualified contractor should inspect and repair as needed.

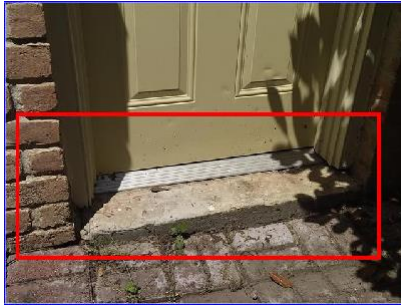
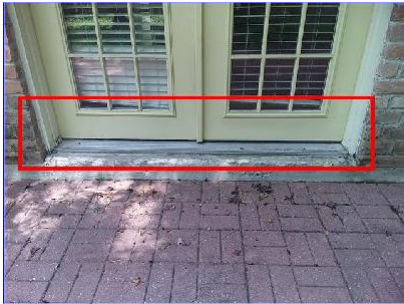
E. Item 16(Picture) left side garage door jamb

E. Item 17(Picture) rear door jambs

Fixed - Per Seller

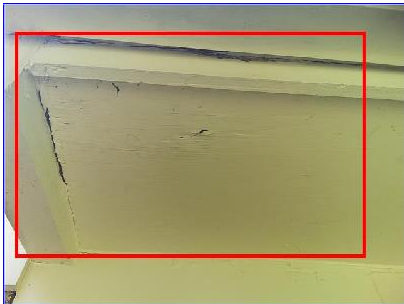
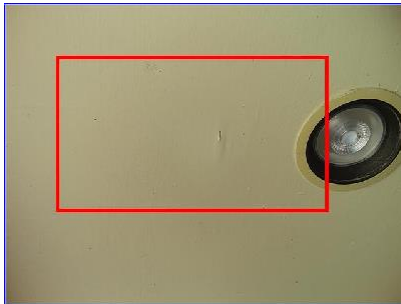
(7) The soffit panels at eave on the exterior deteriorated. Further deterioration may occur if not repaired. A qualified person should repair or replace as needed.

E. Item 18(Picture) front of home

E. Item 19(Picture) front entrance areas

Fixed - Per Seller

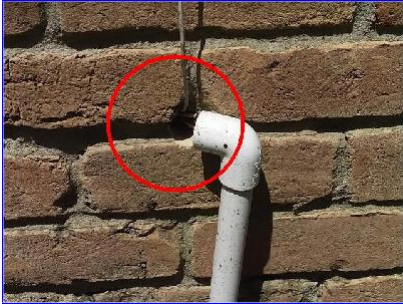
E. Item 20(Picture) left side of home

(8) Areas where wiring or piping passes through walls should be sealed. I recommend having a qualified person seal as needed.

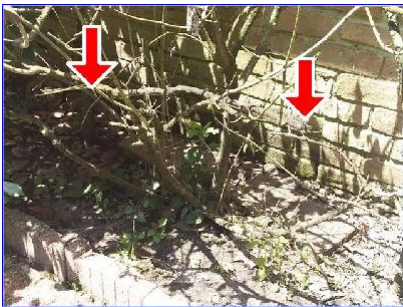
E. Item 23(Picture) multiple areas exterior

(9) Signs of fungi growth is present on the exterior siding in areas. We did not inspect, test or determine if this growth is or is not a health hazard. The underlying cause is moisture. I recommend you contact a mold inspector or expert for investigation or correction if needed.

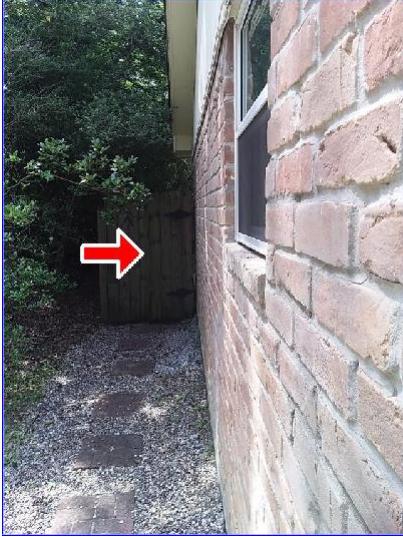
E. Item 24(Picture) left side of home

(10) Brick ties appear to be loose in areas. Maintenance may be needed. I recommend having a qualified contractor inspect and repair as needed.

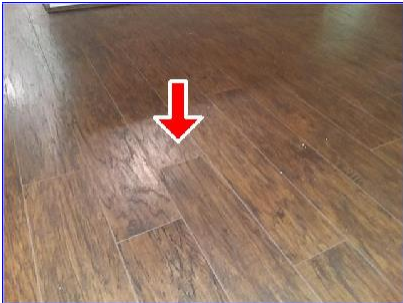
F. Item 1(Picture) various areas living and kitchen areas

(1) The wood style flooring is damaged in areas. Repairs are needed. A qualified contractor should inspect and repair as needed.

Fixed – Per Seller

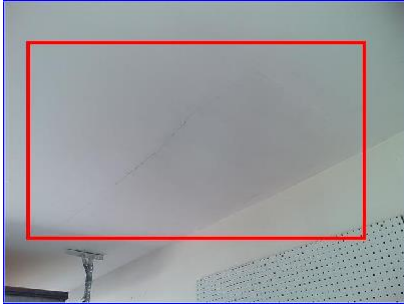
F. Item 2(Picture) garage areas

(2) The Drywall on the ceiling is damaged in areas. While this damage is cosmetic, it needs to be repaired. A qualified contractor should inspect and repair as needed.

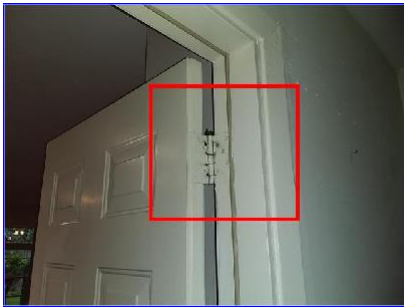
G. Item 1(Picture) garage

(1) The interior garage door does not have the required self closing hinge. This is not considered to be today's standard. I recommend having a qualified person make repairs as needed.

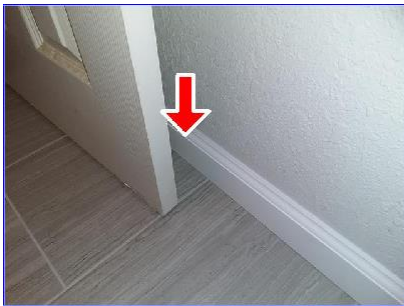
G. Item 2(Picture) multiple areas

(2) There are door stops missing in the home. This is not considered to be today's standard I recommend having a qualified person make repairs as needed.

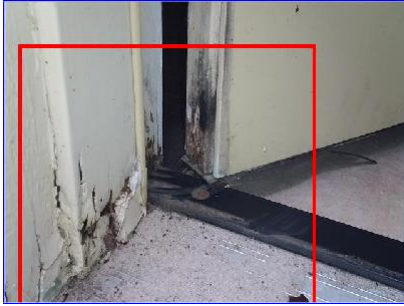
(3) The Entry door is damaged in areas. This is a maintenance issue and is for your information. A qualified contractor should inspect and repair as needed.

Fixed - Per Seller

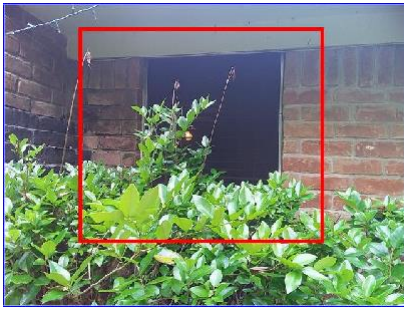
H. Item 1(Picture) rear of home areas

Unable to verify if windows are properly sealed due to large screens. This is for your information.

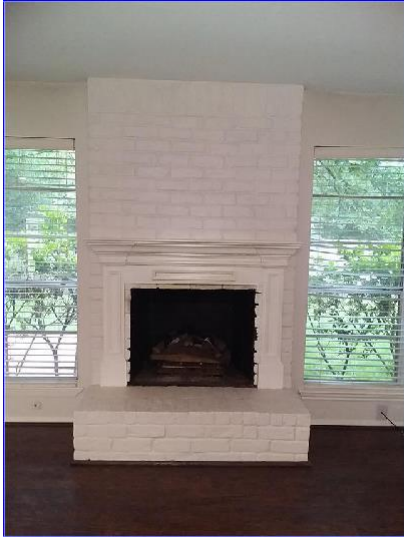
J. Item 1(Picture)

- (1) I do not inspect the shape of fireplace or the design to determine if your fireplace has a proper air draw.
- (2) (natural gas) vented fire logs in the Living room pipe has creosote build-up. I did not inspect for safe use or operation. A qualified contractor should inspect and repair as needed.

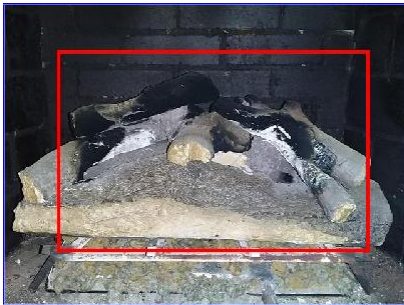
J. Item 2(Picture)

(3) The black soot build-up indicates that Gas Fire logs do not appear to be arranged or positioned according to manufacturer's specs. If logs are not positioned correctly, carbon monoxide can be produced.

Fixed - Per Seller

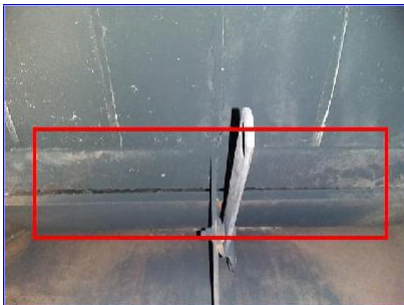
J. Item 3(Picture)

(4) The damper is missing the required clamp or bracket to prevent complete closure on a gas log fireplace. This not considered to be today's standard. I recommend having a qualified person make repairs as needed.

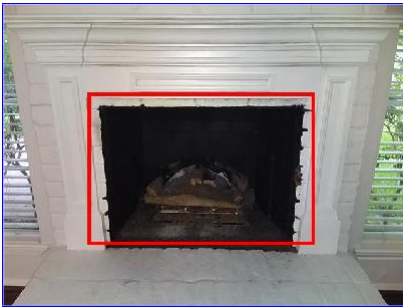
(6) The screen curtains at fireplace in the Living room missing. I recommend repair as needed.

Fixed – Per Seller

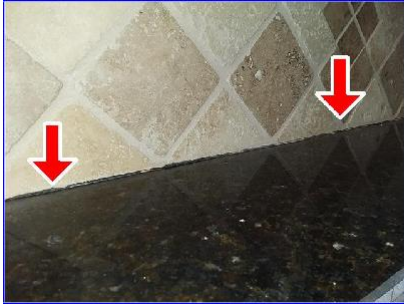
L. Item 1(Picture) kitchen areas

(1) Areas of the home have caulking or grout missing or damaged. Deterioration could occur if not corrected. I recommend having a qualified contractor inspect and make repairs as needed.

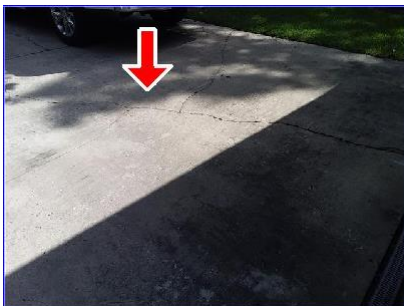
L. Item 4(Picture) drive way areas

(2) The concrete drive and concrete walkway at the exterior areas has settlement cracks. Further deterioration can occur if not repaired. A qualified contractor should inspect and repair as needed.

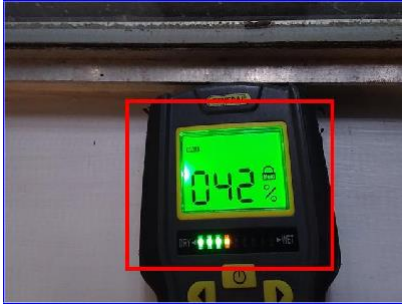
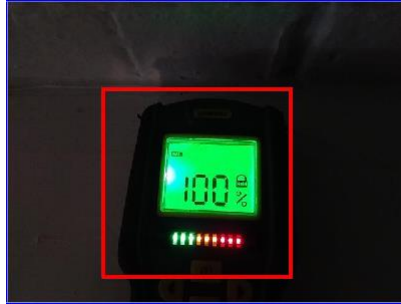
(3) Using thermal image camera and moisture meter area was found to have issues that need to be addressed. I recommend having a qualified contractor further evaluate and make repairs as needed.

L. Item 6(Picture) living room window left side areas

L. Item 7(Picture) living room window right side areas

Fixed - Per Seller

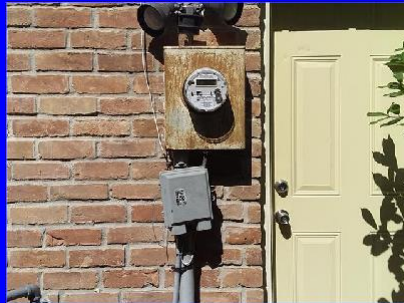
meter box left side of home underground service

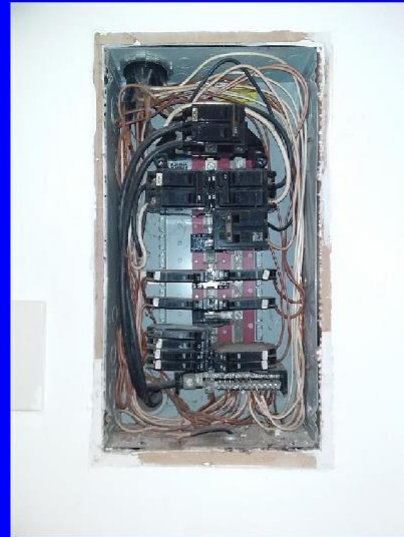
breaker box inside garage 100 amp

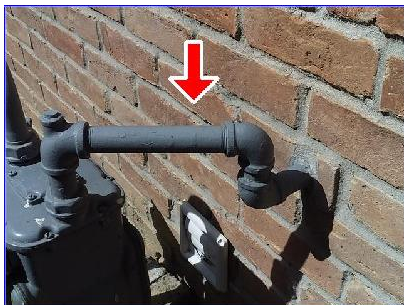
(2) I did not see a bond/ground wire on metal plumbing. If there is not one then I recommend a ground wire and clamp be installed on metal plumbing line within five feet from where plumbing line enters home.

Fixed – Per Seller

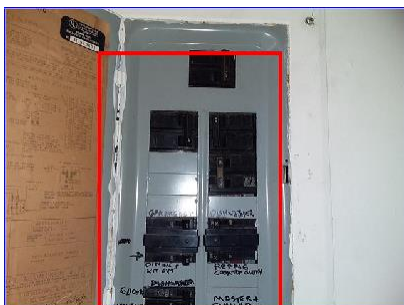
(3) The panel is missing circuit identification. **This is a safety hazard.** I recommend having a qualified person mark circuits as needed.

Fixed – Per Seller

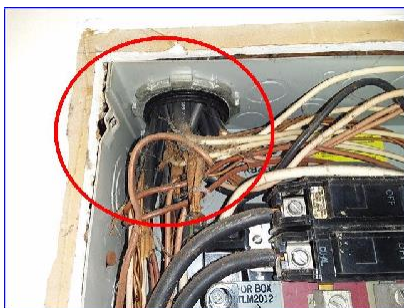
(4) The electrical panel has branch circuit wires bundled together that are entering the panel through one to two entry points. This is not considered today's standard. It is recommended that each sheathed wire enter the panel independently and be sealed for fire blocking purposes. I recommend having a qualified electrician evaluate and make repairs as needed.

Fixed – Per Seller

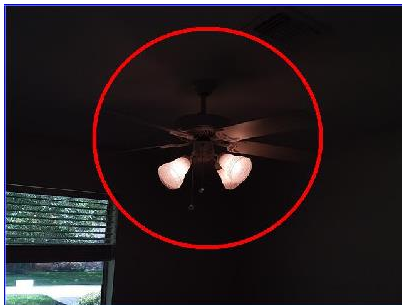
B. Item 1(Picture) left side bedroom

(2) The ceiling fan "wobbles" . Some fans that wobble cannot be corrected without replacement This is for your information. A qualified licensed electrical contractor should perform repairs that involve wiring I recommend repair as needed.

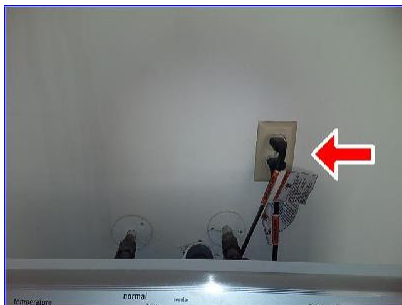
B. Item 2(Picture) washer dryer area

(3) There are no GFCI protected circuits in required area's. This is not considered to be today's standard. I recommend having a qualified electrician make repairs as needed.

Fixed – Per Seller

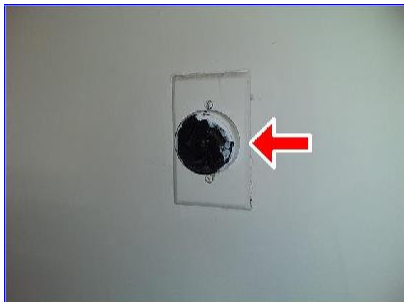
B. Item 3(Picture) washer dryer area

(4) A three prong outlet for dryer is present in laundry room. This is not considered today's standard. Today's standard requires a four prong outlet be installed. I recommend having a qualified electrician to inspect and make repairs as needed.

Per Seller: This outlet is not used since dryer is gas.

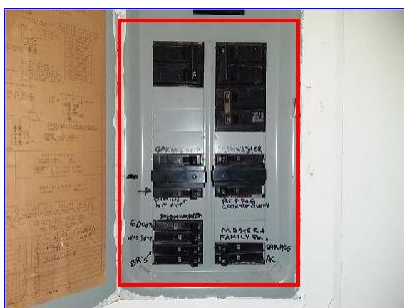
(5) Arc fault breakers are not in required areas of home at electrical panel. This is not considered today's standard. I recommend having a qualified electrician inspect and make repairs as needed.

Fixed - Per Seller

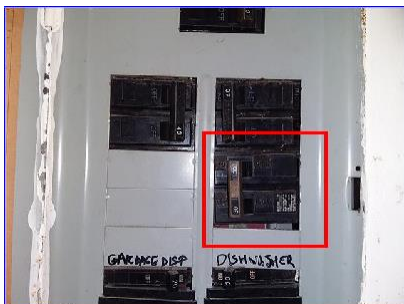
B. Item 4(Picture)

(6) At least one circuit breaker in main panel is of a different brand than panel manufacturer. The manufacturer requires that in order for the panel to be safe, only their brand is allowed to be used inside the panel. Even though these circuit breakers are all "UL approved," they are not approved to be used in panels of different manufacturers unless so indicated on the panel label.

Fixed - Per Seller

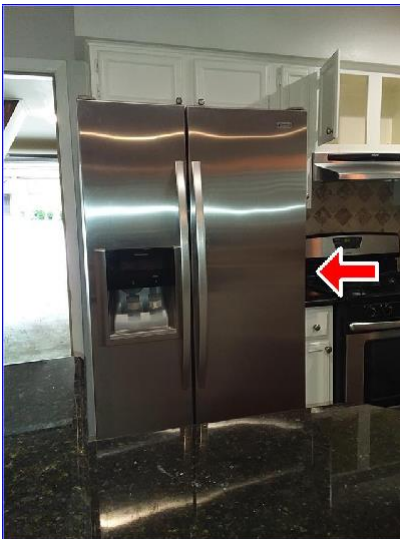
B. Item 8(Picture)

(8) I could not identify or inspect the outlet for refrigerator. I do not move refrigerators in order to access the outlet.

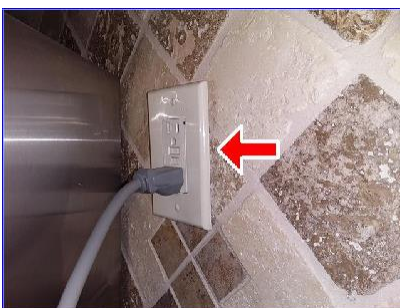
B. Item 9(Picture) most if not all rooms

(9) At least one "three-prong" outlet is loose in wall in most if not all rooms. This is a safety issue that needs to be corrected. Electrical issues are considered a hazard until repaired. A qualified licensed electrical contractor should perform repairs that involve wiring. I recommend repair as needed.

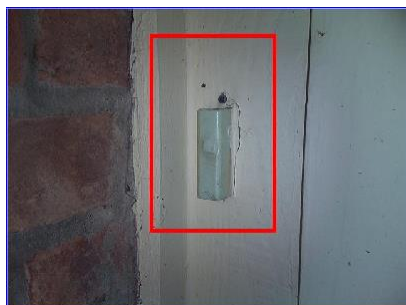
(11) Doorbell did not work properly at the time of inspection. I recommend having a qualified person repair.

Fixed - Per Seller

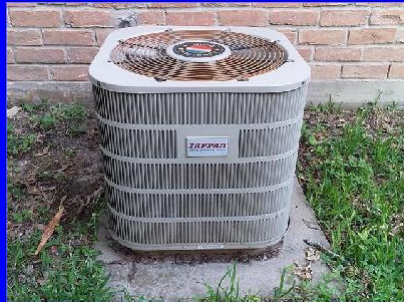
tappan

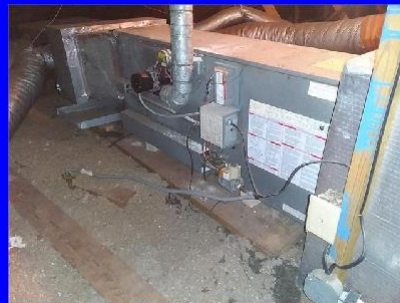
unknown brand

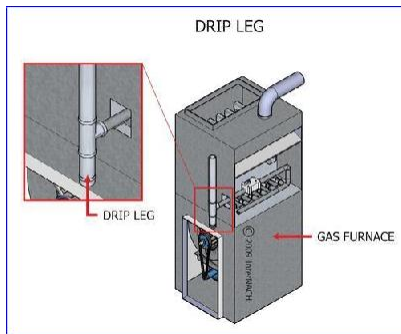
A. Item 2(Picture) dripleg

(3) The gas furnace is installed without the recommended sediment trap or "drip leg" that is designed to extend the life of the unit. This is not considered to be today's standard. I recommend having a qualified person make repairs as needed.

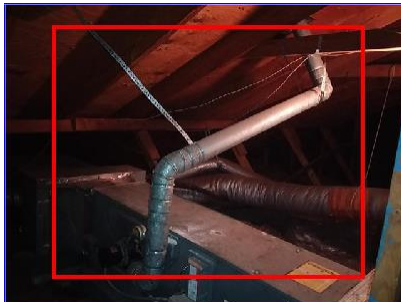
A. Item 4(Picture)

(4) Furnace flue piping appears to be under sized. I recommend having a qualified HVAC contractor further evaluate and make repairs as needed.

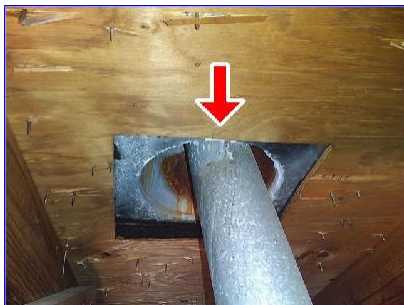
A. Item 5(Picture)

(5) Furnace flue piping is in contact with combustible materials in attic space. This is a safety issue. I recommend having a qualified contractor further evaluate and make repairs as needed.

Fixed – Per Seller

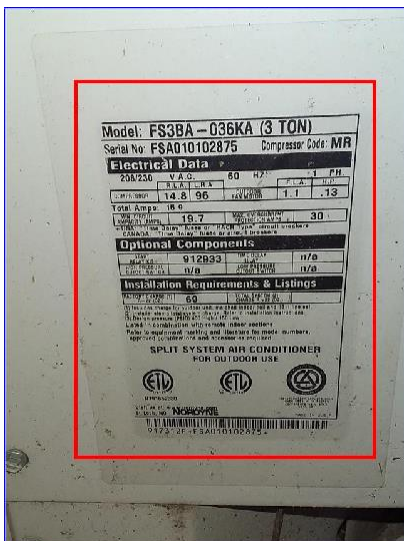
B. Item 1(Picture)

- (1) It is recommended to have HVAC systems serviced annually.
- (2) The condenser outside (AC unit) is very old and may last a few years more, but maybe not. I have seen units fail shortly after a home inspection during the seasonal change from mild to hot weather. I cannot determine how long your AC will last before a replacement is necessary.

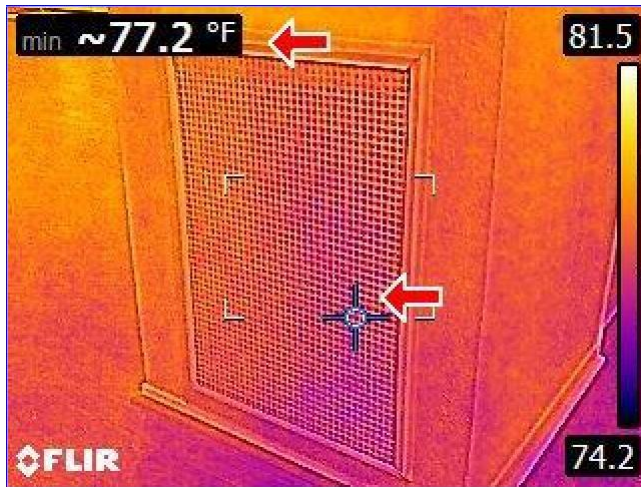
(4) The ambient air test was performed by using infrared thermal equipment at the supply vents of Air conditioner to determine if the difference in temperatures of the supply and return air are between 14 degrees and 22 degrees which indicates that the unit is cooling as intended. The supply air temperature on your system read 67 degrees, and the return air temperature was 77 degrees. This indicates that the unit is **not** cooling properly and a licensed Heat/Air contractor should inspect for cause or problem.

B. Item 4(Picture) return

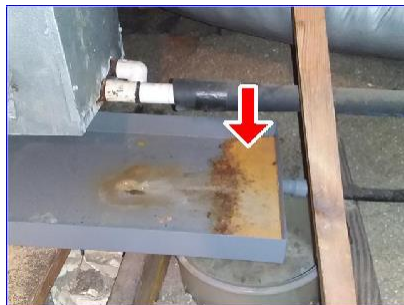
B. Item 5(Picture)

(5) The emergency overflow drain pan for the HVAC system is showing signs of deterioration. Further deterioration may occur if not corrected. I recommend having a qualified person make repairs as needed.

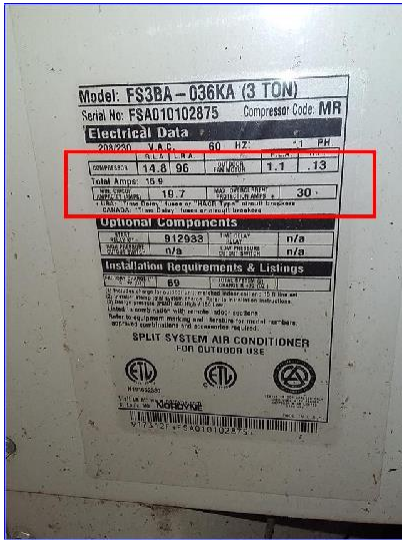
(6) Condenser breaker does not meet minimum standard per the manufacturer specifications. I recommend having a qualified HVAC contractor inspect and repair as needed.

B. Item 6(Picture) 19 amp minimum

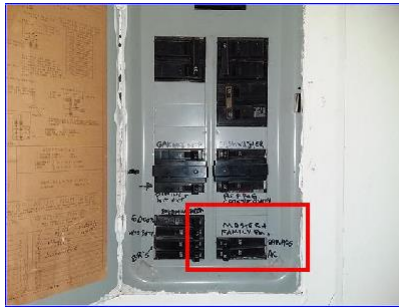
B. Item 7(Picture) 15 amp

Fixed – Per Seller

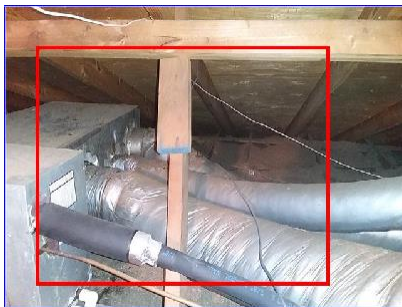
C. Item 1(Picture) various areas

(2) Duct piping appears to be in contact with one another in the attic space. Condensation could occur if not corrected. I recommend having a qualified HVAC contractor further evaluate and make repairs as needed.

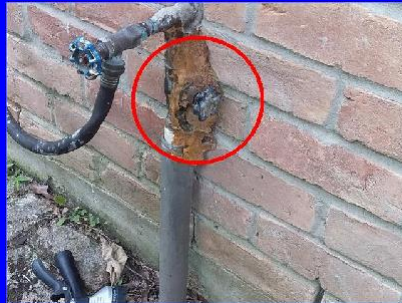
water shutoff right side of home

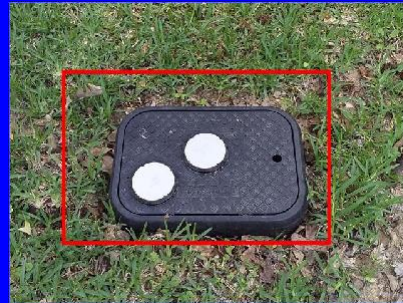
water meter front right of home

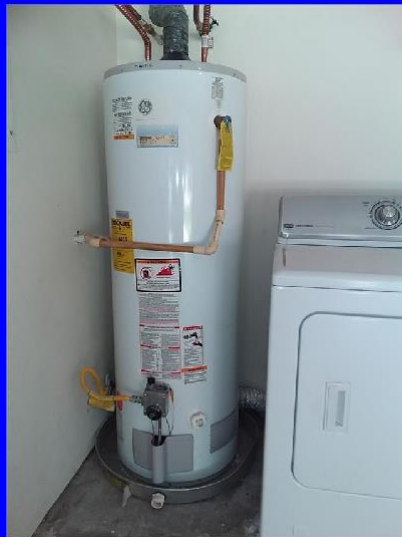
General Electric

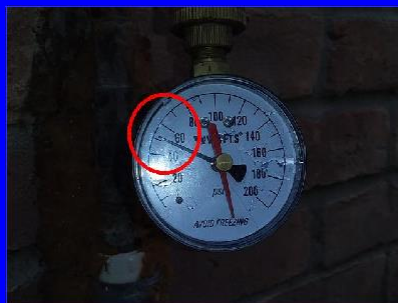
water pressure 50 psi

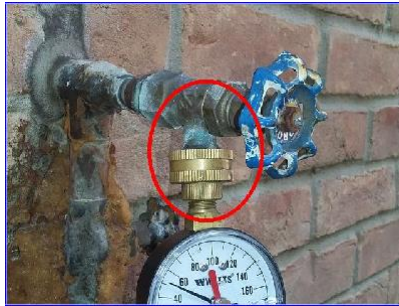
(1) There is no Anti Siphon device installed on exterior faucet(s). This is not considered to be today's standard. I recommend having a qualified person make repairs as needed.

A. Item 2(Picture) all exterior faucets

Fixed - Per Seller

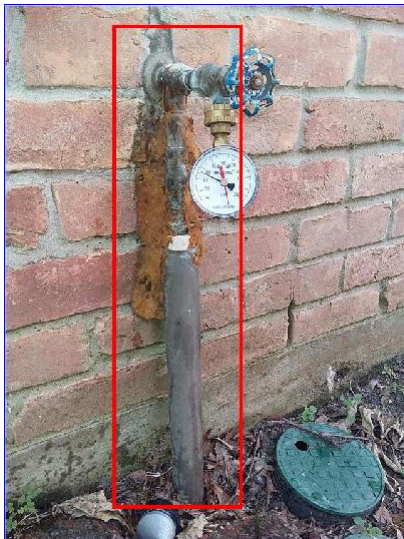
A. Item 3(Picture) right side of home

(2) Supply line is not insulated in areas. I recommend having a qualified plumber inspect and repair as needed.

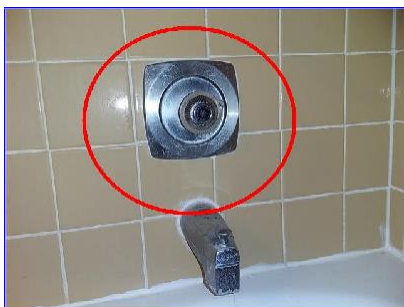
A. Item 4(Picture) guest bath

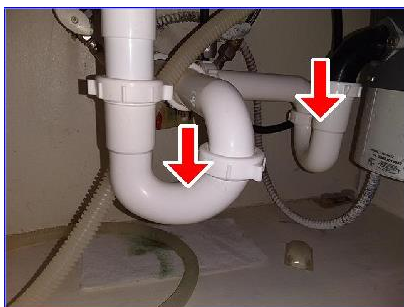
B. Item 1(Picture) kitchen sink

The waste line is "double trapped" which can create an air lock at the Kitchen sink. This is not considered up to today's standard Repairs are needed. A qualified licensed plumber should repair or correct as needed.

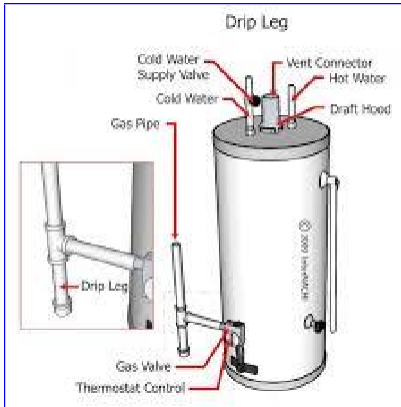
C. Item 1(Picture)

(1) The water heater is installed without the recommended sediment trap or "drip leg" that is designed to extend the life of the unit. This is not considered to be today's standard. I recommend having a qualified plumber make repairs as needed.

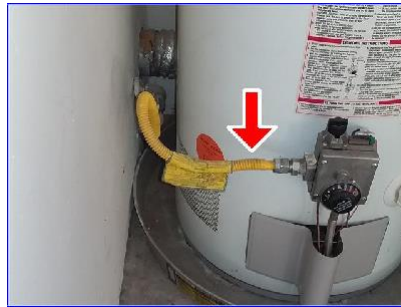
C. Item 2(Picture)

(2) Gas water heater is not installed at the recommended 18 inches above grade. This not considered to be today's standard. I recommend having a qualified plumber make repairs as needed.

Fixed – Per Seller

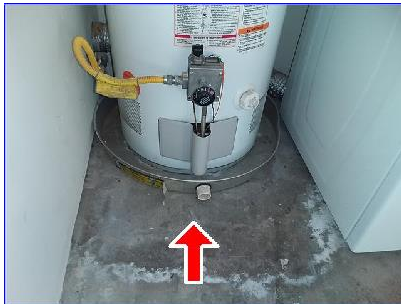
C. Item 3(Picture)

(3) Secondary drain line for water heater does not plumb to the exterior of the home. This is not considered today's standard. I recommend rerouting to exterior.

Fixed – Per Seller

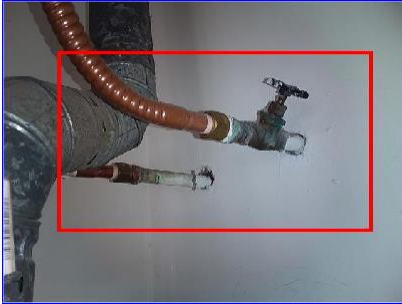
C. Item 5(Picture)

(5) The existing piping for T&P valve on water heater is piped horizontally. A more thorough inspection by a qualified contractor is needed. A qualified licensed plumber should repair or correct as needed.

Fixed – Per Seller

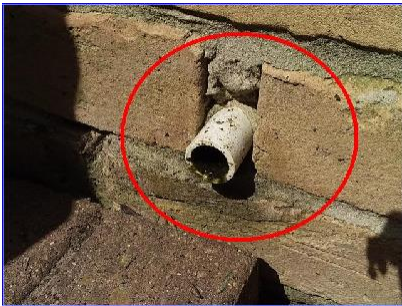
(6) TPR is missing fitting and may be leaking. I recommend having a qualified plumber inspect and repair as needed.

Fixed – Per Seller

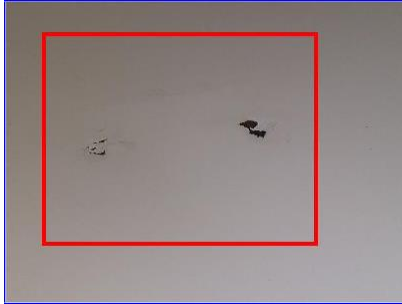
The bathtub is chipped (Cosmetic) at the . This is a cosmetic issue for your information A qualified person should repair as necessary.

D. Item 1(Picture) guest bath

Fixed – Per Seller

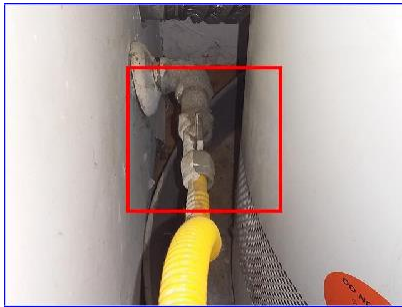
E. Item 1(Picture) various areas

Older style gas valves are in use in areas. I recommend having a qualified plumber further evaluate and make repairs as needed.

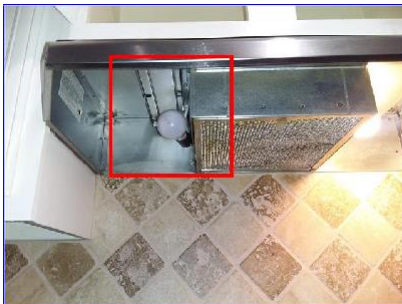
C. Item 1(Picture)

(1) The light bulb for fan did not work when tested. I recommend repair or replace as needed.

Fixed – Per Seller

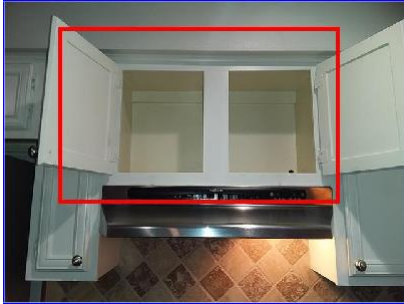
C. Item 2(Picture)

(3) The grease filter on range hood fan has crust or grime build-up. I recommend repair or replace as needed.

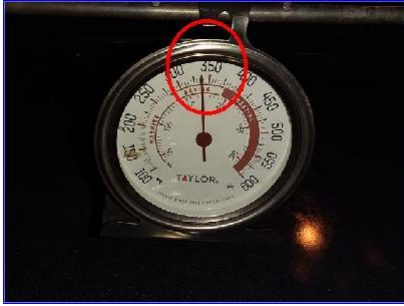
D. Item 3(Picture) tested @ (350)
F

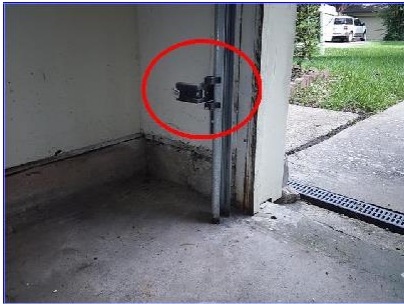
G. Item 1(Picture)

(1) The sensors are in place for garage door(s) and will reverse the door. However the sensors are higher than recommend standard.

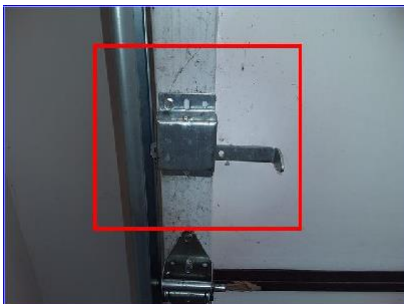
G. Item 2(Picture)

(2) The automatic opener for garage door at the front of home has a lock that has not been disabled for automatic opener. This is a maintenance issue and is for your information. A qualified contractor should inspect and repair as needed.

Fixed - Per Seller

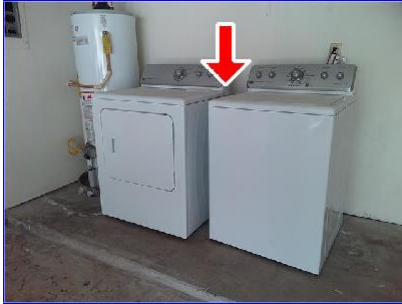
H. Item 1(Picture)

(1) Washer dryer area was not fully inspected due to appliances being installed. This is for your information.

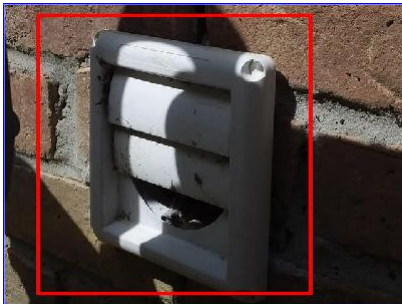
(2) The weather cover for the dryer vent is not adequate. I recommend having a qualified person repair as needed.

H. Item 2(Picture) left side of home

Fixed – Per Seller

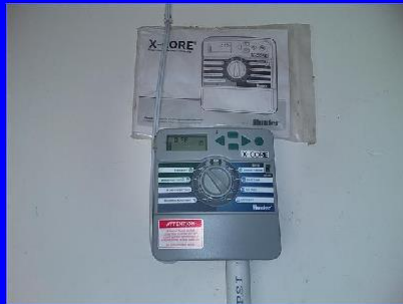
sprinkler system control panel
inside garage

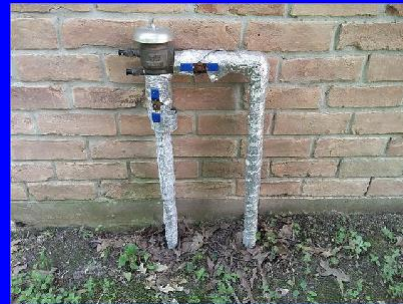
backflow preventer right side of
home

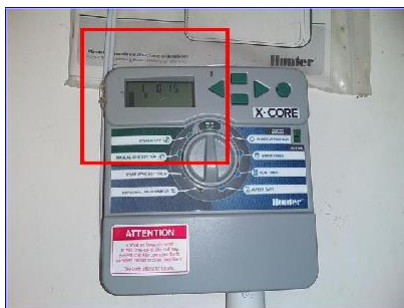
A. Item 1(Picture) zone 1 did not
activate

Sprinkler system is not in working order at the time of inspection. I recommend having a qualified person make repairs as needed.
