Texas WDI Report For: 207 E Texas Street, Calvert, TX 77837
Prepared Exclusively For: Pat Altemus
Inspected On: Monday, March 22, 2021

TEXAS OFFICIAL WOOD DESTROYING INSECT REPORT

207 E Texas Street

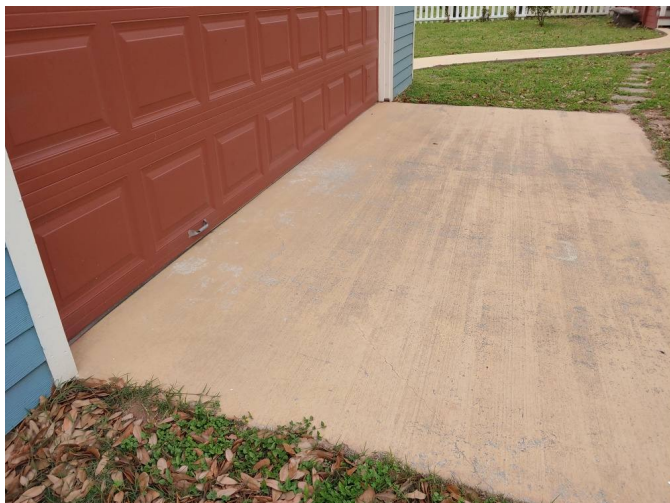
S/S. Separate Slabs

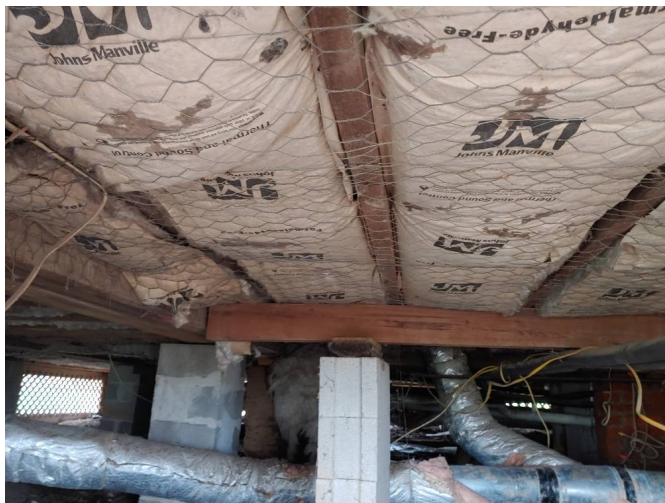
Insulation under home

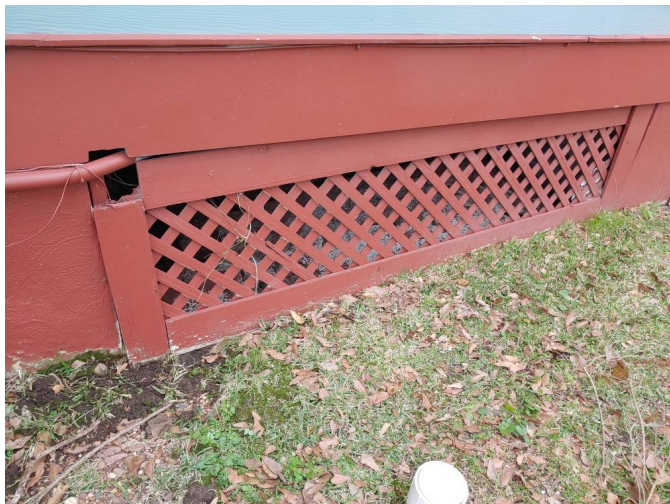
MS. Moisture stain

MS=Moisture Stains

Increases the Chance of: Termites, Carpenter Ants, all other insects.

Remedies: Need to have checked to make sure there is still not an active leak.

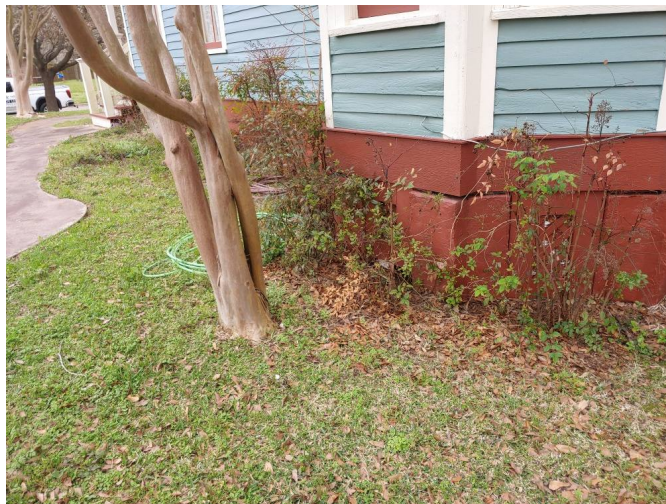
G. Wood to Ground contact on vents

G=Wood To Ground Contact

Increases the Chance of: Termites, Fire Ants, Wood Rot, and all other Ants.

Remedies: Correct all Wood to Ground Contact, no Siding or wood trim in contact with the ground.

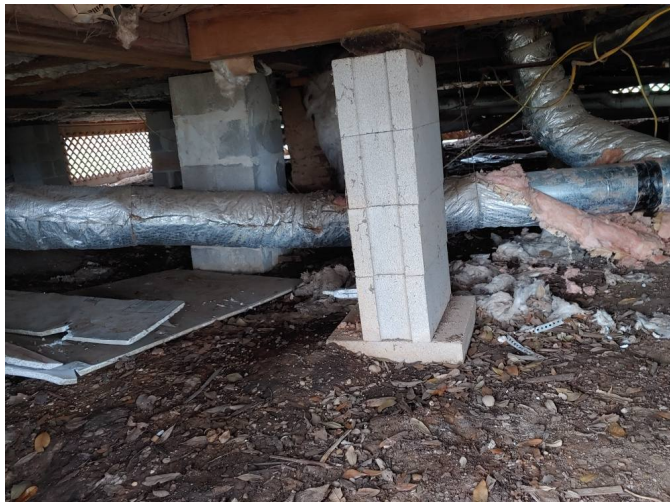
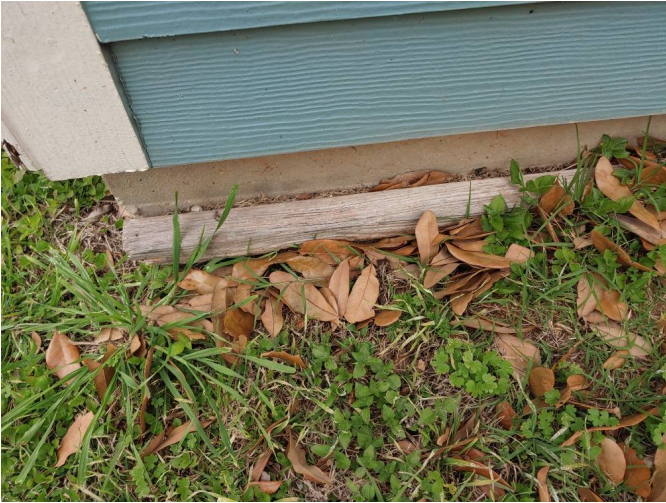
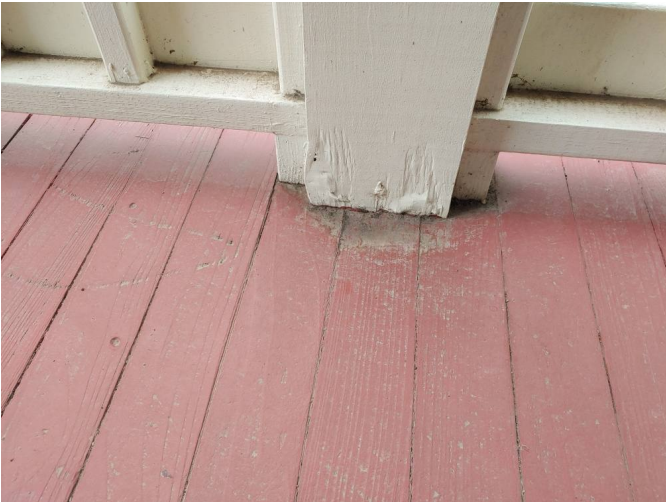
N. Heavy Foliage

N=Heavy Foliage

Increases the Chance of: Carpenter Ants, Spiders, Wood Rot.

Remedies: Keep all tree limbs trimmed back 4 foot from structure. Keep all shrubs, vines, and crepe myrtles 18 inches to 2 foot off the structure.

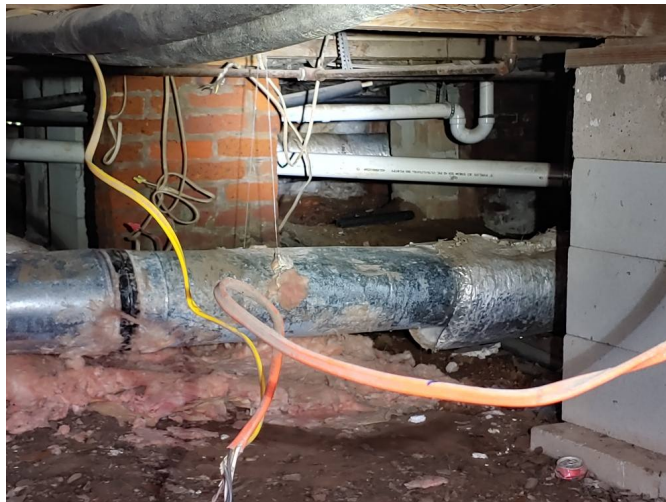
K. Debris under home

K=Debris Under or Around Structure

Increases the Chance of: Termites, Carpenter Ants, Harbors all insects, Wood Rot, Wood Boring Beetles, Carpenter Bees.

Remedies: Keep all debris away from the home. Bricks, Stored wood, leaves & Compost, Keep Gutters & Roof clean of leaves & limbs.

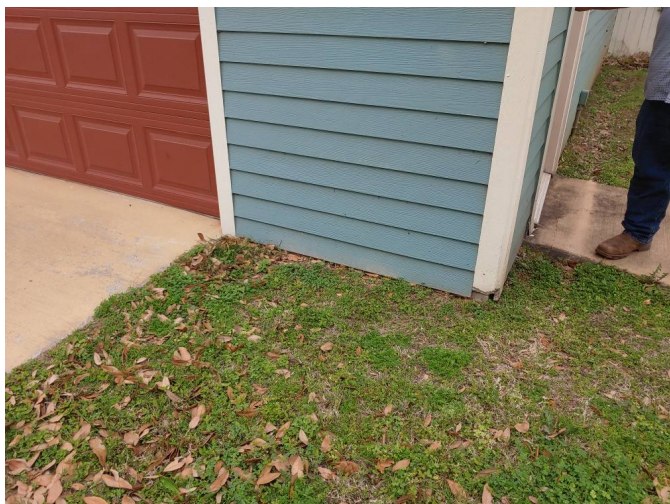
J. Excess water leak

J=Excessive Moisture

Increases the Chance of: Termites, Carpenter Ants, and all other Insects.

Remedies: Fix all leaks; correct all standing water around home, All water and gutters should drain away from the slab.

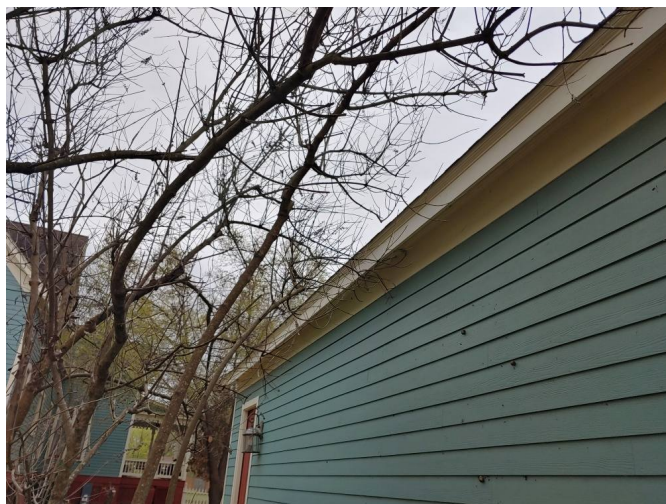
L. Ground High on slab

L=Footing too Low or Soil Line too High

Increases the Chance of: Termites, Fire Ants, Moisture Damage.

Remedies: Try to keep a minimum of 2 to 4 inches of slab exposure around the home.

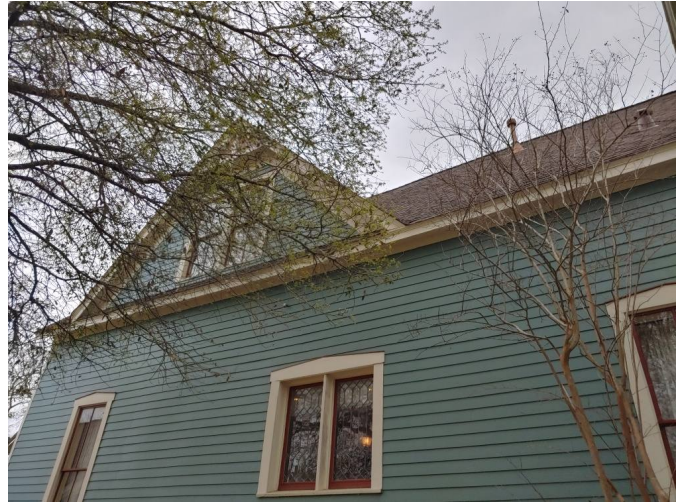
I. Form boards left in place

I=Form boards left in Place

Increases the Chance of: Termites, Carpenter Ants, Fire Ants.

Remedies: Remove when they rot out and replace with caulk or sand.

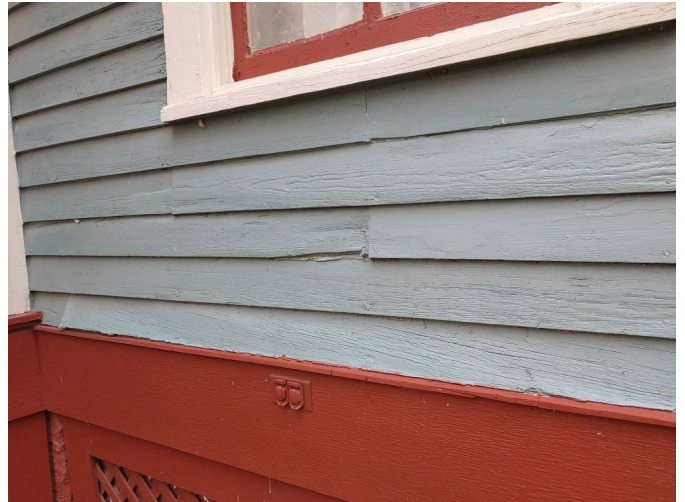
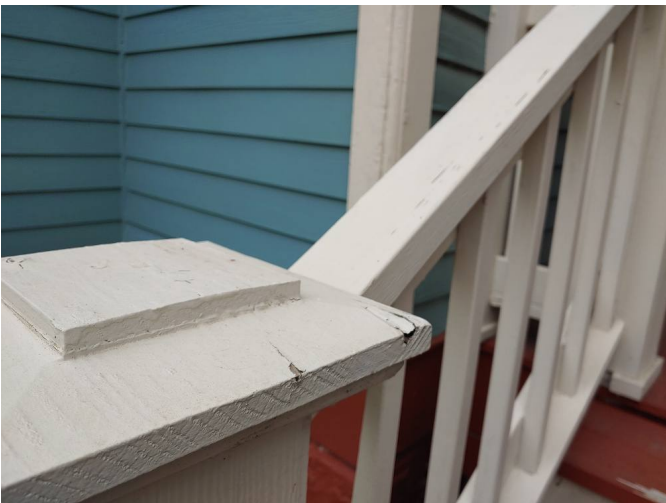
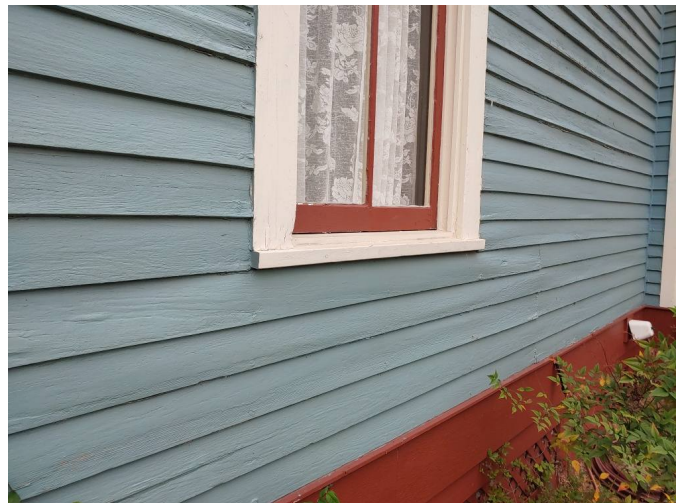
M. Wood rot

M=Wood Rot

Increases the Chance of: Termites, Carpenter Ants, Carpenter Bees, Wood Boring Beetles, all other Insects.

Remedies: Replace all wood rot, caulk and seal, keep all exterior wood painted and sealed.
