TREC REI 7-5

4309 Feagan St C  
Houston TX 77007

# PROPERTY INSPECTION REPORT

Concerning: 4309 Feagan St C, Houston TX 77007

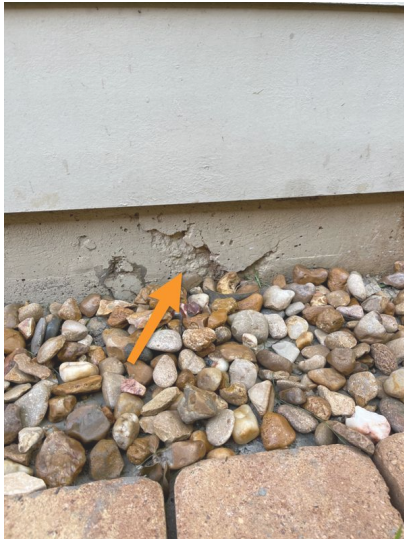
Rear

**1: Foundation Cracks - Minor**

Minor cracking was noted at the foundation. This is common as concrete ages and shrinkage surface cracks are normal. Recommend structural engineer if more serious shifting/displacement occurs.

Recommendation: Contact a qualified professional.

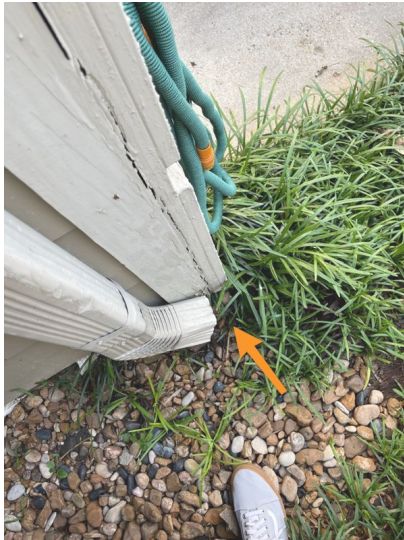
Left side

Observed missing splash blocks at gutter downspouts. Recommend installing splash blocks to prevent possible localized erosion in soil under the foundation.

Recommendation: Contact a handyman or DIY project

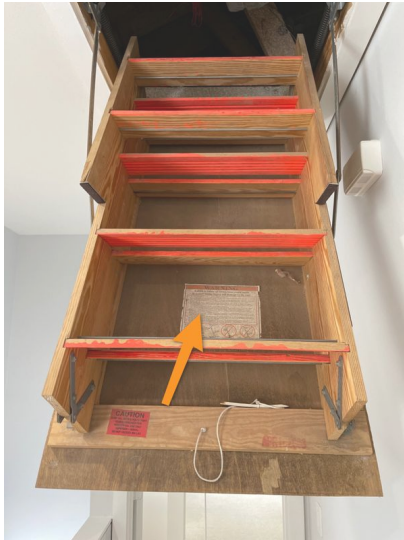
3rd Floor- attic

**1: Missing Insulation- Attic Stairway**

Observed missing insulation on attic stairway. Attic stairways should have an insulated cover to help prevent energy loss.

Recommendation: Contact a handyman or DIY project

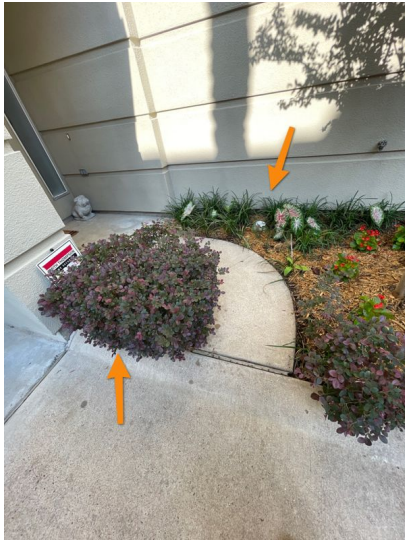
Front

Observed vegetation making contact with exterior walls. Vegetation that is making contact with the surface of exterior walls is detrimental to exterior siding performance.

Recommendation: Contact a qualified landscaping contractor

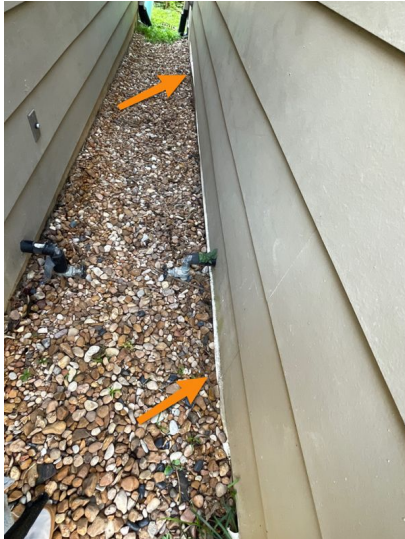
Left side

Observed exposed vapor barrier behind siding. Vapor barrier should be trimmed evenly with siding material to prevent moisture puddling and potentially wicking into siding material.

Recommendation: Contact a handyman or DIY project

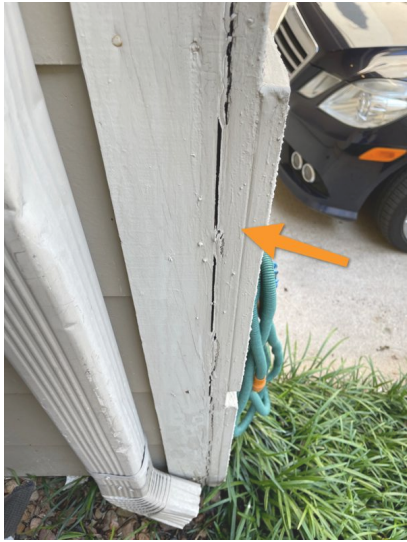
Left side

### 3: Deteriorating Caulk

Observed deteriorating caulk in one or more locations. Deteriorating caulk, over time, will allow moisture penetration. Recommend repairing affected areas to prevent further issues.

Recommendation: Contact a handyman or DIY project

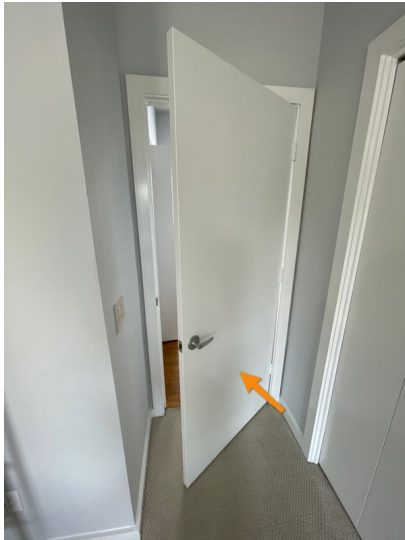
3rd Floor suite

Door doesn't latch properly. Recommend handyman repair latch and/or strike plate.

Recommendation: Contact a qualified handyman.

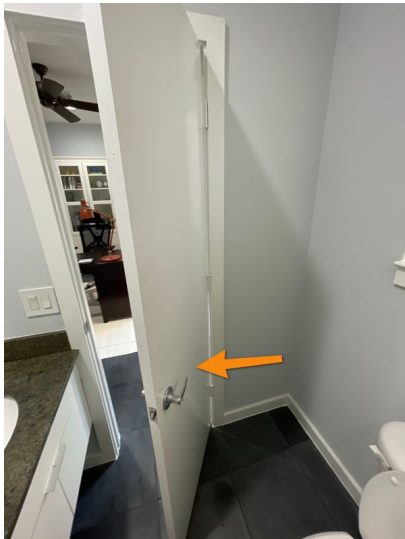
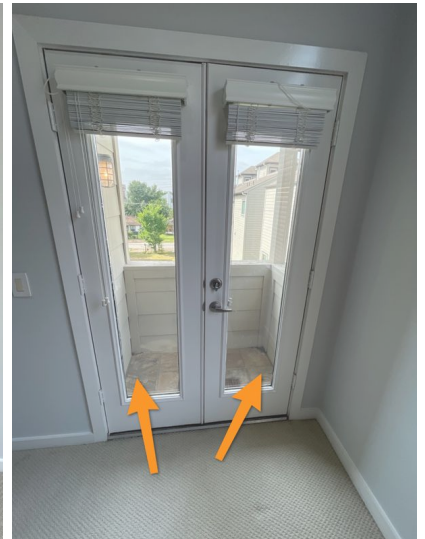
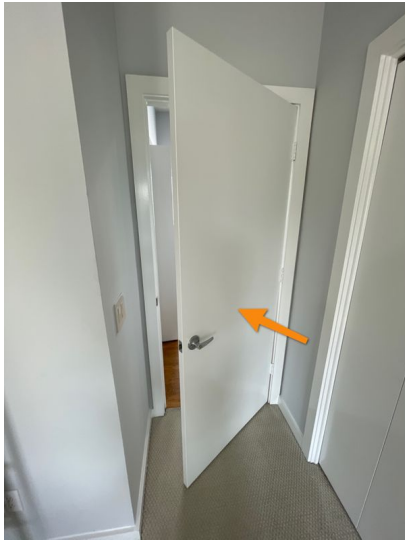
## 2: Missing Doorstop

Observed missing door stops in one or more locations.

Recommendation: Contact a handyman or DIY project

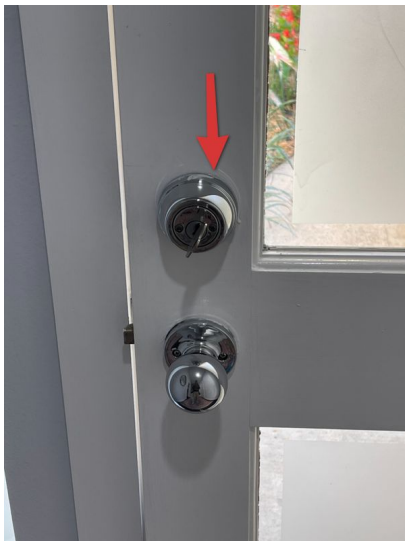
Front door

Observed a keyed deadbolt/lock on door. This poses a safety hazard due to impeding egress.

Recommendation: Contact a handyman or DIY project

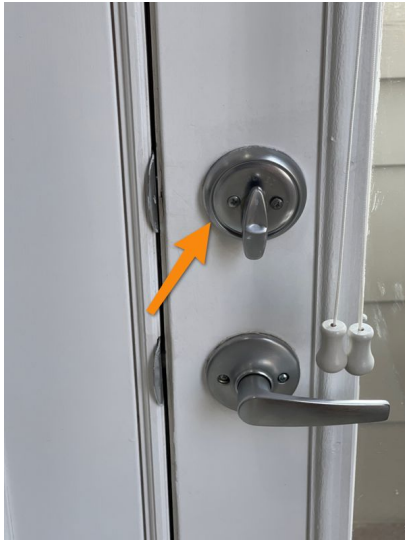
Balcony door

### 4: Defective Door Lock

Observed door lock in one or more locations not effectively locking/unlocking

Recommendation: Contact a handyman or DIY project

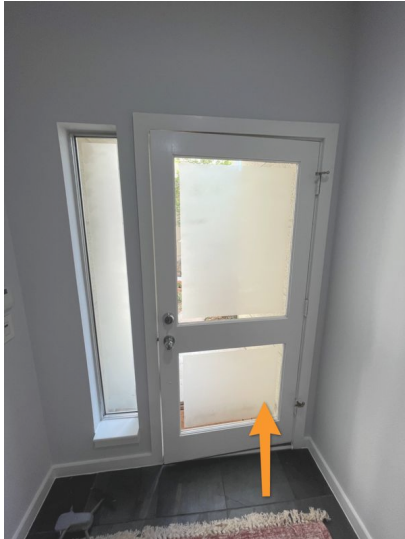
Front door

### 5: Door Operation

Observed door(s) not closing properly when tested. Doors not opening and closing properly could be from the home settling, painting of door and frame or the door needs adjusting.

Recommendation: Contact a qualified professional.

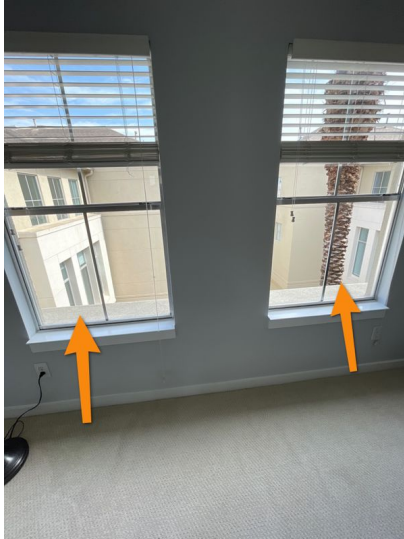
3rd Floor suite

**1: Missing/Damaged Screen(s)**

Observed one or more windows with damaged or missing window screens.

Recommendation: Contact a qualified window repair/installation contractor.

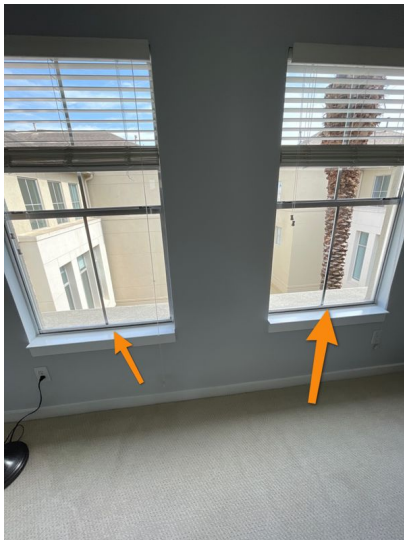
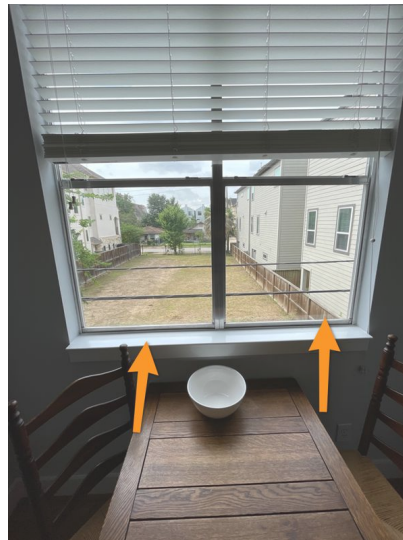
Observed one or more windows not opening properly. Window(s) spring balance not functioning as intended or needs adjustment. Recommend a qualified professional to further evaluate.

Recommendation: Contact a qualified professional.

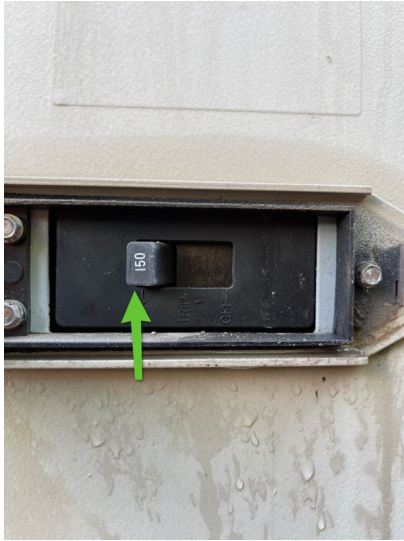
Electrical service to home is 150amps

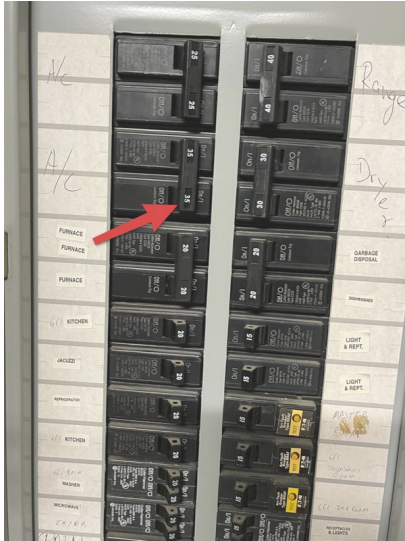
#### 4: Improper Breaker

Observed wrong capacity breaker for one or more circuits. Recommend a qualified electrical professional to further evaluate.

Max breaker 30amp, 35amp installed

Recommendation: Contact a qualified electrical contractor.

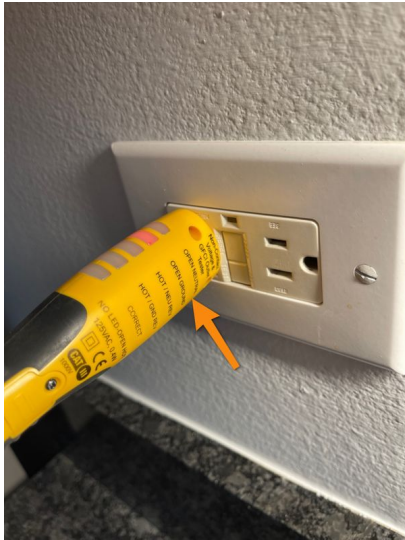
Right side of refrigerator

Observed open ground on one or more outlets. Outlets installed in homes built in the early 60's - 70's were wired with two wires and didn't require a grounding wire. Recommend consulting an electrical contractor for further evaluation.

Recommendation: Contact a qualified electrical contractor.

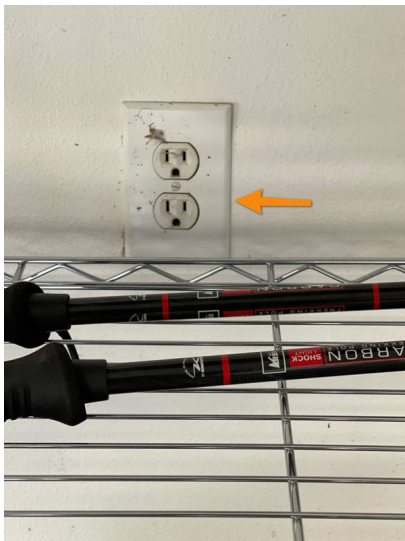
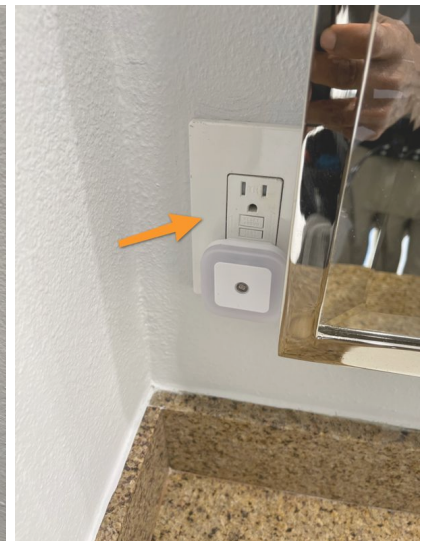
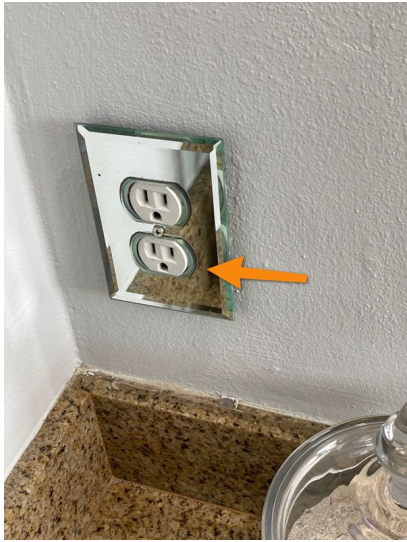
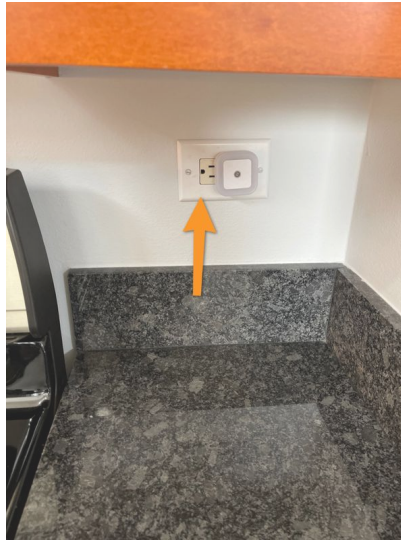
## 2: Missing GFCI Labels

Observed missing GFCI labels at one or more outlets.

Recommendation: Recommended DIY Project

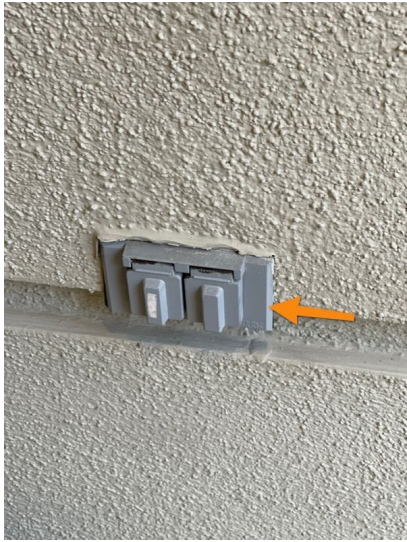
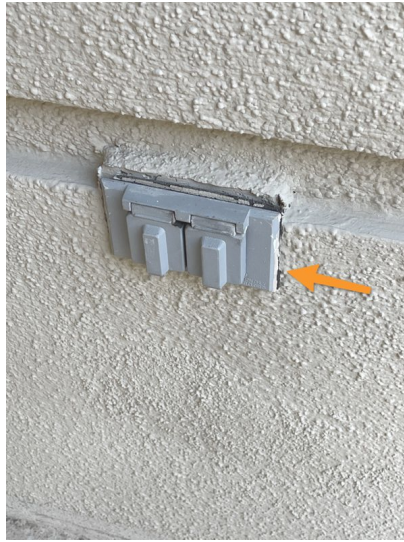
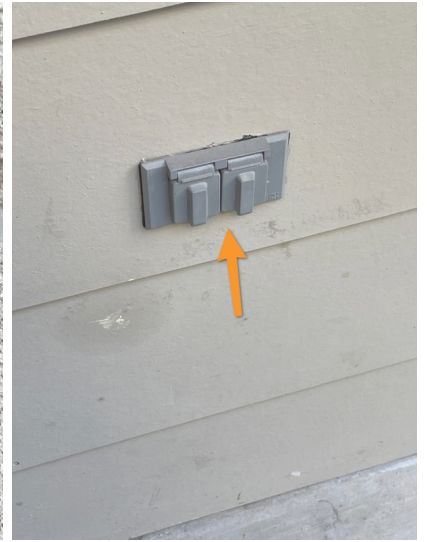
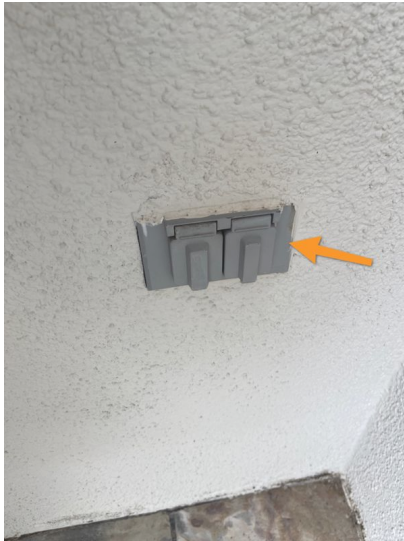
### 4: Bubble Cover

Observed missing bubble cover at one or more exterior outlets. Bubble covers protect outlets from moisture more effectively when they are in use than flip cover protectors. Bubble covers are required on all new construction and therefore this recommendation may not apply to the current structure.

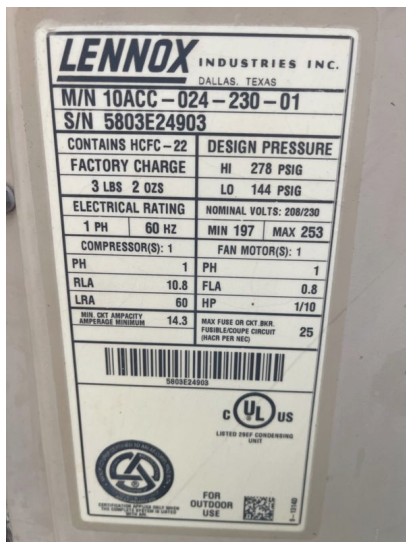
Lennox- Manufactured in May 2003

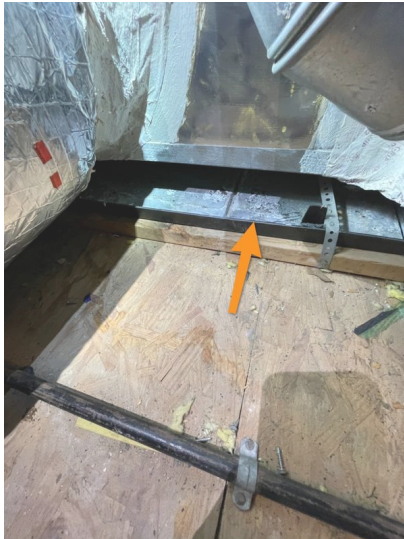
Attic- right side unit

**1: Missing Float Switch**

Missing drain pan float switch on secondary drain pan.

Recommendation: Contact a qualified HVAC professional.

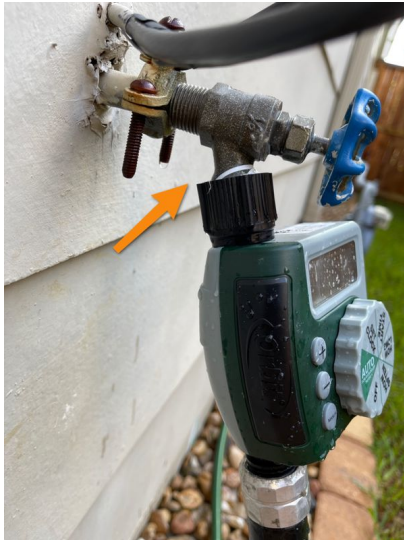
Rear

**1: Missing Backflow Preventer**

Observed hose bibb without backflow preventer device. This device helps to stop and prevent contaminated water, contaminants and chemicals from entering into the water supply. (rear also)

Recommendation: Contact a handyman or DIY project

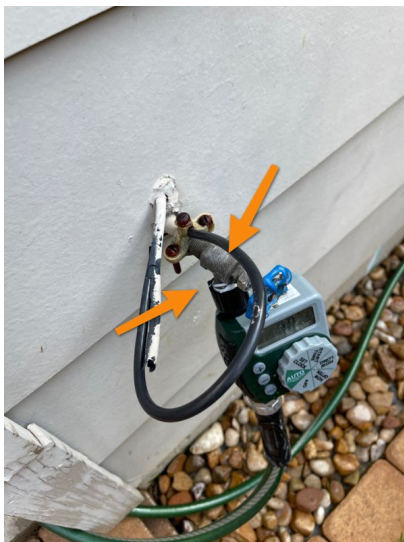
Rear

Observed missing insulation on hose bibb.

Recommendation: Contact a handyman or DIY project

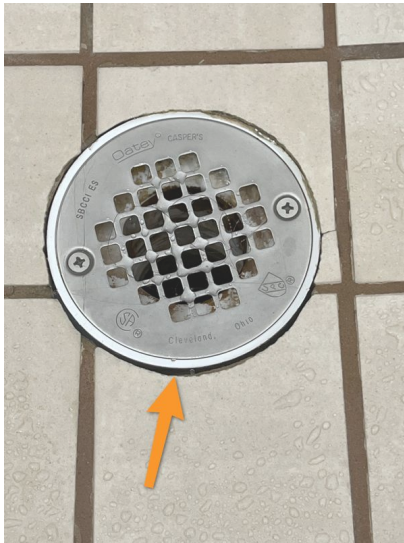
Master Bathroom

**1: Missing Sealant**

Observed missing or deteriorated caulk around shower pan drain.

Recommendation: Contact a handyman or DIY project

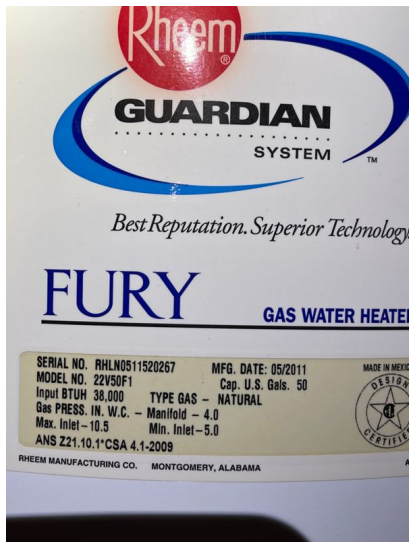
Rheem- Manufactured in May 2011

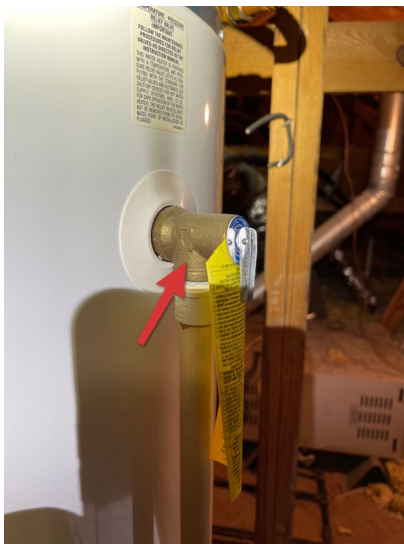
Attic

**3: TP&R Valve Stuck**

The TP&R valve was stuck in the closed position when attempting to test. This may indicate a buildup of sediment in the valve and prevent proper operation. Further evaluation/repair by a licensed plumber is advised.

Recommendation: Contact a qualified plumbing contractor.

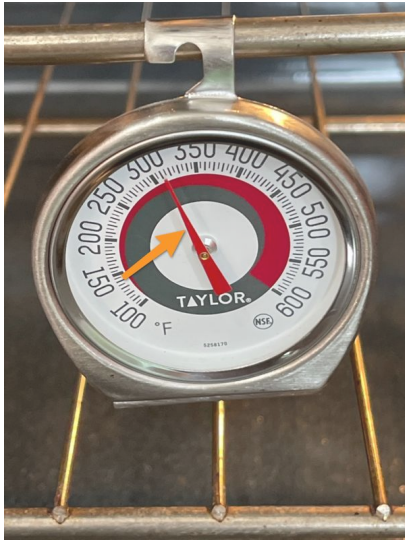
**1: Temp Variance**

Oven set at 350 degrees, temp readings 310 degrees

Recommendation: Contact a qualified professional.

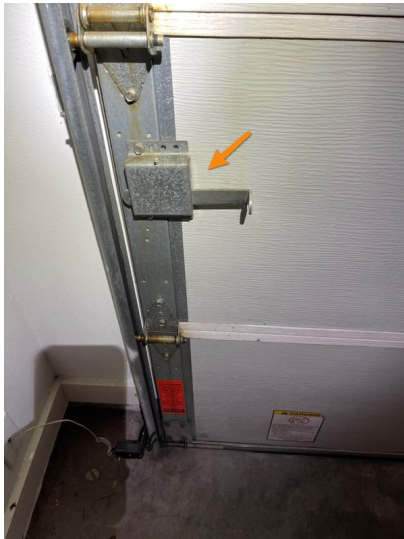
Garage door locking mechanism not disabled with installation of open door operator.

Recommendation: Contact a handyman or DIY project
