Inspection Report

Property Address:
10415 Moraine Lake
Humble Tx 77396

PROPERTY INSPECTION REPORT

By: George Goettee 21045 / G-Tech Home Inspections

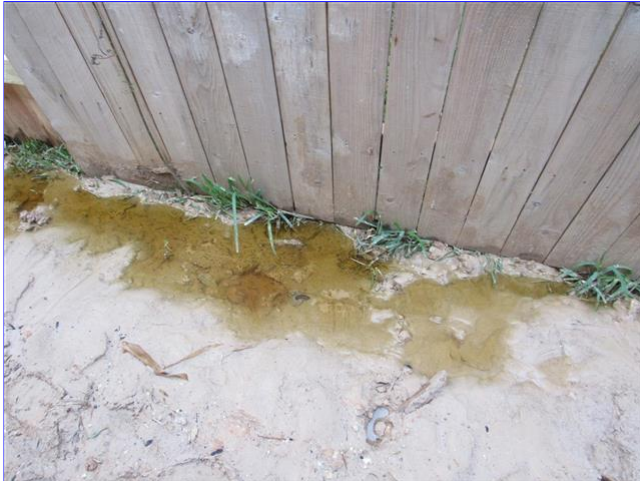
grade appeared to be holding water in some places on January 25 - recommend evaluation by professional contractor/landscaper to drain properly in swales to street

B. Item 1(Picture) grade appeared to be holding water in some places on January 25 - recommend evaluation by professional contractor/landscaper to drain properly in swales to street

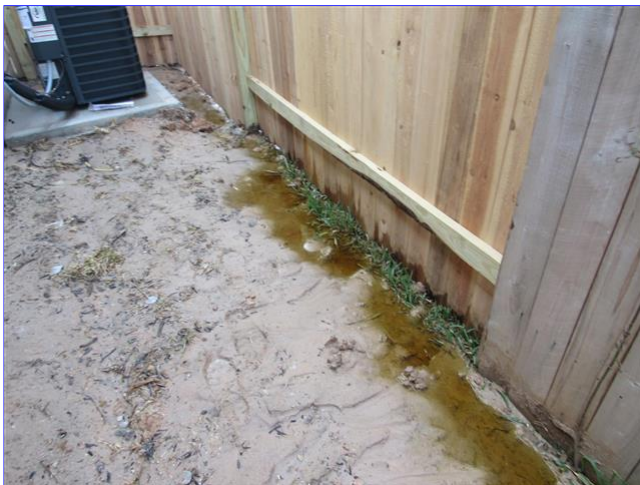
B. Item 2(Picture) grade appeared to be holding water in some places on January 25 - recommend evaluation by professional contractor/landscaper to drain properly in swales to street

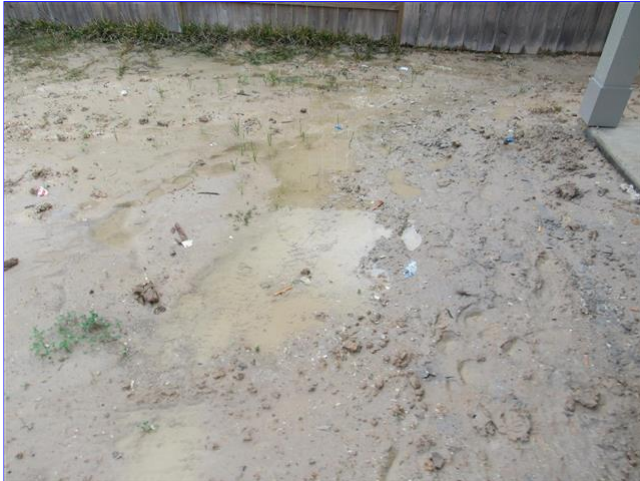
B. Item 3(Picture) grade appeared to be holding water in some places on January 25 - recommend evaluation by professional contractor/landscaper to drain properly in swales to street

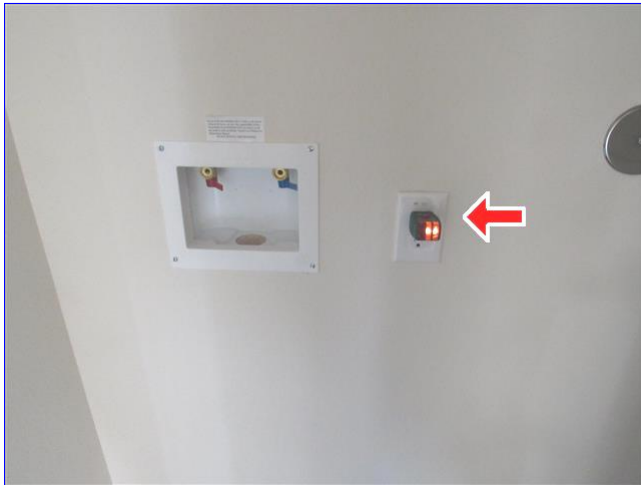
no GFCI for plugs in utility room - recommend adding for safety - required by present code

B. Item 1(Picture) no GFCI for plugs in utility room - recommend adding for safety - required by present code

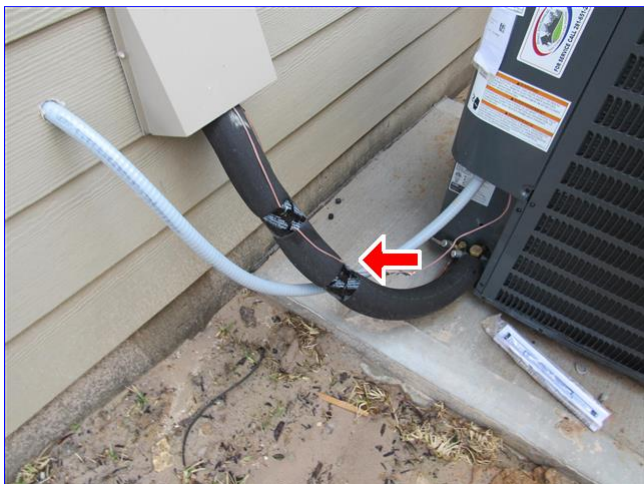
no UV wrap for insulation for suction line at exterior ac unit - recommend adding to prevent damage to insulation

B. Item 1(Picture) no UV wrap for insulation for suction line at exterior ac unit - recommend adding to prevent damage to insulation

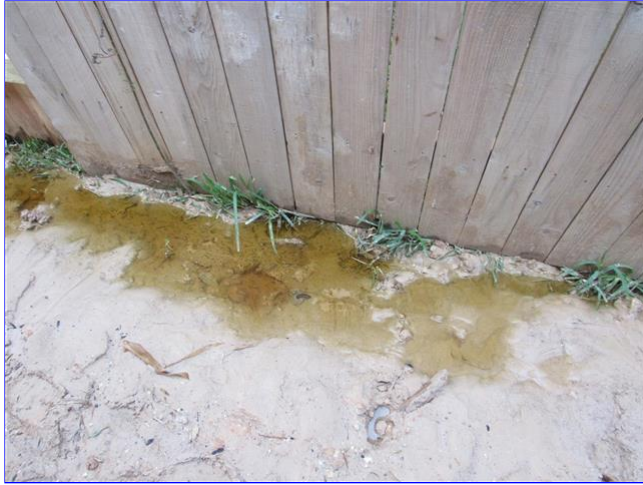
grade appeared to be holding water in some places on January 25 - recommend evaluation by professional contractor/landscaper to drain properly in swales to street

B. Item 1(Picture) grade appeared to be holding water in some places on January 25 - recommend evaluation by professional contractor/landscaper to drain properly in swales to street

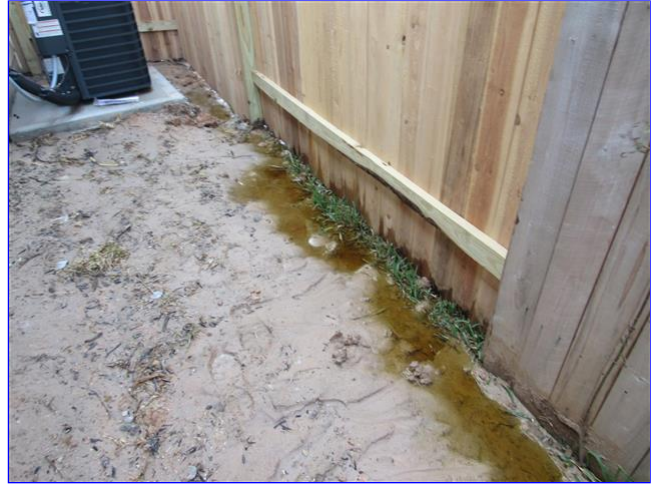
B. Item 2(Picture) grade appeared to be holding water in some places on January 25 - recommend evaluation by professional contractor/landscaper to drain properly in swales to street

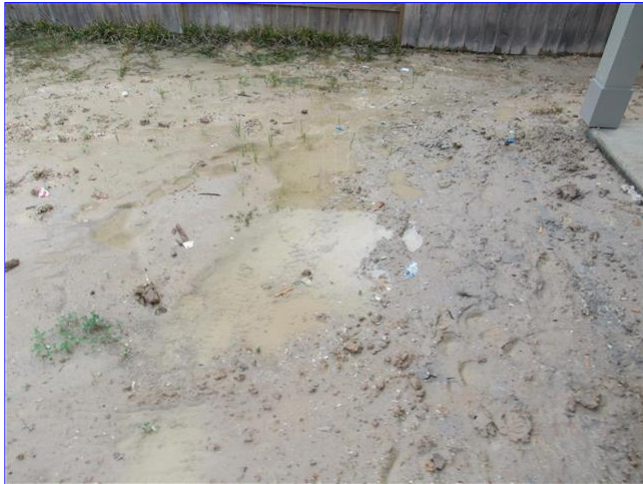
B. Item 3(Picture) grade appeared to be holding water in some places on January 25 - recommend evaluation by professional contractor/landscaper to drain properly in swales to street

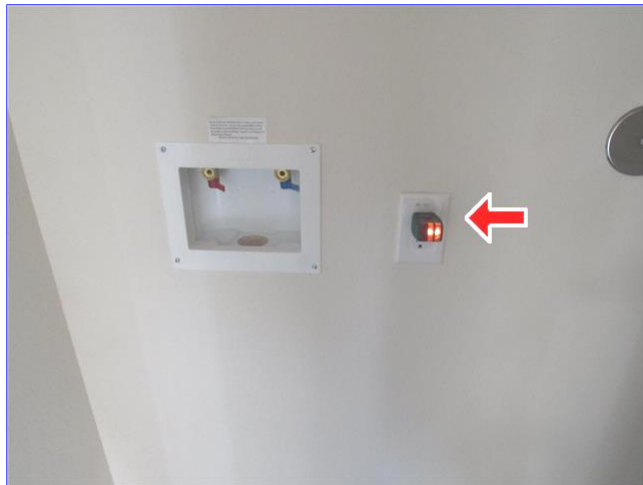
no GFCI for plugs in utility room - recommend adding for safety - required by present code

B. Item 1(Picture) no GFCI for plugs in utility room - recommend adding for safety - required by present code

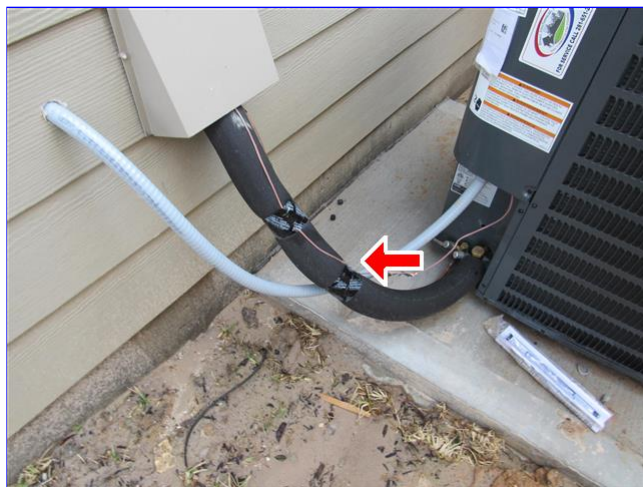
no UV wrap for insulation for suction line at exterior ac unit - recommend adding to prevent damage to insulation

B. Item 1(Picture) no UV wrap for insulation for suction line at exterior ac unit - recommend adding to prevent damage to insulation
