Jay Hicks Inspection Service
"STRUCTURAL & MECHANICAL INSPECTION REPORT"

Property Address: **1216 9th Ave N**

Date of Inspection: **March 28, 2019** Time **9:30** AM PM Term

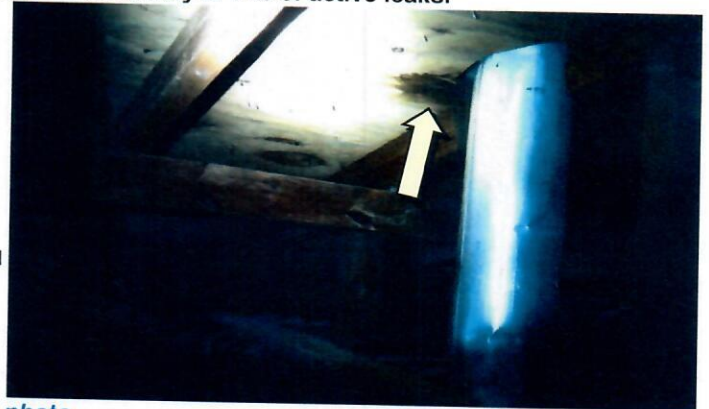
| <input checked="" type="checkbox"/> | <input type="checkbox"/> | <input type="checkbox"/> | <input checked="" type="checkbox"/> | <input checked="" type="checkbox"/> Water damaged roof decking: <i>right side - photo</i> |

****Important Notice**** A professional roofer should inspect the roof and make the appropriate recommendations.

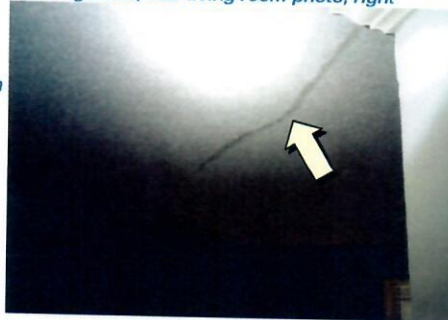
Cracks: *bedroom hallway, front living room, dining room, rear living room-photo, right rear bedroom*

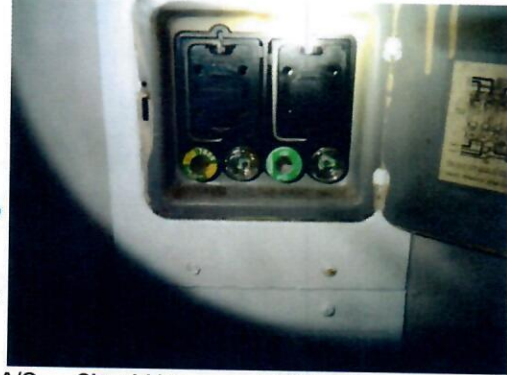
Comments: fuse panel still in use located in right rear bedroom closet, sub panel in middle bedroom closet - improper

Recommend licensed electrician inspect and repair entire electrical system as needed.

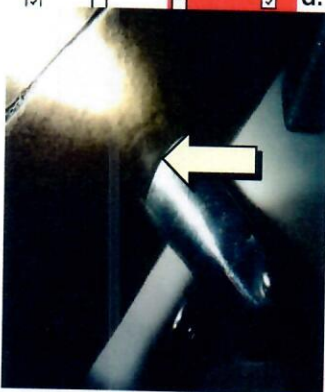
| <input checked="" type="checkbox"/> | <input type="checkbox"/> | <input checked="" type="checkbox"/> | <input checked="" type="checkbox"/> | d. Hall Bath <i>Comments:</i> Lavatory(s): <input type="checkbox"/> Stem packing leaks: <input type="checkbox"/> Hot/cold faucets are not marked <input type="checkbox"/> Missing waste stop: <input type="checkbox"/> Broken waste stop: <input type="checkbox"/> Damaged/cracked sink: <input type="checkbox"/> Unit is loose from wall - improperly Tub/Shower: <input type="checkbox"/> Stem packing leaks <input type="checkbox"/> Hot/cold faucets are not marked <input type="checkbox"/> Missing tub drain plug: <input type="checkbox"/> Broken tub drain plug <input checked="" type="checkbox"/> Open joints indicated / re-caulk or re-grout: around tub spout - photo <input type="checkbox"/> Damaged tub <input checked="" type="checkbox"/> Shower diverter is not operating properly Commode(s) <input type="checkbox"/> Shut off valve leaks: <input type="checkbox"/> Tank is loose from Commode Base: <input type="checkbox"/> Toilet runs <input type="checkbox"/> Commode Base is not secured to floor: <input checked="" type="checkbox"/> Recommend licensed plumber inspect and repair entire plumbing system as needed. |
