HITE TECH INSPECTIONS

HITE TECH TREC REI 7-5

14214 Burgoyne Rd
Houston tx 77077

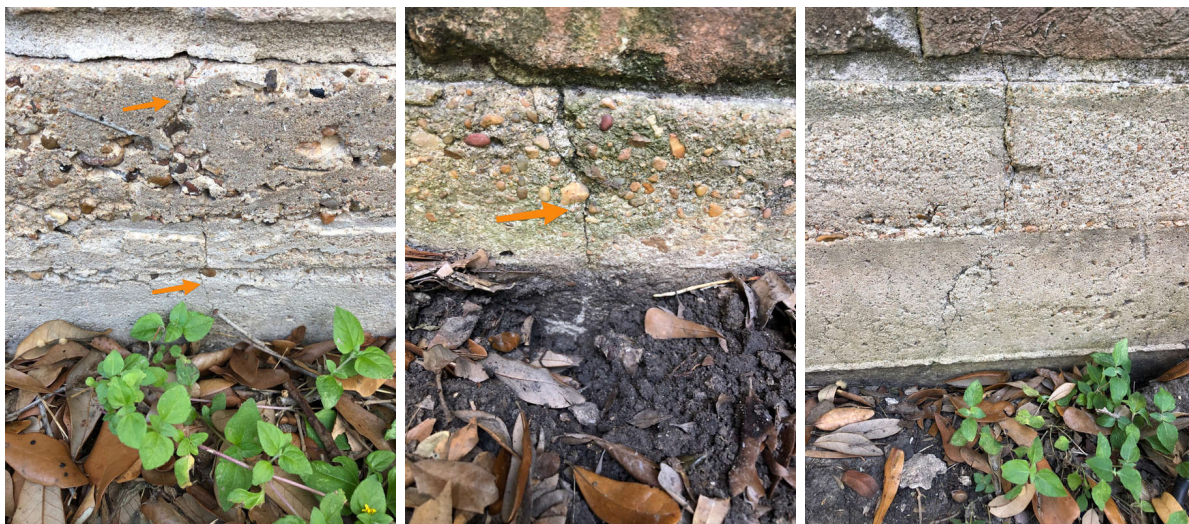
1: Foundation Cracks - Minor

Minor cracking was noted at the foundation. This is common as concrete ages and shrinkage surface cracks are normal. Recommend monitoring for more serious shifting/displacement.

Recommendation: Contact a qualified structural engineer.

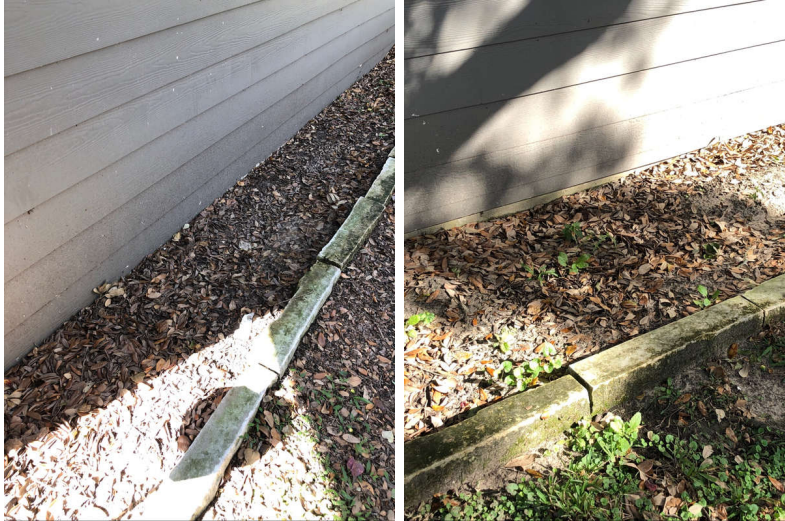
2: Foundation needs to be exposed around perimeter of home

A minimum of 4 in of foundation should be exposed to monitor for pest intrusion and movement.

Recommendation: Contact a qualified professional.

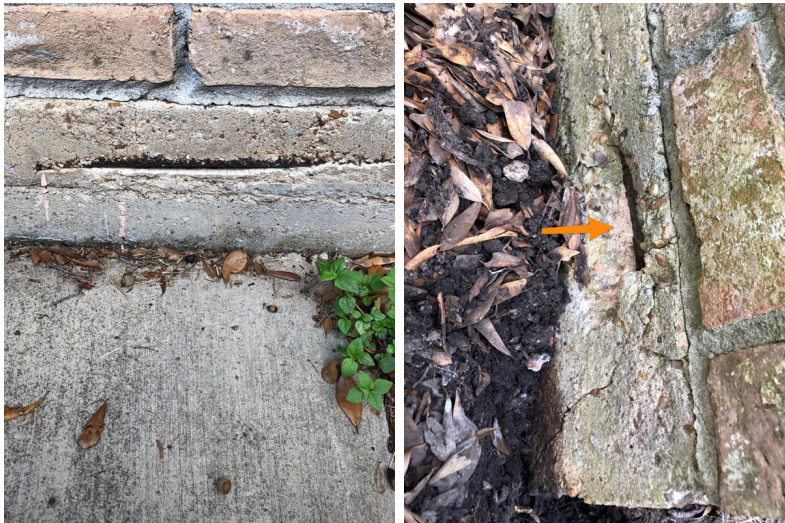
3: Foundation steel exposed

Exposed foundation steel will rust and further deteriorate the concrete.

Recommendation: Contact a qualified professional.

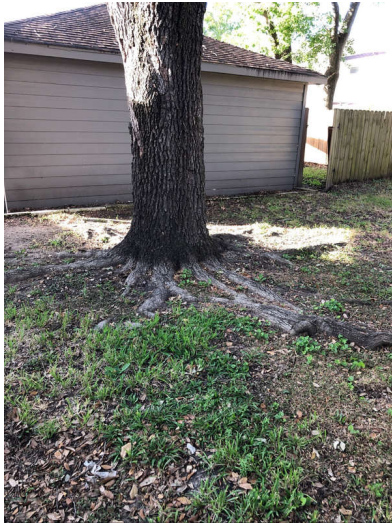
4: Tree is too close to the foundation

Tree roots may can shift the foundation.

Recommendation: Contact a qualified tree service company.

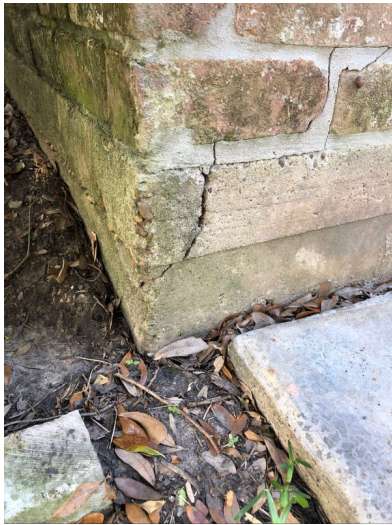
5: Wedge crack in edges of foundation

Wedge cracks appear because of the lack of steel in the corners of the slab. They are only cosmetic, and do not affect the structure. Make sure and keep these places sealed to keep water out of the cracks.

Recommendation: Contact a qualified professional.

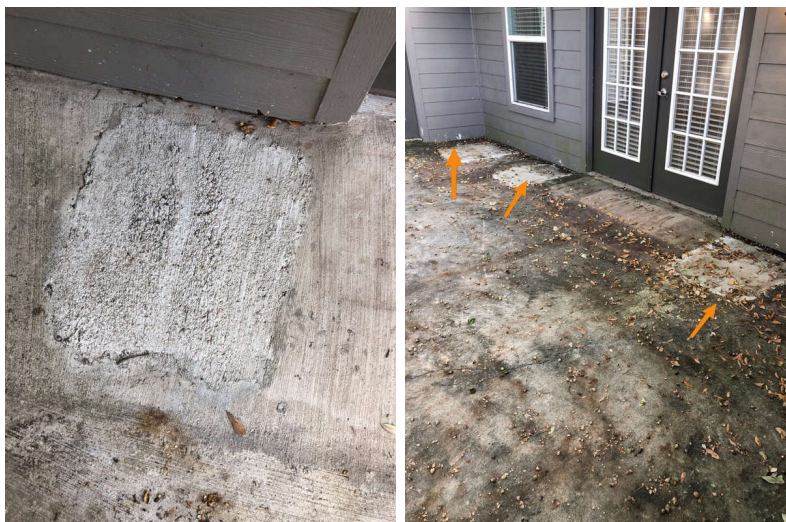
6: Previous repair

Get the paper work on the repair to make sure the home hasn't moved further, and make sure the warranty is transferable.

Recommendation: Contact a qualified professional.

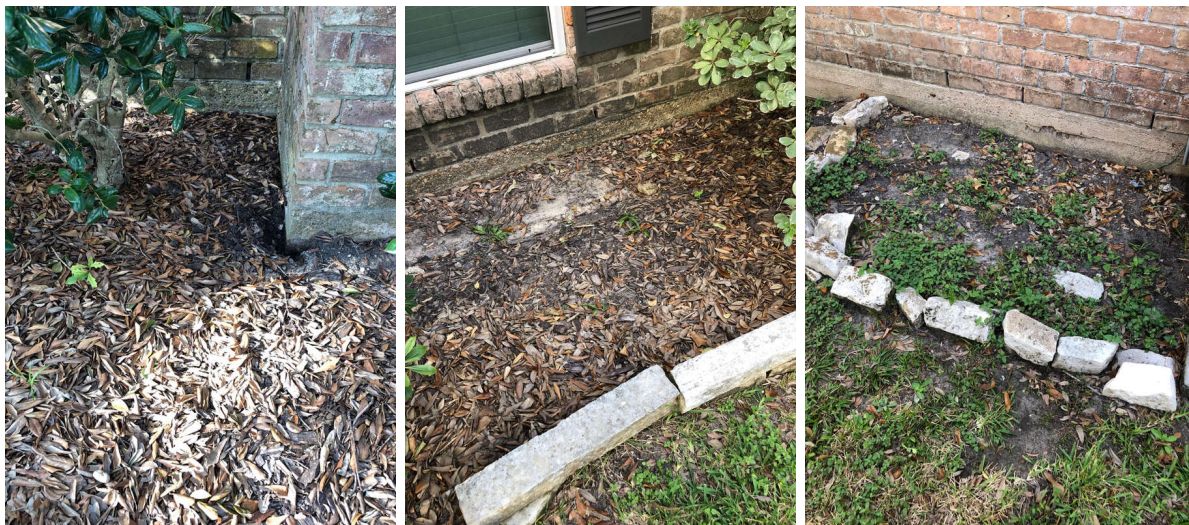
Grading is sloping towards the home in some areas. This could lead to water intrusion and foundation issues. Recommend qualified landscaper or foundation contractor regrade so water flows away from home.

Recommendation: Contact a qualified landscaping contractor

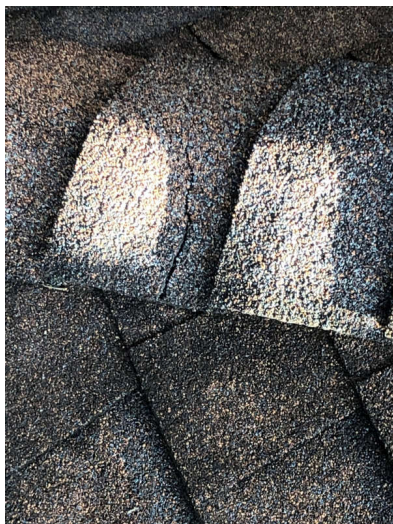
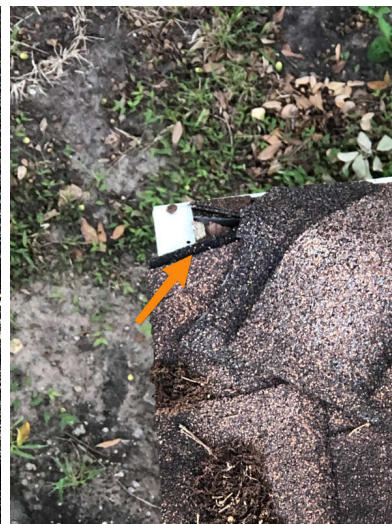
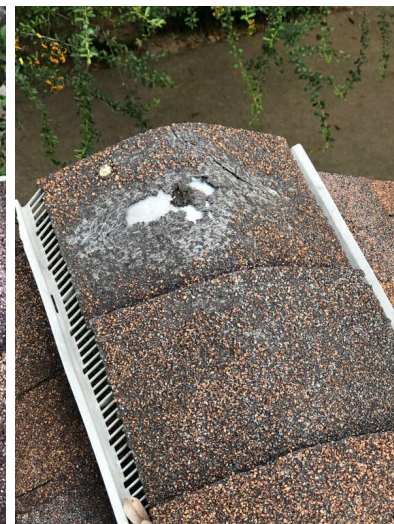
1: Damaged Coverings

Roof coverings exhibited general damage that could affect performance. Recommend a qualified roofer evaluate and repair.

Recommendation: Contact a qualified roofing professional.

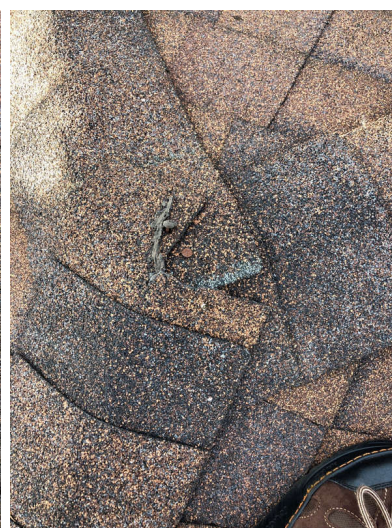
2: Exposed Nails

Under-driven or exposed nails were found in one or more roof coverings. Recommend a qualified roofer evaluate and correct.

Recommendation: Contact a qualified roofing professional.

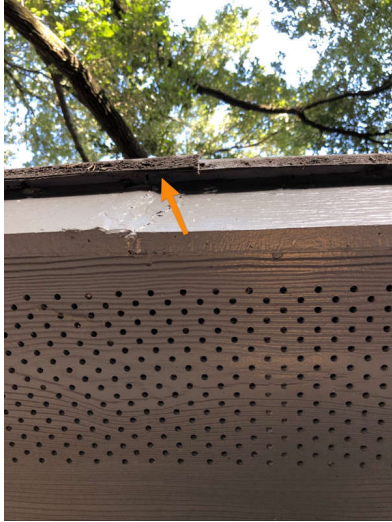
Gaps in flashings can lead to water penetration.

Recommendation: Contact a qualified professional.

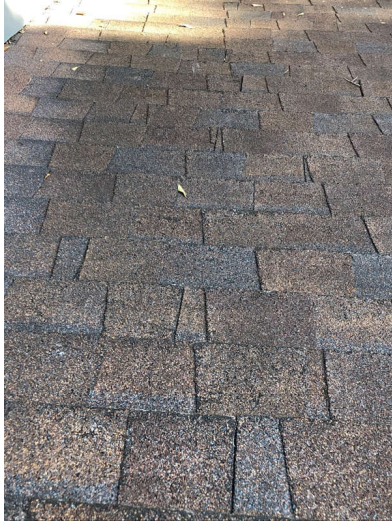
4: Granular loss

Shingles loose granules as they age.

Recommendation: Contact a qualified roofing professional.

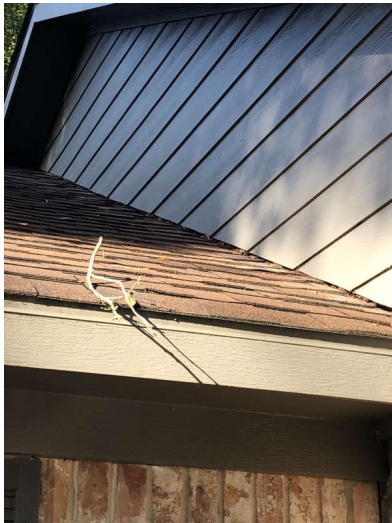
Siding should be 2 from the surface of the roof to avoid water penetration.

Recommendation: Contact a qualified professional.

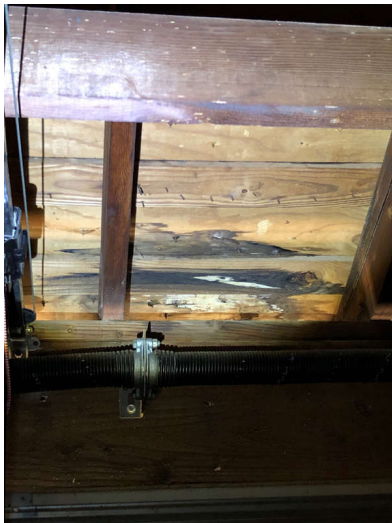
4: Water damage or staining

Water penetrations can lead to structural damaged. Check if the water stains/damage is active or not and repair as needed.

Recommendation: Contact a qualified professional.

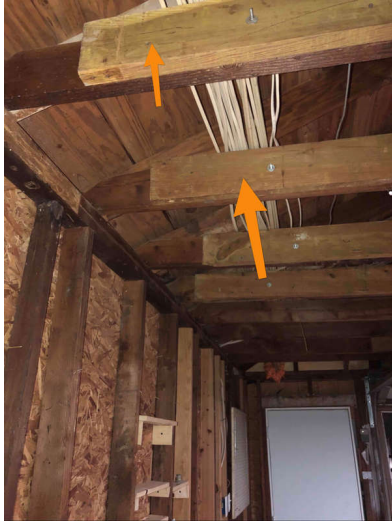
6: Amateur Repair

The repair boards should extend the full length of the board and rest on the wall.

Recommendation: Contact a qualified professional.

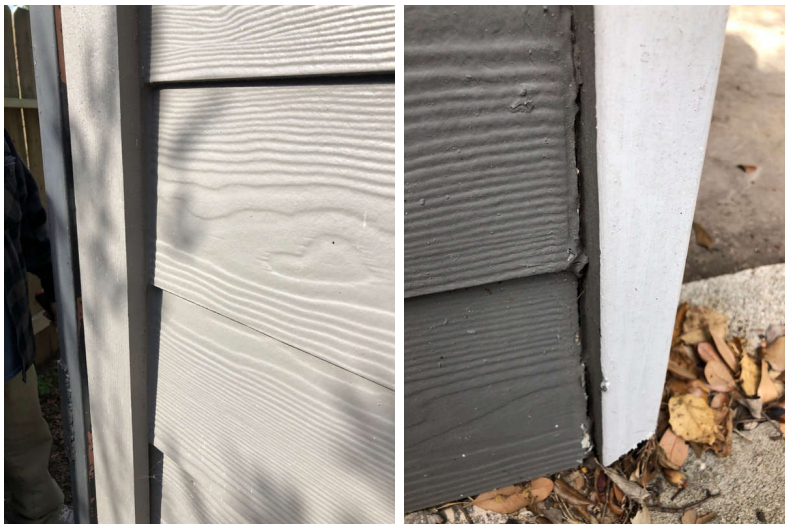
Cement board should be installed with the trim being put on first and then the siding. this prevents the gaps that are created when the trim is installed last. Hardy plank has installation instructions on their website.

Recommendation: Contact a qualified professional.

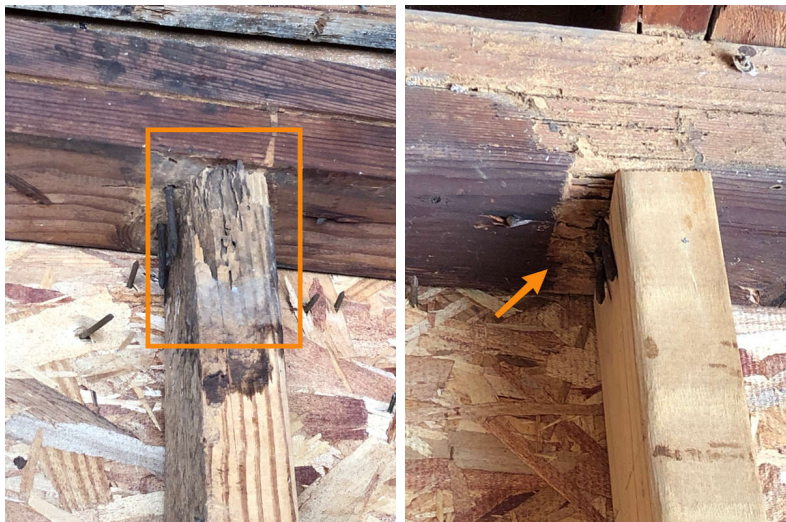
3: Damaged or deteriorated

Damaged or deteriorated studs can loose their supporting strength leading to possible structural sagging.

Recommendation: Contact a qualified professional.

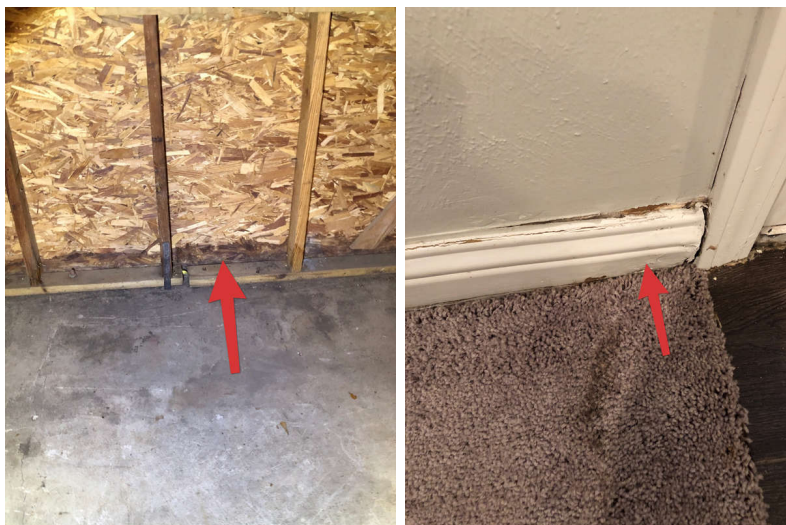
4: Evidence of Water Intrusion

Wall structure showed signs of water intrusion, which could lead to more serious structural damage. Recommend a qualified contractor identify source or moisture and remedy.

Recommendation: Contact a qualified structural engineer.

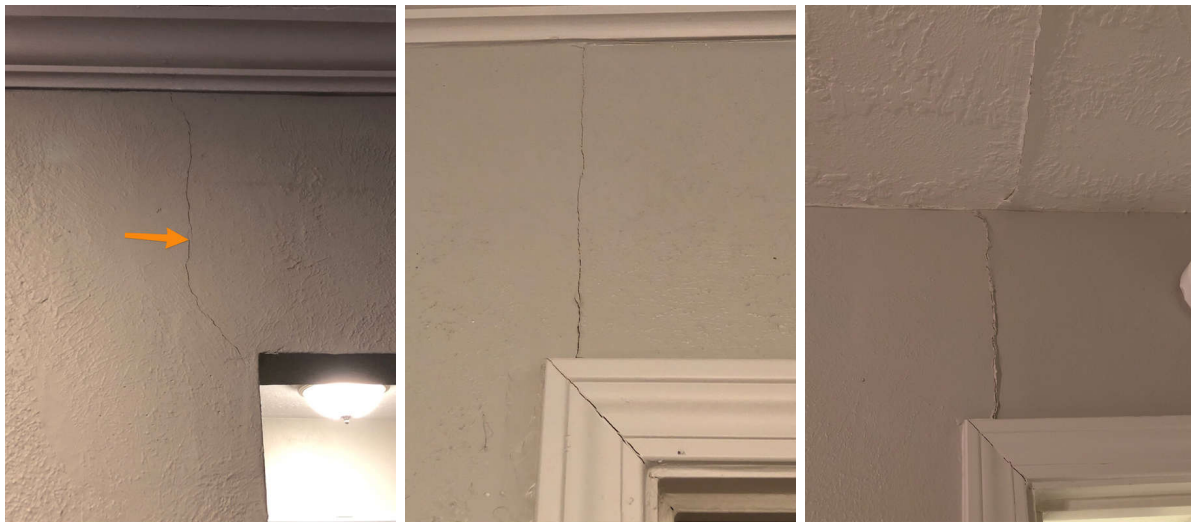
6: Wall board is damaged or cracked

Movement of the structure causes cracks in the wall board.

Recommendation: Contact a qualified general contractor.

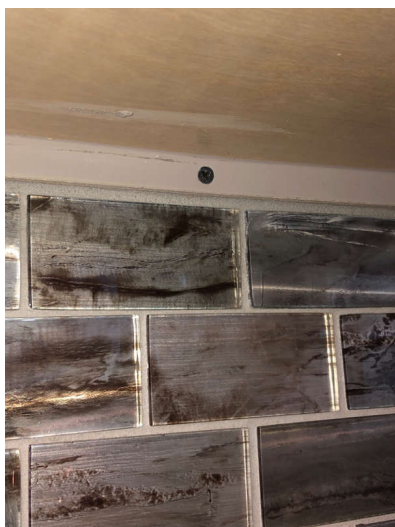
7: Improper fasteners used for cabinets

The proper cabinet fasteners are flat headed and do not penetrate the wood like a bevel headed screw does.

Recommendation: Contact a qualified professional.

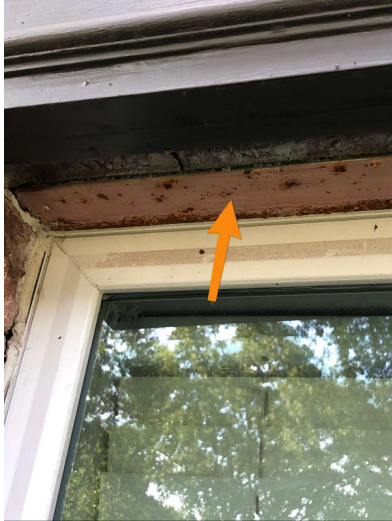
8: Lintel is rusted

Lintels are metal plates that support the brick above them it is important to keep these painted and sealed to prevent rusting.

Recommendation: Contact a qualified professional.

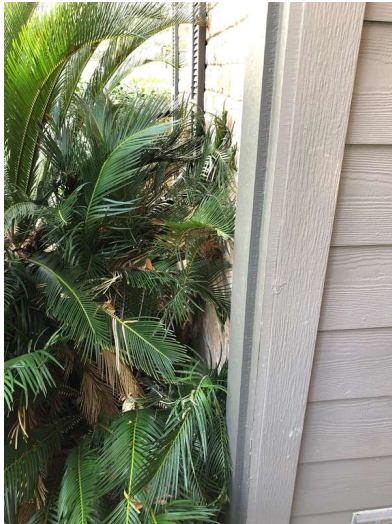
11: Plants in contact with home

Plants hold moisture against the siding causing deterioration to accelerate.

Recommendation: Contact a handyman or DIY project

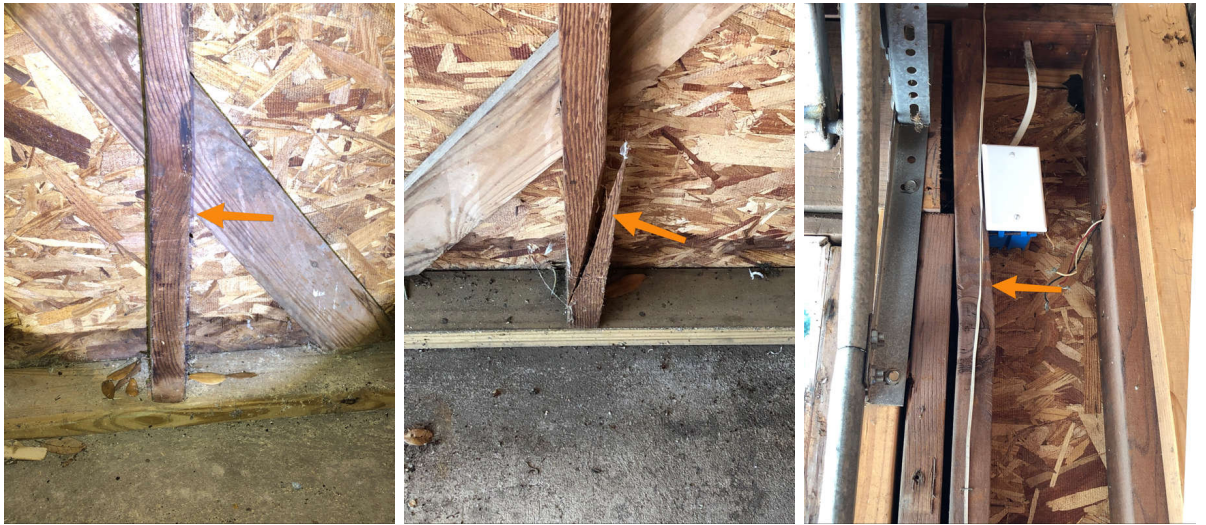
13: Studs are bowing or cracked

Replace studs to properly support structure.

Recommendation: Contact a qualified professional.

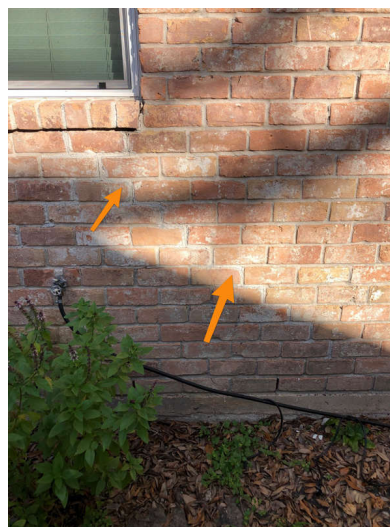
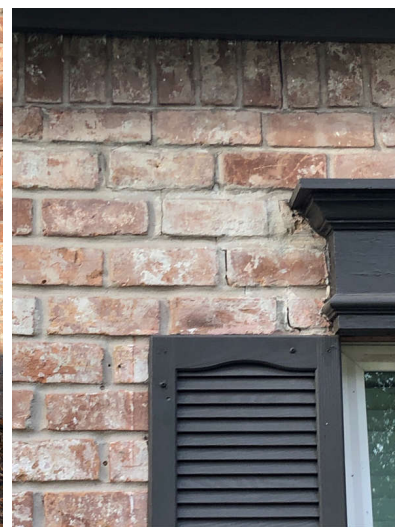
17: Step cracks

Step cracks are a sign of structural movement seal and monitor these cracks.

Recommendation: Contact a qualified professional.

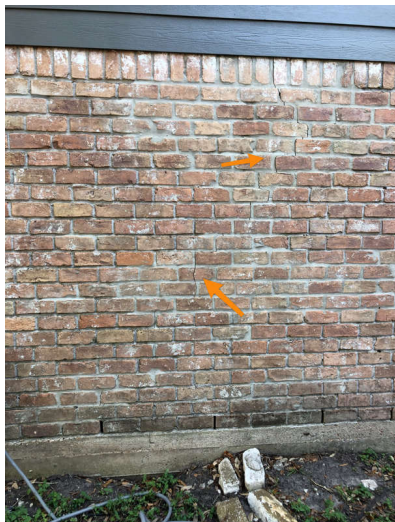
18: Cracks through mortar and brick

Cracks through mortar and brick indicate structural pressure from movement. Seal these cracks and monitor for movement. If movement does proceed contact a structural engineer.

Recommendation: Contact a qualified professional.

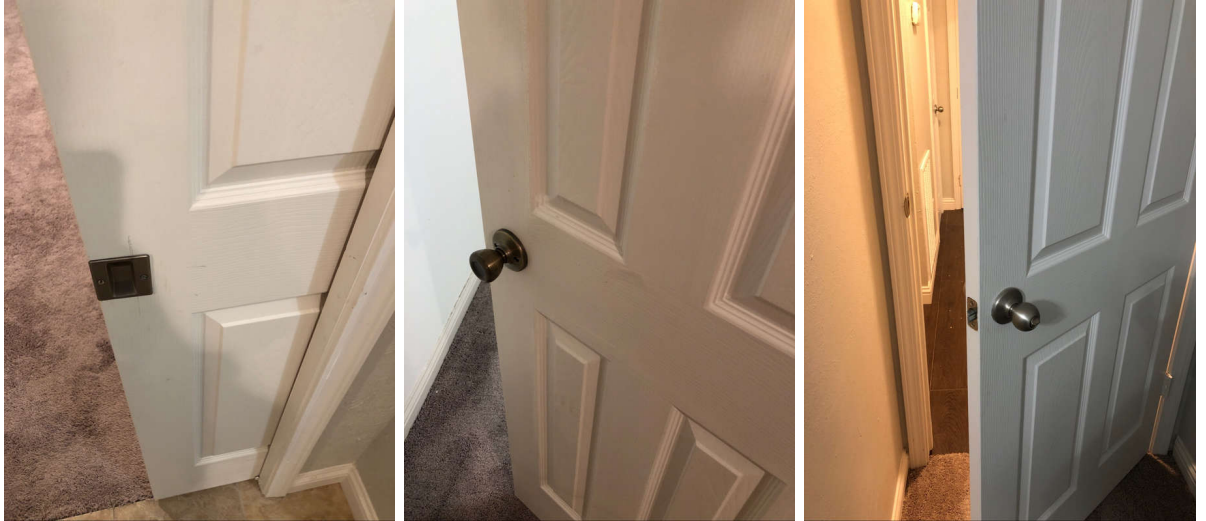
1: Door Doesn't Latch

Door doesn't latch properly. Recommend handyman repair latch and/or strike plate.

Recommendation: Contact a qualified handyman.

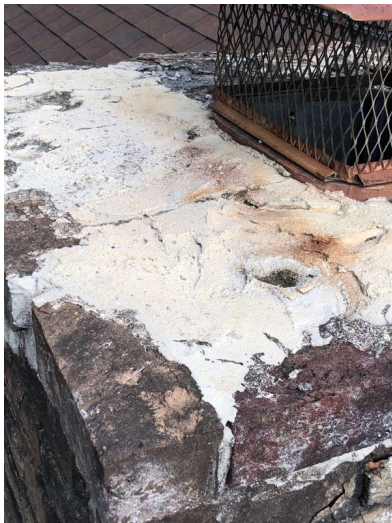
1: Chimney cap has lost its slope

Without a proper slope water will pool on the chimney cap and deteriorate it.

Recommendation: Contact a qualified professional.

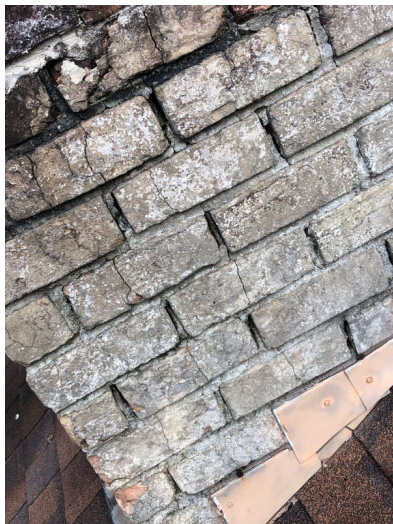
Joints in the masonry have deteriorated and should be repointed. (Repointing is the restoration of the mortar joints).

Recommendation: Contact a qualified professional.

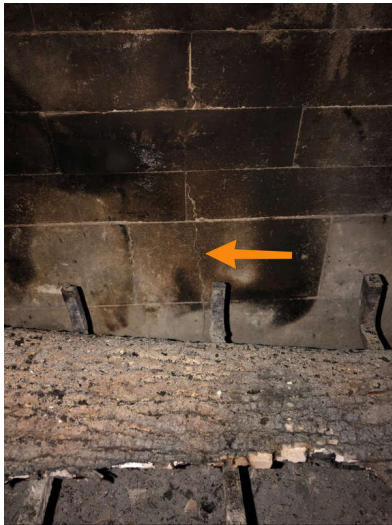
5: Firewall Cracked

The brick lining of the fireplace was cracked in one or more places, which could lead to chimney damage or toxic fumes entering the home. Recommend a qualified fireplace contractor evaluate and repair.

Recommendation: Contact a qualified fireplace contractor.

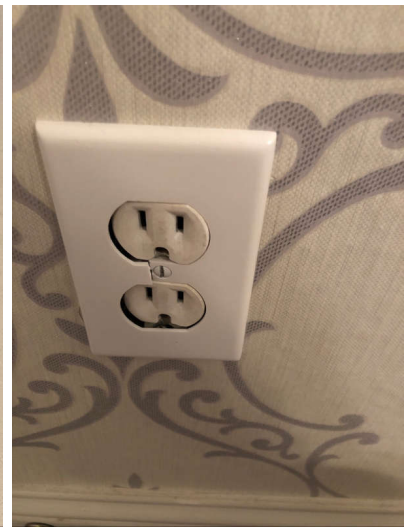
3: Cover Plates Damaged

One or more receptacles have a damaged cover plate. Recommend replacement.

Recommendation: Contact a qualified electrical contractor.

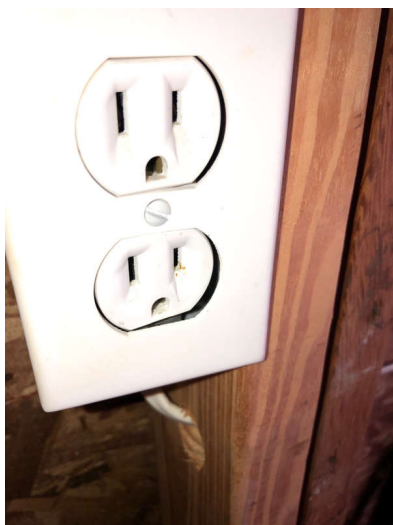
4: Cover Plates Missing or has gaps

One or more receptacles are missing a cover plate. This causes short and shock risk. Recommend installation of plates.

Recommendation: Contact a qualified electrical contractor.

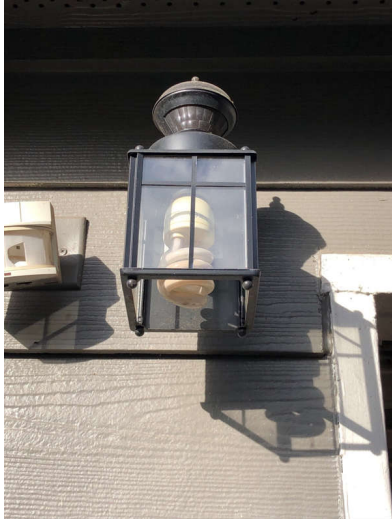
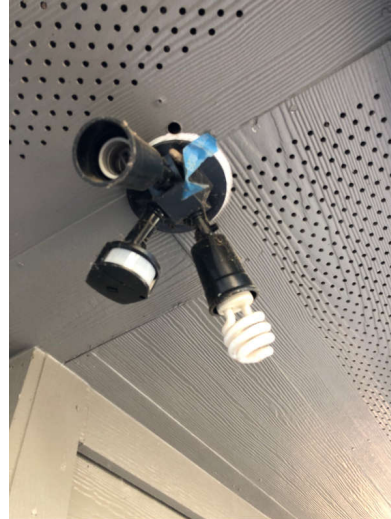
6: Light Inoperable

One or more lights are not operating. New light bulb possibly needed.

Recommendation: Contact a qualified electrical contractor.

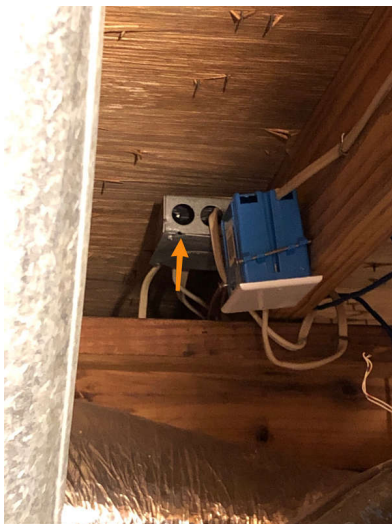
Open junction box observed. Recommend concealing or replacing.

Recommendation: Recommended DIY Project

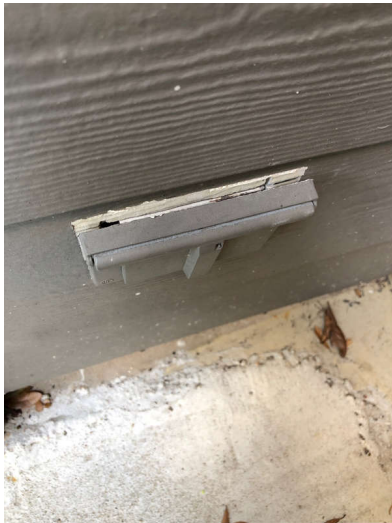
Outdoor receptacles need to be sealed to keep moisture and insects from accessing electrified components and causing damage.

Recommendation: Contact a qualified professional.

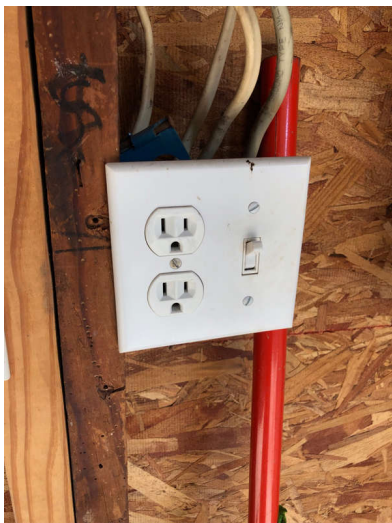
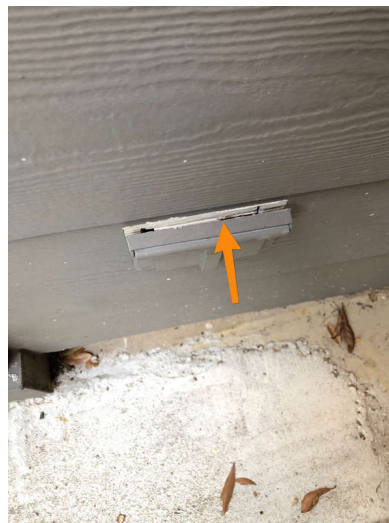
13: Plug is loose

Multiple Locations

Recommendation: Contact a qualified professional.

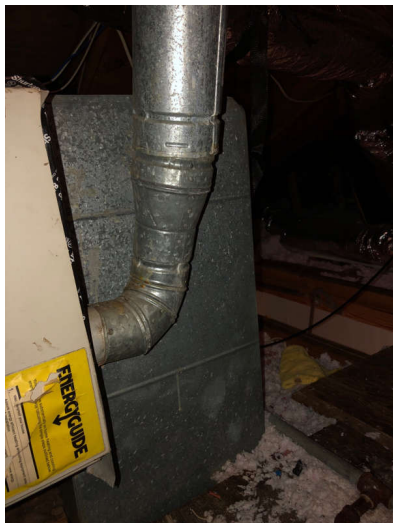
Gas Exhaust pipes will condensate were there is a change in size which can lead to exhaust fumes escaping.

Recommendation: Contact a qualified professional.

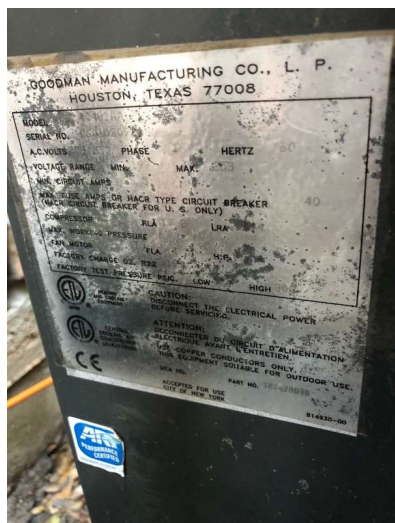
Manufacturer data plate:

Type of Systems: Central Air Conditioner

Unit uses R22 refrigerant:

R22 refrigerant is scheduled to cease production in 2020. This will make refrigerant very expensive and components may not be able to be repaired or replaced in the future because of a lack of availability. If purchaser is buying a home warranty, Research should be done to make sure that warranty company covers R22 refrigerant.

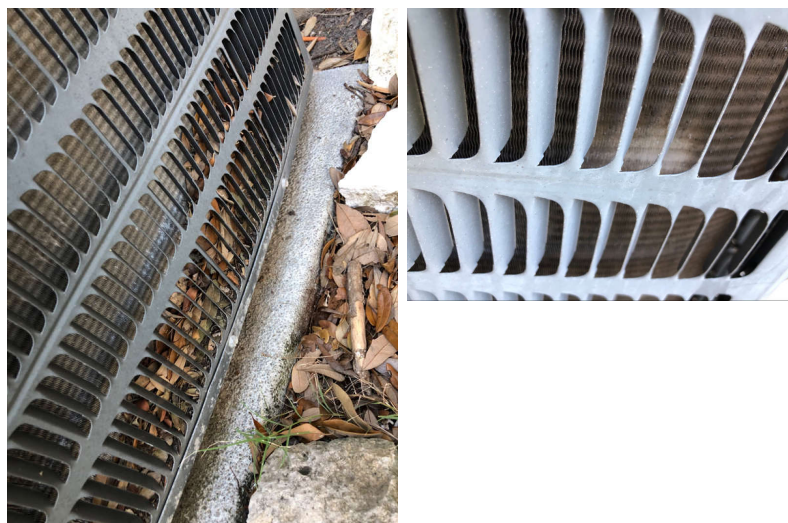
1: Condenser fins are dirty or damaged

Recommendation: Contact a qualified professional.

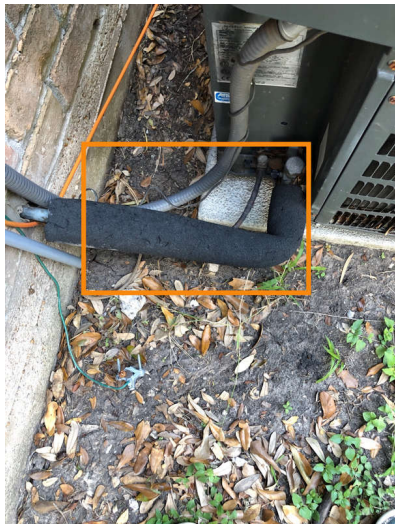
3: Insulation Missing or Damaged

Missing or damaged insulation on refrigerant line can cause energy loss and condensation.

Recommendation: Contact a qualified HVAC professional.

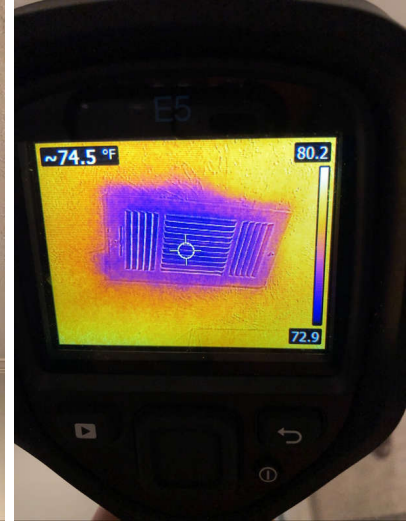
Return air was at 75

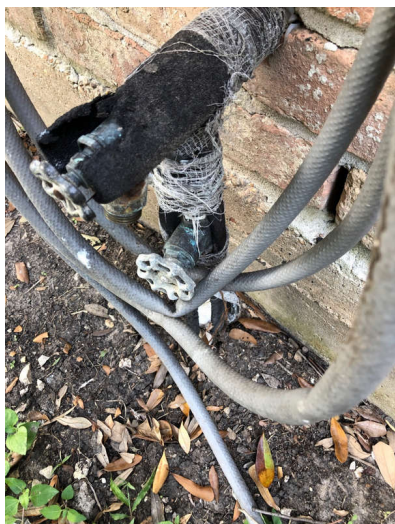
2: Insulation is missing or damaged

If the temperature gets to freezing and the pipes are not insulated they can burst from the freezing water.

Recommendation: Contact a handyman or DIY project

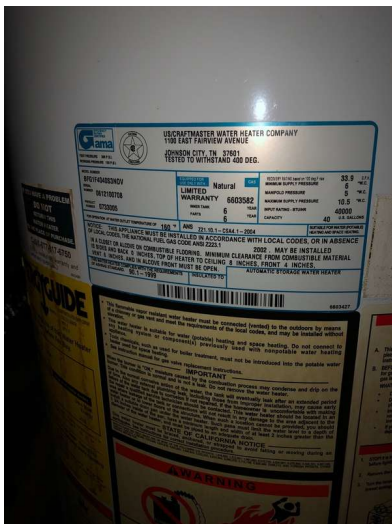
Capacity: 40 Gallons

Energy Sources: Gas

Manufacturers data plate :

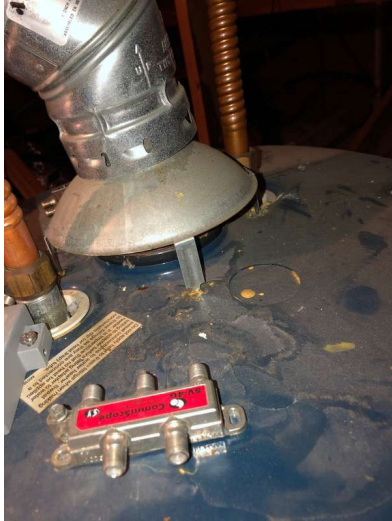
1: Draft hood is not secured

Recommendation: Contact a qualified professional.

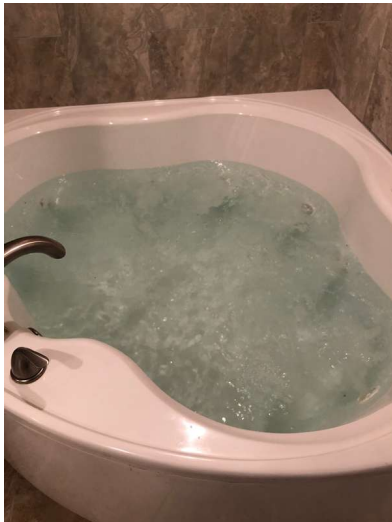
1: No access to spa equipment

Recommendation: Contact a qualified professional.

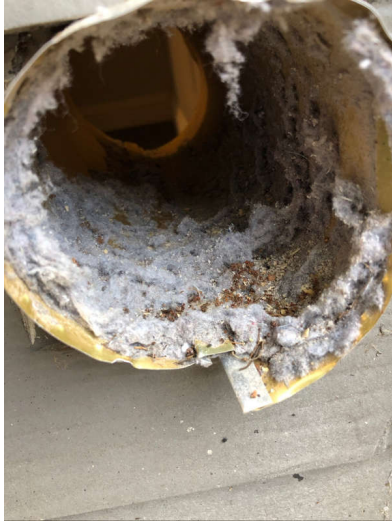
This can cause a fire, because lint is combustible.

Recommendation: Contact a qualified professional.

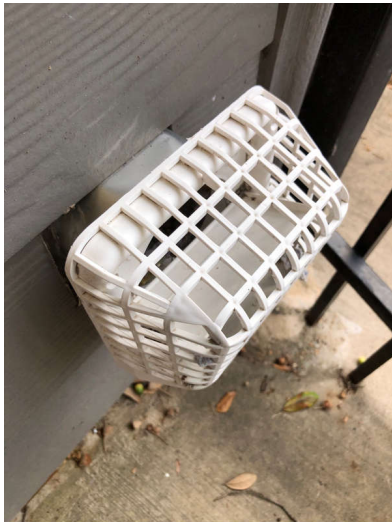
2: Vent is not sealed or secured

Recommendation: Contact a qualified professional.
