PROPERTY INSPECTION REPORT

Concerning: 6513 Clawson St, Houston, TX 77055
(Address or Other Identification of Inspected Property)

By: Brendan Andrew Hirshey, Lic #22135 12/06/2019
(Name and License Number of Inspector) (Date)

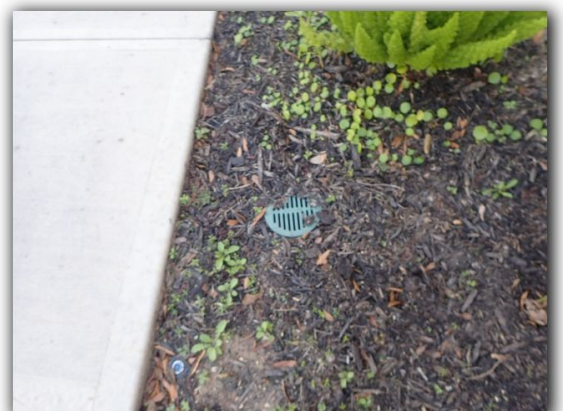
Grading & Drainage

- There is an underground and/or surface drainage system in place. It appears that the surface water collector(s) and/or drain(s) are clogged and/or filled with debris. This condition will adversely affect the performance of the drainage system and corrective measures are needed at this time.

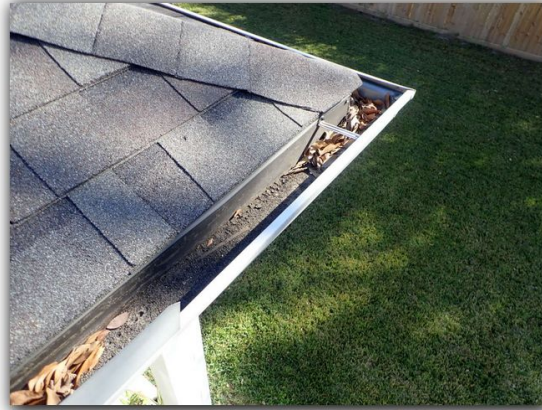
- The gutters require cleaning.

Note: The gutter downspouts should discharge water at least thirty-six inches (36”) away from the foundation perimeter beam. Storm water should be encouraged to flow away from the structure at the points of discharge.

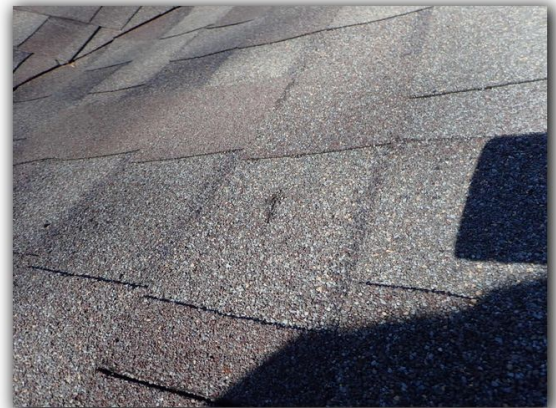
- One or more of the shingles were observed to be lifting on the south side, east side of the roof structure.
- Damaged shingles were observed on the north side of the roof structure.

You are strongly encouraged to have a properly certified roofing contractor to physically inspect the roof, prior to the expiration of any time limitations such as option or warranty periods, to fully evaluate the condition of the roofing material. The observation made to support the rendering of this opinion are listed but not limited to the following:

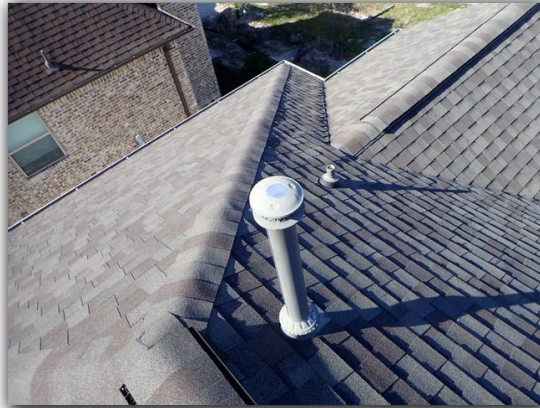
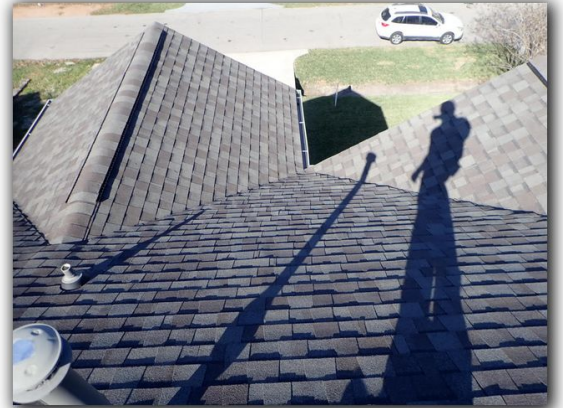
Flashing Details

The flashing details needs to be checked, reset or repaired as necessary. The observations made to support the rendering of this opinion are listed but may not be limited to:

- There was no kickout flashing details observed at the lower bottom edge of the roof line interface and the sidewall that continues past the edge of the roof. The lack of this kickout flashing will allow water to penetrate at these points.
- The flashing is lifting and/or pulling loose and should be re-secured on the south side of the roof structure.
- One or more of the roof level plumbing vent stack flashing details are buckled downward around the plumbing stack. This condition could allow water penetration at this point and corrective measures are recommended.
- The flashing needs to be painted to prevent rust and/or UV damage.
- The storm collar(s) at the roof level gas equipment vent pipe(s) need to be properly sealed to help prevent water intrusion into the structure.

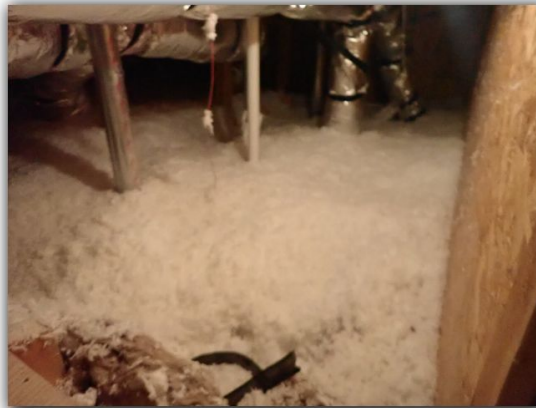
Attic Insulation

- The sidewall insulation was observed to be pulling loose in the attic area and should be corrected as necessary.

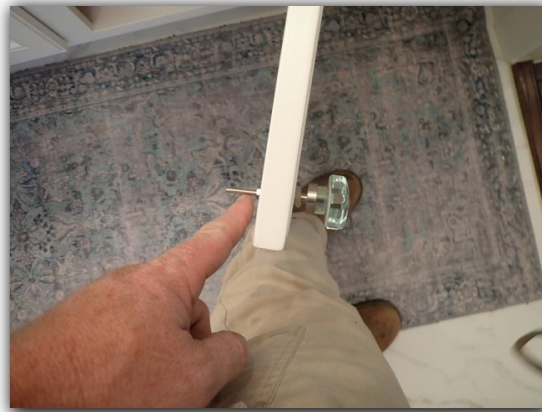
Cabinets & Cabinet Surfaces

- Cabinet knobs fasteners are projected in the master bathroom/guest bathroom. This is a safety risk.

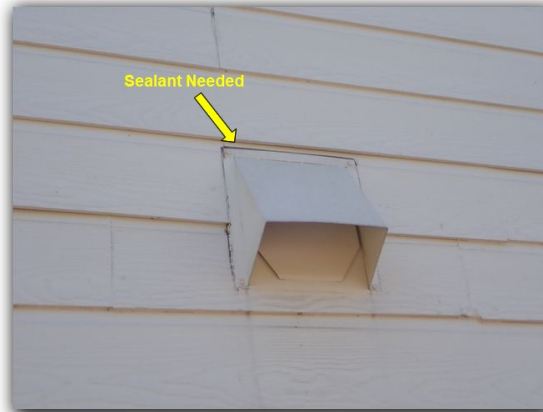
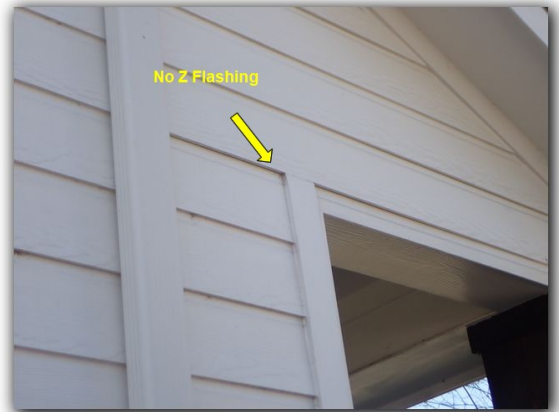
Exterior Walls & Surfaces

- The area between the exterior cladding / veneer and all of the wall penetrations / openings need to be properly sealed. Areas such as utility connections, downspouts, hose bibbs, lighting fixtures, receptacles etc. It is recommended to use an elastomeric caulking / sealant.
- I was unable to locate or observe head flashing details above the projected wood trim on the exterior walls

Note: Minor mortar and/or brick cracks were observed in the exterior veneer.

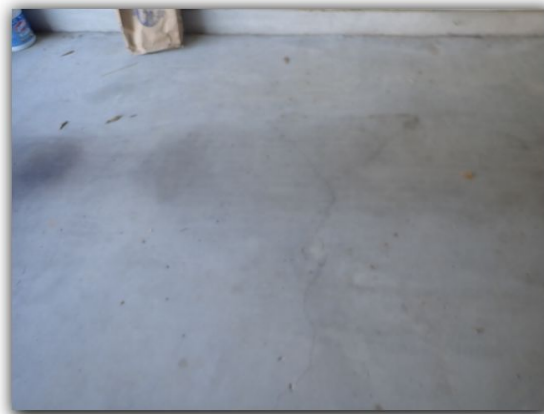
Note: The upstairs sub-floors (flooring) observed to squeak when walked over.

Note: Some cracking of the garage concrete floor finish was observed.

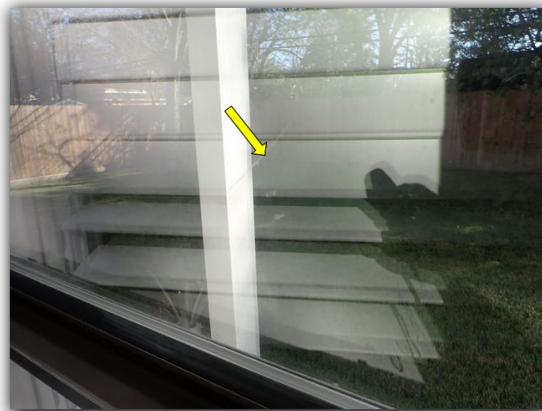
- Scratched window glass was observed in the master bedroom.

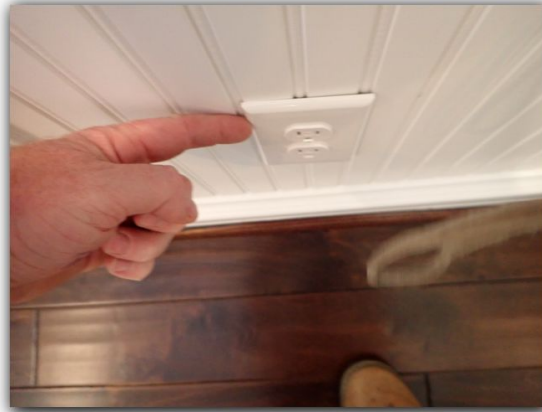
- One or more of the receptacles were observed to be loose at the wall mount in the various locations throughout the house.

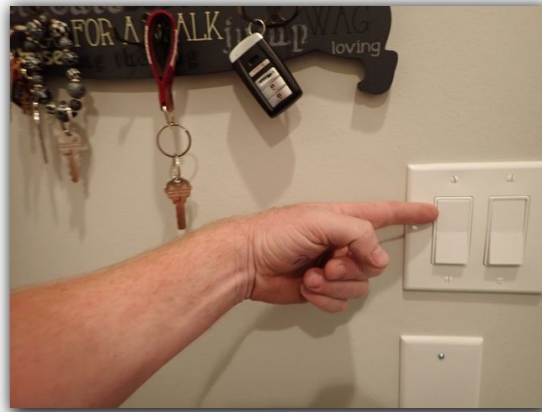
Switches

Note: The operation of the switches in the laundry room is reversed.

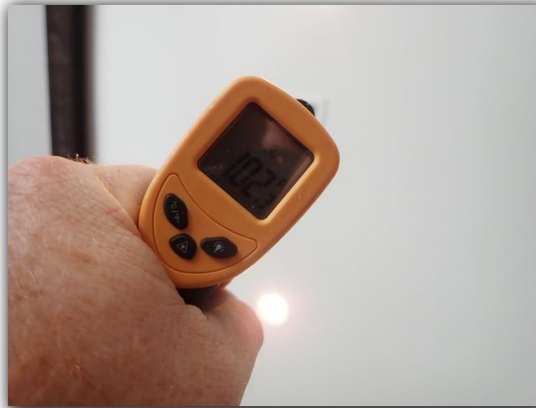
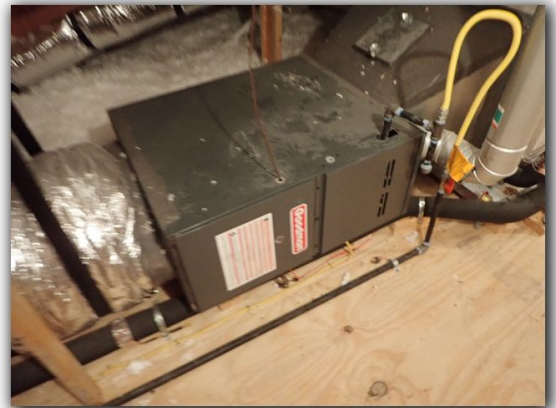
Brand Name: Goodman

This component appears to be performing adequately at the time of this inspection. It is achieving an operation, function, or configuration consistent with accepted industry practices for its age.

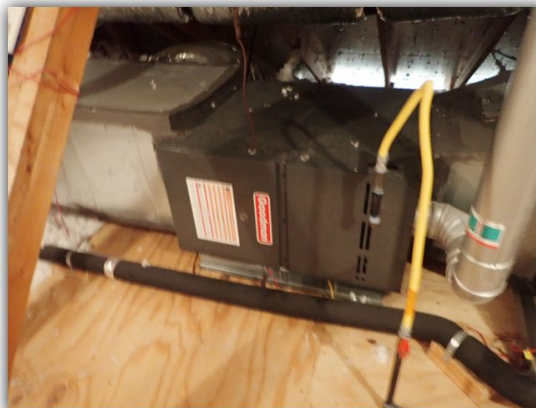
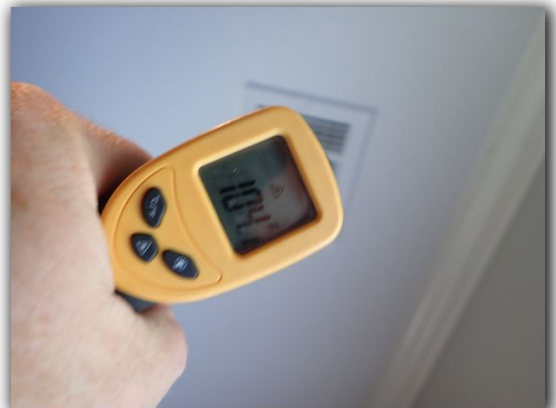
Central Heating System – *Energy Source:* Gas

Brand Name: Goodman

This component appears to be performing adequately at the time of this inspection. It is achieving an operation, function, or configuration consistent with accepted industry practices for its age.

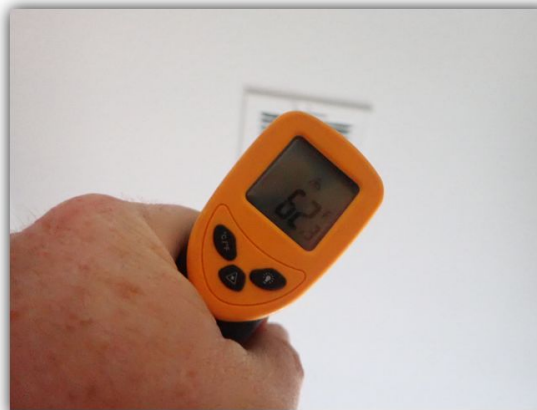
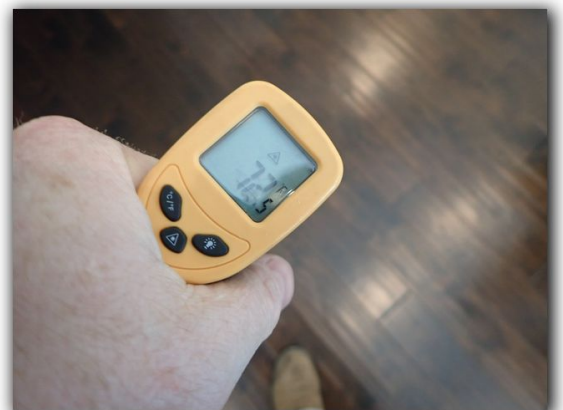
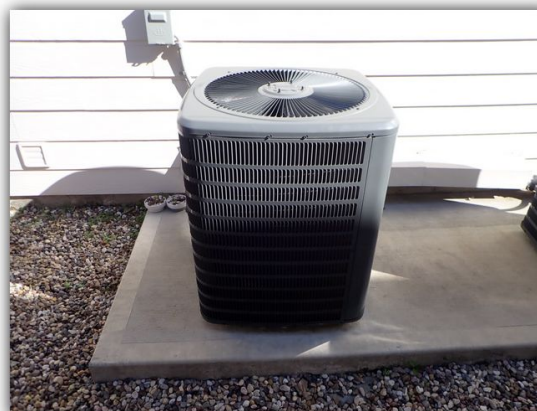
- Air leaks were detected at and around the indoor coil housing. The air leaks should be corrected for improved efficiency.
- **The temperature drop measured across the evaporative coils of the air conditioning system is lower than considered typical. The unit is not cooling properly and servicing is needed.**
- The auxiliary/secondary drain pan under the coil housing is rusted and should be replaced.

The HVAC system and equipment needs to be checked and serviced by a Qualified / Licensed HVAC Technician. The observations made to support the rendering of this opinion are listed but may not be limited to the following:

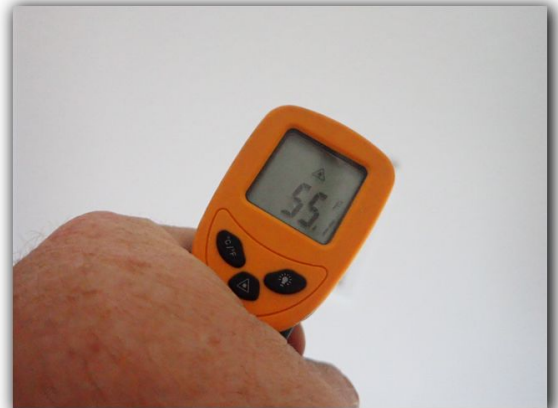
Today's Temperature Differential (Delta-T): 14

- Air leaks were detected at and around the indoor coil housing. The air leaks should be corrected for improved efficiency.
- **The temperature drop measured across the evaporative coils of the air conditioning system is lower than considered typical. The unit is not cooling properly and servicing is needed.**
- The auxiliary/secondary drain pan under the coil housing is rusted and should be replaced.

The HVAC system and equipment needs to be checked and serviced by a Qualified / Licensed HVAC Technician. The observations made to support the rendering of this opinion are listed but may not be limited to the following:

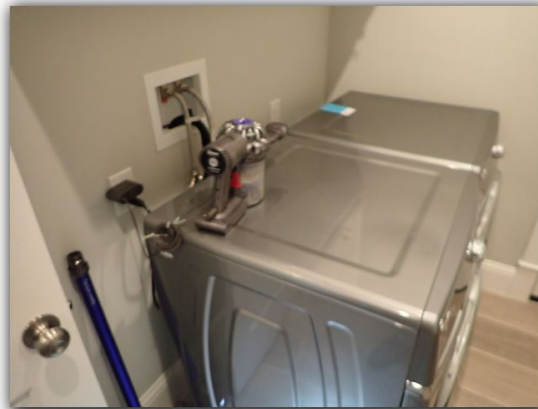
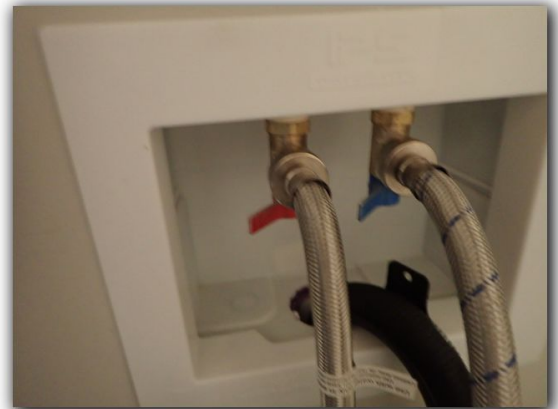
Note: The laundry hose bibb connections are inaccessible at the time of this inspection. I was unable to get to the hose bibbs for inspection due to the laundry equipment in place and/or personal effects, heavy storage, or other conditions outside the control of the inspector.

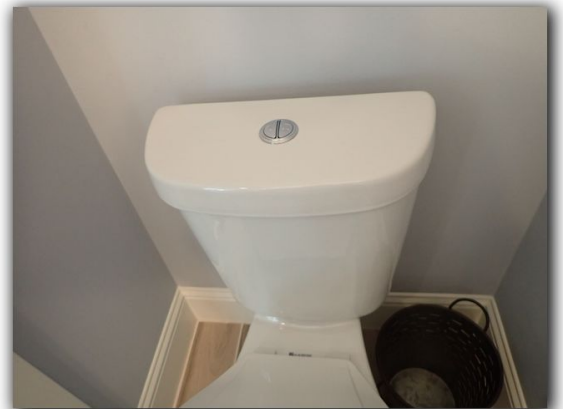
Commode / Toilet

- The commode tank is loose at the bowl connection.

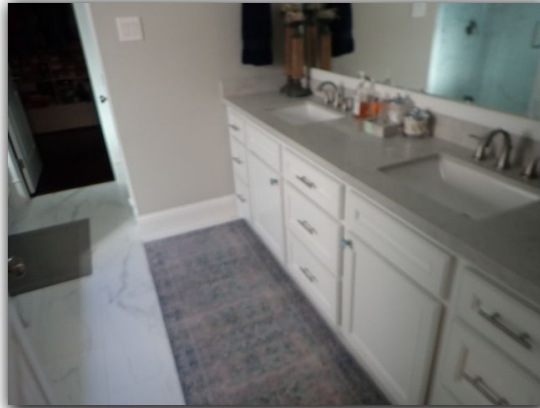
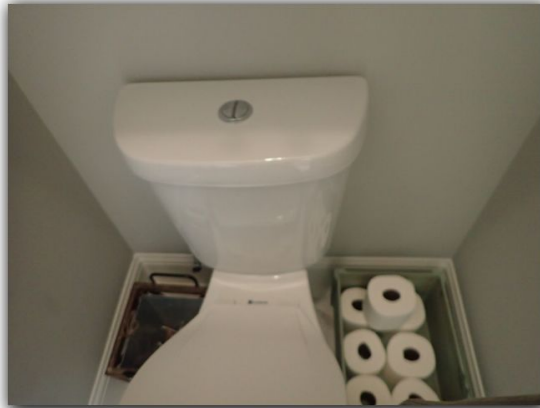
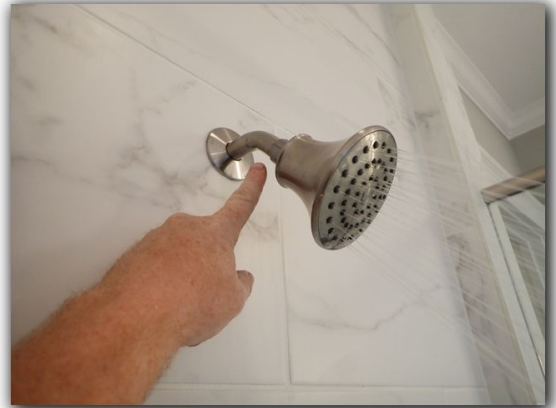
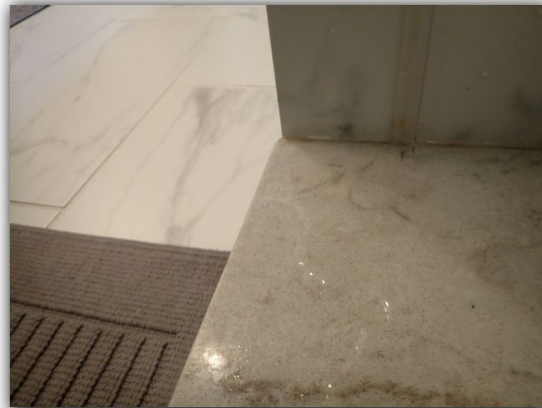
Master Bathroom

- The shower head assembly is loose within the wall cavity area.
- The shower enclosure is not water tight and leaks to the area adjacent to the shower. This condition should be further evaluated and corrected as necessary.

- The commode tank is loose at the bowl connection.

The buyer should have the plumbing system checked by a [Qualified Licensed Plumber](#). The observations made to support the rendering of this opinion are listed but not limited to the following:

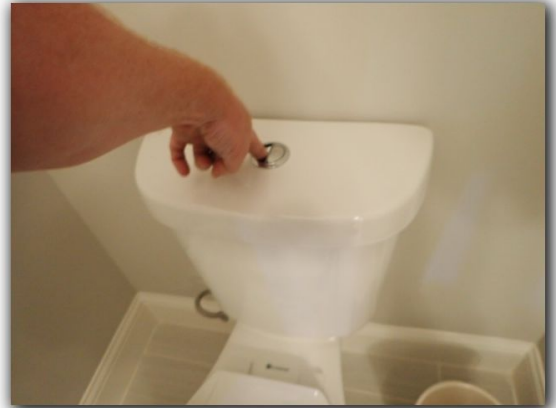
Hall Bathroom

- The commode tank is loose at the bowl connection.

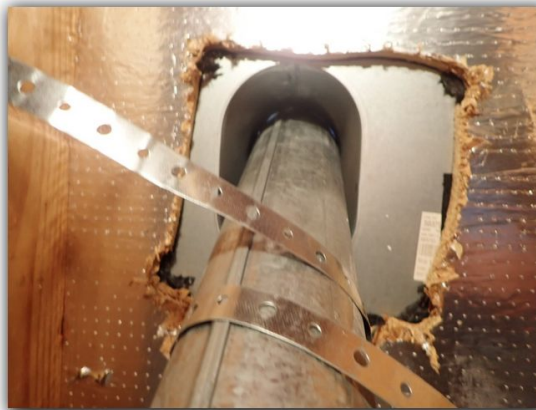
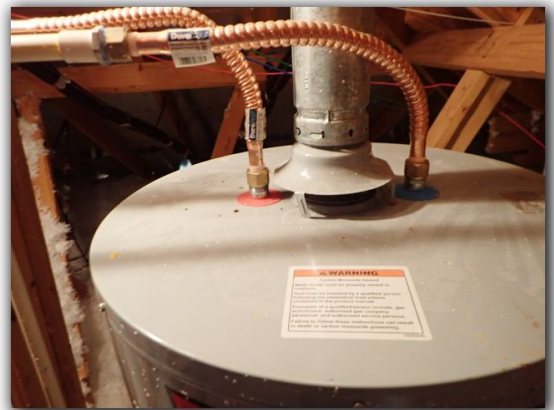
- There was a gas leak detected at or around the gas pilot assembly. The inspector used a TUFF 8800 gas leak detector to locate the leak.
- The vent pipe is not properly mounted at the top of the water heater. This configuration will emit Carbon Monoxide into the heater compartment, which is a known safety hazard.
- The roof level flue storm collar needs to be properly sealed to help prevent water intrusion into the structure.

Note: There is evidence of prior leakage on or around the water heater housing. This should be closely monitored.

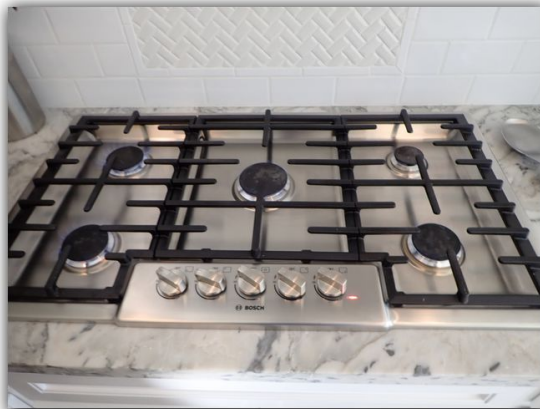
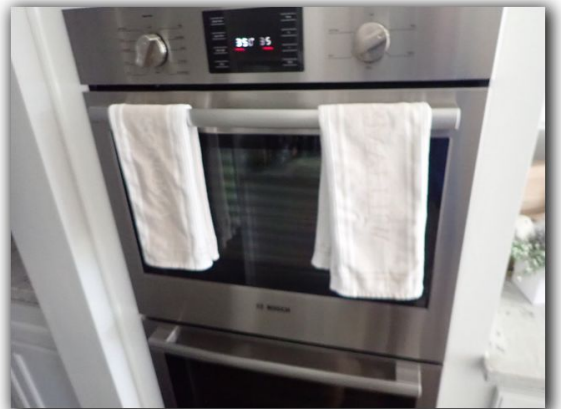
Note: The digital display appears to be dim.

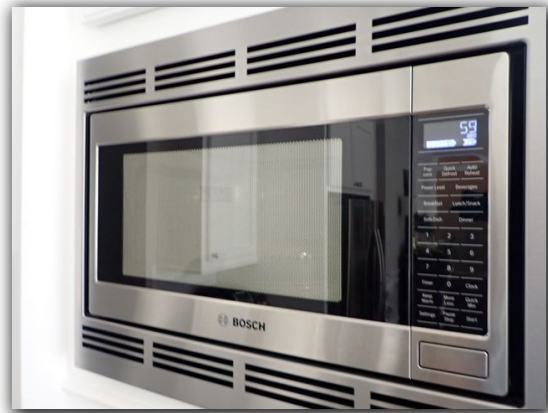
E. Microwave Ovens

Brand Name: Bosch

This component appears to be performing adequately at the time of this inspection.

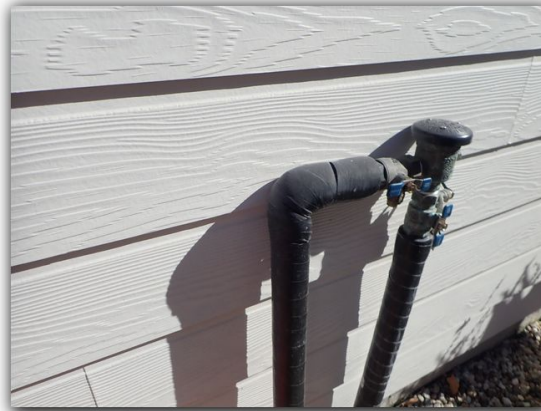
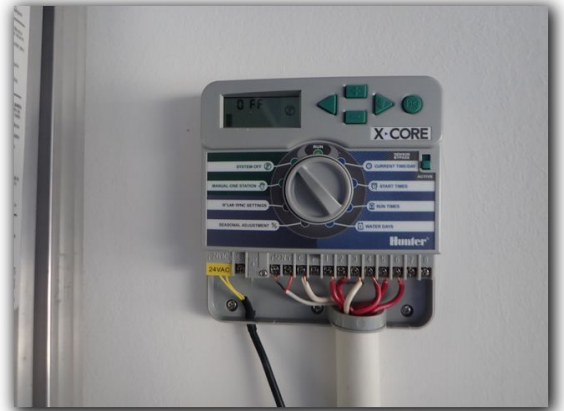
- The exterior moisture (rain/freeze) sensor device does not appear to be properly installed and should be corrected for proper sensor operation.
- One or more of the sprinkler heads appear to be leaking at the base of the head in station(s); **2, 3, 4.** The cause and remedy should be further evaluated and corrected as necessary.
- One or more of the sprinkler heads were observed to be damaged and/or missing in station(s); **3.**
- One or more of the sprinkler heads need to be adjusted so not to disperse water onto concrete flatwork (such as; roadways, sidewalks, porches, patios or driveways) in station(s); **3.**

The sprinkler system and associated components should be further evaluated and/or serviced by a Licensed Irrigation Technician. The observations made to support the rendering of this opinion are listed but not limited to the following:
