FIG Services LLC d/b/a FOX INSPECTION GROUP  
Property Inspection Report #210902RM-4724 Mckinney Street(1)  
8616 Daffodil St. Houston, TX 77063  
(Office)713.723-3330 (Email) [office@foxinspectiongroup.com](mailto:office@foxinspectiongroup.com)

## *PROPERTY INSPECTION REPORT*

**Concerning:** 4724 Mckinney Street, Houston, TX 77023  
(Address of Inspected Property)

**By:** Richard Maynard, TREC: 21735 09/02/2021  
(Name and License Number of Inspector) (Date)

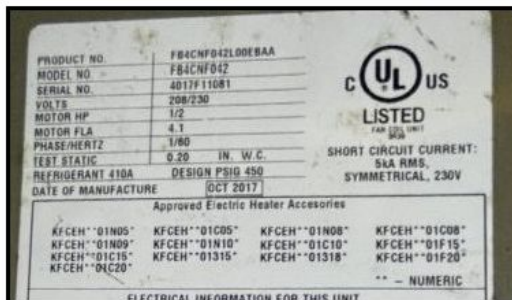
Age: 4 YEARS

Typical life expectancy: between 15 - 25 years as reported by Nachi [Click here for more information](#)

No significant deficiencies or anomalies observed at the time of inspection.

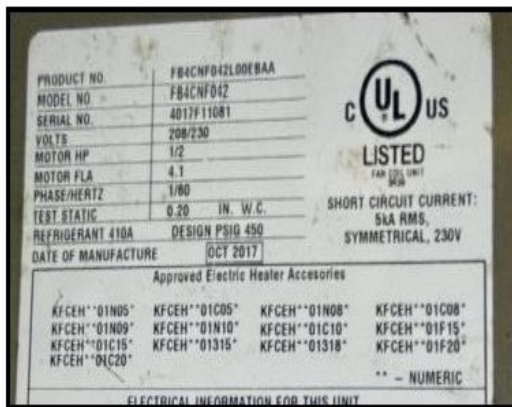
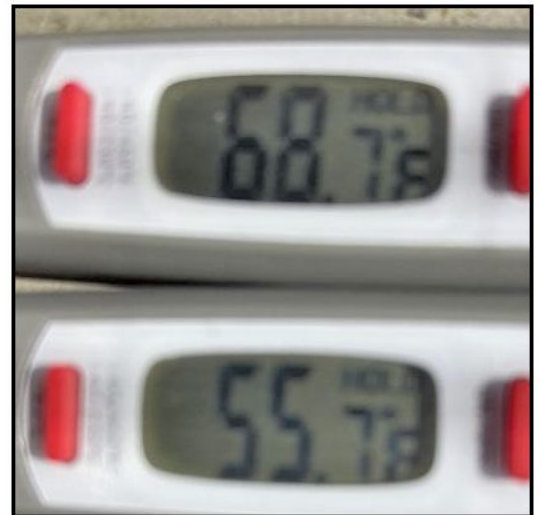
Age: 4 YEARS

Typical life expectancy: between 10 years as reported by Nachi [Click here for more information](#)
