Home Inspection Report

12202 Marion Ln, Santa Fe, TX 77539

PROPERTY INSPECTION REPORT

By: Ron Taylor, Lic #12170. 09/09/2020
(Name and License Number of Inspector) (Date)

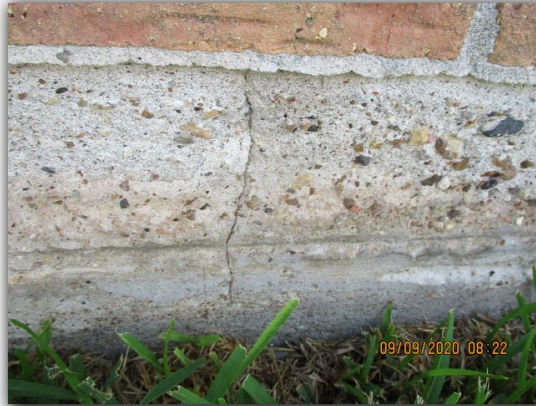
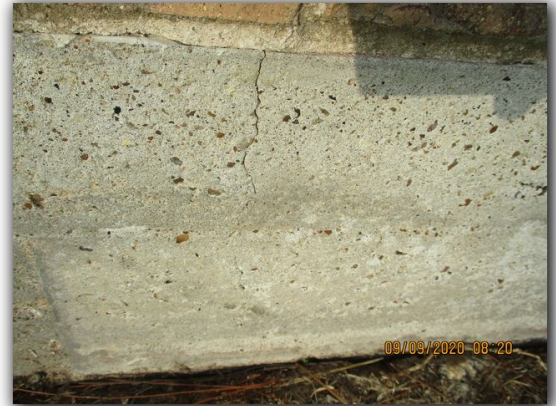
Cracks were observed on the exterior walls/ foundation Various Locations. This implies that some movement of the structure has occurred, as is typical of most houses given the type of soils in the Southeast Texas area..

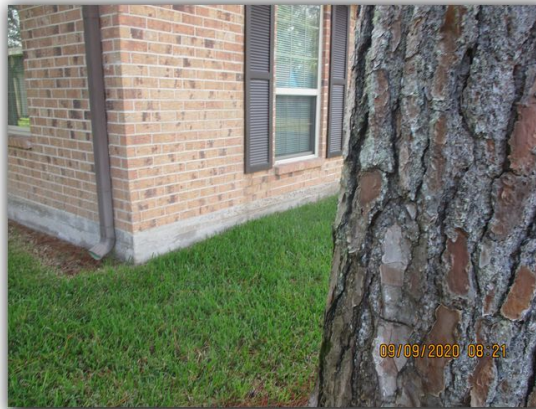
A tree is growing very close to the foundation perimeter at the front of the structure. Trees growing near the house can cause foundation moisture related problems as well as potentially damage to the foundation grade beam. Recommend monitoring this tree for future problems. No Visible problems associated with the tree at the time of inspection.

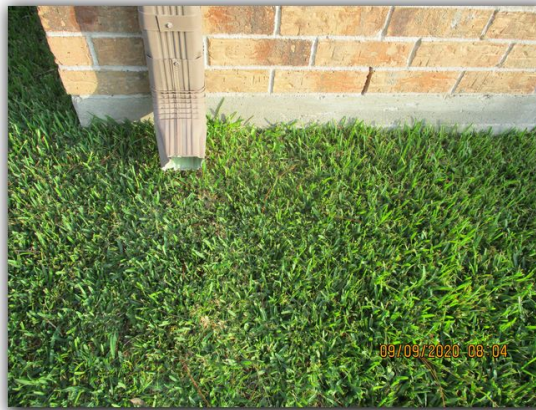
The downspout(s) should discharge water at least five (5) feet from the house. Recommend installing extensions on the gutter downspout elbows.

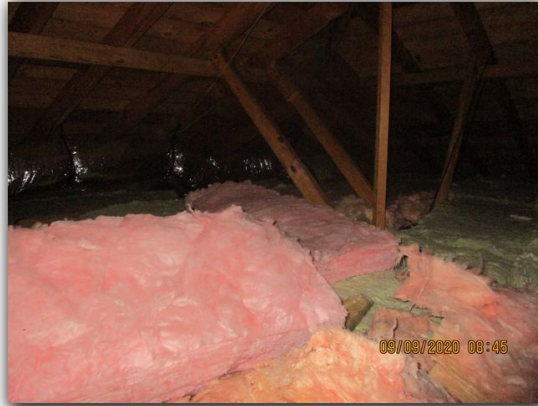
The insulation in the attic is somewhat uneven in depth. Recommend evening out the insulation to prevent gaps in the insulation coverage. Recommend repair.

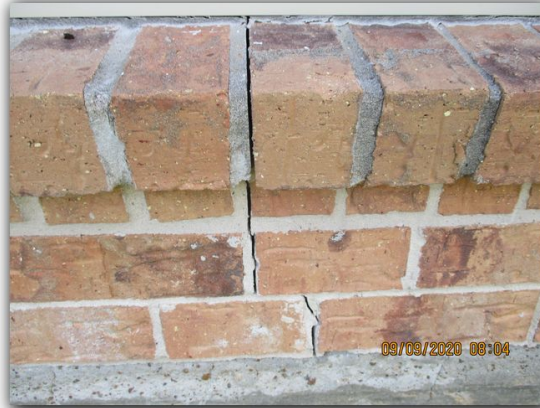
Minor cracking was observed on the exterior walls of the structure-- Various Locations. This implies that some structural movement of the structure has occurred, as is typical of most structures in many parts of Texas area due to the expansive clays present. Recommend monitoring for future movement and repairs to the brick mortar to prevent water penetration and possible damage to the structure.

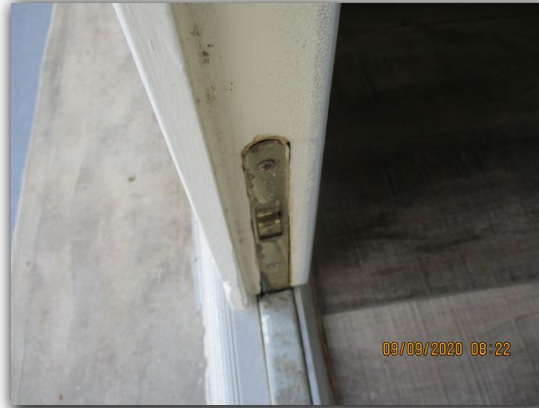
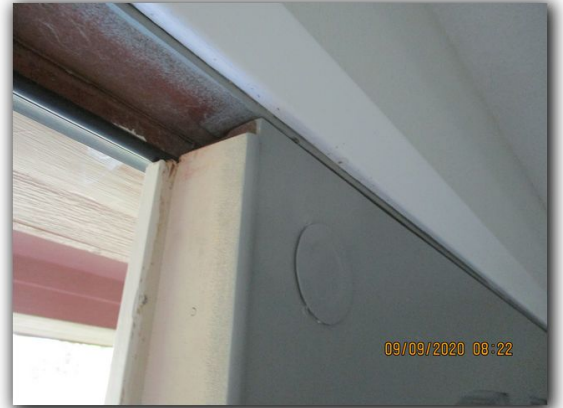
Damaged or missing door hardware-- Front entry. Recommend repair or replacement.

The door(s) have double sided deadbolts Rear entry. This can be a safety issue when emergency escape is necessary. Recommend replacing the double sided deadbolts with single sided deadbolts with a hand operated throw at the interior.

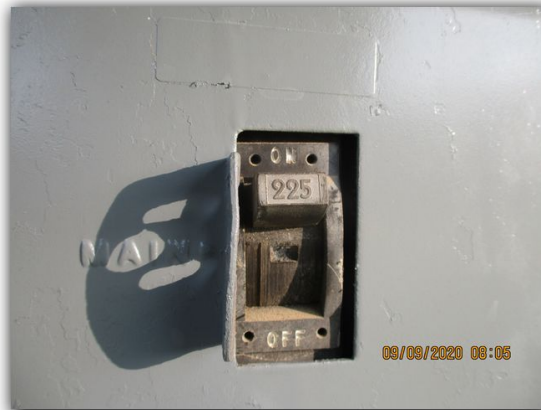
Main Panel:225 amp

Location:South

There is a tripped breaker in the panel box. Tripped breakers are not reset as they may be tripped as a result of an electrical problem or electrical work that is not complete. Recommend having the circuit examined and repaired as necessary.

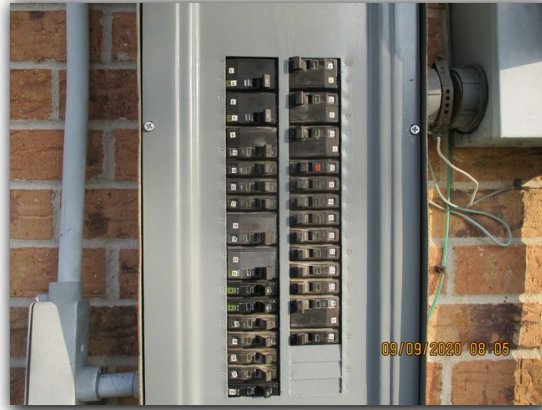
FYI. The 2008 National Electric Code now requires No-Arc or No-Fault protection (AFCI) be installed for family rooms, dining rooms, living rooms, parlors, libraries, dens, bedrooms, sun rooms, recreations rooms, closets, hallways, or similar rooms or areas.

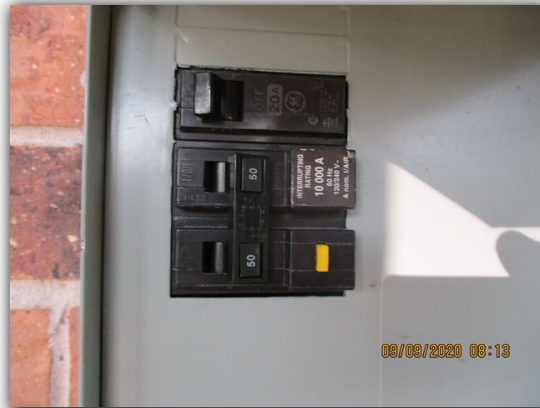
Sub Panel

Box Location: Rating Not Determined / Box Not Properly Labeled Garage Interior

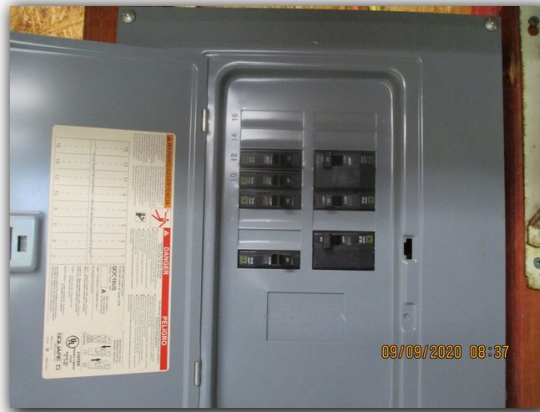
N.E.C. 408.4 Every circuit and circuit modification shall be legibly identified as to its clear, evident and specific purpose or use in sufficient detail on a directory located on the face or inside of the electrical panel doors

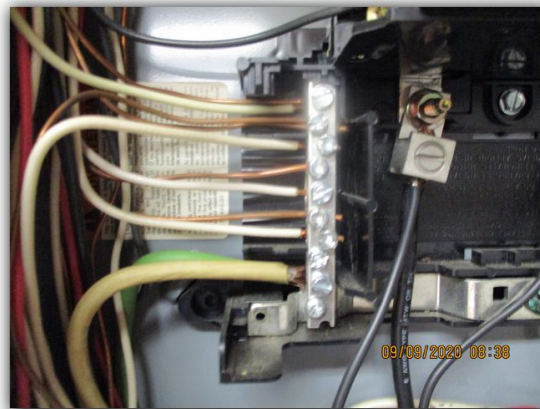
The ground buss bar and the Neutral buss bar should be separated in the subpanel box(es). Neutral wires are not allowed to touch the ground buss bar in subpanel boxes. The ground bonding is through the main panel box not the subpanel box(es). Recommend further examination and repair as needed.

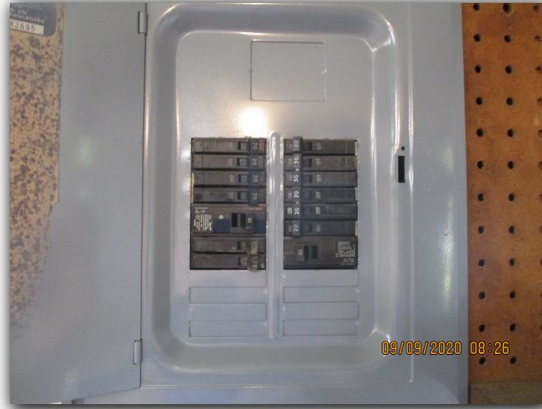
Sub Panel

Box Location: Rating Not Determined / Box Not Properly Labeled Garage Interior

There is inadequate clearance at the front and sides of the panel box. Recommend relocating the panel box for increased safety and to conform to current building standards.

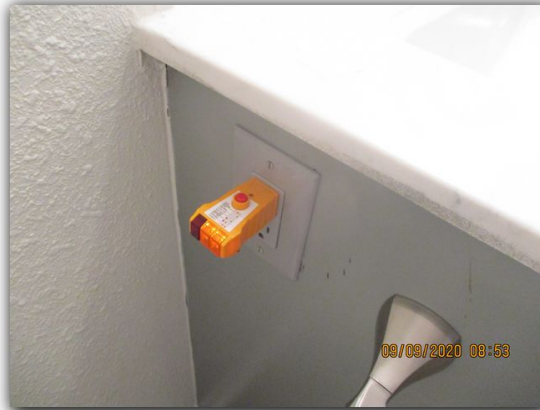
A ground fault circuit interrupter (GFCI) outlet did not respond correctly to testing during the inspection-- kitchen counters. This receptacle should be replaced.

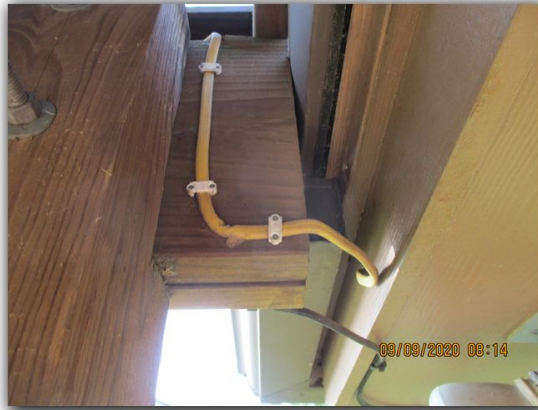
Wiring exposed on the exterior walls at the rear of the structure Recommend protecting the wire by a conduit.

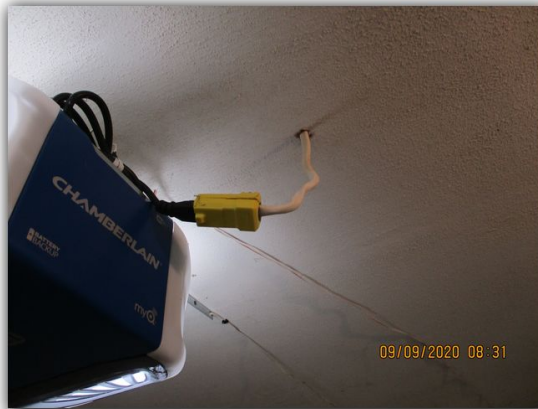
Extension cords should not be used as permanent wiring--garage. Recommend replacing the extension cords with permanent wiring.

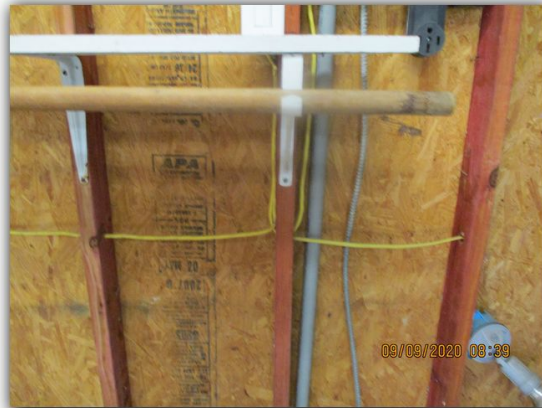
Wiring exposed on interior walls should be relocated or protected--garage. Recommend repair.

The light switch was found not to be working properly in the garage and rear patio. Recommend Repair or replacement.

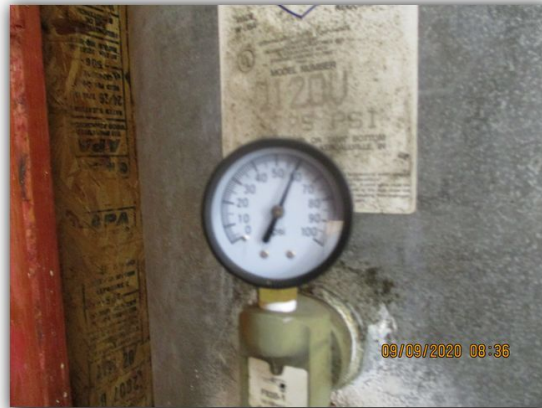
It is recommended that an anti-siphon device be added to the hose connection(s). Recommend Repair.

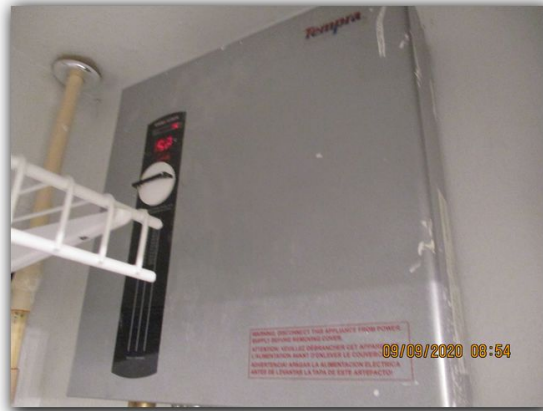
All Components were found to be performing and in satisfactory condition on the day of the inspection.

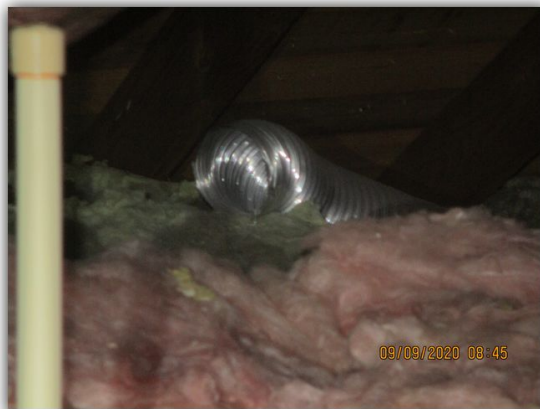
Current building standards require that exhaust fan vent(s) should discharge to the building exterior. Recommend Repair.

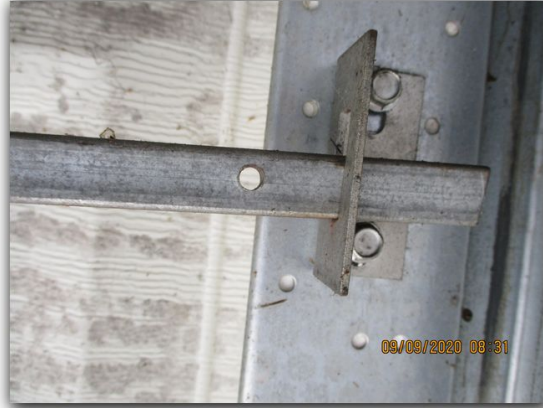
Locks should be removed or disabled from garage doors with garage door openers as per manufacturers recommendations. The Texas Real Estate Standards of Practice require this item to be marked as deficient.
