PROPERTY INSPECTION REPORT

Prepared For: WHR Group, Inc
 (Name of Client)

Concerning: 1852 Bending Stream Drive League City TX 77573 03422
 (Address of Inspected Property) (City, State, Zip) (Invoice/Report Number)

By: Art Byrd Jr 1171 5/24/2021
 (Name and License Number of Inspector) (Date)

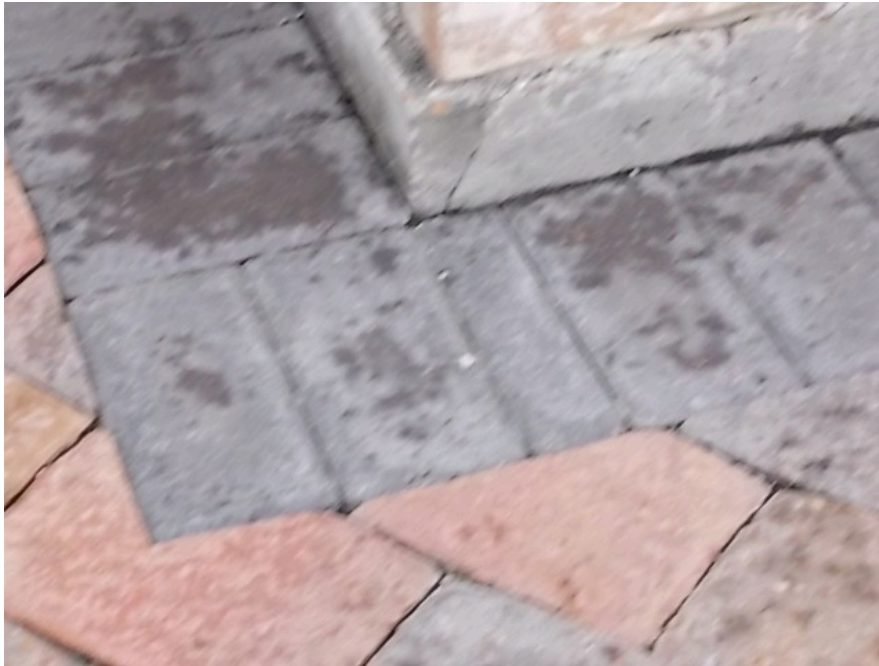
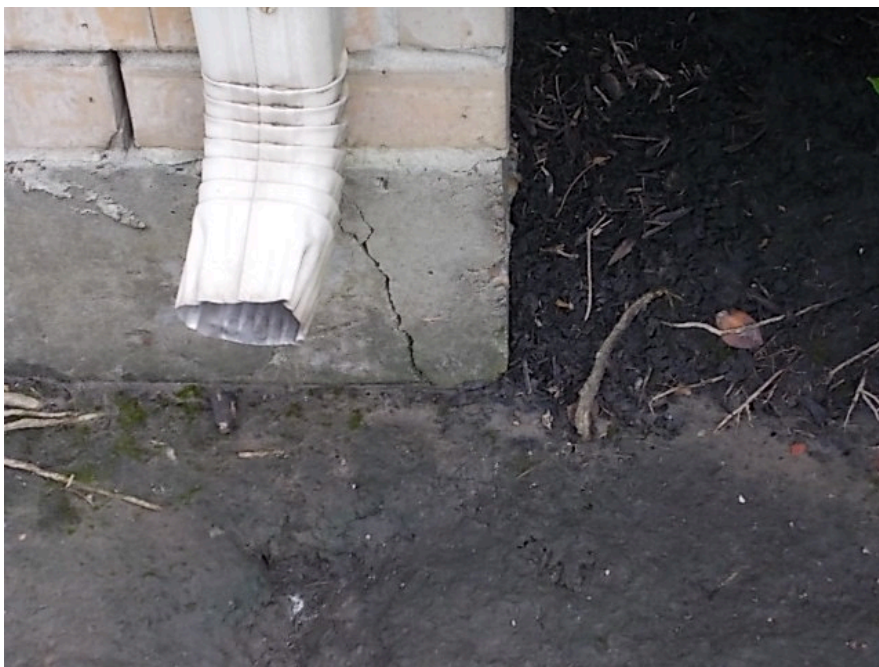
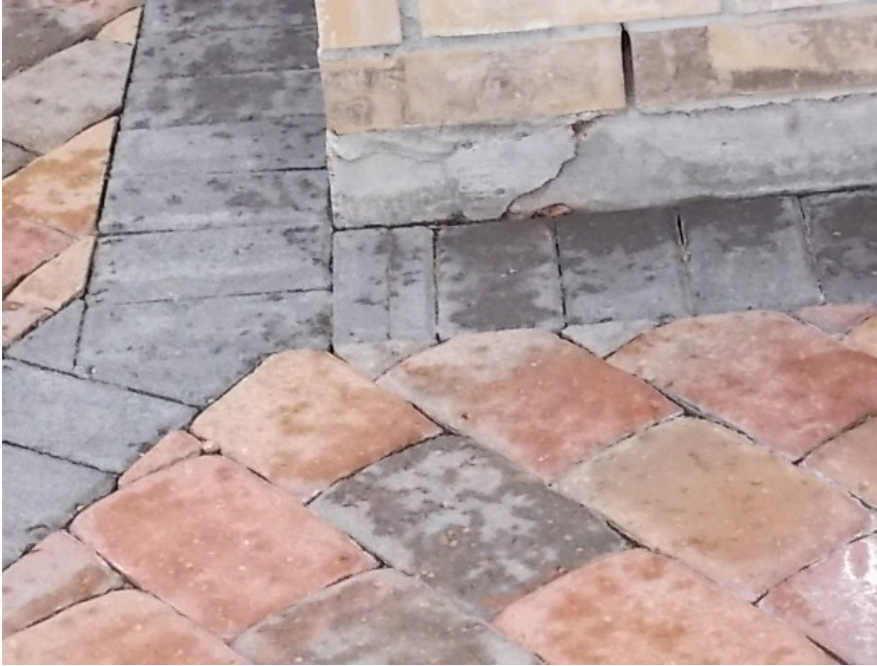
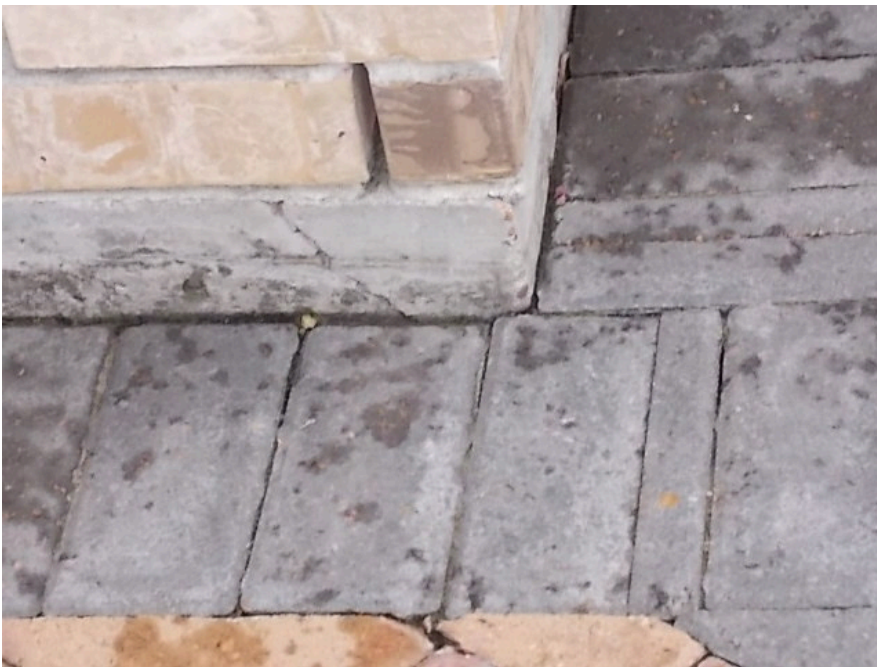
Line Item #: I.A

Description:
Example of multiple corner pops at the exterior foundation walls.

1. Qualified contractor to correct as determined necessary, the multiple corner pops at the exterior foundation walls.

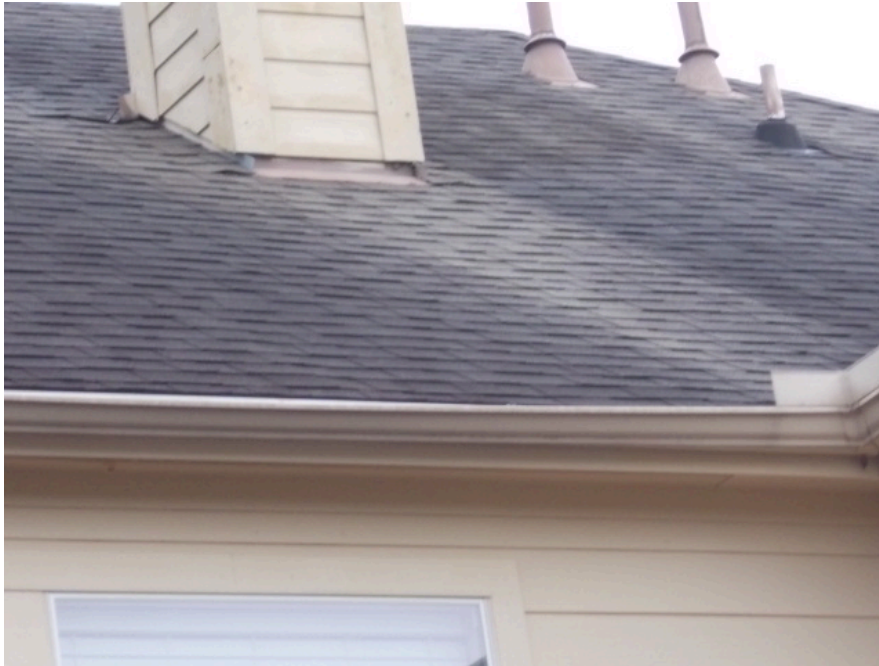
Line Item #: I.C.

Description:
Raised shingles observed at the roof.
Granular loss & stains observed at
multiple areas of the roof.

1. Further evaluation of the roof system by a qualified roofing contractor is needed due to, but not limited to, the conditions below: TBD

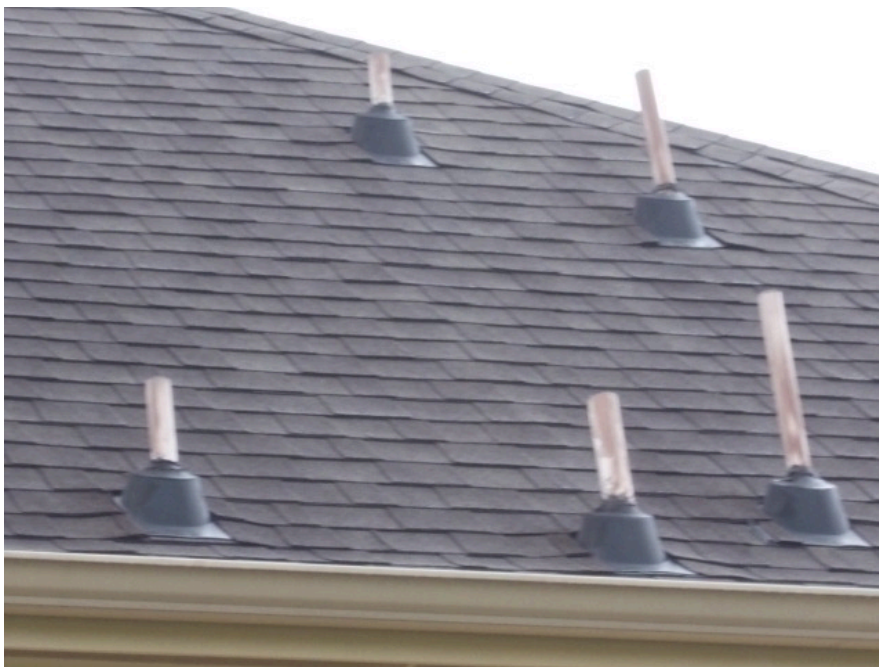
Line Item #: I.C.

Description:
Raised shingles and flashing observed at
the roof.

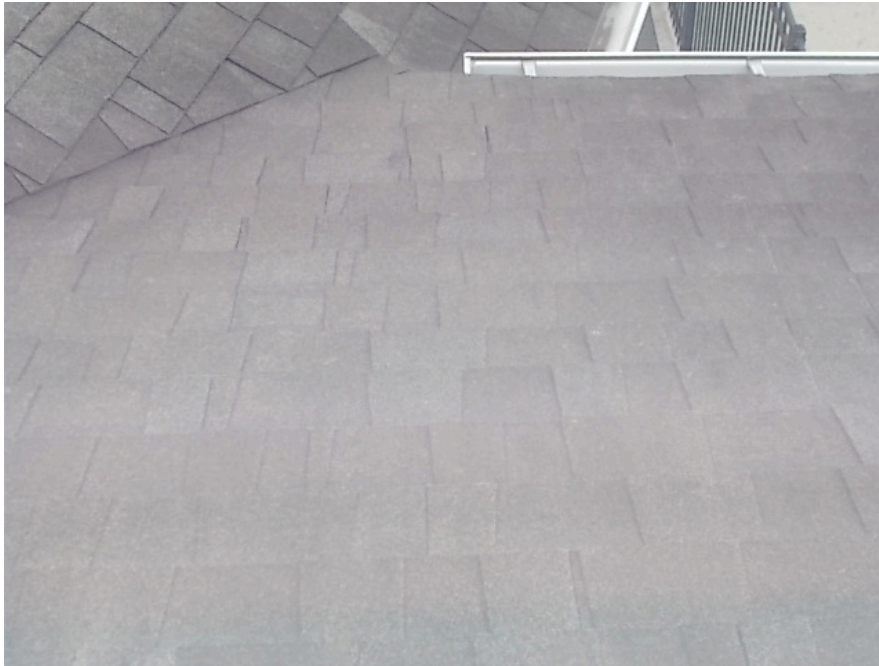
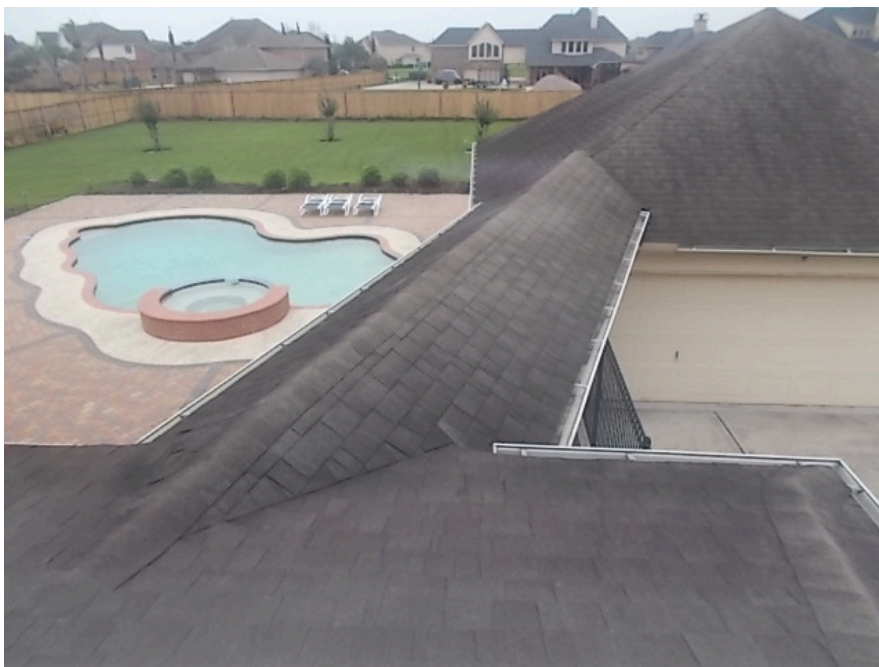
Line Item #: I.C.

Description:
Granular loss observed at multiple areas of the roof.

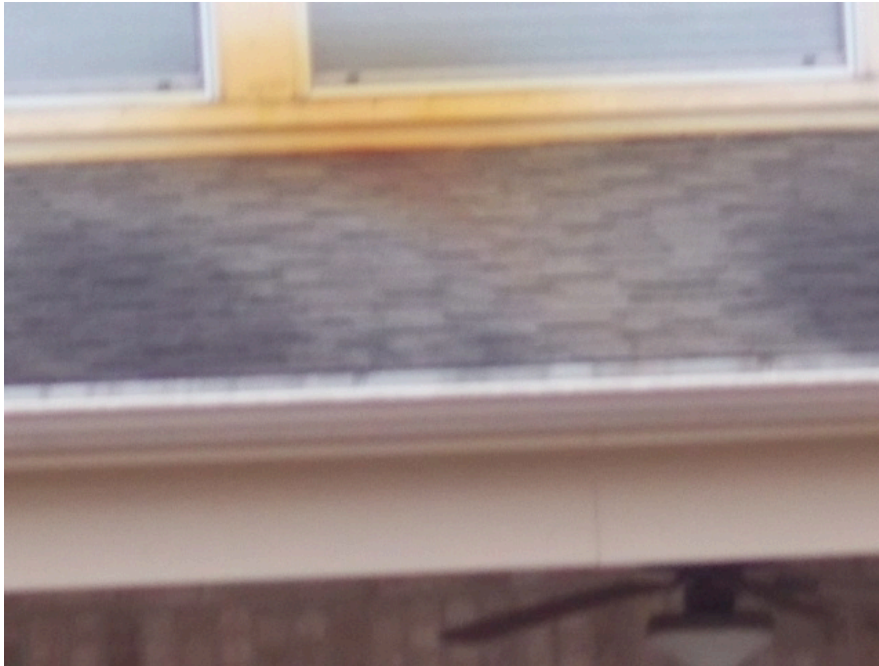
Line Item #: I.C.

Roof over flow stain on the rear roof shingles.

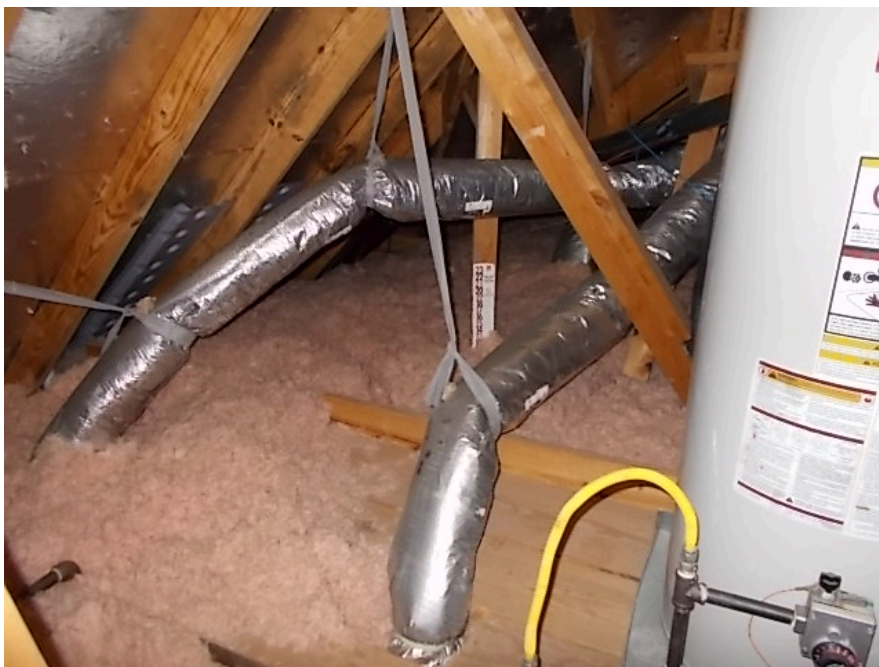
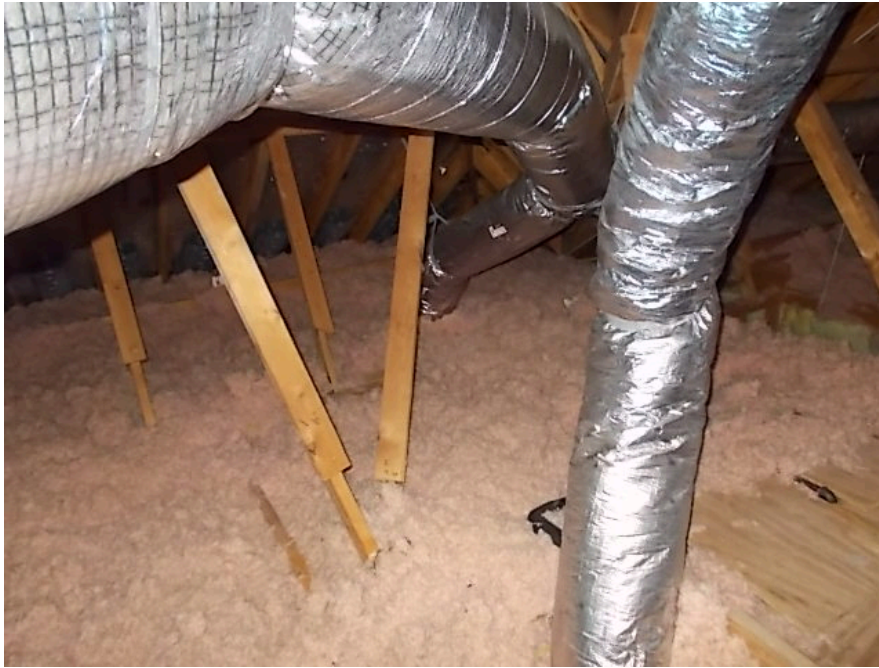
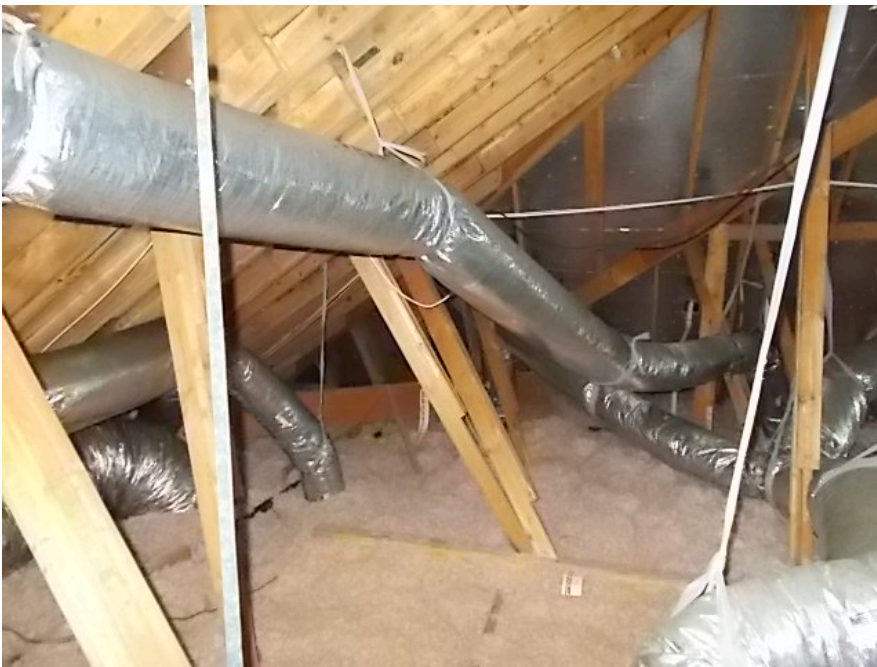
Line Item #: I.D.

NOTE: Inspection of attic was limited due to design, lack of walk boards, and insulation.

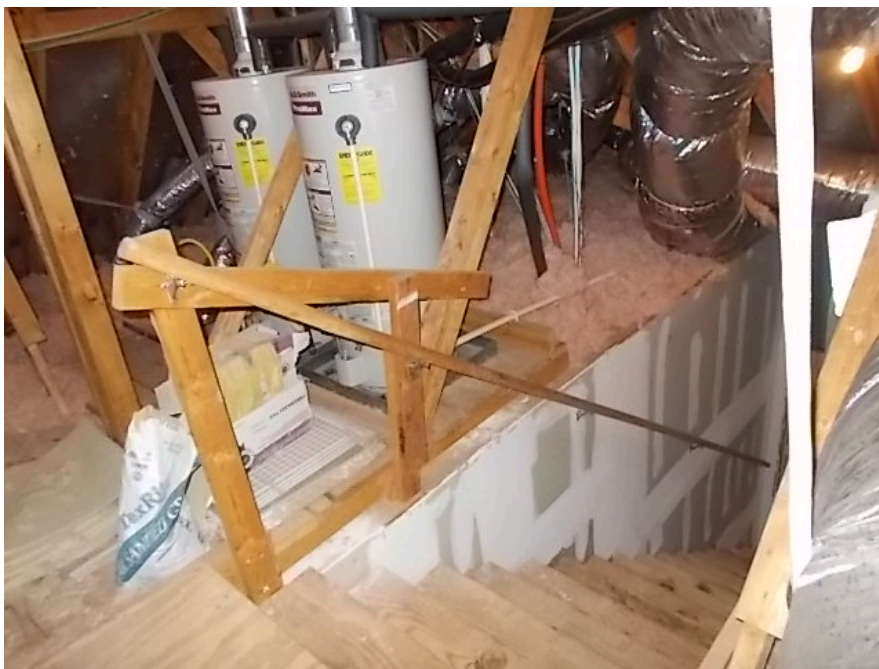
Line Item #: I.D.

NOTE: Inspection of attic was limited due to design and insulation.

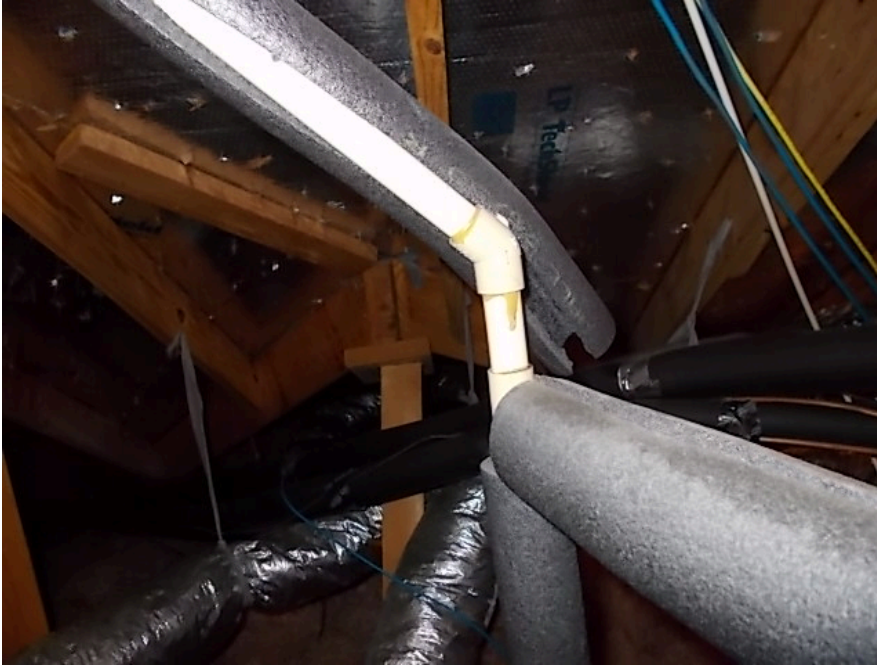
Line Item #: I.D.

NOTE: Inspection of attic was limited due to design.

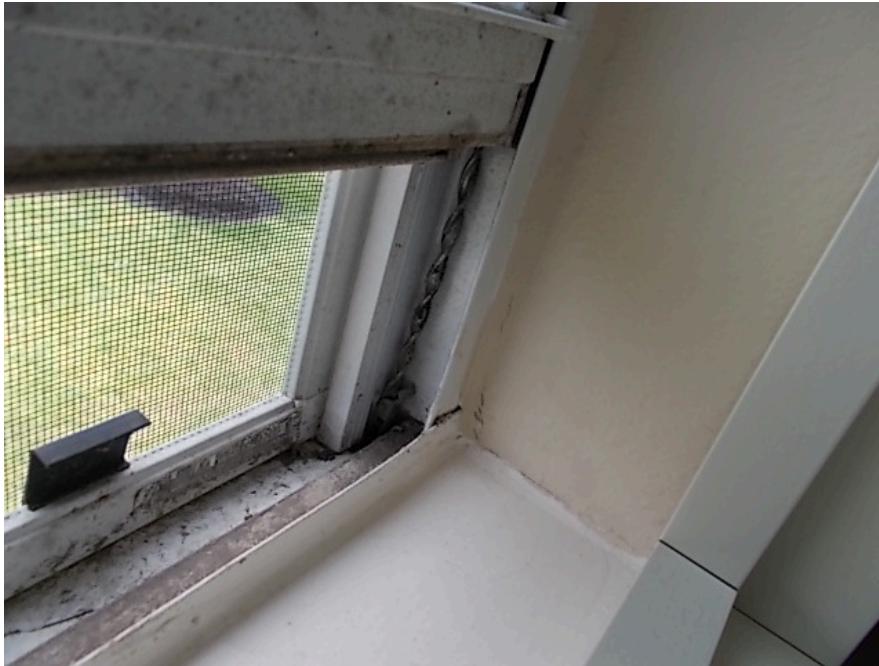
Line Item #: I.H.

Description:
Loose tension springs at the front bedroom window.

1. Qualified window contractor to examine all windows and make all necessary repairs including, but not limited to, the items listed below:

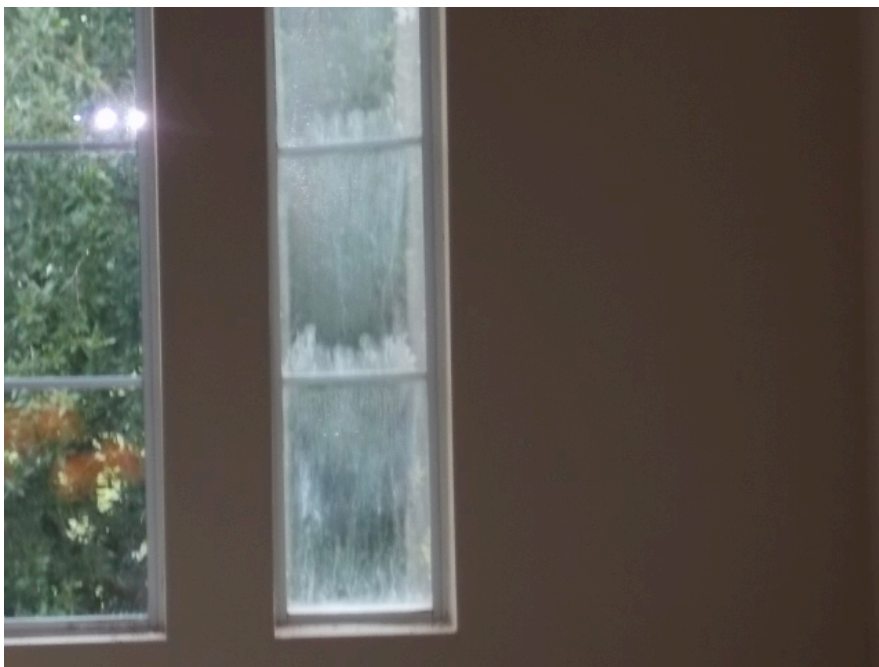
Line Item #: I.H.

Description:
Failed thermal seal at the front second story window.

The determination of failed seals can be affected by such conditions as temperature, humidity, and cleanliness of window surface. Due to these conditions, all failed thermal seals may not have been visible or identified at the time of this assessment. Therefore, all windows should be inspected by the window contractor to determine the total number of failed thermal seals. Due to the nature of visible concerns, the scope and cost estimate of this project is to be determined by a qualified window contractor.

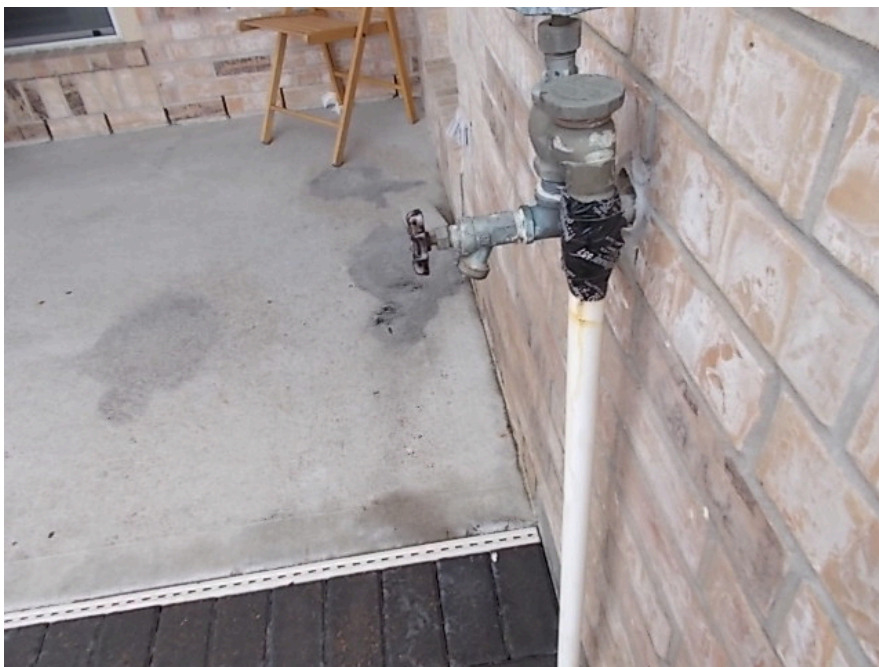
Line Item #: IV.A.

Description:
Missing backflow prevention at the exterior faucets.

1. Qualified contractor to correct as determined necessary the missing backflow prevention at the exterior faucets.

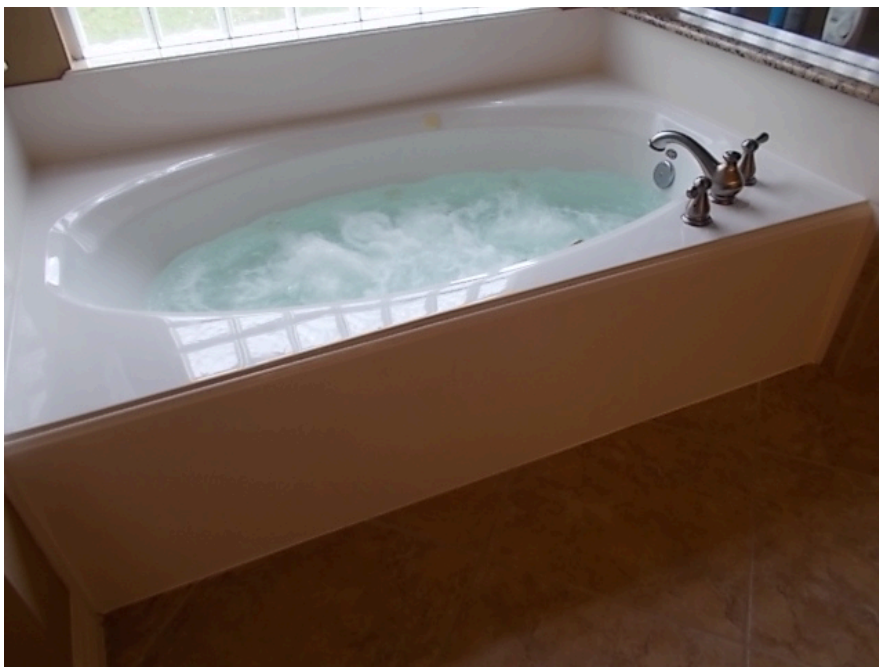
Line Item #: **IV.D.**

Description:
Hydro Therapy Tub

1. Qualified contractor to correct as determined necessary the missing access panel for the hydro therapy tub.

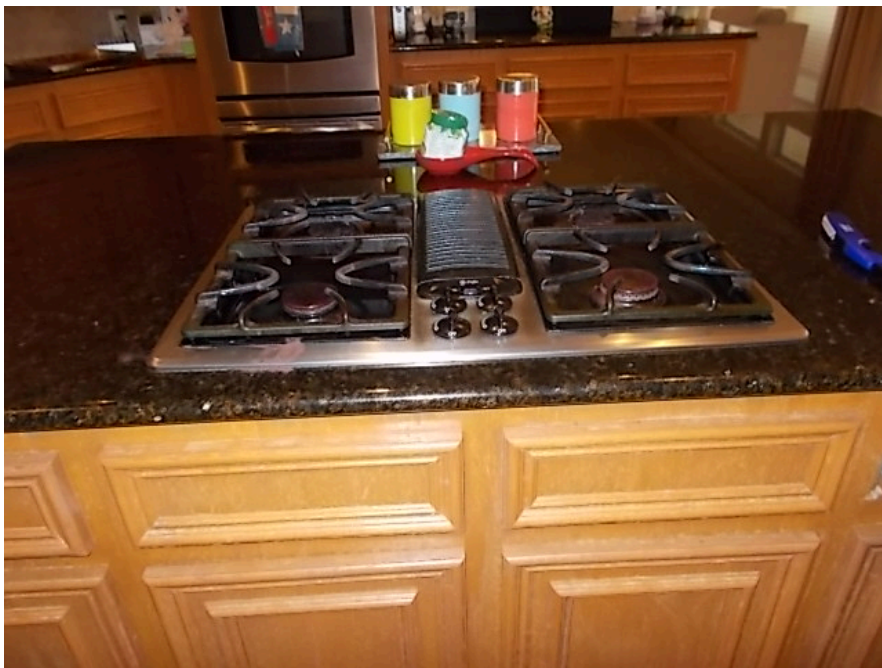
Line Item #: **V.D.**

Description:
Left front burner does not burn properly.

1. Qualified contractor to correct as determined necessary the left front burner that does not burn properly.

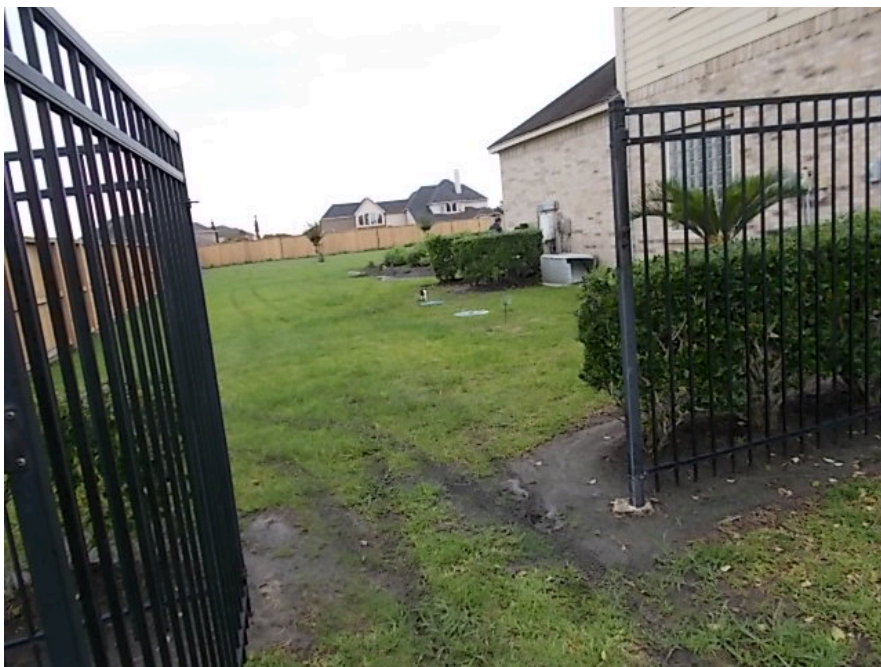
Line Item #: **VI.B.**

Description:
Left side gate is not self closing.

1. Qualified pool contractor to correct as determined necessary the pool light that is not functional and left side gate that is not self closing.

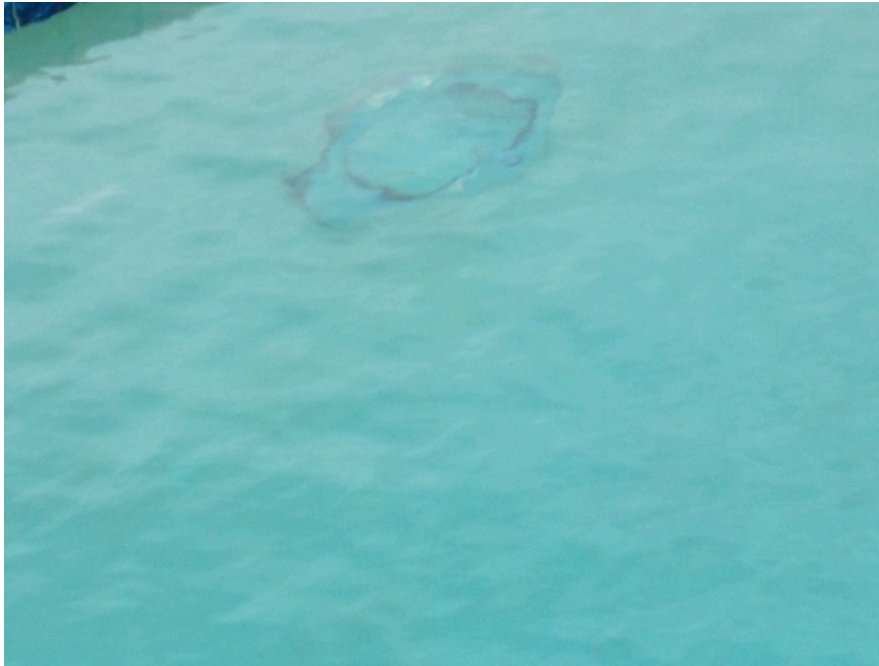
Line Item #: **VI.B.**

Description:
Pool light is not functional.
