20407 Noble Arabian Dr  
Tomball TX 77377

# PROPERTY INSPECTION REPORT

06/04/2021 8:00 am

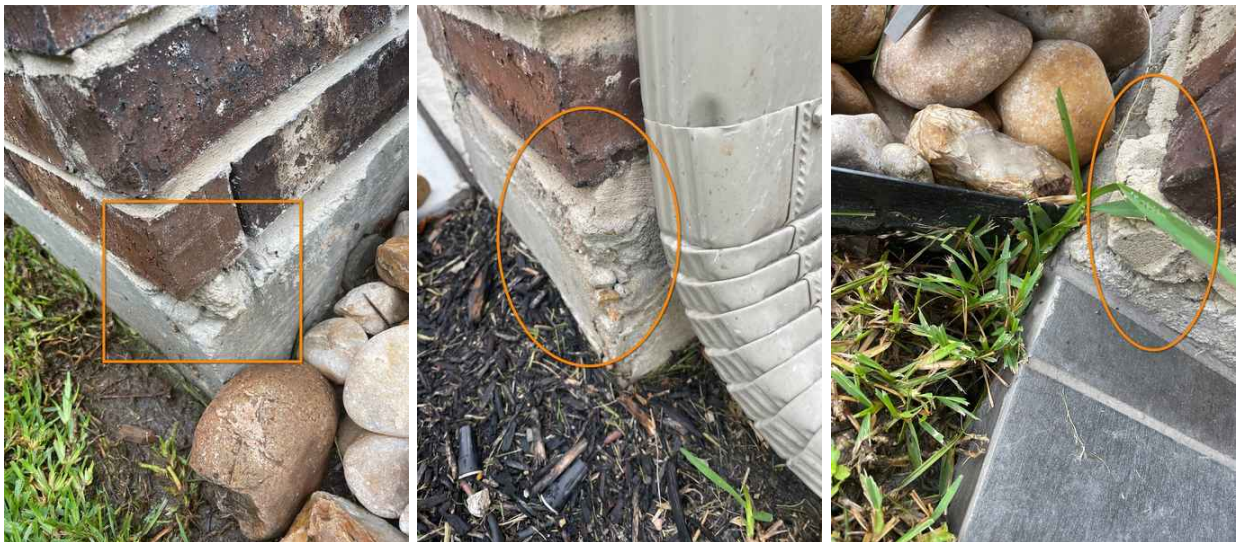
### 1: Corner deterioration

The brick ledge of the foundation is deteriorated in the corners of the foundation. This is typical of Slab-on-Grade foundations. Recommend a simple concrete repair of the cracked areas of the brick ledge by a qualified professional.

Recommendation: Contact a qualified professional.

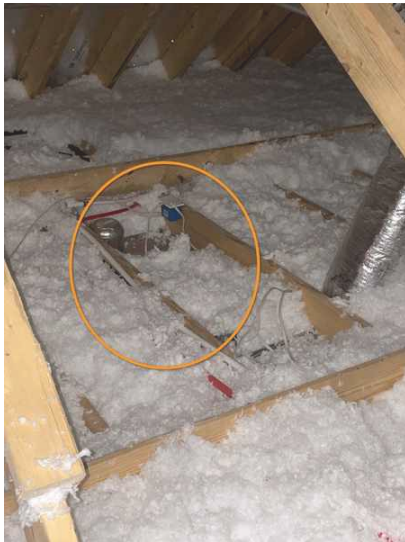
**1: Missing Insulation**

Insulation in one area of the attic has been moved and is in need of correction to prevent energy loss.

Recommendation: Contact a handyman or DIY project

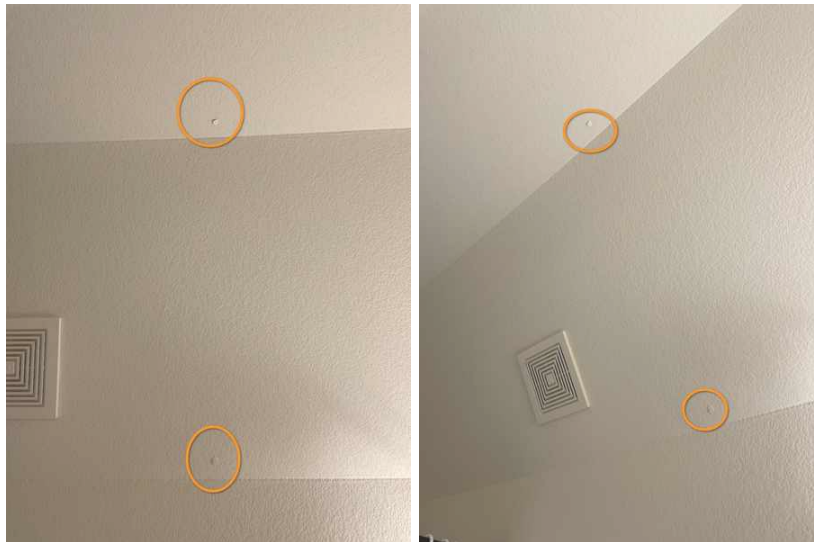
**1: Ceiling - Minor Damage**

Nail pops to the ceiling in a bathroom were visible at the time of the inspection. Recommend correction.

Recommendation: Contact a qualified drywall contractor.

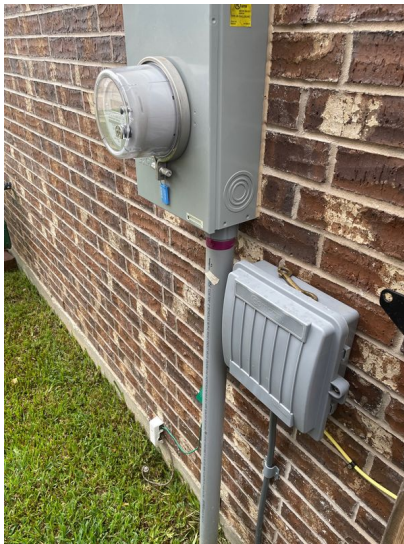
*Service Entrance Type:* Under Ground

This home has a 200 amp service. Functioning properly at the time of the inspection.

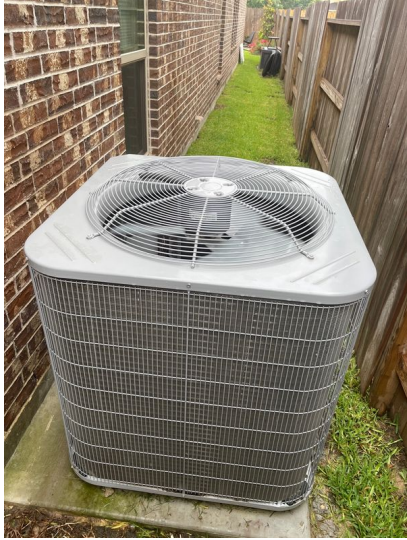
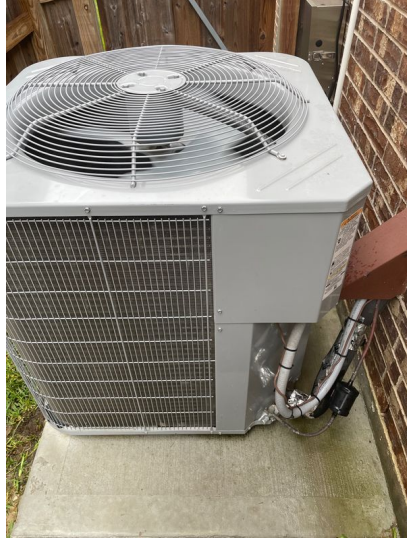
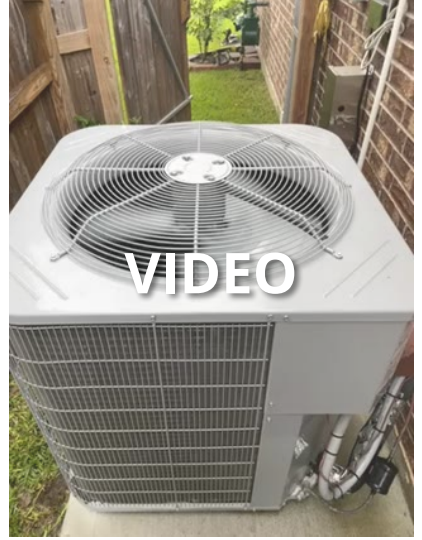
DEVICE	TXV	INDOOR	N/A
FACTORY CHARGED	13.00	LBS	R-410A
INDOOR TXV SUB COOLING	8	°F	
POWER SUPPLY	1	PH	208-230 VOLTS AC
			60 HZ
PERMISSIBLE VOLTAGE AT UNIT			
	253	MAX	197 MIN
SUITABLE FOR OUTDOOR USE			
COMPRESSOR	1	PH	208/230 VOLTS AC
			60 HZ
	19.90	RLA	109.0 LBA
FAN MOTOR	1	PH	208/230 VOLTS AC
			60 HZ
	1/4	HP	1.20 FLA
			3103 KPA
DESIGN / TEST PRESSURE GAGE	450	PSI	1724 KPA
HI	250	PSI	
LO			4826 KPA
MAX DESIGN / WORKING PRESSURE	700	PSID	
MINIMUM CIRCUIT AMPS	26.1	A	
MAX PURE	40	A	230 V
Short Circuit Current: 0 kA (max. symmetrical)			
MODEL NUMBER			
SERIAL NUMBER			
DATE OF MANUFACTURE: Feb-2009			
UL US LISTED

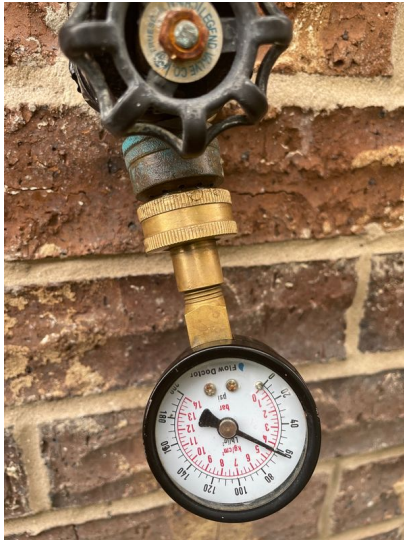
*Static Water Pressure Reading: 60*

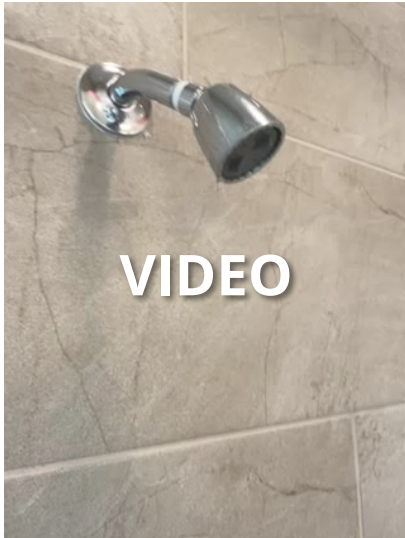
**1: Shower faucet**

The shower faucet (mixer handle) would not properly shut off when tested. Recommend further evaluation and correction by a qualified professional.

Recommendation: Contact a qualified plumbing contractor.

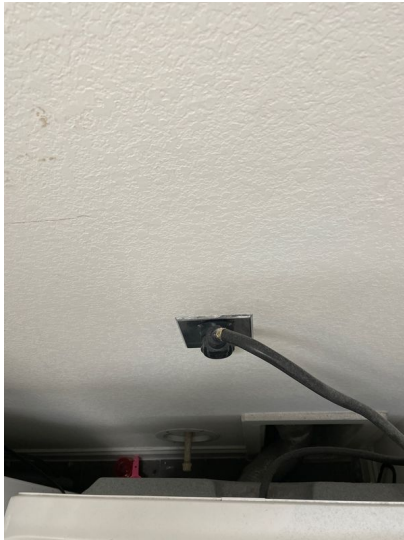
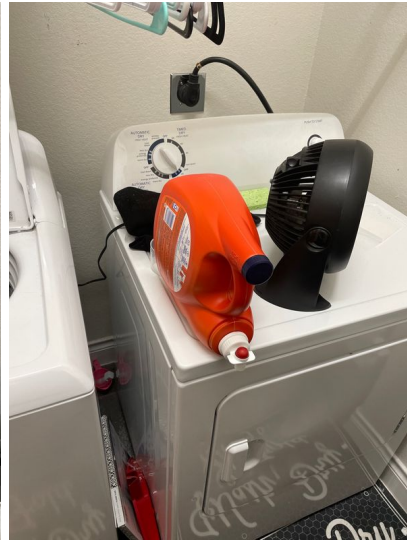
*Comments:*  
*No access to dryer vent :*  
The dryer vent was blocked by the dryer unit, therefore the inspector was not able to properly inspect the dryer venting system.
