PROPERTY INSPECTION REPORT

Concerning: 26902 Soapstone Terrace Ln, Katy TX 77494

By: Michael Rasco - TREC License #24232

08/29/2021 1:00 pm

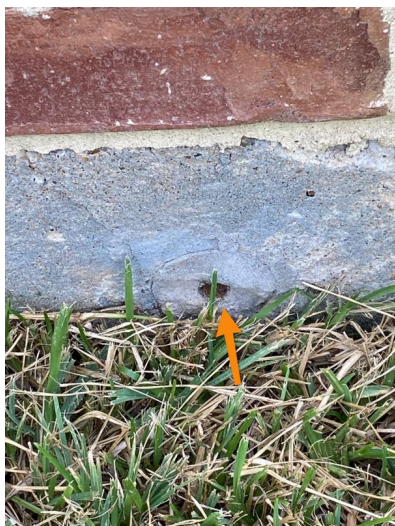
Back of home

1: Foundation steel exposed

Exposed foundation steel will rust and expand, which will damage the concrete surrounding it. All areas of exposed steel should be sealed to prevent further deterioration.

Recommendation: Contact a handyman or DIY project

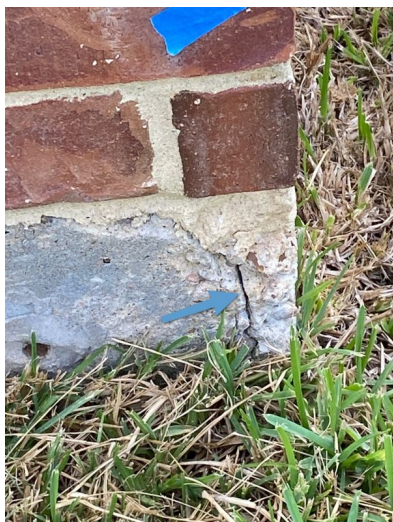
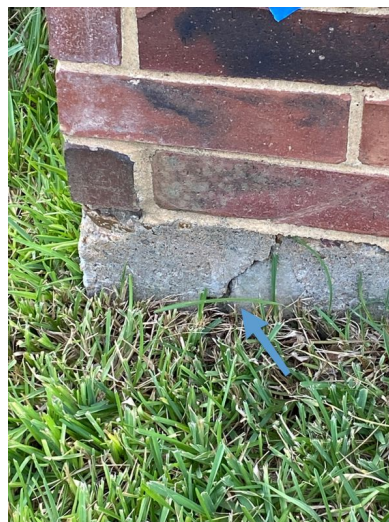
Back left corner of home

3: Wedge crack in edges of foundation

Wedge cracks appear because of the lack of steel in the corners of the slab. They are only cosmetic, and do not affect the structure. Make sure and keep these places sealed to keep water out of the cracks and prevent insect intrusion into the home.

Recommendation: Contact a handyman or DIY project

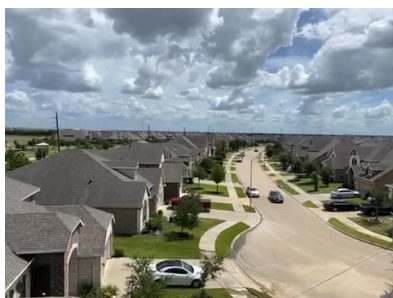
1: Damaged Coverings

Roof coverings exhibited general damage that could affect performance. Recommend a qualified roofer evaluate and repair.

Recommendation: Contact a qualified roofing professional.

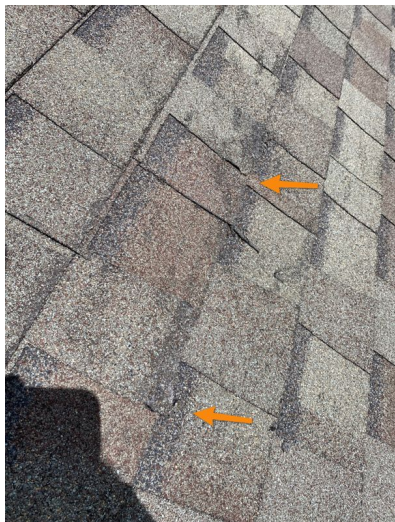
2: Flashings have gaps

Wind driven rain can make its way into these gaps, allowing water to damage to the underlying components leading to expensive repairs. It also allow animals and insects access to the interior space of the home.

Recommendation: Contact a qualified roofing professional.

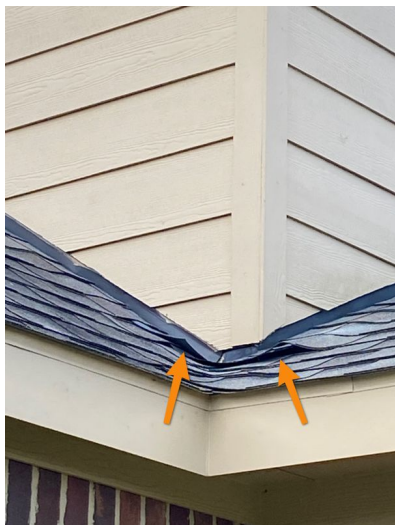
Back of home

3: Raised shingles

Recommendation: Contact a qualified professional.

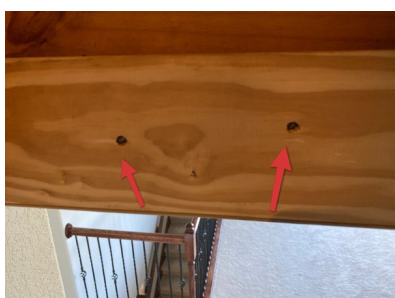
1: Attic entry is not properly secured

Attic entries need to be secured with 16d nails or lag screws. Most attic entries have labels giving instruction on how to properly install the entry. entrance ladder must be secured directly onto the framing without gaps.

Not 16D nails

Recommendation: Contact a qualified professional.

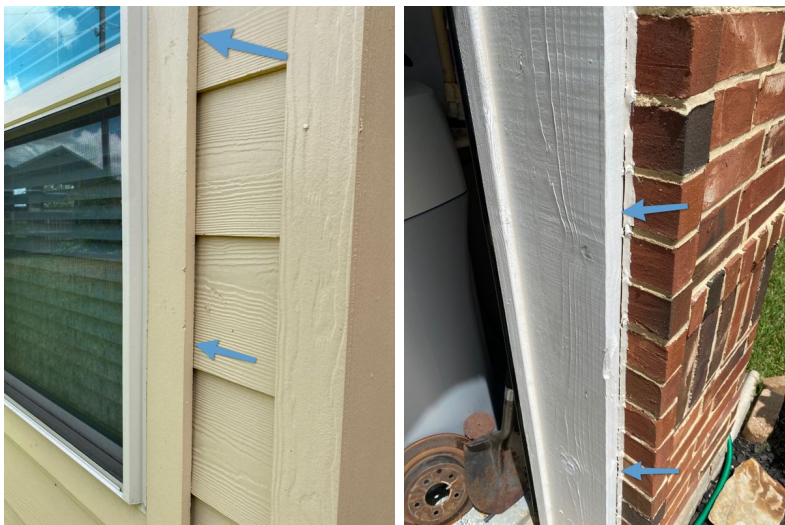
1: Caulking/sealant is deteriorated or missing

Gaps in the caulking/sealant let insects and water penetrate the structure. When caulking starts to separate or crack it is time to replace it.

Recommendation: Contact a handyman or DIY project

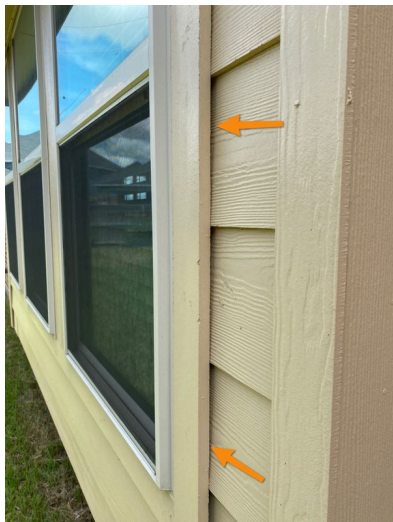
2: Cement board is not installed properly

Recommendation: Contact a qualified siding specialist.

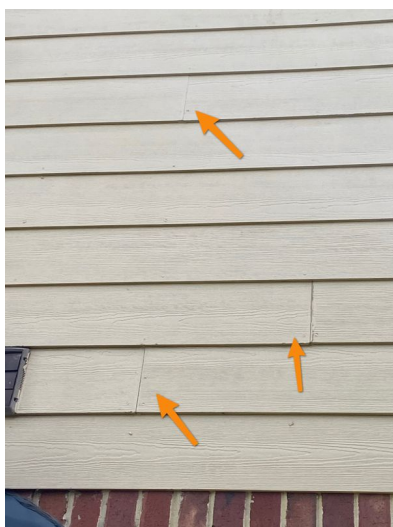
3: Joints are separating in siding

Siding should be sealed at all joints. Reason for separation should be determined in order to assess if repairs are needed to structure.

Recommendation: Contact a qualified professional.

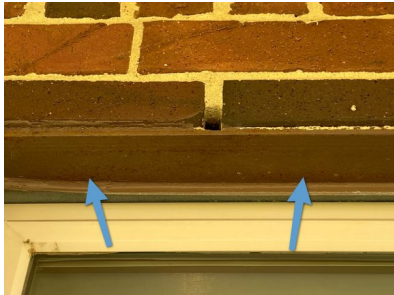
4: Lintels are rusted

Lintels are metal plates that support the brick above them it is important to keep these painted and sealed to prevent rusting. Rust will expand and crack the brick and mortar. In extreme cases, the lintel will not be able to support the brick and will need to be replaced.

Recommendation: Contact a qualified masonry professional.

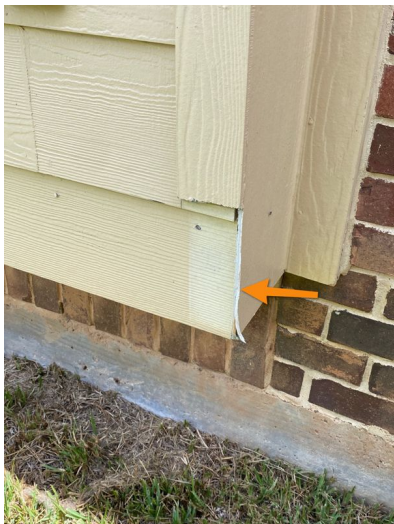
Left side of home

5: Siding or trim is damaged or deteriorated

Damaged or deteriorated siding and trim can allow access to water and insects into the home. Have damaged or deteriorated areas replaced.

Recommendation: Contact a qualified siding specialist.

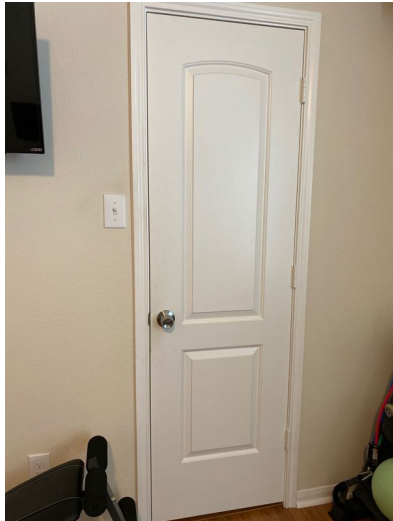
1: Door does not latch

Door doesn't latch properly. Recommend handyman repair latch and/or strike plate.

Recommendation: Contact a qualified handyman.

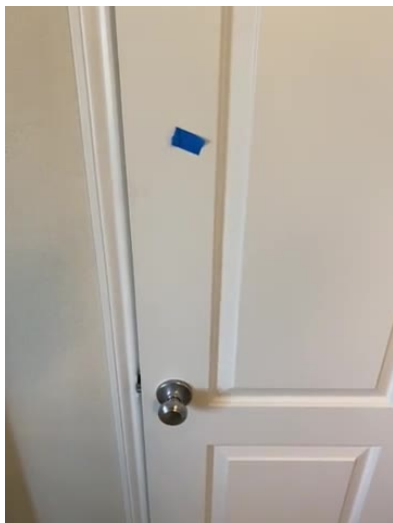
2: Door into garage/attic does not automatically close and latch

Recommendation: Contact a handyman or DIY project

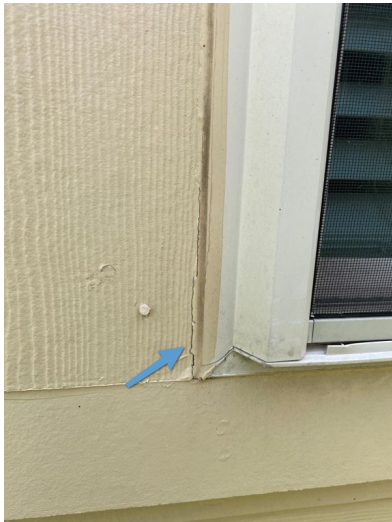
1: Caulking/sealant is deteriorated or missing

Caulking/sealant keep water and pests from entering the home.

Recommendation: Contact a handyman or DIY project

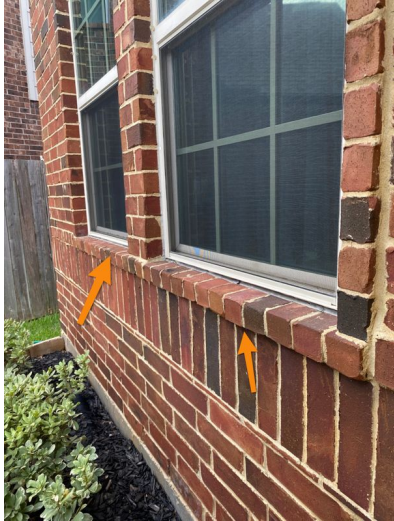
Front windows

2: Window ledge doesn't have correct sloping

Recommendation: Contact a qualified professional.

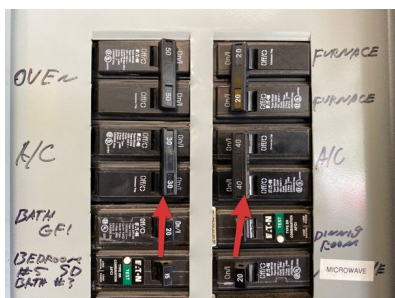
Both condensers outside have a max amp of 25 but the breakers are 30 and 40 amp. They should be changed to match the condenser conditions to proper proper protection

If the unit malfunctions, the breaker will not trip, and the unit will continue to run which could cause damage or a fire.

If the breaker is undersized it will cause the breaker to trip under heavy loads.

Recommendation: Contact a qualified heating and cooling contractor

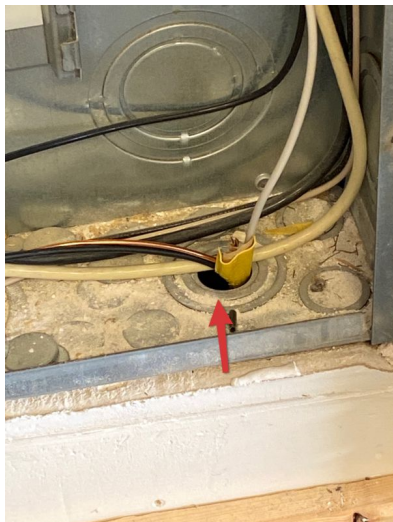
2: Bushing to protect wiring from abrasions is missing or not installed properly

Bushings are installed to protect wires from abrasion when entering the panel box. Without them, the insulation around the wiring can be cut by the sharp metal in the entrance to the panel. This could cause arcing leading to electrical shock or fire.

Recommendation: Contact a qualified professional.

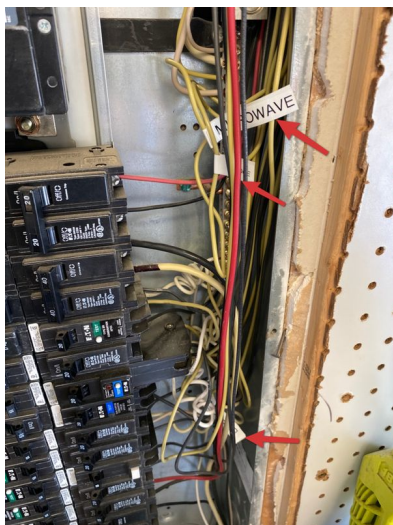
3: Non electrical tape is used in panel

Non-electrical tape can be combustibile and should not be in contact with electricity.

Recommendation: Contact a qualified professional.

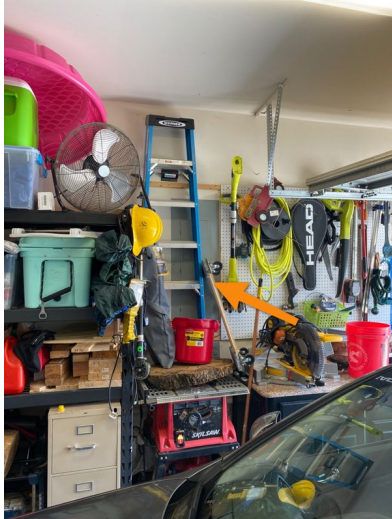
4: Panel does not have proper clearance

Recommendation: Contact a qualified professional.

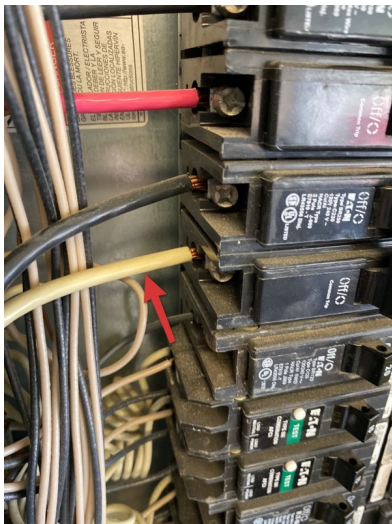
5: Wires are not color coded

Without correct color coding, wiring could be installed incorrectly and wires could be misidentified as grounds or neutrals instead of hot wires.

Recommendation: Contact a qualified professional.

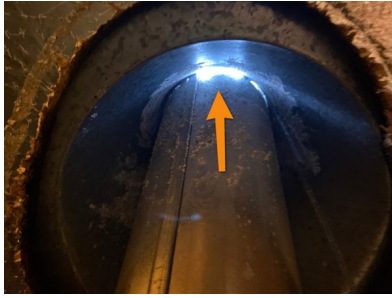
1: Light can be seen where vent penetrates the roof jack

Recommendation: Contact a qualified professional.

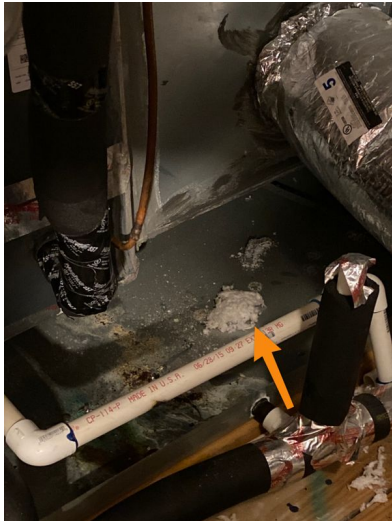
1: Debris in drain pan

Debris can clog the pan drain and cause the pan to overflow when the secondary is running.
Recommendation- remove debris.

Recommendation: Contact a handyman or DIY project

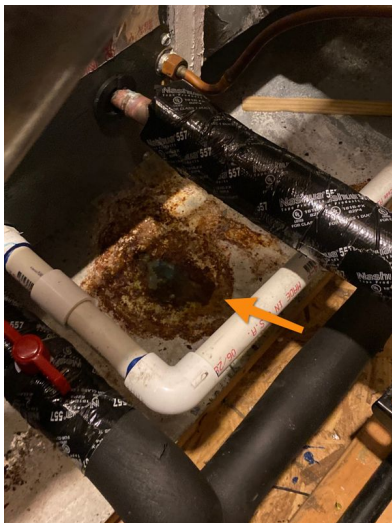
2: Drain pan has evidence of previous moisture

Monitor for moisture in the drain pan, and call an HVAC professional if moisture is discovered.

Recommendation: Contact a qualified professional.

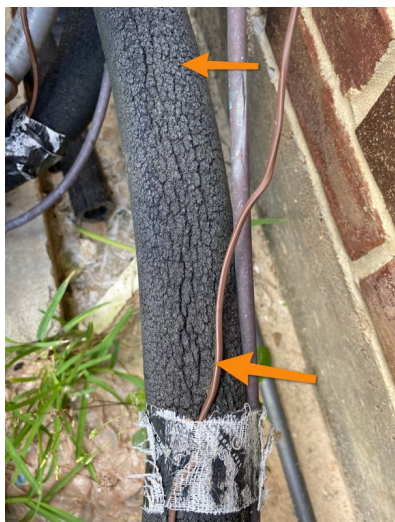
3: Insulation Missing or Damaged

Missing or damaged insulation on refrigerant line can cause energy loss and condensation.

Recommendation: Contact a qualified HVAC professional.

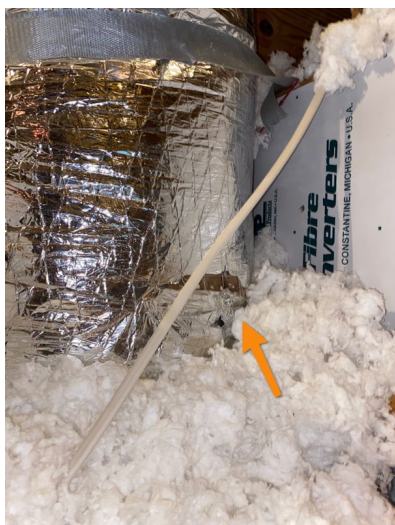
Near entry

1: Duct Damaged or leaking

Air supply duct was leaking or damaged. Recommend a qualified HVAC contractor repair.

Recommendation: Contact a qualified HVAC professional.

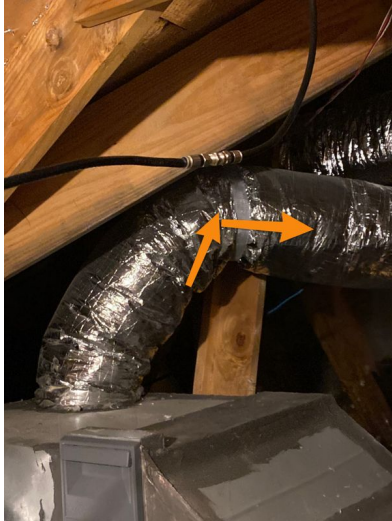
2: Ducts are installed at a sharp angle or constricted not allowing for proper flow of air

Improperly angled ducts do not allow air to flow freely and will not deliver air to the registers needed to cool and heat rooms adequately. Ducts should not exceed 45 to 50 angle to insure efficient airflow.

Recommendation: Contact a qualified HVAC professional.

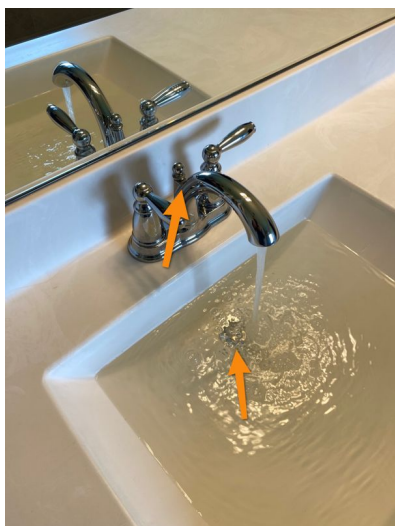
1: Drain stop missing or not working properly

Without a working drain stop drains cannot be tested at a high water volume, and spa tubs cannot be tested.

Master bathroom drain stop is not connected to each other

Recommendation: Contact a qualified professional.

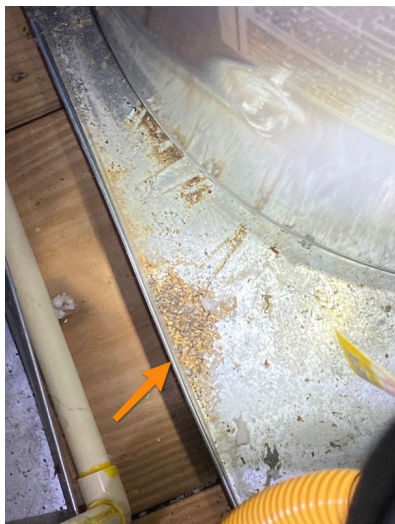
1: Pan has debris in it

Debris in the drain pan can clog the drain and cause water to spill into the structure.

Recommendation: Contact a qualified professional.

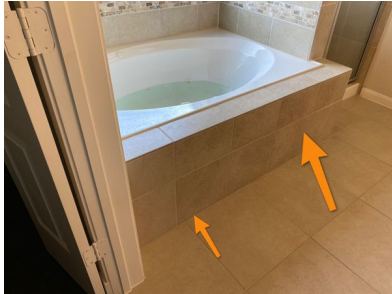
1: No access to spa equipment

The spa equipment cannot be observed or replaced without an access.

Recommendation: Contact a qualified professional.

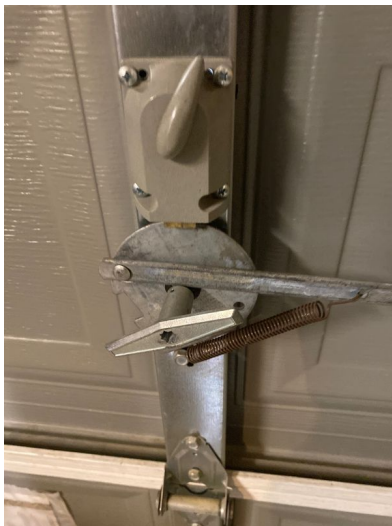
1: Lock is not disabled

If garage door opener is operated while garage door lock is engaged, it can cause damage to door and possibly caused door to come off track causing injury to property and persons.

Recommendation: Contact a qualified professional.
