PROPERTY INSPECTION REPORT

Prepared For: Syed Fahad Akhtar
(Name of Client)

Concerning: 723 Wellington Point, Houston, TX 77094
(Address or Other Identification of Inspected Property)

By: Robert Ramirez, Lic #10013 03/21/2018
(Name and License Number of Inspector) (Date)

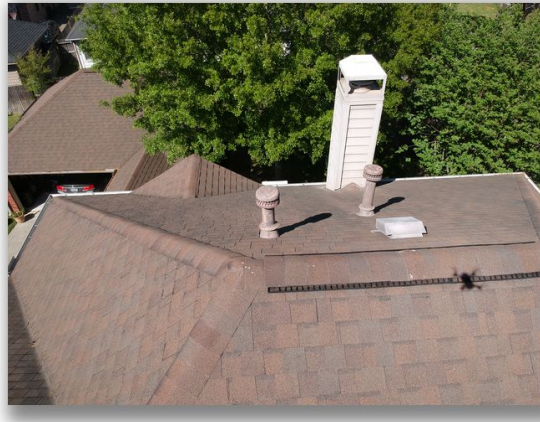
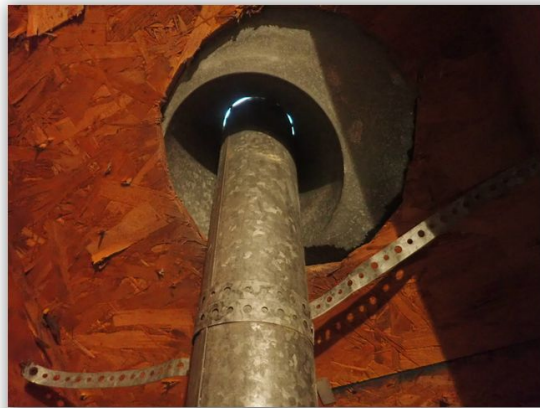
Flashing Details

The flashing details needs to be checked, reset or repaired as necessary. The observations made to support the rendering of this opinion are listed but may not be limited to:

- The storm collar(s) at the roof level gas equipment vent pipe(s) need to be properly sealed to help prevent water intrusion into the structure.

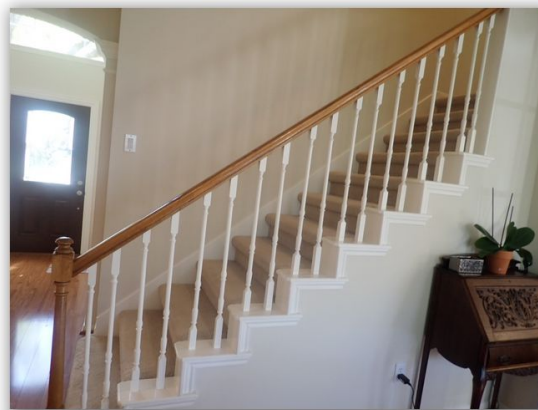
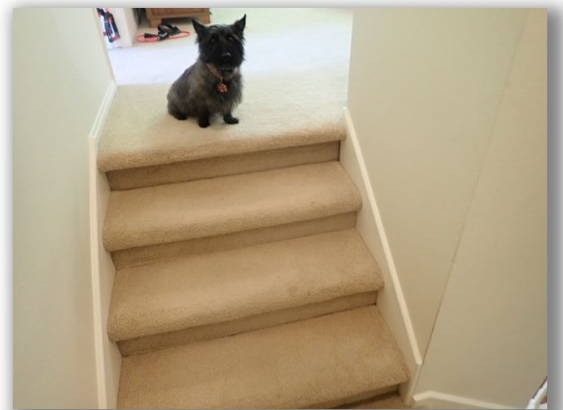
- The stairway guard balusters and/or spindles are installed to far apart under current building standards. This may be an “as-built” condition but Per TREC standards of practice we are required to report this condition as a deficiency. You may consider corrective measures for improved safety.
- The stairway handrail does not run continuous from the bottom of the stairwell to the top of the stairwell so to cover all of the steps (treads). Under current building standards all handrails for the stairway should run continuous for the full length of the flight. The handrail should start directly above the lowest step and run continuously to end directly above the top step.

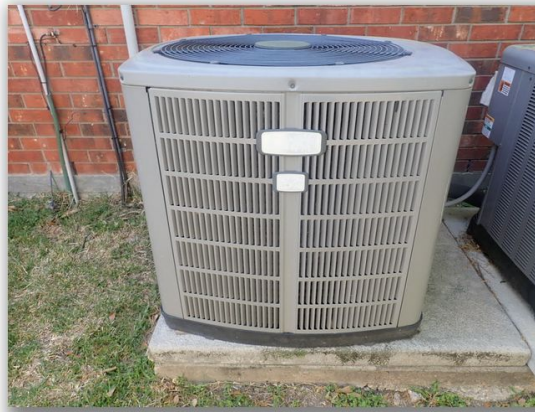
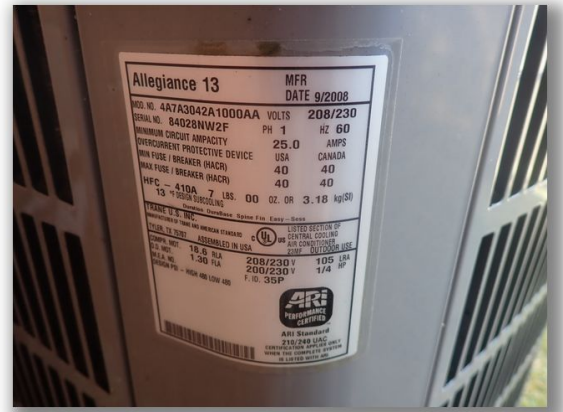
- **The temperature drop measured across the evaporative coils of the air conditioning system is lower than considered typical. The unit is not cooling properly and servicing is needed.**

The HVAC system and equipment needs to be checked and serviced by a Qualified / Licensed HVAC Technician. The observations made to support the rendering of this opinion are listed but may not be limited to the following:

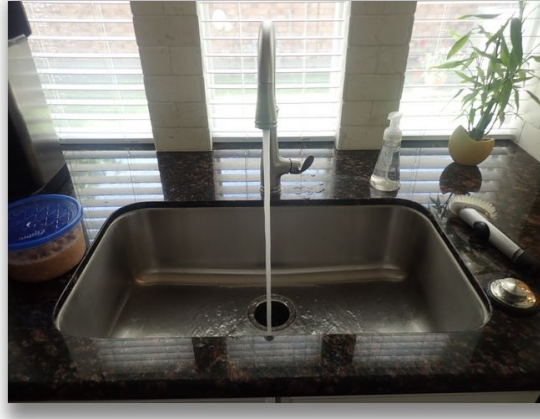
Kitchen Sink

- The drain leaks water into the cabinet when drained under pressure with a large volume of water.

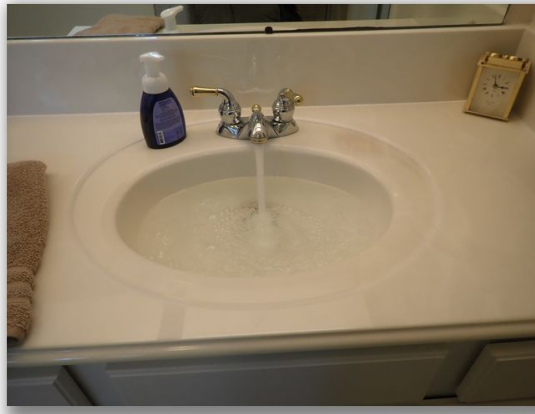
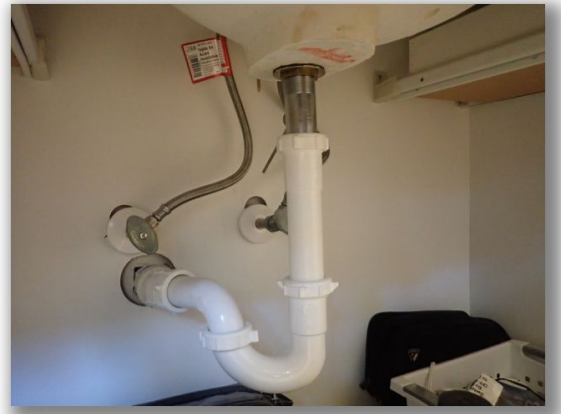
Right Lavatory / Sink

- The stopper is damaged.

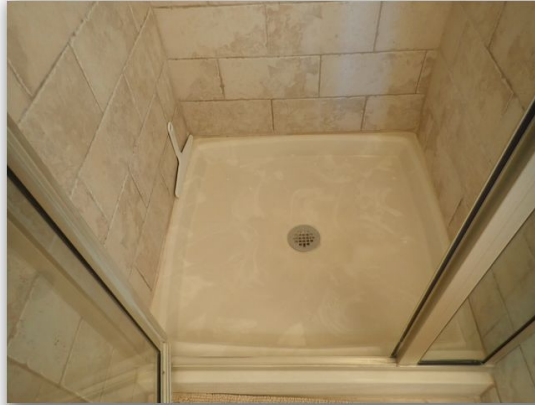
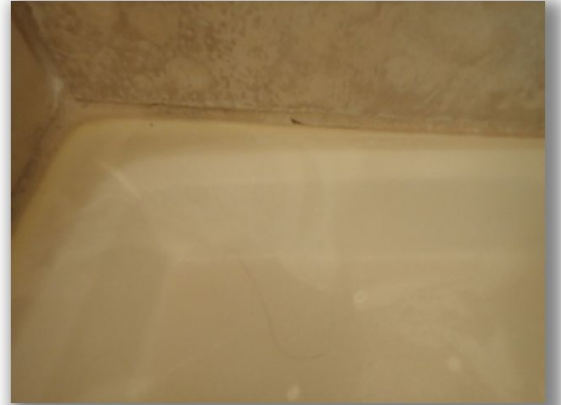
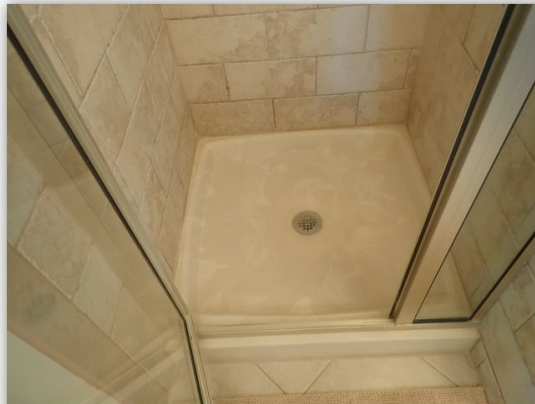
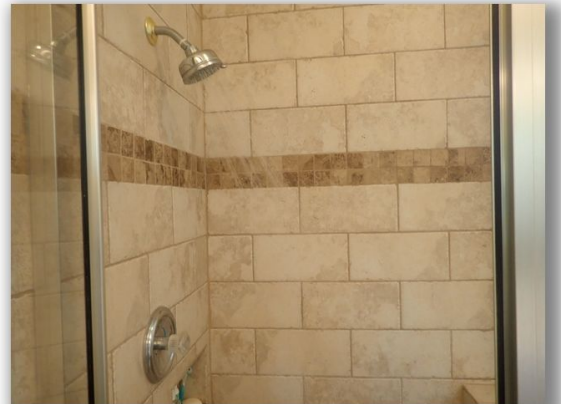
Shower

- Cracked, deteriorated and/or missing shower stall grout and/or caulking should be repaired or replaced as necessary.

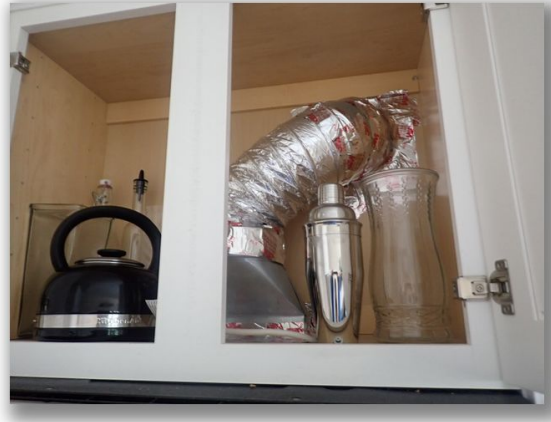
- There is aluminum ductwork in place for the range hood vent. Under current installation standards, aluminum flex ducting should not be used for the range exhaust vent connection.

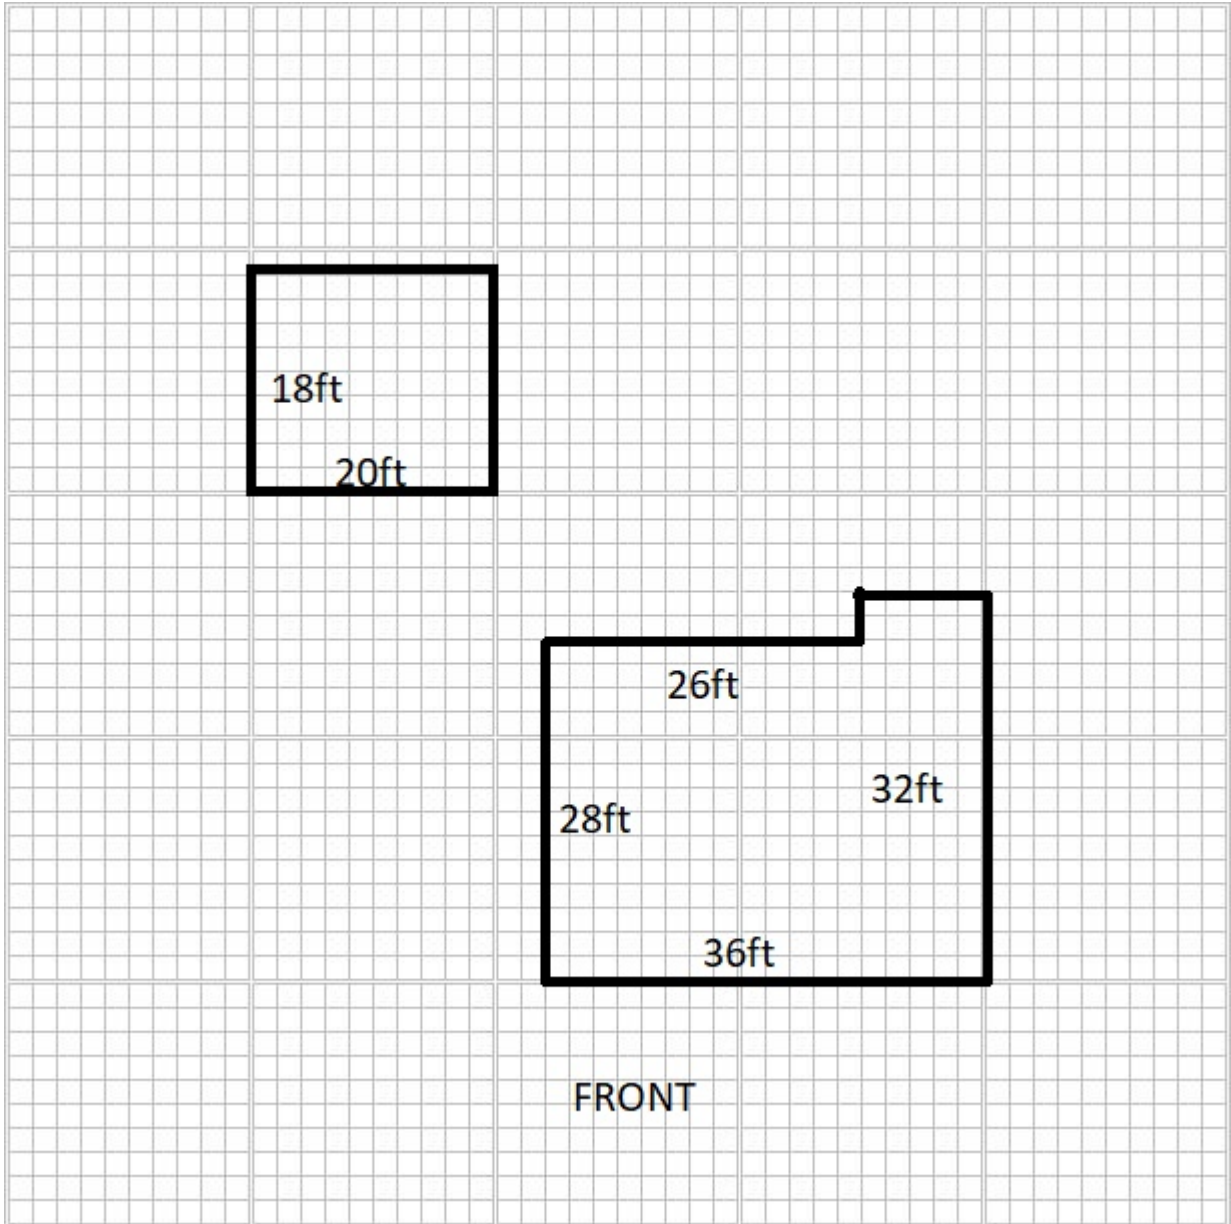
Additional Comments There is no visible evidence of active wood destroying insects found at the time of this inspection.
