# Inspection Report

**Property Address:**  
12519 Sunbrook Dr  
Brookside TX 77581

**HG Home Inspection**

**By:** John Richardson 23855 / HG Home Inspection 12/1/2021

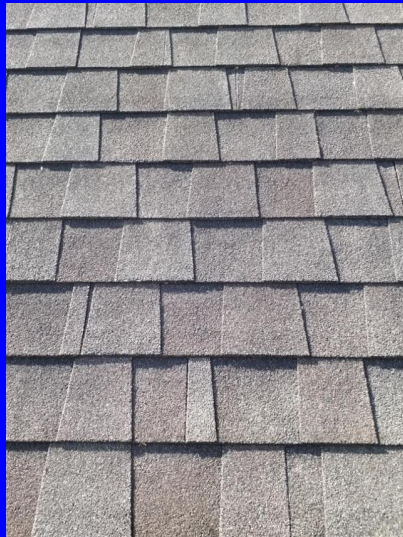
Roof surface

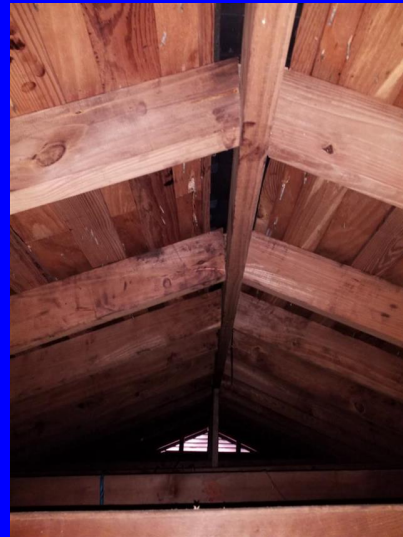
Roof structure stick built with wood slats

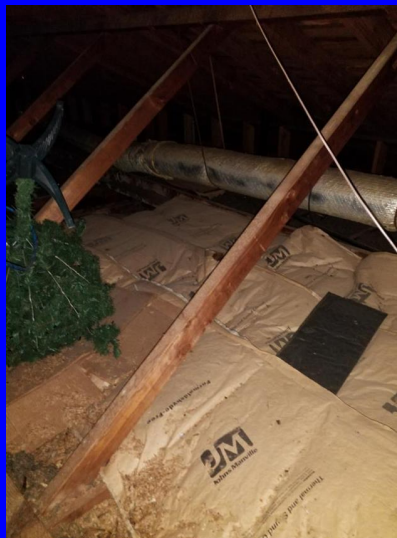
Less than six inches of batt fiberglass and rock wool insulation

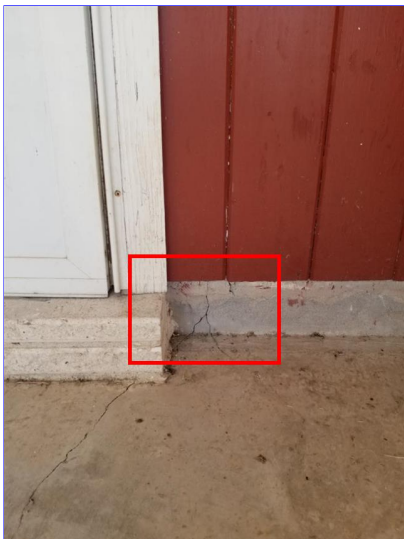
A. Item 1(Picture) Front of home

(2) The foundation has visible cracking. I recommend having a foundation company or Structural Engineer further evaluate.

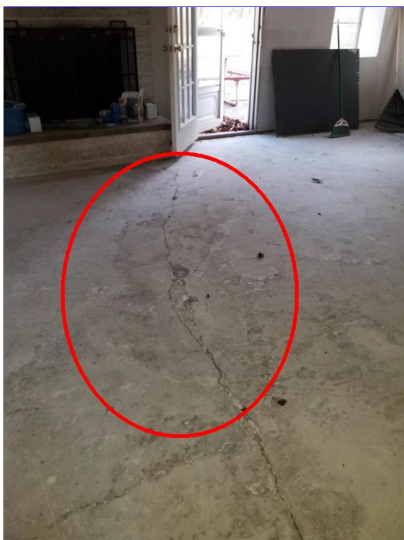
A. Item 3(Picture) Living room

(3) The foundation wall appears to be showing signs of flaking and deterioration. I recommend having a qualified person make repairs as needed.

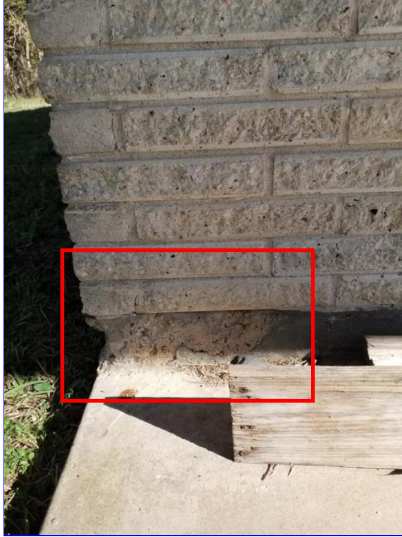
A. Item 4(Picture) Front left corner of home

(4) The foundation has minor corner pop(s) that are considered cosmetic. Further deterioration may occur if not corrected. I recommend having a qualified person make repairs as needed.

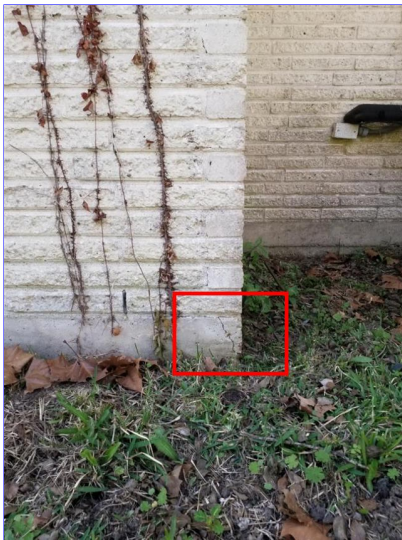
A. Item 5(Picture) Rear of home

(5) The foundation is poured on grade and appears to be performing as designed.

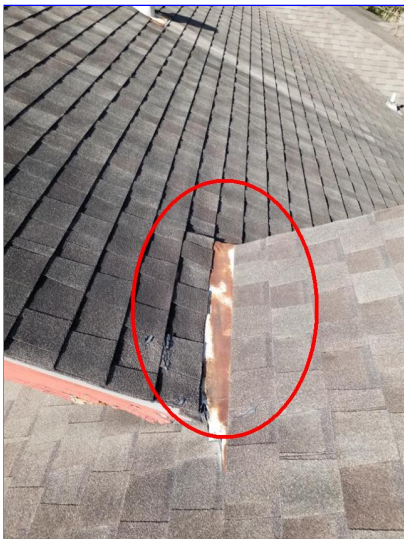
C. Item 1(Picture) Front right side of home

(2) The flashing is deteriorated in areas. I recommend a qualified roofing contractor be consulted for further evaluation and repair.

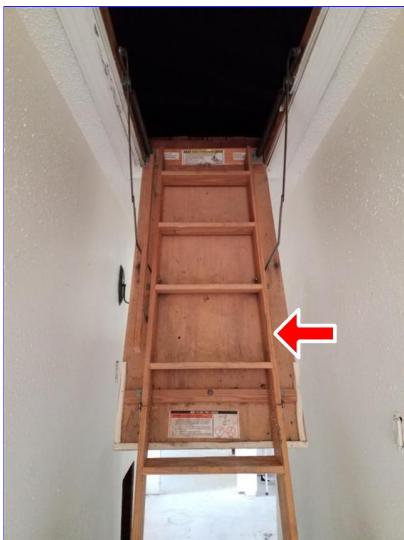
D. Item 1(Picture) Attic stairs

(1) The pull down stairs are not properly insulated. This can cause some heat loss in winter and loss of cool air in summer if not corrected. I recommend repair as desired.

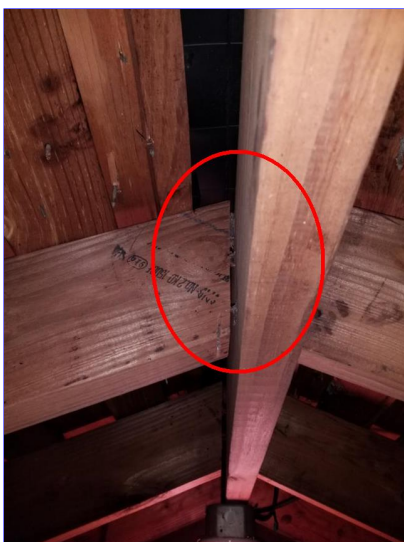
D. Item 2(Picture) Attic

(2) Rafter separation was observed in areas at the attic. I recommend a qualified contractor be consulted for further evaluation and repair.

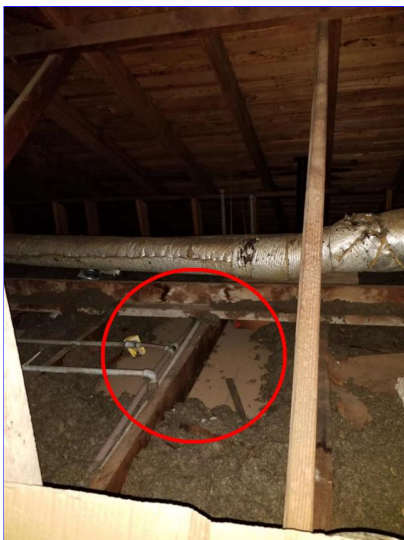
D. Item 3(Picture) Attic, front of home

(3) The attic space has area's of missing insulation. This is causing energy loss and is not today's standard. I recommend having a qualified person evaluate and add insulation as needed.

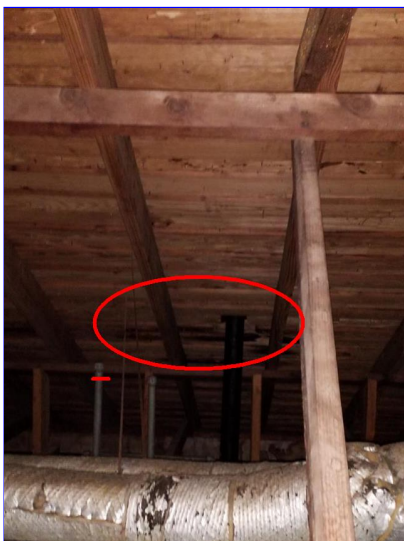
D. Item 4(Picture) Attic, front of home

(4) The roof structure in the attic has water stain indicating a leak did or still exists in areas. The moisture meter was used and it did not indicate an active moisture at the time of the inspection. A qualified contractor should inspect and repair as needed.

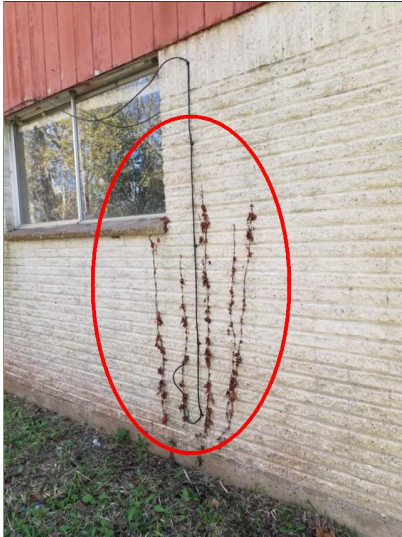
E. Item 4(Picture) Left side of home

(2) There is vegetation growth on exterior of the home. This can cause damage, contribute to premature deterioration and create conducive conditions for certain wood destroying insects. I recommend removal of vegetation and having a qualified pest control company inspect and treat as needed,

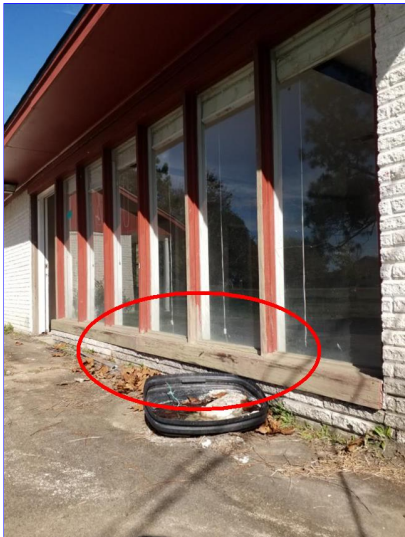
E. Item 7(Picture) Front of home

(3) The exterior siding and trim is deteriorated in areas. Further deterioration will occur if not corrected. A qualified contractor should inspect and repair as needed.

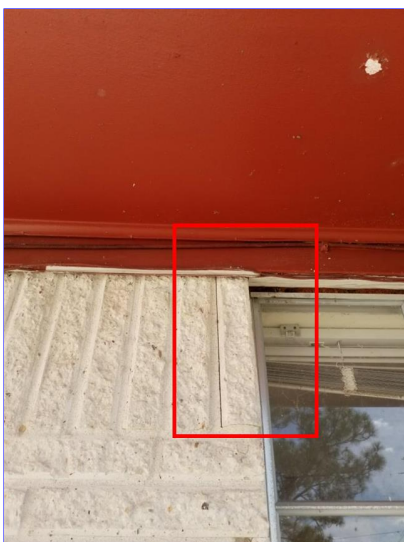
E. Item 20(Picture) Front of home

(4) The Brick siding at the exterior has hairline cracks. Deterioration can eventually occur if not corrected. A qualified contractor should inspect and repair as needed.

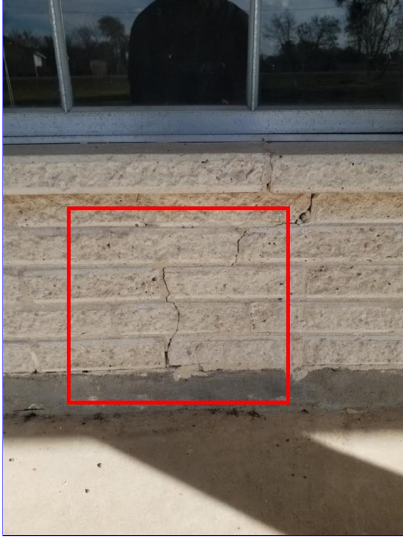
E. Item 21(Picture) Front of home

(5) The Brick siding at the exterior has step cracks caused from settlement. Deterioration can eventually occur if not corrected. A qualified contractor should inspect and repair as needed.

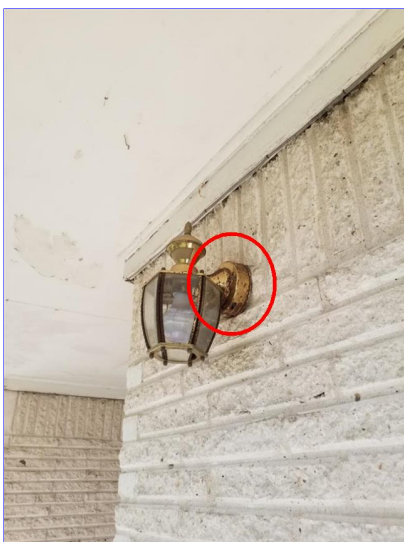
E. Item 26(Picture) Front of home

(6) Areas where wiring or piping passes through walls should be sealed. I recommend having a qualified person seal as needed.

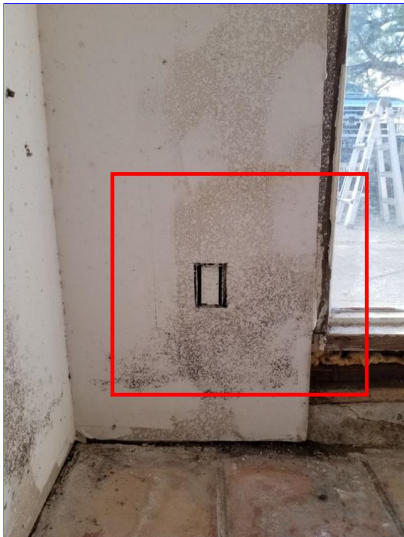
E. Item 28(Picture) Media room

(7) Signs of fungi growth are present. We did not inspect, test or determine if this growth is or is not a health hazard. The underlying cause is moisture. I recommend you contact a mold inspector or expert for investigation or correction if needed.

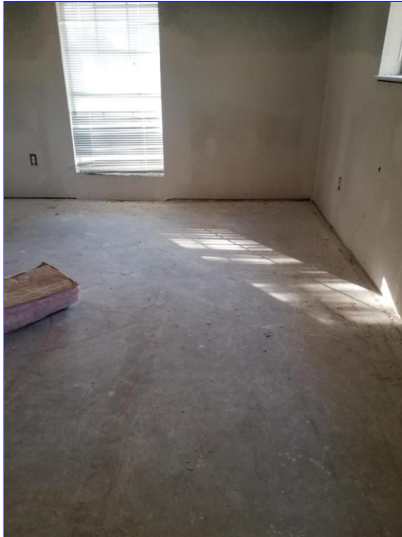
F. Item 1(Picture) Master bathroom

(1) The floor covering is missing in areas. This is for your information.

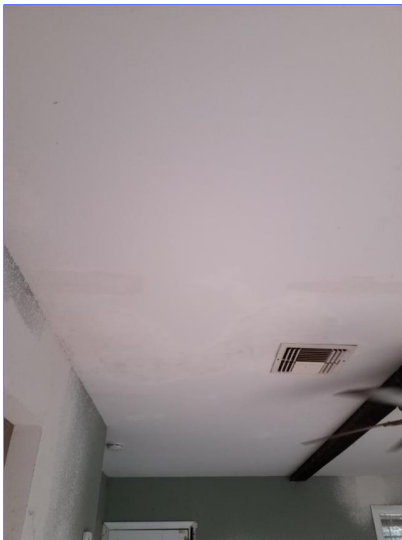
F. Item 2(Picture) Media room

(2) The Drywall on the ceiling shows repair signs in areas. This damage is considered cosmetic. A qualified contractor should inspect and repair as needed.

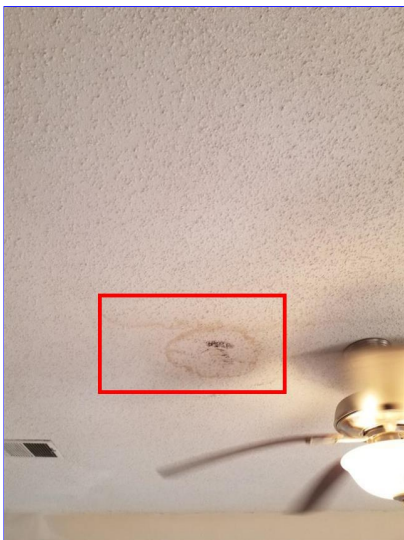
F. Item 3(Picture) Dining room

(3) Signs of fungi growth are present on ceiling in areas. We did not inspect, test or determine if this growth is or is not a health hazard. The underlying cause is moisture or dampness. I recommend you contact a mold inspector or expert for investigation or correction if needed.

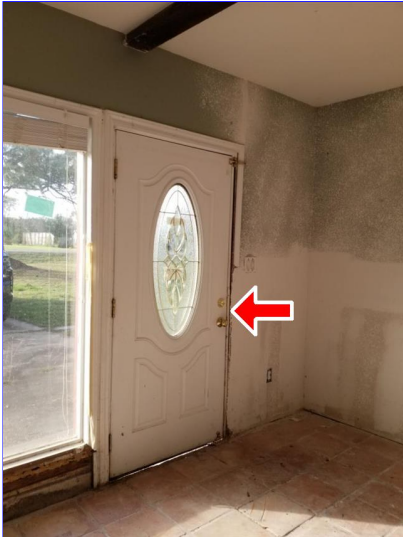
G. Item 1(Picture) Media room

(1) The door does not shut properly and needs adjustment . A repair or replacement is needed. A qualified person should repair or replace as needed.

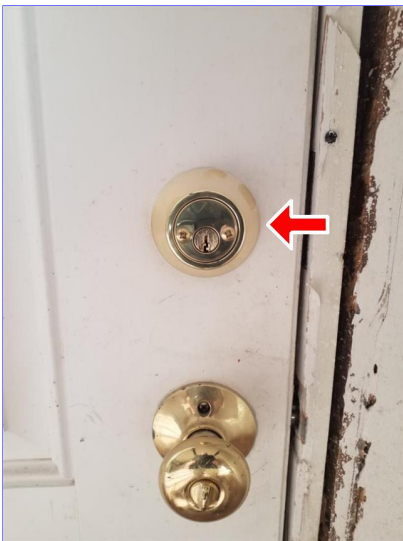
G. Item 2(Picture) Media room

(2) The exterior door has keyed dead bolt lock. This prevents proper egress and is a safety hazard until repaired. I recommend having a qualified person make repairs as needed.

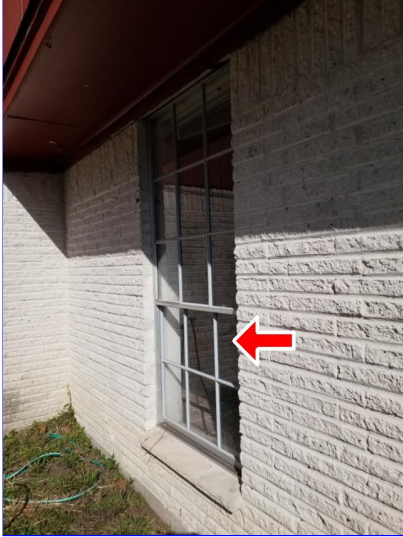
H. Item 1(Picture) Front of home

(1) Windows have damaged or missing screens. This is not considered to be today's standards. I recommend having a qualified person make repairs as needed.

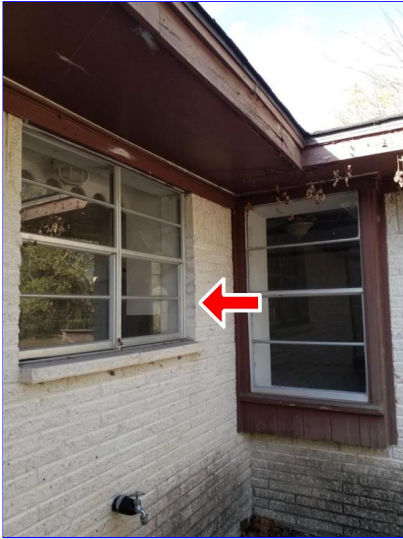
H. Item 5(Picture) Rear of home

(2) There is a cracked glass pane in window. I recommend having a qualified person make repairs as needed.

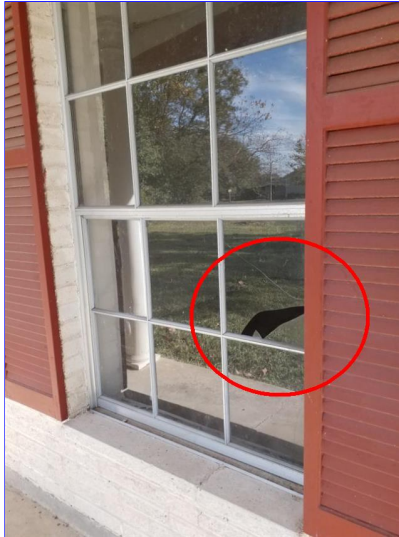
(3) There are window frames that are not properly sealed. This can cause energy loss. I recommend having a qualified person seal and repair as needed,

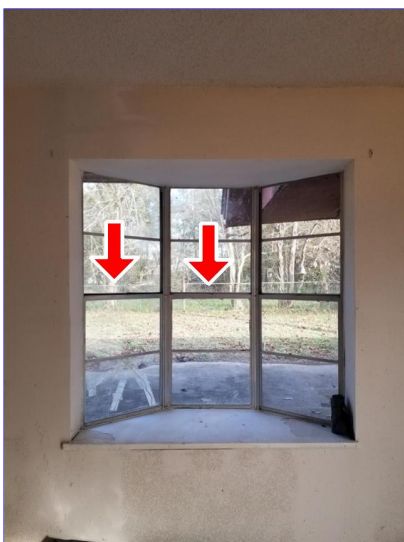
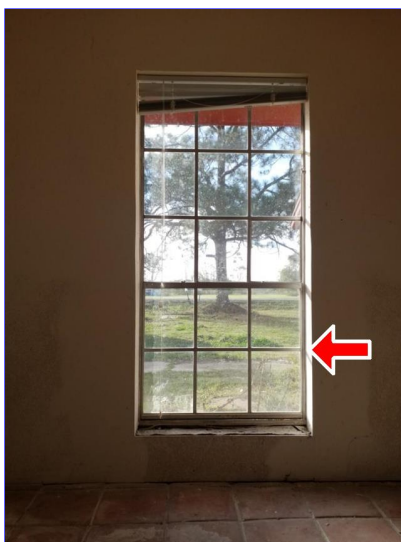
H. Item 11(Picture) Dining room, left and middle window

(4) Some windows are stuck or painted shut in areas. A repair may be needed. A qualified contractor should inspect and repair as needed.

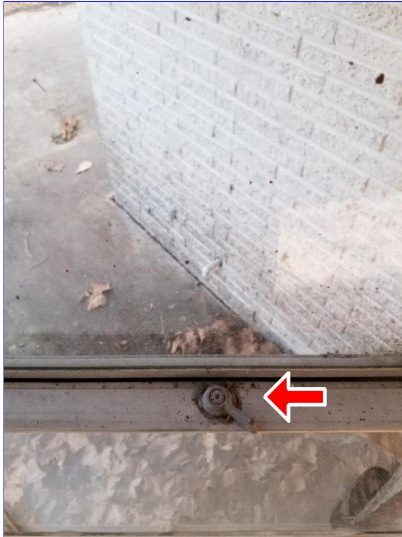
H. Item 13(Picture) Dining room, rear wall, right window

(5) Several windows have damaged lock hardware in areas. A repair may be needed. A qualified contractor should inspect and repair as needed.

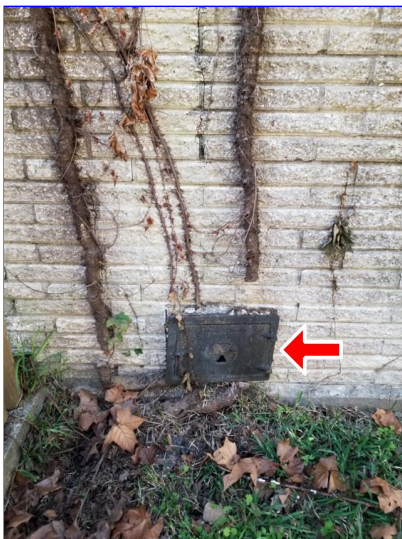
J. Item 1(Picture) Rear of home

(1) The cleanout is damaged in areas at the rear of the home. I recommend a qualified contractor be consulted for further evaluation and repair.

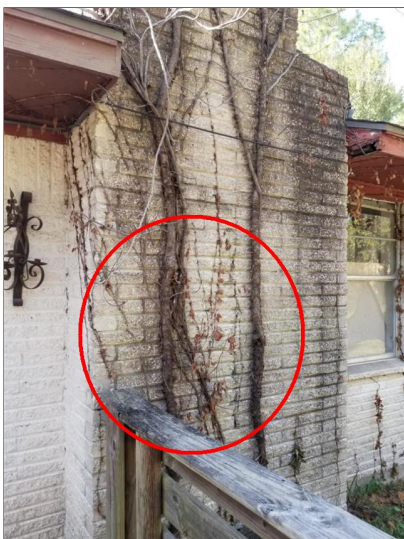
J. Item 2(Picture) Rear of home

(2) The Chimney has settlement cracks. I recommend a qualified contractor be consulted for further evaluation and repair if needed.

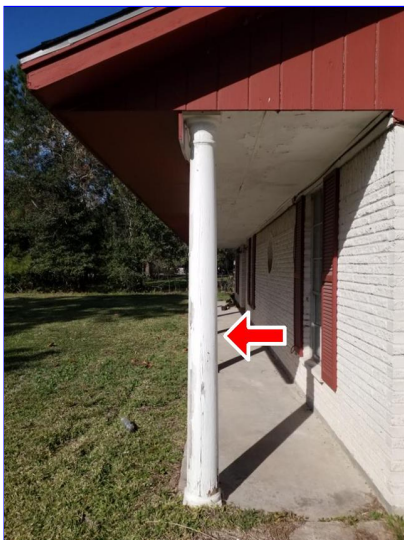
K. Item 1(Picture) Front of home

- (1) The weight load capabilities are not part of this inspection.
- (2) The columns are peeling paint and deteriorating in areas. I recommend a qualified contractor be consulted for further evaluation and repair.

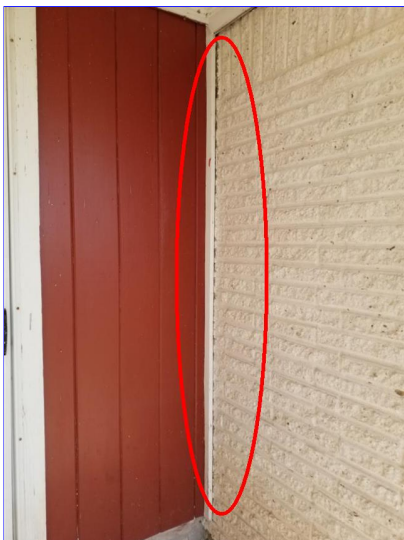
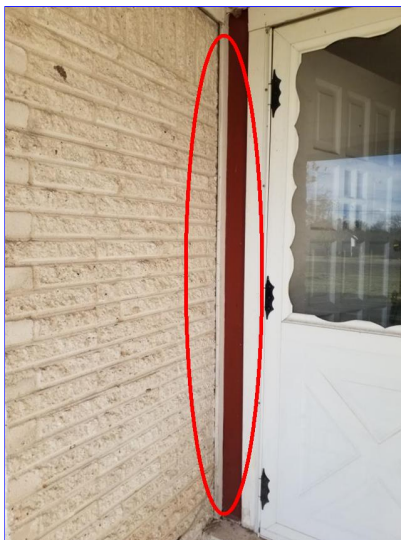
L. Item 1(Picture) Front of home

- (1) Areas of the home have caulking or grout missing or damaged. Deterioration could occur if not corrected. I recommend having a qualified contractor inspect and make repairs as needed.

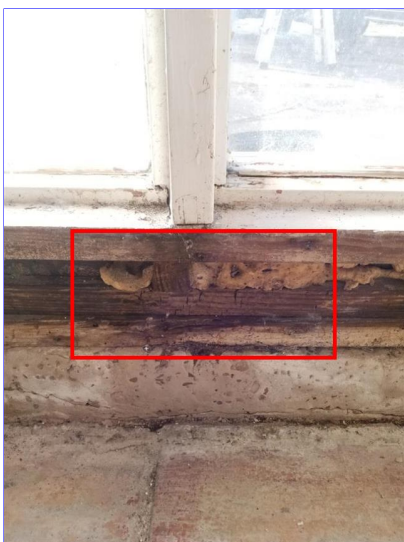
L. Item 3(Picture) Media room

(2) The sill plate is deteriorated in areas. I recommend a structural engineer be consulted for further evaluation and repair if needed.

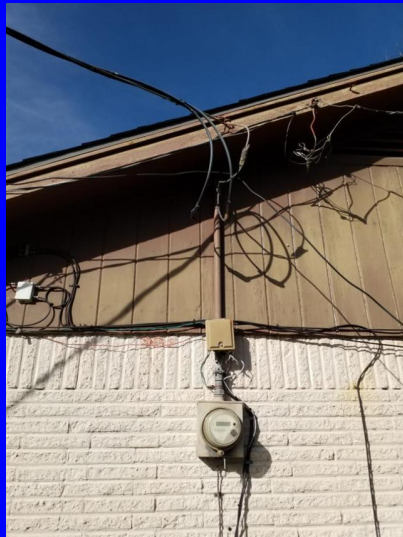
Overhead service, located front right side of home

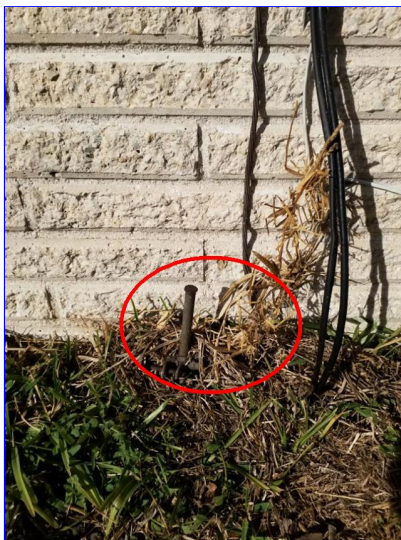
(1) The grounding rod near meter is using improper clamp for grounding of main panel (solid brass clamp is recommended). This is not considered to be today's standard. I recommend having a qualified person replace with proper clamp to assure proper grounding.

A. Item 2(Picture) Improper grounding clamp

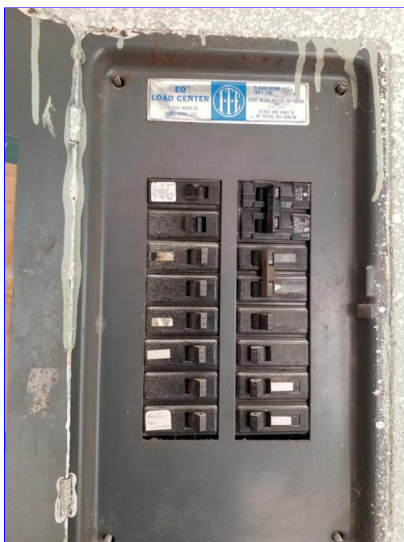
(2) The panel is missing circuit identification. **This is a safety hazard.** I recommend having a qualified person mark circuits as needed.

A. Item 3(Picture) Main service panel

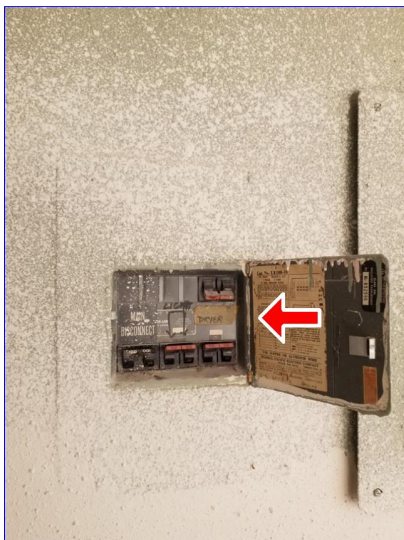
(3) You have a Federal Pacific panel which is legal, but there is a possibility that the circuit breakers may not trip when shorted possibly causing an electrical hazard. Opinions by most licensed electrical contractors on this panel is that it is unsafe. I recommend you consult a licensed electrical contractor for necessary replacement.

A. Item 4(Picture) Sub panel

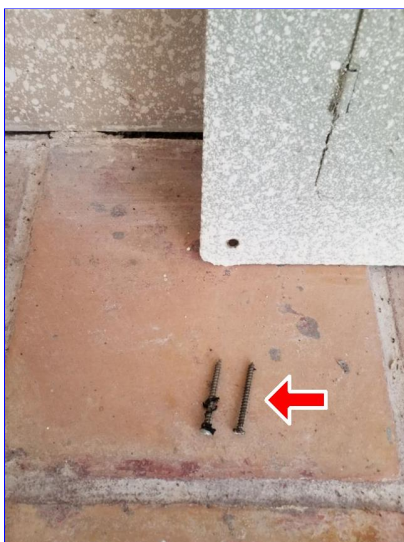
(4) The panel cover is using (sharp) improper screws. This is a safety hazard until corrected. I recommend having a qualified person make repairs as needed,

A. Item 5(Picture) Main service panel

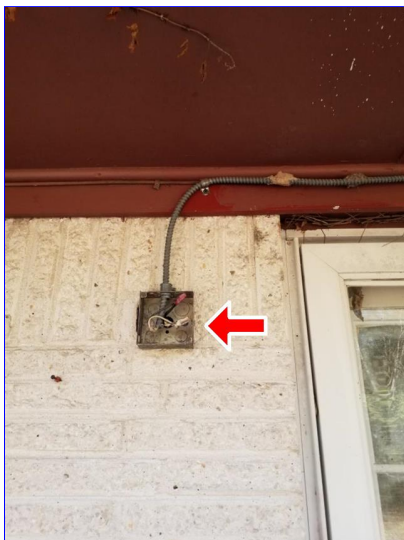
B. Item 1(Picture) Rear of home

(2) The junction box is missing a cover plate in areas. This is a safety issue that needs correcting. I recommend a qualified person repair as needed.

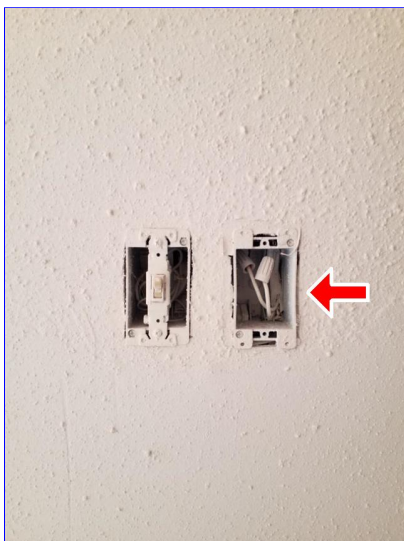
B. Item 3(Picture) Hallway in-between guest bedrooms

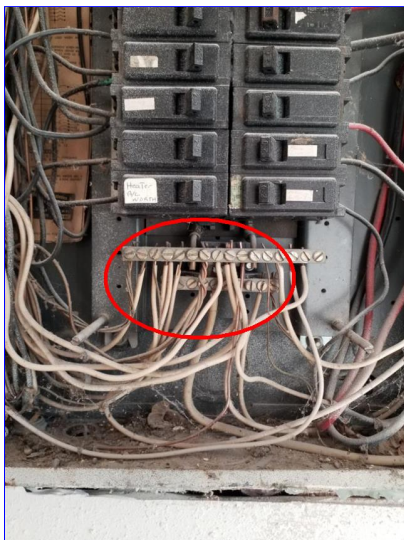
B. Item 4(Picture) Main service panel

(3) Problem(s) discovered with Branch Circuits such as amateur wiring installation, doubled wiring at neutral/grounding bar, and any other problems that an electrical contractor may discover while performing repairs need correcting. I recommend a licensed electrical contractor inspect further and correct as needed.

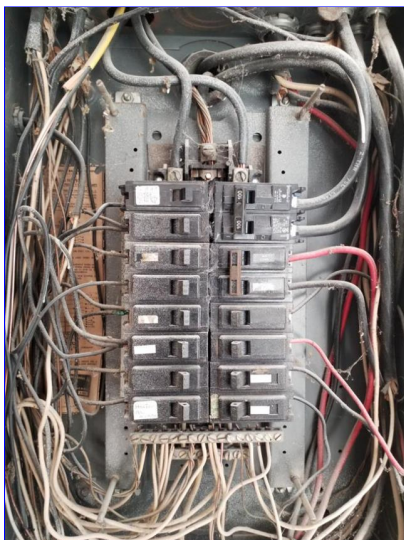
B. Item 5(Picture) Main service panel

(4) Arc fault breakers are not in required areas of home at electrical panel. This is not considered today's standard. I recommend having a qualified electrician inspect and make repairs as needed.

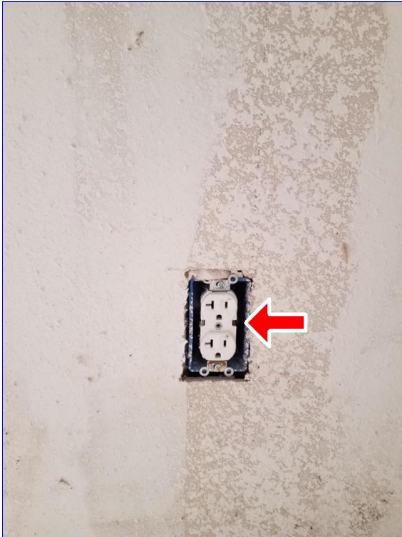
(5) Most if not all outlets are missing cover plates. This is a safety issue that needs correcting. I recommend a qualified person repair as needed.

B. Item 6(Picture) Most if not all outlets

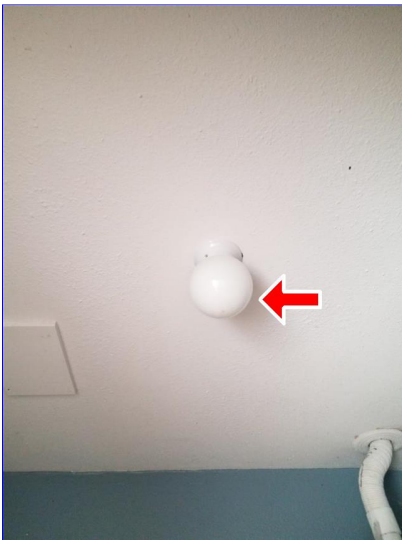
B. Item 7(Picture) Washer dryer room

(6) The light fixture does not work (try bulb first). Electrical issues are considered a hazard until repaired. A qualified licensed electrical contractor should perform repairs that involve wiring.

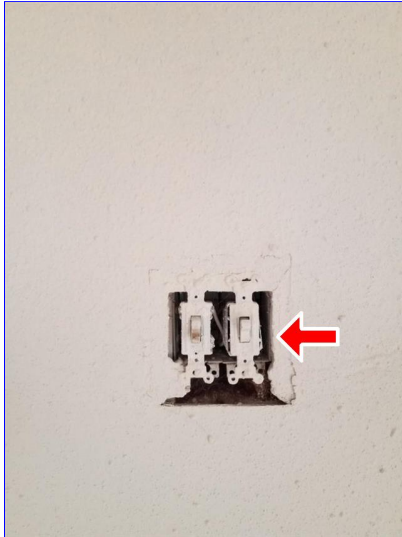
B. Item 8(Picture) Dining room

(7) Several light switches are missing a cover plate in areas. This is a safety issue that needs correcting. I recommend a qualified person repair as needed.

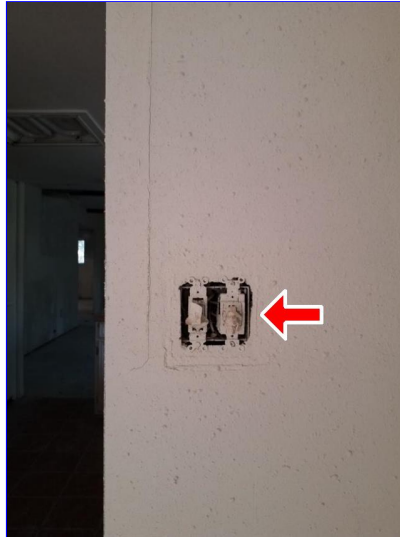
B. Item 9(Picture) Dining room

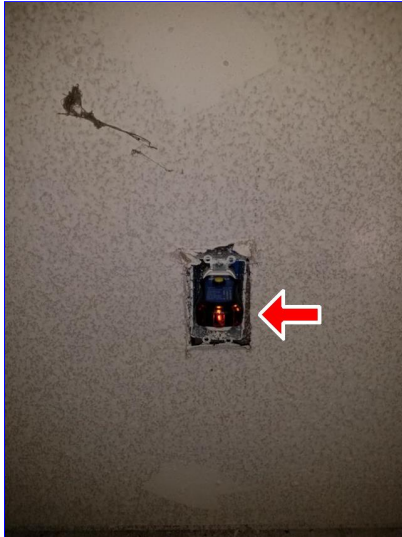
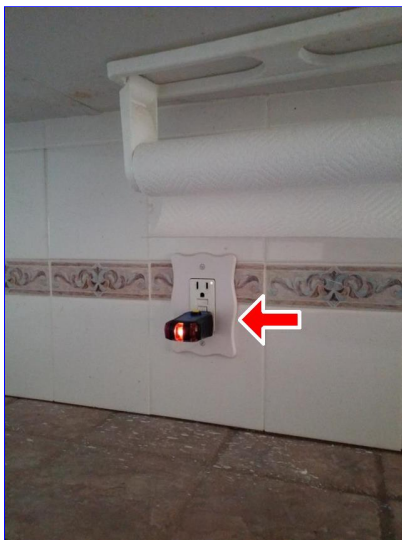
(8) Some outlets throughout the home are ungrounded. This is a safety issue that needs correcting. I recommend a qualified electrical contractor perform all repairs involving wiring.

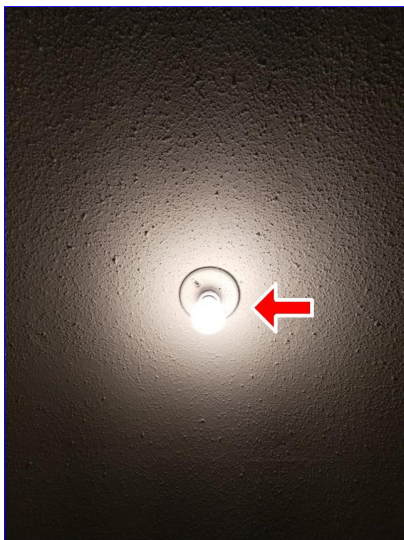
B. Item 13(Picture) Master bedroom closet

(9) The light fixture does work, but is missing globe in areas. This is for your information. I recommend repair as needed.

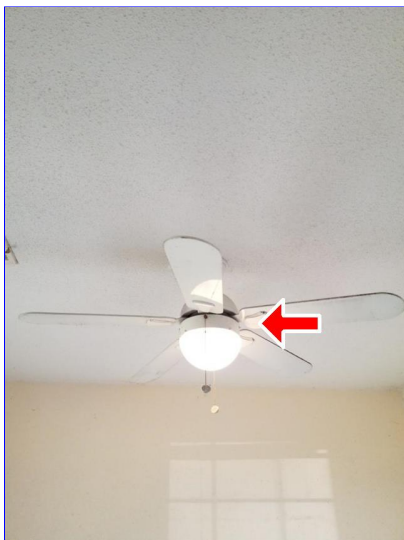
B. Item 14(Picture) Guest bedroom, first room on the right

(10) The ceiling fan does not work and in the Guest bedroom. This is for your information. A qualified licensed electrical contractor should perform repairs that involve wiring.

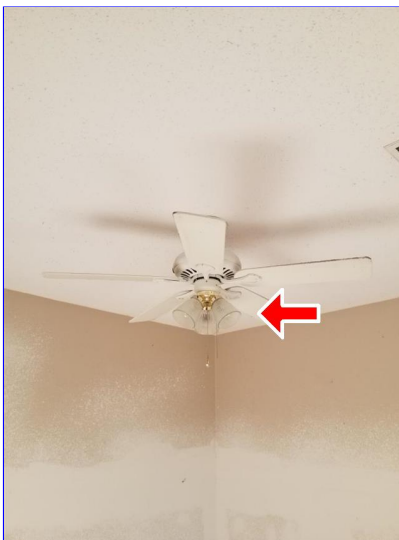
B. Item 15(Picture) Guest bedroom, second room on the right

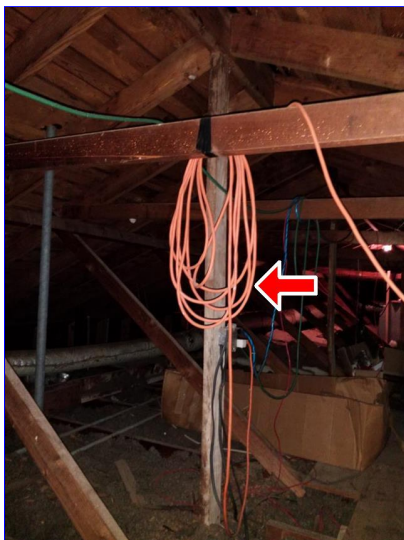
(11) There is an extension cord being used as permanent wiring, and needs to be properly wired or removed.

B. Item 16(Picture) Attic

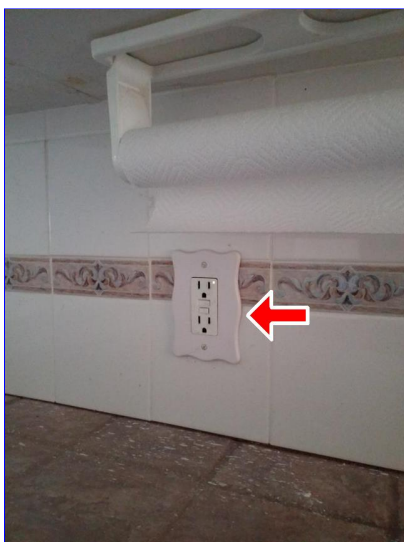
B. Item 17(Picture) Kitchen, left of the sink

(12) There are no GFCI protected circuits in required area's. This is not considered to be today's standard. I recommend having a qualified electrician make repairs as needed.

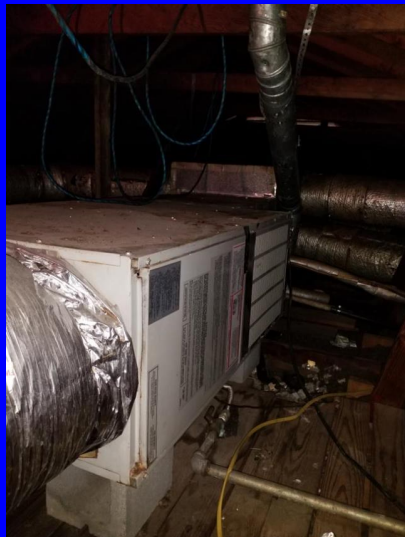
Gas furnace unit #1 (Left side of home)

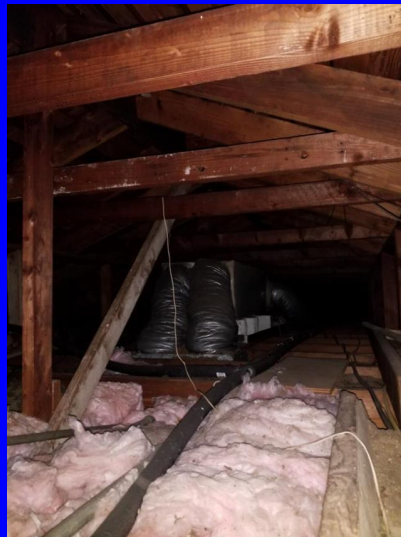
Electric furnace unit #2 (Right side of home)

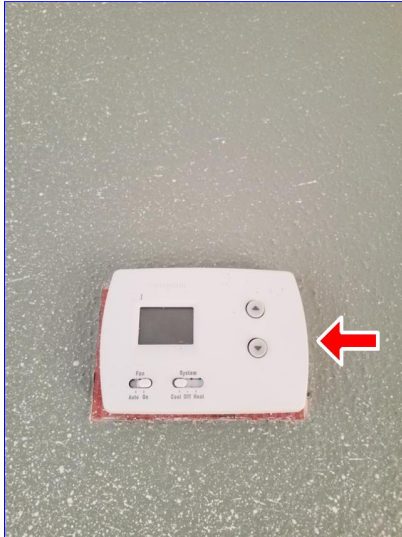
- (1) It is recommended to have HVAC systems serviced annually.
- (2) The thermostat is not functioning. I recommend repair or replace as needed.

B. Item 1(Picture) Unit #2 (right side of home)

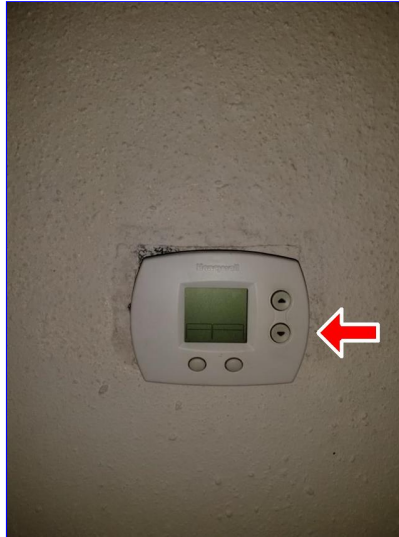
B. Item 2(Picture) Unit #1 (Left side of home)

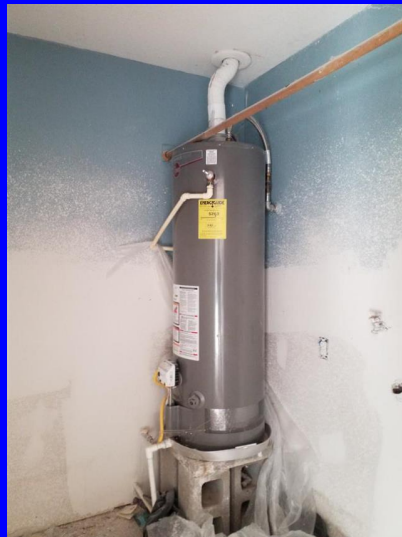
40 gallon gas water heater,  
located in the washer dryer room

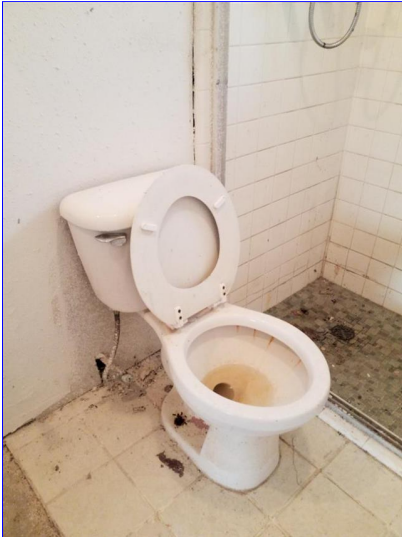
(1) The toilet does not function in areas. I recommend a licensed plumber be consulted for further evaluation and repair.

A. Item 1(Picture) Master bathroom

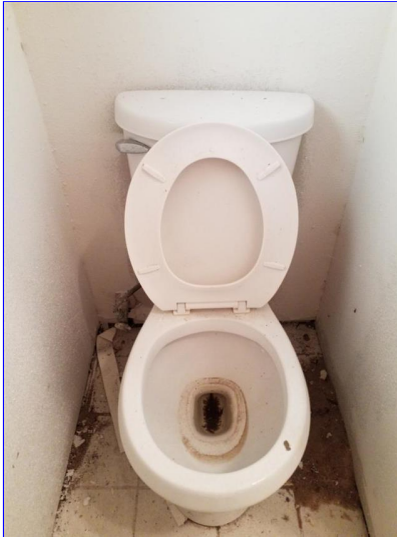
A. Item 2(Picture) Guest bathroom

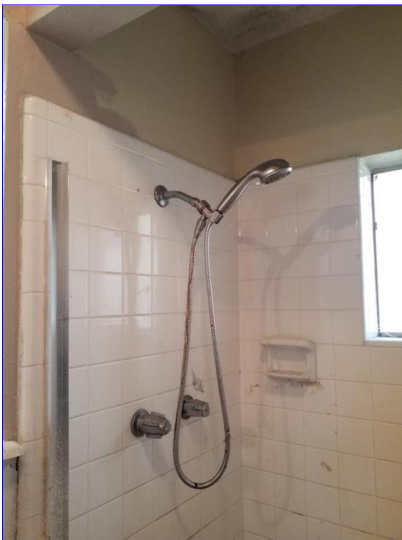
A. Item 3(Picture) Master bathroom

(2) The shower was not functioning in areas. I recommend a licensed plumber be consulted for further evaluation and repair.

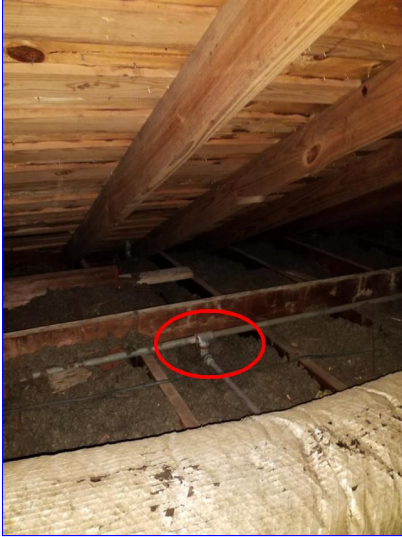
(3) Several connections in the attic are showing signs of corrosion. Repairs are needed. I recommend a licensed plumber be consulted for further evaluation and repair.

A. Item 4(Picture) Attic, rear of home

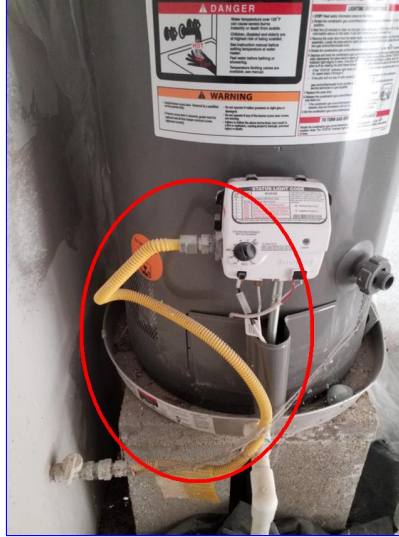
- (1) Unable to test. The gas is shut off to the home.
- (2) The water heater is installed without the recommended sediment trap or "drip leg" that is designed to extend the life of the unit. This is not considered to be today's standard. I recommend having a qualified plumber make repairs as needed.

C. Item 2(Picture) Water heater

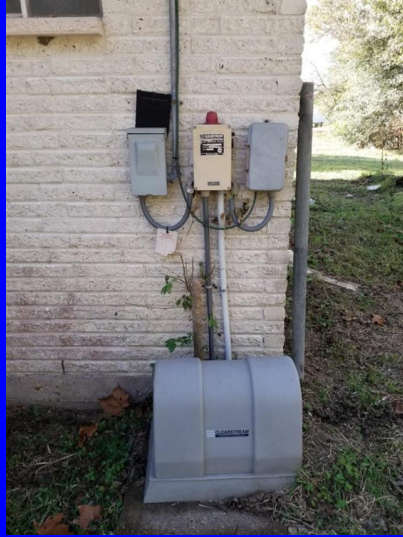
Septic system control panel, located rear of home

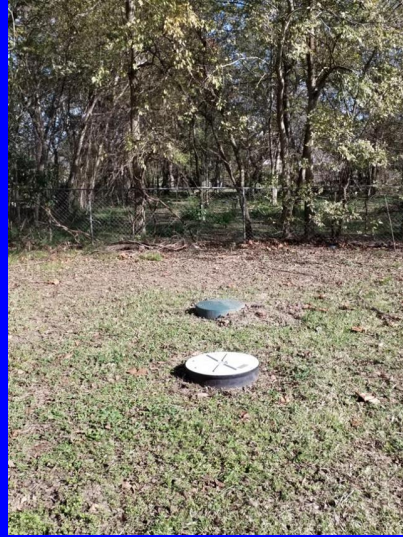
Septic system tanks, located rear of home

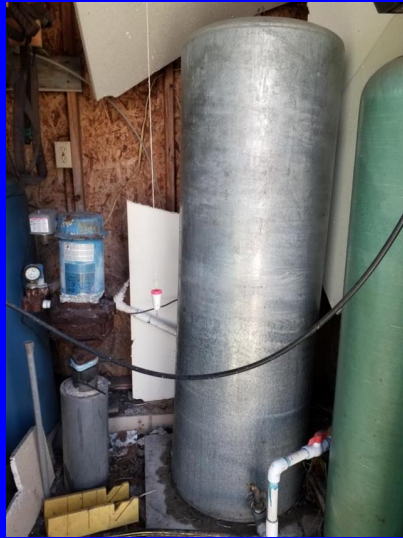
Private water well

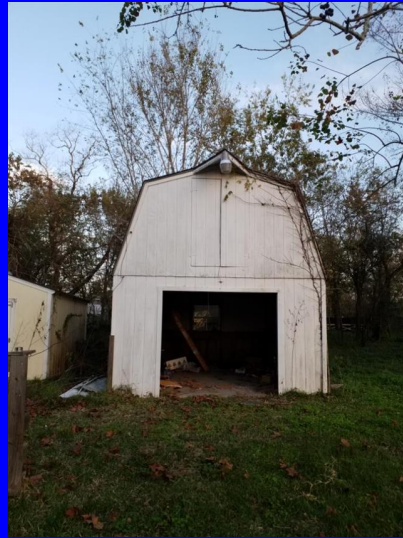
Outbuilding

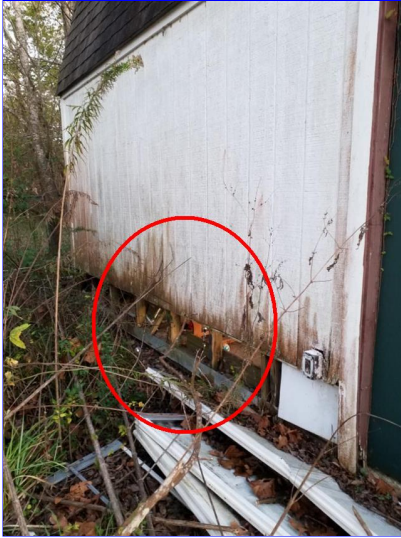
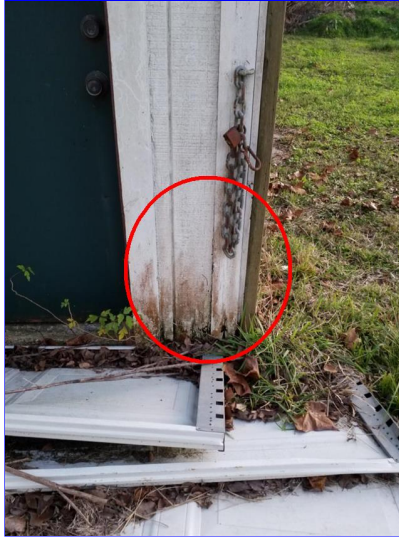
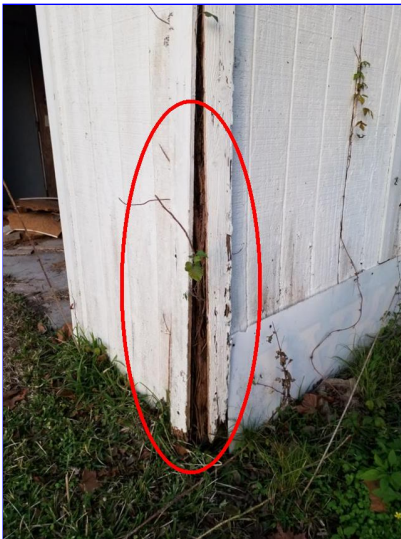
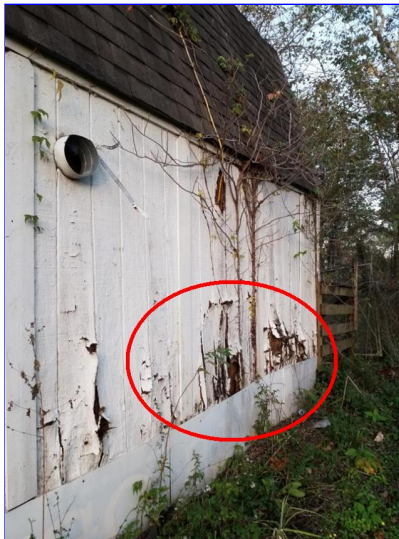
(1) The wood siding is missing/deteriorated in areas. I recommend a qualified contractor be consulted for further evaluation and repair.

C. Item 1(Picture) Left side

C. Item 2(Picture) Left side

C. Item 3(Picture) Front right corner

C. Item 4(Picture) Right side

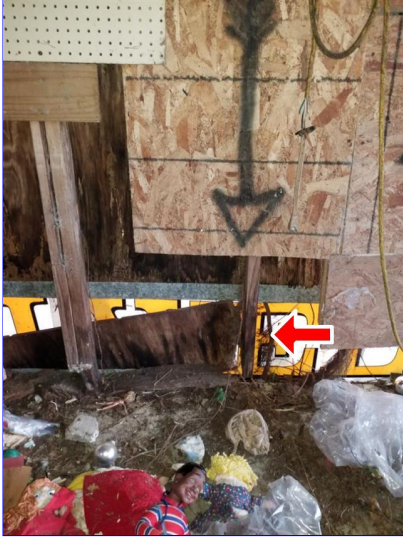
(2) The framing members are deteriorated in areas. I recommend a qualified contractor be consulted for further evaluation and repair.

C. Item 5(Picture) Outbuilding, right side

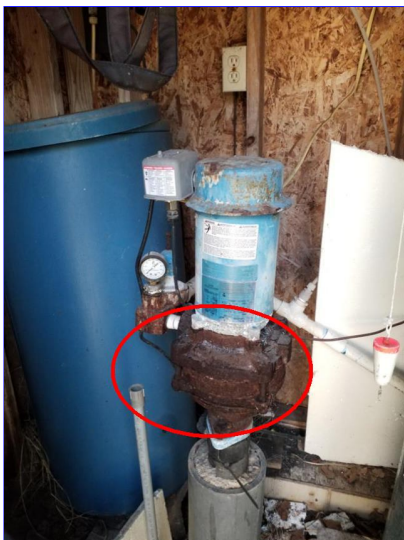
- (3) The water well pump is aged and deteriorated. I recommend a qualified contractor be consulted for further evaluation and repair.

D. Item 3(Picture) Water well pump
