Inspection Report

PROPERTY INSPECTION REPORT

Concerning: 8302 Leafdale Dr, Humble, Texas 77338

By: Zachary T. Ramirez 24196 / TexSpec Home Inspections PLLC 10/14/2021

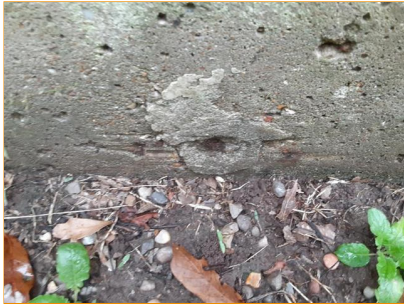
A. Item 1(Picture)

(2) Exposed fasteners and cable ends observed in foundation. Recommend that a qualified contractor evaluate all issues and repair as needed.

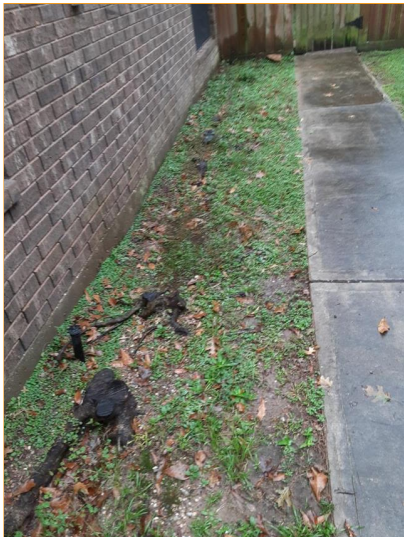
B. Item 1(Picture)

Multiple areas of neutral and negative grade allowing water to pool against foundation. Recommend that a qualified contractor evaluate all issues and repair as needed.

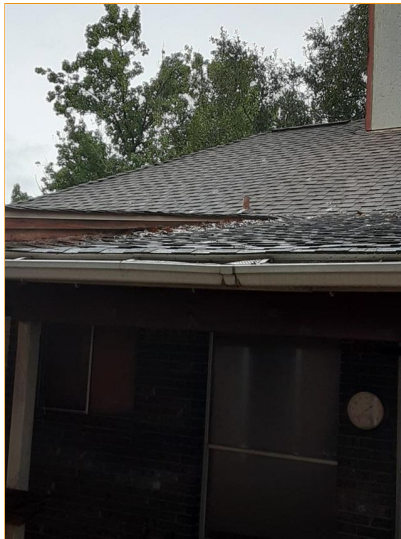
C. Item 4(Picture)

(4) Damaged roof covering material observed at front of home. Recommend that a qualified contractor evaluate all issues and repair as needed.

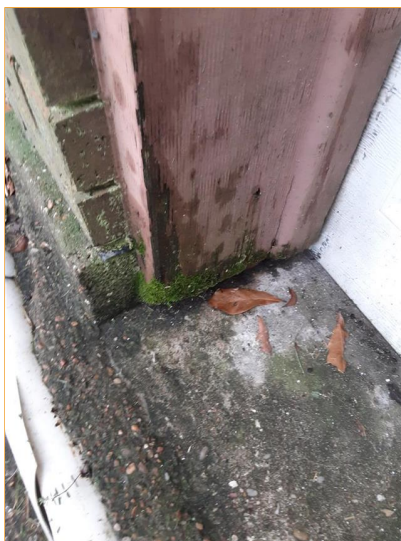
E. Item 15(Picture)

(4) Water damaged soffit observed at back of home.

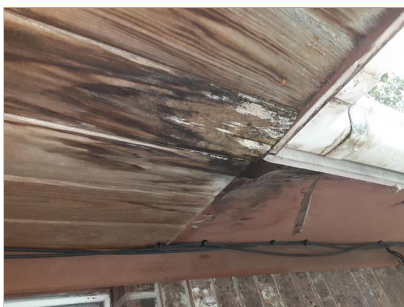
E. Item 16(Picture)

(5) Multiple areas of water damaged fascia, trim and siding observed on outbuilding. Recommend that a qualified contractor evaluate all issues and repair as needed.

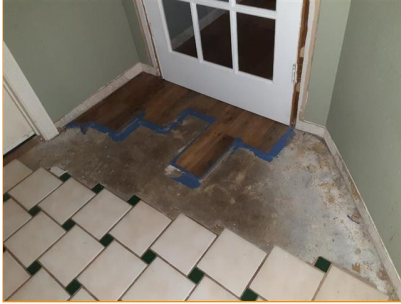
F. Item 1(Picture)

(1) Multiple areas of damaged and unfinished floors.

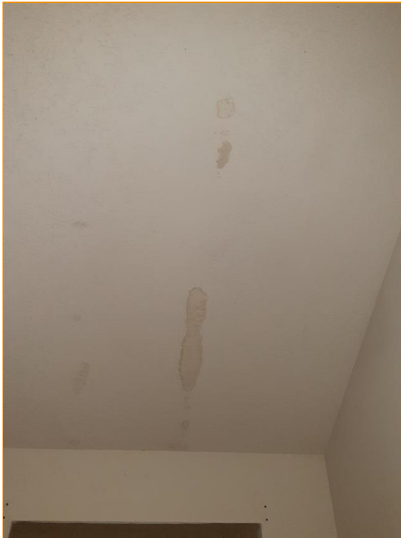
F. Item 3(Picture)

(2) Water stains observed on living room ceiling. Recommend that a qualified contractor evaluate all issues and repair as needed.

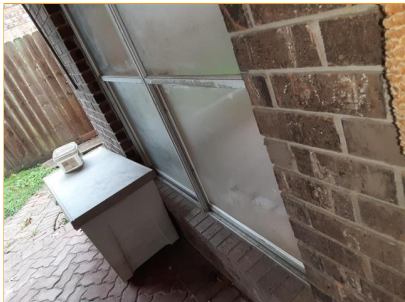
H. Item 1(Picture)

(1) Multiple missing window screens.

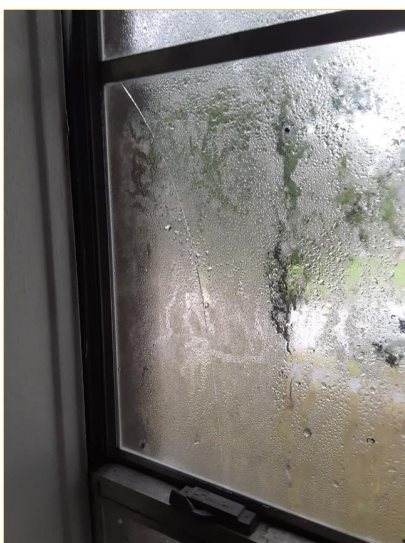
H. Item 2(Picture)

(2) Upstairs left bedroom window pane is broken. Recommend that a qualified contractor evaluate all issues and repair as needed.

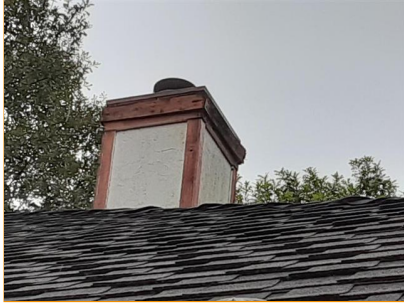
J. Item 1(Picture)

(1) Water damaged wood trim observed around chimney.

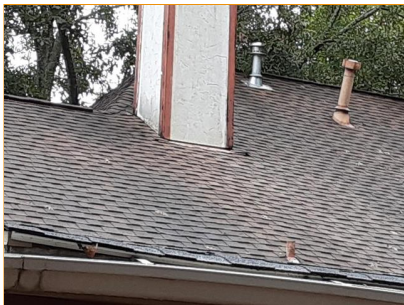
J. Item 3(Picture)

(2) Raised flashing observed on chimney.

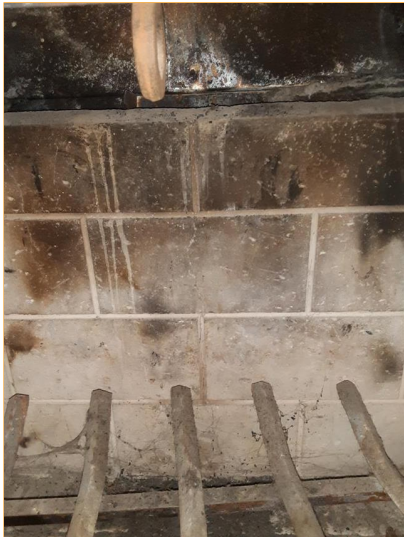
J. Item 4(Picture)

(3) Cracked fire bricks observed in fireplace. Recommend that a qualified contractor and/or chimney sweep evaluate all issues and repair as needed.

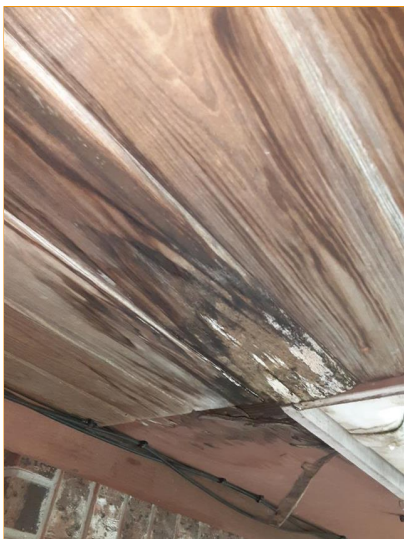
K. Item 3(Picture)

(2) Water damage observed on the back porch cover.

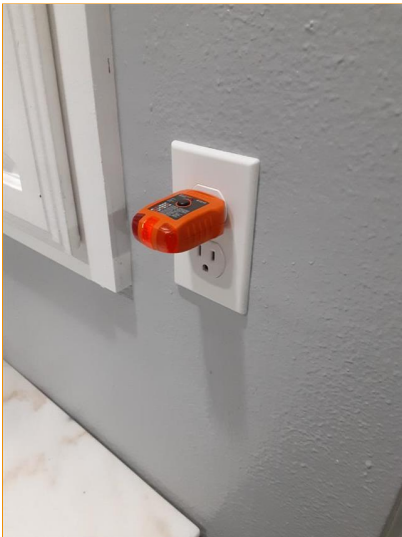
B. Item 12(Picture)

(7) Open ground electrical outlet observed in master bathroom. Recommend that a qualified contractor evaluate all issues and repair as needed.

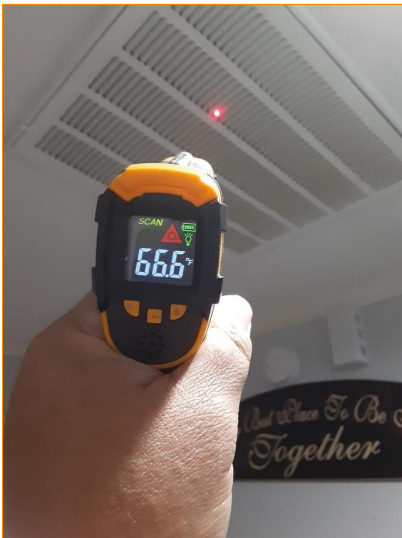
B. Item 1(Picture)

(1) Air conditioner differential was 17.1 degrees. This is within the recommended range of 14 to 22 degrees.

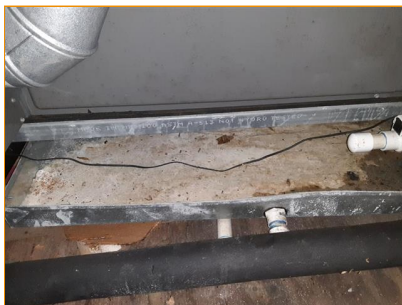
B. Item 6(Picture)

(3) Corrosion observed in air conditioner drip pan. Recommend that a qualified contractor evaluate all issues and repair as needed.

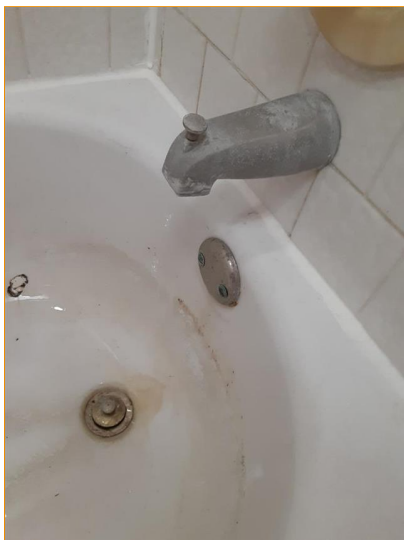
A. Item 10(Picture)

(5) Upstairs bathtub faucet was leaking at time of inspection. Recommend that a qualified contractor evaluate all issues and repair as needed.

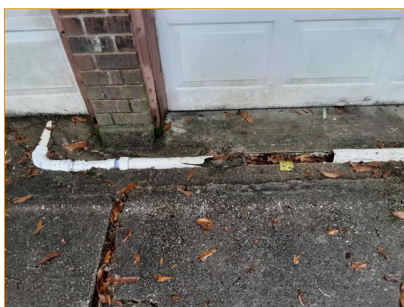
B. Item 1(Picture)

(1) Possible rerouted broken drain line observed.

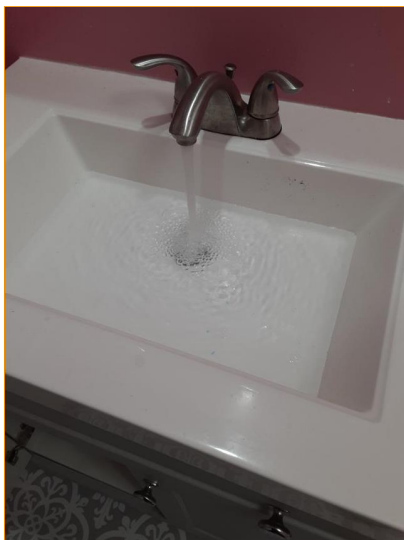
B. Item 3(Picture)

(2) Upstairs bathroom sink drains slow. Recommend that a qualified contractor evaluate all issues and repair as needed.

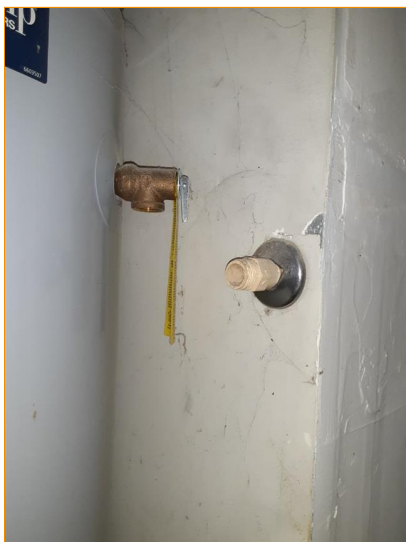
C. Item 6(Picture)

(3) Water heater T&P drain piping is missing. The T&P (Test and Pressure) valve on water heater needs a 3/4 threaded pipe to extend within 6 inches of floor for safety. (PVC is not approved for hot water use). Recommend that a qualified contractor evaluate all issues and repair as needed.

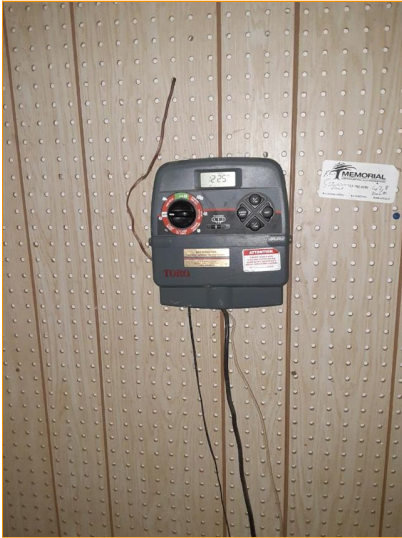
A. Item 1(Picture)

(1) Landscape irrigation system controller located in the garage.

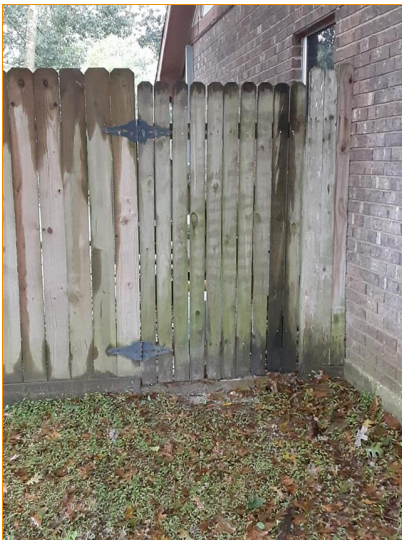
B. Item 1(Picture)

(1) Inadequate gates for access to pool area. The gate must open away from the swimming pool, be 60" minimum in height, have a self-closing mechanism and interior lock, and should be equipped with an alarm for safety purposes.

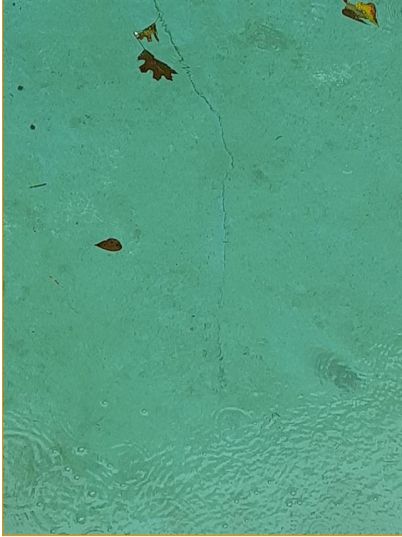
B. Item 10(Picture)

(7) Crack observed at the bottom of the swimming pool. Recommend that a qualified contractor evaluate all issues and repair as needed.
