PROPERTY INSPECTION REPORT

Concerning: 24906 LAKECREST PARK, Katy, TX 77493
(Address or Other Identification of Inspected Property)

By: KELLY HERBERT, Lic #TREC21822 03/09/2018
(Name and License Number of Inspector) (Date)

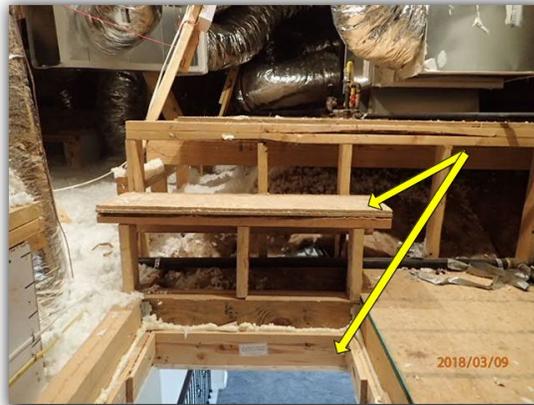
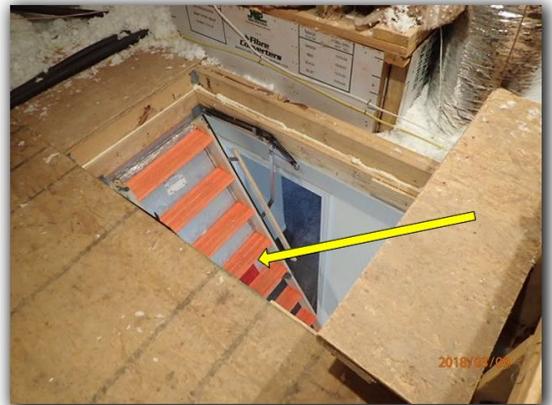
Step-up to furnace in Attic over pull-down stairs creates a safety hazard. Recommend a safety railing.

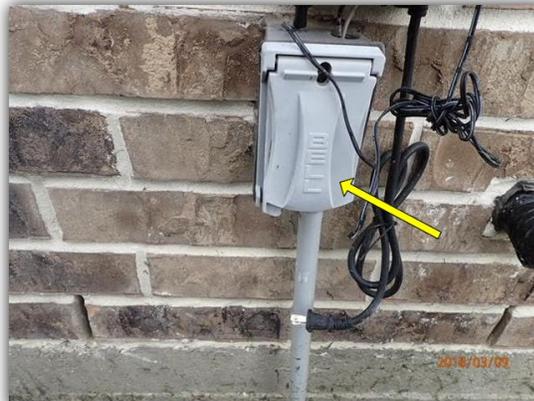
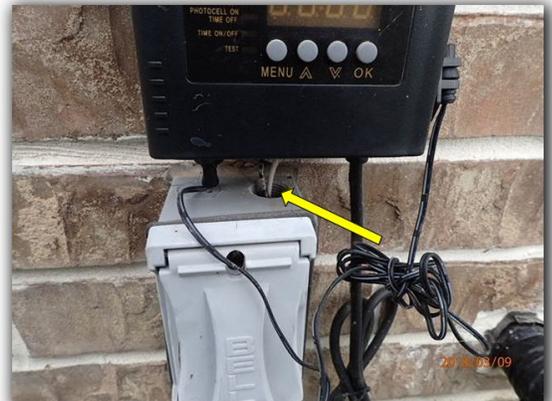
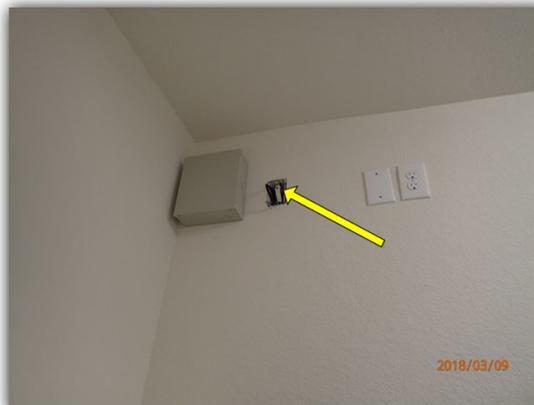
Outlet loose at Master Bath (Mirror)

Exterior Outlet cover does not fit properly. Repair as required.

Exterior Outlet junction box not sealed.

Open junction box at Garage

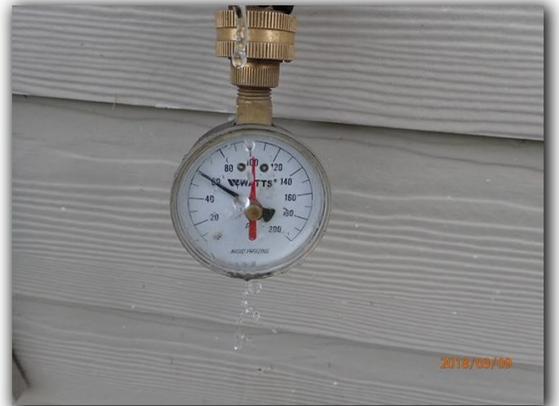
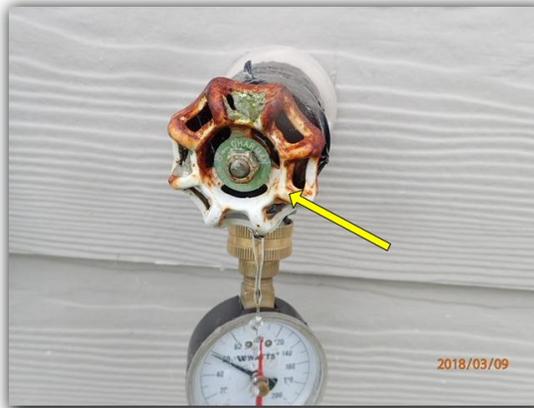
Hose bib at Right/rear leaks at stem. Repair as required

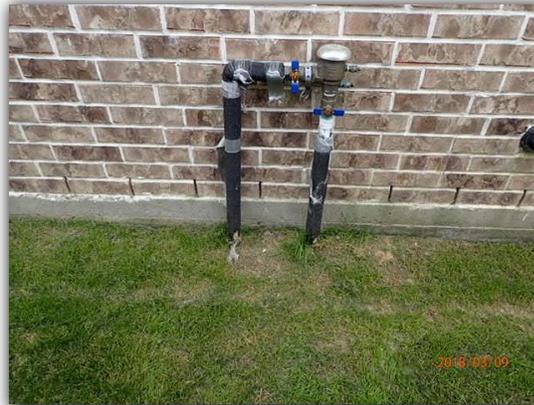
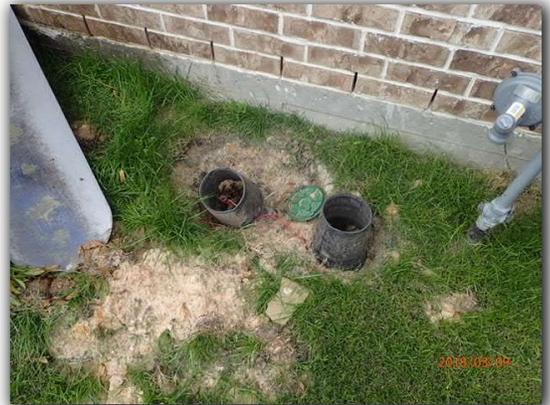
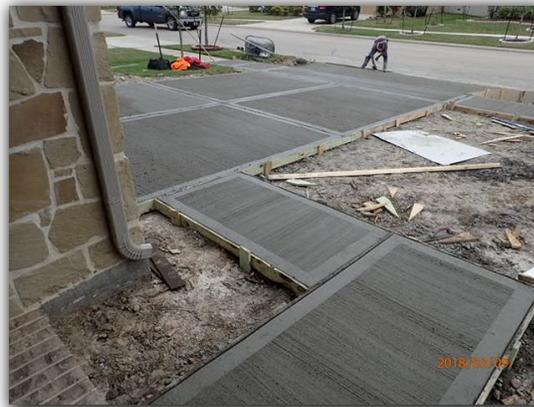
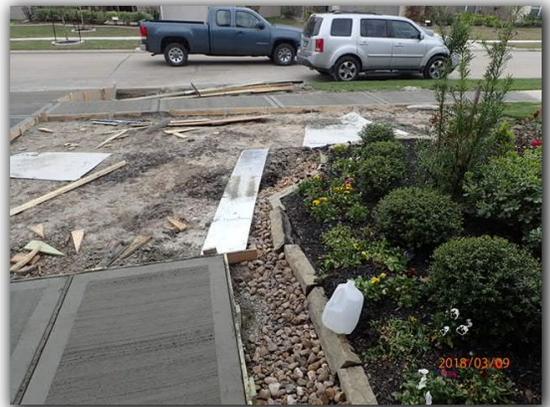
**Sprinkler system not inspected.
Anti-siphon valves in off position
Insulation damaged on Anti-siphon valve
Concrete/Driveway being installed at time of inspection**
