# Inspection Report

**Property Address:**  
13543 Portobello Dr.  
Houston Texas 77083

**Inspectall LLC**

<b>Date:</b> 10/27/2021	<b>Time:</b> 02:03 PM	<b>Report ID:</b> 135431
<b>Property:</b> 13543 Portobello Dr. Houston Texas 77083	<b>Customer:</b> Ms. Linda Nguyen	<b>Real Estate Professional:</b> Tina Rupani key Realty

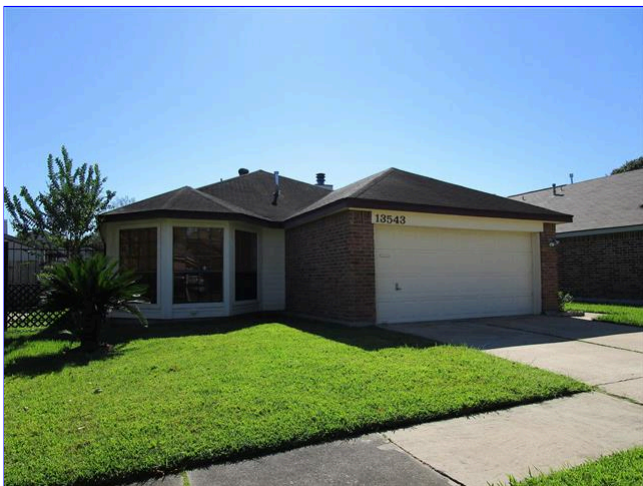
B. Item 1(Picture)

**Deficiencies:** Observed standing water front left side of property. The landscape at the front left side of home may require a trench or drain if water stands or puddles after heavy rain. I am unable to determine due to no rain during inspection period.

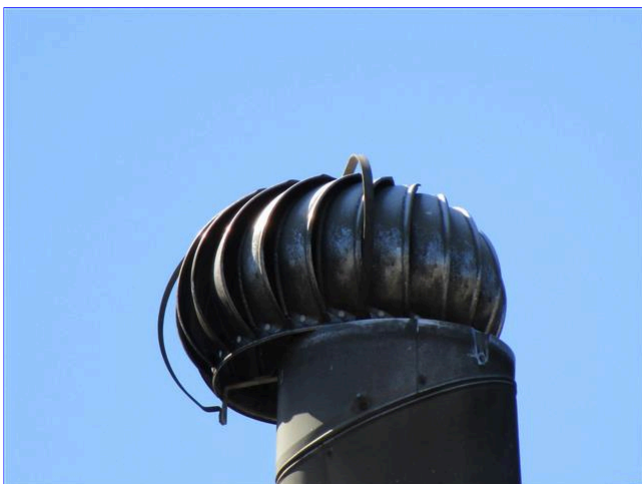
C. Item 4(Picture)

(2) **Deficiencies:** Front turbine vent is not fasten at the base. A roofer is recommended to evaluate and make the necessary repair(s).

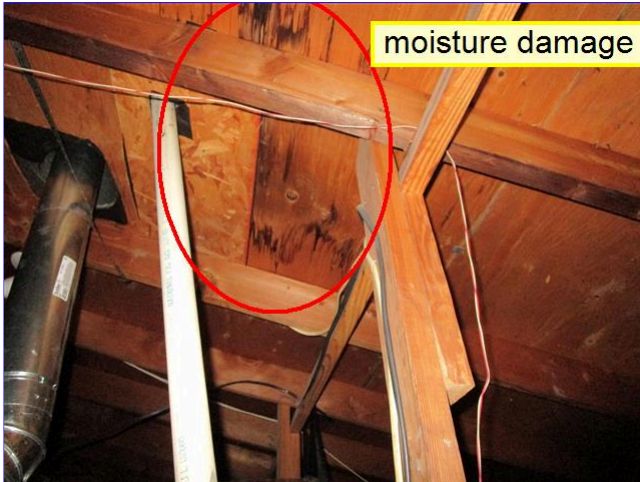
D. Item 1(Picture)

(1) **Deficiencies:** Noted moisture damaged on decking. A qualified roofer is needed to make the corrections as needed.

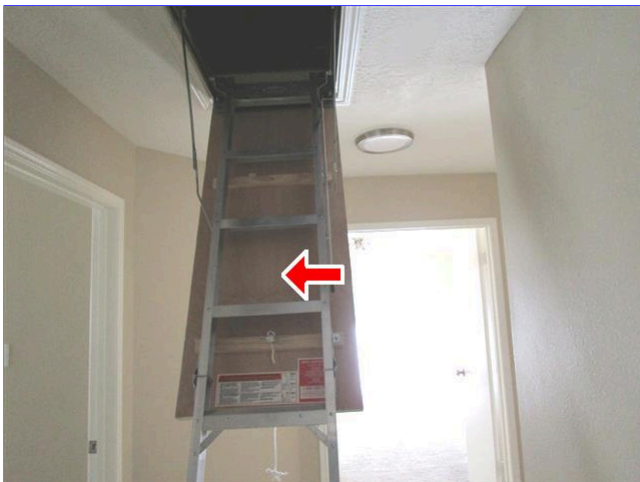
D. Item 2(Picture)

(2) **Deficiencies:** The attic door is missing insulation & weather strip. This can cause some heat loss in winter and loss of cool air in summer if not corrected. A qualified contractor should inspect and repair as needed.

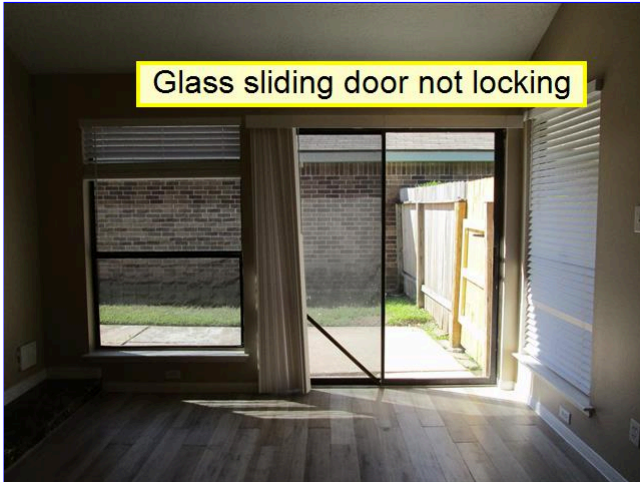
G. Item 1(Picture)

**Deficiencies:** Locking mechanism at sliding glass door in living room is malfunctioning. Screens are missing at both sliding doors.

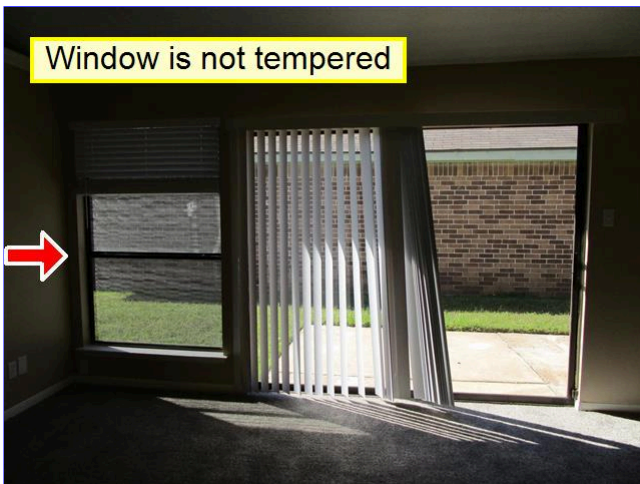
H. Item 1(Picture)

**Deficiencies:** The following windows are not tempered: windows next to both sliding doors& window in master bath room. The window in breakfast area is damaged (cracked). A qualified contractor is needed to make the corrections.

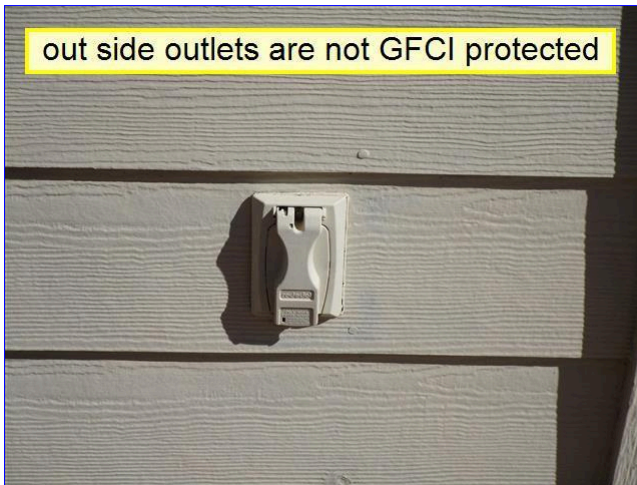
B. Item 1(Picture)

(2) **Deficiencies:** Exterior receptacles not GFCI protected. receptacles, receptacle at back sliding door living room shows to have no power.

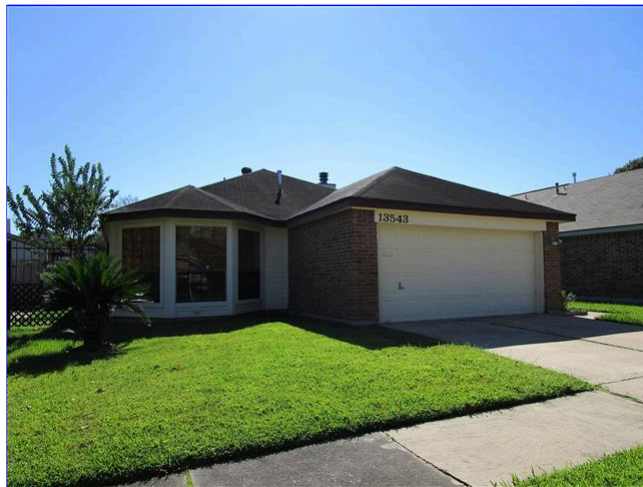
B. Item 1(Picture)

**Deficiencies:** Observed standing water front left side of property. The landscape at the front left side of home may require a trench or drain if water stands or puddles after heavy rain. I am unable to determine due to no rain during inspection period.

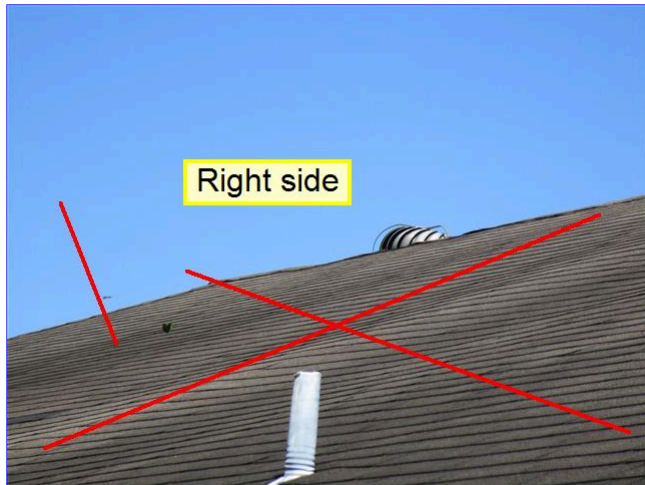
C. Item 1(Picture)

(1) **Deficiencies:** Noticeable roof repair. There are some dips or sags on the left & rear sides of the roof. Appears possibly due to the fact that "Plywood clips" were not used (*seen from attic space*). Occasionally these dips or deflection could cause a leak unless repaired. I recommend a qualified contractor perform the work

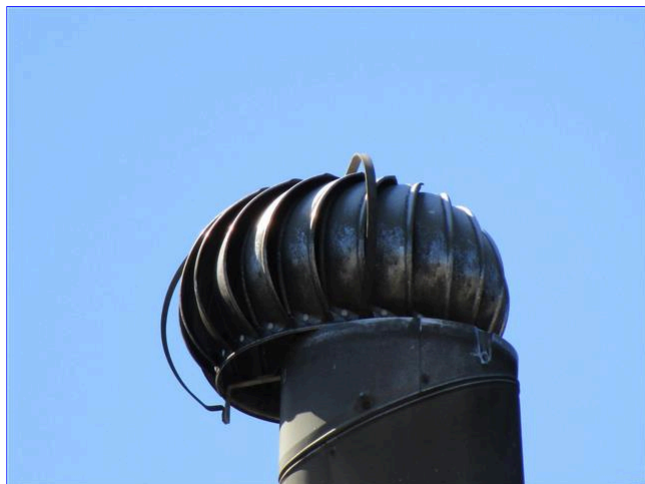
C. Item 4(Picture)

(2) **Deficiencies:** Front turbine vent is not fasten at the base. A roofer is recommended to evaluate and make the necessary repair(s).

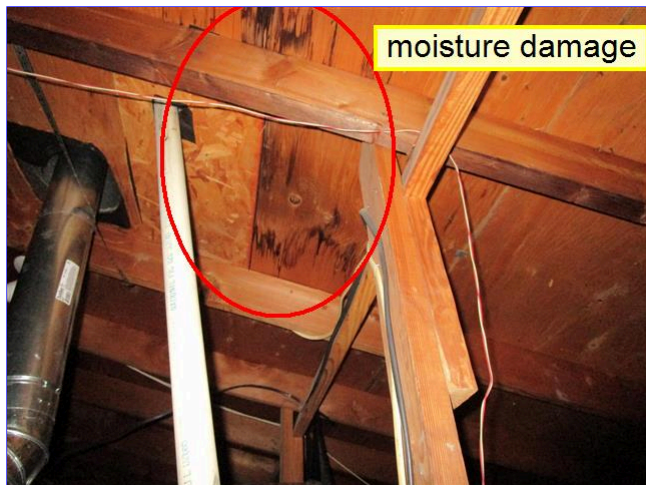
D. Item 1(Picture)

(1) **Deficiencies:** Noted moisture damaged on decking. A qualified roofer is needed to make the corrections as needed.

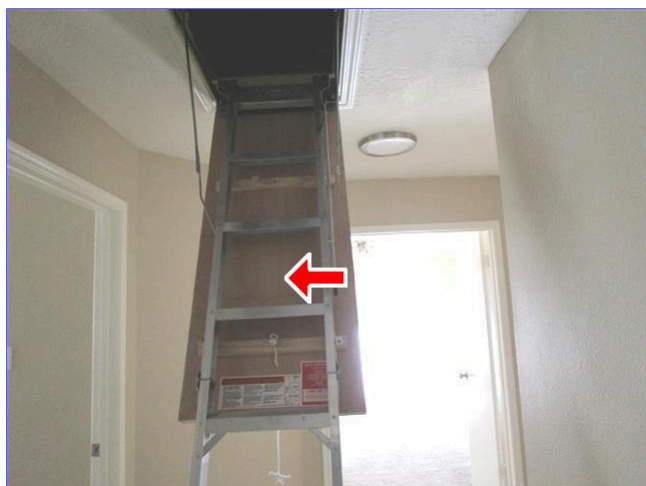
D. Item 2(Picture)

(2) **Deficiencies:** The attic door is missing insulation & weather strip. This can cause some heat loss in winter and loss of cool air in summer if not corrected. A qualified contractor should inspect and repair as needed.

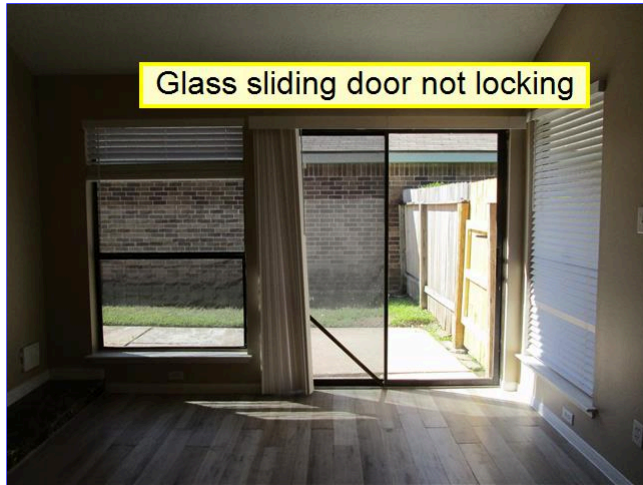
G. Item 1(Picture)

**Deficiencies:** Locking mechanism at sliding glass door in living room is malfunctioning. Screens are missing at both sliding doors.

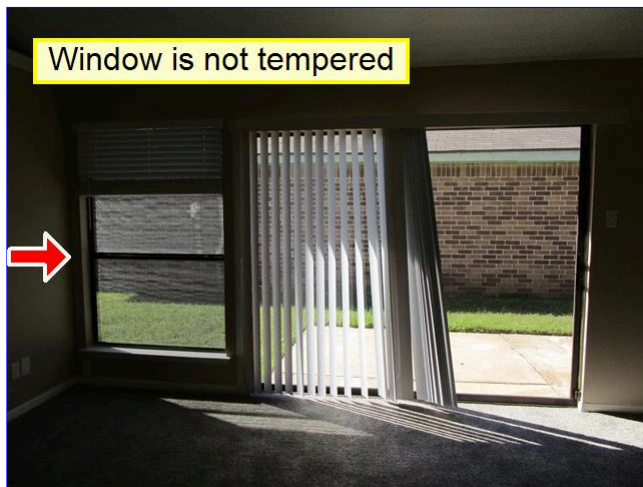
H. Item 1(Picture)

**Deficiencies:** The following windows are not tempered: windows next to both sliding doors & window in master bath room. The window in breakfast area is damaged (cracked). A qualified contractor is needed to make the corrections.

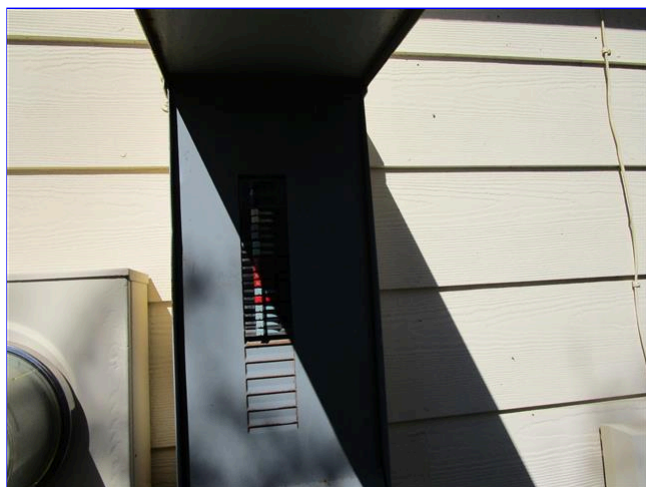
A. Item 1(Picture)

**Deficiencies:** Main breaker missing anti oxidation lubricant, labeling is worn on panel board. ( Electrician is recommend to evaluate)

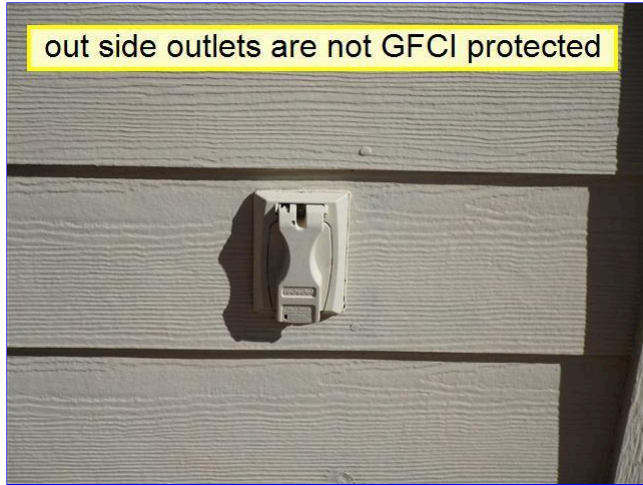
B. Item 1(Picture)

(2) **Deficiencies:** Exterior receptacles not GFCI protected.receptacles,receptacle at back sliding door living room shows to have no power.

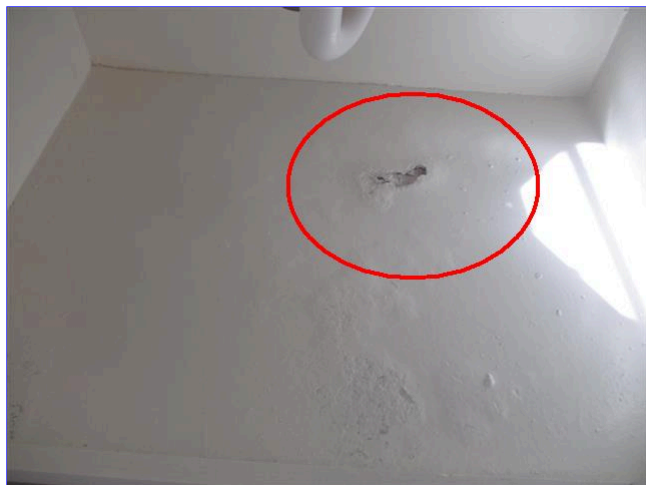
B. Item 2(Picture)

(2) **Deficiencies:** Moisture damage noted to the base of the bathroom vanity cabinet.

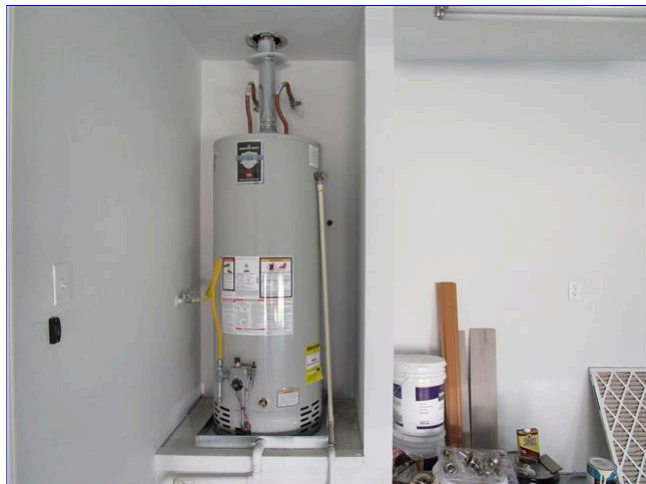
E. Item 1(Picture)

**Deficiencies:** Noted no hot water distribution at time of inspection,(water heater not operable). A qualified plumber is needed to make the correction.
