PROPERTY INSPECTION REPORT

4723 Casemont Drive / Spring, Texas 77386

January 24, 2020

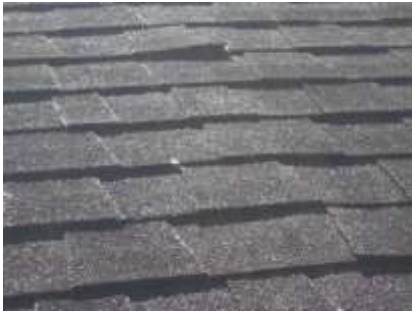
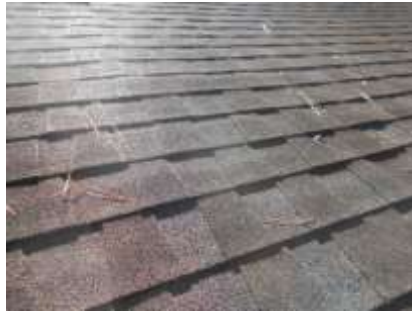
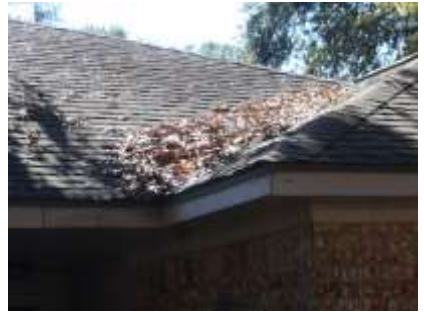
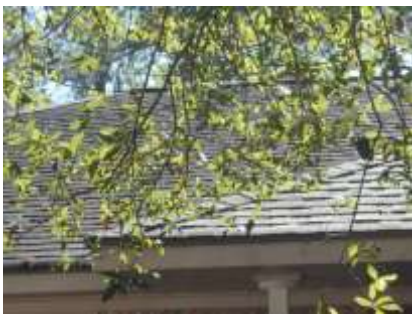
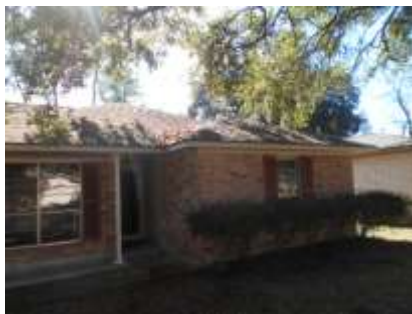
- G. Doors (Interior and Exterior) –**
 Comments: *Install self-closing device on the garage to house barrier door. The spring is broken on the garage door. Replace broken spring.*
 Is garage barrier door self-closing? Yes no N/A

*There is loose and raised flashing on the back slope of roof.
Secure flashing. There has been previous roof repairs.
Replace damaged shingles on the back slope.
Clean debris from the roof. Trim branches away from the roof
secure raised shingles on the front of house.*

*Install self-closing device on the garage to house barrier door.
The spring is broken on the garage door. Replace broken spring.*

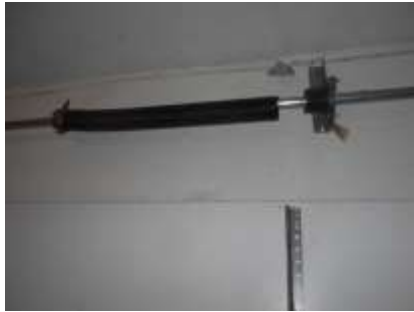
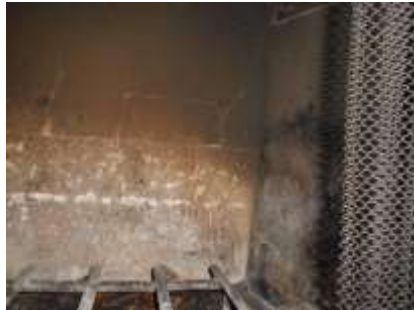
- Interior Firebox and Visible Flue Replace cracked insert in the fireplace.
Type(s): Metal Box And Flue masonry/Brick Insert other
- Attic Flue Penetration Fire stopping
- Damper Operation
- Gas Log Lighters & Valves (location)

Replace cracked insert in the fireplace.

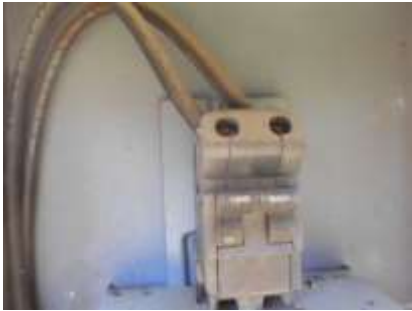
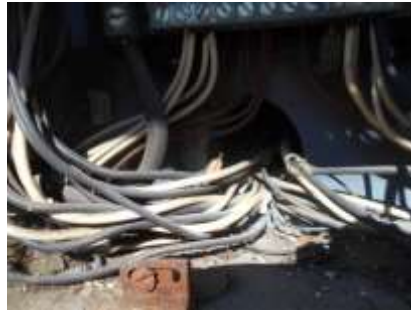
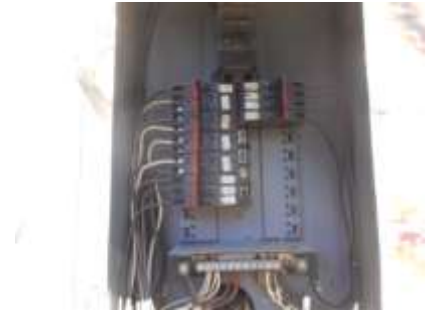
Comments: This house is serviced by a F P electric panel . These panels have known defects (see insert)

- Visible Wiring Types(s): (Service)
 - Copper Aluminum
- Install anti-oxidant paste to service conductors.*
- Install plastic gromets to protect wires ran thru the panel housing.*
- Wiring Condition(s)
- Service Drop/Weatherhead/Mast
- Grounding System (Electrode/Conductor(s))
- Panel board(s)
- Main Disconnect(s)
- Over current Protection

Federal Pacific Electric Company (FPE) was one of the most common manufacturers of circuit breaker panels in North America from the 1950s to the 1980s. Millions of their panels were installed in homes across the country. Yet, as the years passed, electricians and home inspectors often found Federal Pacific Electric panels failed to provide proper protection to homeowners and their families. Experts now say that FPE panels can appear to work fine for years, but after one overcurrent or short circuit, they can overheat and become fire hazards.

An expert who investigated the potential hazards of Federal Pacific Electric panels stated under UL 489 test conditions, that FPE panels fail to trip at a much higher rate than standard panels.

When a breaker fails to trip, an extreme amount of power from the outside electrical supply surges into a home's panel and circuits. Once that happens, it cannot be stopped or shut off manually. Electricity will burn until it runs out of fuel or the wires melt. The panel could overheat and catch fire, causing serious harm to a home and its occupants. Many Federal Pacific Electric panels and breakers can operate properly for years. But if and when they do malfunction, a disaster could occur.

*Install anti-oxidant paste to service conductors.
Install plastic gromets to protect wires ran thru the panel housing.*

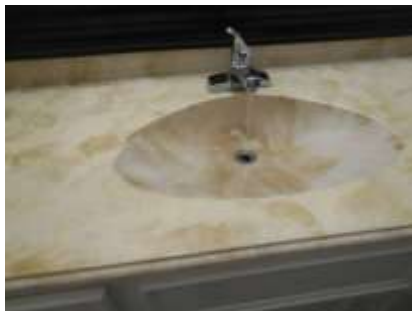
Comments: water volume drops when multiple faucets are ran together. Have evaluted by a plumber.

*Water volume drops when multiple faucets are ran together. Have evaluated by a plumber.
The toilets in both bathrooms are loose. Secure the toilets to the floor.
The shower stem leaks at the hall bathtub faucet. Have faucet repaired.
Install back-flow preventers on exterior faucets.*

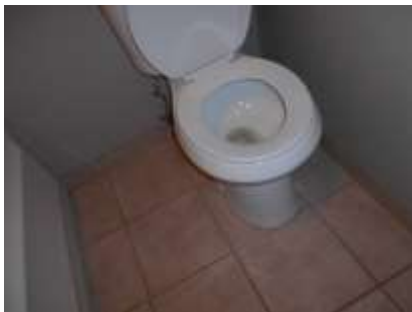
- Bath Room Group(s) (3) master
 - Lavatory(s)
 - Faucet Assembly(s)/Supply Pipes/Valves
 - Drains/Pipes/Stops
 - Tub and Shower Units
 - Faucet Assembly(s)/Supply Pipes/Valve
 - Drains/Pipes/Stops
 - Enclosures(s)/Shower Pan
 - Commode(s)
 - Supply Pipes, Valves, Bowl, Tank, Anchorage *The toilet is loose. Secure toilet to the floor.*

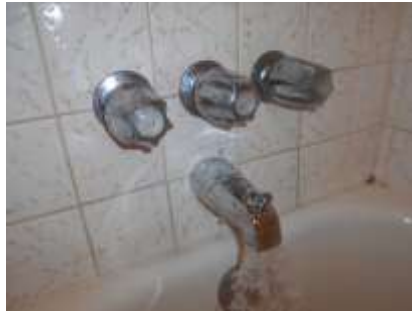
- Bath Room Group(s) (3) hall
 - Lavatory(s)
 - Faucet Assembly(s)/Supply Pipes/Valves
 - Drains/Pipes/Stops
 - Tub/Shower Units
 - Faucet Assembly(s)/Supply Pipes/Valves *The shower stem leaks. Have faucet repaired.*
 - Drains/Pipes/Stops
 - Enclosures(s)/Shower Pan
 - Commodes
 - Supply Pipes, Valves, Bowl, Tank, Anchorage *The toilet is loose. Secure toilet to the floor.*

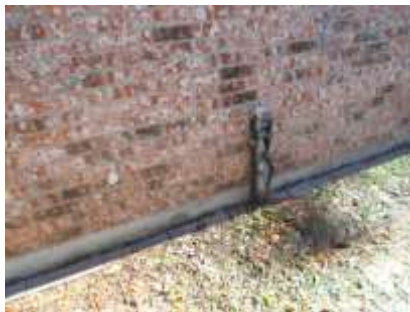
- Exterior Faucets/Fixtures*
/ Backflow preventions

Install back-flow preventers on exterior faucets

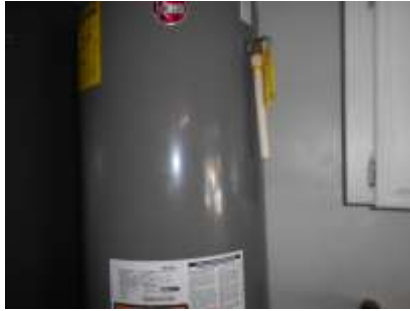
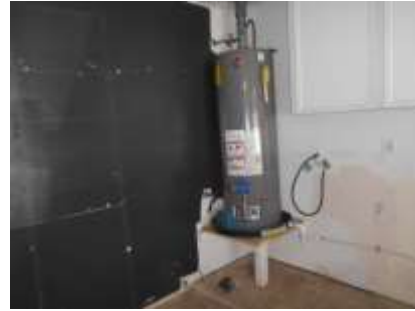
- (Report as deficient those conditions specifically listed as recognized hazards by TREC rules.)
- Tank & Fittings and Installation
- Temp & Pressure Relief Valve/Drain line Extend T&P drain line to exterior.
- Safety Pan & Drain and Location
 Attic *garage (or room opening into garage)* *other*
- Physical Protection *yes* *no*
- 18" Clearance from Ignition Source to Floor
- Is shut off valve accessible *yes* *no* is drip leg present *yes* *no*

- D. Hydro-Massage Therapy Equipment –**
Comments: The tub stopper is missing and unit could not be tested.
 - Operation/Controls/Switches
 - Ground Fault Protection yes no Install GFCI protection.
 - Valves/Ports
 - Pump/Motor/Accessibility yes no

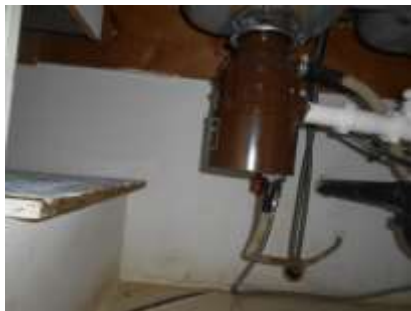
- B. Food Waste Disposers -**
Comments: disposer does not work. Replace the disposer.
 - Operation
 - Splash Guard, Grinding Components
 - Checked for Mounting/Excessive Vibration
 - Checked for Water Leaks

B. Food Waste Disposers -
Disposer does not work. Replace the disposer.

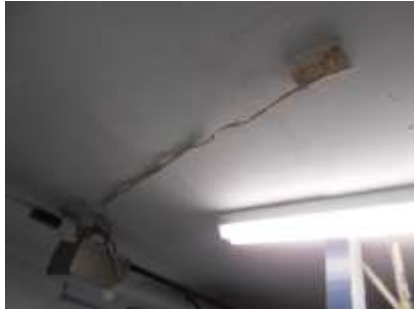
Comments: Install auto reverse sensors. Install outlet for garage door operator and remove extension cord connection.

G. Garage door Operators
Install auto reverse sensors.
Install outlet for garage door operator and remove extension cord connection.
