## PROPERTY INSPECTION REPORT

**Prepared For:** Rose James

**Concerning:** 7200 W TC Jester, Houston, TX

**By:** Stan Snyder, Lic #5285

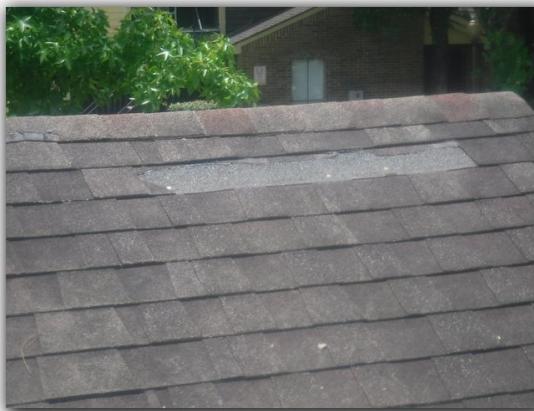
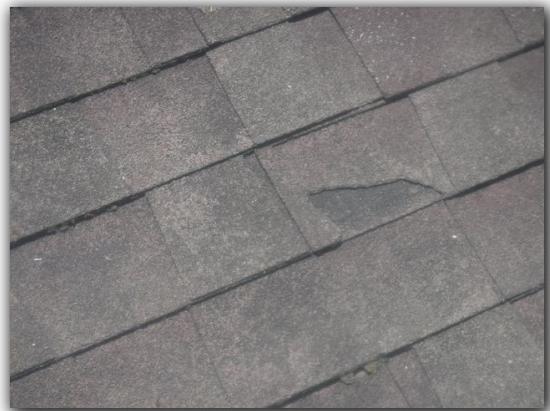
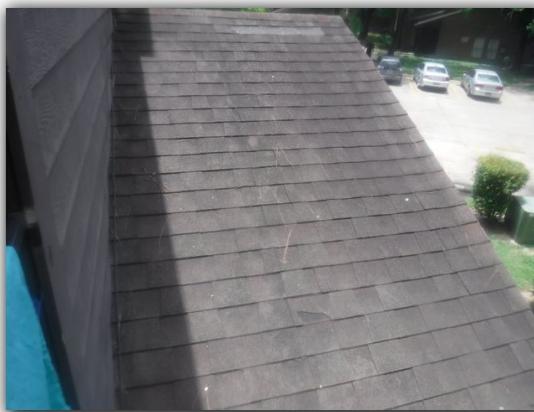
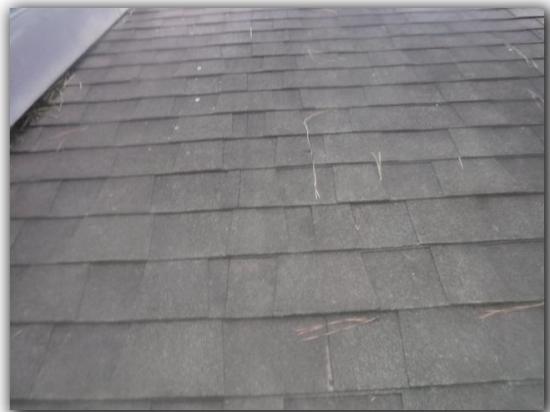
- Torn, damaged, perforated or missing shingles at various locations was observed and noted.

- Past repair to the roof covering was noted on the south side of the complex.
- Roof decking deflection and / or sagging
- Roofing covering installed over older roof covering
- Inappropriate roof covering for slope of the roof
- Trim, soffit, fascia boards are in need of repair
- counter-flashed
- Skylight covers not secured and / or flashed properly
- Exposed or lifting nail heads

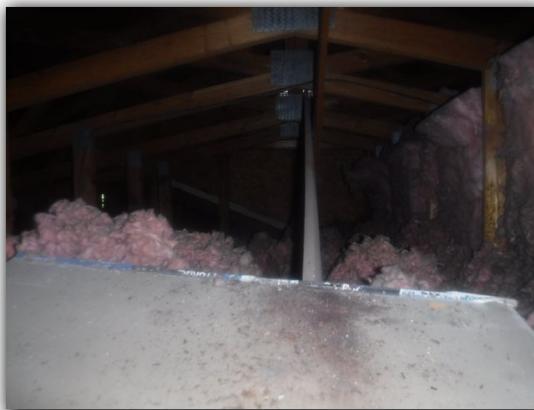
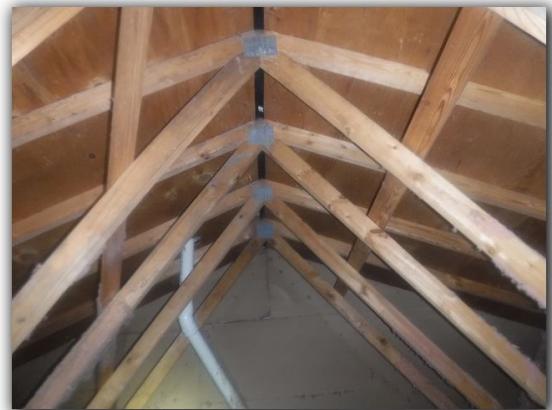
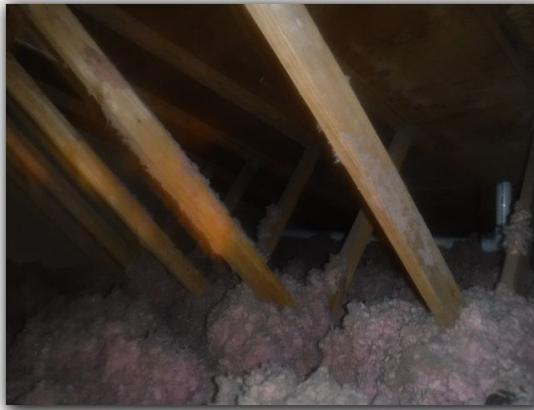
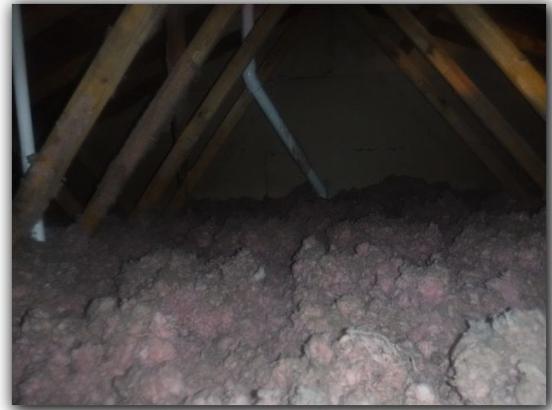
Unit 1004 attic

Insufficient attic insulation. Current code requires 13 inches of insulation for an R factor of 38.

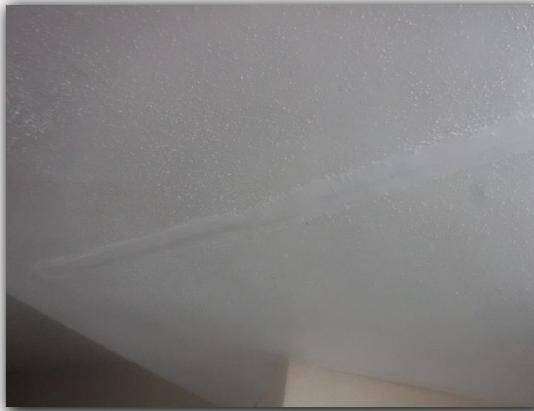
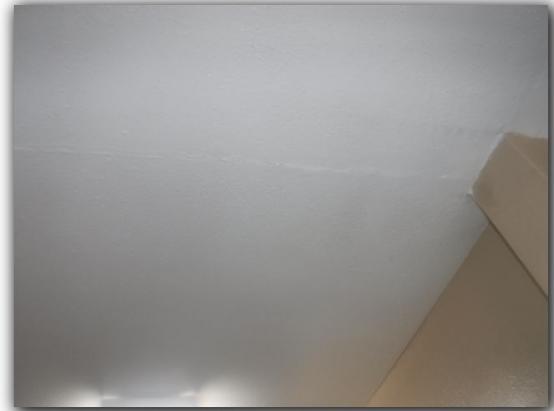
- There are 2 large ceiling cracks in the kitchen area of unit # 1002.

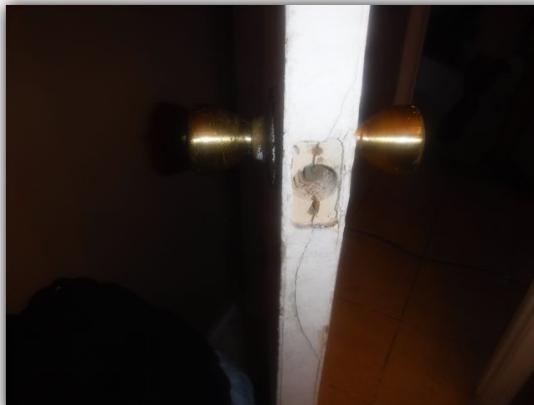
- The closet doors were missing from unit 1001 and unit # 1003 front bedrooms.
- The bathroom entry door and the entry door to the front bedroom are damaged

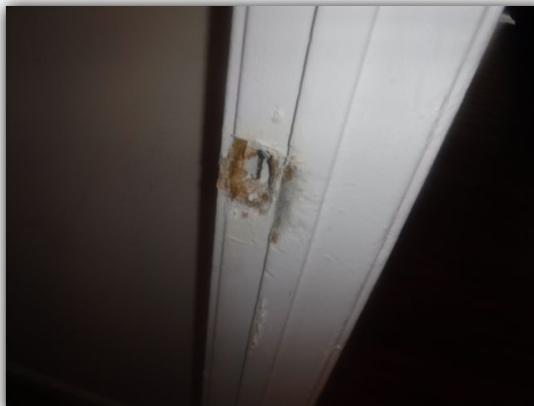
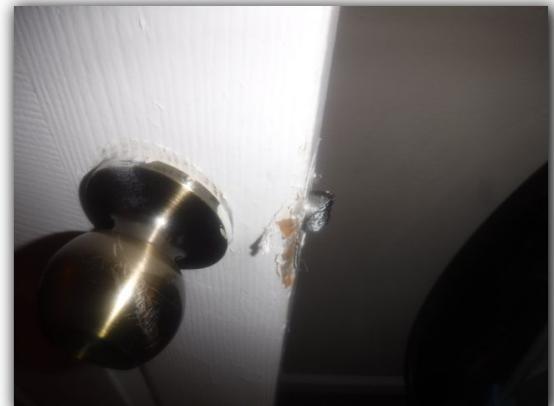
- The door and door jamb is damaged at the entry to the front bedroom in unit # 1003.

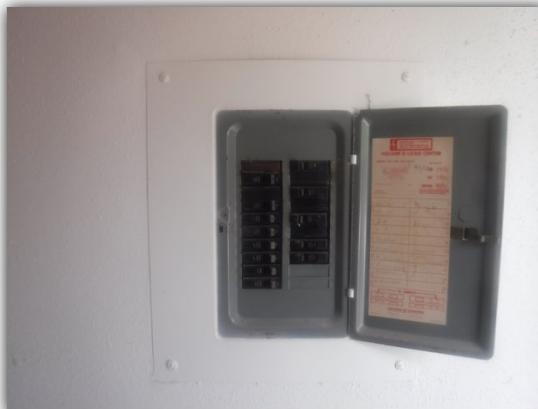
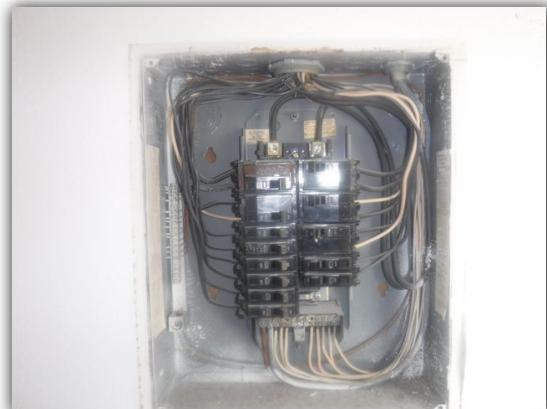
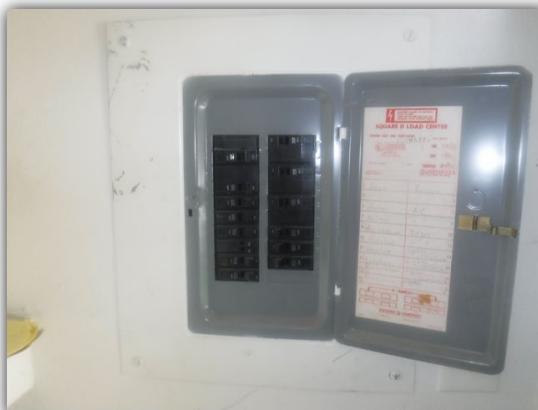
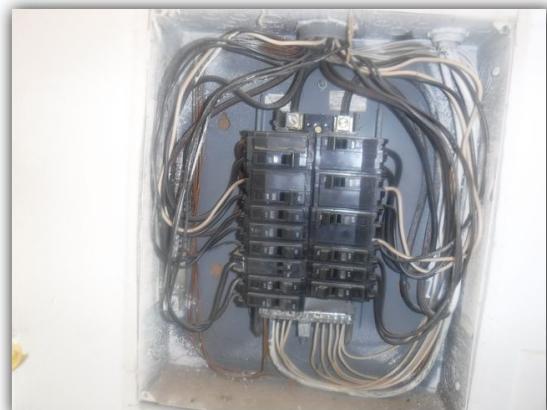
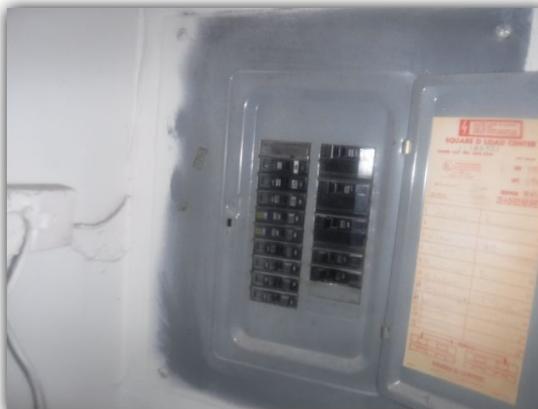
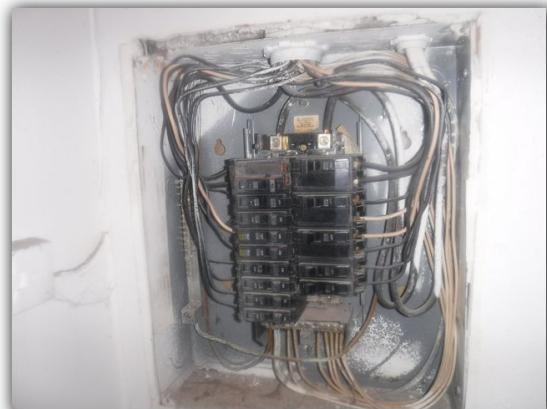
**Main Disconnect Panel All units are provided with a Square-D 100 amp panel**

All panels are located in the closet across from the main entries of all units. Electrical panels are code required to not be behind any door that can lock and should be accessible to all occupants.

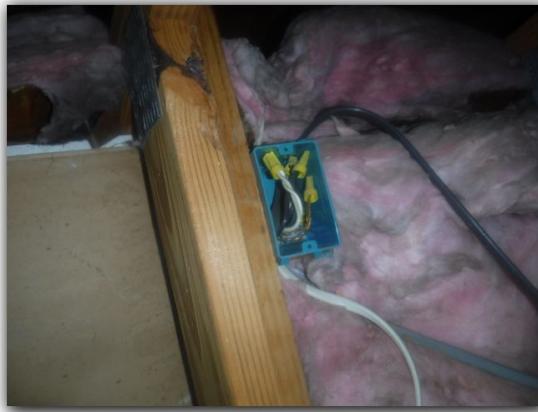
- Test indicate reverse polarity       Wiring is unsupported beneath the structure  
 One or more junction boxes do not have covers in the attic of unit 1002

One or more connections are not in

junction boxes

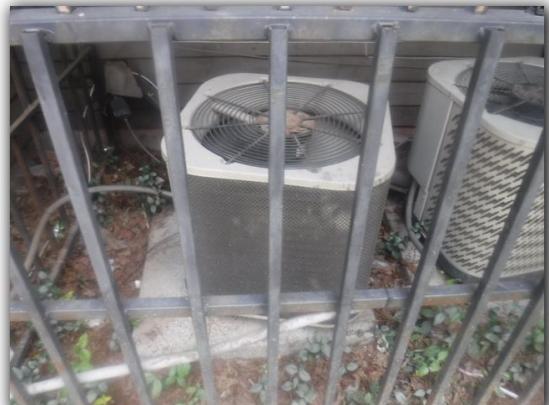
Unit #1001 Goodman

Supply Air Temp: 57 °F      Return Air Temp: 75 °F      Temp. Differential: 18 °F

The condensing unit serving this cooling system is very old and is probably nearing the end of its useful life.

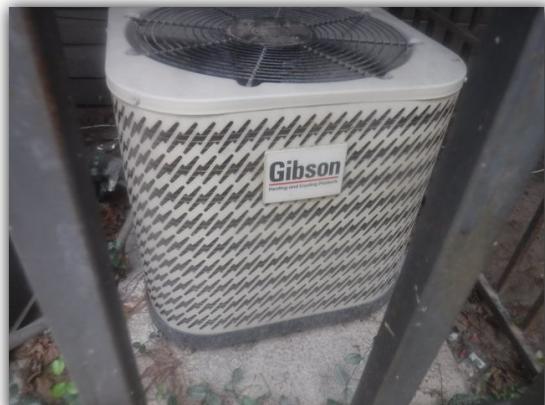
Unit #1002 Gibson

Supply Air Temp: 53 °F      Return Air Temp: 73 °F      Temp. Differential: 20 °F

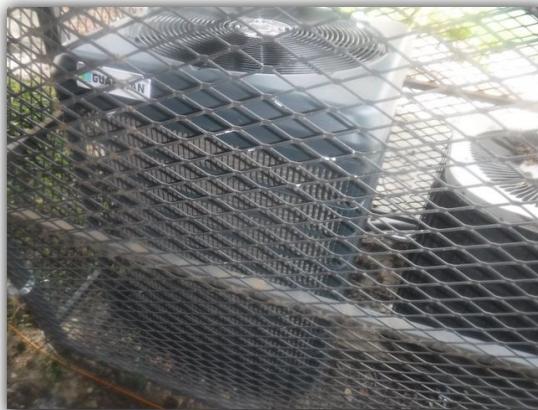
Unit #1003 Guardian

Supply air Temp 50 F      Return air Temp 73 F      Temp. Differential 23

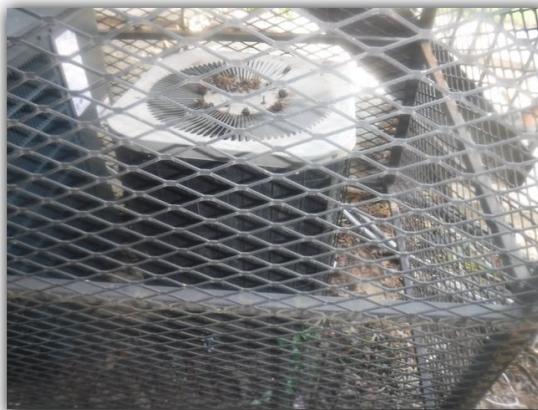
Unit # 1004 Goodman

Supply air Temp 58 F      Return air Temp 75 Temp. Differential 18

It was noted that the Goodman units serving units # 1001 & 1004 are very old and are probably nearing the end of their useful lives.

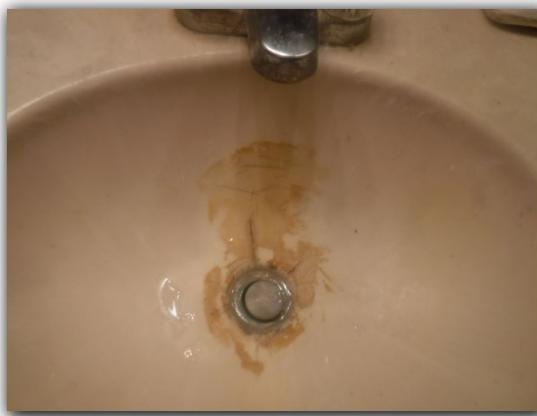
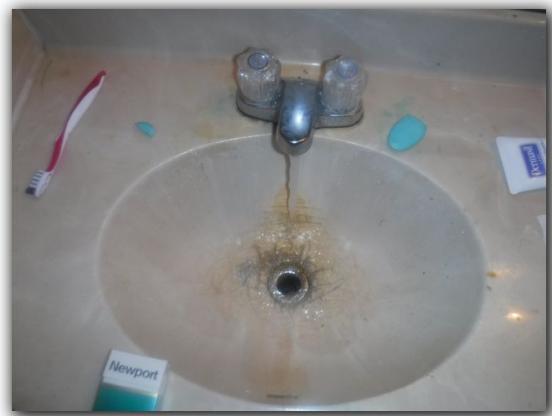
| <input checked="" type="checkbox"/> Sinks in unit #1001 and unit 1002 are cracking and in overall poor condition. | |

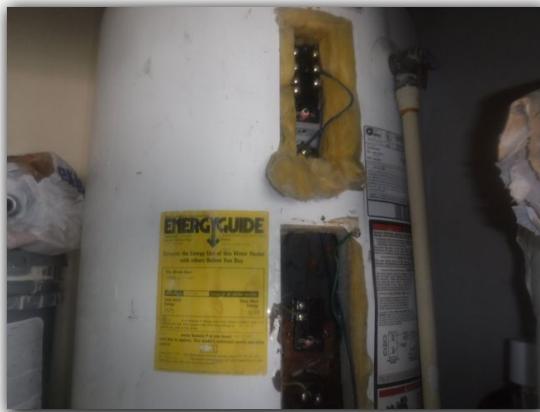
- One or more covers are missing or damaged for the water heater at unit # 1004. It is also this inspectors opinion that this water heater is probably nearing the end of its useful life.
