# Web Presentation

**Property Address:** 20802 Bradley Gardens Drive, Spring, TX 77379

**Cliff-Bell Real Estate Inspectors**

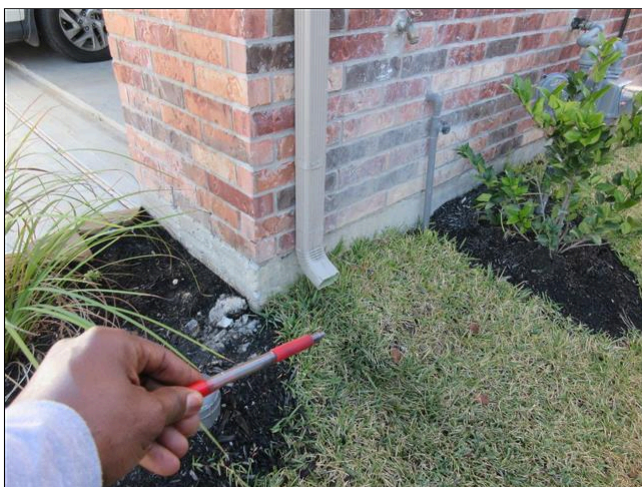
B. Item 1(Picture)

**Missing gutter downspout's, elbows, or splash blocks.**

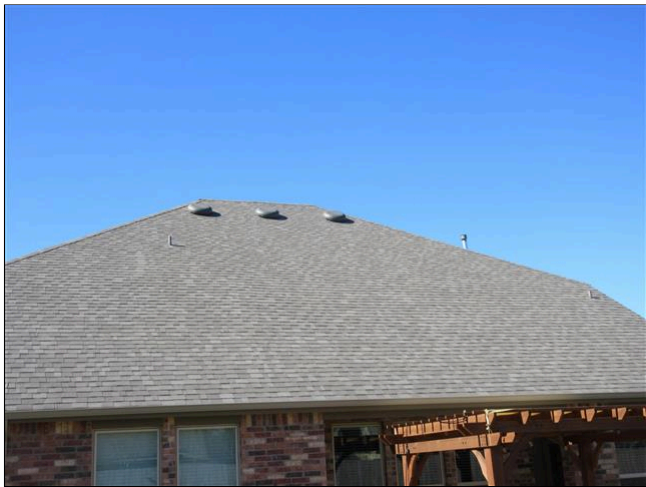
C. Item 1(Picture)

**Inspectors visual inspection of the roof was limited due to the height and / or slope of the roof. Inspector was unable to access and 'walk the roof'. Shingle installation and shingle condition could not be closely observed. A Certified Roofing Company should be consulted.**

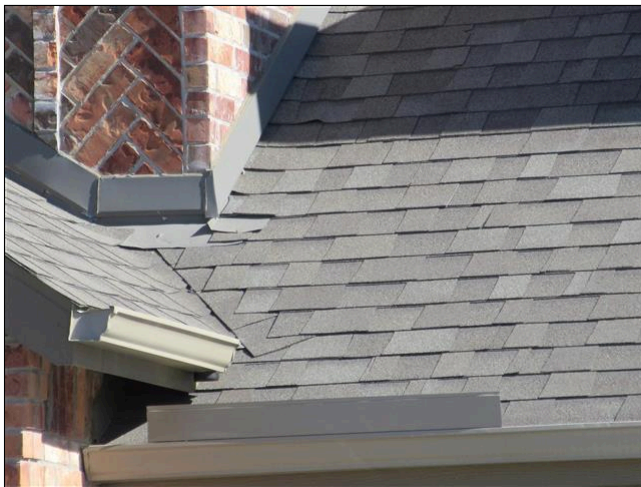
C. Item 6(Picture)

**The roof covering is lifted OR bulging in some areas.** I am unable to determine if this condition will leak or fail. Areas of lifted shingles should be repaired or replaced to prevent water intrusion or wind driven rain **(all affected may not be pictured)**. A qualified person should further evaluate entire roof covering; repair or replace as needed.

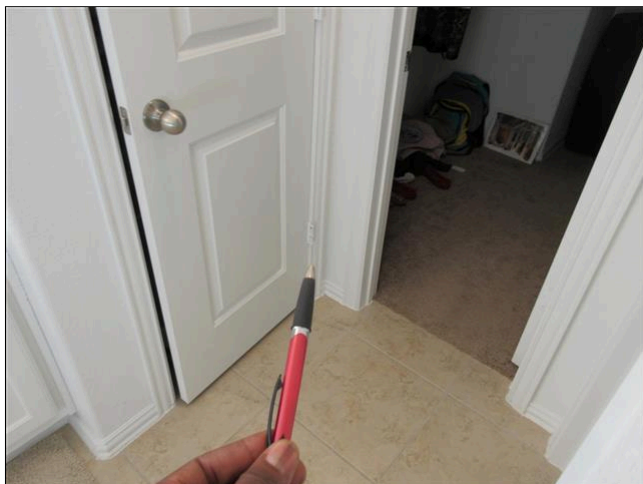
G. Item 1(Picture)

**Doors hinge(S) are loose, damaged, or no longer functions as intended in one or more rooms.**

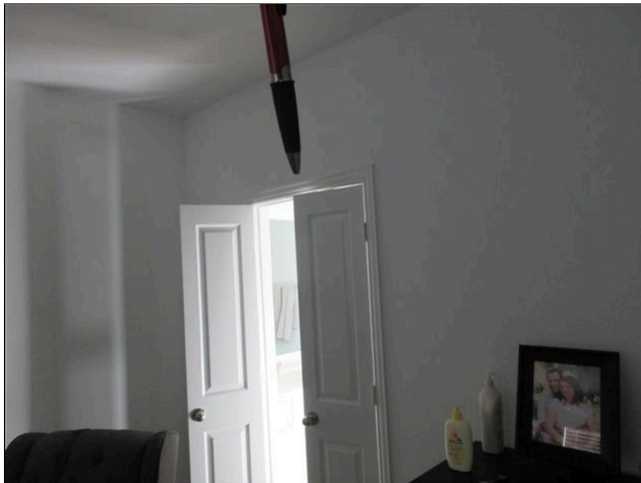
G. Item 3(Picture)

**Some doors do not properly latch as intended or doors inadequately latch (loose) due to damage or deficient hardware. In need of repair.**

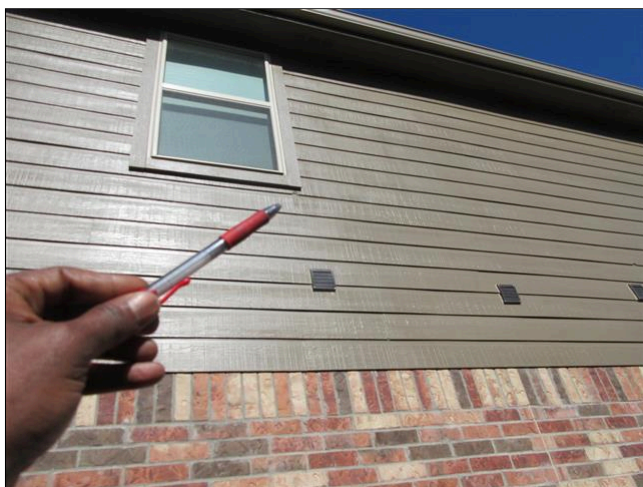
L. Item 1(Picture)

**Wood trim or siding is missing or damaged in some areas.**

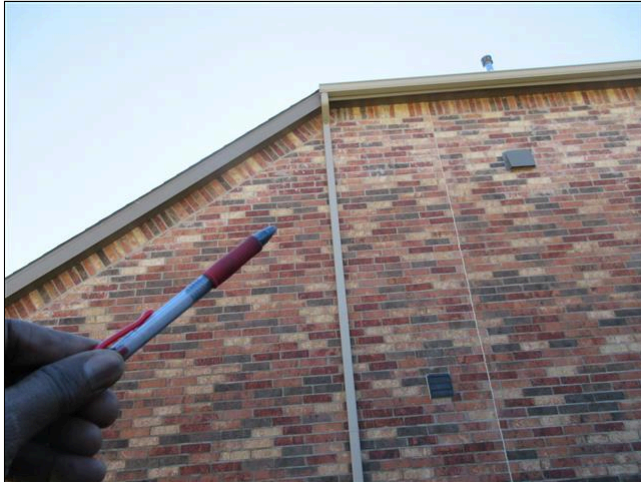
L. Item 5(Picture)

**Damage or wall penetrations in need of repair, sealant, or caulking to prevent pest or water intrusion. All affected areas are NOT pictured. Recommend further evaluation by a professional.**

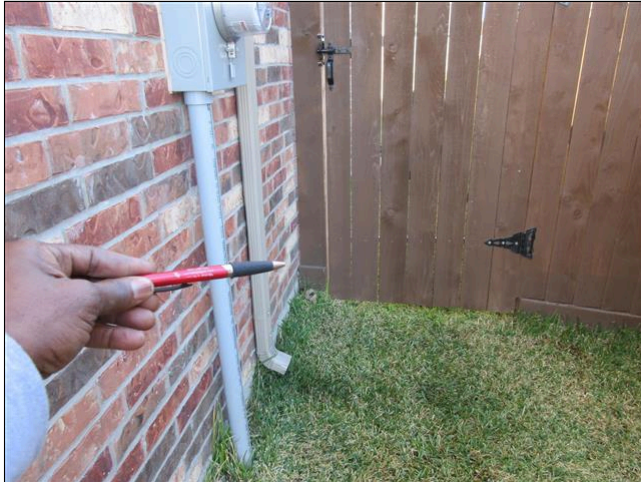
O. Item 1(Picture)

**Loose or wobbly wooden fence on at least one side of structure. Fence footer is not installed close enough to wall for fence to fit flush against wall.**

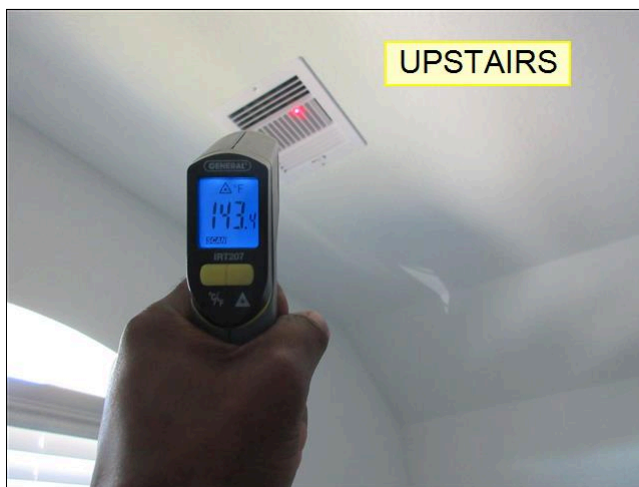
A. Item 1(Picture)

**The ambient air test was performed by using thermometers on the heating equipment to determine if the difference in temperatures of the supply in different rooms. The test indicates the distribution of warm air varies from room to room. Hot air temps are uneven. Recommend cleaning, servicing, and further evaluation of Hot & Cool air distribution by a licensed professional.**

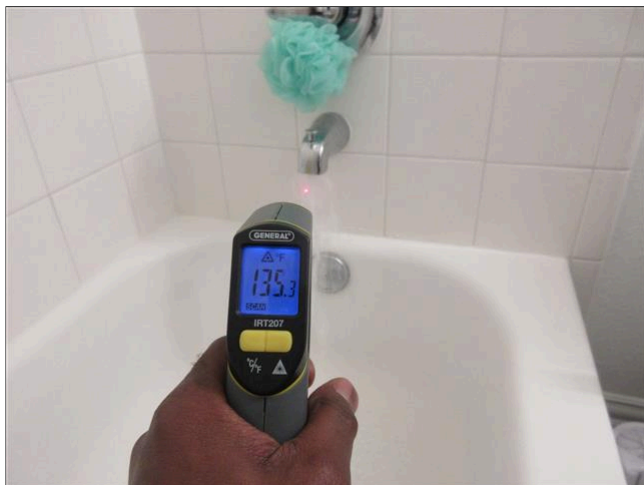
C. Item 1(Picture)

**What Temperature Should Your Hot Water Be? You may be surprised to know that while the EPA (Environmental Protection Agency) recommends setting your water heater at 120 degrees. OSHA (Occupational Safety & Health Administration) recommends setting your water heater thermostat at 140 degrees under certain circumstances.**

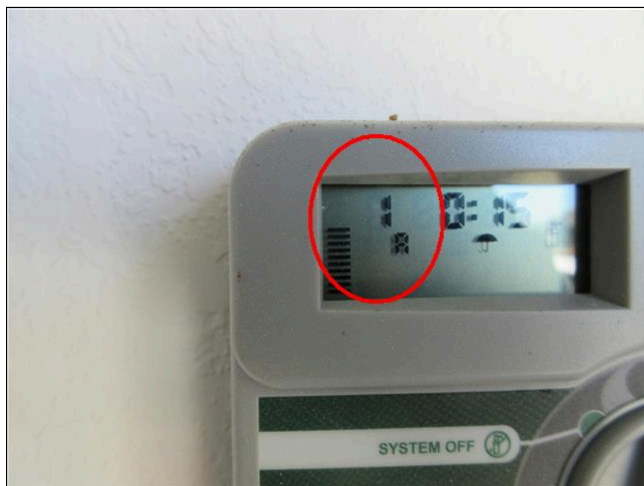
A. Item 1(Picture)

**Deficiencies in water flow or pressure at the zone heads. Missing and/or broken heads in need of repair.**

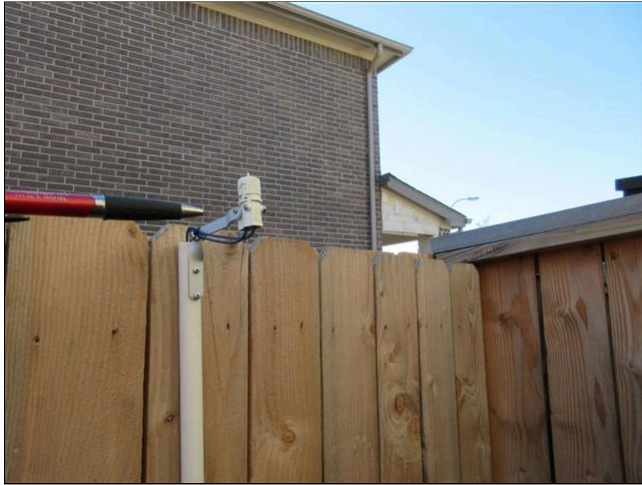
A. Item 7(Picture)

**Rain sensor does not function as intended.** A rain sensor or rain switch is a switching device activated by rainfall. There are two main applications for rain sensors. The first is a water conservation device connected to an automatic irrigation system that causes the system to shut down in the event of rainfall.
