Inspection Report

2715 Lakeside Dr.
Pearland TX 77584

Hilsher Group LLC

Date: 8/10/2018	Time: 9:00 AM	Report ID: 08-10-2018A
Property: 2715 Lakeside Dr. Pearland TX 77584	Customer: Session Linsey	Real Estate Professional: Phyllis Peak

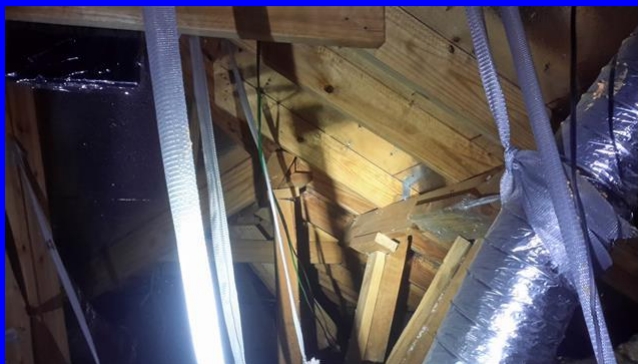
Stick built 2x6 rafters with TechShield

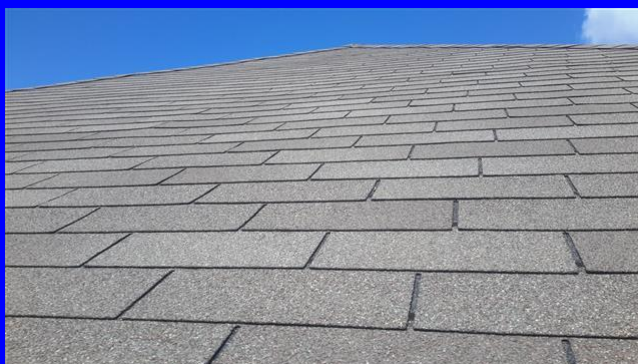
Roof overview, back

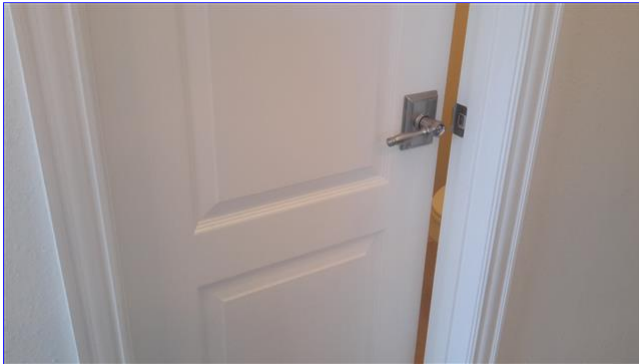
[Comments:](#)
(1) One or more interior doors swing closed when opened. Recommend repair or replace as needed.

G. Item 1(Picture) Master closet

G. Item 2(Picture) Master bathroom water closet

G. Item 3(Picture) Master bedroom

G. Item 4(Picture) Laundry room

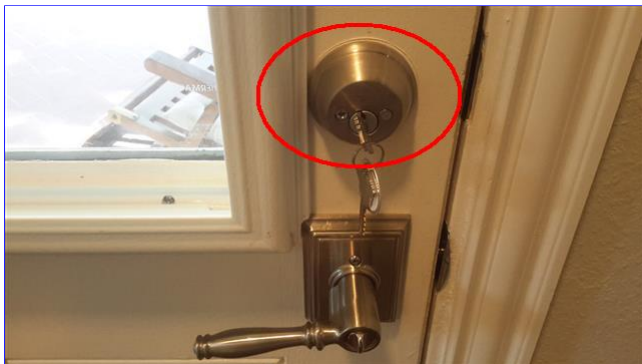
G. Item 5(Picture) Back door

(2) Thumb latches missing on one or more exterior doors. Doors that lead to exterior require thumb latches for ease of egress. Recommend repair or replace as needed.

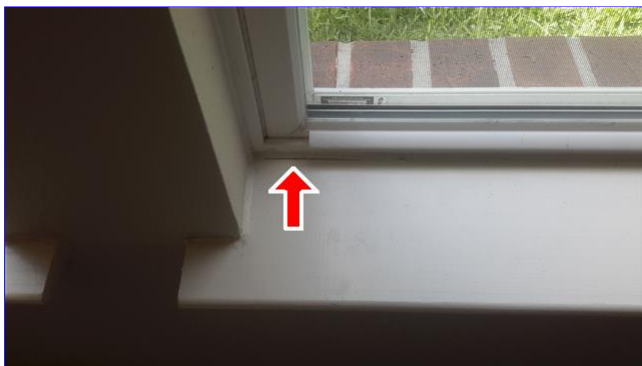
H. Item 1(Picture) Dining area

There are window frames that are not properly sealed. This can cause energy loss. I recommend having a qualified person seal and repair as needed,

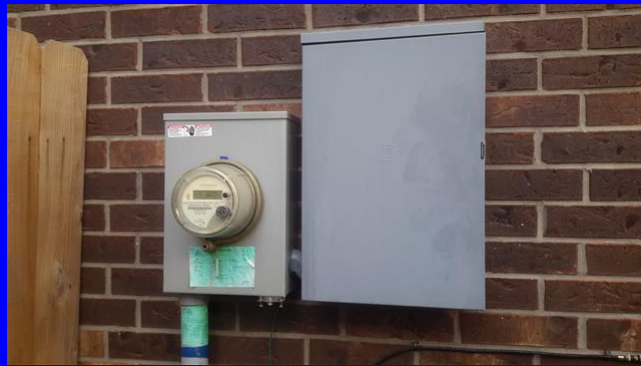
Electric meter and main panel

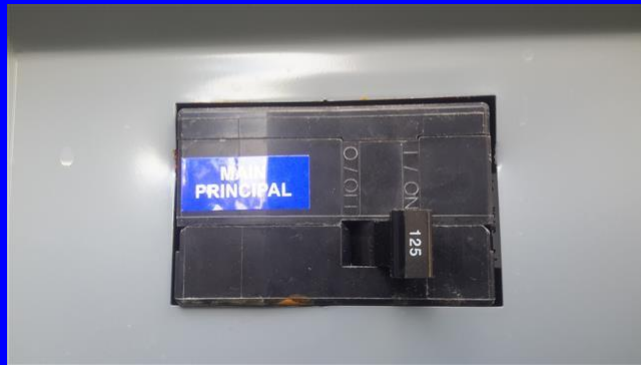
125 amp main service disconnect outside

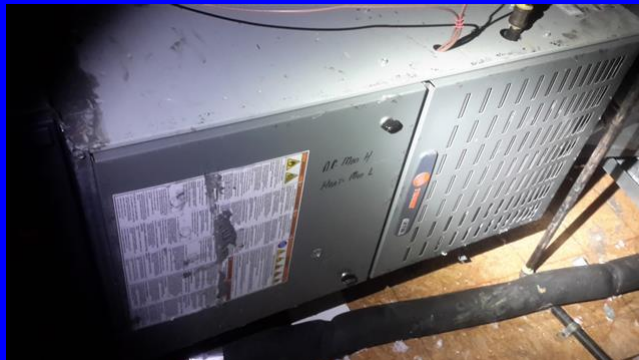
Trane furnace in attic

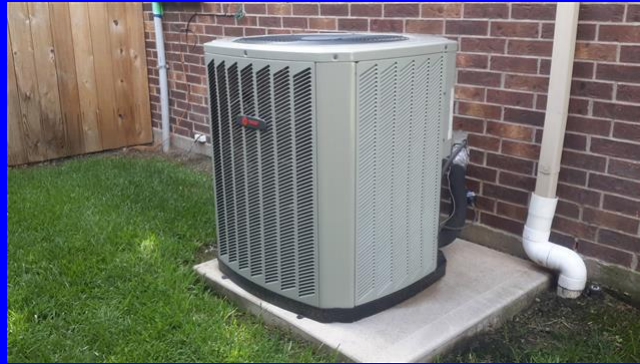
AC unit

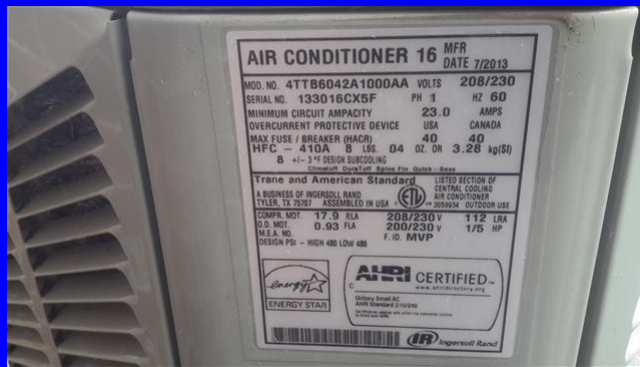
2013 Trane 5 ton

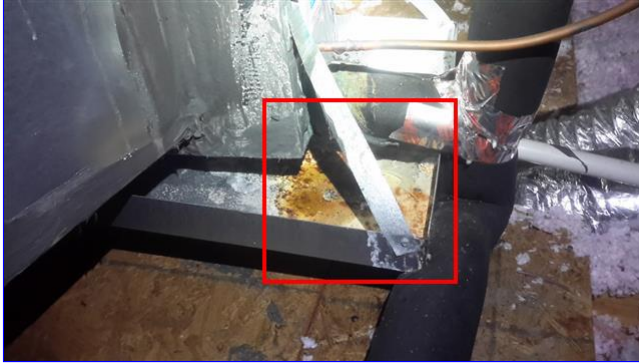
B. Item 1(Picture) Drain pan

(3) The emergency overflow drain pan for the HVAC system is showing signs of deterioration. Further deterioration may occur if not corrected. I recommend having a qualified person make repairs as needed.

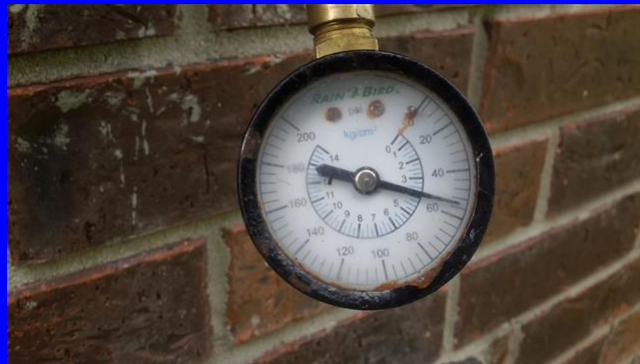
54 psi

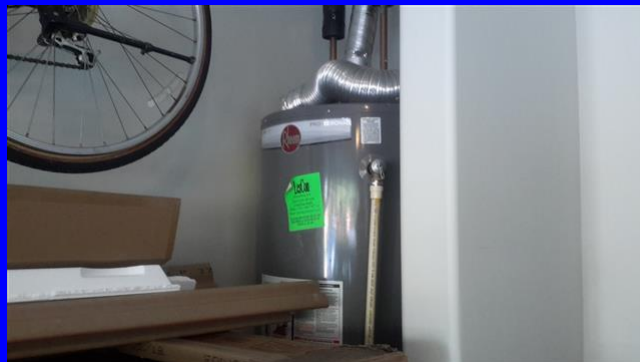
Water heater in garage

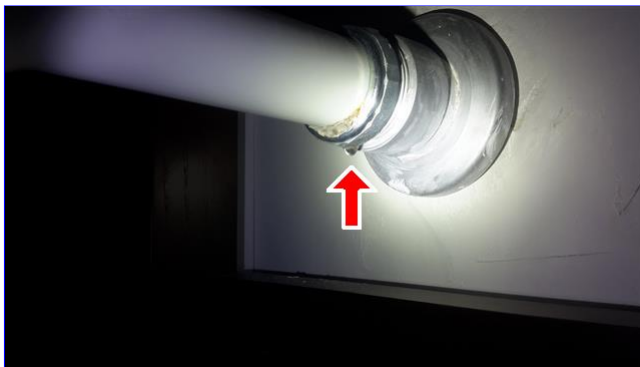
B. Item 2(Picture) 1st floor powder room

(2) Observed a small leak under sink in 1st floor powder room. Recommend repair or replace as needed.

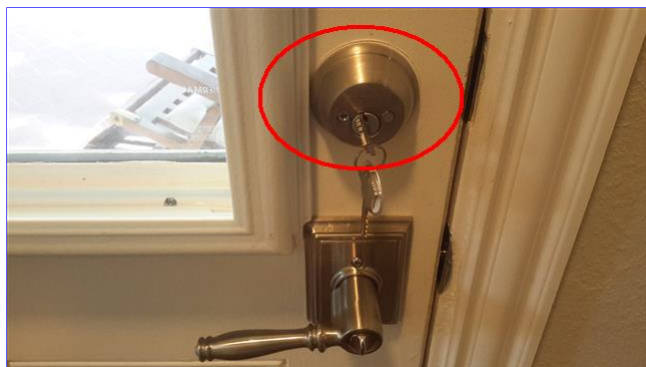
G. Item 5(Picture) Back door

(2) Thumb latches missing on one or more exterior doors. Doors that lead to exterior require thumb latches for ease of egress. Recommend repair or replace as needed.

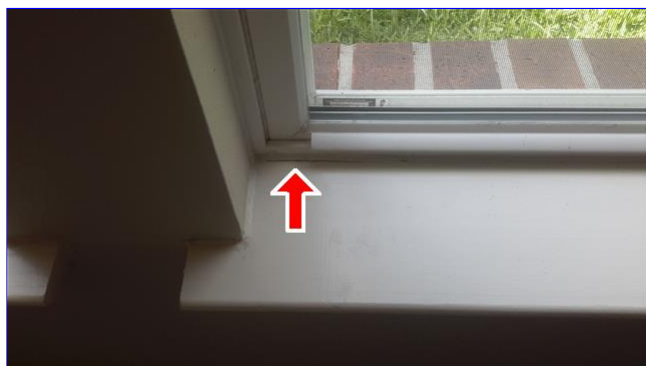
H. Item 1(Picture) Dining area

There are window frames that are not properly sealed. This can cause energy loss. I recommend having a qualified person seal and repair as needed,

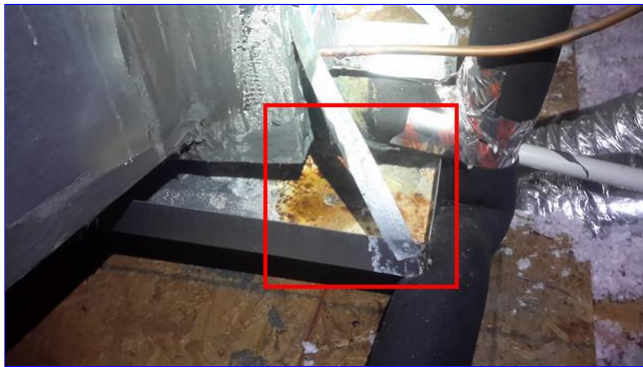
B. Item 1(Picture) Drain pan

(3) The emergency overflow drain pan for the HVAC system is showing signs of deterioration. Further deterioration may occur if not corrected. I recommend having a qualified person make repairs as needed.

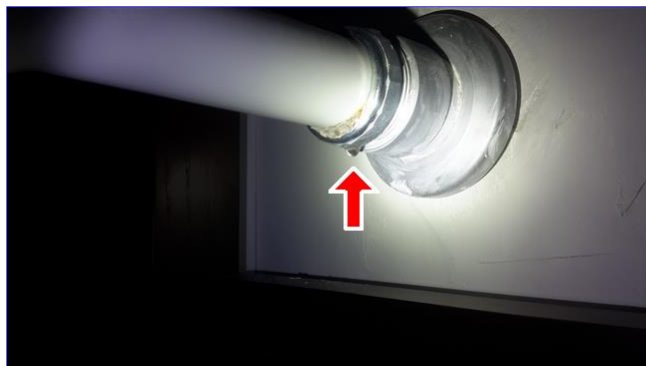
B. Item 2(Picture) 1st floor powder room

(2) Observed a small leak under sink in 1st floor powder room. Recommend repair or replace as needed.
