Texan Inspection Services

Property Inspection Report

5307 Royal Sunset Court, Katy, TX 77493
Inspection prepared for: David L. Rose Danette R. Rose
Real Estate Agent: -

Date of Inspection: 4/22/2020 Time: 1:00 PM
Age of Home: 2019 Size: 2173
Weather: Cloudy-82 degrees
Interested Parties

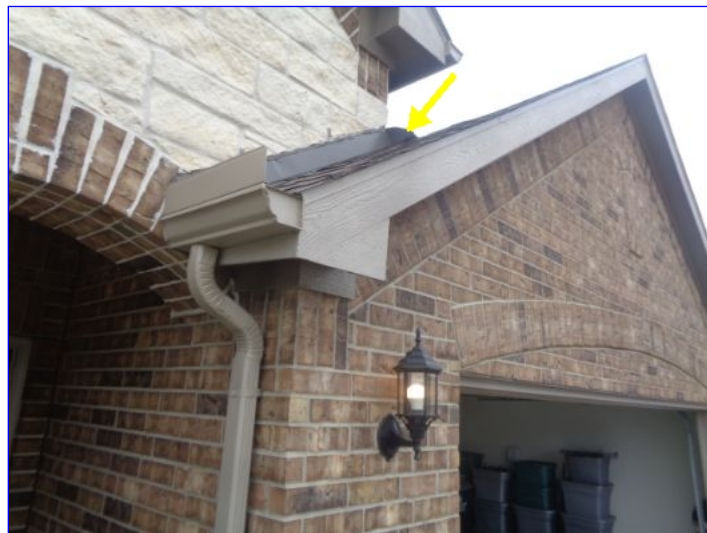
- Note: Shingles and flashing are not lifted to observe nail pattern or determine condition of material installed below due to the potential to cause damage or leakage. Some issues and or defects are not visible as they are covered by roofing materials, flashing etc. Not all portions of the roof covering may be visible. Unforeseen issues could be revealed in the event repairs or replacement are undertaken.
- Observed a small hole in the furnace flue pipe roof jack; this condition should be improved.
- Observed the kick out flashing at the right side of the foyer to extend too far, recommend shorting the flashing to prevent water from by passing the lower gutter.

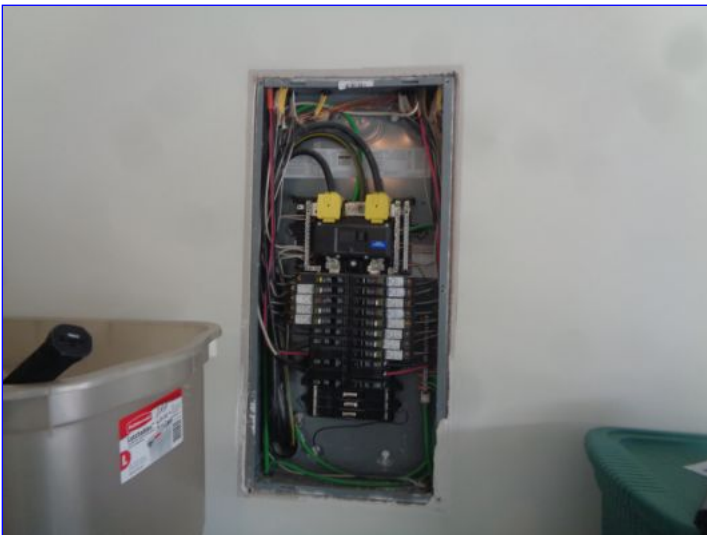
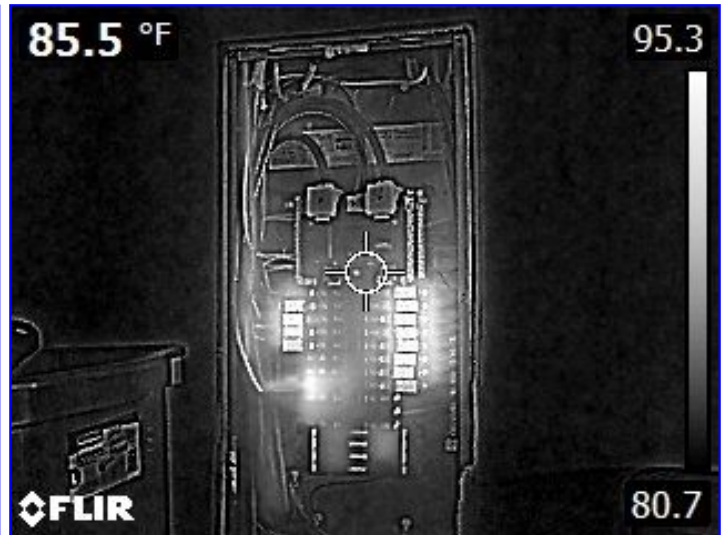
Panel Locations: Electrical panel is located in the garage (right wall)

Materials & Amp Rating: Service entry wiring is aluminum

150 amp Square D Brand

- The main electric service panel was performing as intended at the time of the inspection.

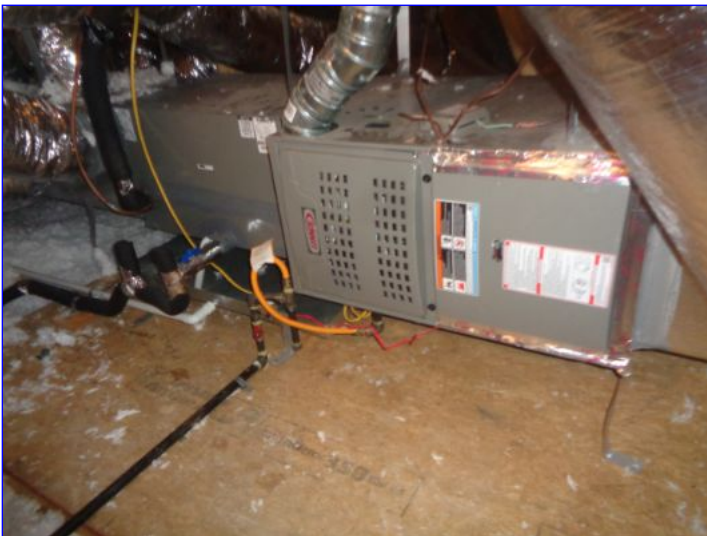
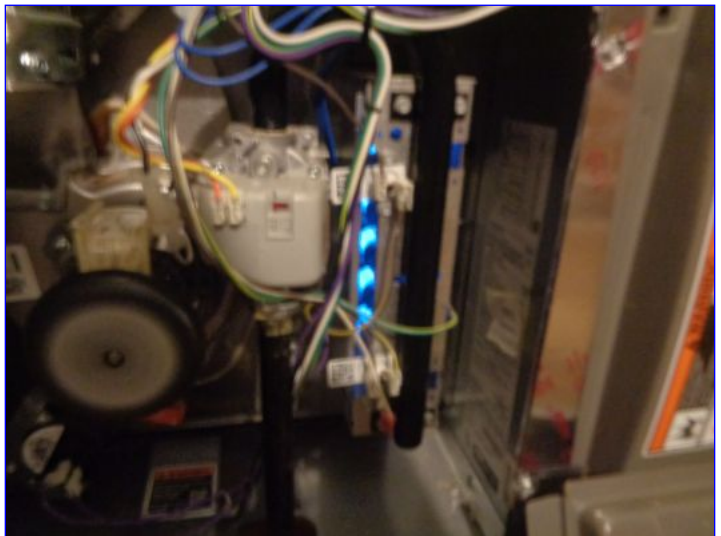
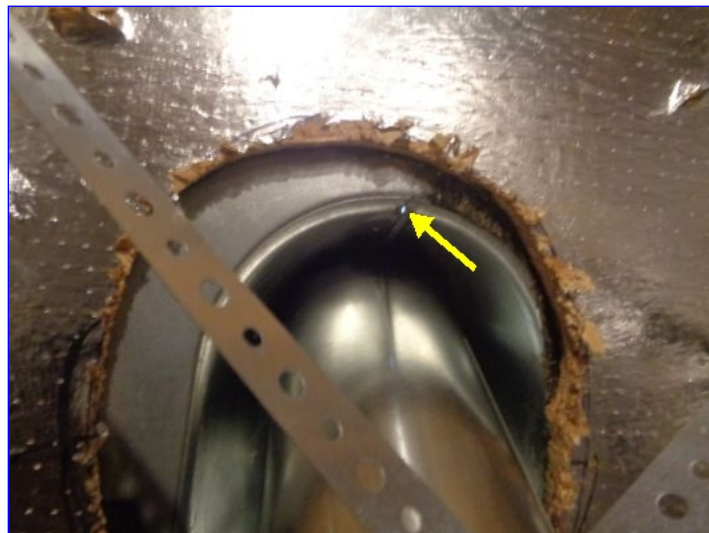
Type of System: Central Forced Air System

Lennox Brand

Manufactured date 2019

- Note: We recommend that the heating system be completely serviced before each heating season. Filters should be changed as needed. Checking humidifiers, electric air filters and proper airflow is not within the scope of this inspection. Heat pumps are not operated when the outside temperature is above 70 degrees.
- The unit(s) operated and vented properly upon inspection.

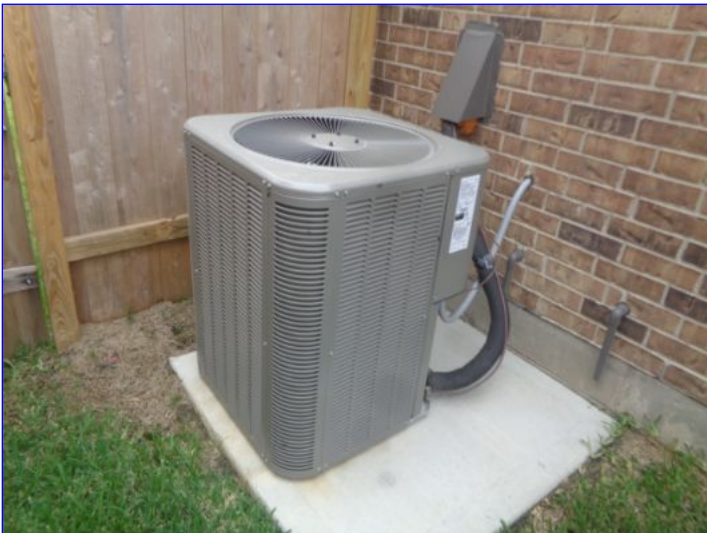
Coil # CHX35-42B-6F-1 model # 14ACXS036-230A22 3 ton unit Manufactured date 2019

- Note: We recommend the AC system be completely serviced before each cooling season and the condensate drain flushed with chlorine bleach every 2 months during the cooling season to prevent clogging. Air conditioning units are not checked when the outside temperature is below 60 degrees because of possible damage to the compressor unit.
- The 7/3 unit operated to control and produced a temperature differential of 18 degrees. This is within test limits of 15 to 20 degrees.

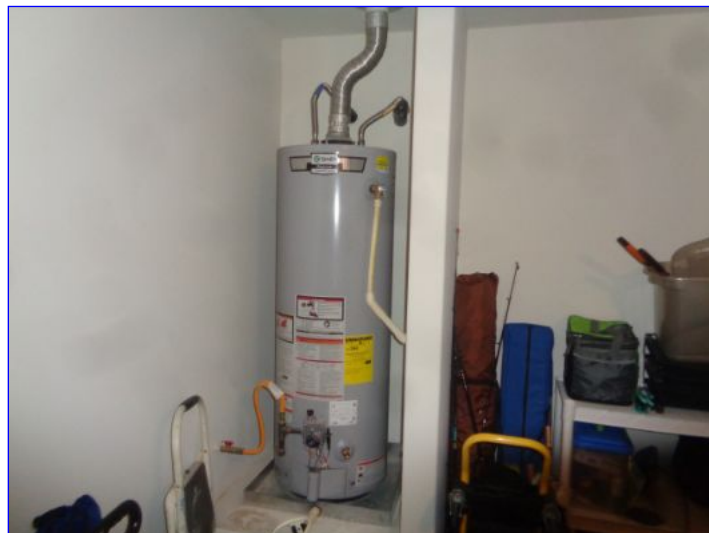
Energy Source: **Natural Gas**
Garage
 Capacity: **40 gallons**
1
A.O. SMITH Brand
Model # GCR-4C250 Manufactured date not 2019
 Comments:
 • The water temperature was measured at 119 degrees which is within acceptable limits for safety.
