## PROPERTY INSPECTION REPORT

**Concerning:** 21803 Black Owl, Humble, Texas 77338  
(Address or Other Identification of Inspected Property)

**By:** Joe Cordova – TREC #9628 02/27/2021  
(Name and License Number of Inspector) (Date)

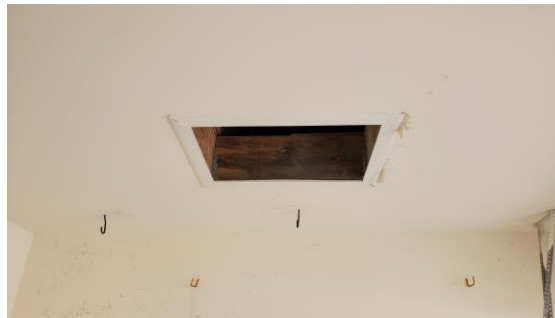
Provide a sheetrock panel for the attic access in the garage ceiling.

1. Provide a sheetrock panel for the attic access in the garage ceiling.
2. The door to the master bedroom should be adjusted or repaired as necessary to allow the door to latch properly.
3. Several door stops throughout the home are missing and should be replaced to prevent potential damages to the adjacent walls.
4. The tub in the guest bathroom on the 2nd floor is chipped. This condition may be more than just cosmetic and should be repaired as necessary.
5. It is recommended that an anti-siphon device (vacuum breaker) be added to the hose bibs on the exterior of the home.
6. The drain line for the dishwasher appears to be clogged and should be repaired as necessary to allow for proper drainage of dishwasher.
7. The light under the microwave is inoperative and in need of repair

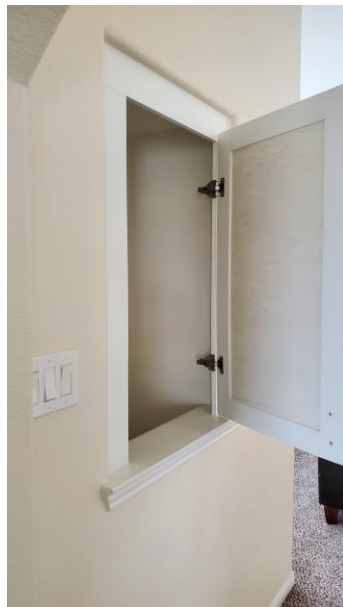
For improved safety, it is recommended that bars be added to the opening of the laundry chute to avoid children from having unobstructed access to the chute.

1. For improved safety, it is recommended that bars be added to the opening of the laundry chute to avoid children from having unobstructed access to the chute.

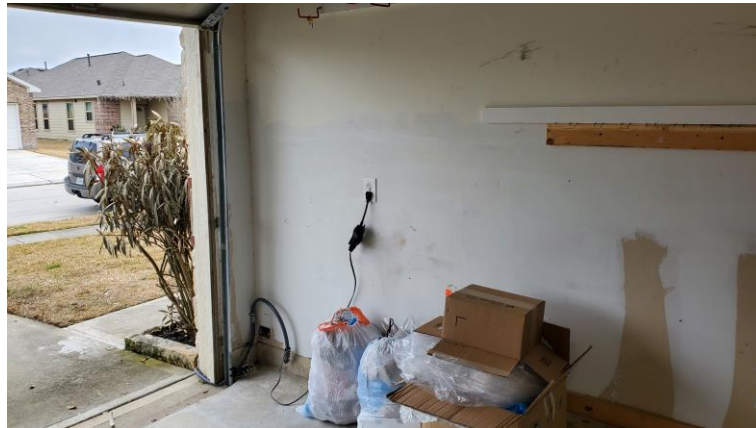
The installation of the distribution wiring for the landscape lighting is non-standard. It is suspected that installation was performed by an amateur, rather than a licensed electrician. Make repairs.

3. Electrical coverplates are missing behind the range in the kitchen and should be replaced.
4. The installation of the distribution wiring for the landscape lighting is non-standard. It is suspected that installation was performed by an amateur, rather than a licensed electrician. Make repairs.

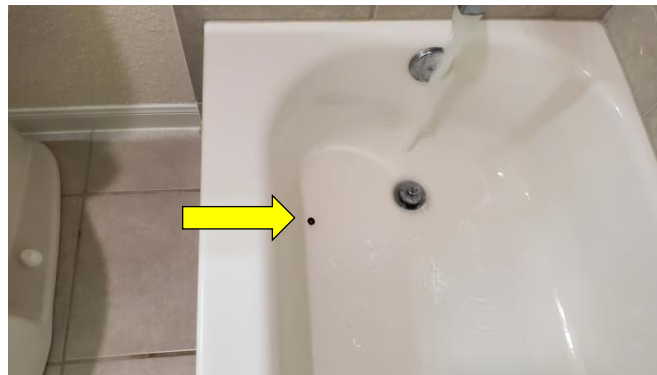
The tub in the guest bathroom on the 2<sup>nd</sup> floor is chipped. This condition may be more than just cosmetic and should be repaired as necessary.

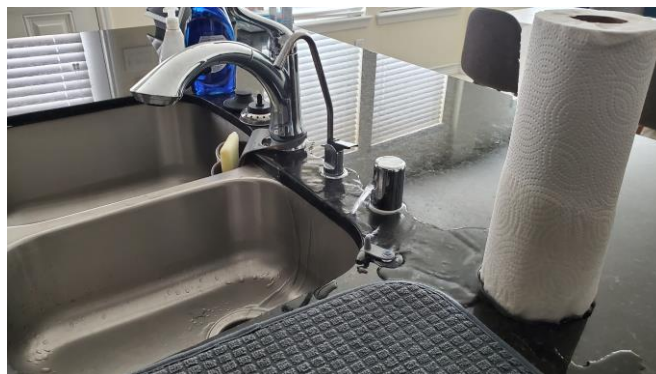
The drain line for the dishwasher appears to be clogged and should be repaired as necessary to allow for proper drainage of dishwasher.
