Inspection Report

Property Address:
164 Mcgoey Circle
Conroe Texas 77384

PROPERTY INSPECTION REPORT

By: Ray Basinger TREC # 20337 / House To Home Inspection 7/13/2021
(Name and License Number of Inspector) (Date)

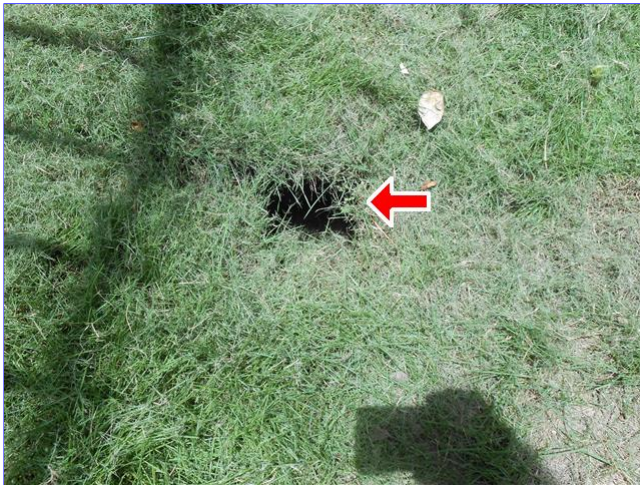
B. Item 1(Picture) Drain needs grate

(2) This house has some french drains to help with drainage along the sides of the house. I recommend having a qualified landscape company evaluate the drains and clean as needed. One of the french drain registers appears to be missing at the left side of the house. I recommend installing the grate to prevent a trip hazard.

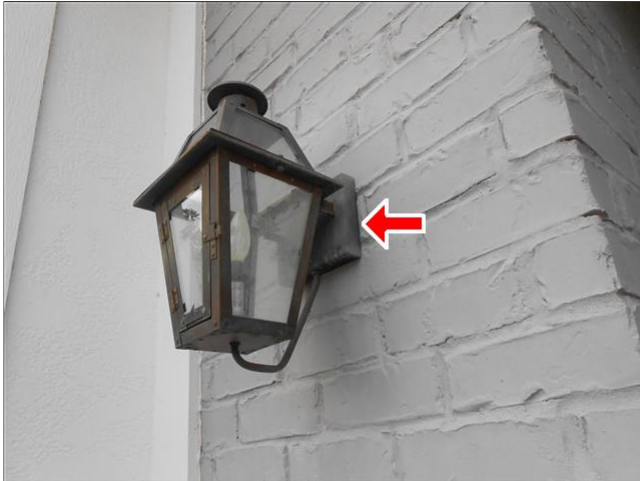
(1) The lighting fixtures on the exterior of the house and garage are not sealed to the walls. I recommend sealing the exterior light fixtures to the walls to prevent moisture and pest intrusion into the wall. The pictures shown are not all inclusive of every light fixture in need of sealing.

E. Item 1(Picture) This area needs to be sealed to the wall to prevent moisture and pest intrusion into the wall.

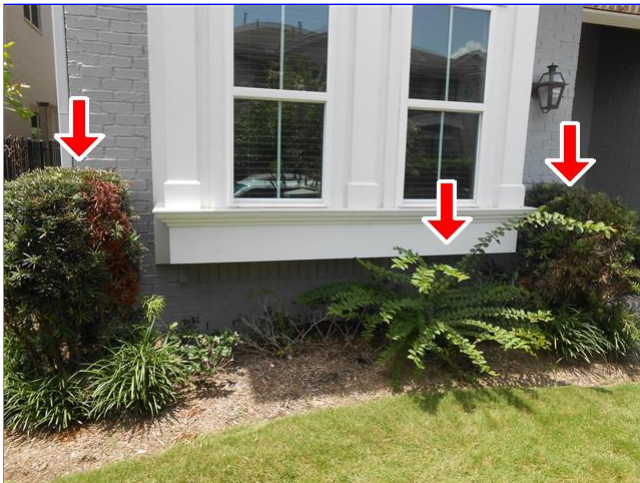
(2) There is over growth of vegetation and foliage against the exterior wall at the front of the house. I recommend trimming back all overgrowth and foliage. Over grown vegetation and foliage against a wall can hold moisture in that area and may damaged the siding or brick. Over grown vegetation can also provide a good avenue for insects to penetrate the wall. The pictures shown in this section are not all inclusive of every area in need of attention.

E. Item 2(Picture) Excess vegetation needs to be trimmed back

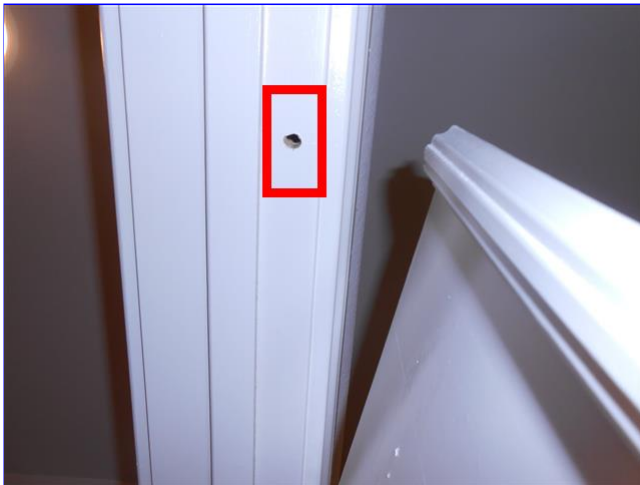
- (1) There are two or more missing door stops throughout the house. I recommend installing door stops to prevent drywall and door damage.
- (2) The second floor right rear bedroom closet door contacts the door frame when being closed causing the door to be difficult to close. I recommend adjusting as needed.
- (3) The top steel locking plate is missing at the tops of the media room entry french doors. I recommend installing the locking plates at the tops of the doors to help secure the door as well as preserve the wood door frame.

G. Item 1(Picture) Missing locking plate

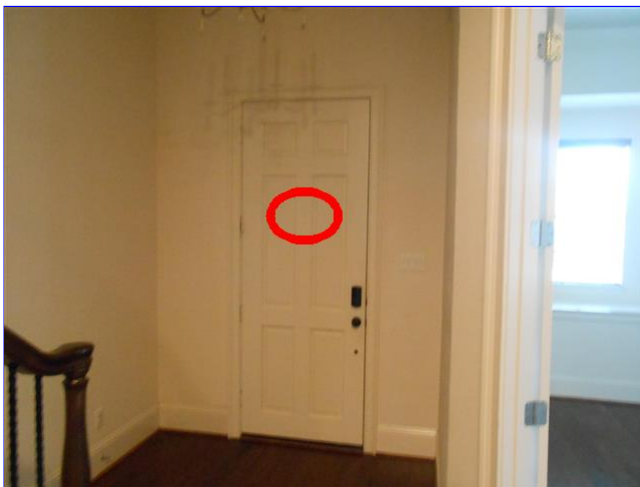
- (4) The front entry door has no peep hole or window to identify guest before opening the door. I recommend installing a peep hole for security.

G. Item 2(Picture) Install peep hole

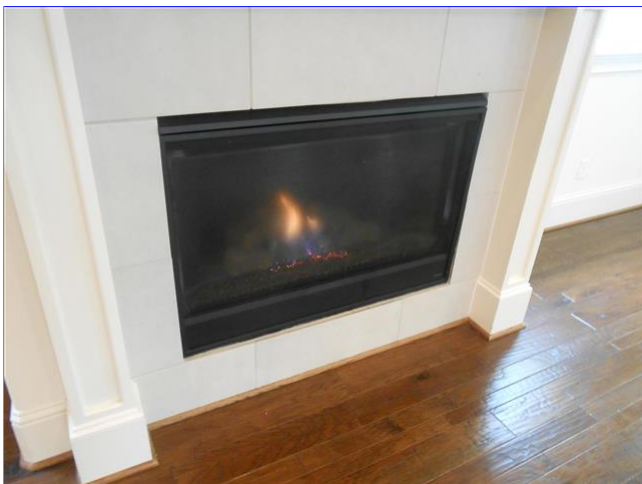
There were no deficiencies detected concerning the function of the fireplaces at the time of the inspection. The fireplaces were lit to inspect for function. The fireplace exterior chimneys were also inspected for defects. I recommend asking the current owners for the remote control used to active the fireplace as well as the user manual.

J. Item 1(Picture) View of the living room fireplace lit and active

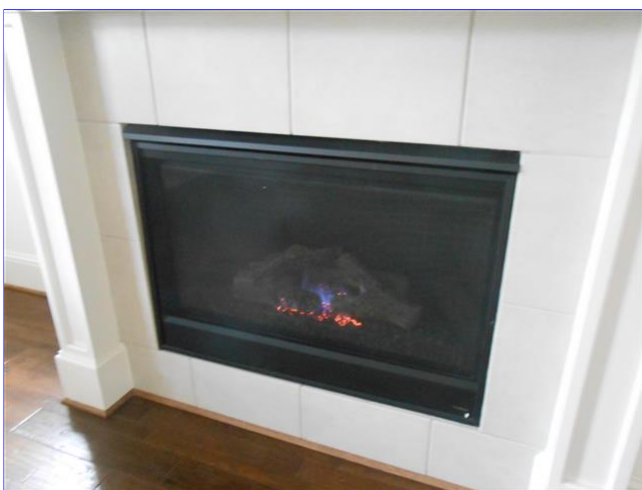
J. Item 2(Picture) View of the study fireplace lit and active

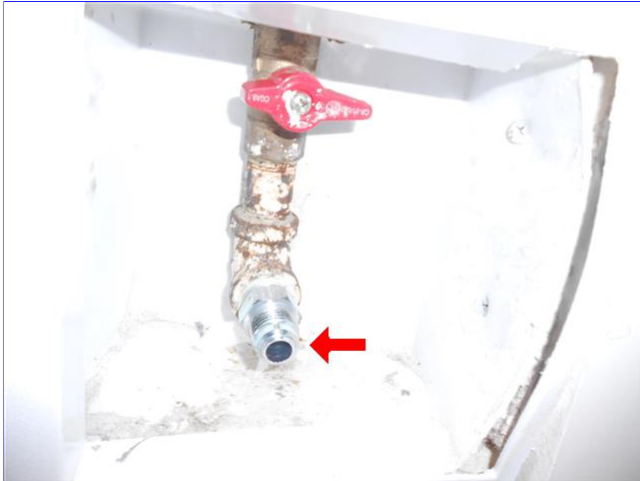
There is an un-capped and unused gas valve in the laundry room. I recommend capping all unused gas valves to prevent accidental activation.

L. Item 1(Picture) Unused gas valves need to be capped

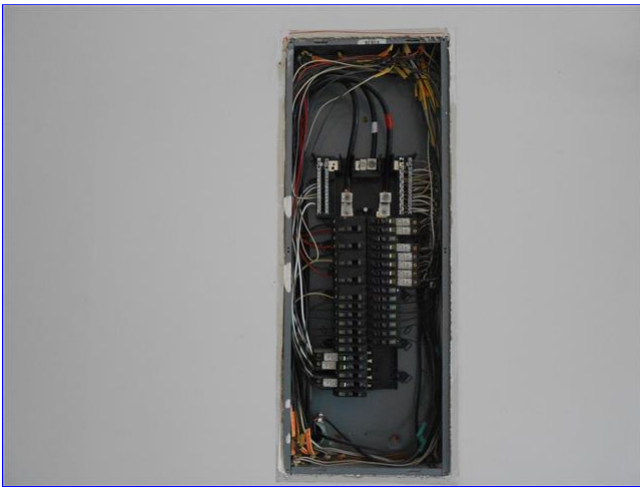
A. Item 2(Picture) View of the breaker panel open for inspection

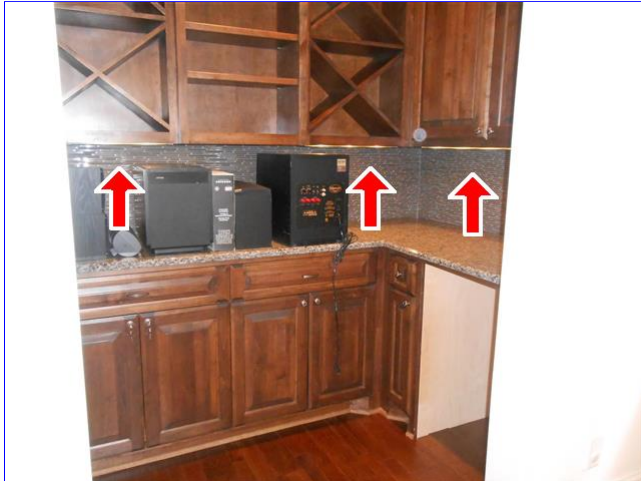
(1) There is no power at the power outlets under the cabinets in the wine storage area. I recommend having a licensed electrician evaluate and repair as needed.

B. Item 1(Picture) No power at outlets

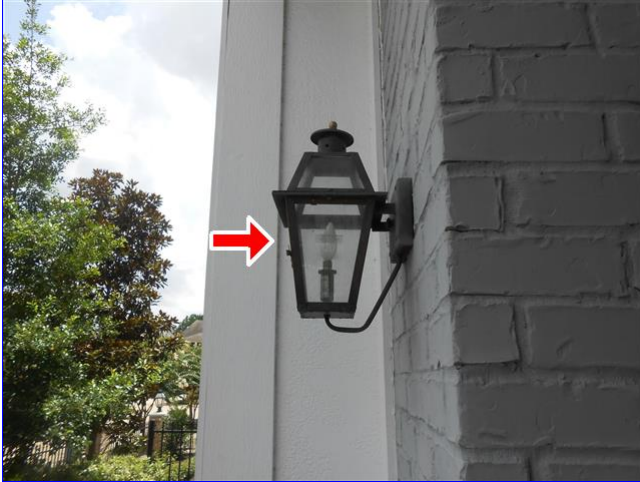
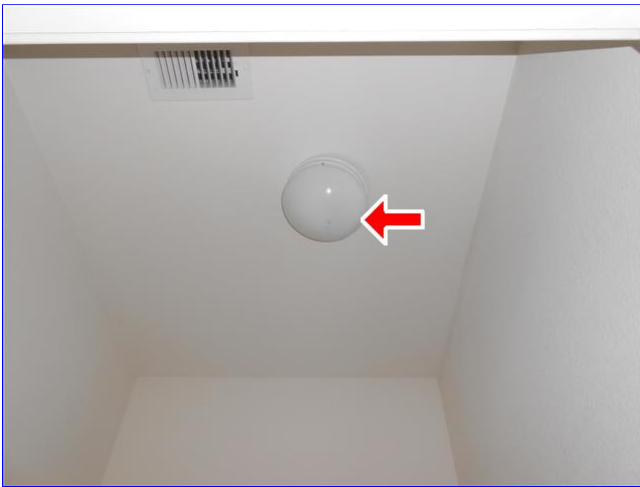
(2) There are light bulbs that did not light up with switch activation at the interior and exterior of the house. I recommend replacing all non functioning light bulbs and retesting the fixtures. The pictures shown may not be all inclusive of every missing/non lighting fixture.

B. Item 2(Picture) This light failed to light with activation of the light switch.

B. Item 3(Picture) This light failed to light with activation of the light switch.

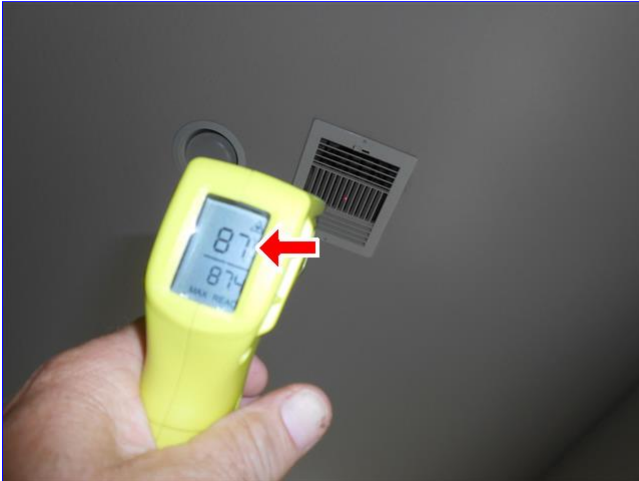
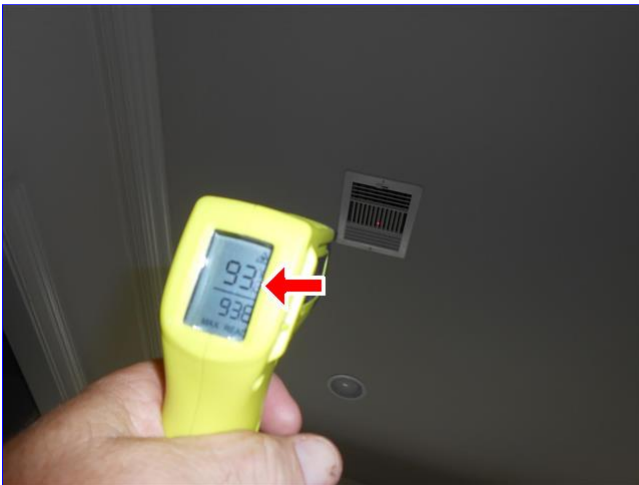
A. Item 3(Picture) View of the furnace temperature measured at a outlet register.

A. Item 4(Picture) View of the furnace temperature measured at a outlet register.

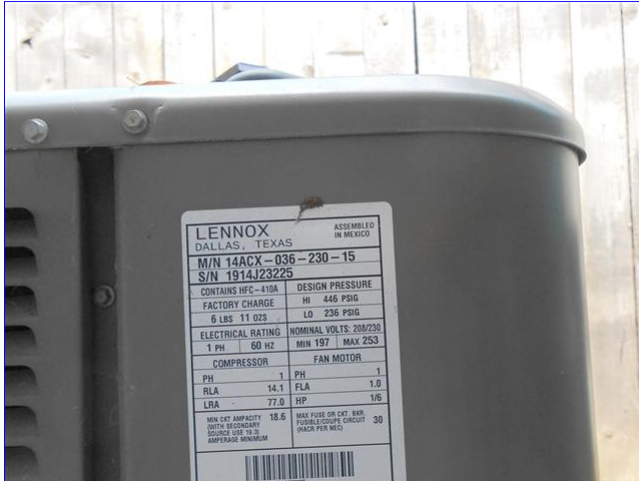
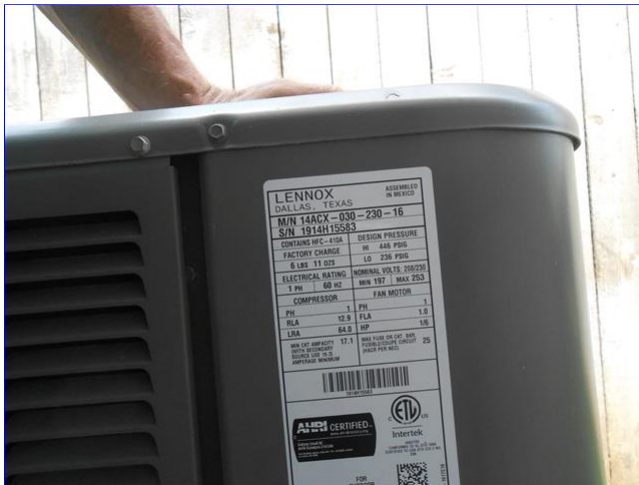
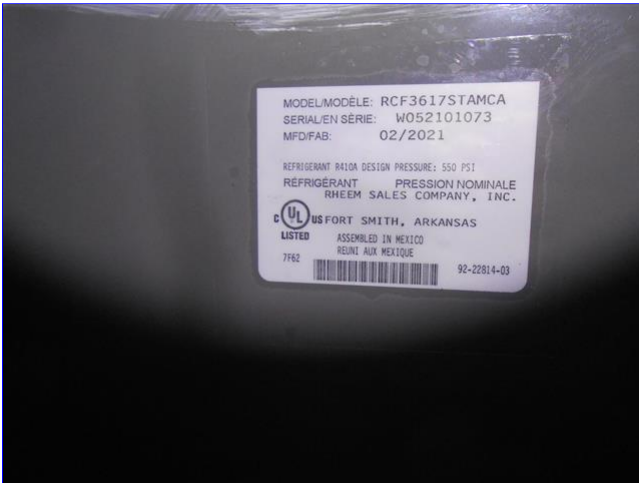
B. Item 1(Picture) View of the first floor cooling condenser information label

B. Item 2(Picture) View of the second floor cooling condenser information label

B. Item 3(Picture) View of the first floor cooling system evaporator information label

B. Item 8(Picture) View of the second floor cooling system evaporator information label

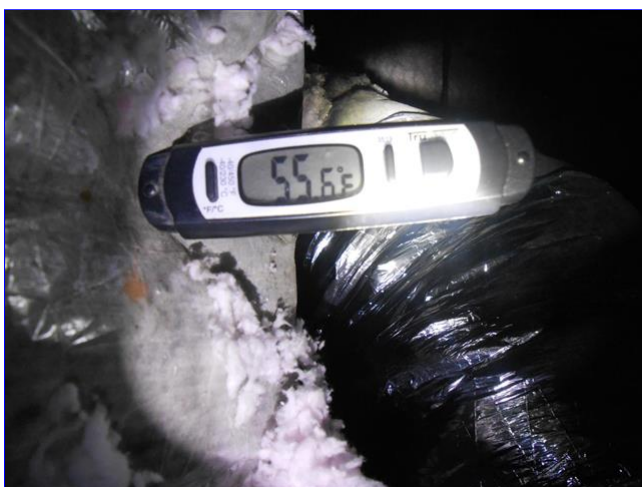
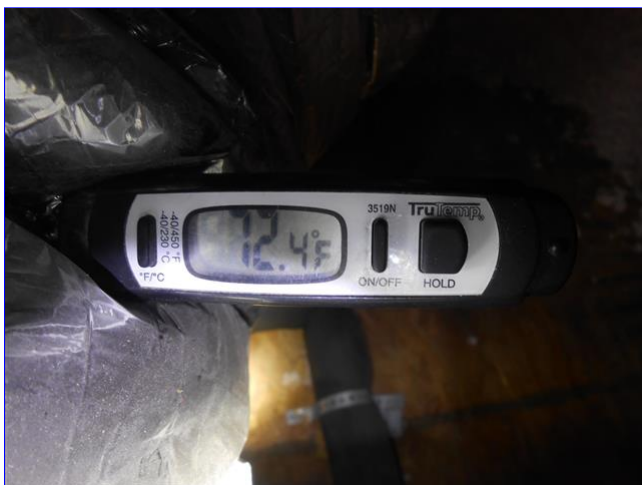
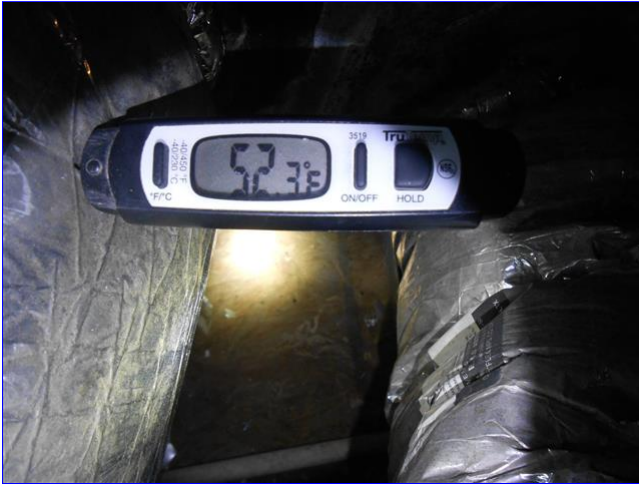
There were no deficiencies detected concerning the function of the cooling systems at the time of the inspection. The temperature delta between the return air temperature and the outlet air temperature across the evaporator coil was on average 18.6 degrees F for the first floor cooling system and 20.1 degrees F for the second floor cooling system. These deltas are considered acceptable deltas. The Delta on a correctly functioning air conditioner should be between 16 and 25 Degrees F.

B. Item 4(Picture) View of the first floor cooling system measured return air temperature at the evaporator.

B. Item 5(Picture) View of the first floor cooling system measured exit air temperature at the evaporator.

B. Item 6(Picture) View of the second floor cooling system measured return air temperature at the evaporator.

B. Item 7(Picture) View of the second floor cooling system measured exit air temperature at the evaporator.

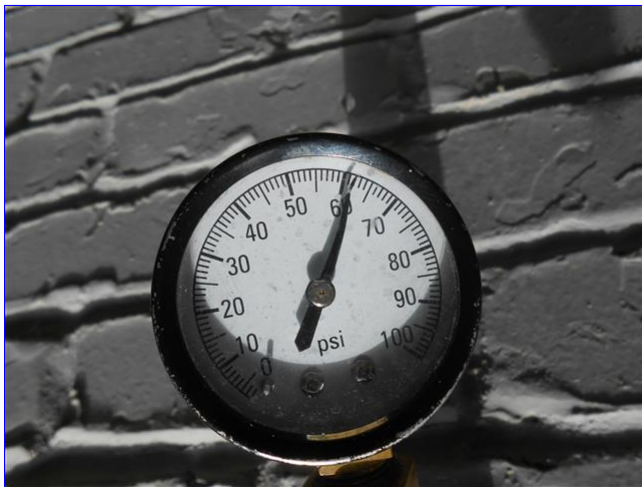
There were no deficiencies detected concerning the water supply and fixtures at the time of the inspection. The water pressure to a home should be between 40 PSI and 80 PSI. The water pressure to this home was measured at 60 PSI this water pressure is within the acceptable pressure range.

A. Item 1(Picture) View of measured water pressure

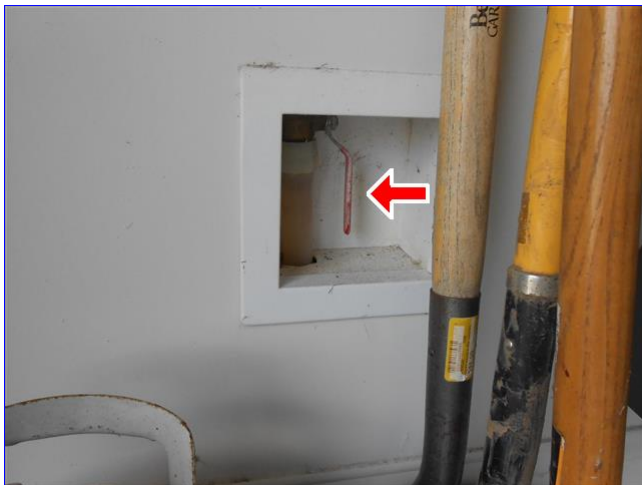
A. Item 2(Picture) View of main water shut off valve

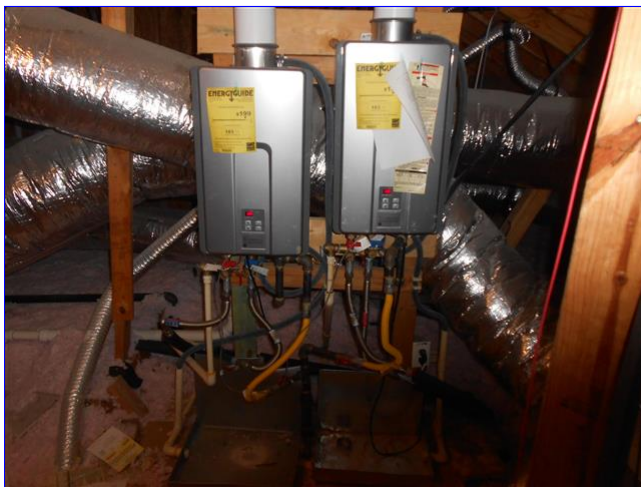
There were no deficiencies detected concerning the function of the water heaters at the time of the inspection. The water heaters were inspected for proper plumbing concerning water, gas, electrical and venting. All hot water supply areas were also inspected for hot water presence and orientation.

C. Item 1(Picture) View of the water heaters

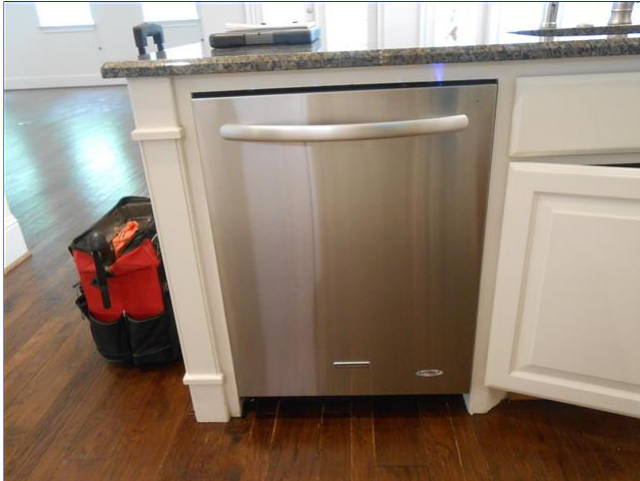
The dishwasher was inspected for rust on the interior of the dishwasher and dish racks. The dishwasher was also inspected for proper door function and soap dispenser operation. The dishwasher was then test ran for one complete cycle on normal wash and heat dry mode. There were no deficiencies detected concerning the function of the dishwasher at the time of the inspection.

A. Item 1(Picture) View of the Dishwasher

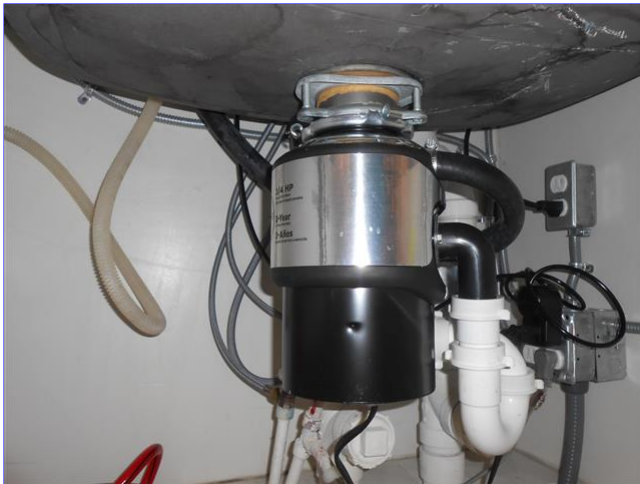
There were no deficiencies detected concerning the function of the food waste disposer at the time of the inspection. The food waste disposer was turned on and the grinding hammers were inspected for freedom of movement. The disposer was also inspected for the proper wiring and plumbing as well as for any possible water leaks.

B. Item 1(Picture) View of the Food Waste Disposer

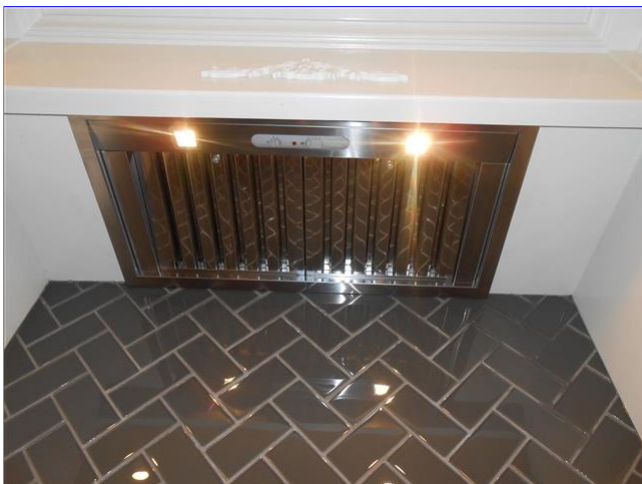
There were no deficiencies detected concerning the function of the range exhaust vent at the time of the inspection. The range exhaust vent was tested on all available fan speeds and the light was tested on all available settings. The range exterior vent exit was also inspected for function and defects.

C. Item 1(Picture) View of the range exhaust vent.

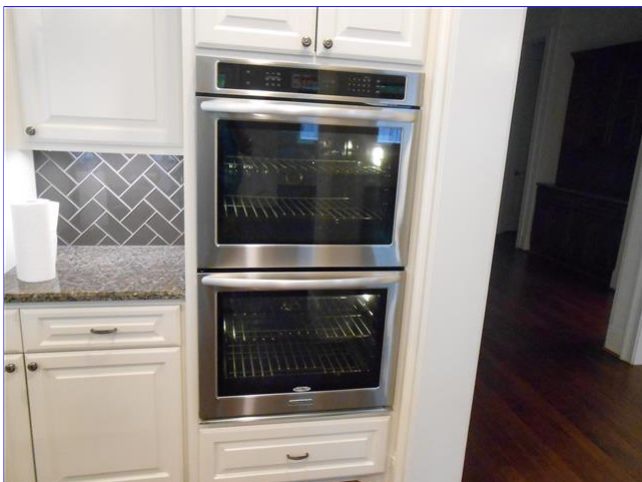
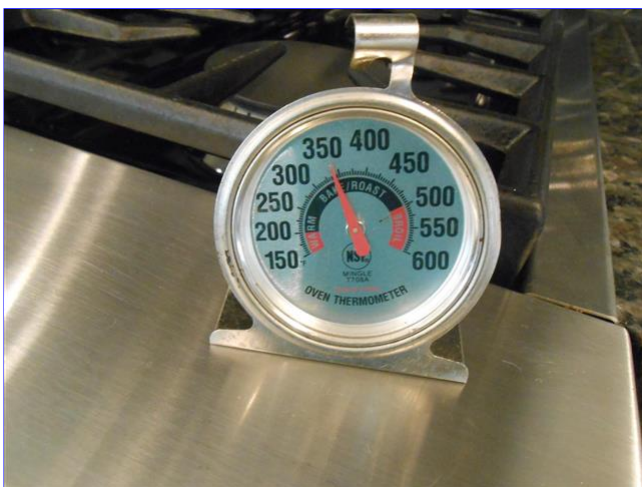
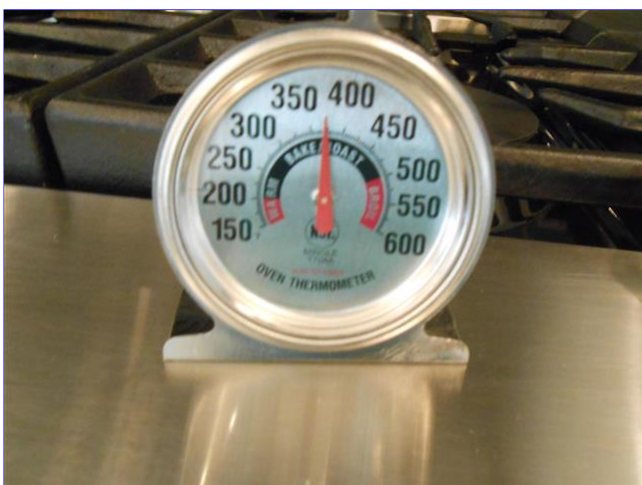
(1) There were no deficiencies detected at the time of the inspection concerning the double ovens. The ovens were set to 350 Degrees F and given time to preheat. The oven temperature was then measured with a thermometer. At the time of the Inspection the thermometer temperature measurement and the oven temperatures were within 25 degrees. This is considered an acceptable tolerance.

D. Item 1(Picture) View of the ovens under test.

D. Item 2(Picture) View of measured top oven temperature.

D. Item 3(Picture) View of measured lower oven temperature.

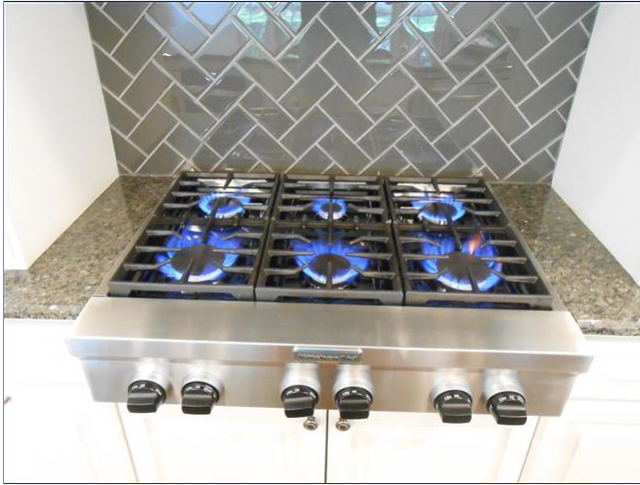
inspection. The cooktop burners were tested on high and low settings. The gas shut off was within 6' of the cooktop as required.

D. Item 4(Picture) View of the cooktop functioning.

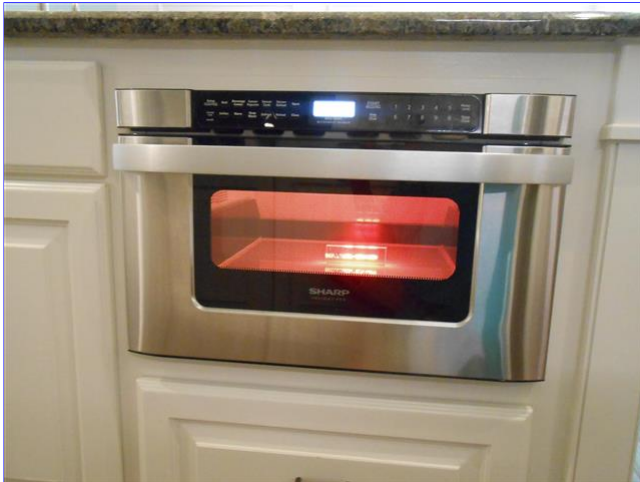
There were no deficiencies detected concerning the function of the microwave at the time of the inspection. The microwave was tested for function using a microwave detector/tester to test for the presence of microwaves and the microwave pattern within the microwave. The turn table was also inspected for function.

E. Item 1(Picture) View of the Microwave under test.

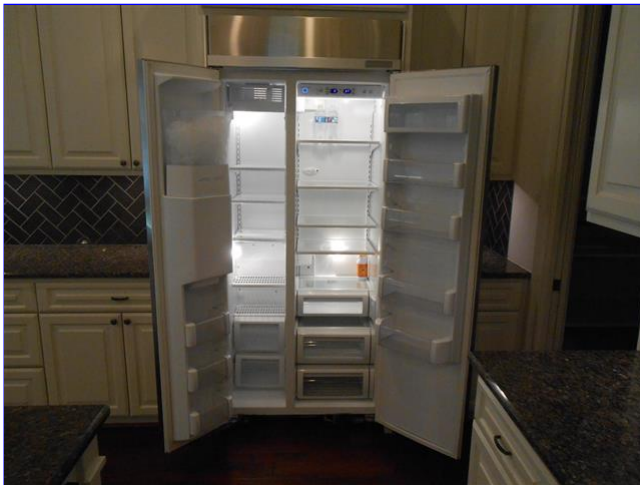
This house is equipped with a built in refrigerator, Kitchen Aid brand. The refrigerator appeared to be functioning as intended the refrigerator was cold and the freezer had ice present at the time of the inspection.

I. Item 1(Picture) View of the Refrigerator

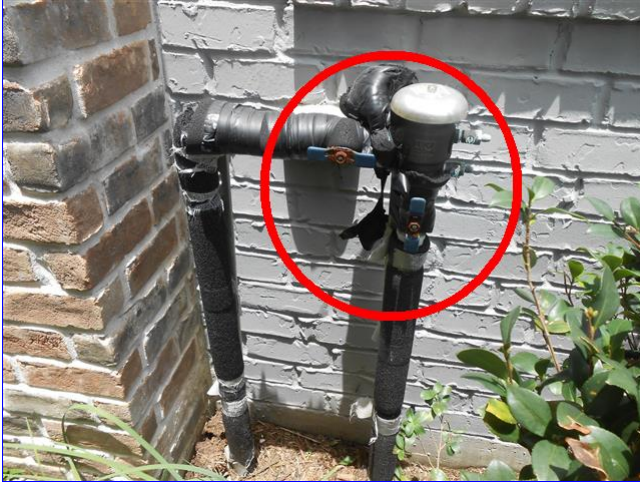
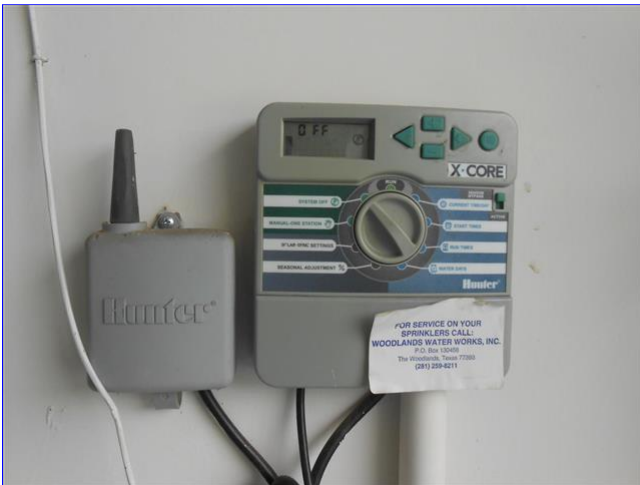
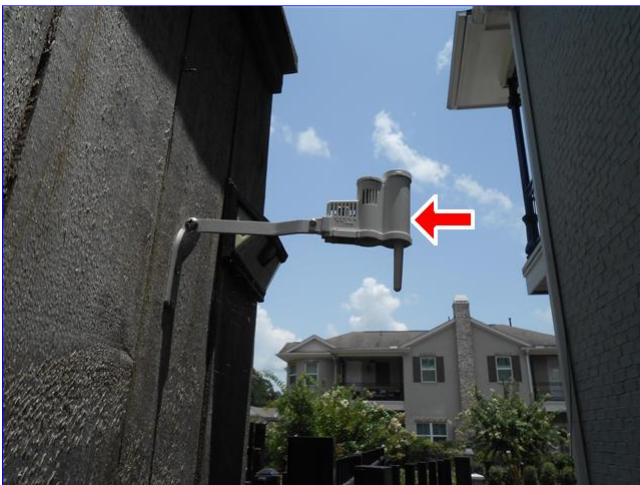
There were no deficiencies detected concerning the function of the sprinkler system at the time of the inspection. A backflow preventer was present and appeared to be installed correctly. A rain/moisture sensor switch was also detected during the inspection. The property has a 6 zone sprinkler system. All the sprinkler heads in all zones performed as intended. Some of the spray heads may need to be adjusted to get the best coverage and to prevent them from spraying unwanted areas such as driveways, sidewalks, walls and fences.

A. Item 1(Picture) View of the sprinkler system anti back flow device.

A. Item 2(Picture) View of sprinkler system controller

A. Item 3(Picture) View of the sprinkler system rain /moisture sensor.
