Inspection Report

Property Address:
8506 Beechaven Rd
La Porte TX 77571

HG Home Inspection

10/29/2021

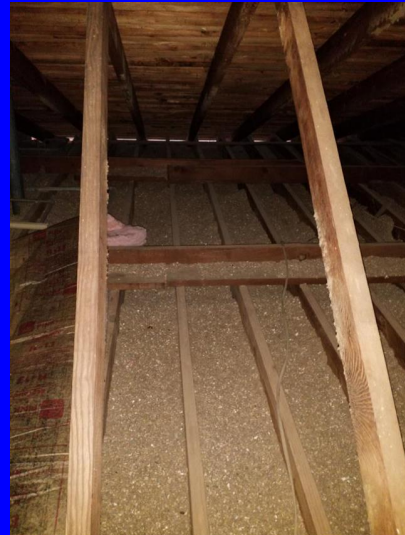
Less than six inches of cellulose insulation

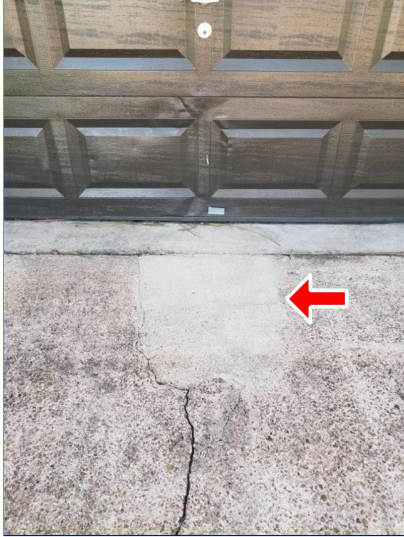
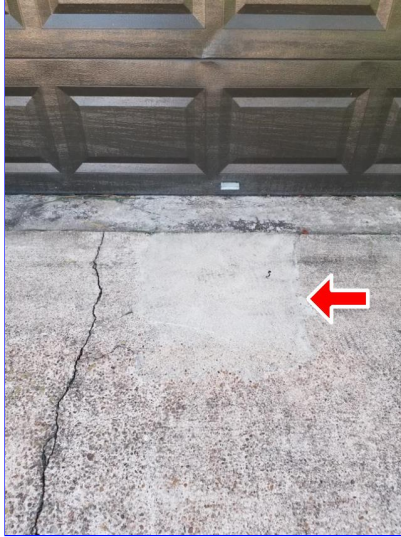
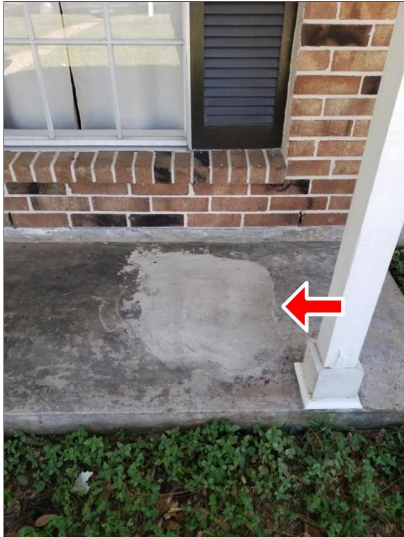
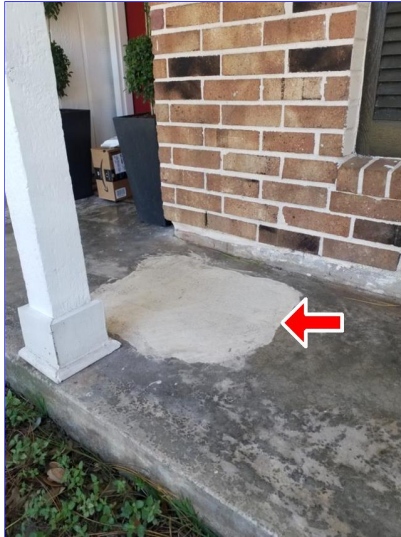
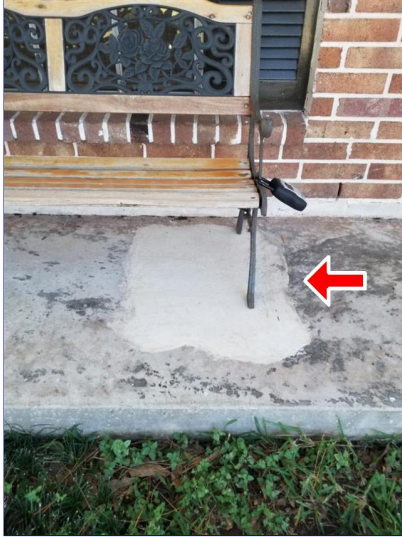
A. Item 1(Picture) Front of home

(2) There are signs of previous foundation repairs. I recommend requesting a copy of all work done, warranty (if available) and contacting foundation company that performed work to assure all recommended repairs have been done. It is also recommended to have a plumber check plumbing system after foundation repairs have been done due to the risk of breakage during leveling.

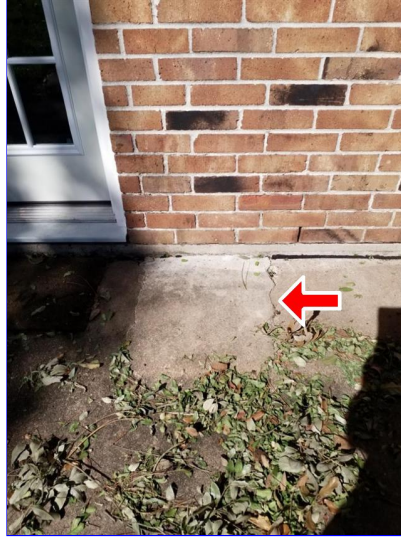
A. Item 6(Picture) Rear of home

(3) The foundation wall has visible cracking. I recommend having a foundation company or Structural Engineer further evaluate.

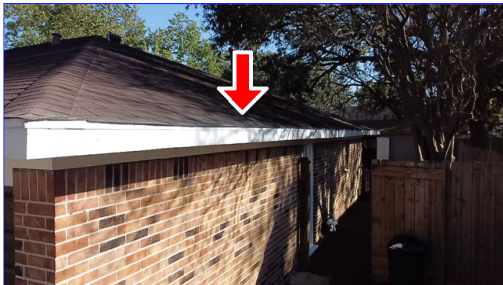
B. Item 1(Picture) Add gutters

The home does not appear to have adequate drainage. This will cause erosion if not corrected. I recommend having a qualified person install needed gutters.

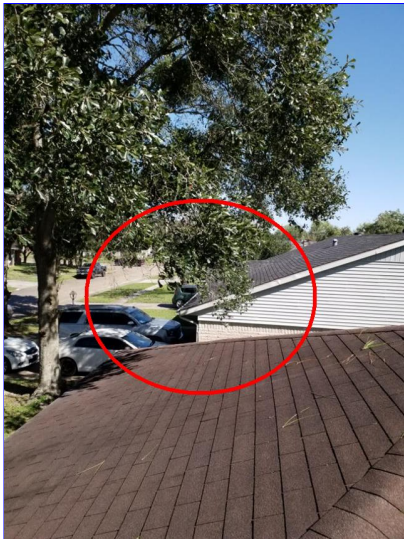
C. Item 5(Picture) Front of home

(5) The tree limbs that are in contact with roof or hanging near roof should be trimmed.

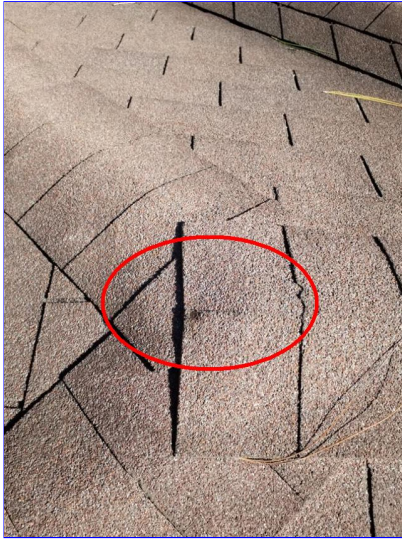
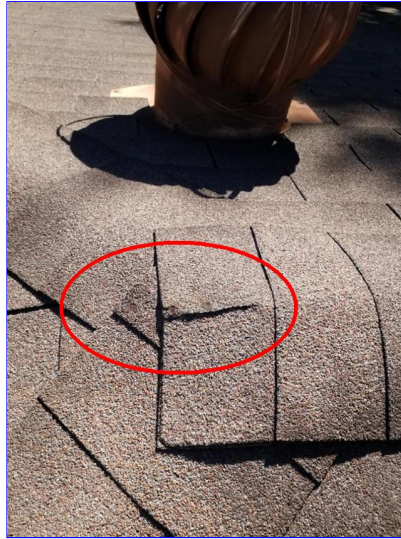
C. Item 6(Picture) Front of home

(6) The roofing surface has exposed nail heads that are showing signs of deterioration. Further deterioration will occur if not corrected. I recommend having a qualified person repair or replace as needed,

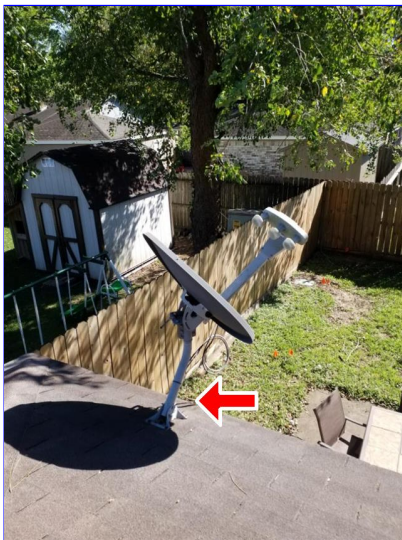
C. Item 8(Picture) Rear of home

(7) There is a satellite dish bracket mounted on roof that is screwed directly through roofing surface. This is not considered to be today's standard. I recommend having a qualified person remove and patch roofing as needed. (The area will need periodic maintenance)

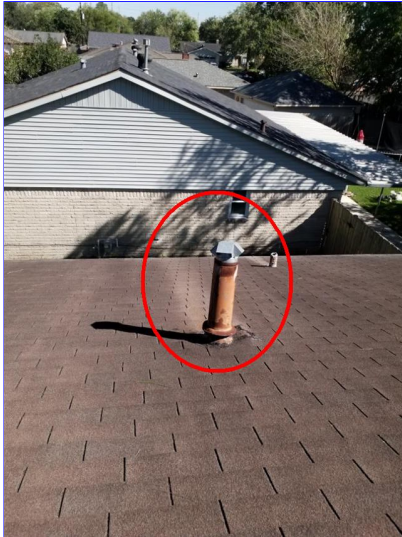
C. Item 9(Picture) Left side of home

(8) The appliance vent is showing signs of corrosion in areas. I recommend a qualified contractor be consulted for further evaluation and repair.

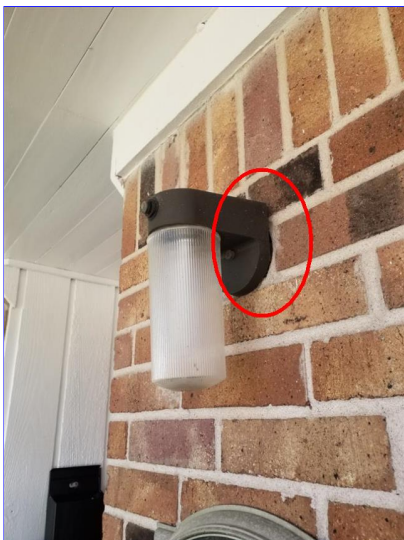
E. Item 1(Picture) Front of home

(1) Areas where wiring or piping passes through walls should be sealed. I recommend having a qualified person seal as needed.

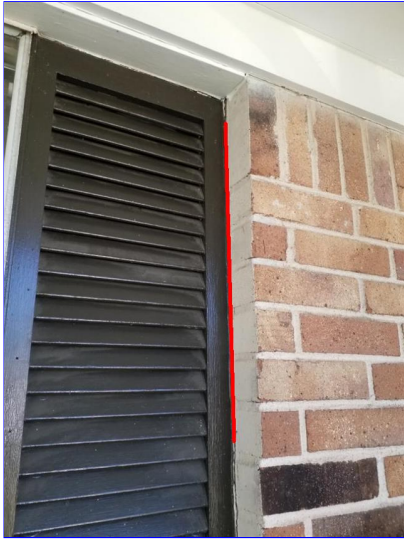
E. Item 4(Picture) Front of home

(2) The siding exterior has caulking that is weathered or missing and some lifted nails. Deterioration can eventually occur if not corrected. A qualified person should repair as needed.

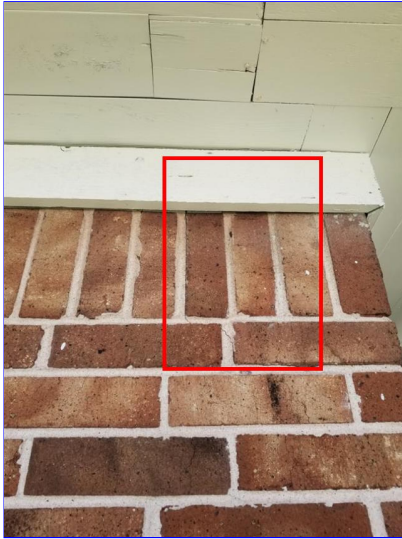
E. Item 5(Picture) Front left side of home

(3) The Brick siding at the exterior has hairline cracks. Deterioration can eventually occur if not corrected. A qualified contractor should inspect and repair as needed.

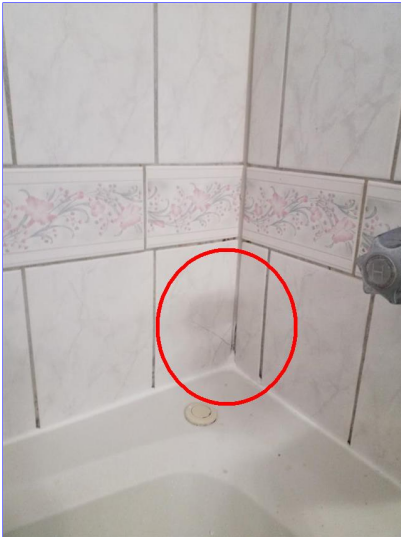
E. Item 12(Picture) Master bathroom

(6) The Tile surround at bathtub on the wall has several hairline cracks at the master bath. This damage is considered cosmetic. A qualified person should repair or replace as needed.

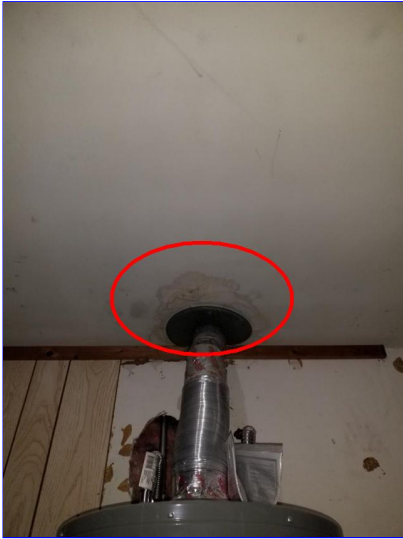
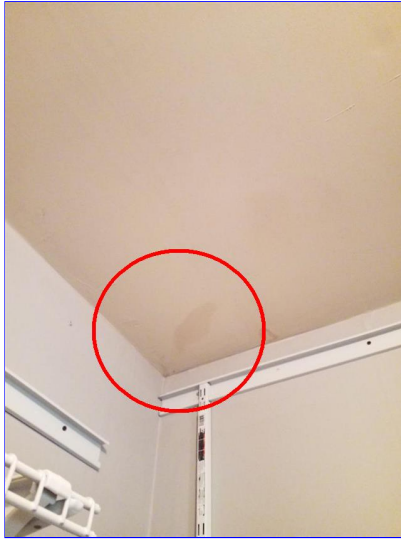
F. Item 1(Picture) Garage

(1) The Drywall on the ceiling reveals a light stain which appears from a water leak. Stain appears old in areas. This damage is considered cosmetic. A qualified person should repair or replace as needed.

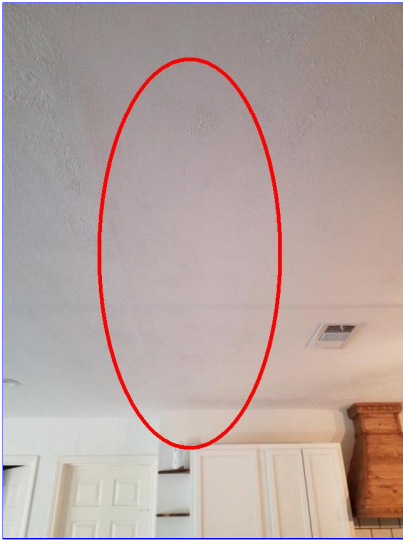
F. Item 3(Picture) Kitchen

(2) The Drywall on the ceiling shows repair signs in areas at the Kitchen. This damage is considered cosmetic. A qualified contractor should inspect and repair as needed.

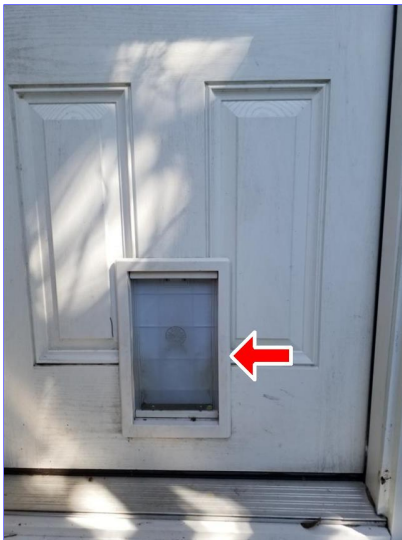
G. Item 3(Picture) Right side of home

(2) The side entry door has a pet access door installed. This can cause some heat loss in winter and loss of cool air in summer if not corrected. A qualified contractor should inspect and repair as needed.

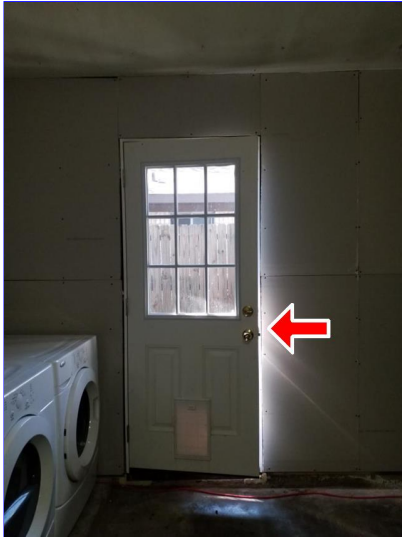
G. Item 4(Picture) Right side of home

(3) The side entry door does not shut properly. This is a small repair. A qualified person should repair or replace as needed.

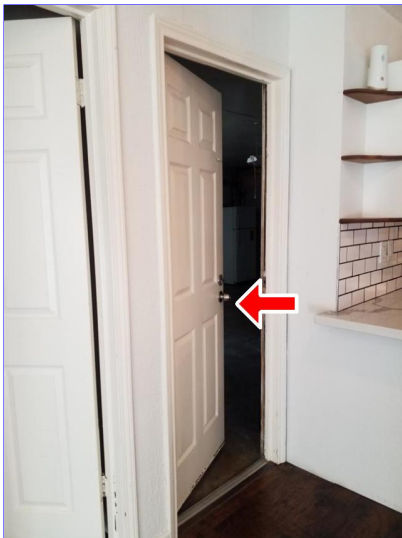
G. Item 5(Picture) Interior door to garage

(4) The interior garage door does not have the required self closing hinge. This is not considered to be today's standard. I recommend having a qualified person make repairs as needed.

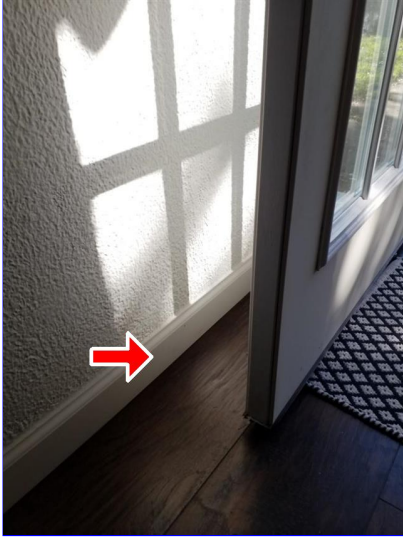
G. Item 6(Picture) Back door

(5) There are door stops missing in the home. This is not considered to be today's standard I recommend having a qualified person make repairs as needed.

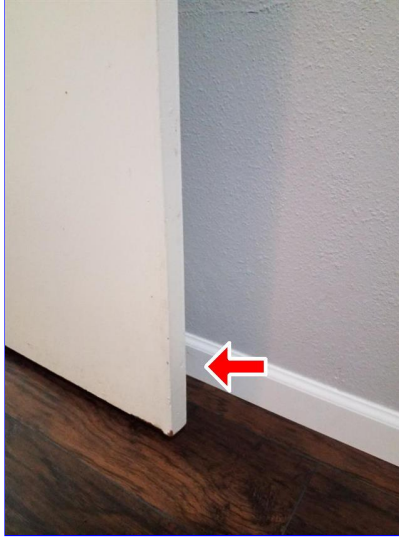
G. Item 7(Picture) Guest bedroom, on the left

(6) The Closet door rubs at top when closing in areas at the Guest Bedroom. This is a small repair. A qualified person should repair or replace as needed.

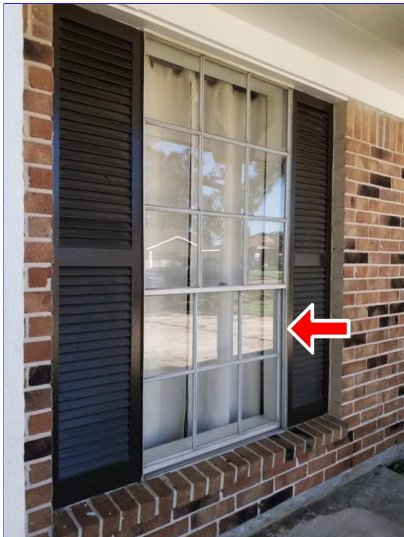
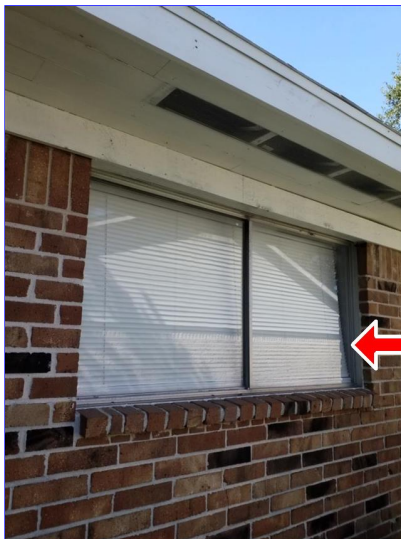
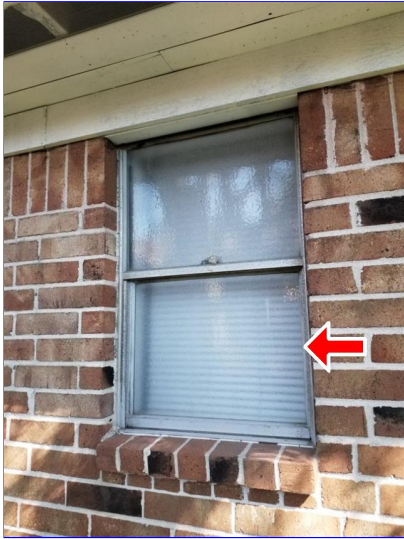
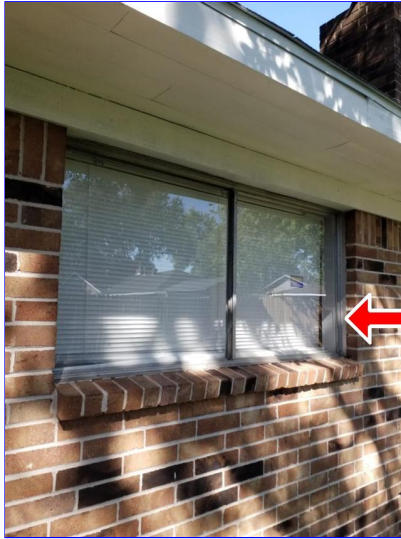
H. Item 1(Picture) Front of home

(1) Windows have damaged or missing screens. This is not considered to be today's standards. I recommend having a qualified person make repairs as needed.

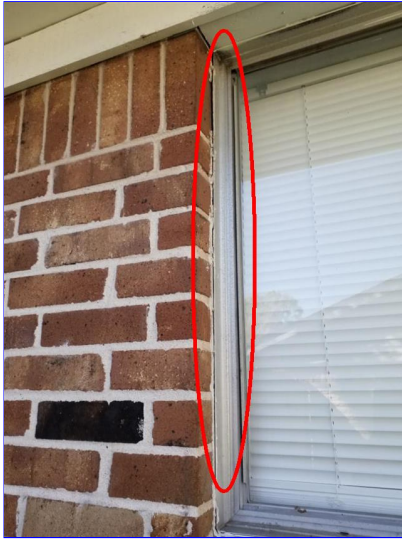
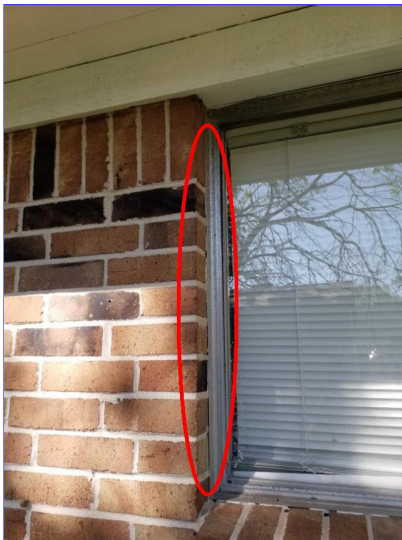
H. Item 7(Picture) Left side of home

(2) There are window frames that are not properly sealed. This can cause energy loss. I recommend having a qualified person seal and repair as needed,

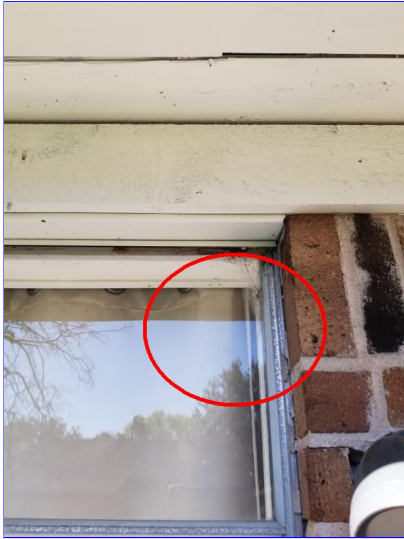
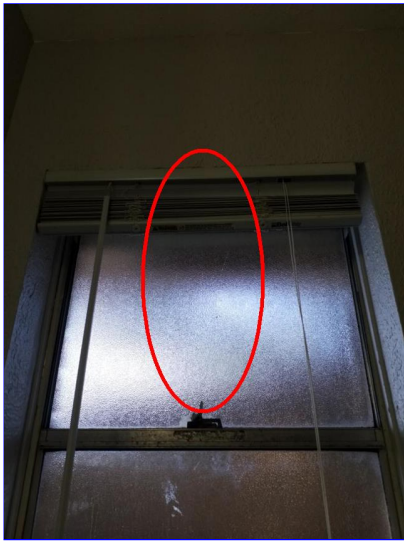
H. Item 10(Picture) Rear of home

(3) There is a cracked glass pane in window. I recommend having a qualified person make repairs as needed.

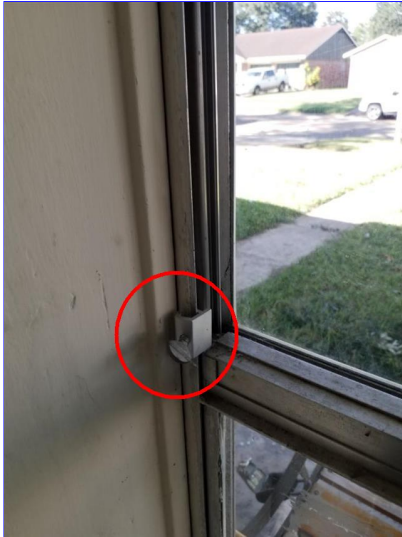
H. Item 13(Picture) Guest bedroom, on the left

(4) Some windows have safety locks installed. This is a hindrance to egress. I recommend a qualified person remove these.

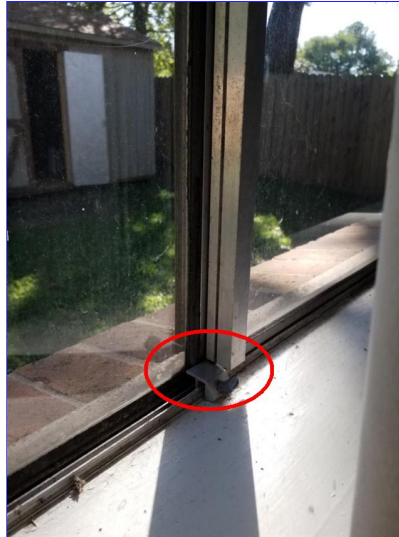
H. Item 14(Picture) Master bedroom

(5) One window is missing lock hardware in areas at the Guest Bedroom. A repair may be needed. A qualified contractor should inspect and repair as needed.

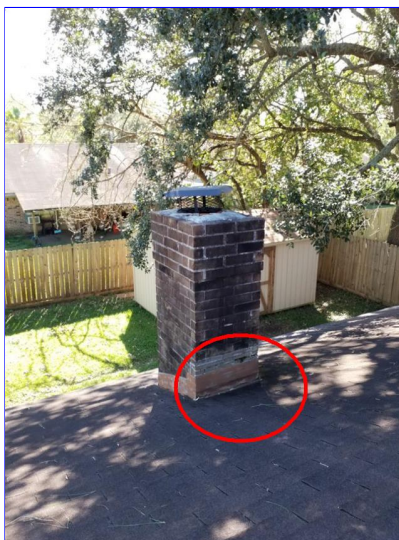
J. Item 2(Picture) Chimney

(2) The mortar crown is deteriorated. I recommend a qualified contractor be consulted for further evaluation and repair.

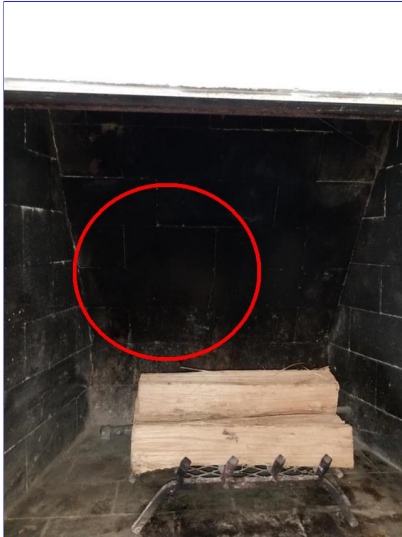
J. Item 4(Picture) Fireplace

(3) The firebrick are loose and missing mortar in areas at the fireplace. I recommend a qualified contractor be consulted for further evaluation and repair.

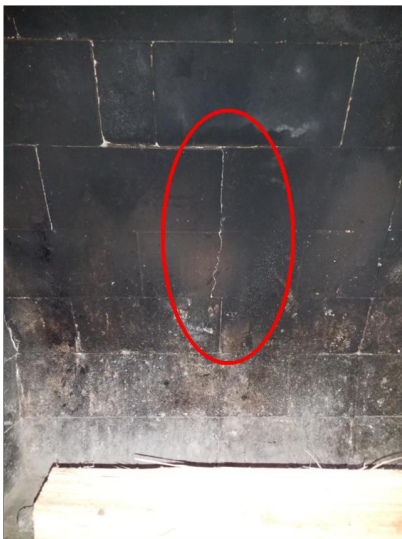
J. Item 5(Picture) Fireplace

(4) The firebricks have settlement cracks in areas at the fireplace. I recommend a qualified contractor be consulted for further evaluation and repair.

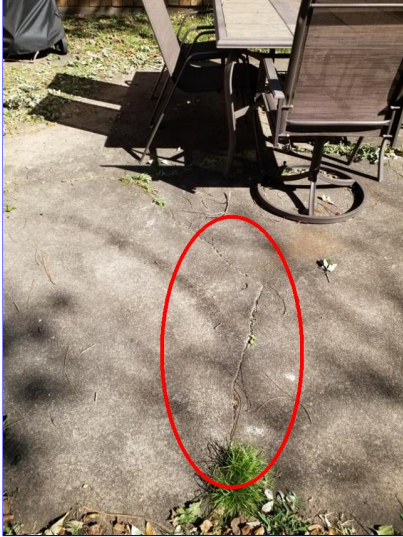
K. Item 1(Picture) Rear patio

- (1) The weight load capabilities are not part of this inspection.
- (2) The rear patio has settlement cracks. I recommend a qualified person be consulted for further evaluation and repair if needed.

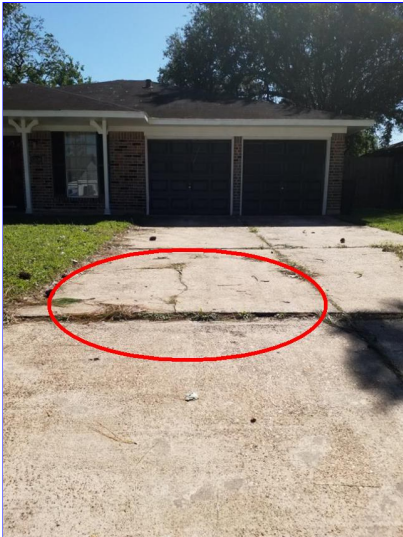
L. Item 1(Picture) Driveway

- (1) Areas of the home have limited access due to furniture or occupants belongings. This is for your information.
- (2) The concrete drive at the front of home is uneven, and can be a tripping hazard. A fall or injury can occur if not corrected. A qualified contractor should inspect and repair as needed.

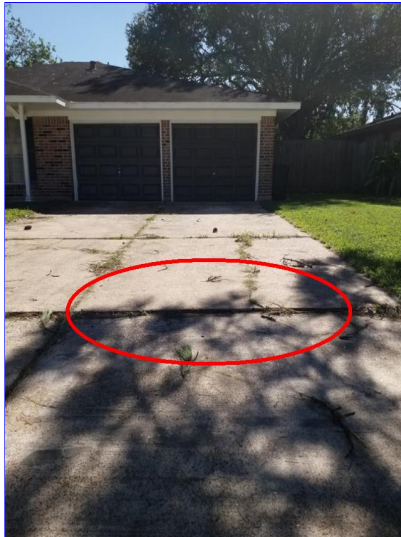
L. Item 2(Picture) Driveway

- (3) The concrete walkway at the front of home is uneven, and can be a tripping hazard. A fall or injury can occur if not corrected. A qualified contractor should inspect and repair as needed.

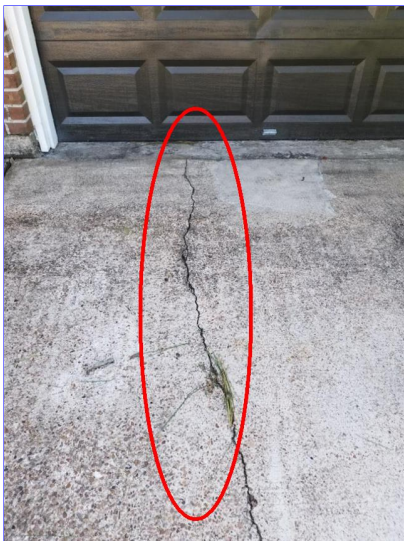
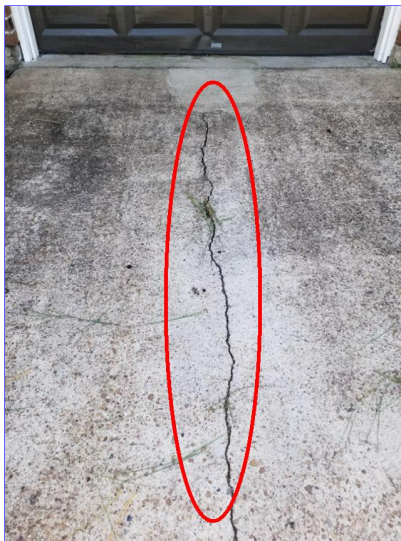
L. Item 4(Picture) Driveway

(4) The concrete drive at the front of home has settlement cracks. Water can cause further deterioration if not repaired and sealed properly. A qualified person should repair or replace as needed.

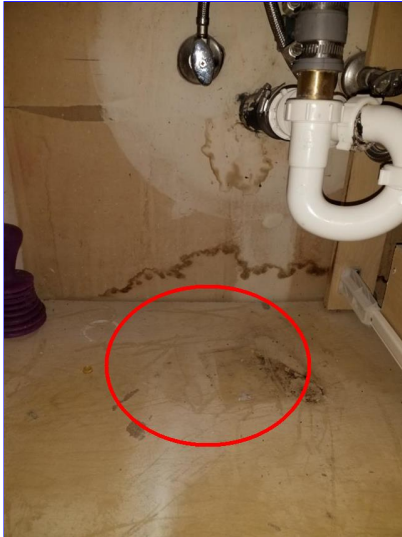
L. Item 6(Picture) Guest bathroom

(5) Evidence of previous water leak under sink. The stain appears old. I recommend having a qualified person repair as needed,

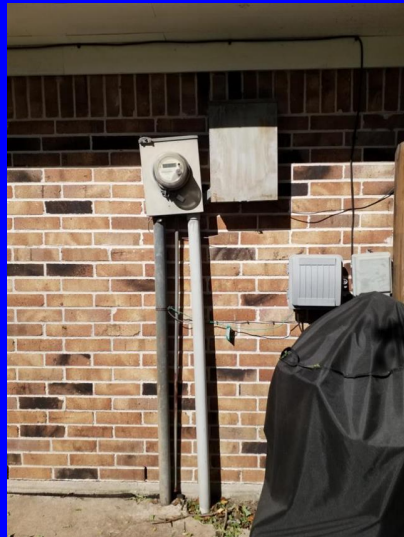
Underground service, located rear of home

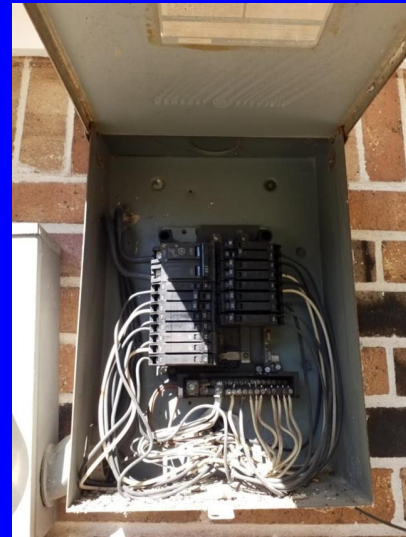
100 AMP main service panel, located outside, rear of home

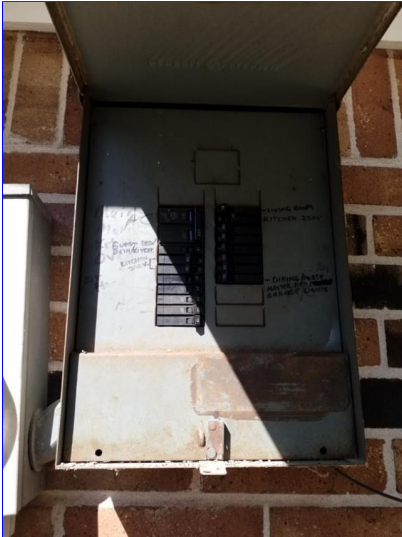
A. Item 1(Picture) Main service panel

(1) The panel is showing deterioration and is not sealed properly. Electrical issues are considered a hazard until repaired. I recommend having a qualified person make repair or replace as needed,

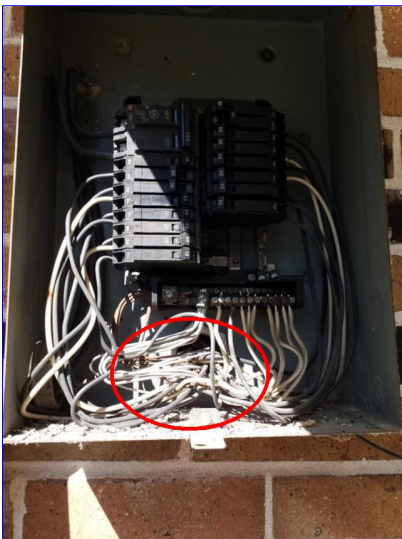
A. Item 2(Picture) Main service panel

(2) The electrical panel has branch circuit wires bundled together that are entering the panel through one to two entry points. This is not considered today's standard. It is recommended that each sheathed wire enter the panel independently and be sealed for fire blocking purposes. I recommend having a qualified electrician evaluate and make repairs as needed.

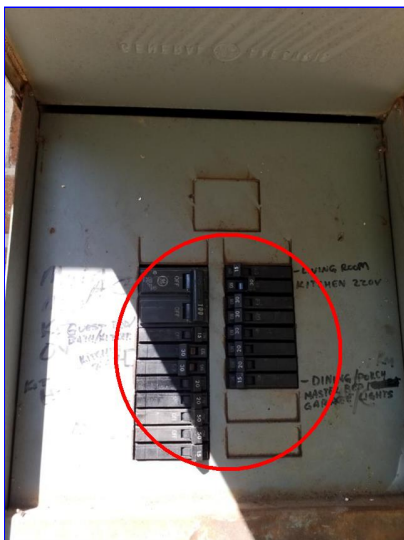
B. Item 1(Picture) Main service panel

(3) Arc fault breakers are not in required areas of home at electrical panel. This is not considered today's standard. I recommend having a qualified electrician inspect and make repairs as needed.

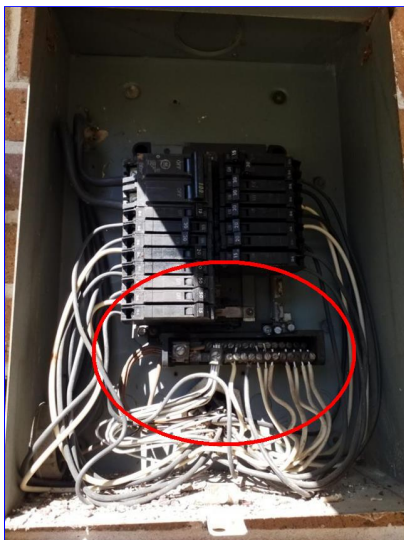
B. Item 2(Picture) Main service panel

(4) Aluminum wire is installed on 120 VAC branch electrical circuits in the subject house. These single strand, branch circuit aluminum wires were used widely in houses during the mid 1960s and 1970s. According to the U.S. Consumer Product Safety Commission, problems due to expansion can cause overheating at connections between the wire and devices (switches and outlets) or at splices, which has resulted in fires. For further information on aluminum wiring contact the U.S. Consumer Product Safety Commission via the Internet at <http://www.cpsc.gov/> . It is recommended that the electrical system be evaluated by a licensed electrical contractor.

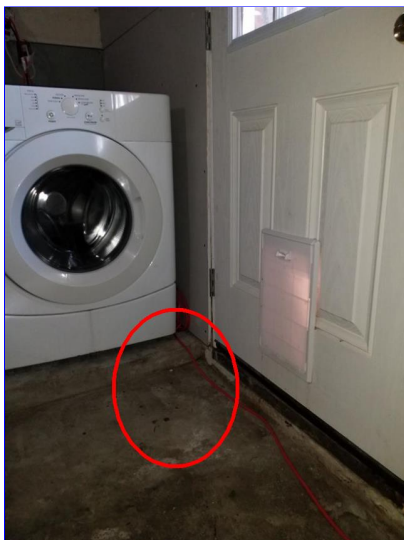
B. Item 3(Picture) Garage

(5) There is an extension cord being used as permanent wiring, and needs to be properly wired or removed.

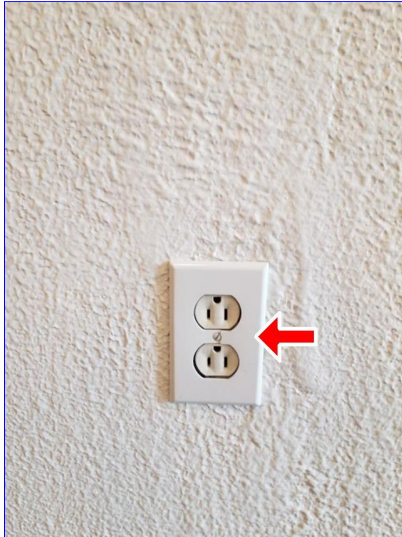
B. Item 4(Picture) Living room, left side

(7) At least one is loose in wall in the living room. This is a safety issue that needs to be corrected. A qualified licensed electrical contractor should perform repairs that involve wiring.

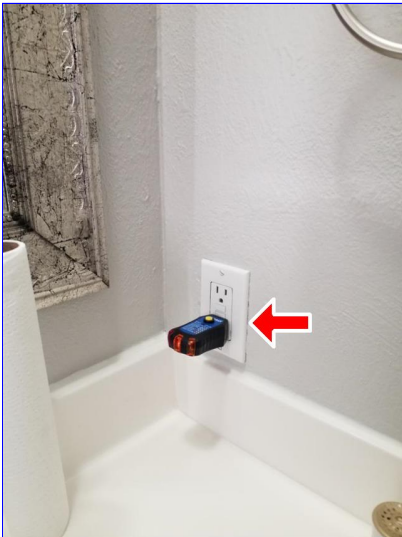
B. Item 7(Picture) Guest bathroom

(9) At least one works even when tripped, which is currently not a true GFCI outlet in the guest bath. This is a safety issue that needs to be corrected. A qualified licensed electrical contractor should perform repairs that involve wiring.

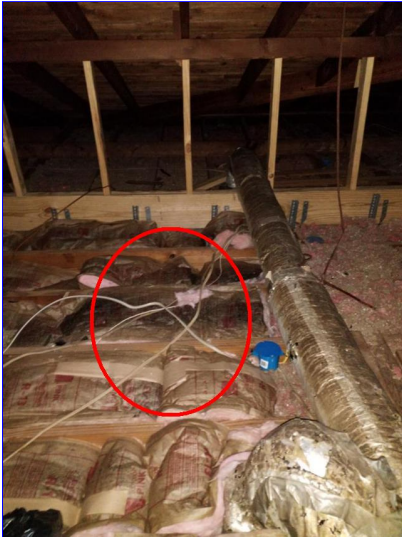
B. Item 13(Picture) Attic

(11) The electrical wiring in attic was not secured to wood members properly, and was not installed neatly or in 90 degree turns as in standard workmanlike practice. This may indicate that a licensed electrical contractor did not perform the work or did not follow standards (for your information).

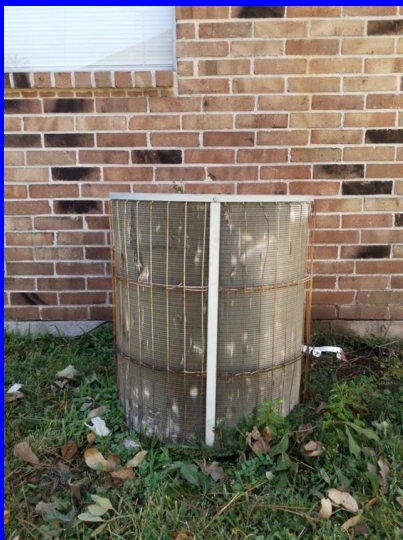
HVAC outside condenser

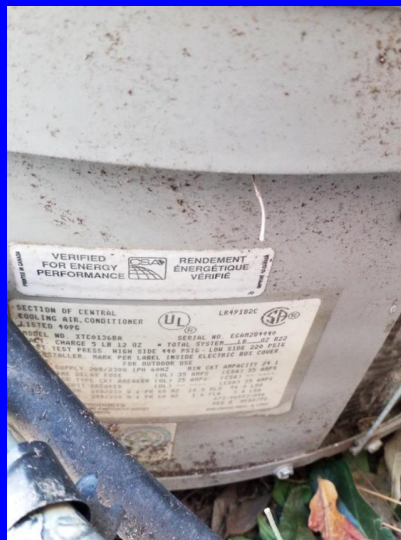
Condenser data plate

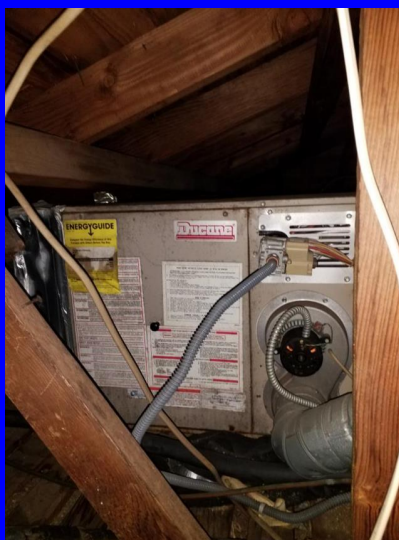
Gas furnace

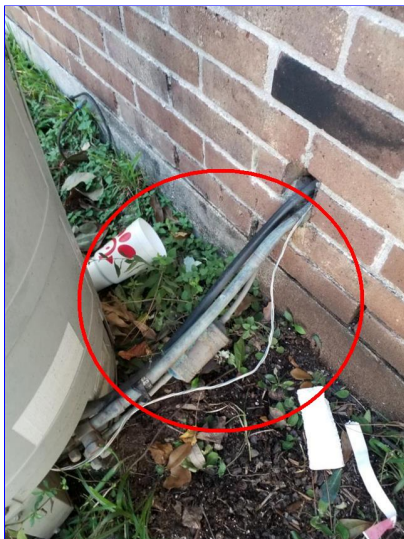
B. Item 2(Picture) Missing insulation

(3) The suction line is missing insulation. This could damage the unit and shorten its lifespan. I recommend a licensed HVAC technician be consulted for further evaluation and repair.

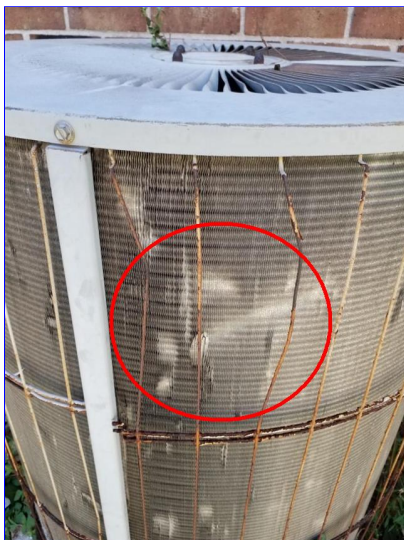
B. Item 5(Picture) HVAC condenser

(4) The condenser fins are damaged in areas. This could damage the unit and shorten its lifespan. I recommend a licensed HVAC technician be consulted for further evaluation and repair.

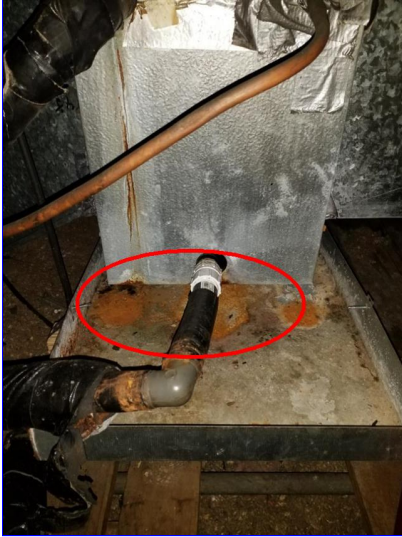
B. Item 7(Picture) Overflow drain pan

(5) The emergency overflow drain pan for the HVAC system is showing signs of deterioration. Further deterioration may occur if not corrected. I recommend having a qualified person make repairs as needed.

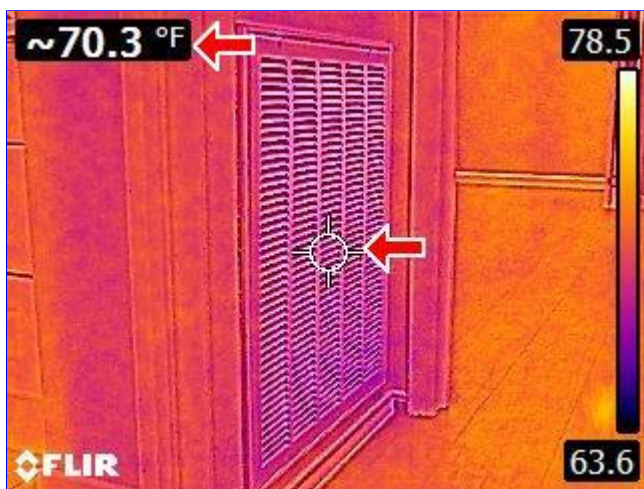
B. Item 9(Picture) Return

(6) The ambient air test was performed by using infrared thermal imaging equipment at the supply vents of air conditioner to determine if the difference in temperatures of the supply and return air are between 14 degrees and 22 degrees which indicates that the unit is cooling as intended. The supply air temperature on your system read 50 degrees, and the return air temperature was 70 degrees. This indicates the range in temperature drop is normal.

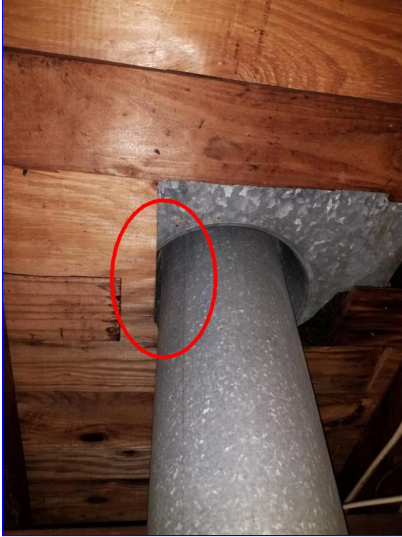
C. Item 1(Picture) Vent for gas furnace

- (1) I recommend changing all HVAC filters upon move in.
- (2) The vent for the gas water heater does not have proper clearance from combustibles material in areas at the attic. I recommend a HVAC technician be consulted for further evaluation and repair.

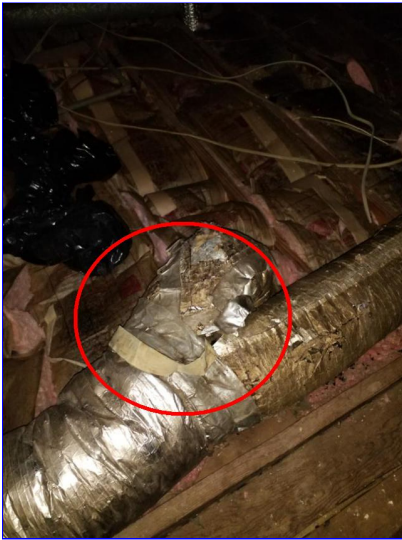
C. Item 2(Picture) Attic

(3) The duct piping in the attic is aged and appears to be deteriorated in areas. I recommend a licensed HVAC technician be consulted for further evaluation and repair if needed.

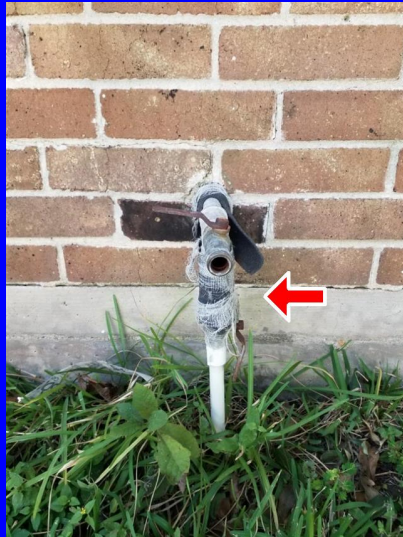
Water main shutoff, located front left side of home

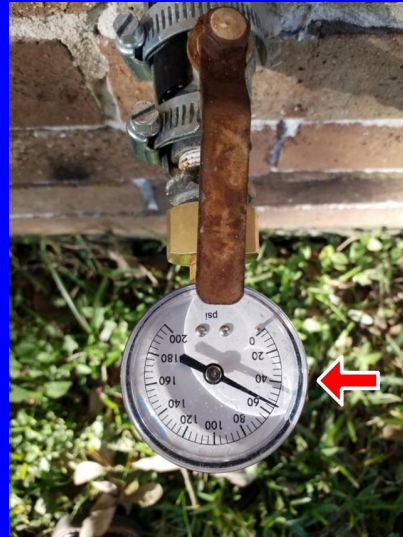
55 PSI

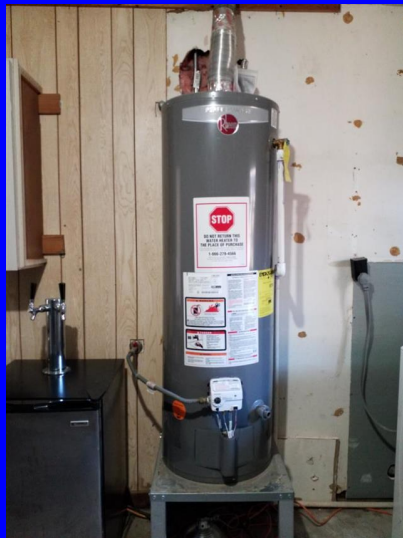
40 gallon gas water heater, located in the garage

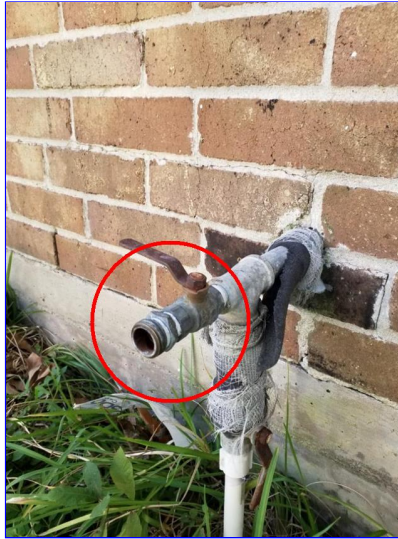
A. Item 2(Picture) Front left side of home

(1) There is no Anti Siphon device installed on exterior faucet(s). This is not considered to be today's standard. I recommend having a qualified person make repairs as needed.

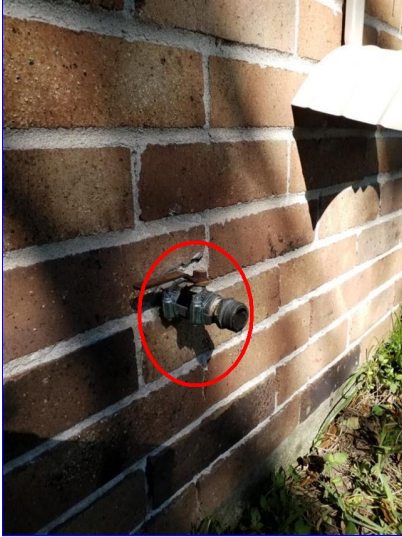
A. Item 4(Picture) Rear of home

(2) The exterior faucet is leaking. I recommend a qualified contractor be consulted for further evaluation and repair.

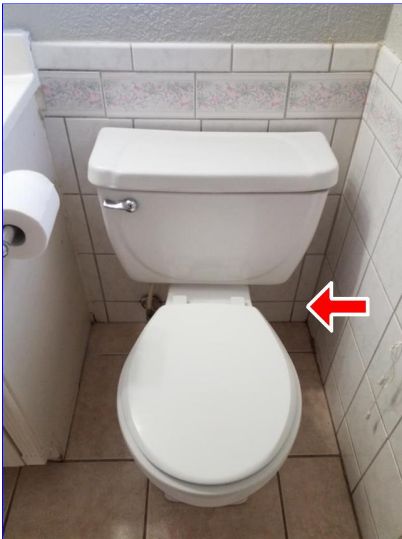
A. Item 5(Picture) Master bathroom, runs continuously

(3) The toilet does not work properly at the master bath. Repairs are needed A qualified licensed plumber should repair or correct as needed.

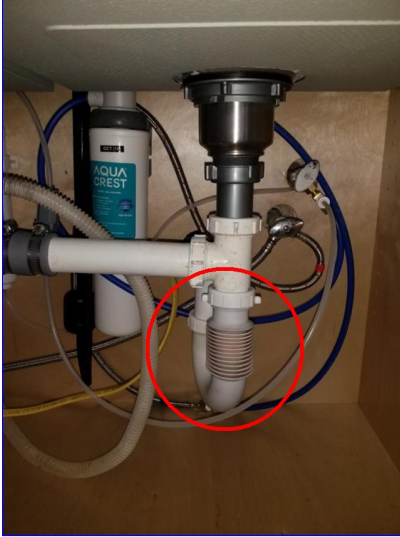
B. Item 1(Picture) Kitchen sink

(1) Amateur plumbing repairs were observed in areas. This is not considered today's standard. I recommend a licensed plumber be consulted for further evaluation and repair.

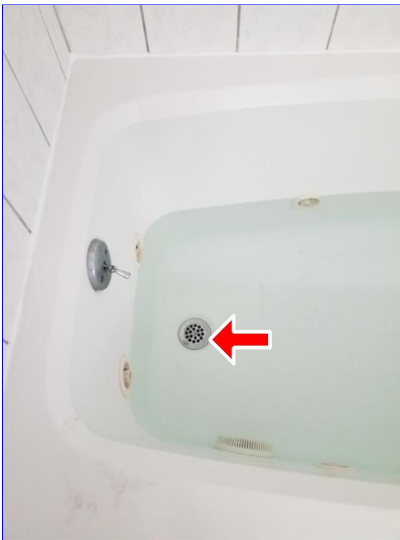
B. Item 3(Picture) Master bathroom, Hydro massage tub

(2) The drain stopper mechanism does not function properly in areas at the Master bathroom Hydro massage tub. This is for your information.

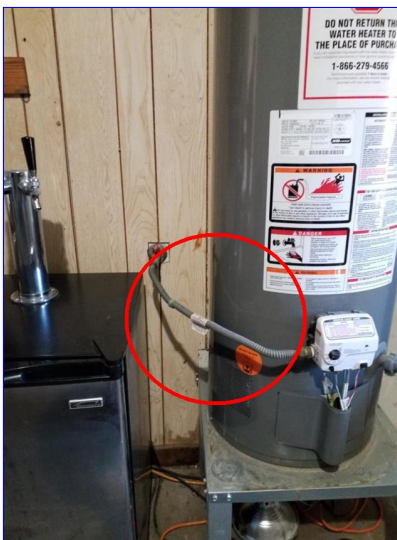
C. Item 2(Picture) Water heater

(1) The water heater is installed without the recommended sediment trap or "drip leg" that is designed to

extend the life of the unit. This is not considered to be today's standard. I recommend having a qualified plumber make repairs as needed.

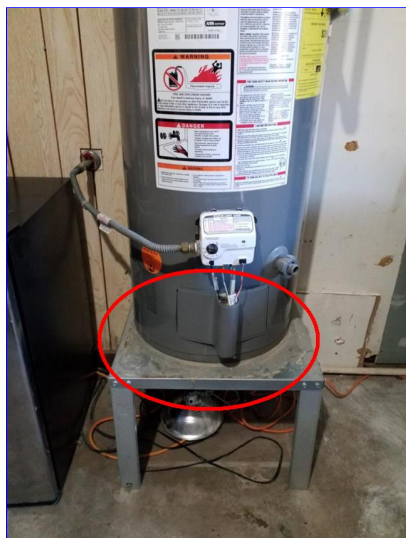
C. Item 3(Picture) Water heater

(2) The water heater is installed without the recommended emergency overflow drain pan. This is not considered to be today's. I recommend having a drain pan installed by a qualified person.

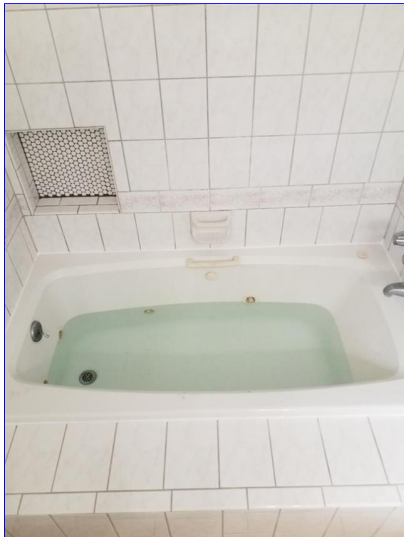
D. Item 1(Picture) Hydro massage jet tub, master bathroom

- (1) The jetted tub is missing access panel. I recommend adding access panel.
- (2) The jet tub did not function at the time of inspection. I recommend a qualified contractor be consulted for further evaluation and repair.

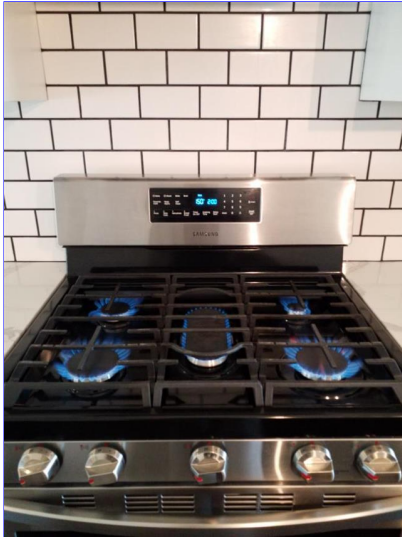
(1) Tested and working properly at the time of inspection.

D. Item 1(Picture) Burners work

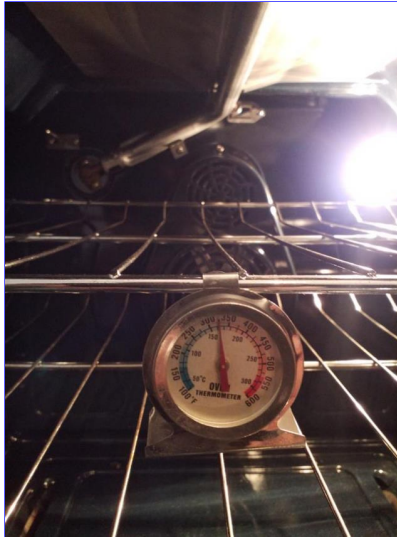
D. Item 2(Picture) Oven works
